HISTORIC STRUCTURE REPORT

Elk Lake Guard Station

Deschutes National Forest

Prepared by Jennifer Self in fulfillment of partial requirements for
Historic Structure Report graduate course, AAAP 610.

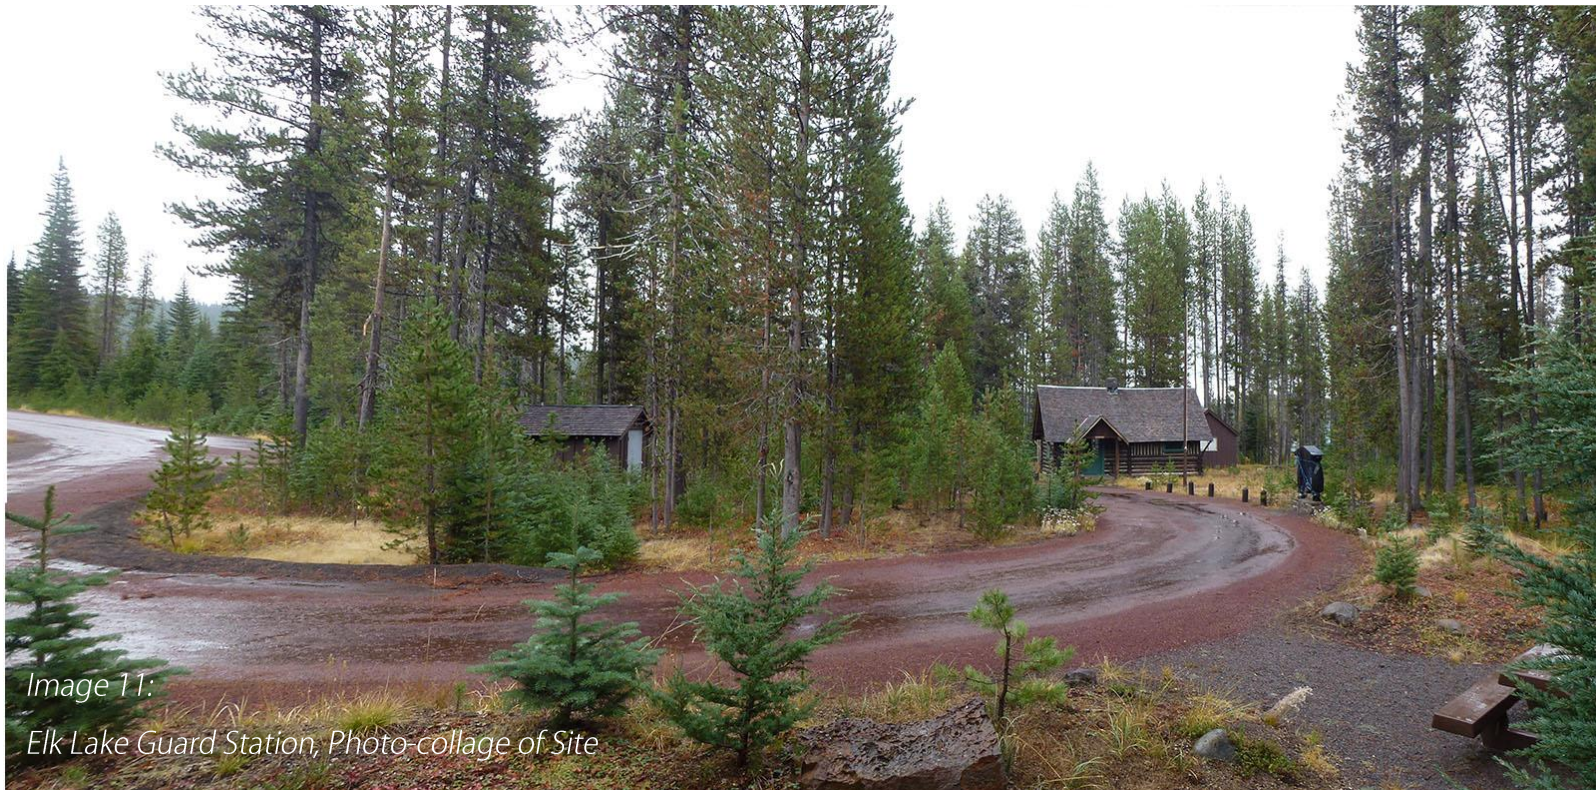
Image 11:
Elk Lake Guard Station, Photo-collage of Site

- Overall the site and immediate setting is in good condition and maintains a high level of integrity given its remote location and lack of surrounding development.

- Trim any vegetation that is touching or is in close proximity to the roof and exterior walls.
- Maintain proper clearance and fuels reduction around the building to mitigate losses from wildfire.
- Monitor tree and tree root growth to ensure it is not causing damage to the building's foundation.
- Remove trees which are too close to the building and potentially damaging the structure due to root system undermining the foundation or branches growing too close to the building.⁹
- Improve trail and overall connection from the guard station to the lake shoreline.
- Maintain and retain the appearance of a red cinder paved roadway to the guard station.

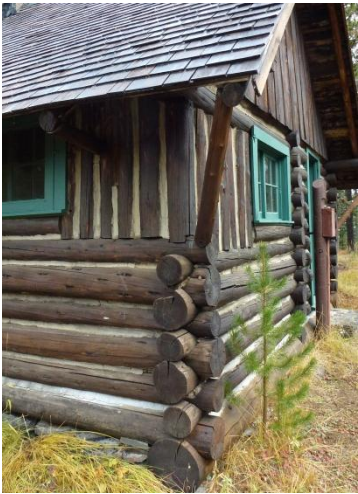
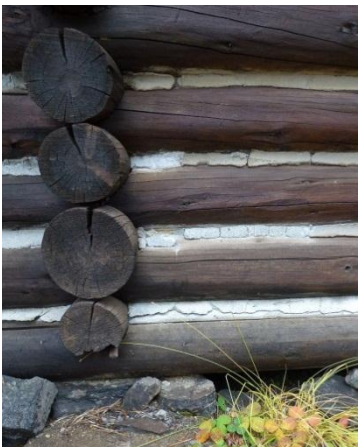
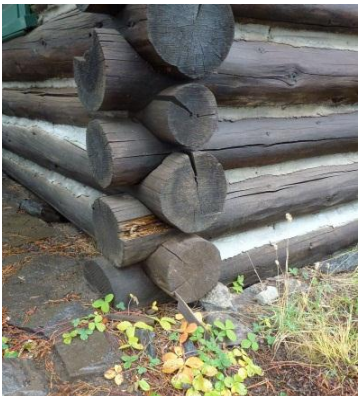
Image 13, 14, 15

The southwest corner of the building exhibits a unique log detailing feature surrounding the windows. (See top photo) Portions of the northwest and southwest elevations are constructed of horizontal peeled logs within the lower half, while the upper half is constructed of vertical half logs. Additional details of the exterior walls include symmetrically cut flush log ends, peeled log diagonal braces at each of the buildings corner to support the roof structure, and

- Overall, the exterior walls are in good to fair condition. While the majority of logs are structurally sound, there are numerous places where the chinking is deteriorated or has completely failed.
- Chinking located near the north corner of the building on the northwest elevation has inscribed markings: "RHB 1962 GAM" and "9-24-67".
- A significant amount of chinking has failed along the northwest elevation.
- The log second up from grade to the north of the southeast facing door is rotten.
- The log end second up from grade level at the east corner of the building is rotten.
- Although the building is constructed using inverted saddle notches, log ends appear to be structurally sound.
- There appears to be no significant exterior damage from pests or wildlife.
- Large checks in the log open upwards; this allows for moisture penetration.

- Properly document the inscribed markings in the chinking with scaled photographs for the US Forest Service building files.
- Repair and replace failed or deteriorated chinking where necessary. If needed, replace wire mesh and oakum insulation in-kind. Repairs and replacement of mortar should be done with lime mortar. Cement mortar is not recommended. Cement mortar on log structures can lead to detrimental moisture problems.
- Repair or replace sections of rotten logs. This can be done by splicing the rotten section and doing selective replacement rather than replacing the entire log.
- Consider using the product CheckMate for filling in checks which open upwards. This product has been used by the Yosemite Historic Preservation Crew in a similar climatic environment. Research this product and alternatives for the best suited for the context and building type.

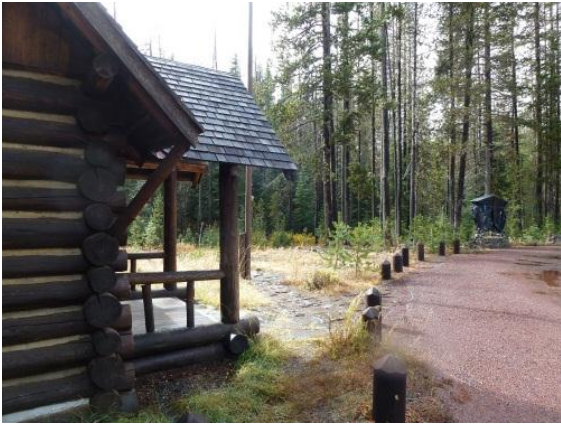
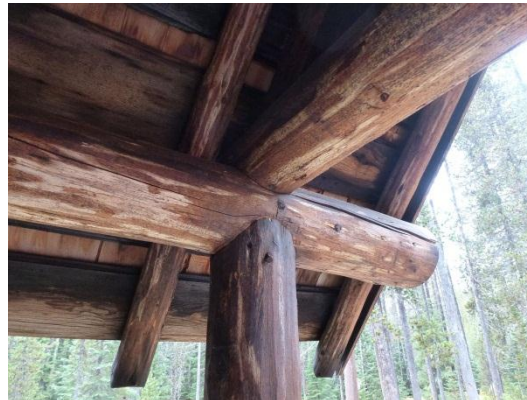
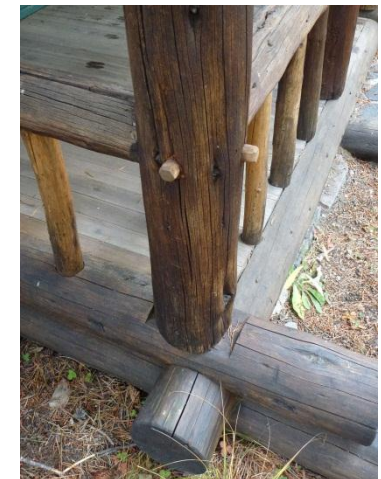
Image 16, 17, 18:

- Porches are structurally sound and maintain a high level of integrity due to recent preservation efforts.

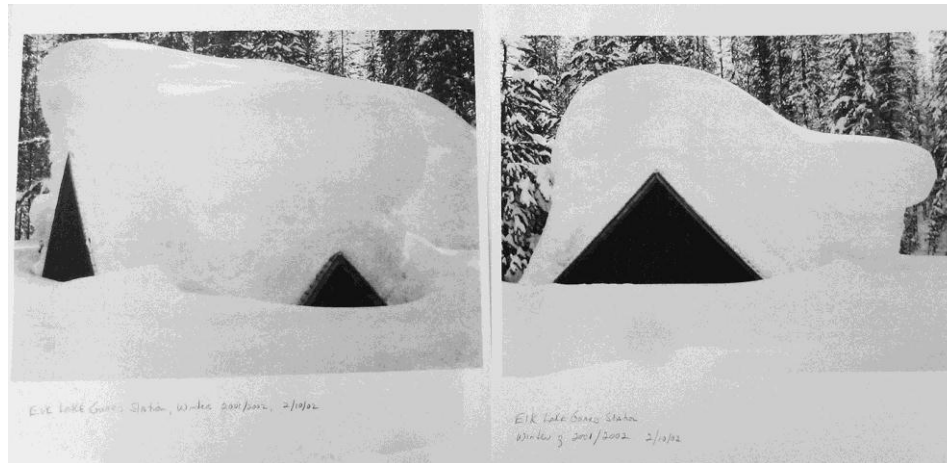
Image 19:
Guard Station in heavy
snow, February 2002

- Overall, the roof is in sound condition and maintains a high level of integrity due to recent preservation efforts.
- A sag is present at the west corner of the roofline.
- Rafters contain metal strapping near the juncture of the rafter and exterior log wall. It is unknown if these features are contemporary to the construction of the building.

- Consult with a structural engineer to determine if the structural integrity of the roof is being threatened by heavy snow loads at the southwest corner.

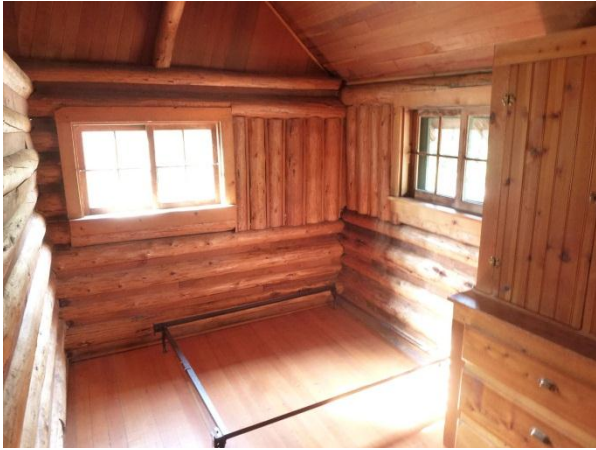
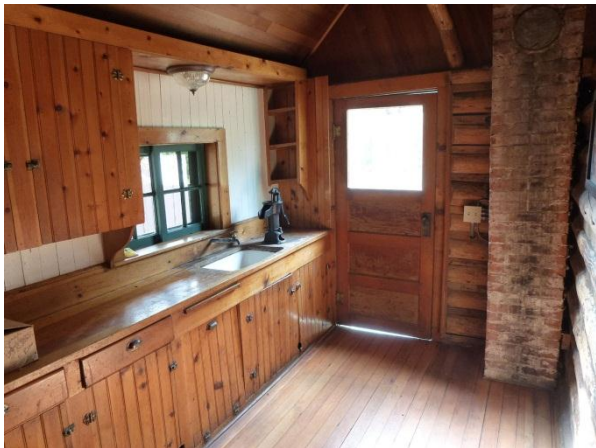
*Image 22, 23:
Interior details*

While the structural truss supports are exposed, the roofing members (purlins and backside of the shingles) have been finished with 4" tongue and groove clear grained Douglas fir. In the 1960s, a ceiling was installed above the partition walls. Later in the 1970s, the ceiling was modified to accommodate a sleeping loft. The ceiling was removed in recent decades during restoration efforts. The roof support is composed of two large 24' trusses. Each truss is anchored to the perimeter wall as well as the central partition wall just north of the buildings center. A 1/2" diameter steel cable runs across the top of the east-west partition wall. This cable is designed to keep the northwest and southeast walls from creeping outward while heavy snow is pressing on the roof.

- Overall, the interior is in good condition and maintains a high level of integrity due to recent preservation efforts.
- Pests have chewed through the corners of historic cabinet doors.
- Hand pump fixture is located on the right-hand side of the sink and is inoperable. It is unknown if this fixture is original to the building.
- Original layout and configuration of space is in-tact.

- Maintain original layout of the guard station.
- Install hardware cloth and copper wool at potential pest entry points to deter them.
- Place traffic mats in areas of the building that visitors frequent to preserve the original hardwood floor.

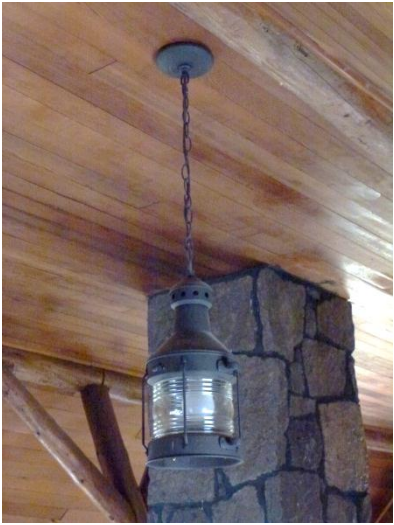
Image 27:
Modern light fixtures

The guard station has been upgraded at an unknown time to accommodate modern electrical wiring. Electrical outlets and conduits are fastened directly to the interior log walls. Four pendent lighting fixtures hang above the four quarters of the interior space. While these fixtures are compatible to the historic character of the building, they are not historic. An additional light fixture is located above the kitchen sink. Plumbing to the building is supplied by pump from the lake to the kitchen sink. The sink retains a hand pump, however this fixture is not operable.

- Ensure the guard station is listed on emergency management GIS maps and layers. Doing so will aid in relaying the importance of the historic resource during hazard events and inform personnel of its existence.
- Ensure PIT volunteers are trained to accommodate disabled visitors in the outdoor interpretive space.
- Ensure electrical outlets and fixtures are cleaned during the opening of the building for seasonal use.
