# **University Housing Thermal Testing Report**

**Energy Studies in Buildings Laboratory  
Center for Housing Innovation  
University of Oregon  
Eugene, OR 97403, U.S.A.**

**September 1995**

**U.S. Department of Energy Contract No. DE-FC51-94R020277**

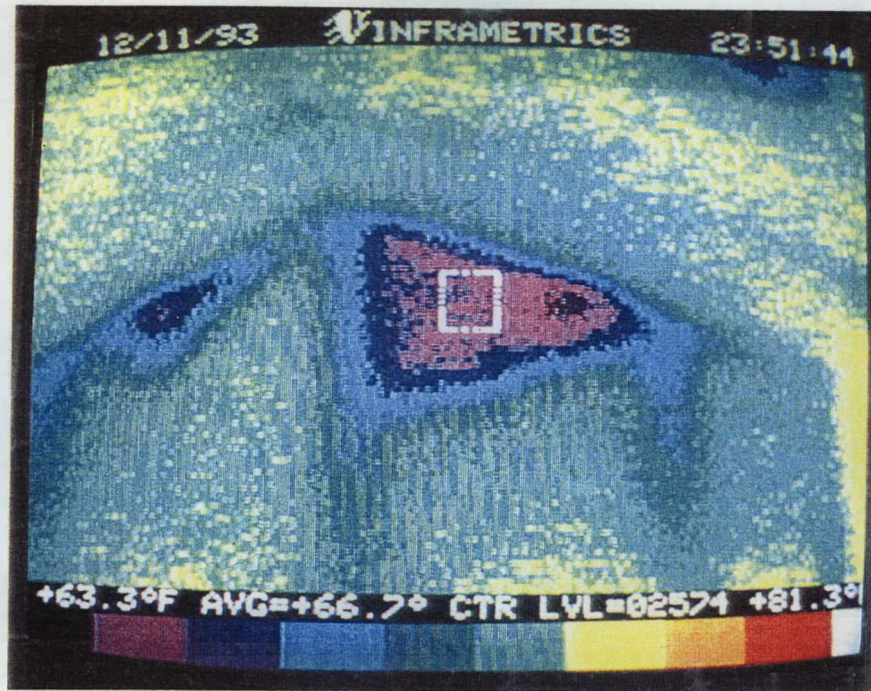
Both Units 1 and 2 had significant areas of missing or improperly installed insulation at the transition of vaulted insulation to flat roof insulation over the bathroom. This transition occurred within the overall roof envelope, so workers may have been more careless in installing this insulation. For the most part, thermal defects relating to missing or improperly installed insulation correspond to installation at the site whether in Units 1,2,3 or 4. These results suggest that a higher level of quality control is achievable in the factory when installing insulation. In addition, these results also suggest that roof panels with factory installed insulation would have resulted in fewer thermal defects in the overall envelope.

Figure 7.3-1, Missing or improperly installed insulation at the transition from a vaulted roof to a flat roof, Unit 1, 1 story SSIC Unit

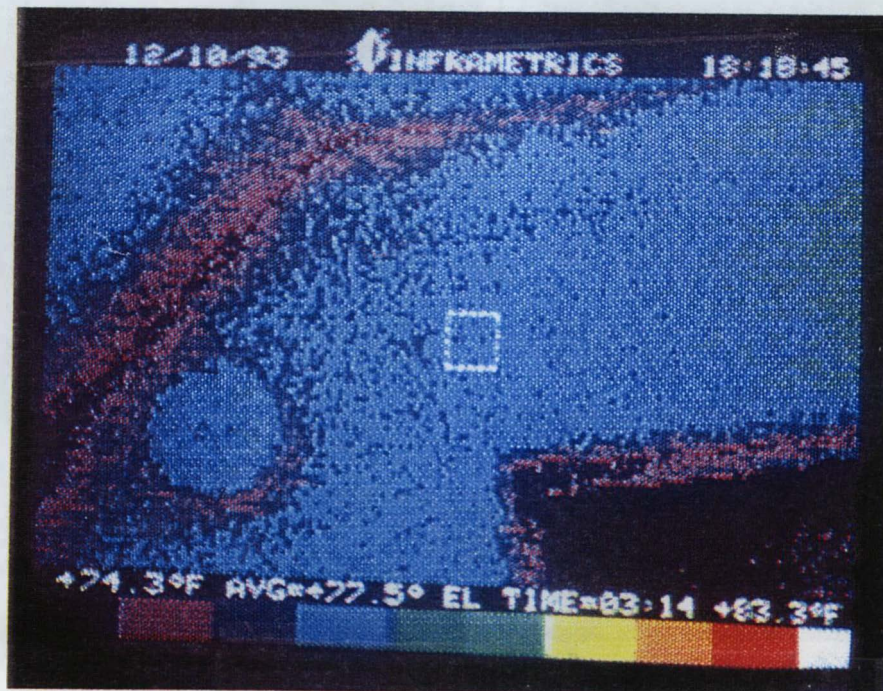
The results obtained by the thermographic imaging showed that Units 3 and 4 had the most significant problems with insulation in the walls and ceiling. Units 3 and 4 were constructed of open panel walls with insulation installed on site.

Figure 7.3-2, Heat loss at joint of wall to roof, around fresh air vent, and around window Unit 4, 1 1/2 Story Open Panel Unit

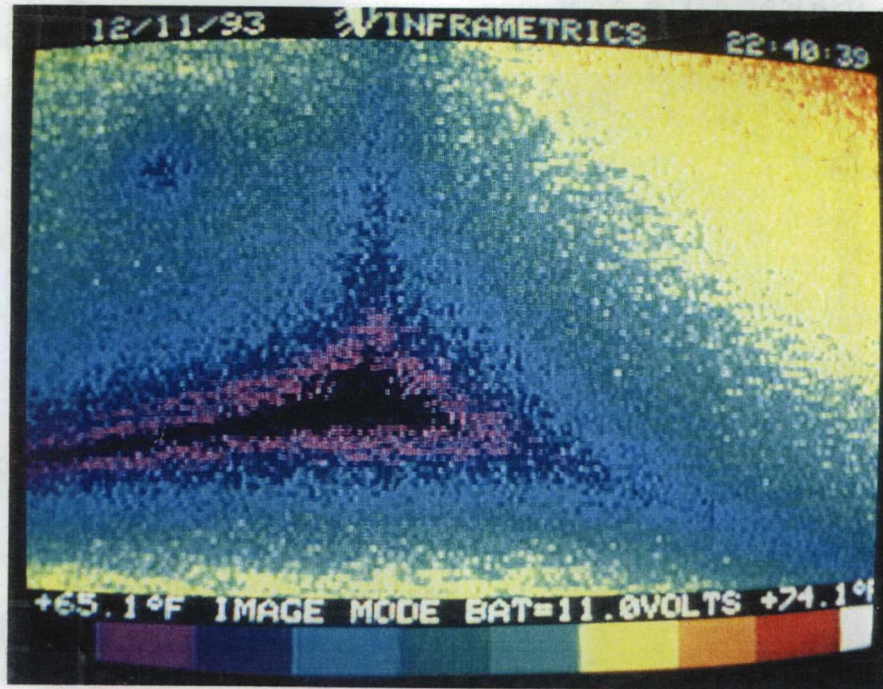
**Figure 7.3-3**  
**Heat loss at intersection of panels and wall slab at building corner typical of all Units, heat loss through electrical outlet also visible in upper left corner**

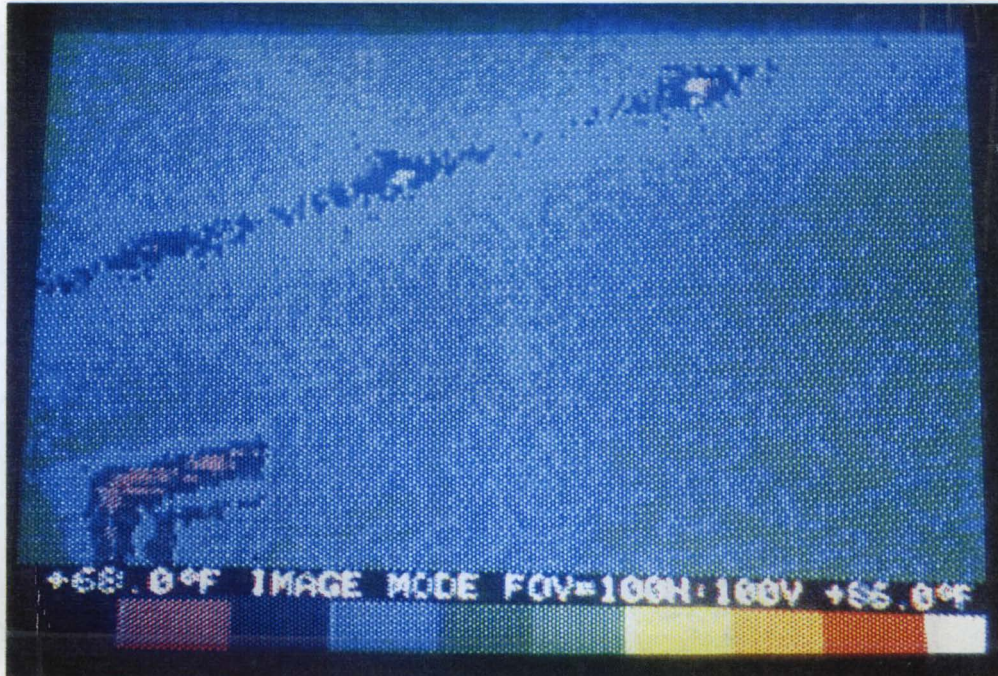
**Figure 7.3-4**  
**Heat loss at joint of wall and vaulted ceiling and at window.  
 Heat loss at wall framing and roof truss framing more pronounced.**
