A RESTORATION AND PRESERVATION PLAN
FOR THE J.M. MOYER HOUSE
BROWNSVILLE, OREGON

June 1987

A TERMINAL PROJECT

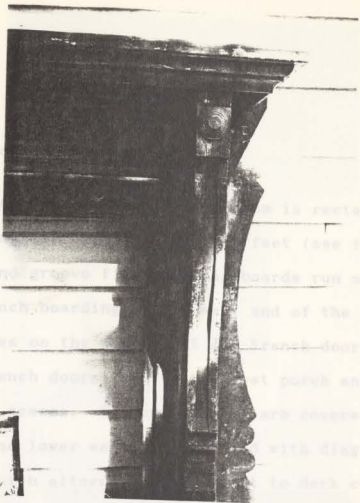
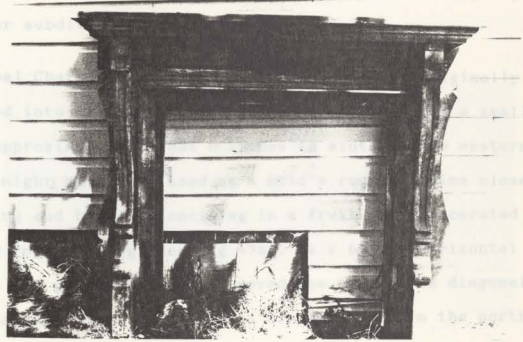
Figure 37: Original livingroom mantel piece dining
located in garage.

RECOMMENDATIONS: The original mantel piece is being stored in the garage (see fig 37). Marbleizing on the mantel matches the section of baseboard that is located under the window seat in the parlor. It is recommended that the mantel piece be brought inside the house for protection against further deterioration. It might be displayed as the Moyers' original mantel piece in one of the parlors or sitting room until future restoration occurs. Under no circumstances should the mantel be repainted. Cleaning with a mild soap and water is advised only after experimenting on small test areas. Further restoration of the piece should be undertaken only by a professional. Long range plans should include restoration of the mantel, removal of the bookcase in the north wall, reconstruction of the second entrance door and installation of the pocket doors between the living room and sitting room.

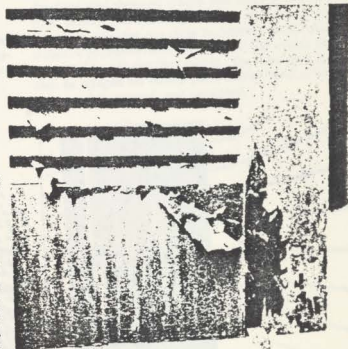
Fig. 6 This is an example of intercoat peeling. A latex top coat was applied directly over old oil paint and, as a result, the latex paint was unable to adhere. If latex is being used over oil, an oil-base primer should be applied first. Although much of the peeling latex paint can be scraped off, in this case, the best solution may be to chemically dip strip the entire shutter to remove all of the paint down to bare wood, rinse thoroughly, then repaint. Photo: Mary L. Oehrlein, AIA.

Where peeling was the result of using incompatible paints, the peeling top coat should be scraped and hand or mechanically sanded. Application of a high quality oil type exterior primer will provide a surface over which either an oil or a latex topcoat can be successfully used.

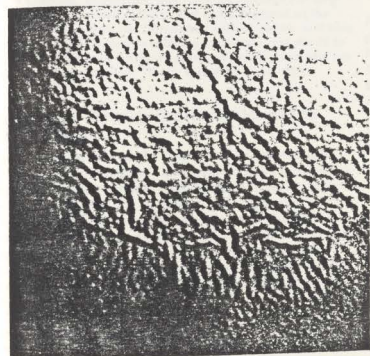
Fig. 7 Wrinkled layers can generally be removed by scraping and sanding as opposed to total paint removal. Following manufacturer's application instructions is the best way to avoid this surface condition. Photo: Courtesy, National Decorating Products Association.

The wrinkled layer can be removed by scraping followed by hand or mechanical sanding to provide as even a surface as possible, then repainted following manufacturer's application instructions.

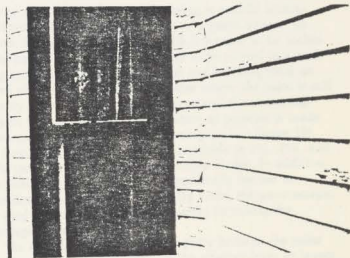
Fig. 8 Peeling to bare wood—one of the most common types of paint failure—is usually caused by an interior or exterior moisture problem. Photo: Anne E. Grimmer.

There is no sense in repainting before dealing with the moisture problems because new paint will simply fail. Therefore, the first step in treating peeling is to locate and remove the source or sources of the moisture, not only because moisture will jeopardize the protective coating of paint but because, if left unattended, it can ultimately cause permanent damage to the wood. Excess interior moisture should be removed from the building through installation of exhaust fans and vents. Exterior moisture should be eliminated by correcting the following conditions prior to repainting: faulty flashing; leaking gutters; defective roof shingles; cracks and holes in siding and trim; deteriorated caulking in joints and seams; and shrubbery growing too close to painted wood. After the moisture problems have been solved, the wood must be permitted to dry out thoroughly. The damaged paint can then be scraped off with a putty knife, hand or mechanically sanded, primed, and repainted.

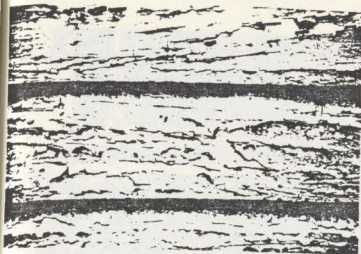
Fig. 9 Cracking, alligatoring, and flaking are evidence of long-term neglect of painted surfaces. The remaining paint on the clapboard shown here can be removed with an electric heat plate and wide-bladed scraper. In addition, unsound wood should be replaced and moisture problems corrected before primer and top coats of paint are applied. Photo: David W. Look, AIA.

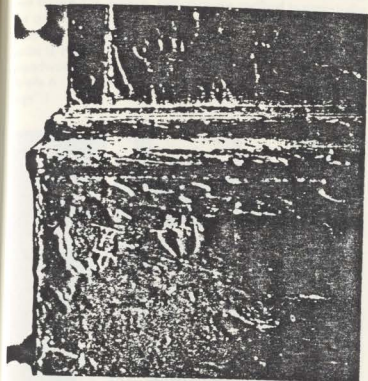
Fig. 10 An excellent example of inadequate scraping before repainting, the problems here are far more than cosmetic. This improperly prepared surface will permit moisture to get behind the paint film which, in turn, will result in chipping and peeling. Photo: Baird M. Smith, AIA.

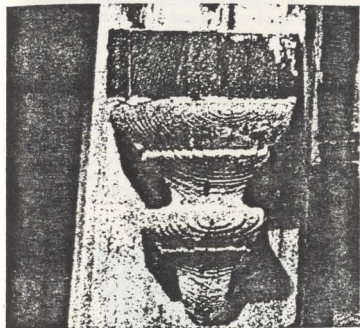
Fig. 12 Sandblasting has permanently damaged this ornamental bracket. Even paint will not be able to hide the deep erosion of the wood. Photo: David W. Look. AIA.
