RESTORATION AND PRESERVATION PLAN WITH DRAWINGS FOR
THE WOODEN BALUSTRADE AND URNS THAT EMBELLISHED
THE ROOF STRUCTURE OF VILLARD HALL

December 1988

A THESIS PROJECT

Presented to the Interdisciplinary Studies Program:
Historic Preservation,
the School of Architecture and Allied Arts,
and the Graduate School of the University of Oregon
in partial fulfillment of the requirements
for the degree of
Master of Science

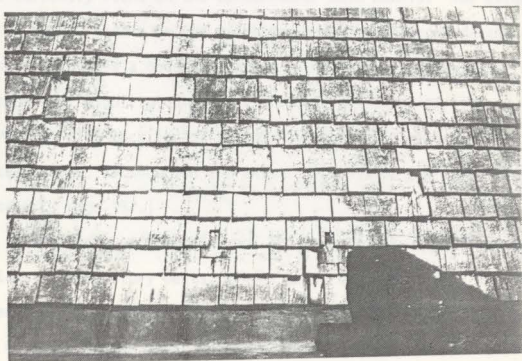
FIGURE 6. Evidence of the Original Point of Attachment Between Main Roof and the Wooden Balustrade: 1988 View

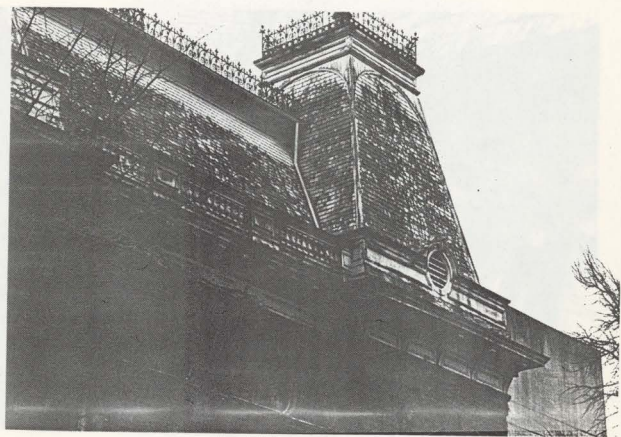
As illustrated by Figures 7 and 8, the existing-condition photographs and drawings for this balustrade show the historically inaccurate moulding profiles and extensive use of 1" plywood for the structure of the pedestals and rail sections of the balustrade. The moulding profiles observed during the field investigation were identical in profile to the mouldings dated circa 1949 which were presented during the Spring Term 1988 East Porch Restoration Workshop (see Appendix A, pages 89-104; and Appendix C, page 188). The original balustrade pedestals had deep-panel mouldings similar to those currently found on the corner-tower base panels. The evidence left by paint shadows on the existing corner-tower engaged-base pedestals provides a good indication of the original balustrade's location and height in comparison with the existing one (see Figure 9). (The location of the cornice gutter, directly under the balustrade, is shown on the existing-condition roof plan in Appendix C, page 181.)

FIGURE 7. North-Elevation Balustrade--
Existing Condition: 1988 View 1

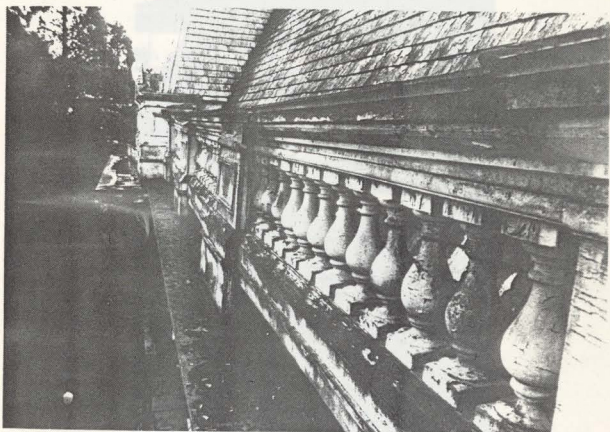
FIGURE 8. North-Elevation Balustrade--
Existing Condition: 1988 View 2

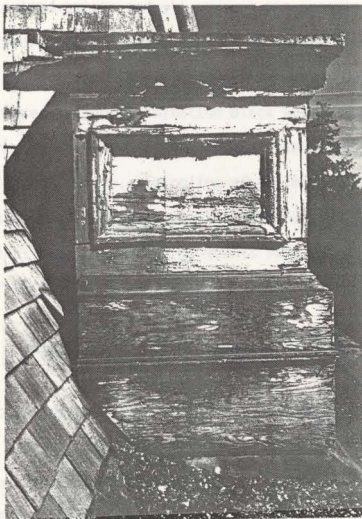
FIGURE 9. West Elevation of Southeast
Corner Tower Base Pedestal:
1988 View
(Note paint-shadow evidence.)

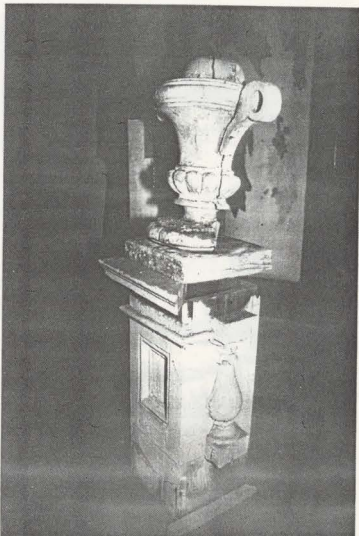
FIGURE 16. Remains of the Morris M. Marks House
Front-Porch Roof-Line Urn/Balustrade
Stored in the Attic: 1988 View
(Note the broken base of the urn.)

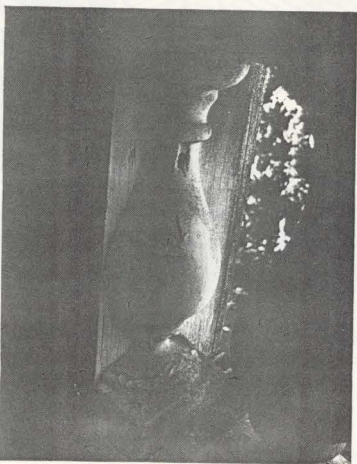
It was also during the Robinson Theatre construction that the north balustrade was completely rebuilt using plywood and was unfaithfully restored with moulding profiles similiar to those found during the existing-condition inspection of the East Porch (see Appendix B, pages 159-72 and Appendix C, pages 184 and 186-87). The most noteworthy differences between the original balustrade and the existing balustrade on the north elevation is the shallow profile of the pedestal-panel moulding and the reduction from 11 turned balusters to 10 in the center section of the tripartite balustrade. The investigation further determined that the only original material found on the existing north balustrade is that of the individual bulbous-shaped turned cedar balusters (see Figures 28 and 29). Another important discovery which may be noted from the drawings is the evidence of the original point of attachment for each pedestal by a wrought-iron knee brace (see Appendix B, pages 119-20; and Appendix C, page 185). The location of the original balustrade along the base of the corner pavilion was easily determined by the existence of a distinct paint-shadow line on the wooden base of each corner pavilion (see Appendix B, pages 129-35; and refer to Figure 9).

FIGURE 28. Turned Baluster of the North-Elevation Balustrade: 1988 View
(Note nail holes show evidence of having been reused.)

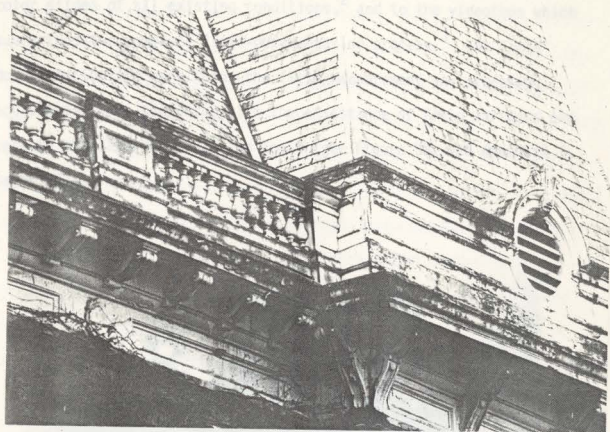
FIGURE 29. Existing Condition of North-Elevation Balustrade: 1988 View

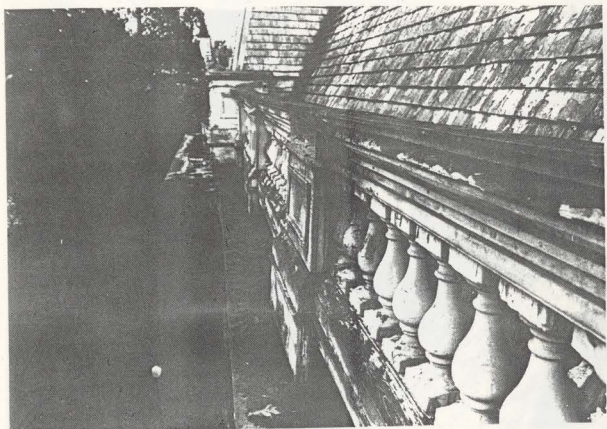
PHOTOGRAPH 2. North-Elevation Balustrade Above
the Cornice: Existing Condition

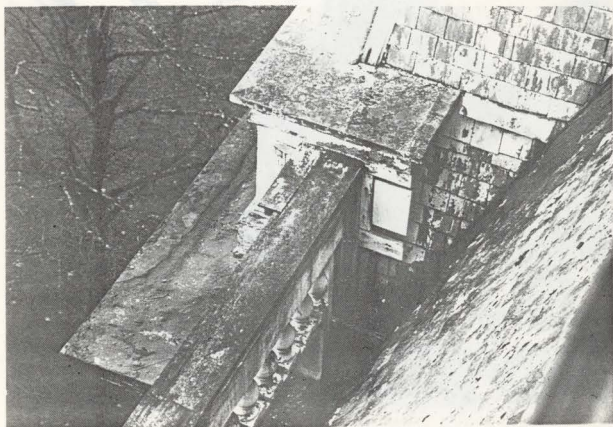
PHOTOGRAPH 3. North-Elevation Balustrade as Viewed
From the Main Roof: Existing Condition

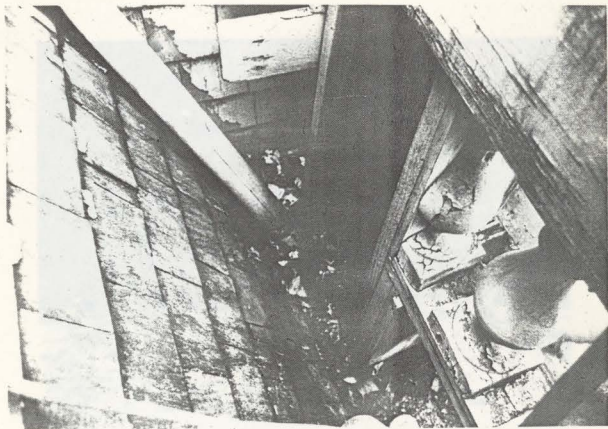
PHOTOGRAPH 4. Detail of Area Behind the Engaged Pedestal of the Existing North-Elevation Balustrade (Note trapped sediments and location of the leader drain from the main roof.)

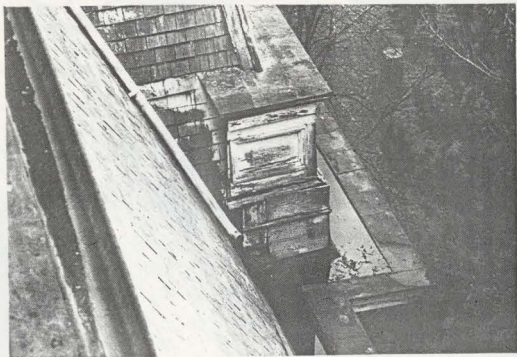
PHOTOGRAPH 7. Northeast Corner-Tower Engaged
Pedestal: Existing Condition
(Note vertical paint-shadow line.)

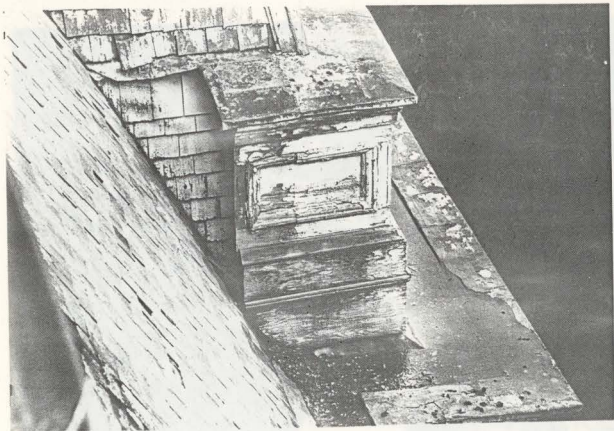
PHOTOGRAPH 8. West Elevation of Southeast Corner-Tower Engaged-Base Pedestal: Existing Condition (Note that the top of the pedestal and tin roofing have been cut away from roof valley.)

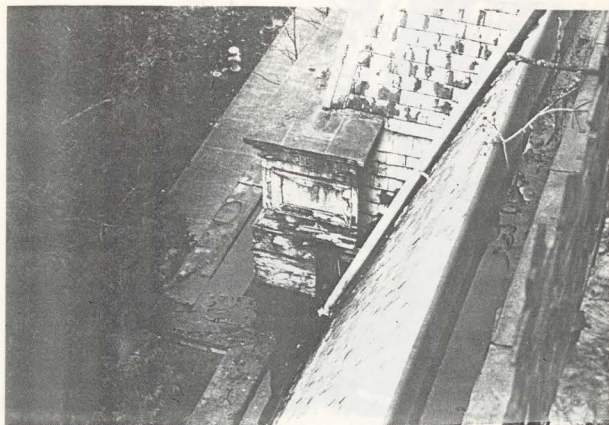
PHOTOGRAPH 9. South Elevation of Southeast Corner-Tower
Engaged-Base Pedestal: Existing Condition

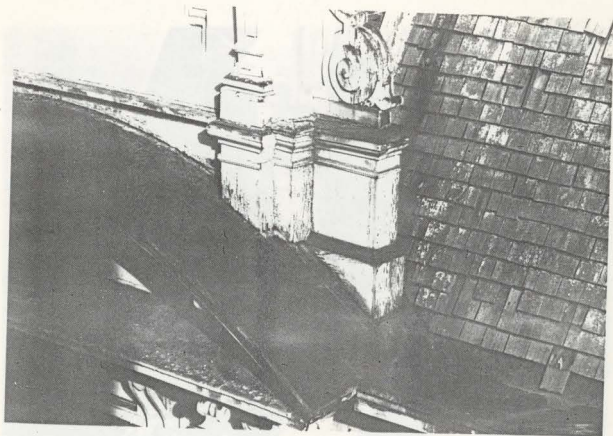
PHOTOGRAPH 10. Existing Condition of the West-Elevation
Blind-Dormer-Engaged Pedestals
(Note extensive remodeling with
plywood as the primary material.)

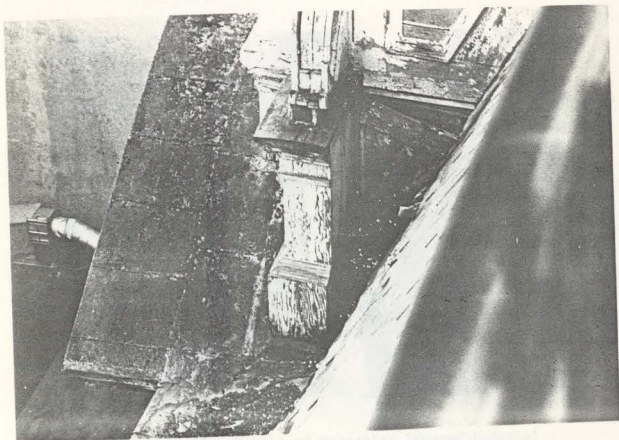
PHOTOGRAPH 11. Detail of Sediment Build-Up Behind the Engaged Pedestal of the Centrally Located Blind Dormer: Existing Condition

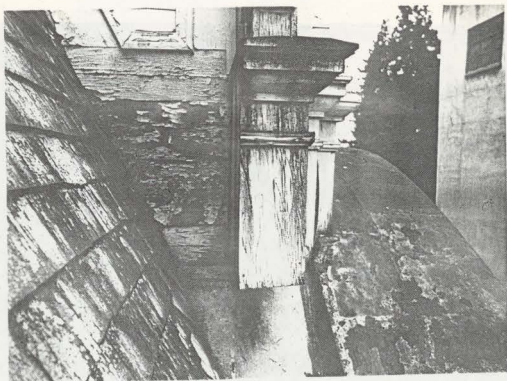
PHOTOGRAPH 12. Detail of Remodeled Engaged Pedestal
of the West-Elevation Centrally-
Located Blind Dormer

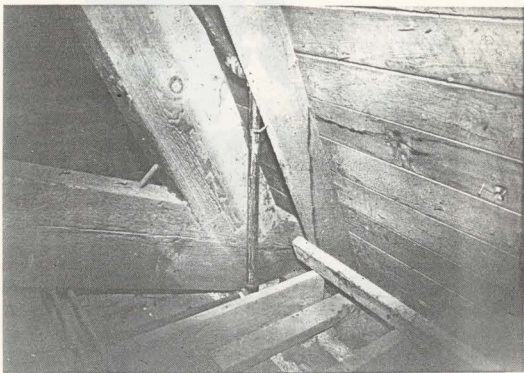
PHOTOGRAPH 13. Detail of Main Roof Truss:
Existing Condition

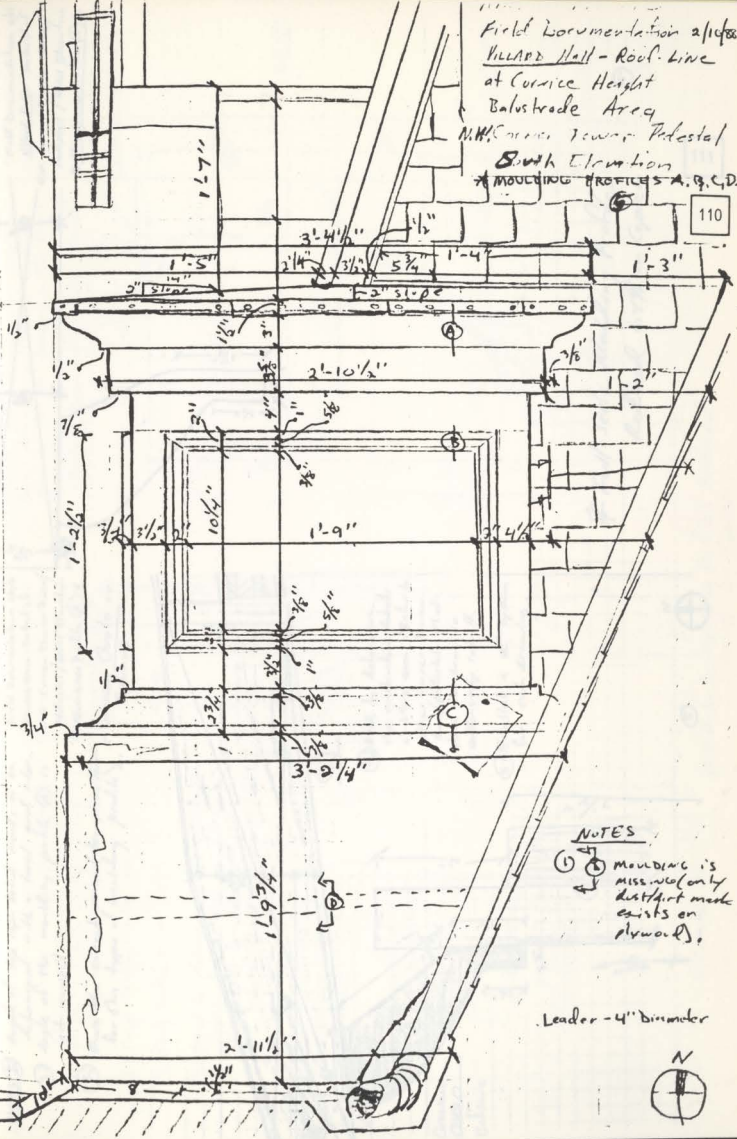
NOTES
 (D) moulding is missing only dashed mark exists on plywood.

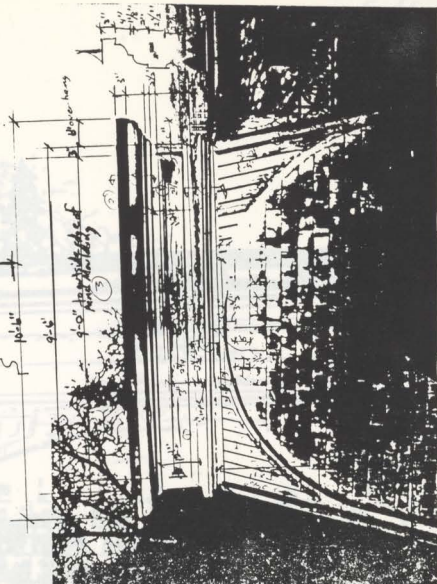
- ① Moulding found at top of Carris Tower (Wood Ave) is identical to profile B of the base elevation.
- ② Toned plate but on corner tower roof is badly deteriorated.
- ③ East Tower Elevation has been removed south from the SW corner Tower (Carris Hill) in the winter of 1986. (See Hill Photo)
