HISTORIC STRUCTURES REPORT:

THE EDUCATION BUILDING AND COMMERCE HALL,
(THE WEST AND EAST WINGS OF THE GILBERT COMPLEX)
ON THE UNIVERSITY OF OREGON CAMPUS, EUGENE

A TERMINAL PROJECT
BY DAVID ADAM SINGER

UNIVERSITY OF OREGON
HISTORIC PRESERVATION DEPARTMENT
MARCH 2000

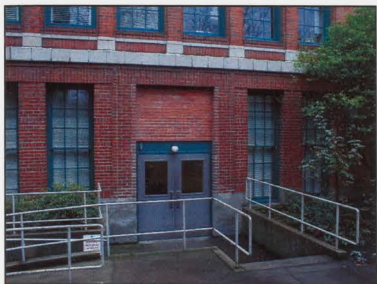
FIGURE 14: HANDICAP RAMP AT EAST ENTRY, 1975
NOTE THAT THE TRANSOM WAS BRICKED-IN

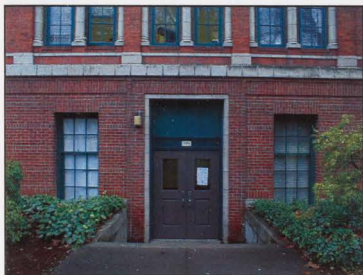
FIGURE 16: SOUTH ENTRY WITH ALTERED TRANSOM

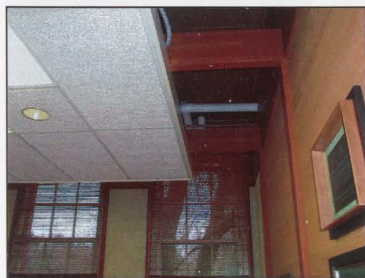
FIGURE 19: SUSPENDED CEILING, RM 201

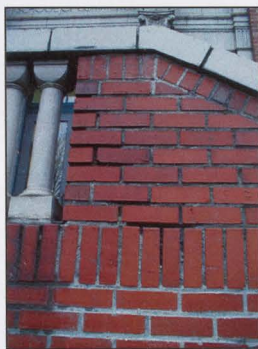
FIGURE 23: MORTAR DISINTEGRATION AT STAIR

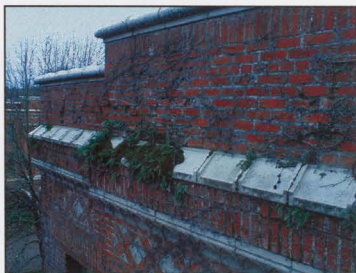
FIGURE 27: ACCUMULATION OF MOSS AND VEGETATION ON THE ENTABLATURE ABOVE THE THIRD FLOOR

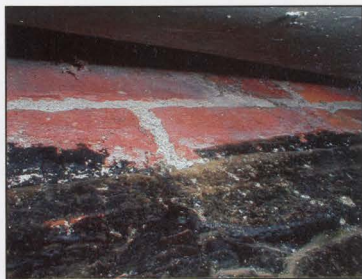
FIGURE 28: A MOIST ENVIRONMENT IS NOT APPARENT BEHIND THE PROTECTION OF THE COPPER FLASHING ON THE PARAPET WALL

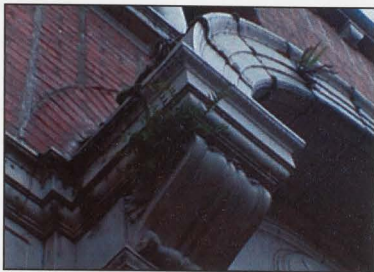
FIGURE 29: VEGETATION TAKING ROOT WHERE THE MORTAR HAS DISINTEGRATED DUE TO WATER INFILTRATION

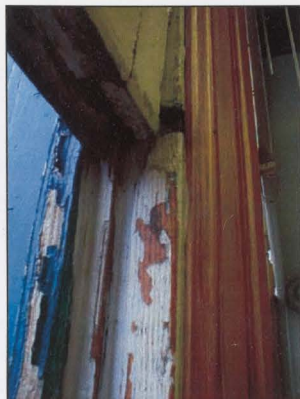
FIGURE 37: PAINT DETERIORATION AND DESICCATION OF WINDOW JAMB AND SASH.

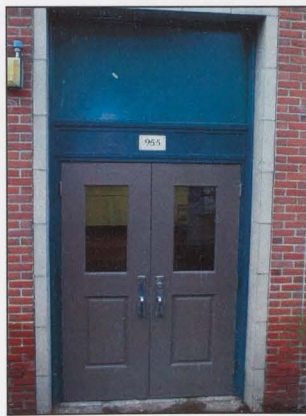
FIGURE 39: PAIRED SOLID WOOD DOORS AT SOUTH ENTRY WITH TRANSOM REMOVED.

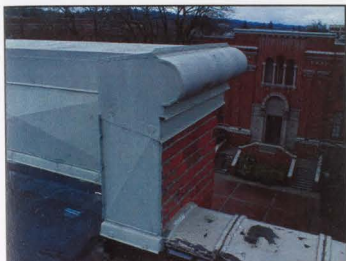
FIGURE 56: BACK OF CAVITY WALL WITH COPPER COPING INSTALLED

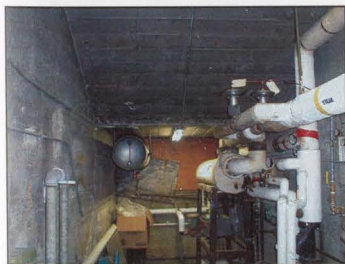
FIGURE 59: FOUNDATION STEM WALL UNDER STAIR VAULT.
NOTE THE COLD JOINTS AND THE BOARD FORMED MARKS

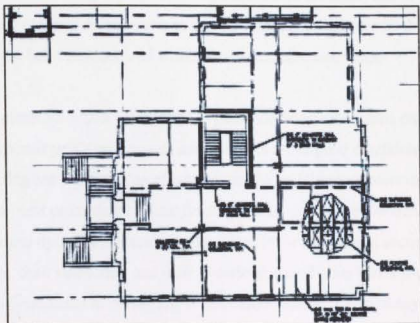
FIGURE 82: PROPOSED SEISMIC UPGRADING SCHEME.
DEGENKOLB ENGINEERS, PORTLAND

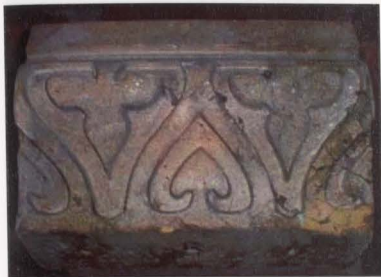
**FIGURE 111: BELT COURSE PIECE**

Type: Belt course piece
 Number: 2 each
 Glazing: Glazed buff clay body
 Size: 18"x10 1/2"x7"
 Condition: Fair (chipped)
 Original Location: Extra piece

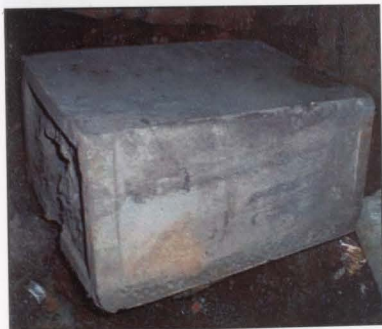
**FIGURE 112: BELT COURSE PIECE**

Type: Belt course piece
 Number: 2 each
 Glazing: Glazed buff clay body
 Size: 15"x12"x7"
 Condition: Fair (chipped)
 Original Location: Commerce

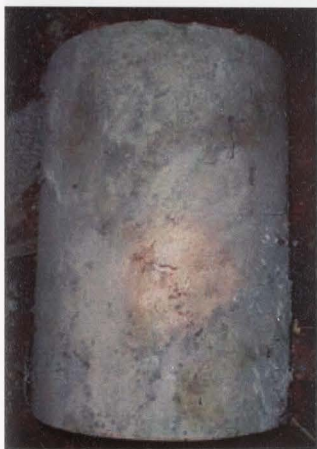
**FIGURE 114: PILASTER SECTION**

Type: Pilaster section
 Number: 2 each
 Glazing: Glazed buff clay body
 Size: 15"x11"x6" radius
 Condition: Fair (chipped)
 Original Location: Education
