# *Preserving the Institution*

A Preservation Strategy for the impending closure  
of the Sonoma Developmental Center

**BRIAN MATUK**

University of Oregon June 2016

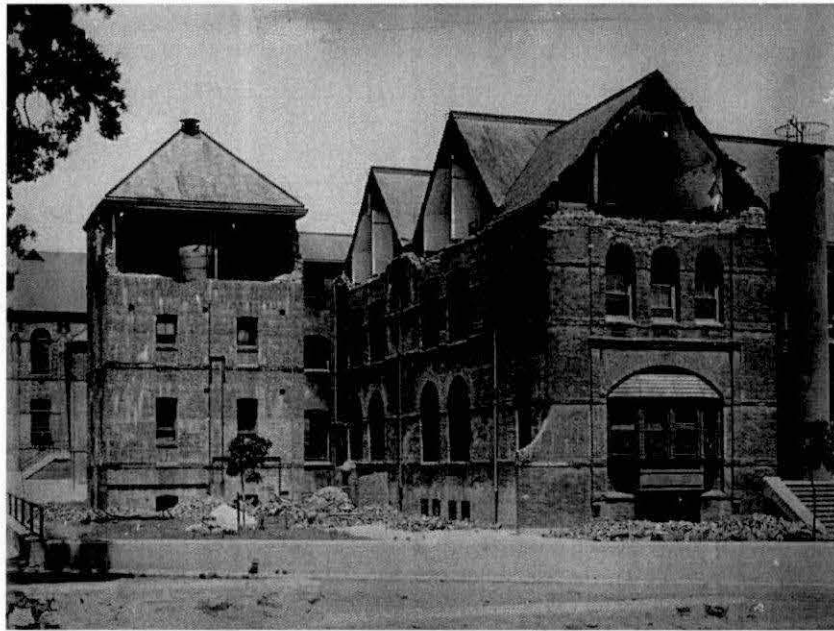
**Photograph 2.2.** 1906 photograph of earthquake damage.

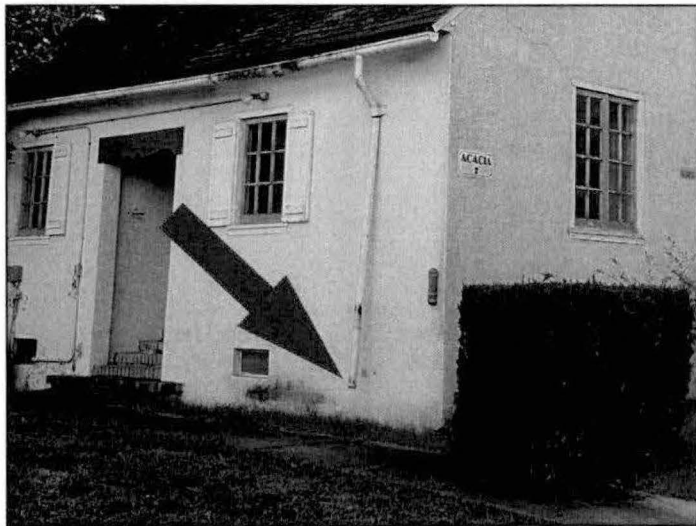
Photograph A.8. Broken downspout.

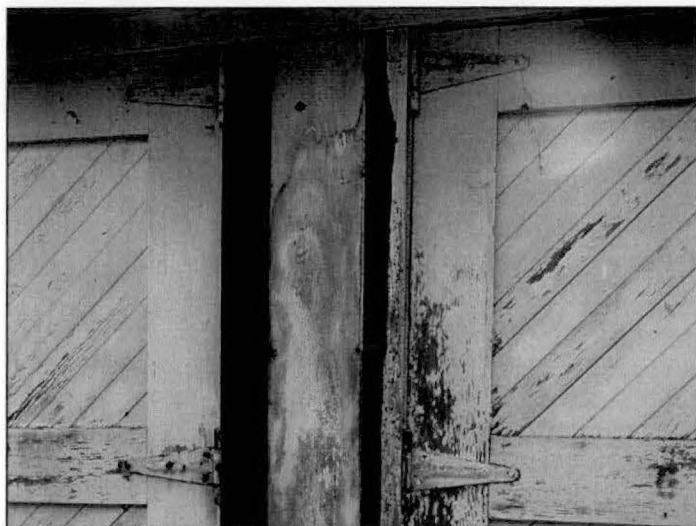
**Photograph A.17.** Gaps in exterior envelope, caused by broken wood siding between the garage doors.

### *Several gaps in exterior envelope - Urgency Score 3*

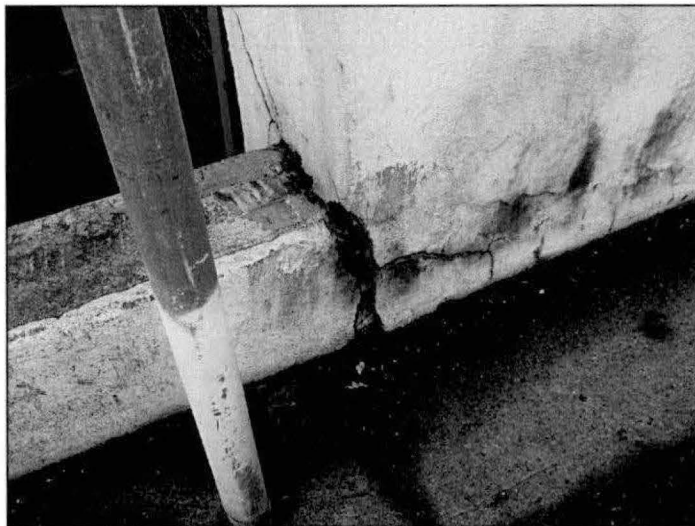
Photograph A.21. Severe cracking of concrete sill wall.

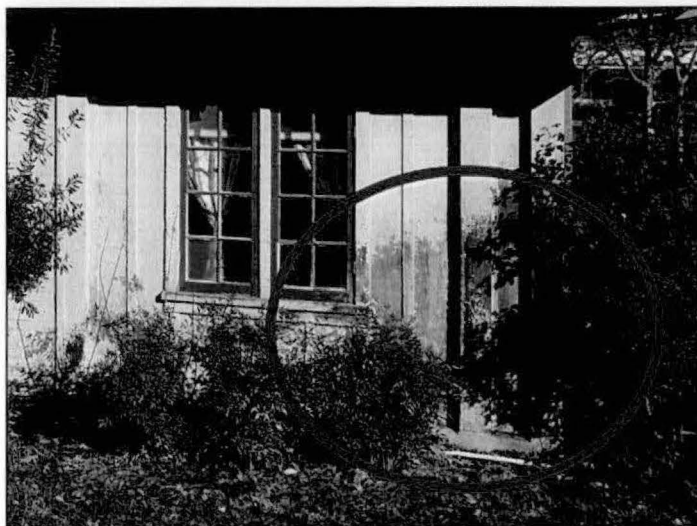
**Photograph A.22.** Moderate rising damp on wood siding.

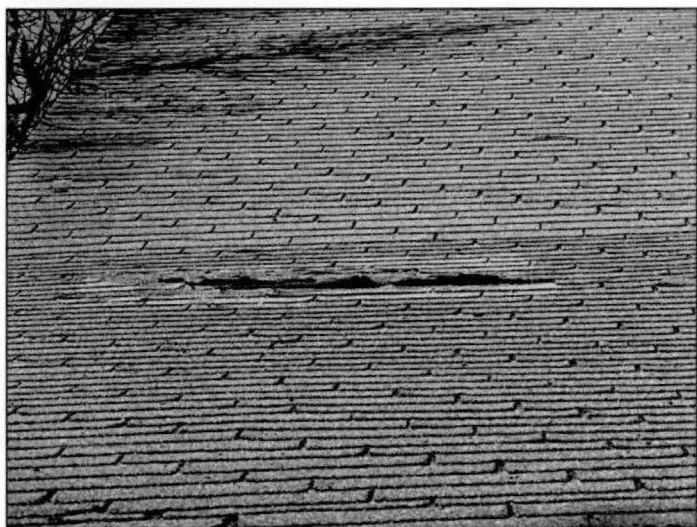
**Photograph A.23.** Severe deterioration of composition shingle roofing.

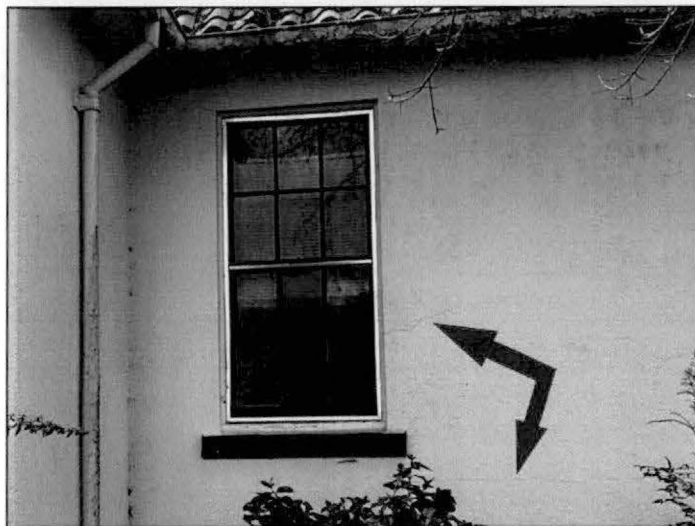
Photograph A.42. Minor hairline cracking of stucco.

### *Minor hairline cracking of stucco - Urgency Score 2*

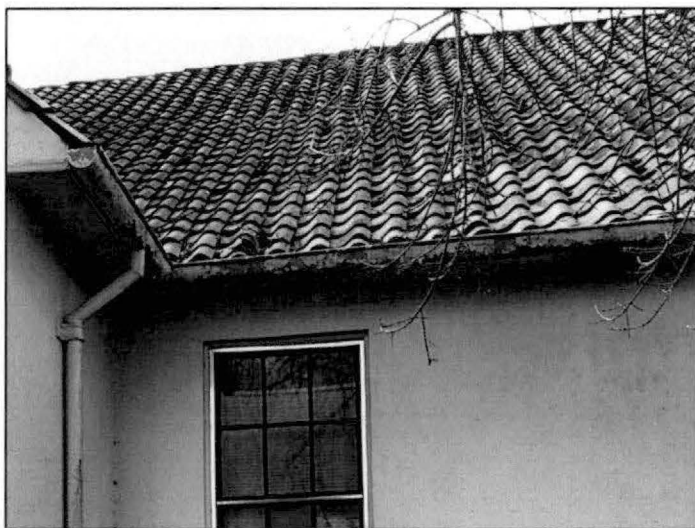
Photograph A.43. Corroding gutters.

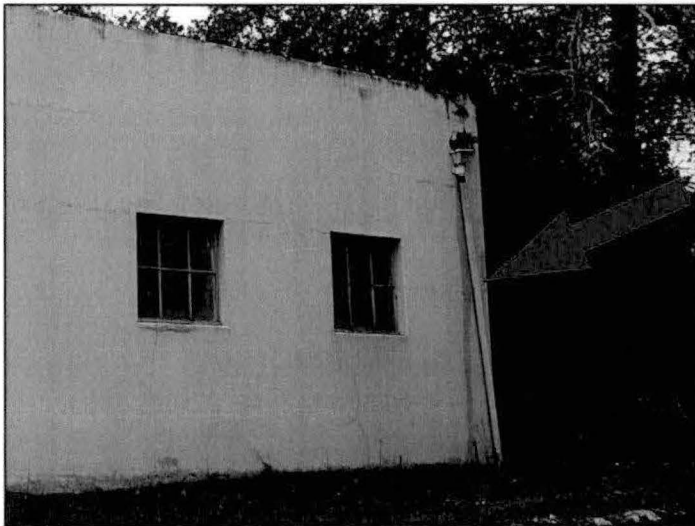
Photograph A.47. Broken downspout.

A broken downspout should be replaced with an operable one. This is to arrest any moisture infiltration to those areas directly attributed to a defective gutter system, if applicable.

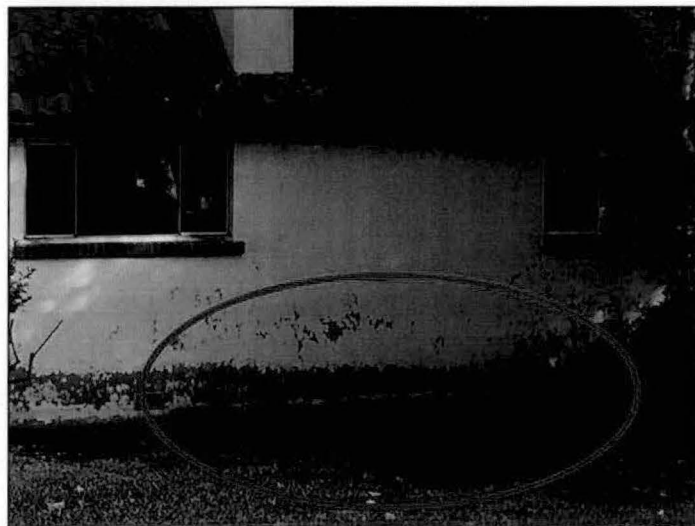
Photograph A.51. Severe rising damp on concrete.

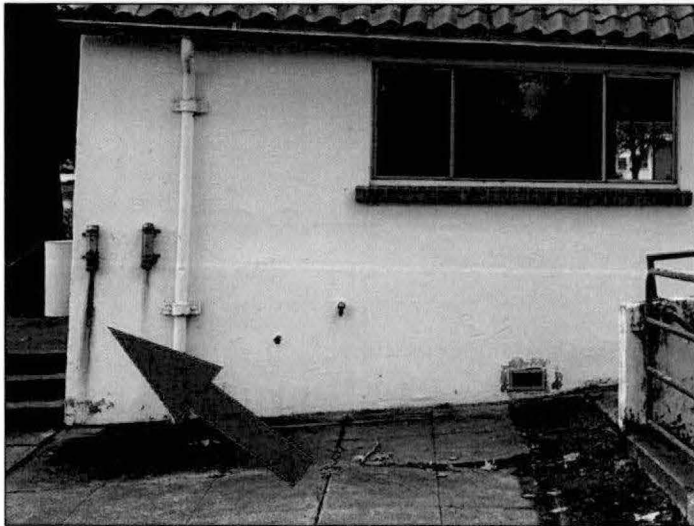
**Photograph A.52.** Rust staining on concrete from corroding exterior metal components.

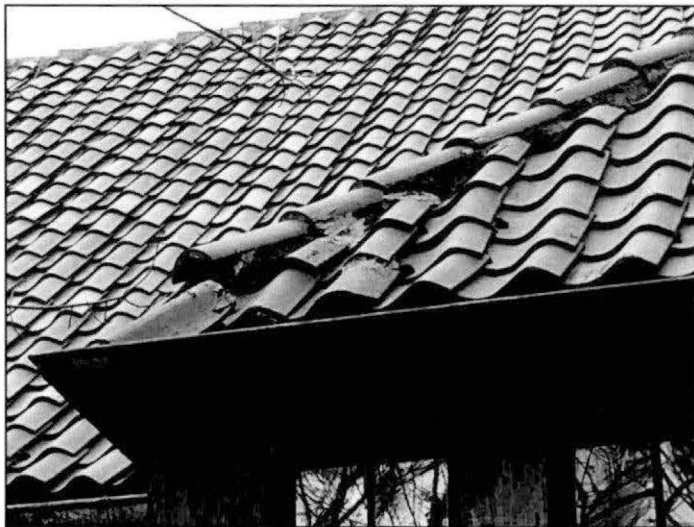
**Photograph A.53.** Minor biological growth on roof tiles.

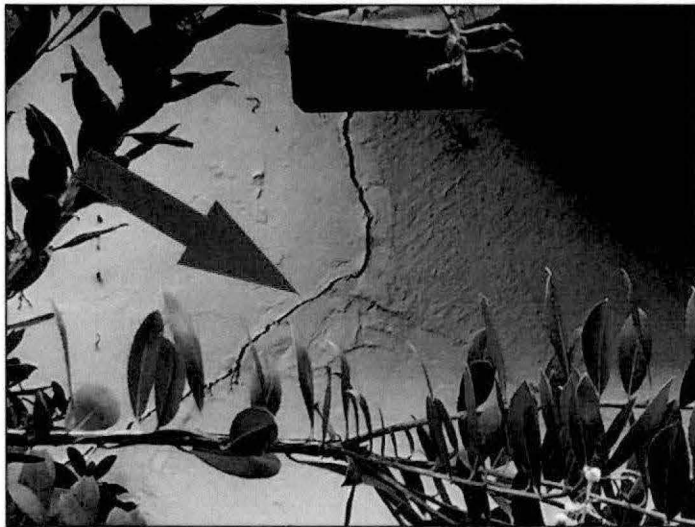
Photograph A.59. Moderate cracking of concrete.

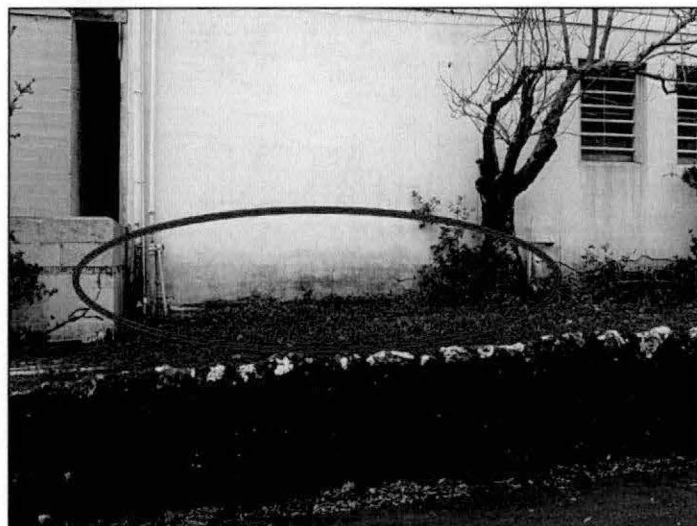
Photograph A.63. Moderate rising damp on concrete.

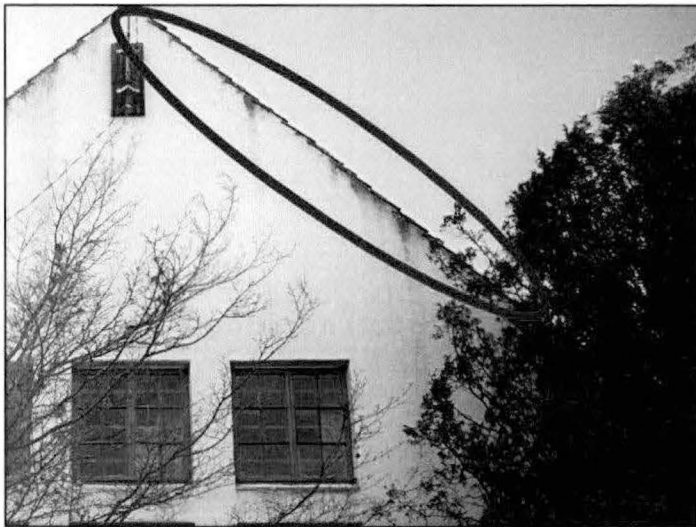
**Photograph A.69.** Minor moisture infiltration of concrete.

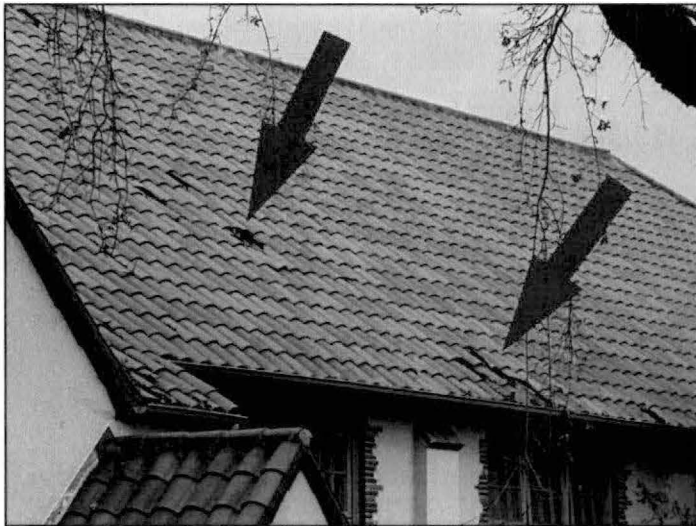
**Photograph A.74.** Minor roofing damage: broken tiles.

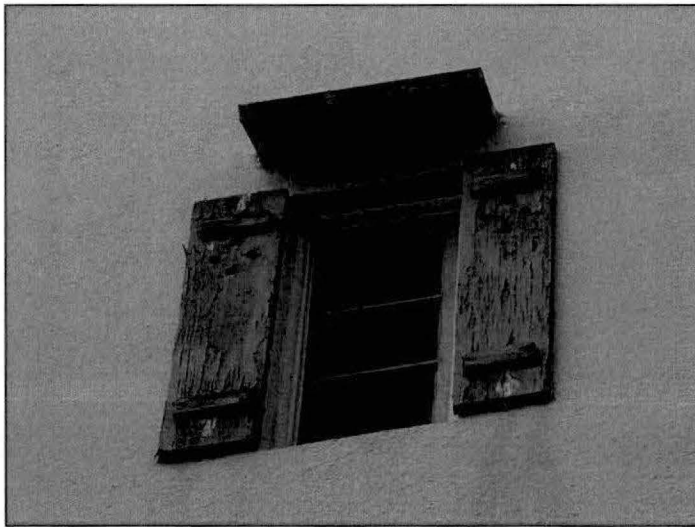
**Photograph A.83.** Minor paint peeling on decorative window shutters.

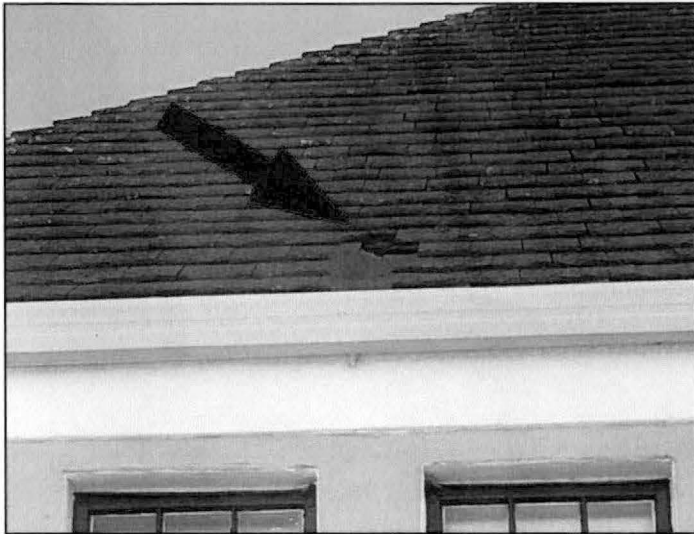
Photograph A.97. Several slate roof tiles missing.

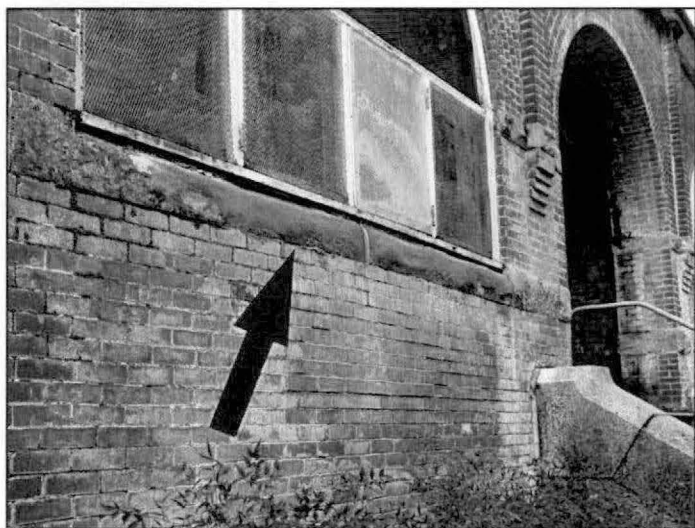
Photograph A.109. Severe weathering of uncut stonework.

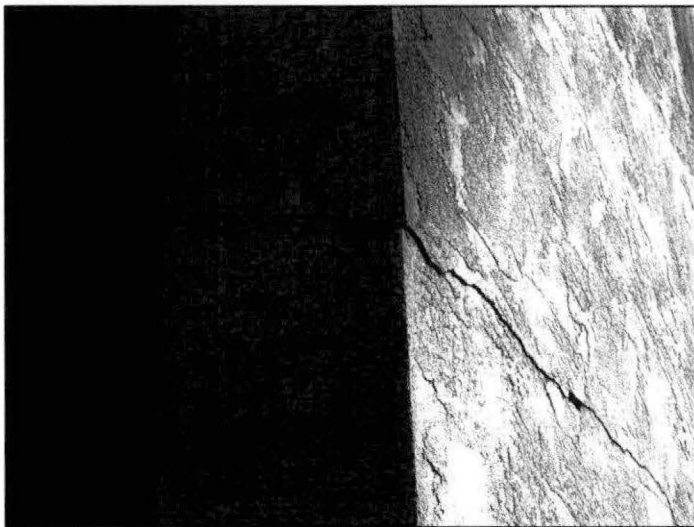
**Photograph A.111.** Severe cracking of stucco.

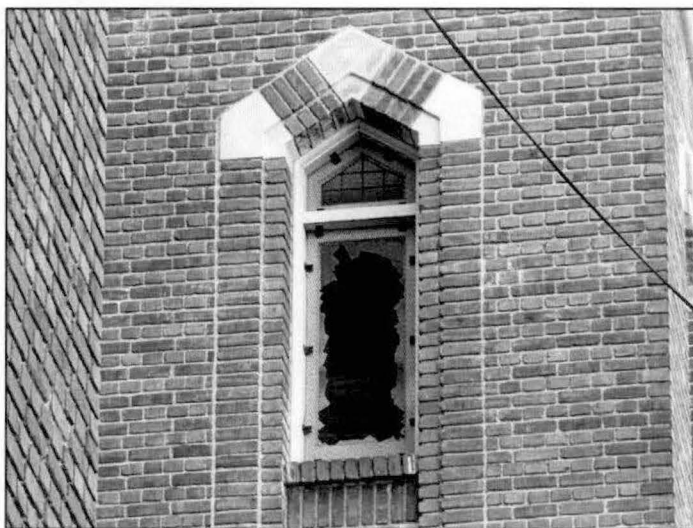
**Photograph A.117.** Several windows have broken glazing.

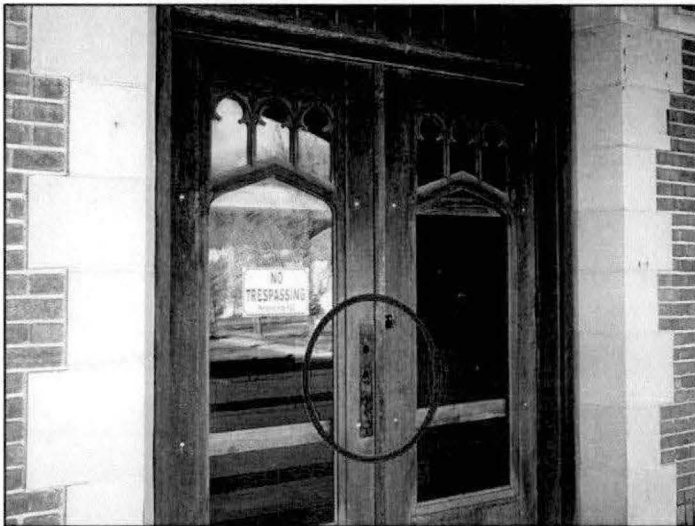
**Photograph A.119.** Door hardware missing from the main entry doors.

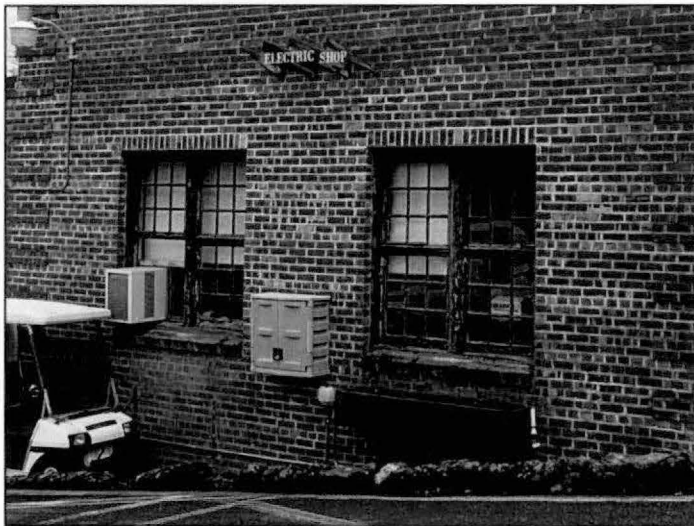
**Photograph A.129.** Severe paint peeling on wood windows

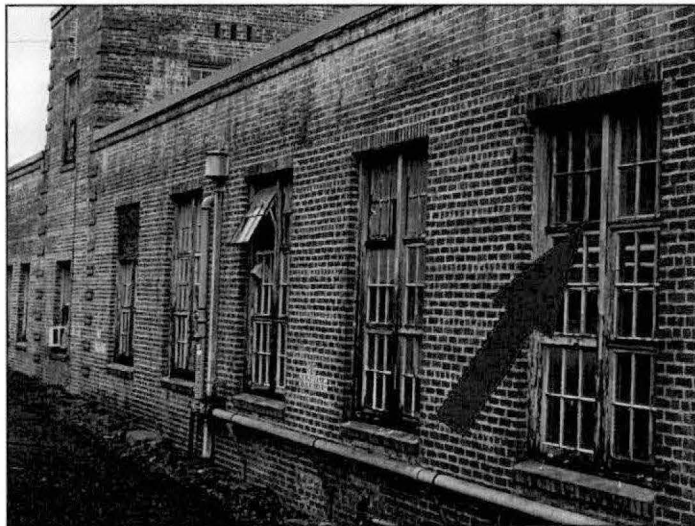
**Photograph A.131.** Broken window glazing.

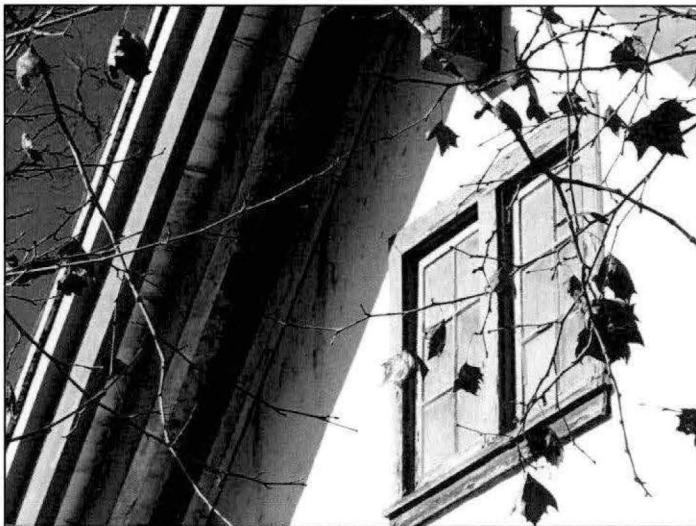
**Photograph A.141.** Minor rust staining onto concrete from corroding sheathing under eaves.

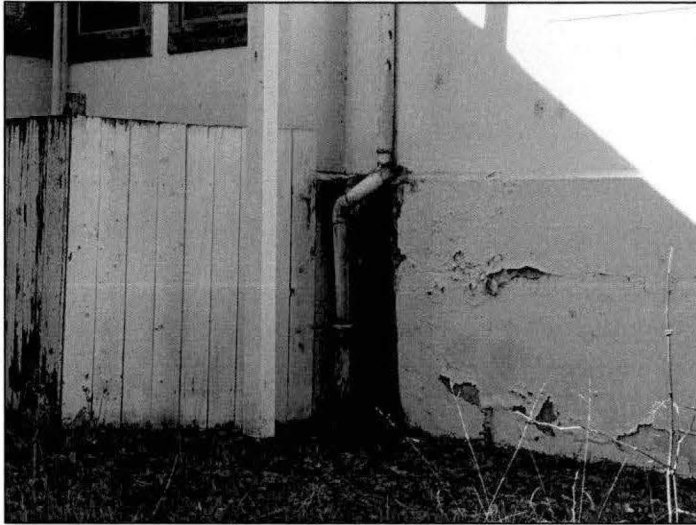
Photograph A.144. Leaking downspout.

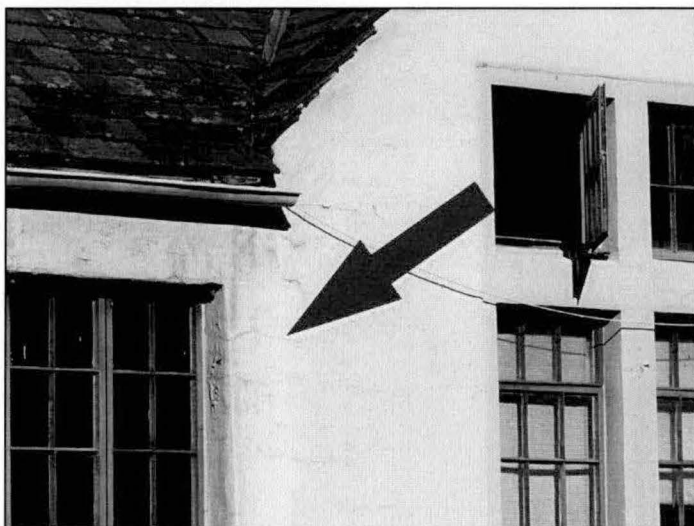
**Photograph A.148.** Minor hairline cracking in concrete.

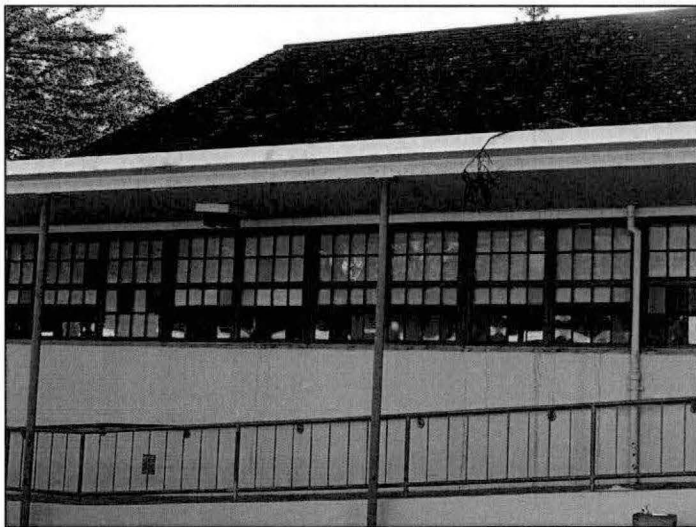
**Photograph A.150.** Several broken window glazings have been replaced with opaque material

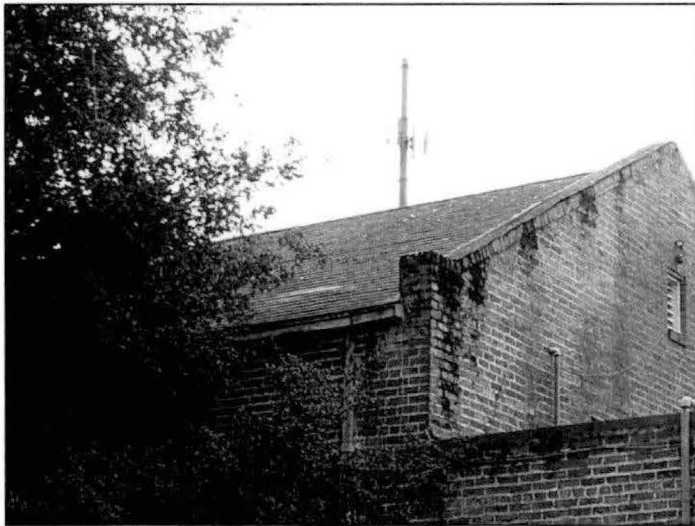
**Photograph A.156.** Minor biological growth on composition shingle roofing.

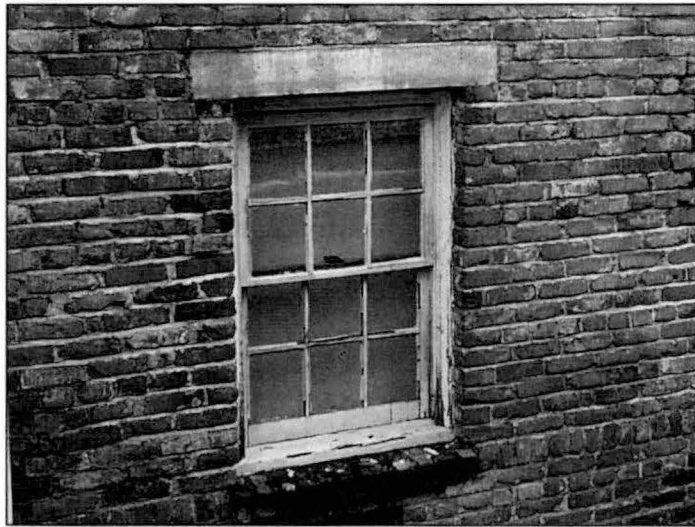
**Photograph A.158.** Paint chipping on wood windows.

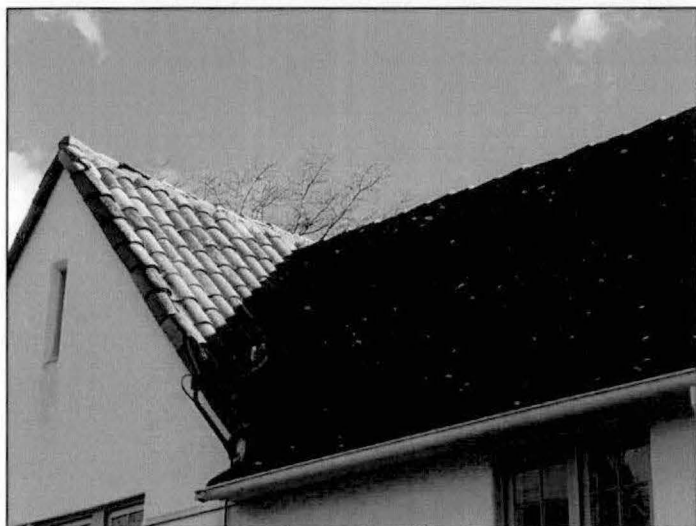
**Photograph A.163.** Minor biological growth on ceramic tile roofing.

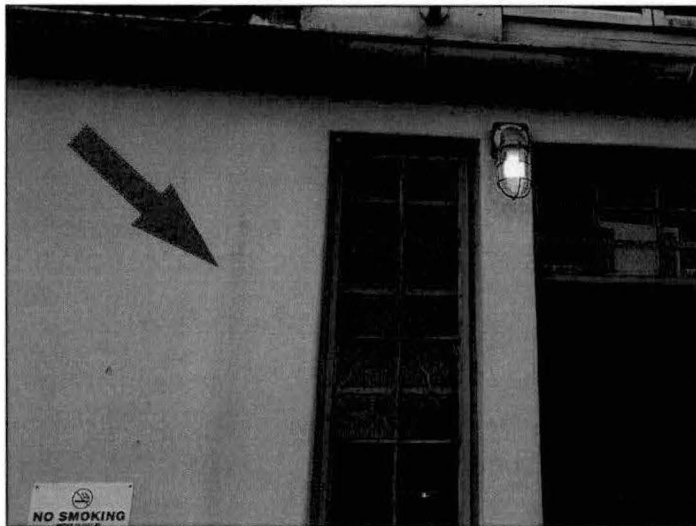
**Photograph A.168.** Moderate moisture infiltration caused by corroding and leaking gutter.

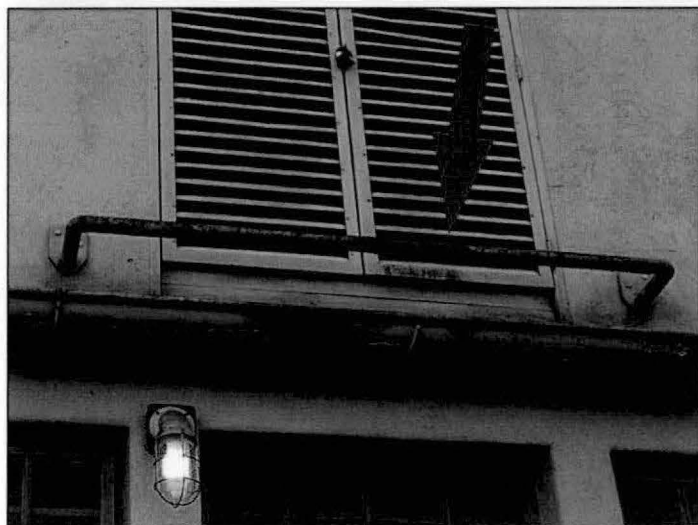
**Photograph A.169.** Severe corrosion of metal railing.

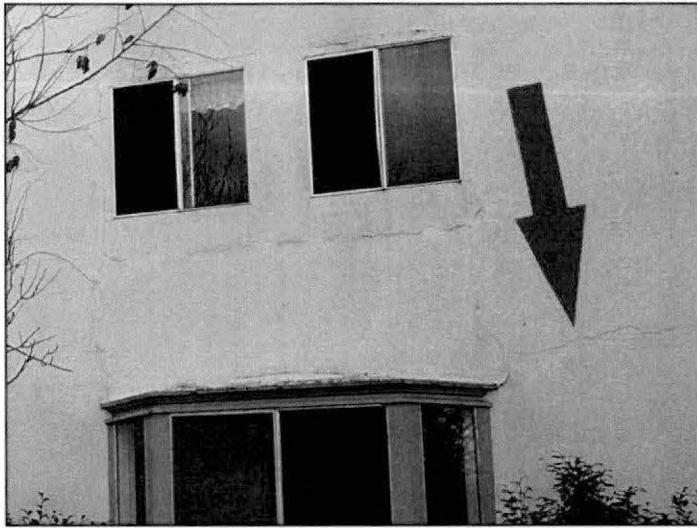
Photograph A.174. Moderate cracking in stucco.

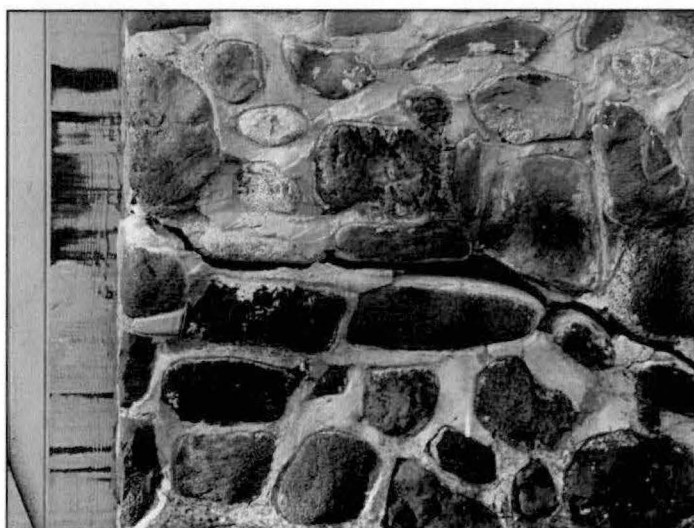
Photograph A.178. Severe cracking in stone.

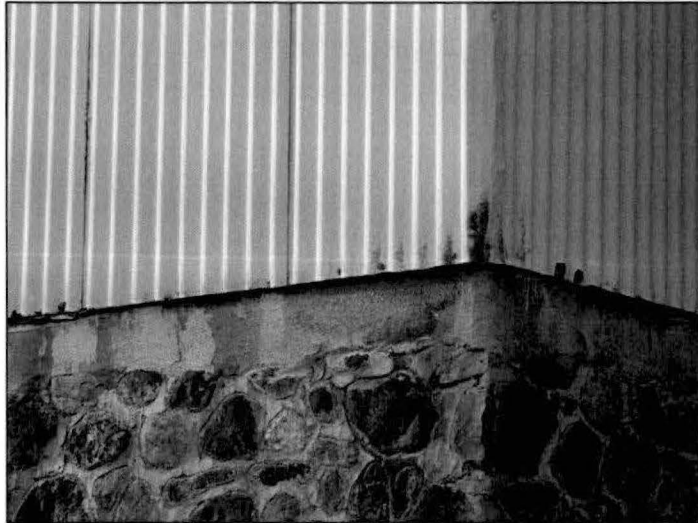
**Photograph A.179.** Minor corrosion of corrugated metal siding.

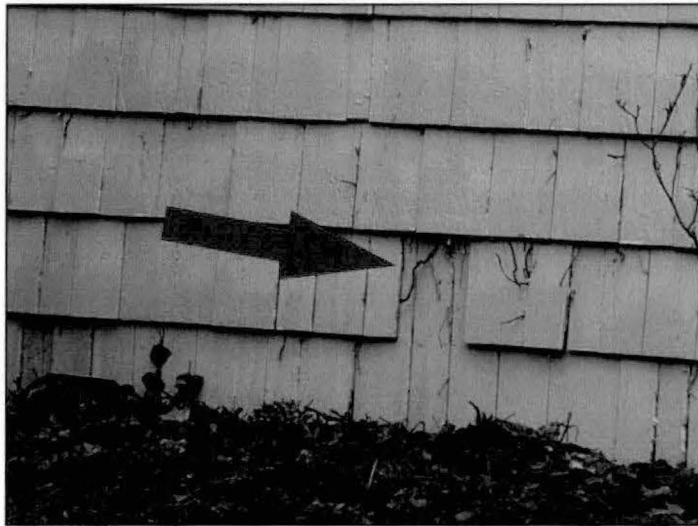
Photograph A.182. A few missing exterior shingles.

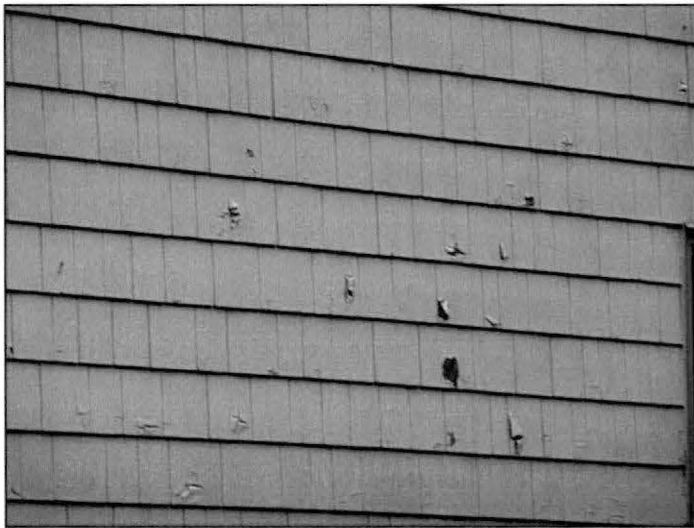
**Photograph A.185.** Minor paint peeling on wood shingles.

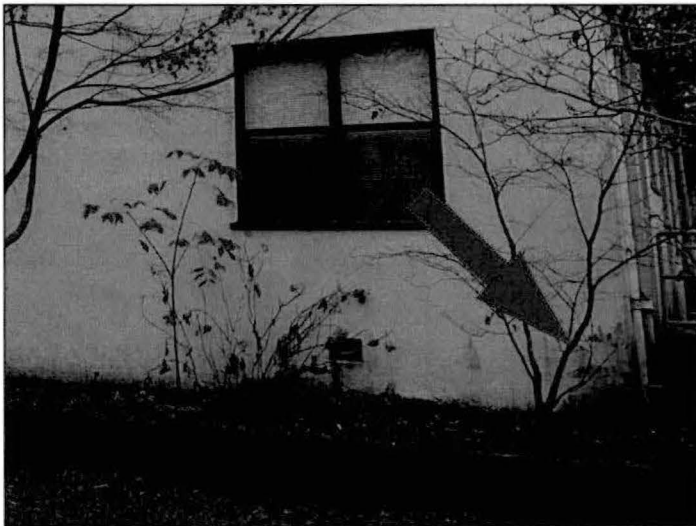
**Photograph A.190.** Minor rising damp on stucco.

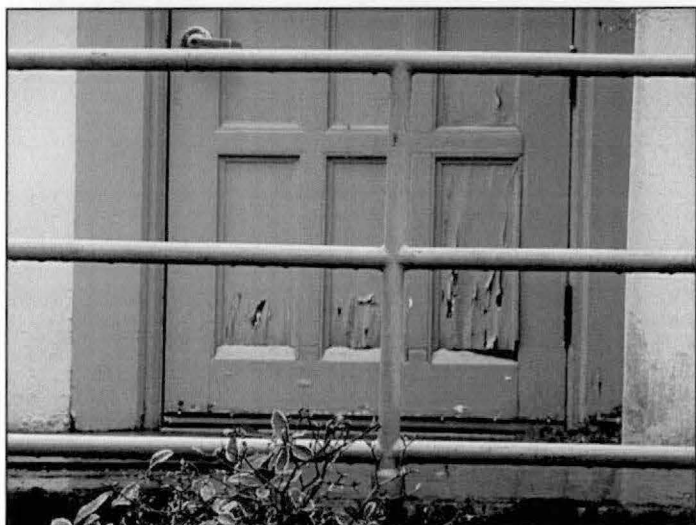
**Photograph A.191.** Moderate paint peeling on main entry door.

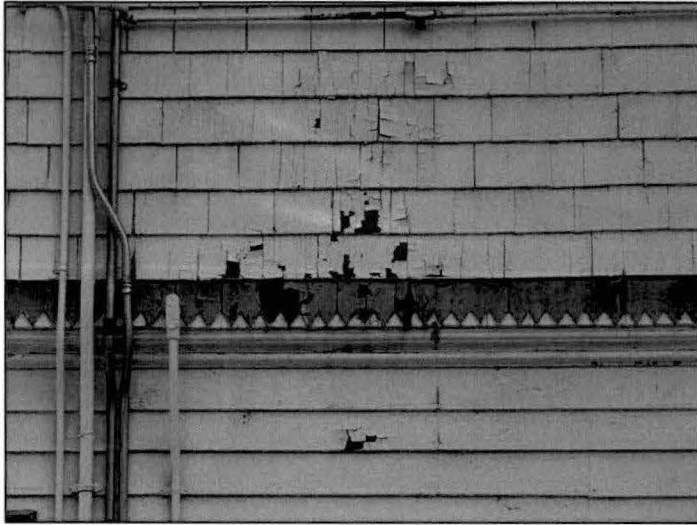
**Photograph A.205.** Moderate paint peeling on wood siding.

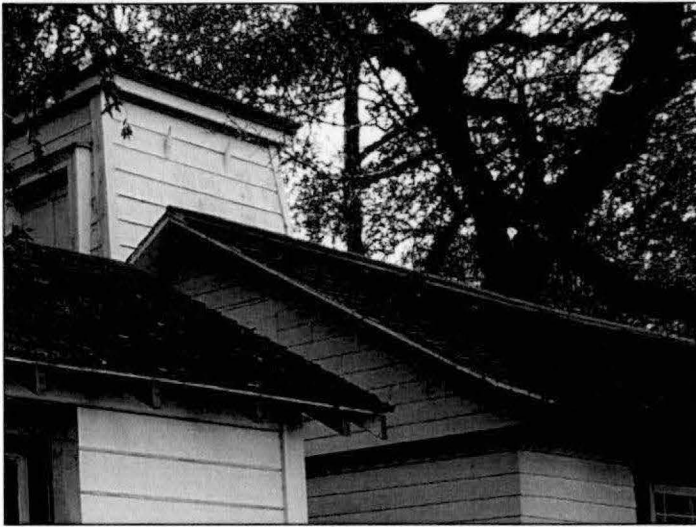
Photograph A.209. Severe biological growth on roofing.

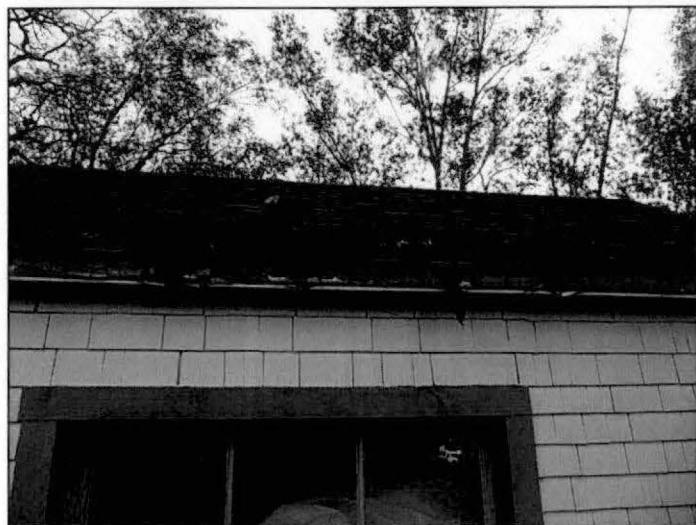
**Photograph A.213.** Severe biological growth on composition shingle roofing.

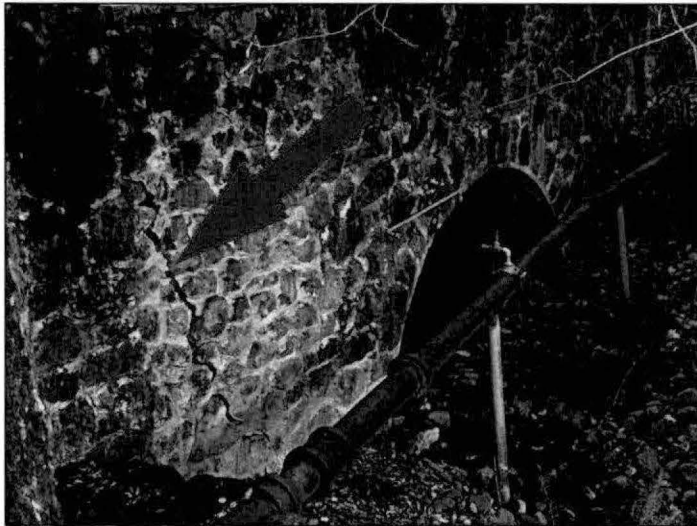
Photograph A.217. Severe cracking of stone masonry.

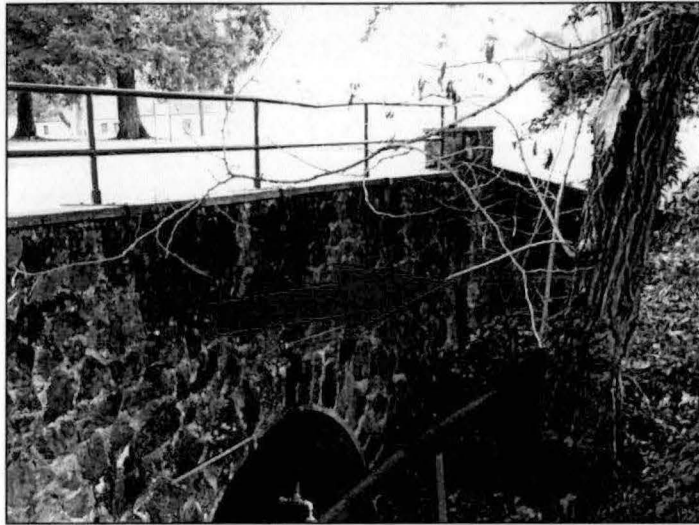
**Photograph A.218.** Minor paint staining on stone wall.

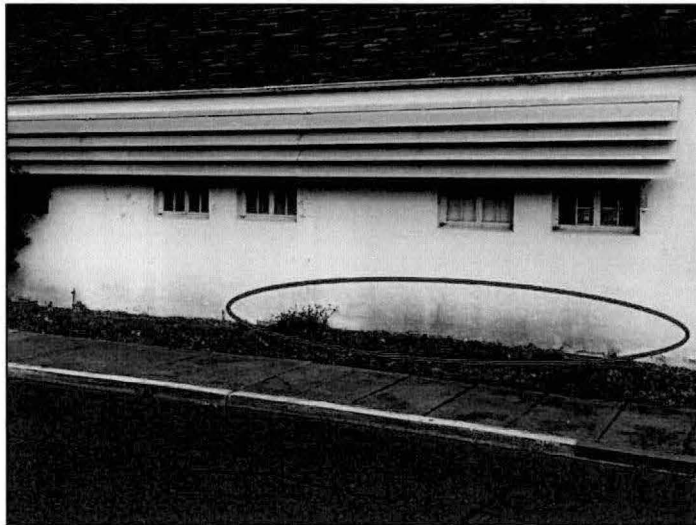
**Photograph A.222.** Moderate rising damp on concrete.

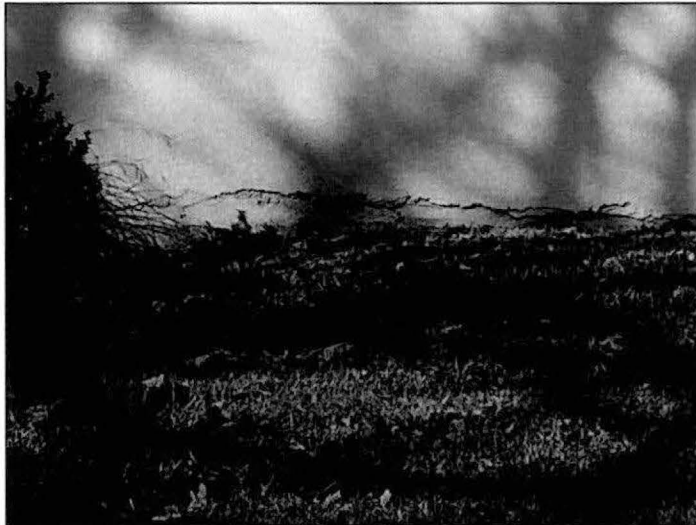
Photograph A.228. Minor chipping of stucco near soil level.

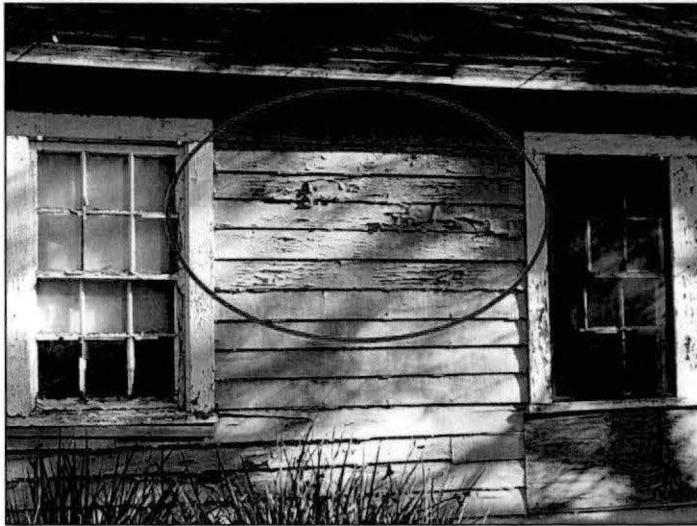
**Photograph A.233.** Severe deterioration of wood siding.

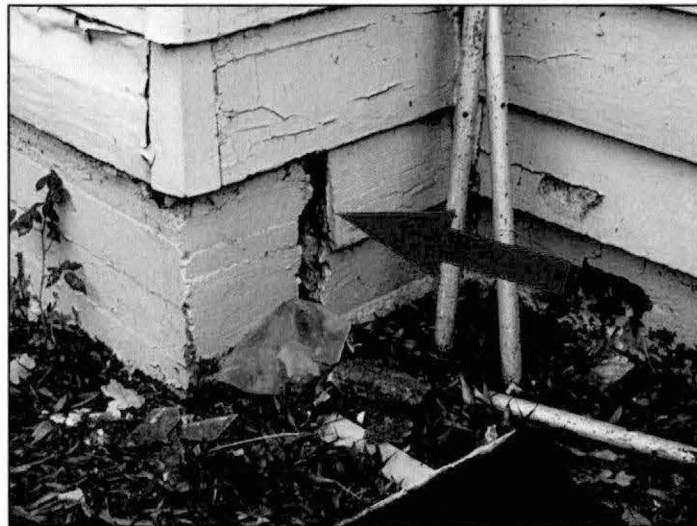
**Photograph A.234.** Severe cracking in concrete foundation.

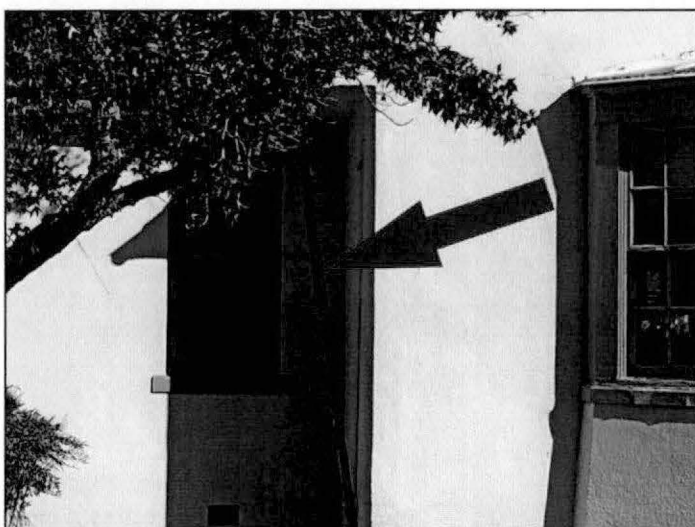
Photograph A.240. Broken downspout.

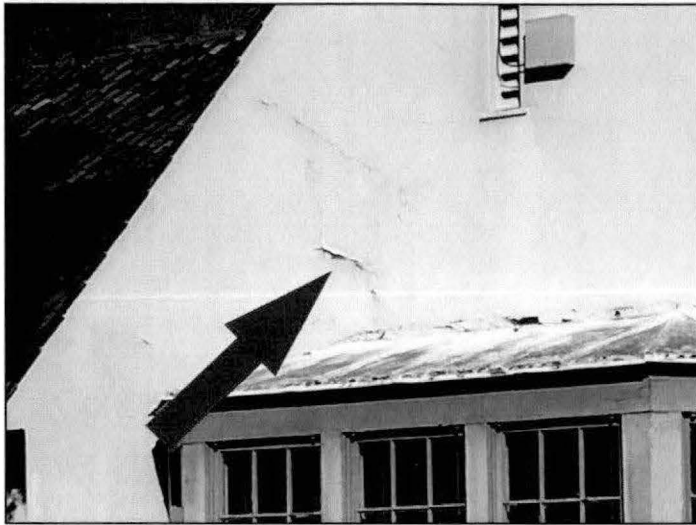
**Photograph A.241.** Minor paint chipping on stucco exterior.
