HISTORIC STRUCTURES REPORT:

THE EDUCATION BUILDING AND COMMERCE HALL,
(THE WEST AND EAST WINGS OF THE GILBERT COMPLEX)
ON THE UNIVERSITY OF OREGON CAMPUS, EUGENE

A TERMINAL PROJECT
BY DAVID ADAM SINGER

UNIVERSITY OF OREGON
HISTORIC PRESERVATION DEPARTMENT
MARCH 2000

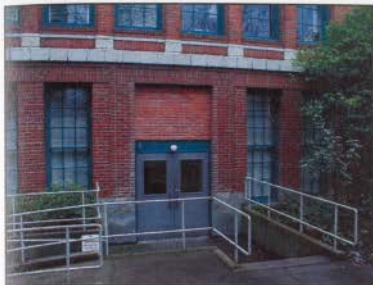
FIGURE 14: HANDICAP RAMP AT EAST ENTRY, 1975
NOTE THAT THE TRANSOM WAS BRICKED-IN

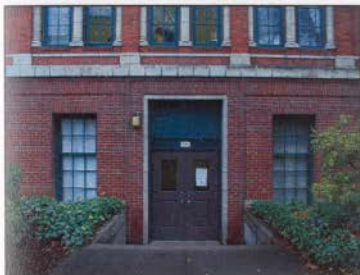
FIGURE 16: SOUTH ENTRY WITH ALTERED TRANSOM

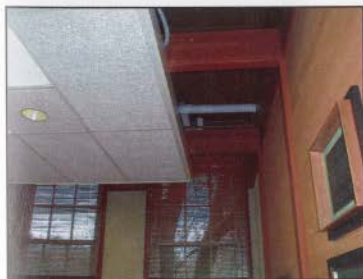
FIGURE 19: SUSPENDED CEILING, RM 201

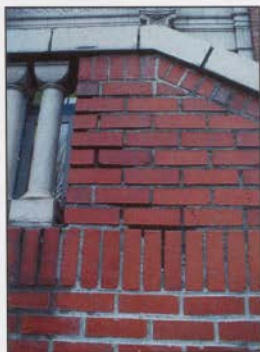
The two dogleg staircases and their respective landings on the front elevation are made of cast-in-place concrete. Small areas of the finish surface of the concrete are chipping away or cracking at the nosing of the risers, and what appears to be the original concrete finish of the stairs is visible beneath. The low brick walls with terra cotta coping that follow the stair's configuration are experiencing some deterioration. The coping is damaged where it was manipulated from the previous configuration, as well as other minor chipped spots on the corners and arrises. Some of the coping has been filled with a cement grout. The set of terra cotta balusters and the terra cotta coping which fronts the upper landing also has some similar damage where the terra cotta body is exposed. The glaze does not only seem to be spalling, but rather the body is chipped by what appears to be mechanical abrasion. The brick walls that support the landing are experiencing some movement due to the expansion of a steel lintel, which is rusting above a ventilation opening in the stair vault.

FIGURE 23: MORTAR DISINTEGRATION AT STAIR

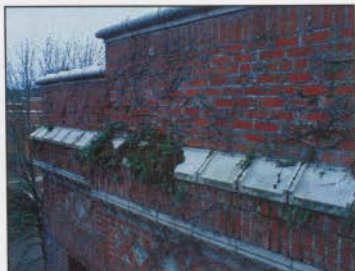
FIGURE 27: ACCUMULATION OF MOSS AND VEGETATION ON THE ENTABLATURE ABOVE THE THIRD FLOOR

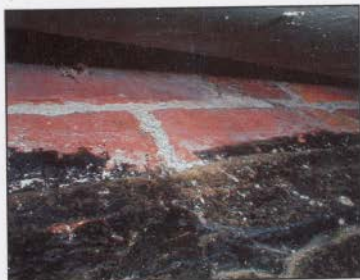
FIGURE 28: A MOIST ENVIRONMENT IS NOT APPARENT BEHIND THE PROTECTION OF THE COPPER FLASHING ON THE PARAPET WALL

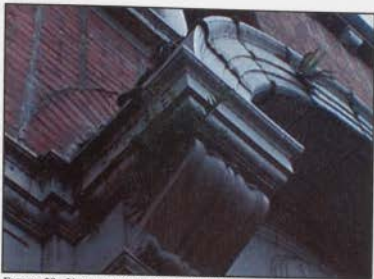
FIGURE 29: VEGETATION TAKING ROOT WHERE THE MORTAR HAS DISINTEGRATED DUE TO WATER INFILTRATION

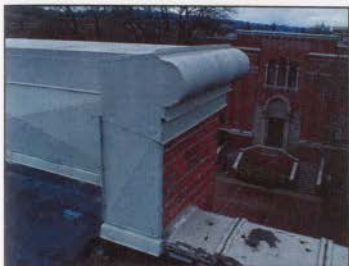
FIGURE 56: BACK OF CAVITY WALL WITH COPPER COPING INSTALLED

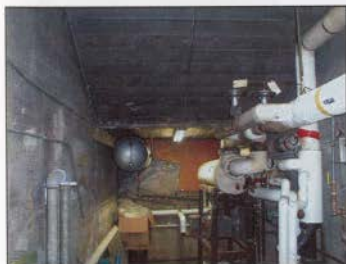
Commerce Hall rests on a cast-in-place concrete perimeter stem wall, with a slab-on-grade sub-floor similar to the Education Building. Evidence on the inside of the stair vault where the mechanical space is located, indicates that the foundation was poured in layers. Several cold joints are visible among the board formed marks in the concrete stem wall. A well built, segmental, brick arch leads from the janitors closet in room 184, through the foundation wall to the stair vault. The concrete stem wall is plastered on the exterior with a cement stucco finish, exposed one to two feet above finish grade. Five square concrete footings support the internal structure. The stairwell has a concrete strip footing which supports the interior unreinforced brick bearing walls of the stair.

FIGURE 59: FOUNDATION STEM WALL UNDER STAIR VAULT.
NOTE THE COLD JOINTS AND THE BOARD FORMED MARKS

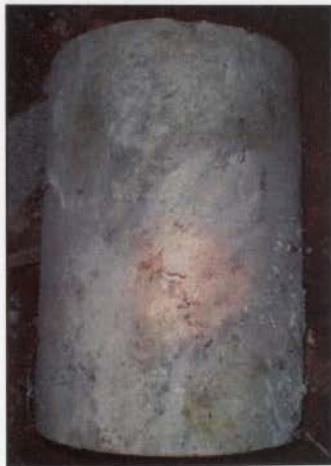
**FIGURE 114: PILASTER SECTION**

Type: Pilaster section
Number: 2 each
Glazing: Glazed buff clay body
Size: 15"x11"x6" radius
Condition: Fair (chipped)
Original Location: Education
