✓  
**Terminal Project:** A Study of the Probable Original Layouts, Uses, and Interior Appearance of the Officers' Quarters (HS-11) at American Camp

San Juan Island National Historical Park

Master's of Science, Historic Preservation

December 9, 2005

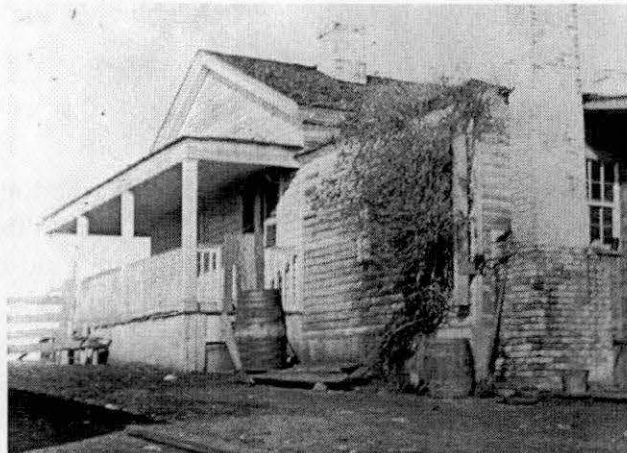
Fig. III-3. Southwest corner of HS-11. The date of the photo is unknown and the westward expansion of the rear addition (flush with the main building and chimney) was not recorded in historic documents from the military period. The rear addition is likely a kitchen and/or dining space.

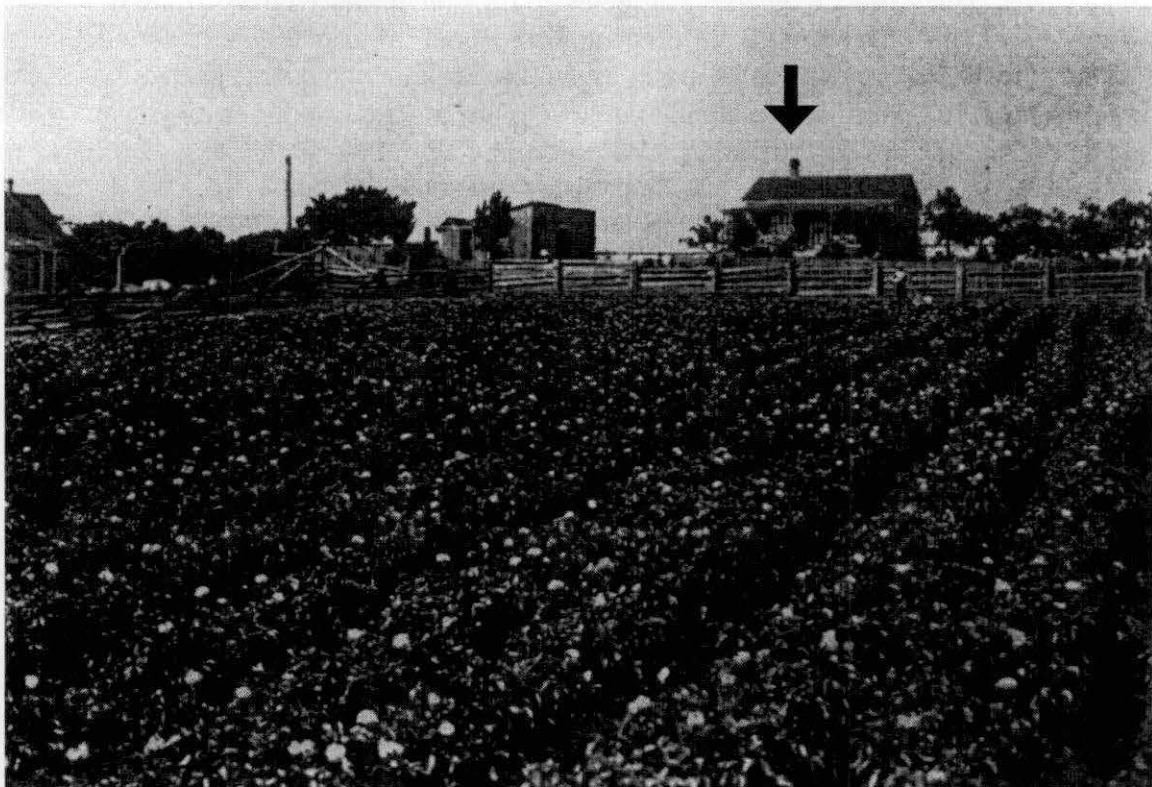
Fig. III-4, above. This photograph, dated June 16, 1912 is of the McRae House / HS-11's southern elevation. Note that Rooms 7 and 8 are missing in this photograph. They were present in the c. 1903 photograph. Here, a south facing porch has been added. Also, note the presence of a single, thinner chimney flue to the west. (see arrow). The fields in the foreground were related to the McRae House / HS-11.

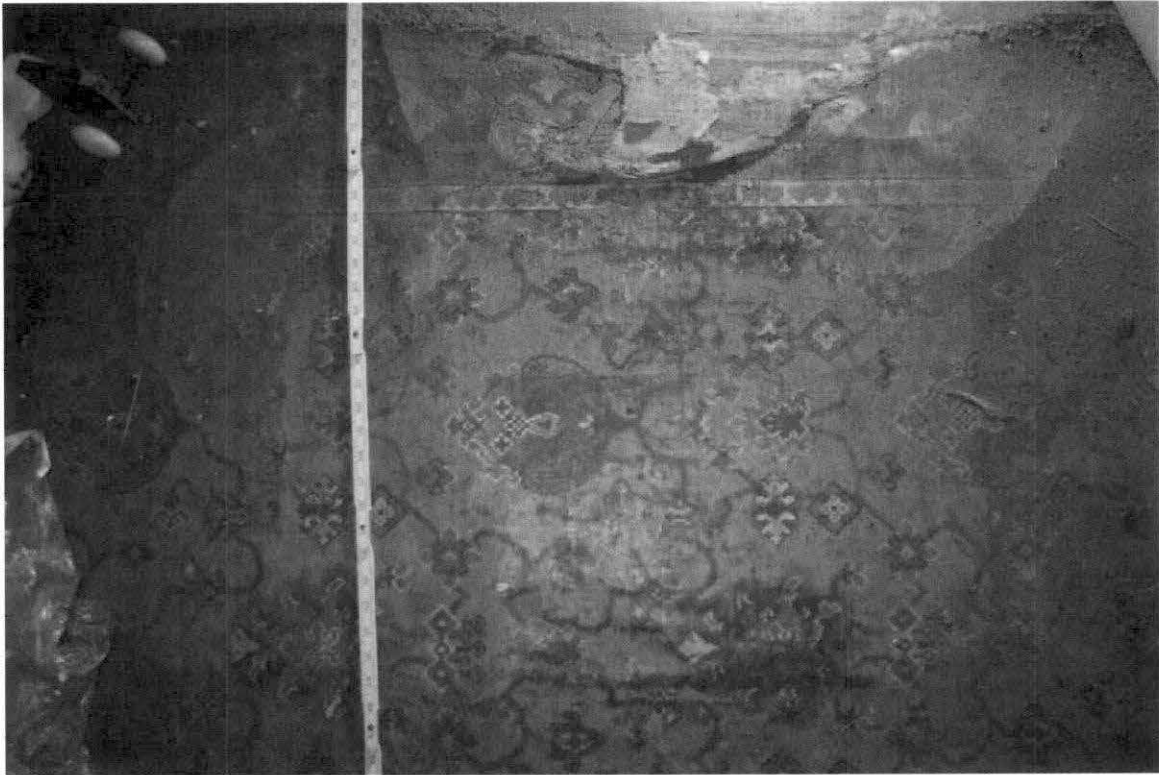
Fig. V-3. Linoleum carpet detail in Room 1 (E2) Photograph by Aaron Lemchen March 2005.

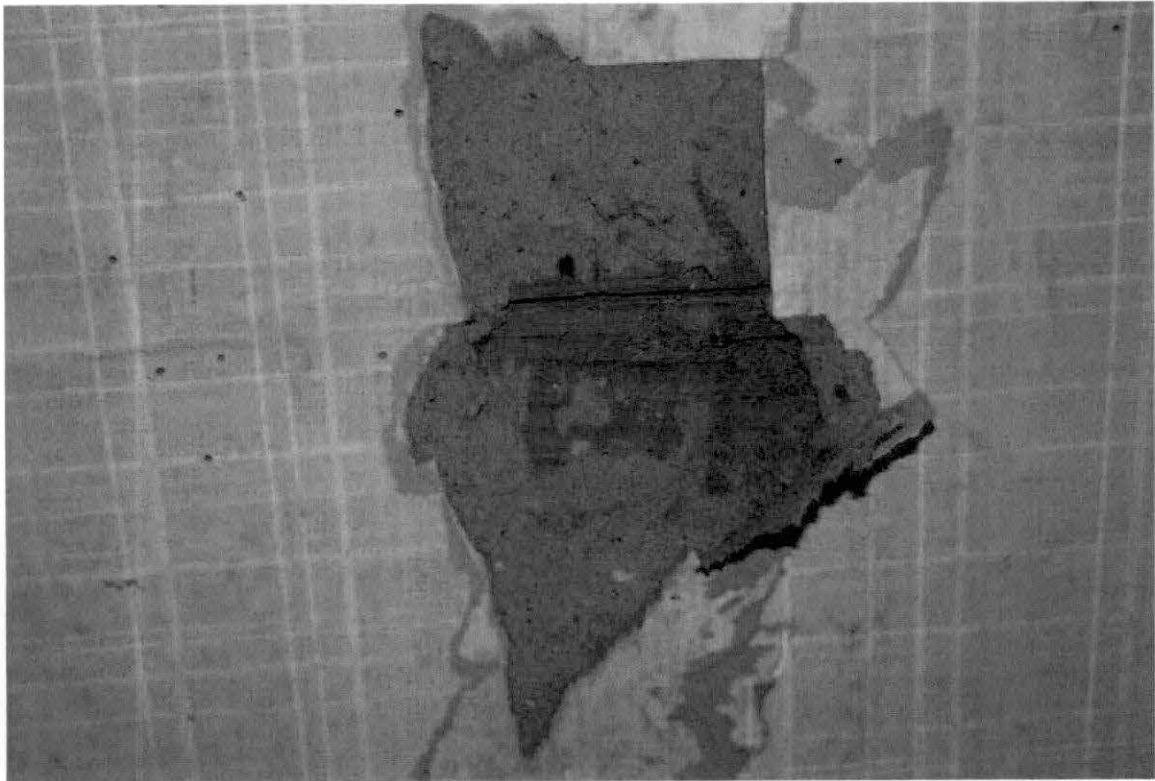
Fig. V-4. Opening in the south wall of Room 1 (E2) showing layers of heavy paperboard and wallpaper over horizontal wood planks. Photograph by Aaron Lemchen October 2005.

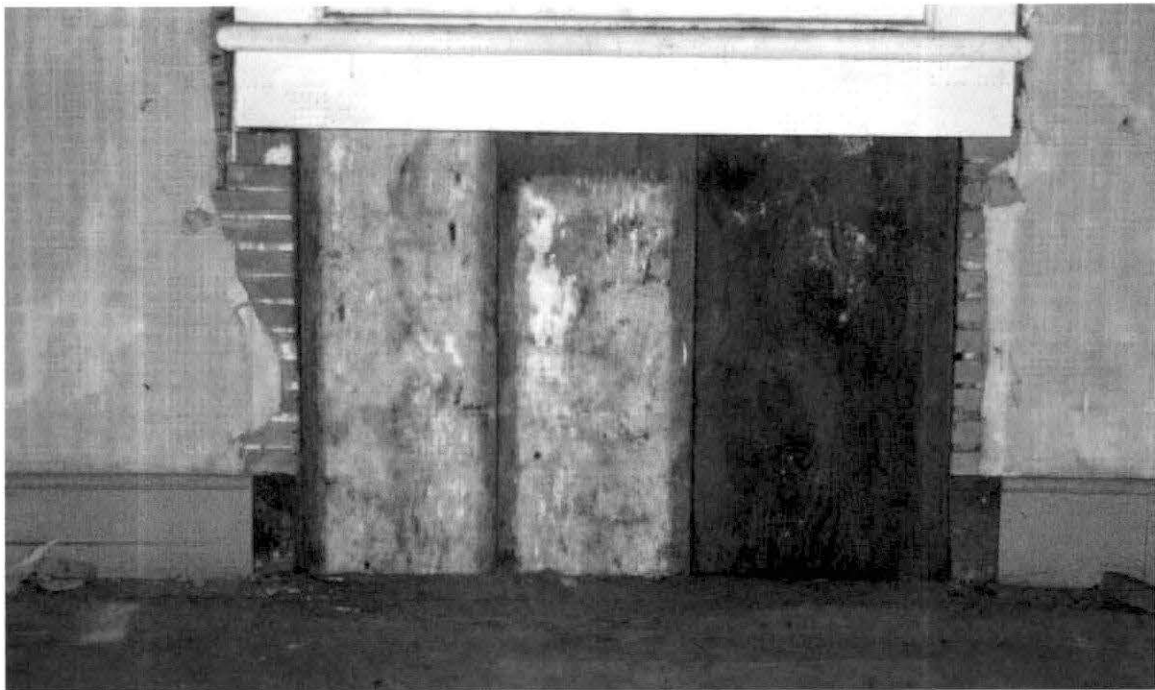
Fig. V-5. Opening in the east wall of Room 1 (E2) beneath the window showing evidence of modern reuse of what appears to be Military era whitewashed planks exhibiting the ghosts of former battens and perhaps molding. This was a former (c. 1925) doorway to Room E1, before restoration by the NPS. The planks were installed during the c. 1978 restoration. Photograph by Aaron Lemchen October 2005.

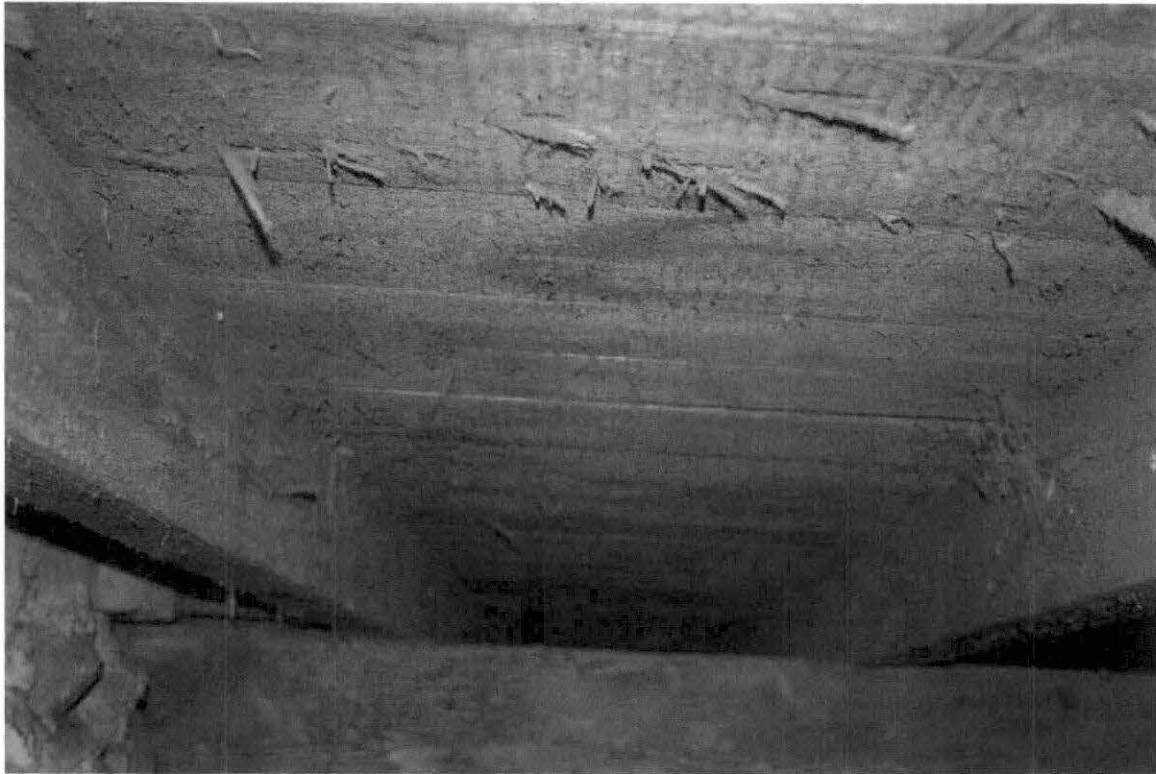
Fig. V-6. Near the top of this photo is evidence of machine cut and wire nails protruding through the first layer of flooring into the crawlspace. Note that they are in line, following butt joints in the second layer of flooring above. It suggests that a wall was likely affixed to the other side of the flooring through toe nailing, and corroborates the evidence in the room above that there was a former division in this room between Rooms 1 and 2 at this location. This example is just west of the restored east hearth under Room 2 (E5). Photograph by Aaron Lemchen March 2005.

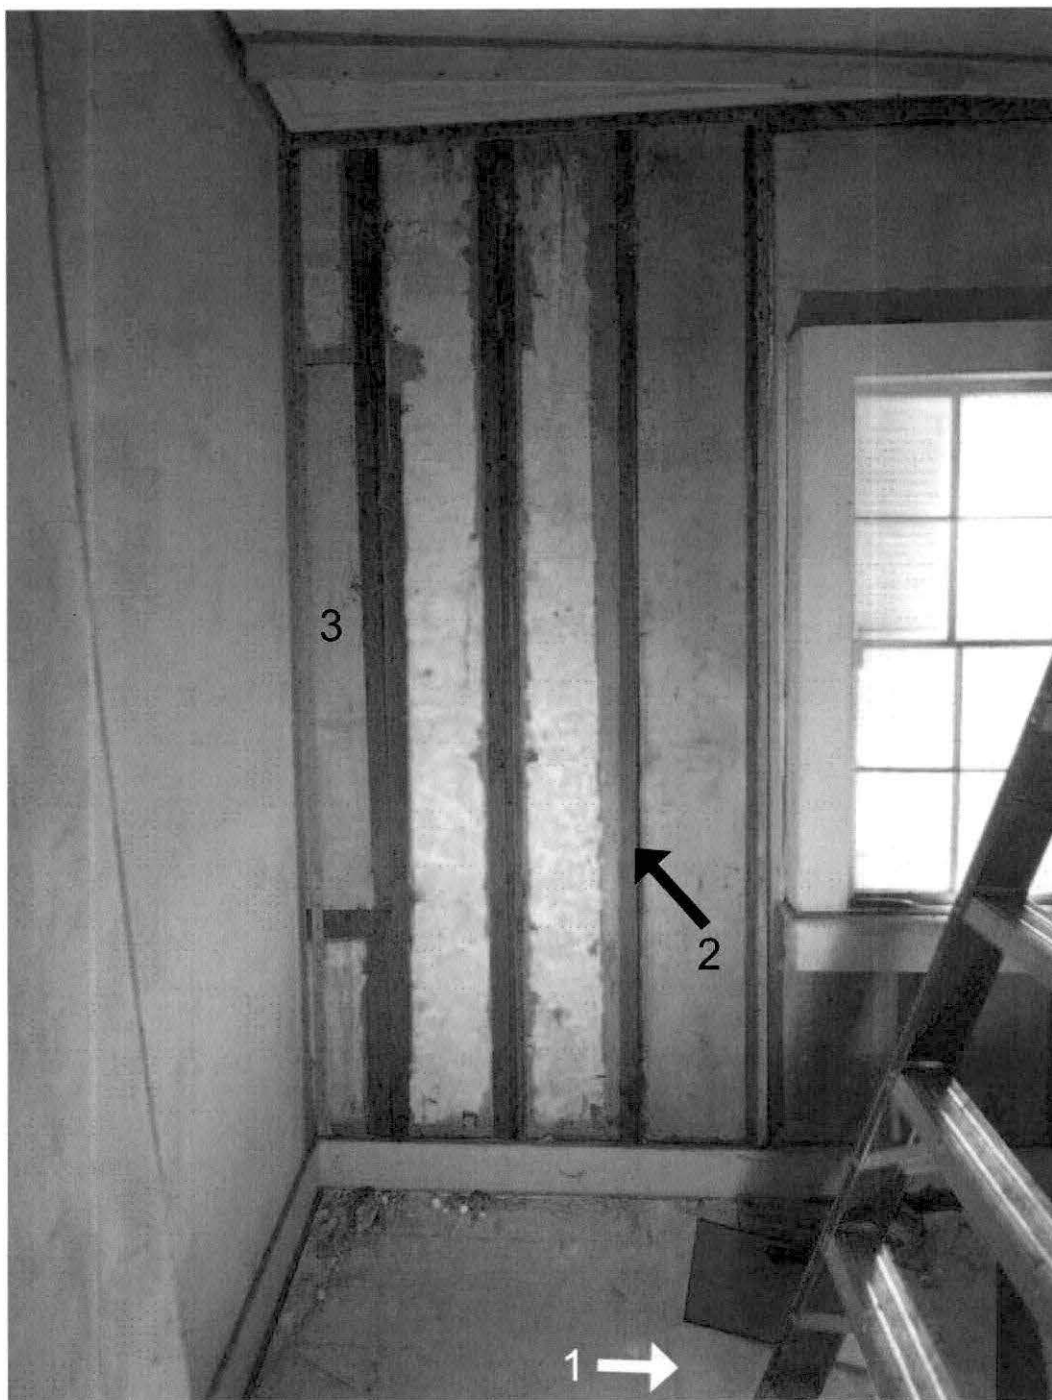
Fig. V-7. East wall of Room 2 (E5). Note the aligned butt joint and paint shadow in the floor boards at the bottom of the picture (1). Also note its alignment with the paint shadow on the vertical structural planks, which also appear to have shadows in the paint and wallpaper from previous battens (2). This suggests the presence of an earlier wall division that ran on either side of the hearth. A patch where a window once was can be seen in the board at the leftmost section of the east wall in this picture. It was butted against by the north wall (3). This patch was likely an original window during the military or agricultural era. Photograph and image enhancement by Aaron Lemchen March and June 2005.

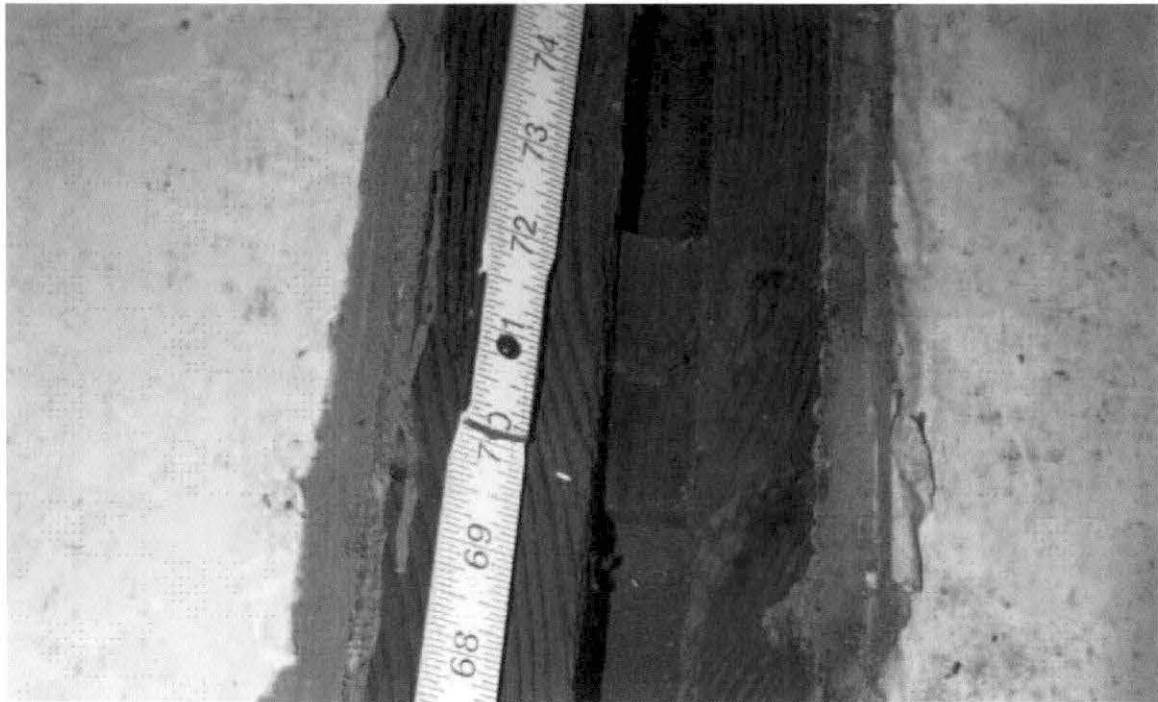
Fig. V-8. Room 2 (E5), Detail of block located between two planks. Photograph by Aaron Lemchen March 2005.

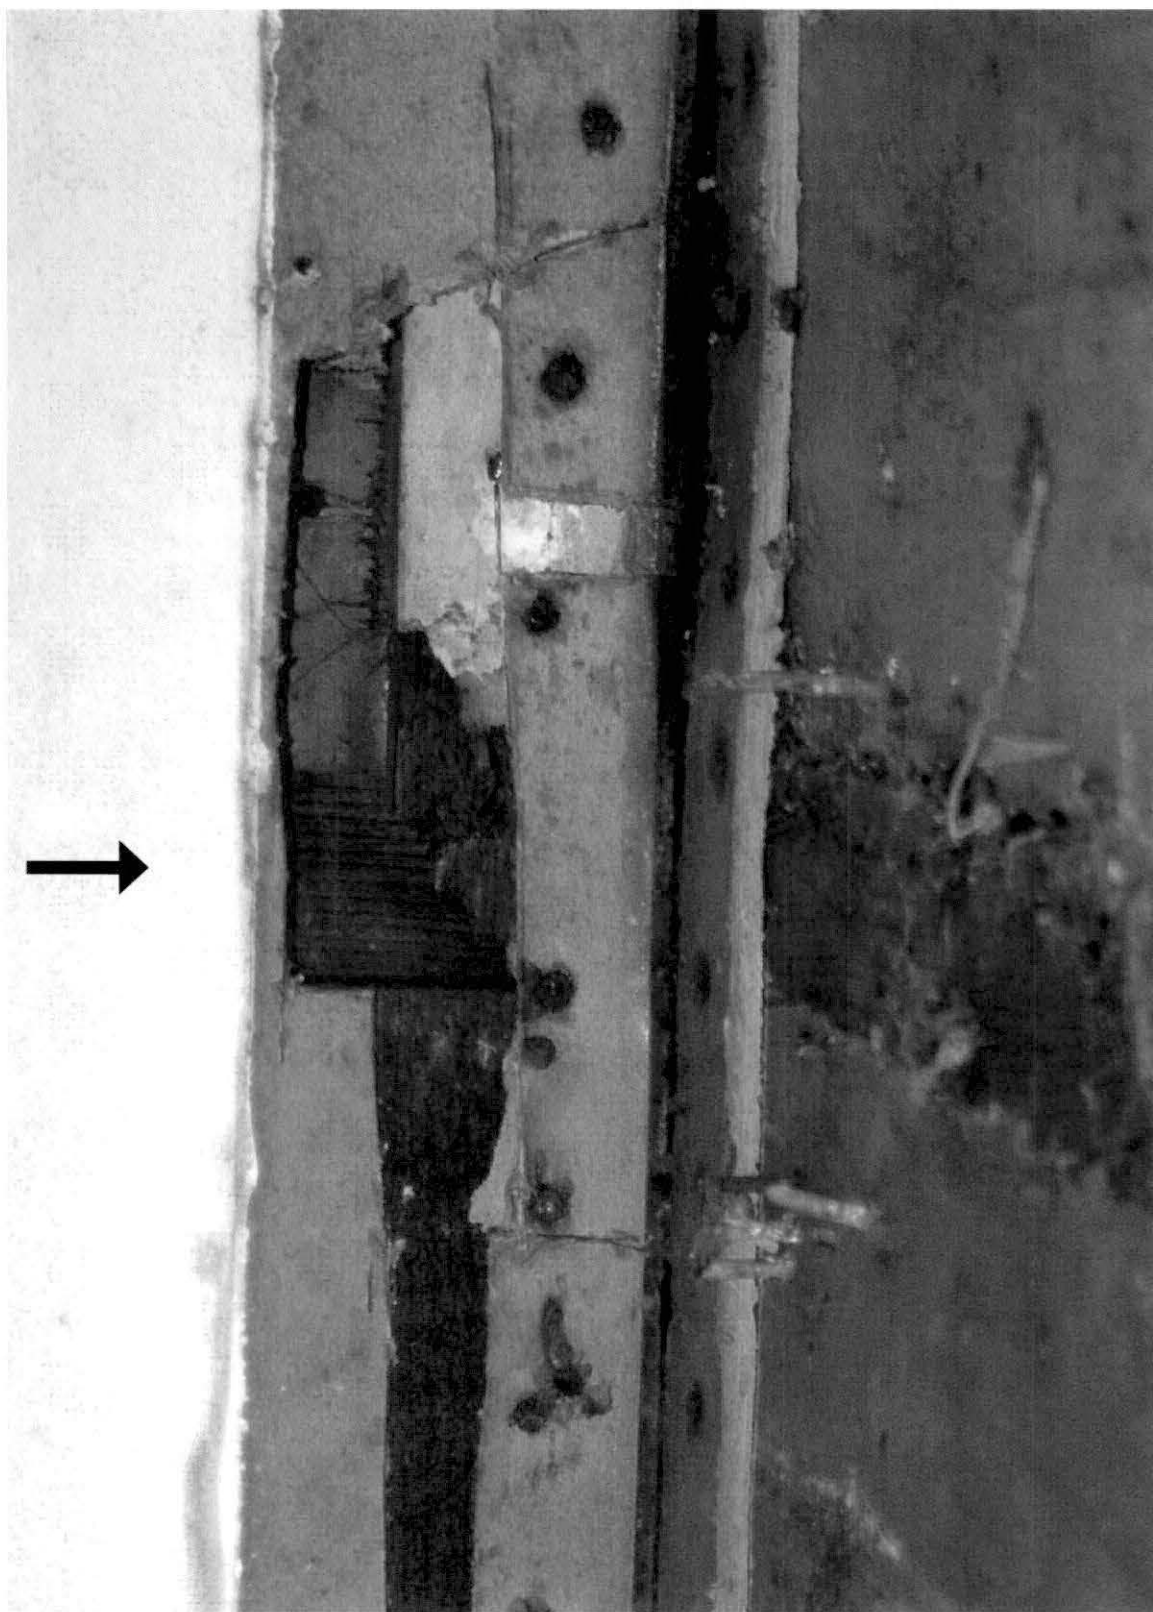
Fig. V-9. Exploratory hole cut into the ceiling's Beaver Board covering (see arrow) at the point where it is normally covered by battens. It is in alignment with a paint shadow and butt joints the floor relating to the former north wall in Room 2. Photograph by Aaron Lemchen March 2005.

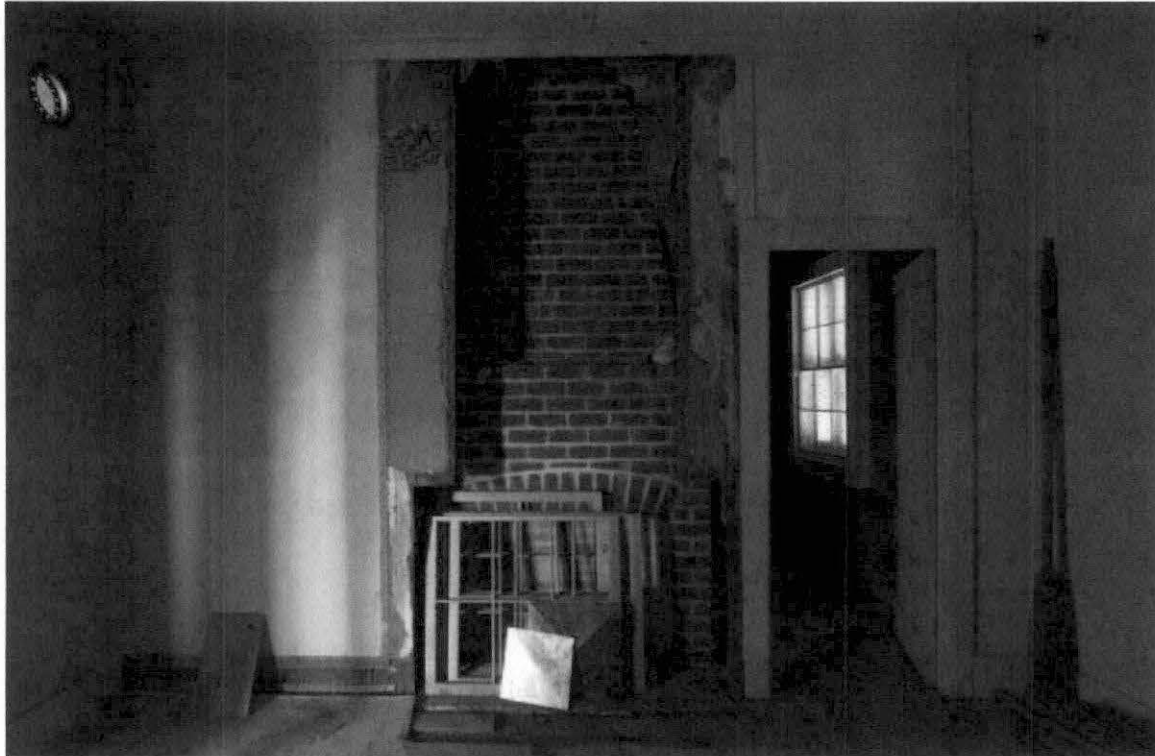
Fig. V-10. Room 3 (E7), south wall showing restored fireplace as well as the various layers of finishes. Photograph by Aaron Lemchen March 2005.

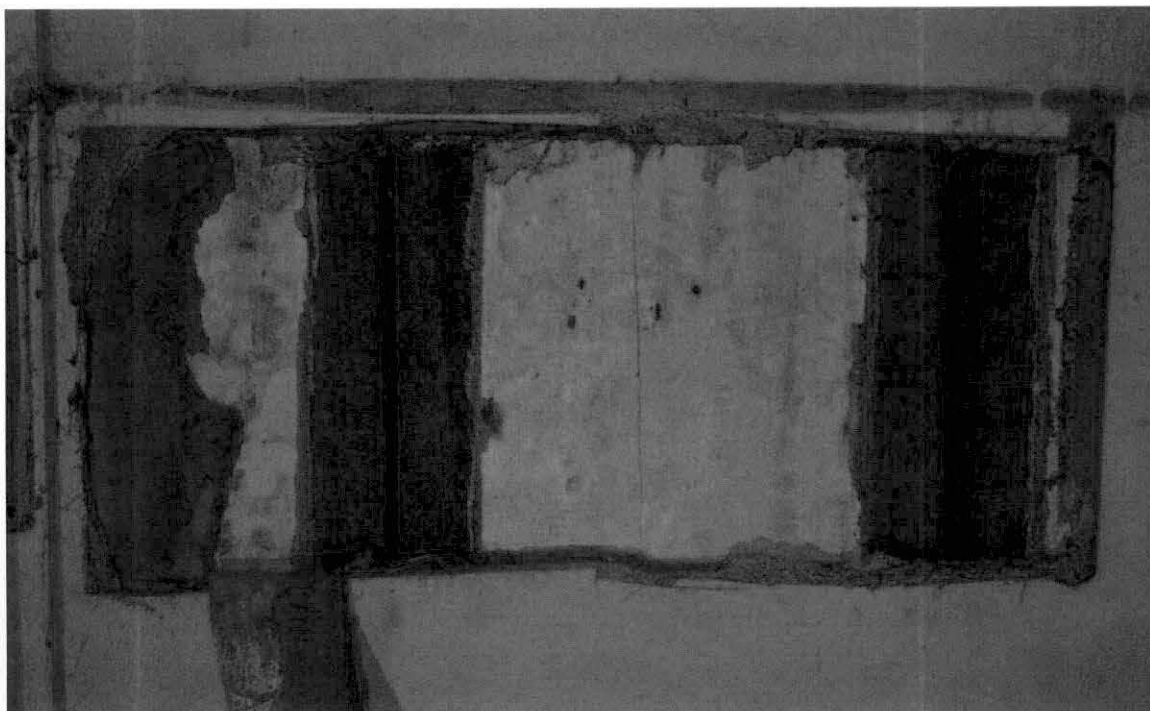
Fig. V-11. North wall of Room 3 (E7) showing areas without paint or wallpaper. Note, evidence of interior battens on the joints of the vertical wood that have since been removed. Photograph by Aaron Lemchen March 2005.

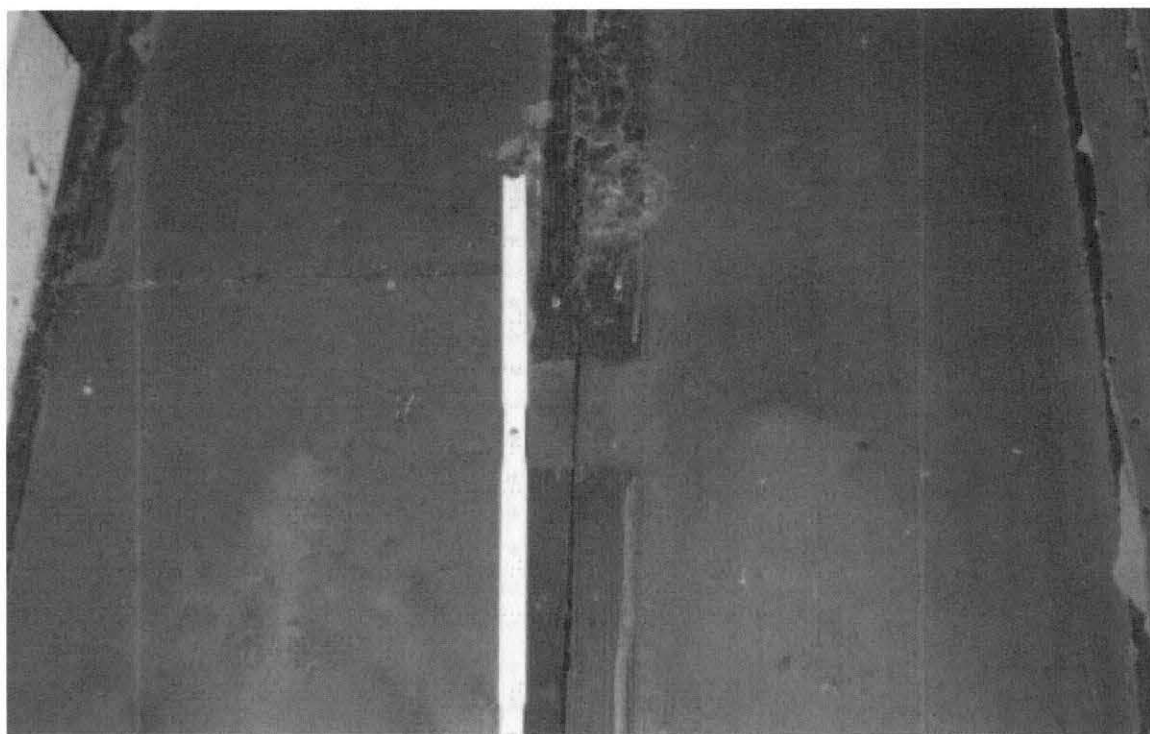
Fig. V-12. West wall of Room 4 (E8) showing break in paint shadow at approximately the same height as the marking in Room 2's east wall seen in Figure V-7. This suggests the likelihood of a cabinet / closet affixed to this location as in the case of the block in Figure V-7. Photograph by Aaron Lemchen March 2005.

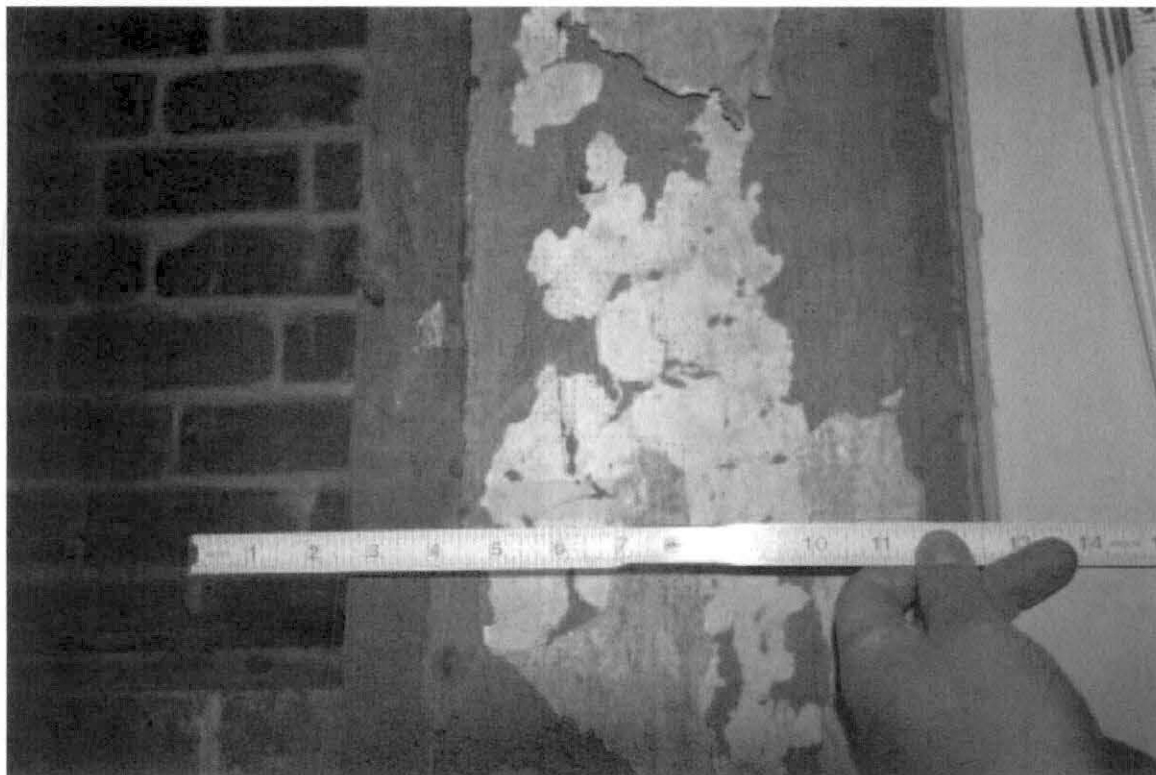
Above; Photo of remnant wallpaper on the south wall of Room 3 (E7), note the restored chimney to the left.

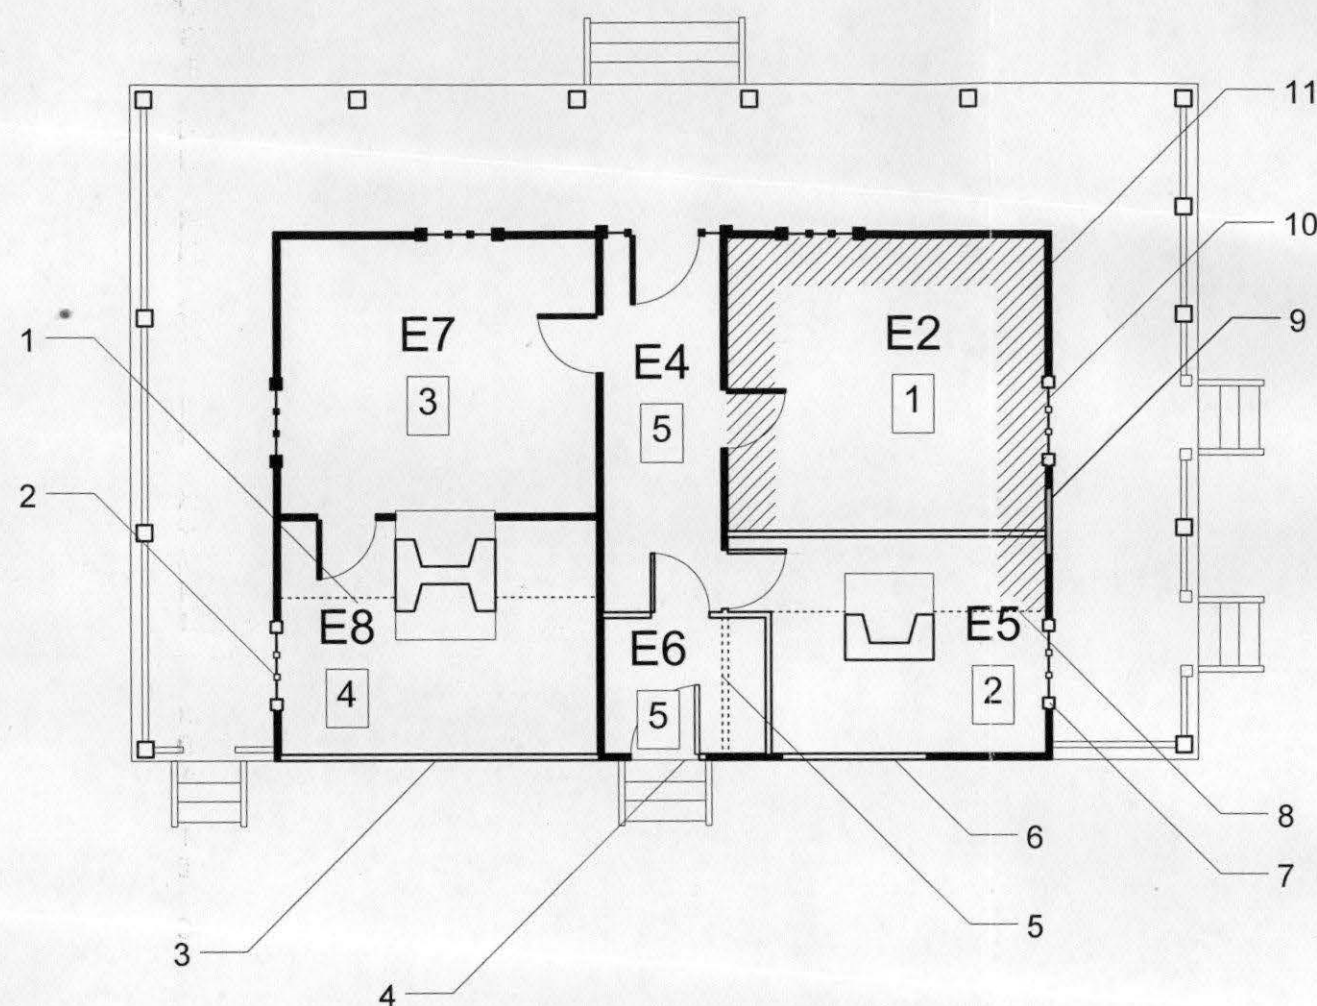
1. BREAK OR JOINT IN FLOORING AND LOCATION OF FORMER WALL. EVIDENCE FOUND IN MARCH 2005 IN CRAWLSPACE. ROW OF NAILS ROUGHLY IN LINE WITH JOINT. CURRENT WALL LIKELY MOVED FROM THIS LOCATION TO THE PRESENT LOCATION JUST TO THE NORTH
