Historic Structure Report New Mine Casemate Fort Columbia State Park

**Terminal Project
Historic Preservation Program
School of Architecture and Allied Arts
University of Oregon
November 2008**

Chapter 3: Physical Description and General Assessment

Conditions as of October 2008. Photo reference numbers correspond to images in Volume 2: Photographic Documentation.

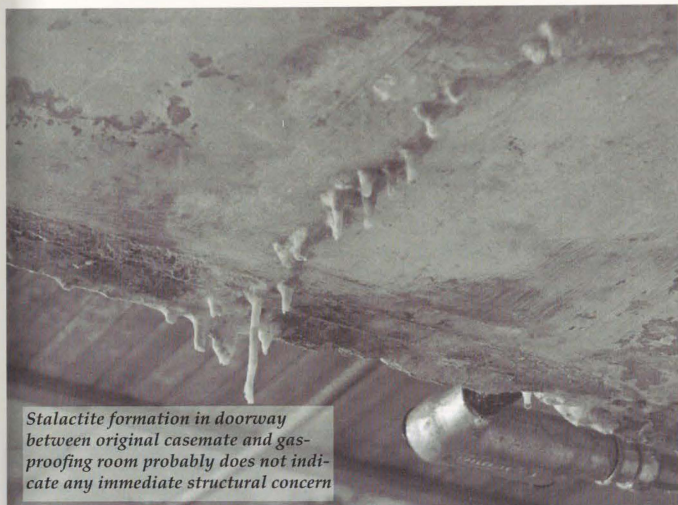
Stalactite formation in doorway between original casemate and gas-proofing room probably does not indicate any immediate structural concern

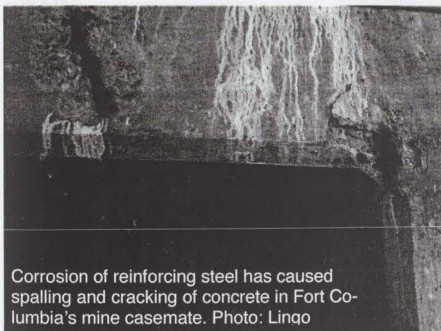
Corrosion of reinforcing steel has caused spalling and cracking of concrete in Fort Columbia's mine casemate. Photo: Lingo

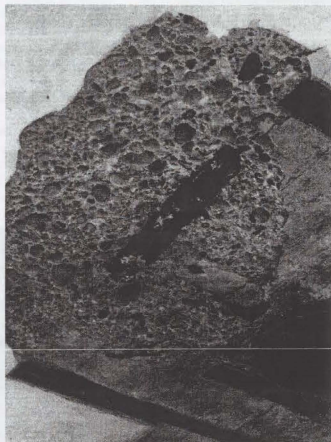
Embedded metal has caused spalling in the ceiling of Fort Columbia's mine casemate. Feb. 2008.

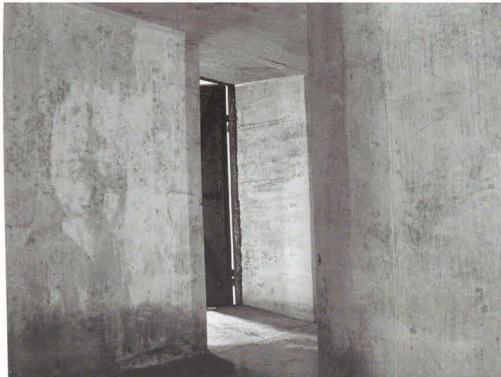
Photo 9. (Above) Looking east from the manhole area in the west tunnel. Door frames have been cast in place throughout the casemate in testimony to the high quality of workmanship. This feature has the potential to create structural problems from steel jacking if corrosion causes expansion of steel elements.

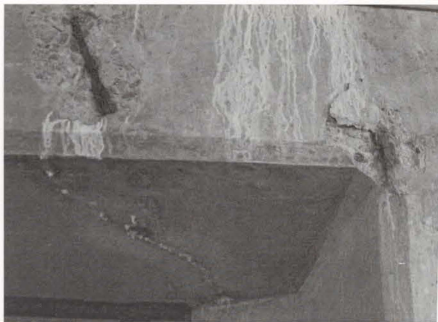
Photo 32. (Above). Closeup of doorway showing spalls with exposed rebar and cracking with stalactites.

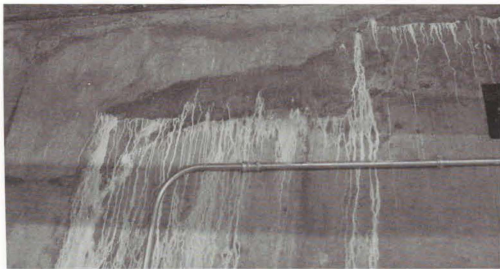
Photo 36. (Left). Detail of construction joint with efflorescence, plotting room south doorway, east side.

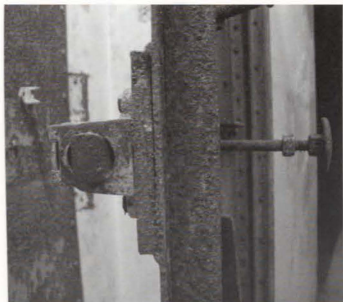
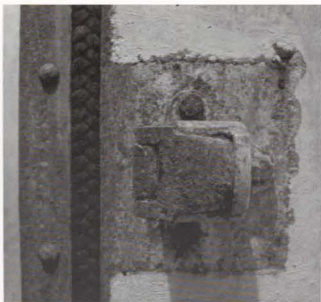
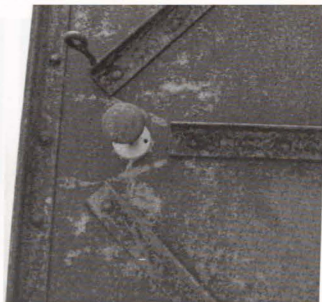
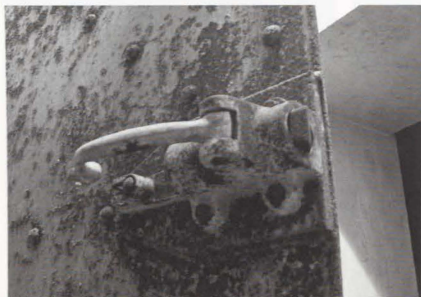
Photos 46-49. Details showing locking mechanisms on gas-proof doors, east air lock. Traces of the original paint are still visible on the doors. Paint scheme appears to be gray with a red primer.

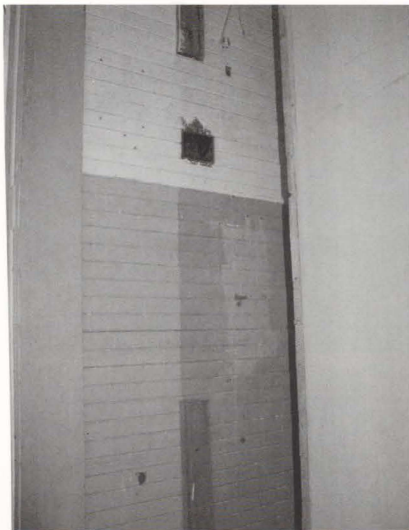
Photo 65. (Above). Several layers of historic paint are visible on the beadboard east partition wall of the dormitory.

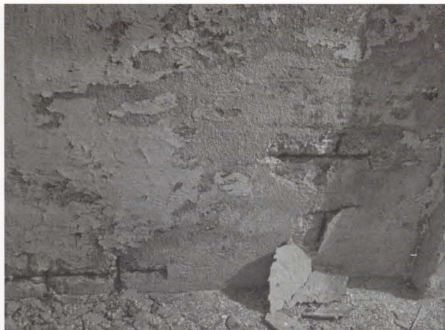
Photo 67. (Left). Peeling paint and spalled concrete with exposed rebar indicate moisture problems in the west wall of the dormitory. The concrete in this section of the casemate was poured directly against the rock outcrop of Chinook Point.

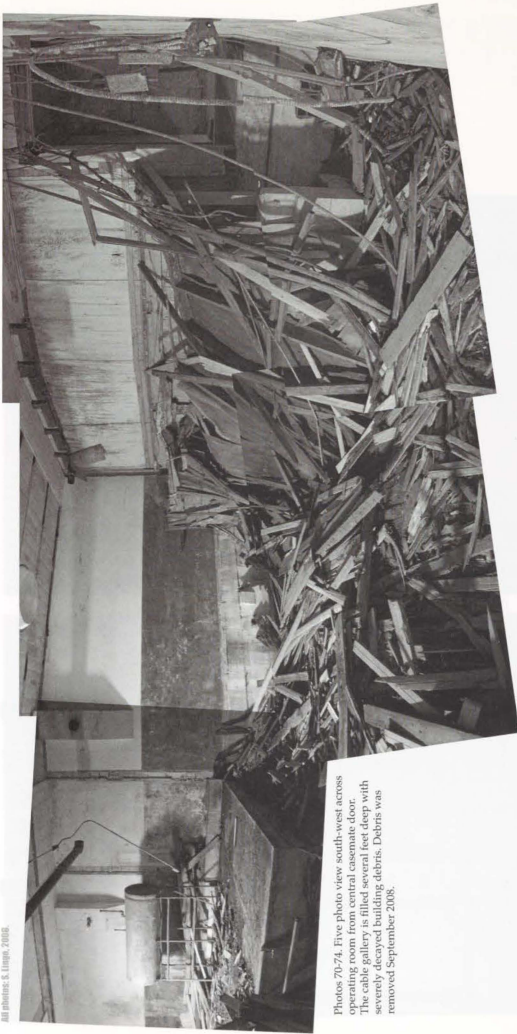
Photos 70,74. Five photo view south-west across operating room from central casemate door. The cable gallery is filled several feet deep with severely decayed building debris. Debris was removed September 2008.

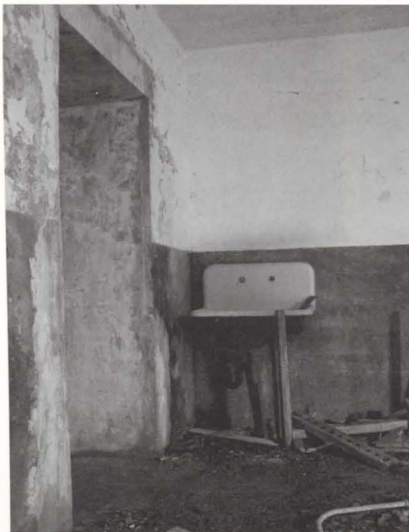
Photo 75. (Above). Battery room sink on east wall of casemate. Concrete infill above door from 1943 tunnel addition is shown. Repainting the casemate is not recommended based on the desire to preserve historic finishes. Although the interior of the 1921 casemate was painted, the 1941-43 addition appears to have received a plastered finish. Additional testing is necessary to determine the exact nature of the finishes.

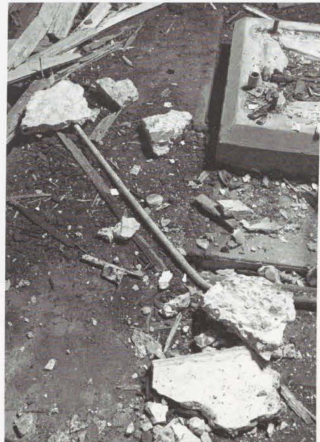
Photo 83. (Below). Large pieces of concrete falling from the ceiling do create a safety issue for casemate visitors.

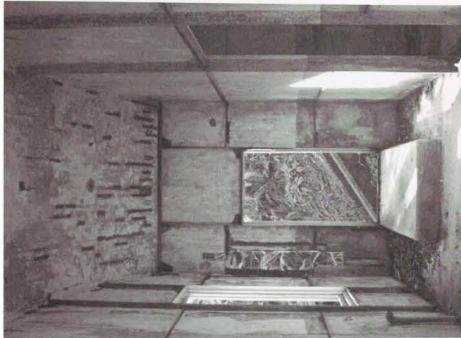
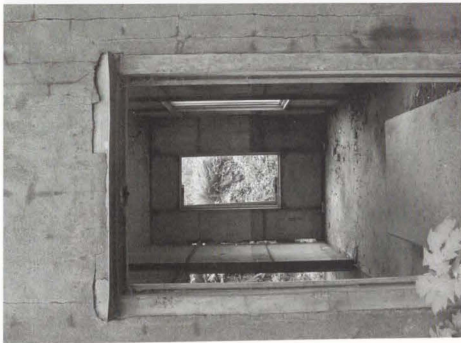
Photos 96-99. The searchlight powerhouse is a World War I vintage building constructed of concrete and expanded metal lath panels. It provided power to the searchlight station on Chimook Point. It is visible in construction photos of the casemate. The building is in a serious state of deterioration.
