WILD NOTIONS:
PRESERVATION OF HISTORIC BUILDINGS IN OREGON WILDERNESS

A THESIS

Presented to the Historic Preservation Program,
and the Graduate School of the University of Oregon
in partial fulfillment of the requirements
for the degree of
Master of Science

March 2020

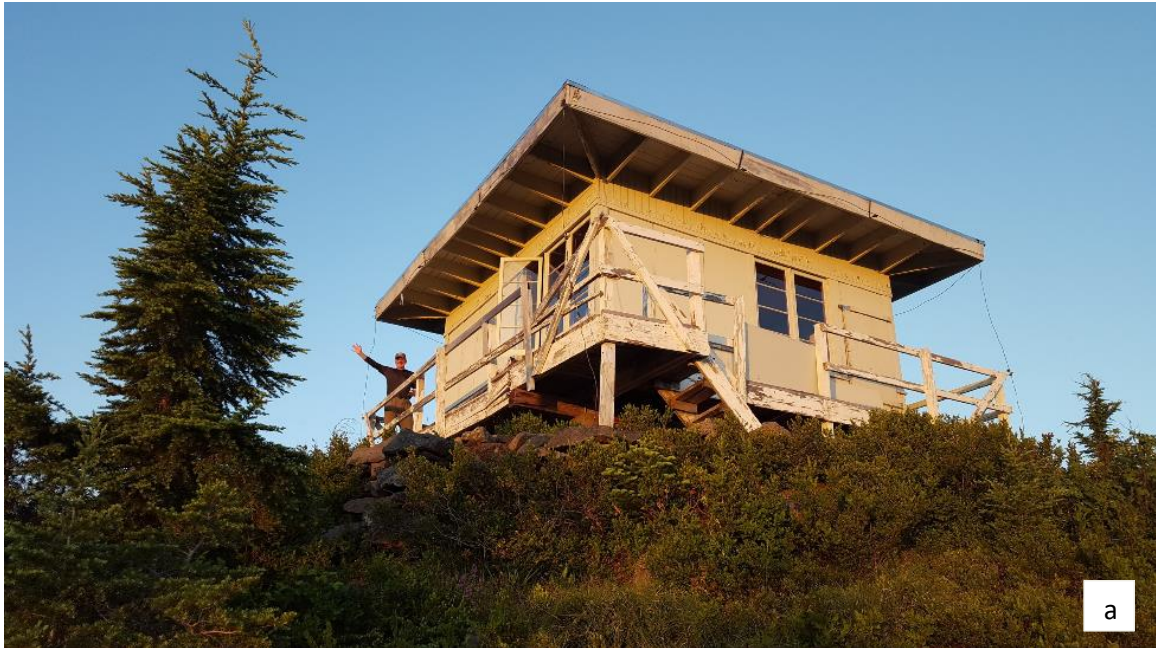
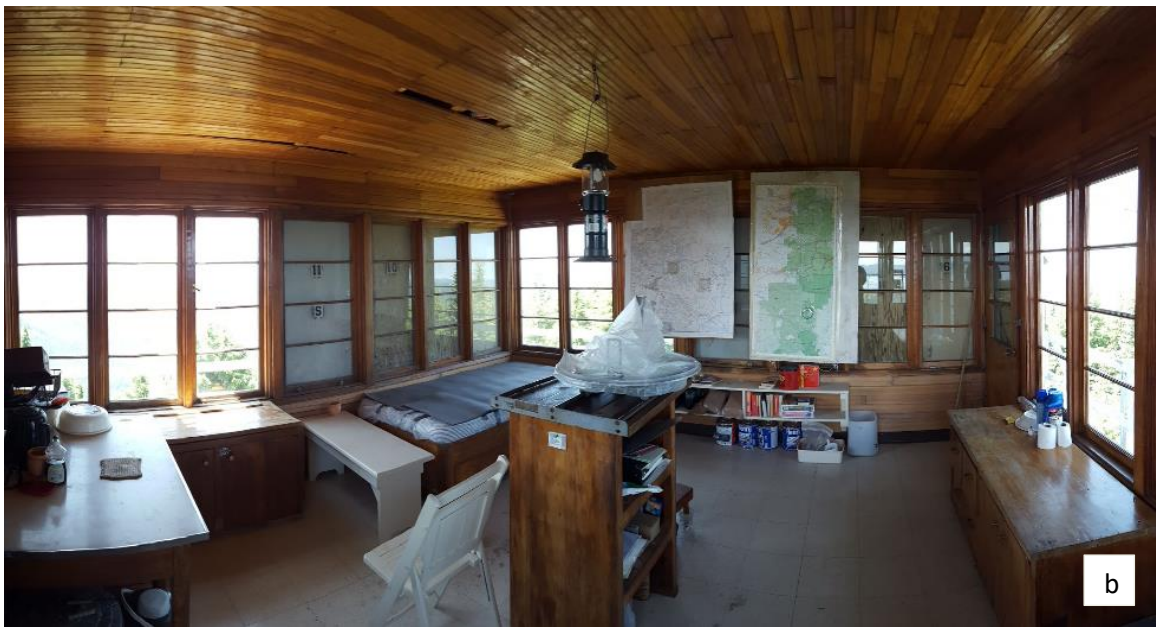
Figure 5.1 Exterior (a) and interior (b) views of Waldo Mountain Lookout in the Waldo Lake Wilderness, Willamette National Forest in July 2017. This building exemplifies the correlation between administrative use, appropriate maintenance, and sustained good conditions.

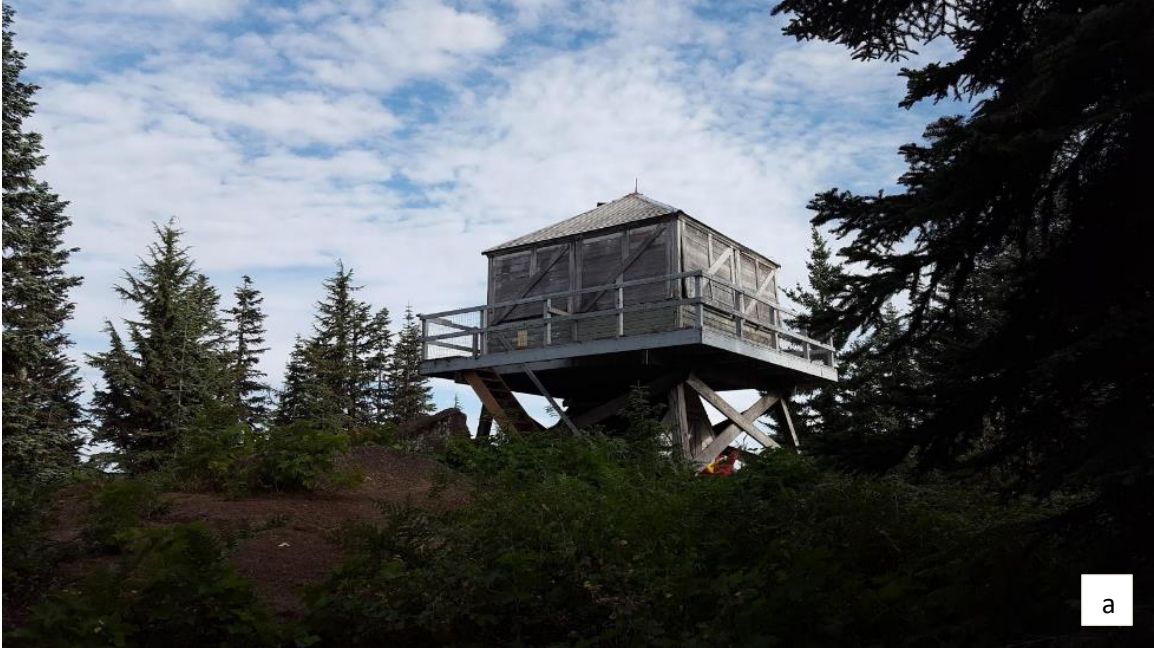
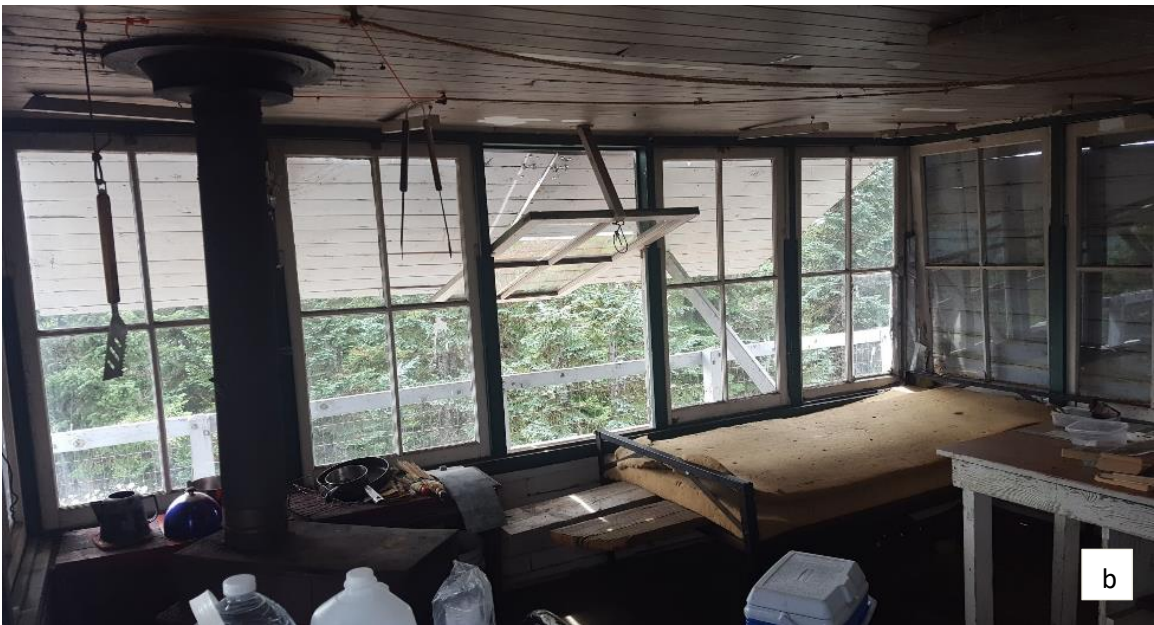
Figure 5.2. Exterior (a) and interior (b) views of Devil's Peak Lookout in the Salmon-Huckleberry Wilderness, Mount Hood National Forest in July 2017. This building exemplifies the effect of no administrative use and improvised maintenance on condition.

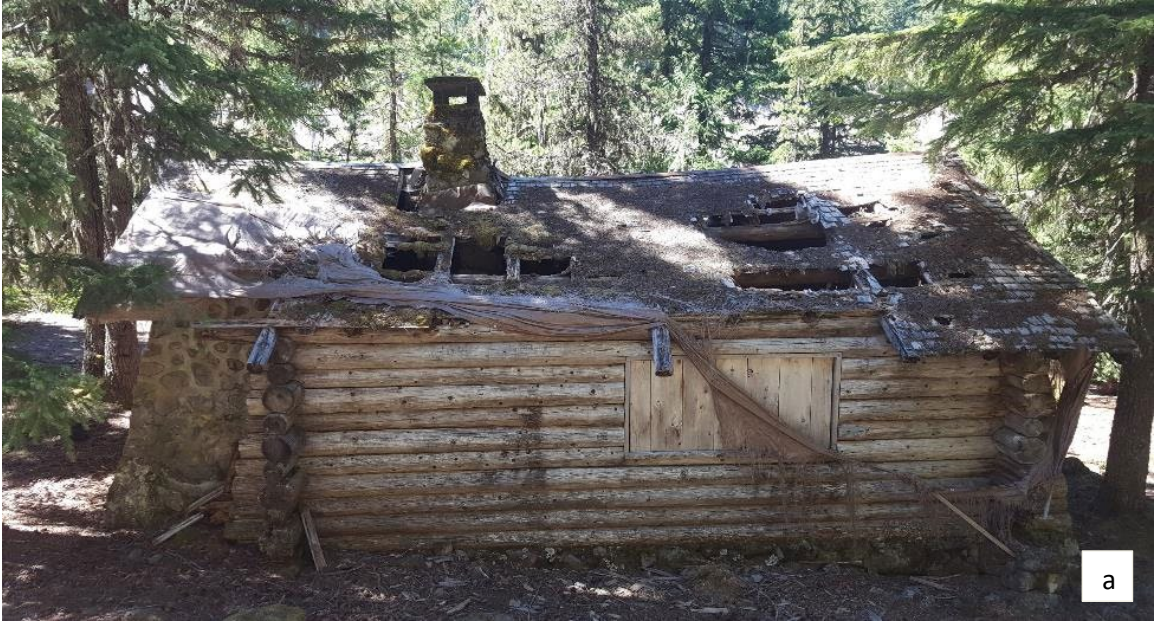
Figure 5.3. Exterior (a) and interior (b) views of the Upper Sandy Guard Station in the Mount Hood Wilderness, Mount Hood National Forest in July 2017. This building exemplifies the correlation between no active use (administrative or otherwise), no maintenance, and poor conditions.

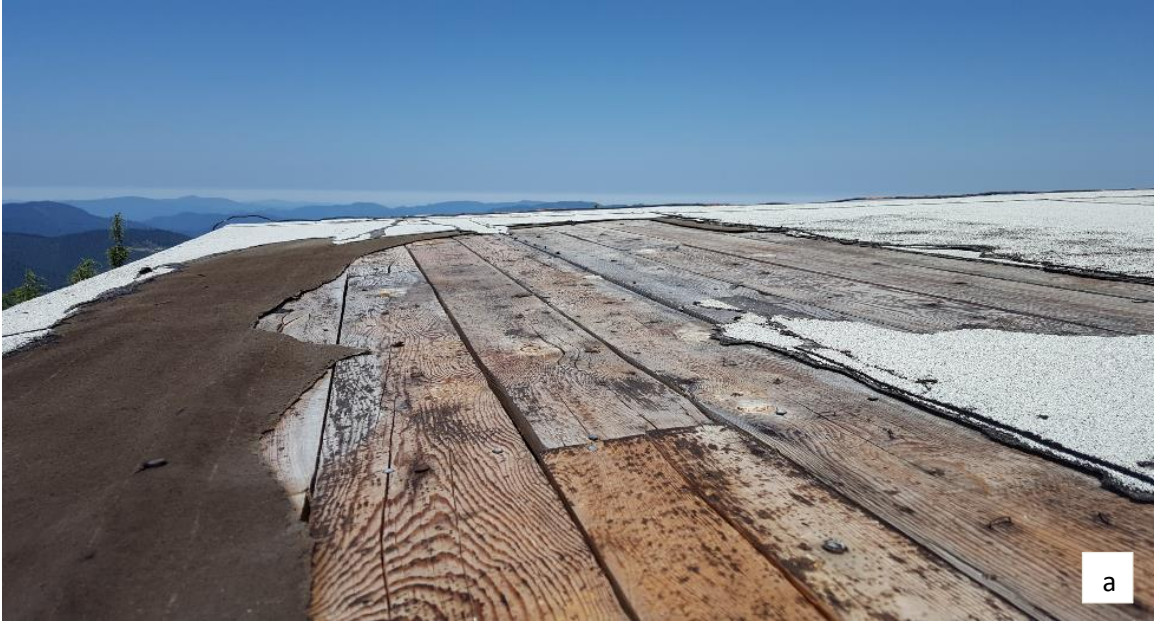
Figure 5.4. Preservation opportunities represented by (a) Waldo Mountain Lookout, which needs roof repairs in order to sustain its otherwise good conditions and high integrity, versus (b) Kinzel Cabin, which is in poor condition, require no urgent work items, and is a ruin.

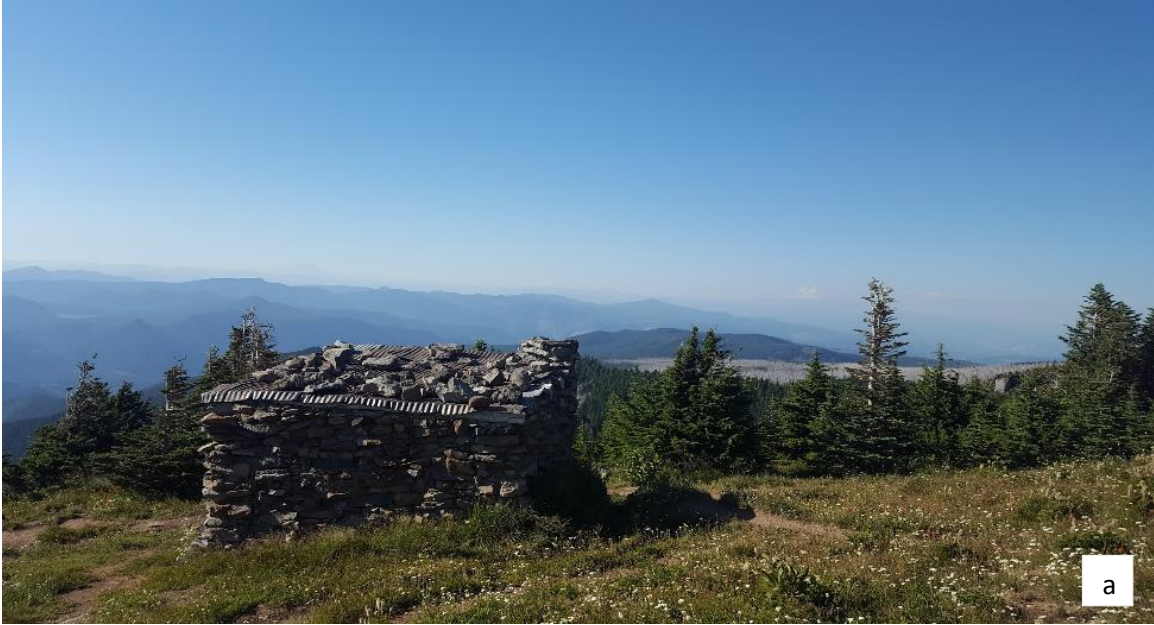
Figure 5.5. Preservation opportunities represented by (a) McNeil Point Shelter which is in fair condition, requires urgent roof repairs, but retains its integrity, versus (b) Cooper Spur Shelter which is in good condition, has no urgent needs, and has fair integrity impacted by the addition of a non-historic standing seam roof, rubber curtain, and orange spray foam insulation.

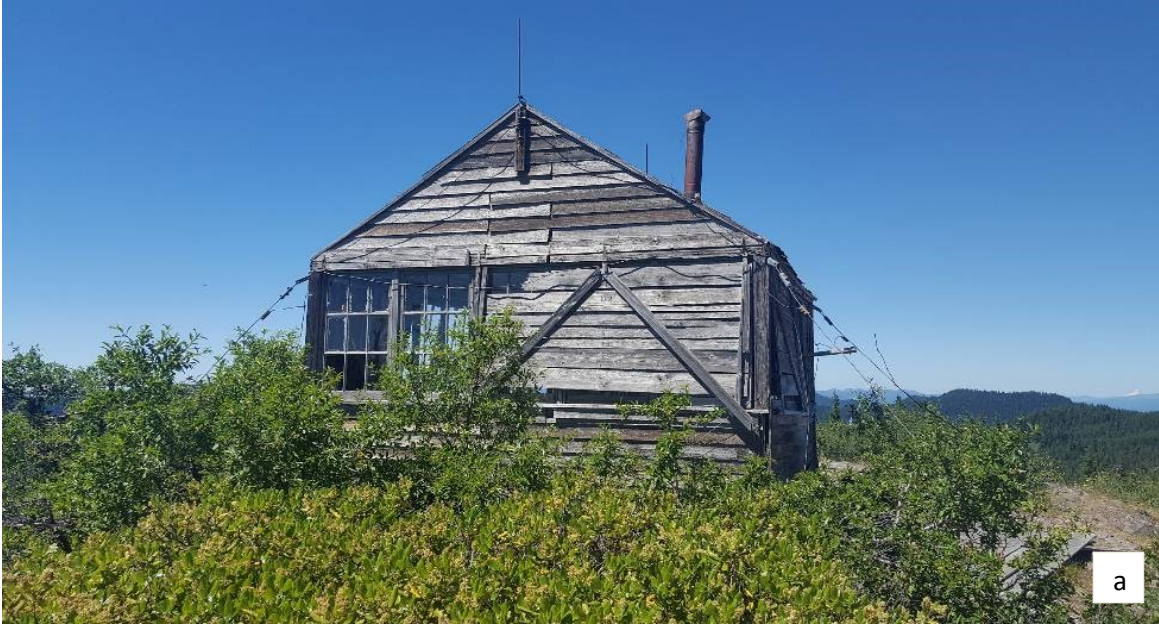
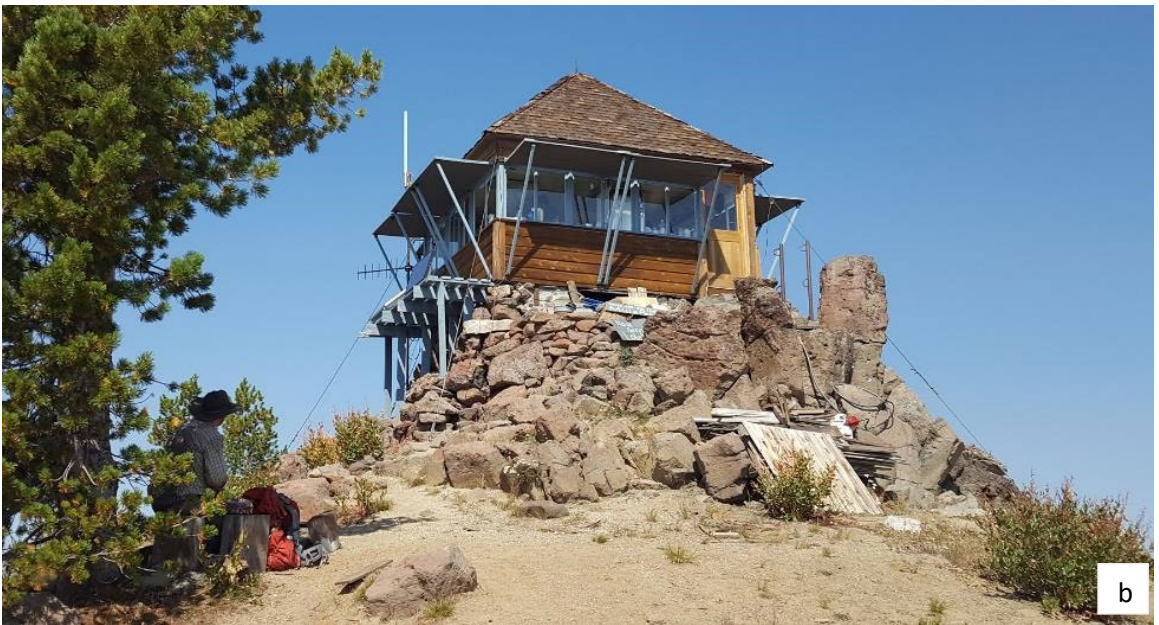
Figure 5.6. Preservation opportunities represented by (a) Olallie Mountain Lookout, which is in poor condition but retains integrity, versus (b) Mule Peak Lookout which is in good condition but has sustained some losses to integrity.

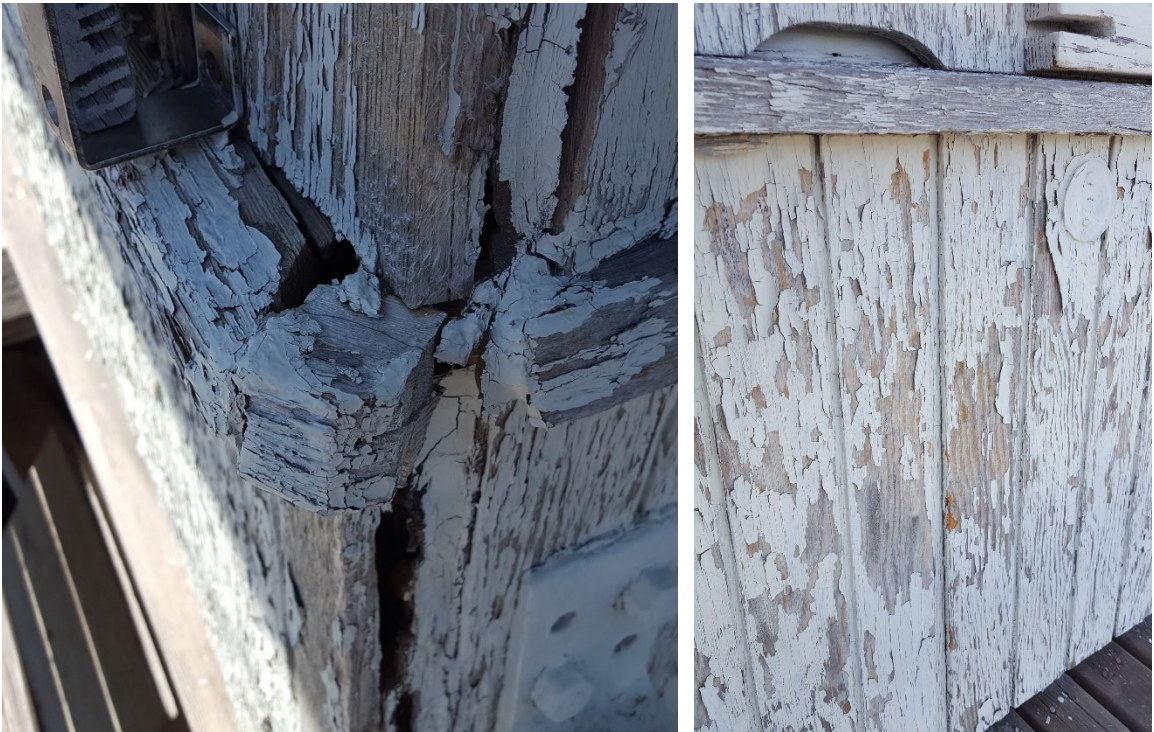
Figure 8. Photos of specific damage versus typical conditions

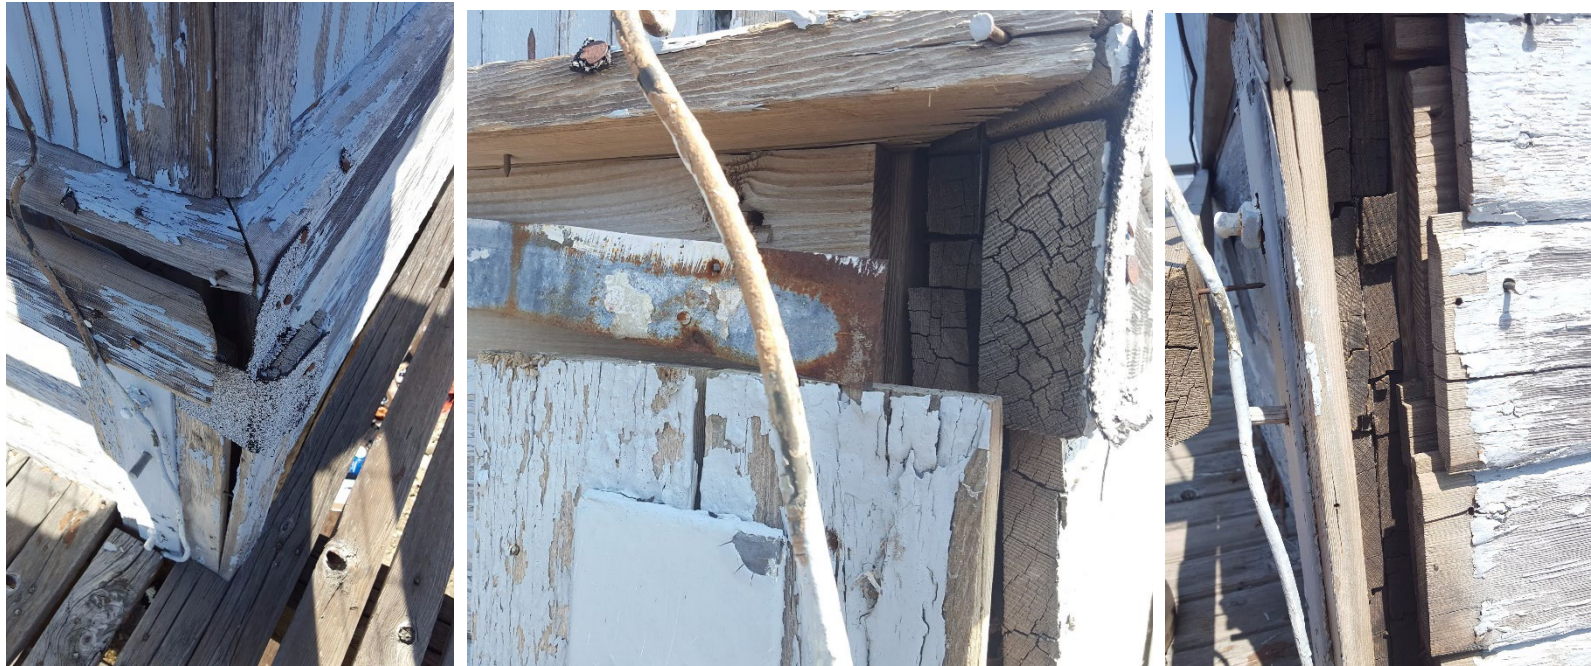
Exterior finishes - The lookout was previously treated with a light grey latex-based paint. Weathering, UV damage, and exposure have stripped almost all paint from the exterior, particularly on the southeast side. The lookout was also previously wrapped to preserve it from forest fires, and is now riddled with large rusting staples. *Recommended treatment:* remove staples from the exterior, test for lead, scrape surfaces, and apply primer and paint throughout.

Condition at the southwest corner

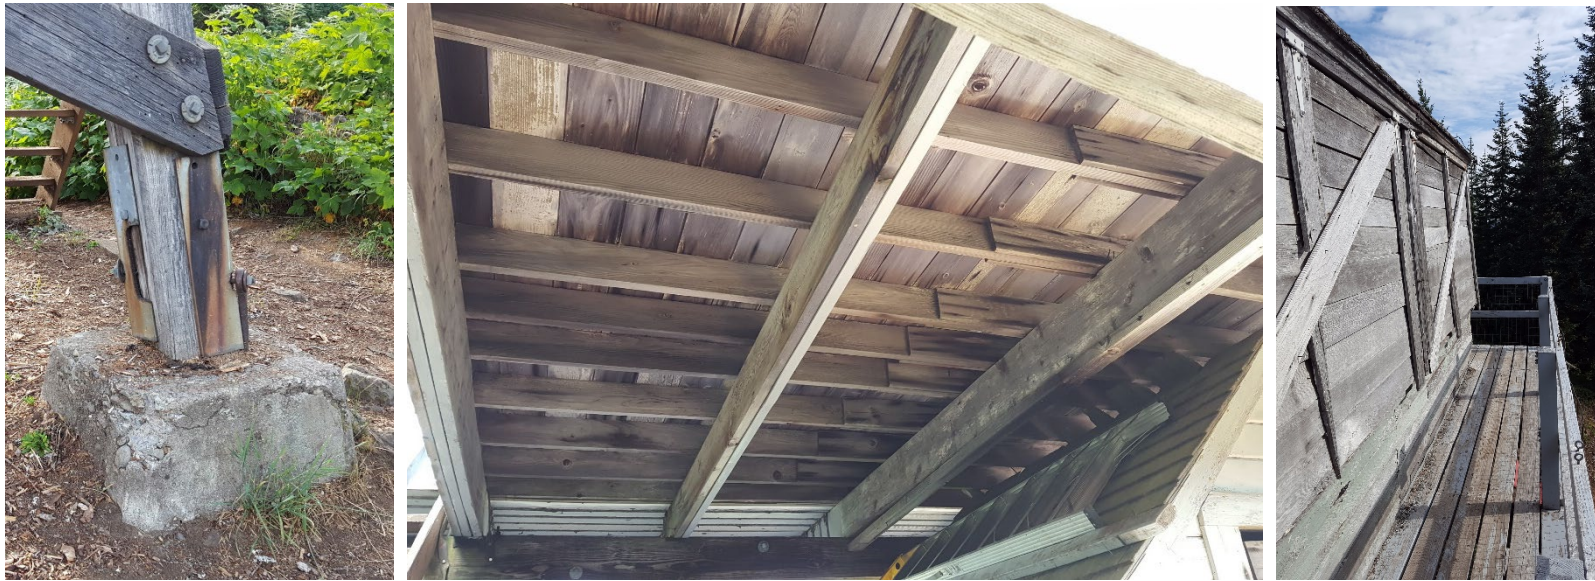
Catwalk - The catwalk deck and railing are in good condition.

Typical construction and condition of footing, tower, floor structure, and catwalk

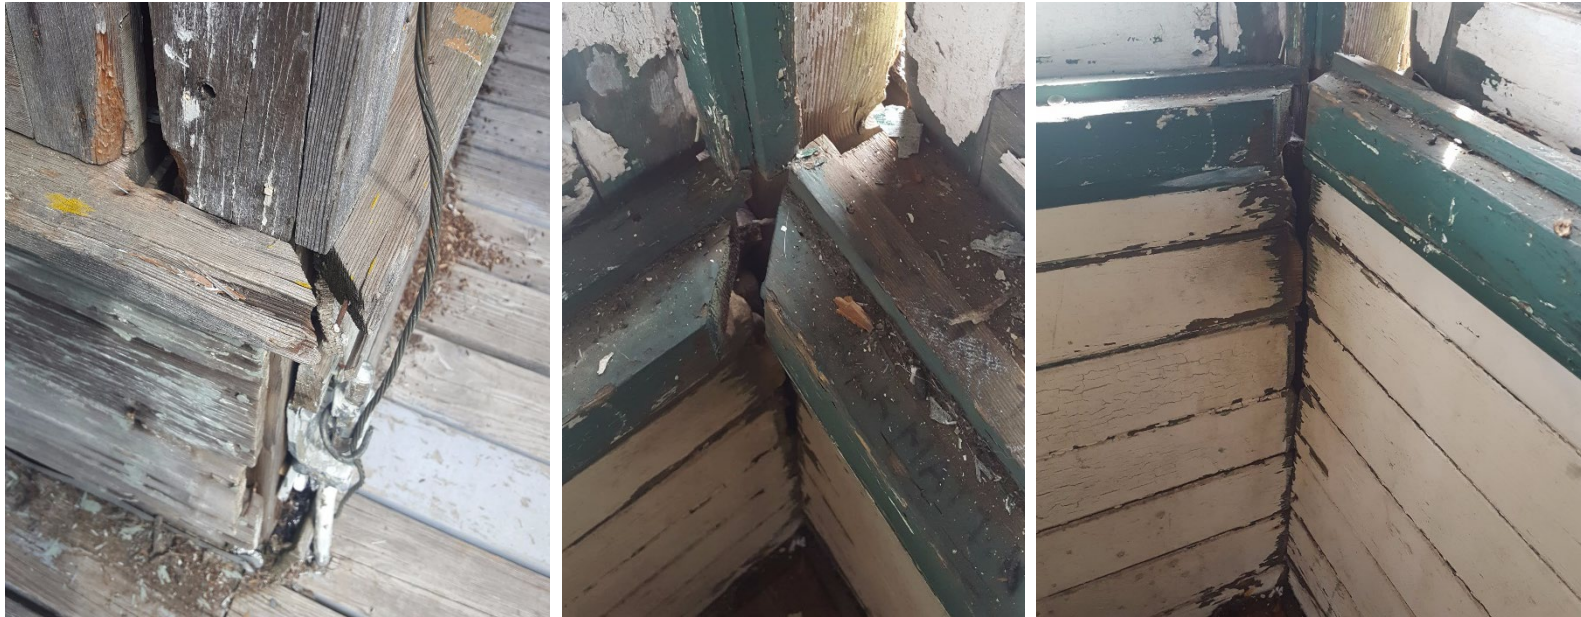
Separation of the south and west walls

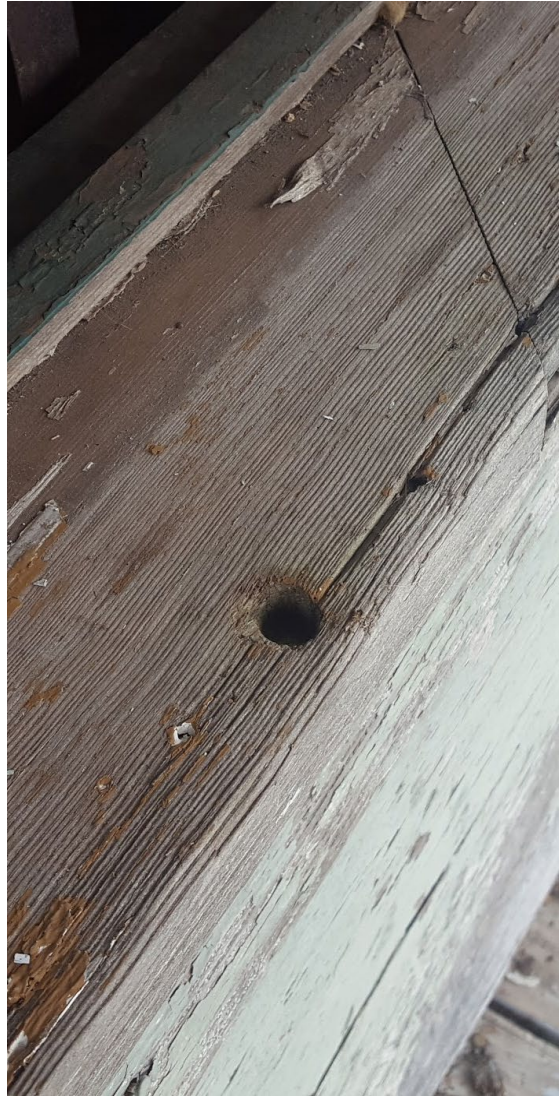
Typical condition, window sills

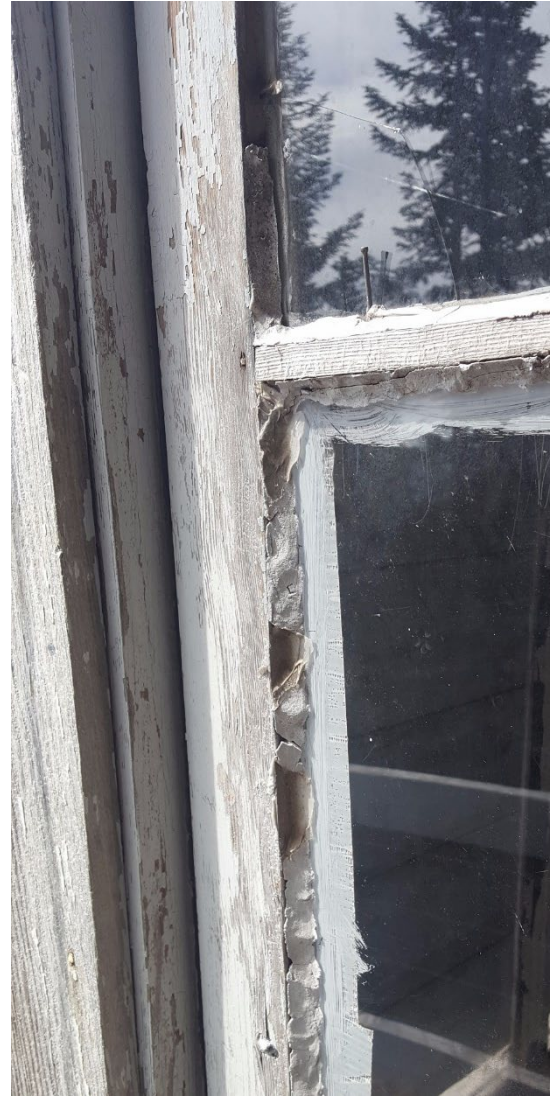
Typical condition, sash and glazing

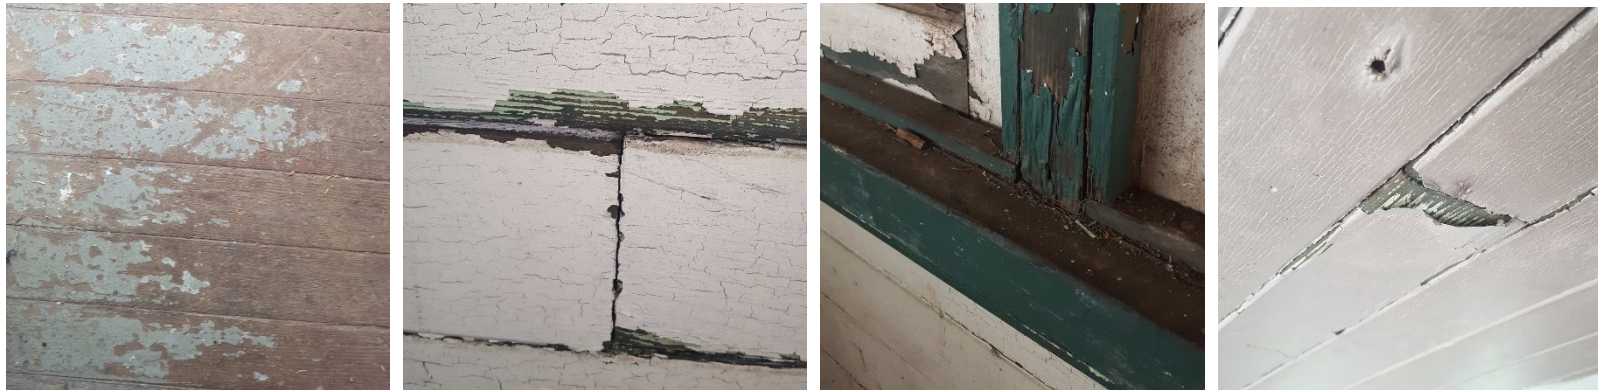
Interior finishes - All the interior finishes are in fair or poor condition. They have been stained by smoke, worn, and weathered. The failing paint indicated that several color campaigns have been used over the years. The floor paint is a light green over white, the walls and ceiling are painted white over light green and dark green, the trim is consistently dark green, and the window sash are painted white over dark green. *Recommended Treatment:* test for lead content; then clean, scrape, prime, and paint all surfaces. Further research is needed to identify the original Depression-era paint campaign that the Forest Service would have used. It may be appropriate to choose an all-white interior with a light green floor and dark green trim.

Typical condition of floor, walls, trim, and ceiling finishes

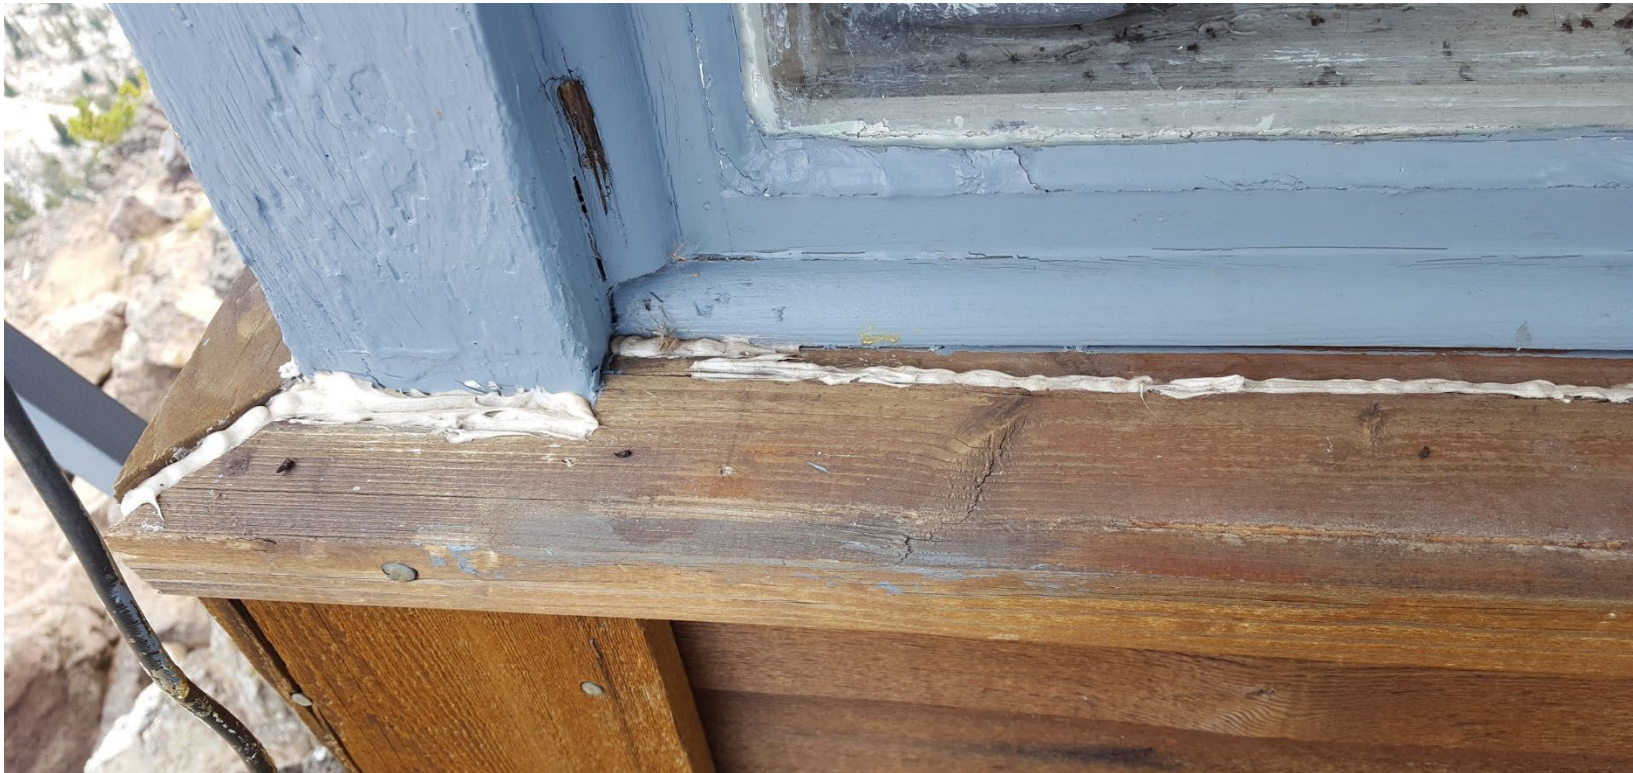
Windows sills - Like the shiplap siding, these window sills were replaced with cheap lumber that lacks a clear, straight grain. It is likely that they are even made of the same material cut into 14' sections which would be correctly sized for siding but too short for sills. The sills are unpainted and flat, rather than sloped to shed water. The undersides are treated with a bead of white caulk. Several have cracked and are unpatched or ineffectively patched with caulk. The ends of each sill should meet at a beveled corner, but the lumber is too short and each corner is patched with up to ½" of caulk. The window sills are intact but they appear to have been replaced along with the siding, and a combination of poor planning and poor craftsmanship has created an altered design that will not last as long as the originals likely did. If archival or maintenance records can confirm the original design, it could be restored. *Recommended Treatment:* consult records for a better understanding of original architectural details; then consider replacing window sills.

Typical condition of window sills, unpainted and caulked

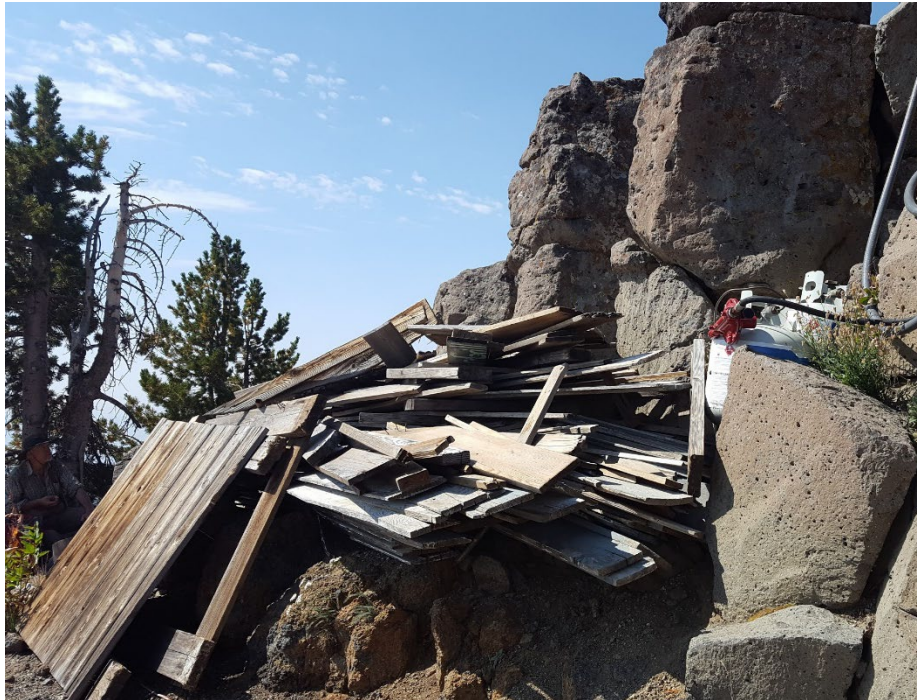
Fuel Storage - Propane and tools are stored on a flat spot adjacent to the building. A concrete slab further downhill on the east side used to provide a safe place for storing propane tanks inside a short wooden fence. Lookout staff relocated the propane supply because the concrete slab tipped. Propane tanks are connected to kitchen appliances and light fixtures inside the lookout via hoses that run through a gap in the foundation which allows access to the crawlspace. A large supply of firewood is also stored on the west side of the building.
Recommended Treatment: consider storing propane away from the lookout or phase out propane use in favor of solar power.

Slash pile, discarded lumber, and propane storage on the east side

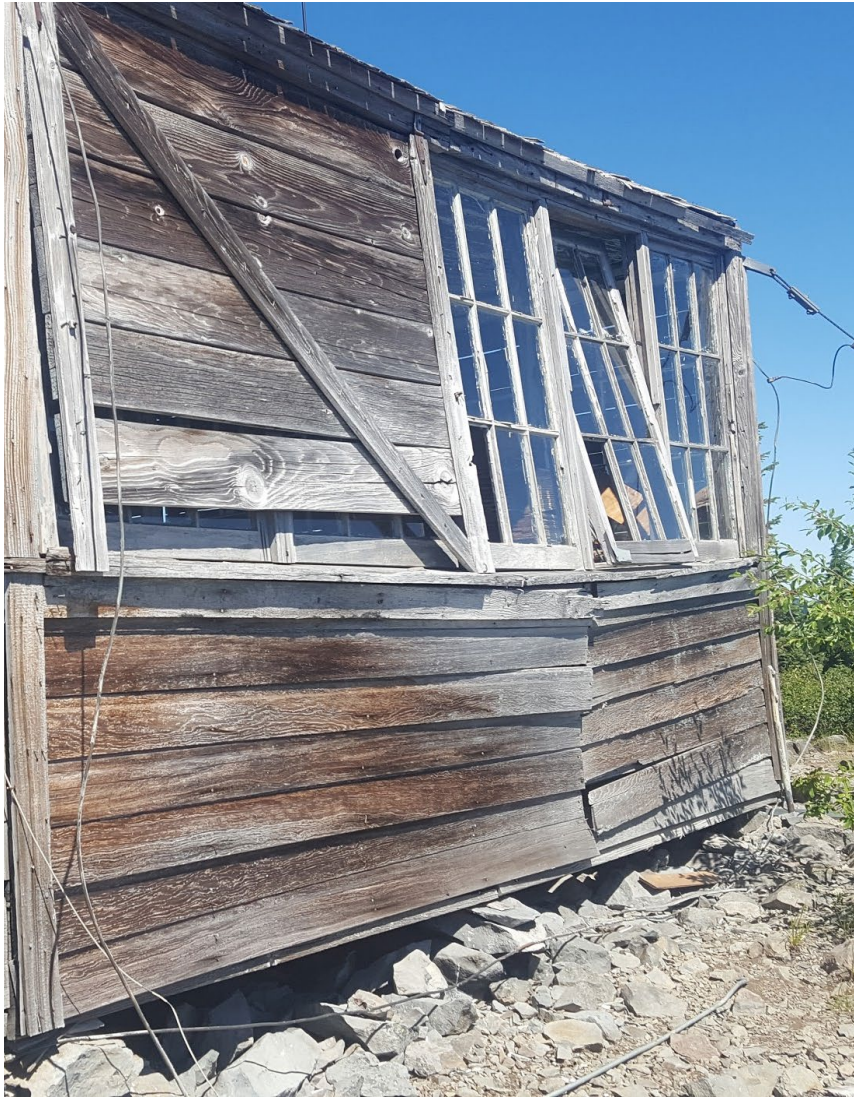
Wall Structure - The lookout is framed in nominal 2" x 4" studs spaced 2' apart and reinforced with diagonal braces. A temporary wall across the interior reinforces the ceiling and walls. All materials are in good condition, but a structural failure in the roof has placed the east and west walls in critical condition. These walls have buckled out approximately 6" from plumb. Nevertheless, corner-to-corner measurements across the interior indicate that the lookout is still primarily still square, level, and plumb despite the structural failures at the center of two walls. The east and west sides have hinged along a vertical axis (unsupported by the foundation) and a horizontal axis (weakened by a row of windows). *Recommended Treatment:* reinforce studs with additional 2x4s which will be concealed behind the siding. This may not be necessary if other structural concerns in the roof are addressed and seem to be sufficient.

East wall condition

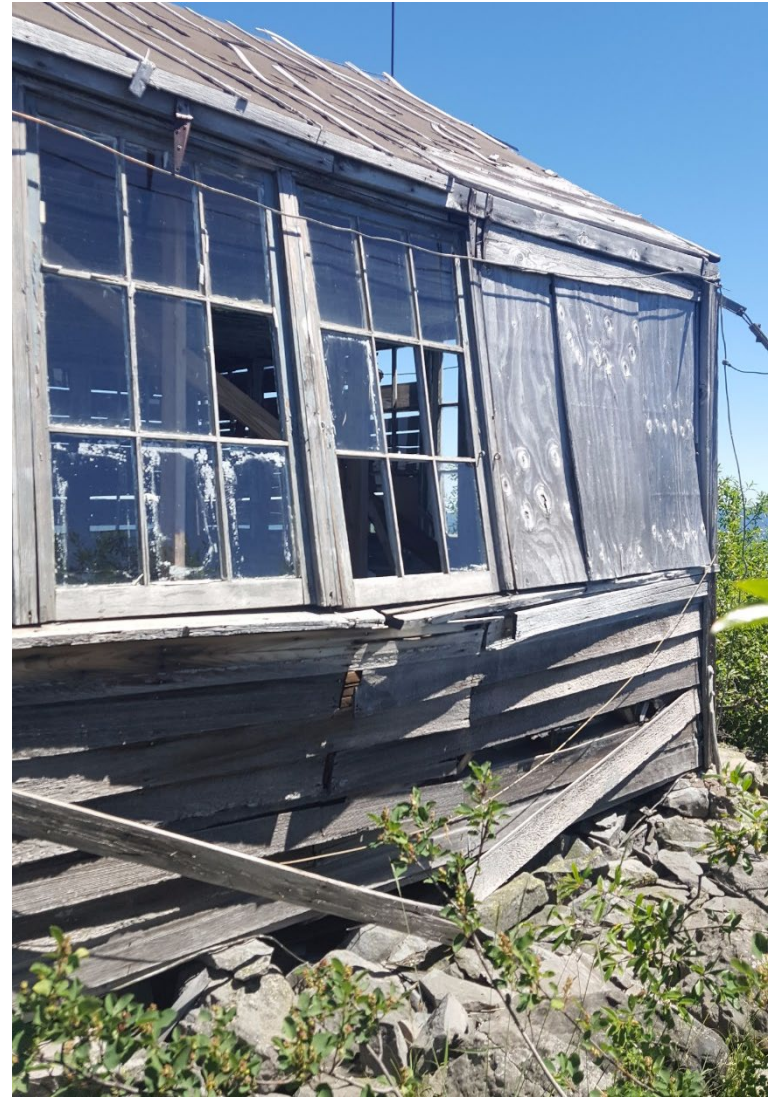
West wall condition

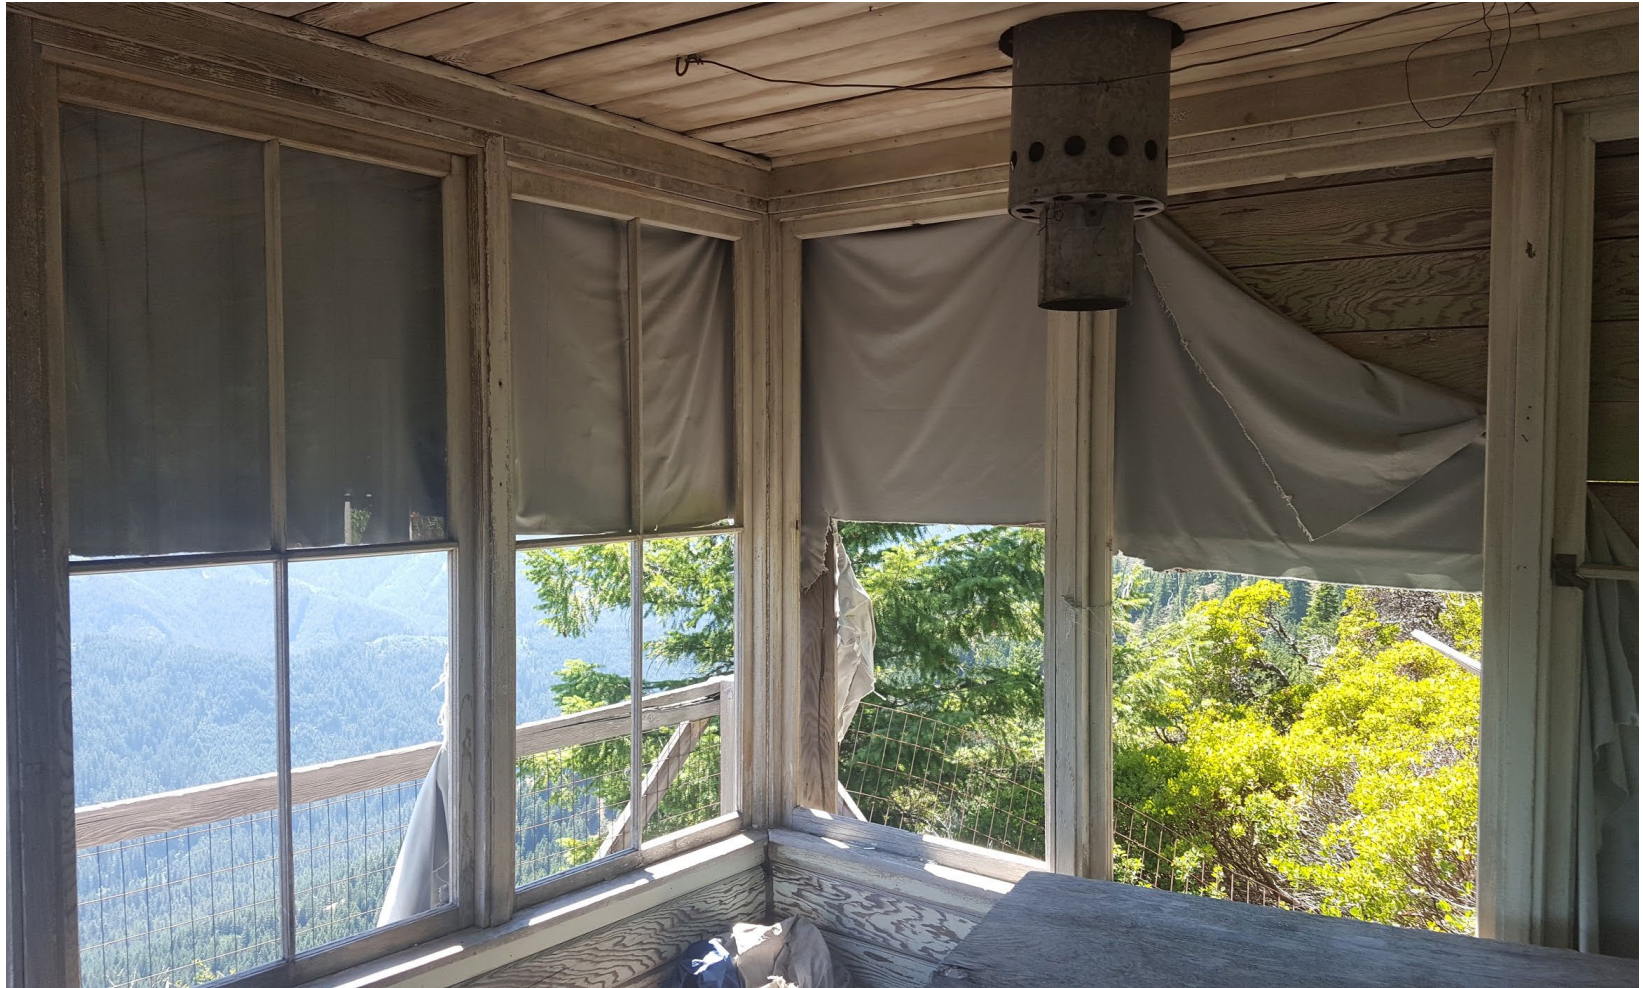
Windows in poor condition, with broken panes and muntins

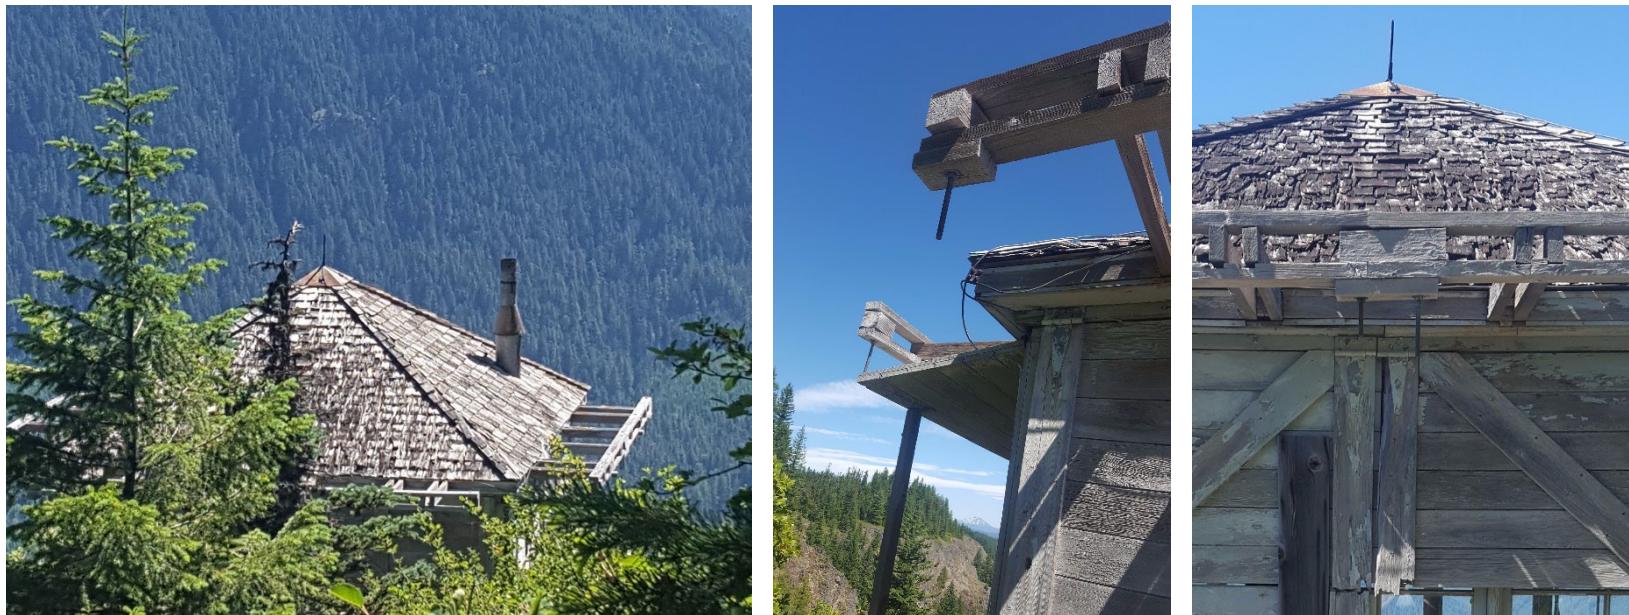
Roof cladding - The hipped roof was not accessible during this assessment but appears to be in critical condition. It has an estimated slope of 9/12 and is clad in cedar shingles with a 5” reveal. All shingles are ready for replacement.

Typical construction and condition of external rafters and shingle roof.

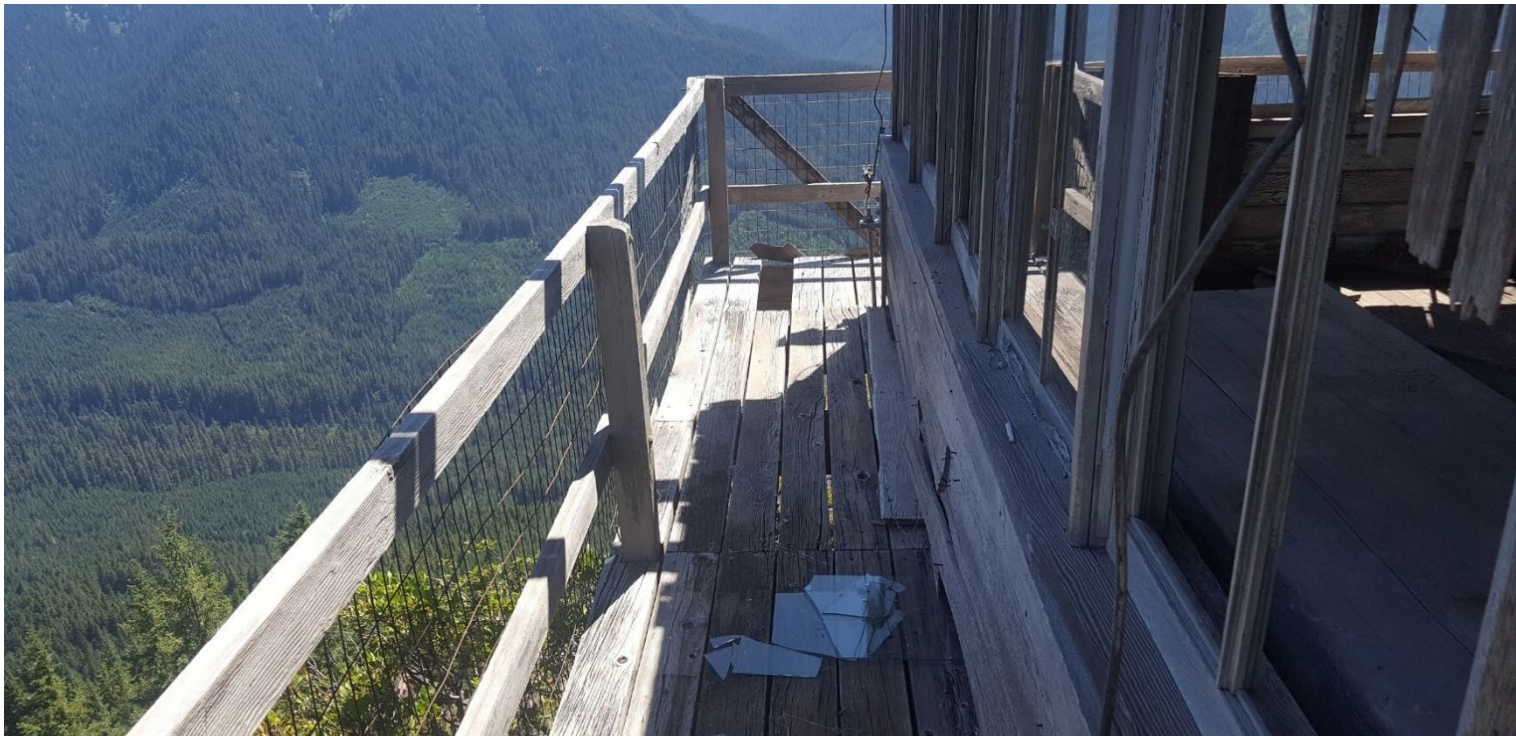
Weathered catwalk, broken glass, and broken windows on the southeast elevation

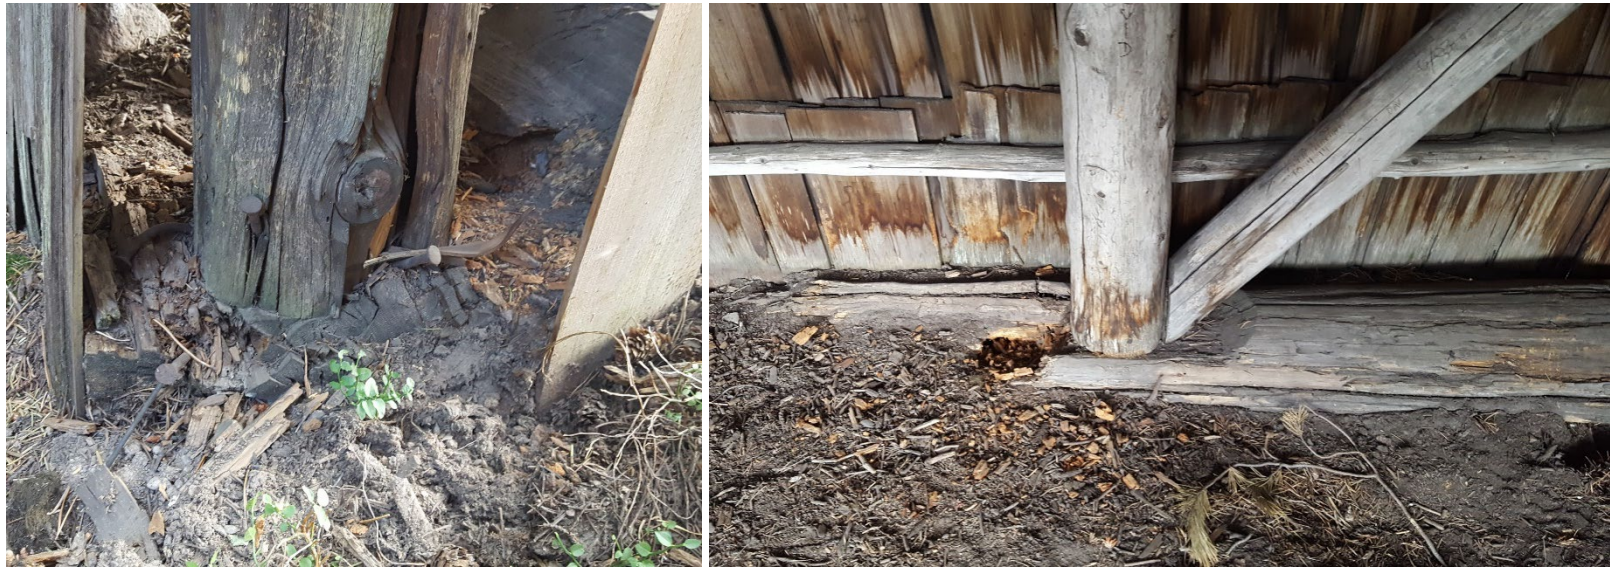
Posts - The shelter walls are framed in logs and clad in a mixture of cedar shakes and shingles. Eight of the ten posts have rotted where they meet disintegrated sill logs or directly touch the ground. Sills are causing posts to come out of alignment. Several posts are racked. The northeast corner has sunk by roughly 6" to 1'. The west posts have tipped such that the top ends have shifted west and the bottom ends have shifted east. The shelter has racked forward but its side walls are still plumb. Graffiti is extensive across the posts and beams, and it is irreversible. *Recommended Treatment:* replace each post in full or repair them by cutting off the rotten sections and splicing in new sections using scarf joints about 1' high.

Typical condition of sills and posts demonstrated by the northeast corner and the rear wall
