WILD NOTIONS:
PRESERVATION OF HISTORIC BUILDINGS IN OREGON WILDERNESS

A THESIS

Presented to the Historic Preservation Program,
and the Graduate School of the University of Oregon
in partial fulfillment of the requirements
for the degree of
Master of Science

March 2020

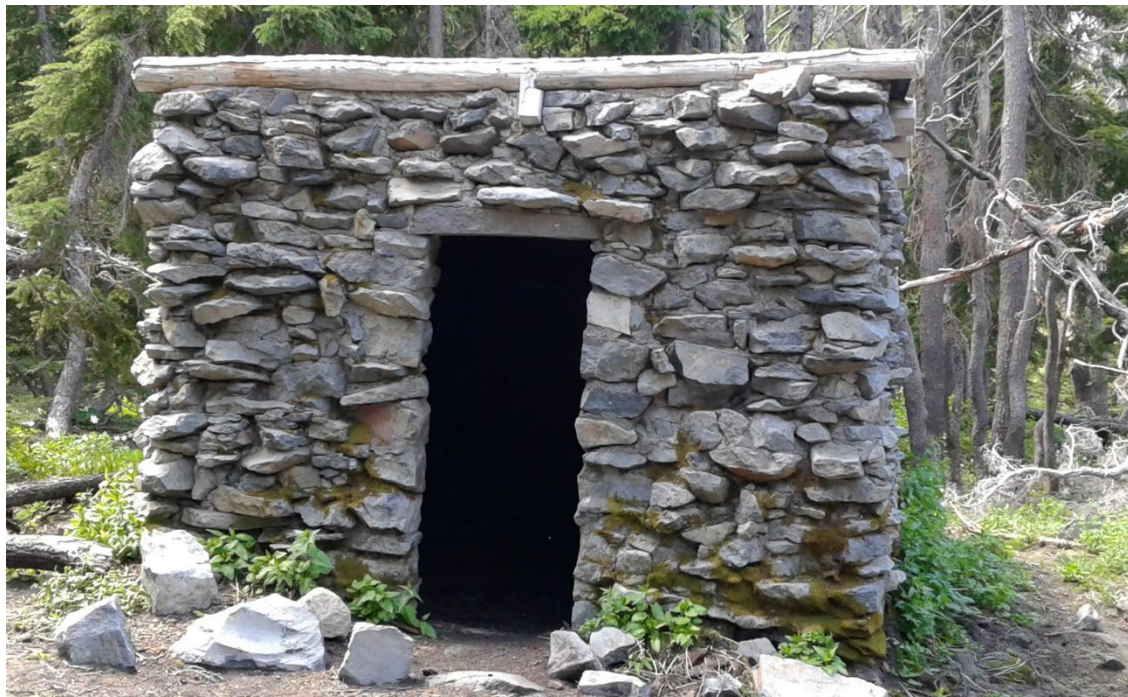
Walls - Cairn Basin Shelter has a 12' x 12' square footprint and masonry walls rising to a height that ranges from 9' at the front to 5'6" at the rear. The walls are in direct contact with the ground. A single entrance is located on center in the east elevation. The random rubble walls are 1' thick, smooth to the interior and rough to the exterior with no recognizable coursing. Masonry units appear to be a local igneous rock. On average, mortar joints are 1"-2" thick and applied with a rough or rustic technique. The strong, light grey mortar appears to have a high degree of Portland cement. Overall, the masonry is in good condition. Approximately 5% of exterior mortar has failed and exposed loose stones and small holes. The damage is exclusively cosmetic and has not lead to any structural damage. *Recommended Treatment:* walls can be repointed for cosmetic purposes, but this is not a significant work item. Loose or fallen chunks of mortar can be broken up with a hammer and dispersed around the site.

Typical wall construction and condition, north elevation

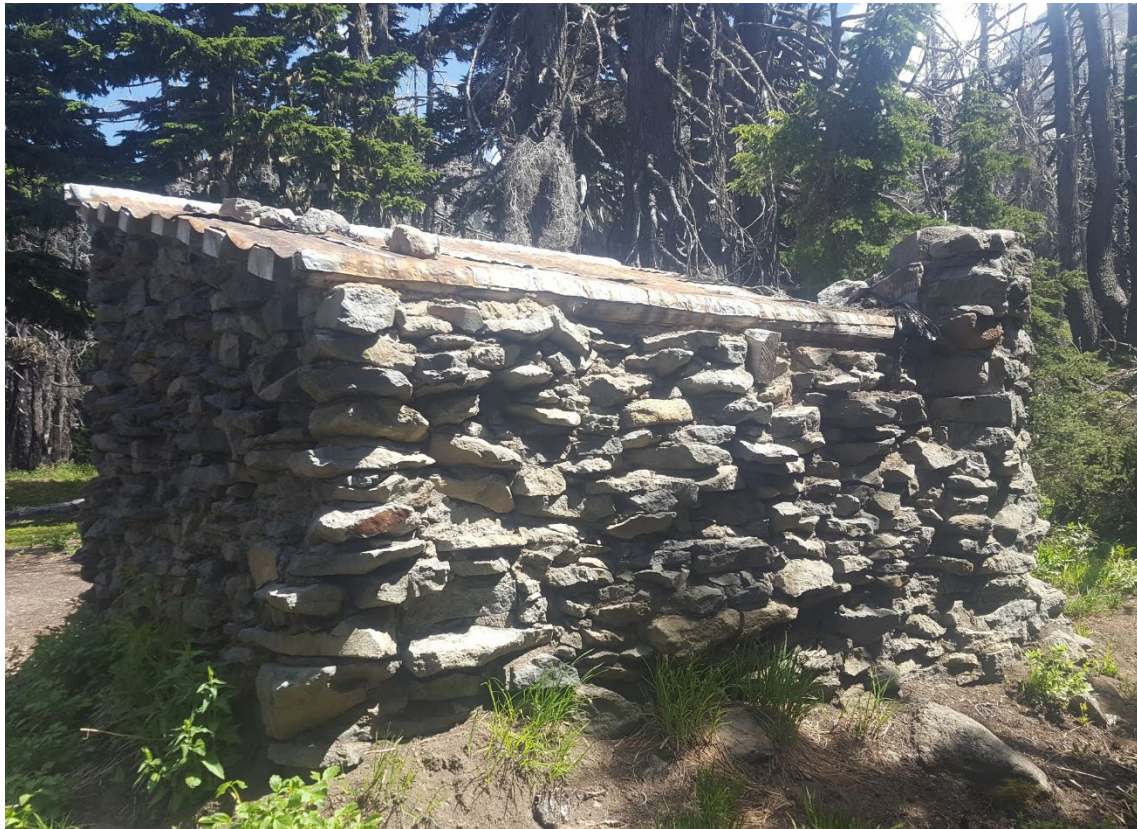
Chimney & Fireplace - A stone chimney located at the rear of the shelter creates a bulge in the exterior masonry wall at the southwest corner. It is in good condition. The chimney is uncapped and the flue is clear. The fireplace appears to be intact but is roughly built in comparison to the fireplace at McNeil Point Shelter. *Recommended Treatment:* if historical photographs or illustrations can be used to verify the original form of this fireplace at Cairn Basin Shelter, it could be repaired to match the original.

Rear elevation and chimney

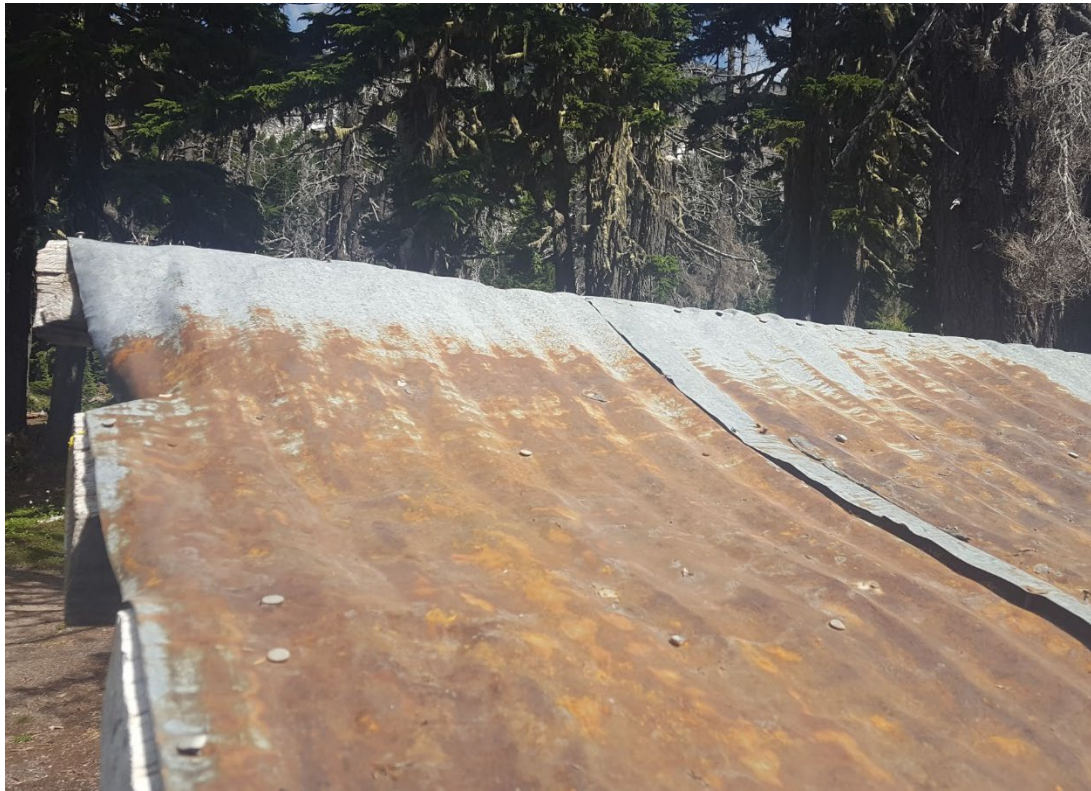
Typical roof construction and condition

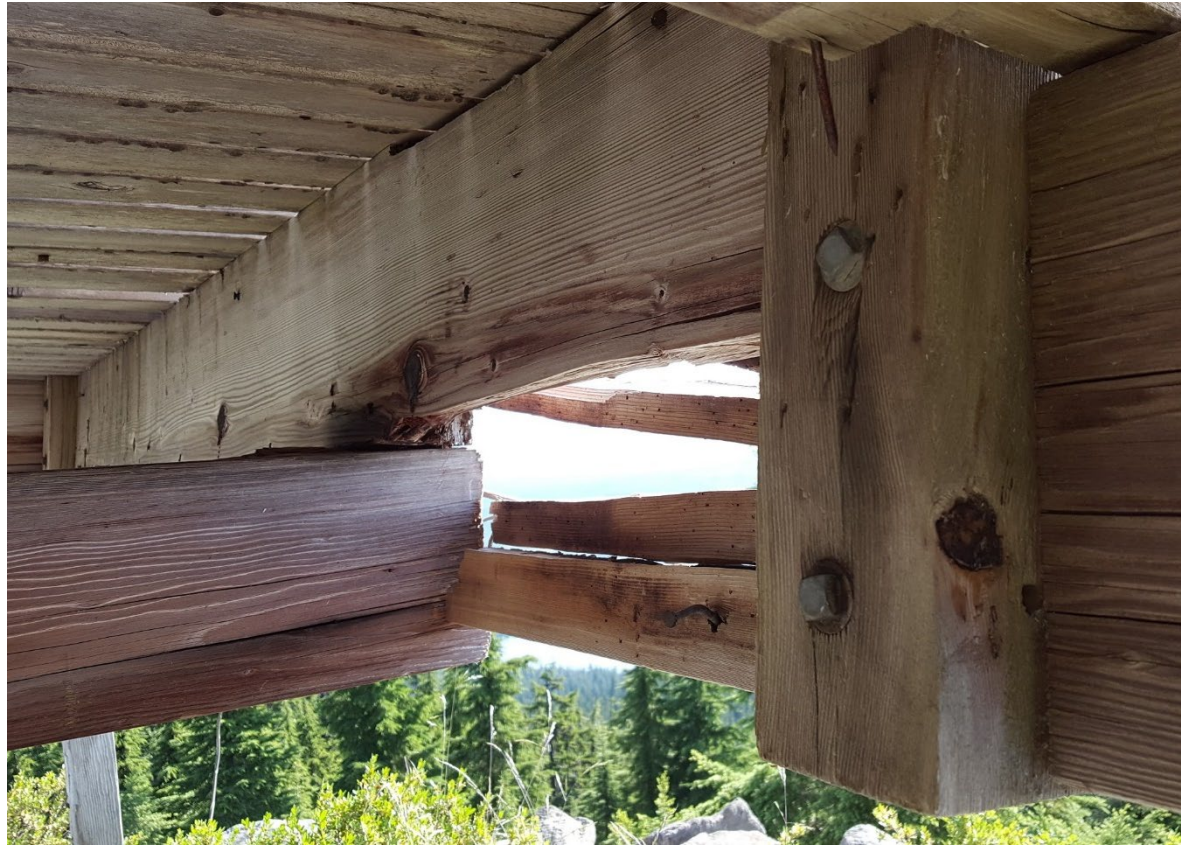
Damaged section of the catwalk on the east elevation

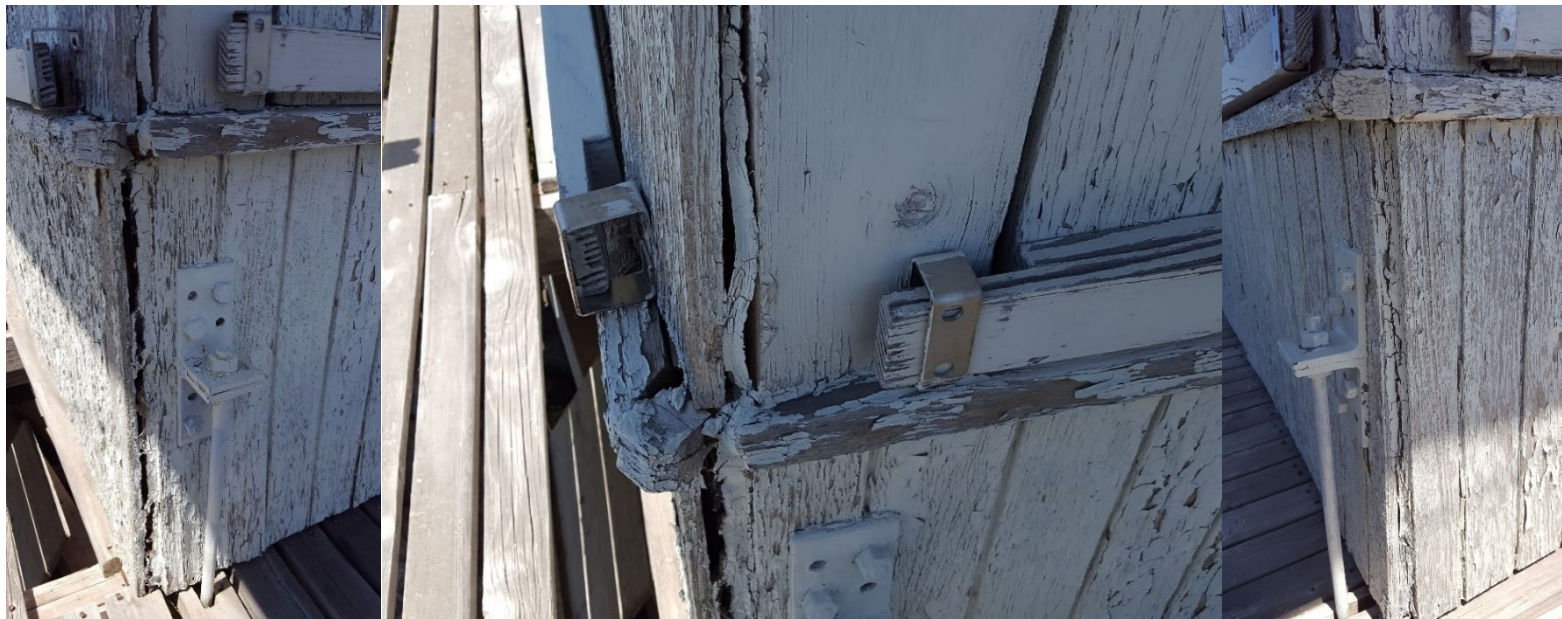
Condition at southeast corner

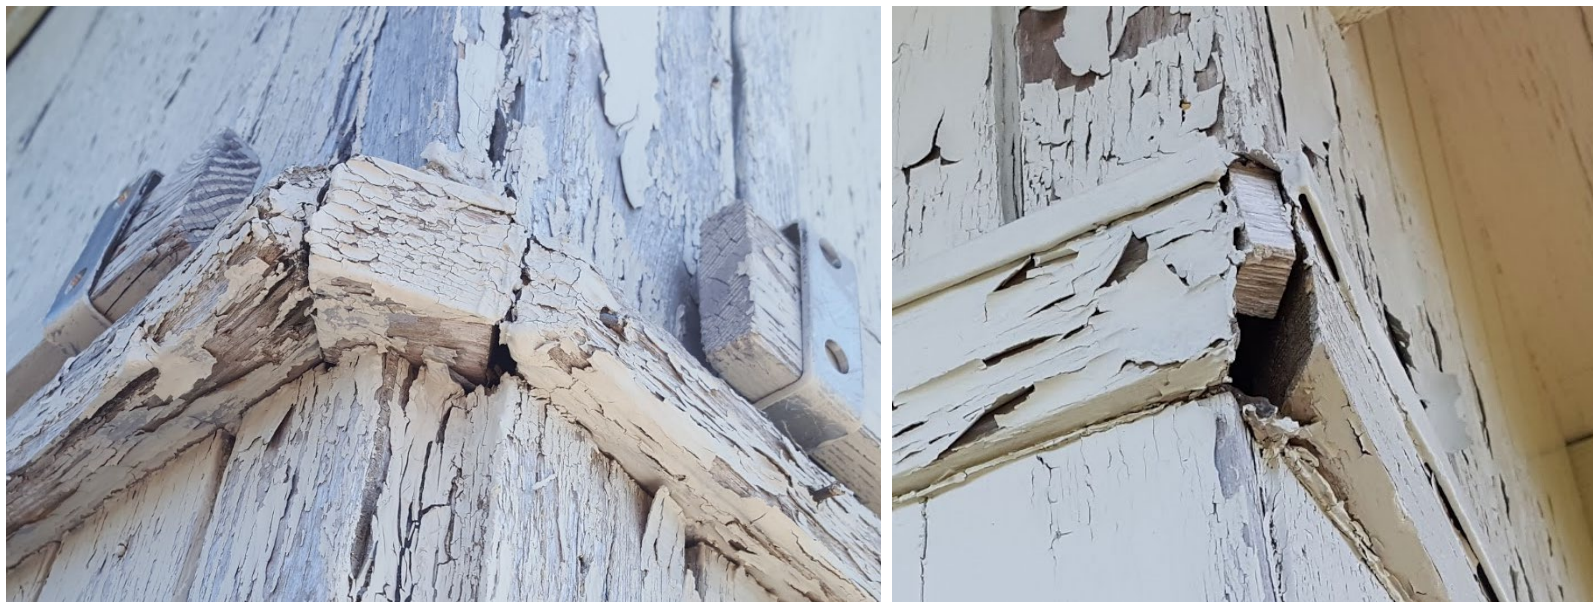
Typical construction and condition of trim below windows, above windows

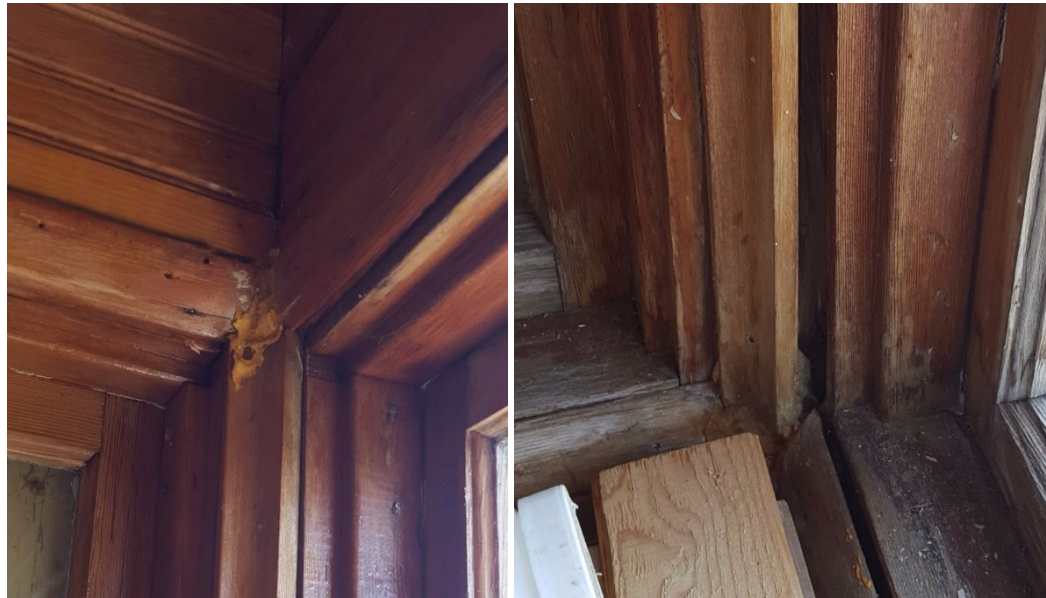
Trim and wall condition at the southeast corner
