STORIC STRUCTURES REPORT

STIMSON-GREEN MANSION AND CARRIAGE HOUSE

*TERMINAL PROJECT
TOWARDS PARTIAL FULFILLMENT
OF A MASTERS OF SCIENCE
IN HISTORIC PRESERVATION*

WINTER 2002-2003

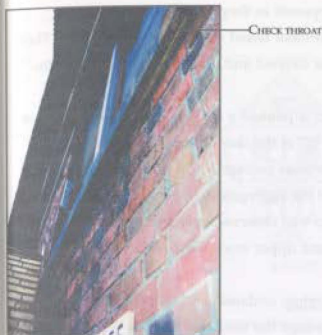
Fig. 3.3.1.10

Extensive re-pointing of the brickwork over nearly entire facades—south, west and north—is evident as well as spot re-pointing on the east facade—primarily at basement level with some at the first floor level. Some patching, such as around the faucet on the east facade, is also evident. These were done with hard light gray and dark gray to black mortars having multi-sized to fine, often multicolored aggregate. Repairs were layered over previous repairs. Joints finishes included: struck joints; finished at the brick face with a rough surface; or spread onto the surface of adjacent brick.

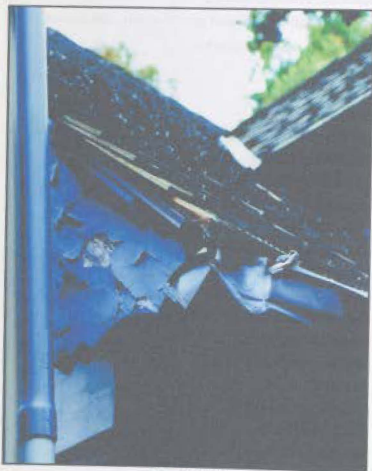
Fig. 3.4.2.8

CONTEMPORARY PHOTOGRAPH SHOWING THE GUTTER DOWNSPOUT OFF THE NORTHEAST CORNER OF THE CARRIAGE HOUSE. NOTE EXTENSIVE VEGETATION GROWTH AT BASE.

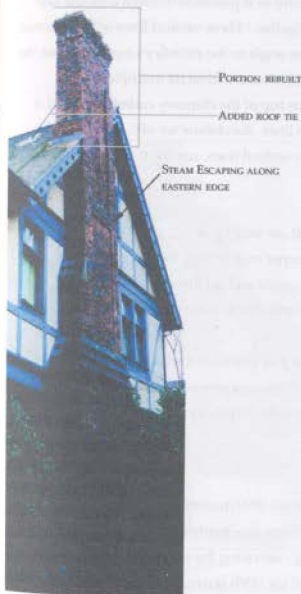
Fig. 3.6.2.1

- re-pointing with light-gray, fine aggregate, hard mortar—evident at base of chimney. The joints were struck. This mortar is over a dark gray, medium-hard mortar having multicolored, exposed aggregate. Areas where the repairs are failing indicate the re-pointing was superficial and that joints were not sufficiently raked out. This repair continues over all of the basement and first story heights;
- at the second story and above are partial repairs to joints;
- upper portion of chimney rebuilt following the February 2001 earthquake (roof ties added at this time).

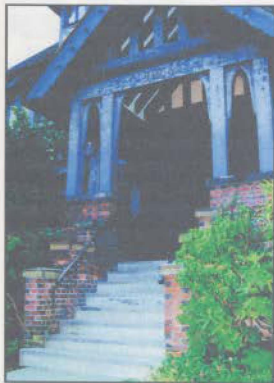
Fig. 3.7.1.1.3

CONTEMPORARY VIEW OF CEMENTITIOUS REPAIRS TO SANDSTONE CAPS ON SOUTH WALL OF MAIN ENTRY PORCH. NOTE HOW TIMBERS ARE CUT TO RECEIVE WASH.

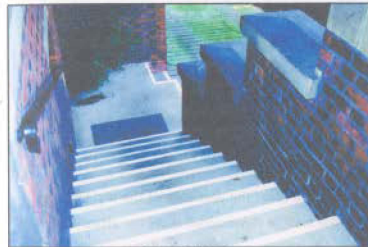
Fig. 3.7.1.3.2

Stone copings exhibit mortar loss from the joints and an overall light soiling. Green growth is on the tops of the sandstone copping.

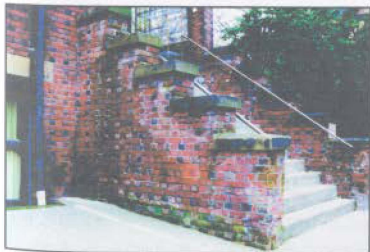
Fig. 3.7.1.4.1

On the north cheek is a diagonal crack at the step located second to the top and extending west to the capstone, as well as extensive dark coloring of the brick (suggesting a high moisture content), green growth and spalling of brick at the lower end.

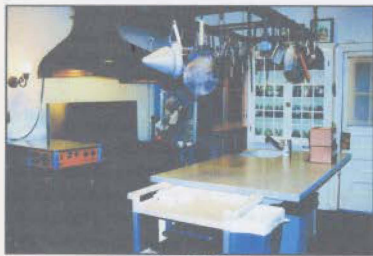
Fig. 3.8.1.8

- plaster was painted off-white. Cracks in the ceiling extend diagonally from the southwest corner to the northeast corner stopping at the light in the center of the room—the undated (ca 1899) ground floor plan
