Edwards, Allen

ALMA103109

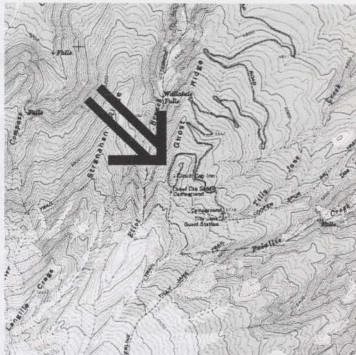
Fig. 2 Location of Cloud Cap Inn. Note switchbacks in the steep Cloud Cap Road and the proximity of the inn to the Eliot Glacier.
USGS *Mount Hood North, OR.*

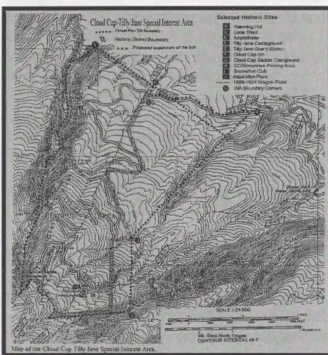
Fig. 7 USFS Map of the Cloud Cap/Tilly Jane Special Interest Area and Historic District boundary. USFS

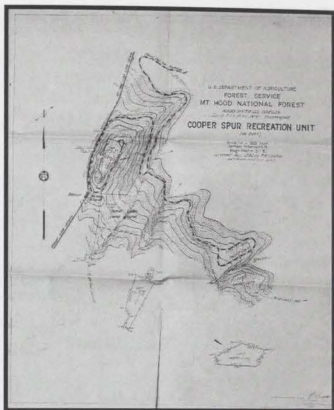
Fig. 16 This USFS map indicates the path of the proposed tramway through the Cloud Cap site. USFS collection.

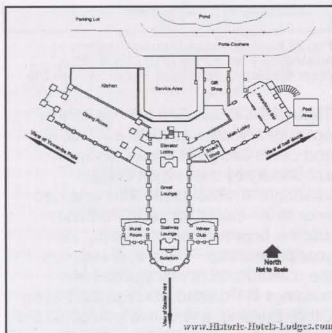
Fig. 23 Ahwahnee Hotel floor plan.
www.historic-hotels-lodges.com/California/ahwahnee-hotel/tour/photos/ahwahnee-floorplan.gif accessed 2/21/2012.

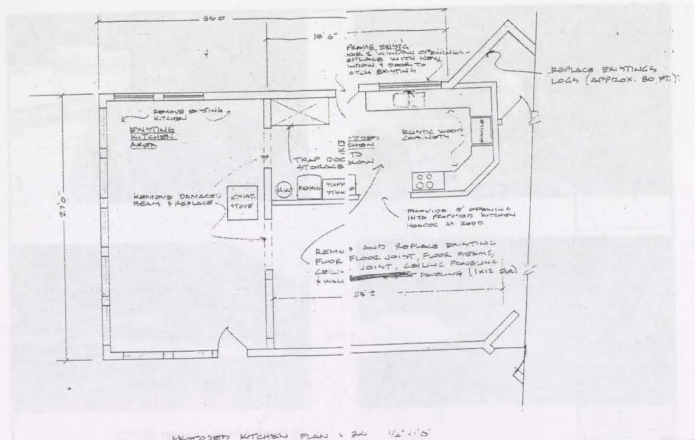
Gorge Engineering Inc.
White Salmon, Washington
509.493.4151

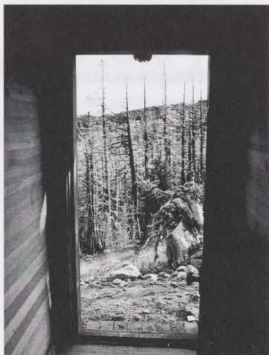
Fig. 49 The proximity of fire damage to the inn is currently highly visible. View SE out the west wing doorway.

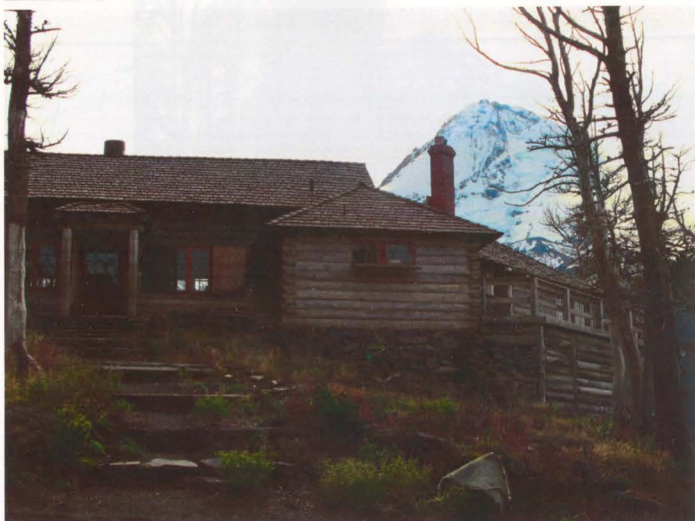
Fig. 50 The Cloud Cap Inn view looking south.

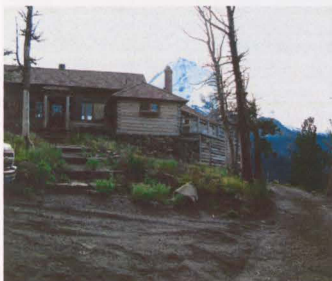
Fig. 52 Cloud Cap site at entrance. Note vehicle induced erosion and deterioration of stone barriers along road and path. Facing S

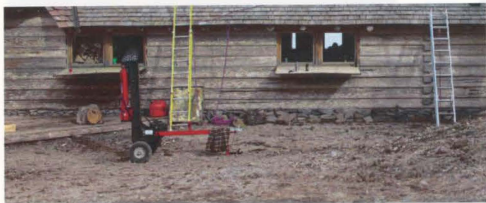
Fig. 60 The east wing foundation is in good condition from repairs in 2006.
Facing NE

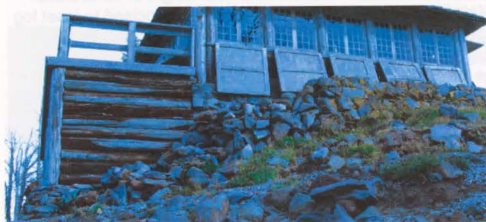
Fig. 61 The west wing foundation is in good condition. Note some deterioration to rock pile. Maintain rocks annually as they shift and reduce support of west wing foundation.
Facing E

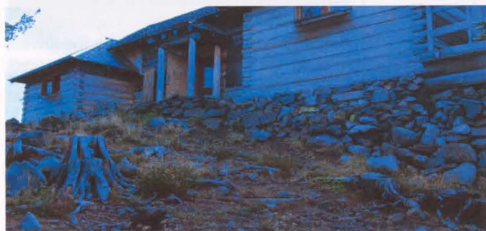
Fig.62 The central hall foundation of the north side is in good condition.
Facing E

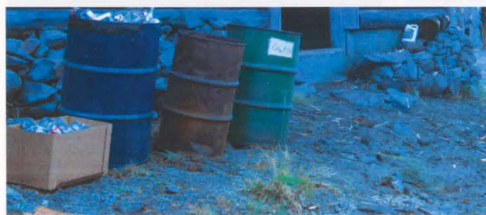
Fig.63 The foundation on the north side of the west wing is in good condition. Rocks applied to the outside of the modern concrete foundation should be reapplied around the basement doorway.
Facing SW

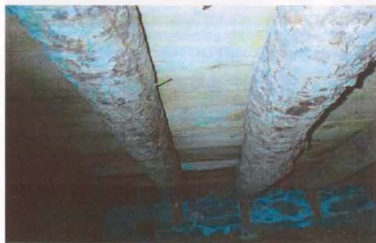
Fig. 69 2002 photo by Nancy Niedernhofer, from Oregon SHPO collection. Floor joists in west wing. Facing W

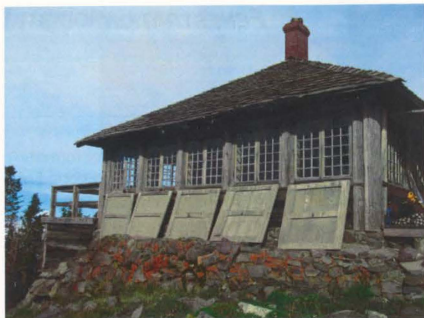
Fig. 83 18-lite wood casement windows on west wing. View facing NE

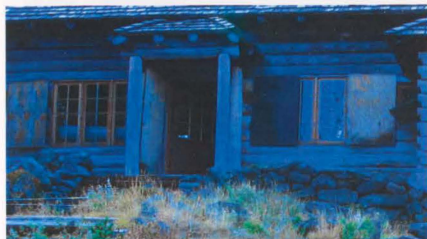
Fig. 84 8-lite casement windows on central hall. Note evidence of moisture trapping at sill level from shutter. View facing N

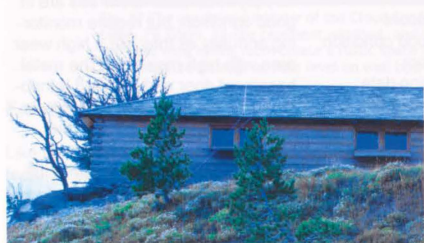
Fig. 85 Single-lite hopper windows on east wing. View Facing W

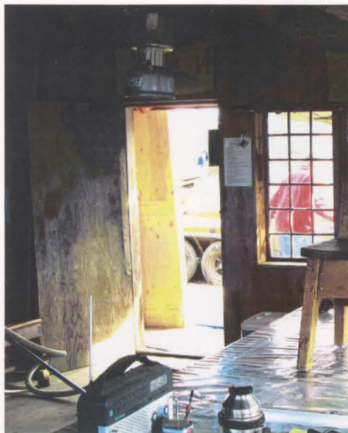
Fig. 86 The west wing exterior door is the only door experiencing deterioration and is a temporary plywood door. View facing E

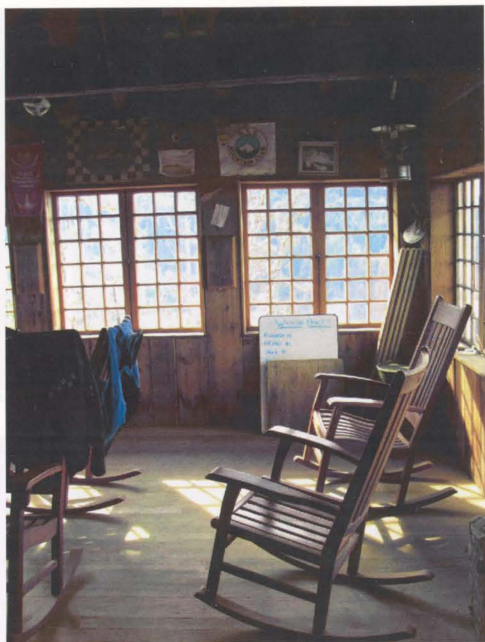
Fig. 87 The unadorned interior of the Cloud Cap Inn is remarkably hospitable. Fir floors, 18-lite casement windows, and heavy timber framing in the west wing dining room create a rustic space bathed in natural light. Note moisture damage at floor level on wall boards. View facing SW

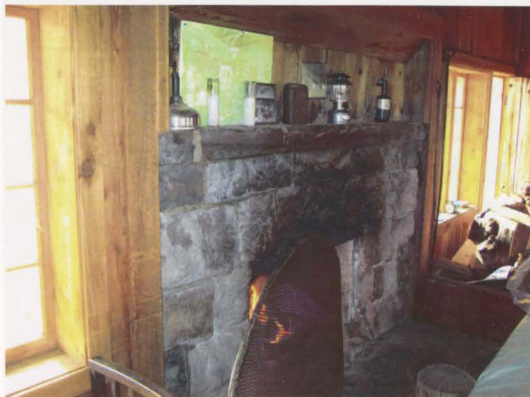
Fig. 88 Hearth and south wall in central hall.
View facing NE

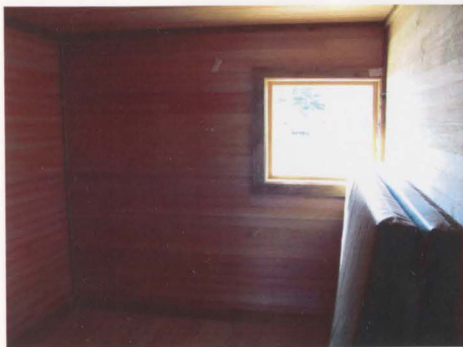
Fig. 92 View of third bedroom on north side of east hallway. Other bedrooms are all in similar good condition from 2006 repair. View facing N

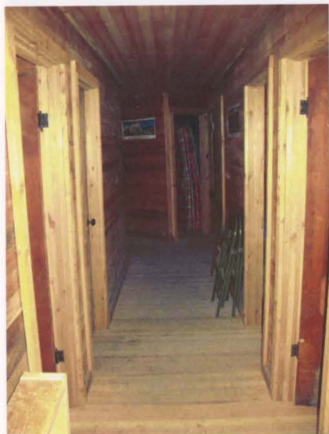
Fig. 93 Douglas fir tongue and groove on floors, walls, and ceilings in the east wing. This wing is in excellent condition as it was repaired in 2006. Note lack of light fixtures. View down east wing hallway. View facing E

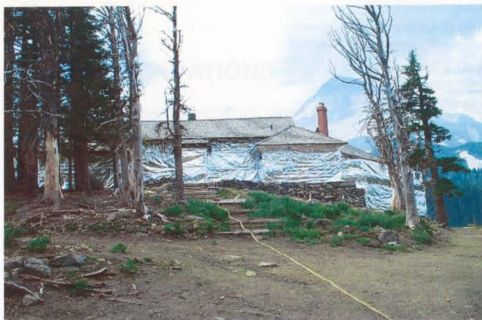
Fig. 94 USFS custom heat reflective foil placed on building during 2008 Gnarl Ridge fire. Photo from *The Oregonian*
www.oregonlive.com/outdoors/index.ssf/2008/10/forest_service_archaeologist_w.html (accessed 2/20/2012)

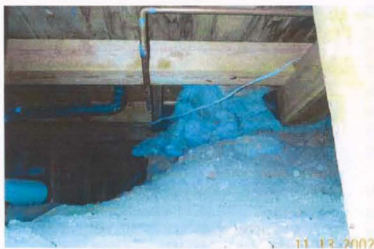
Fig. 95 2002 photo by Nancy Niedernhofer of plumbing system installed in 1997. Plumbing should be monitored annually for leaks due to severe weather to prevent moisture damage in foundation and subflooring. View facing E

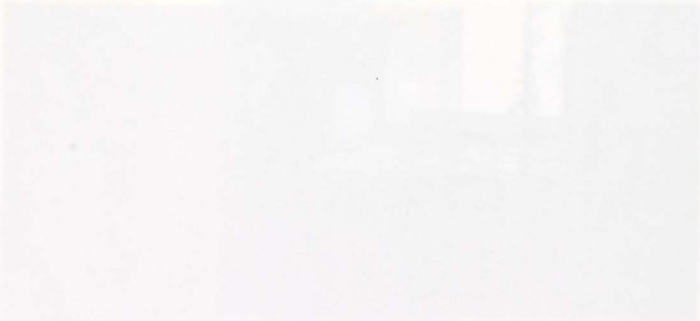
[Faded text block, likely a paragraph or list of items, illegible due to low contrast.]

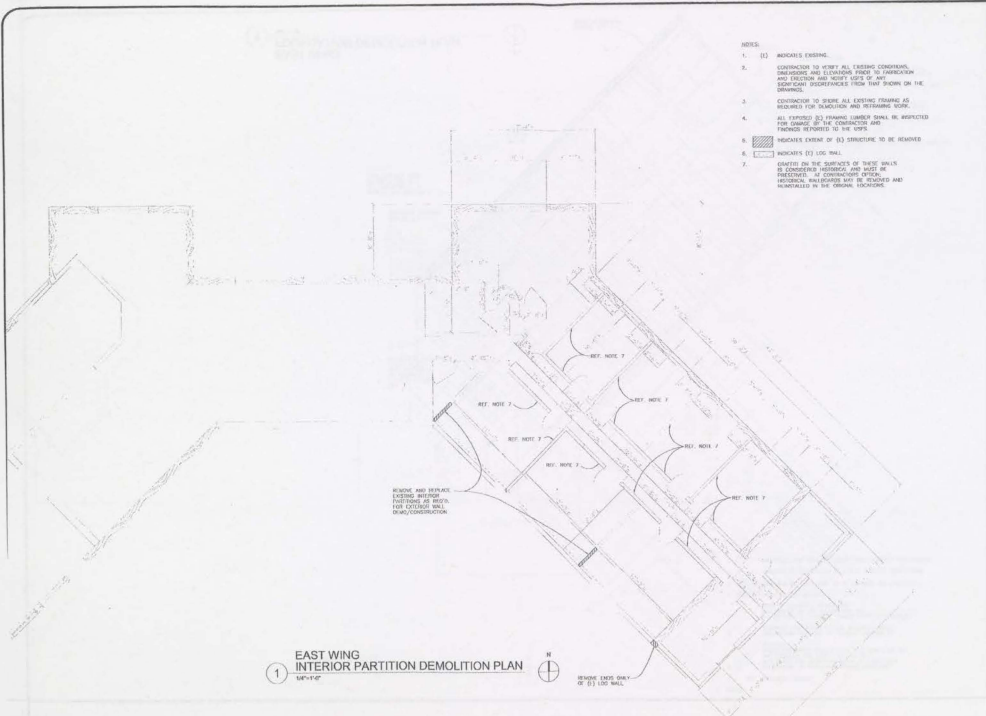
1 EAST WING
INTERIOR PARTITION DEMOLITION PLAN

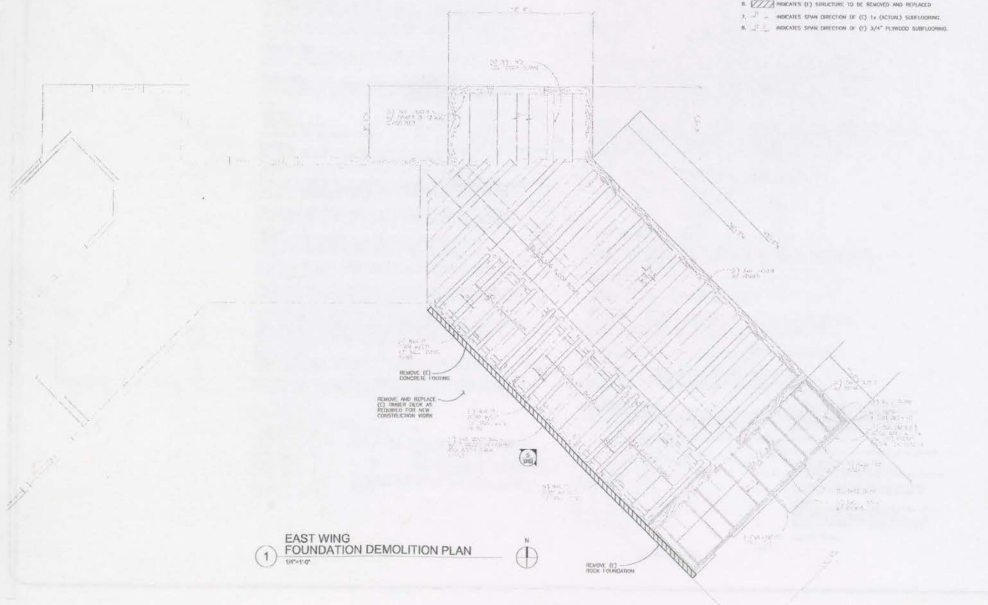
1 EAST WING FOUNDATION DEMOLITION PLAN

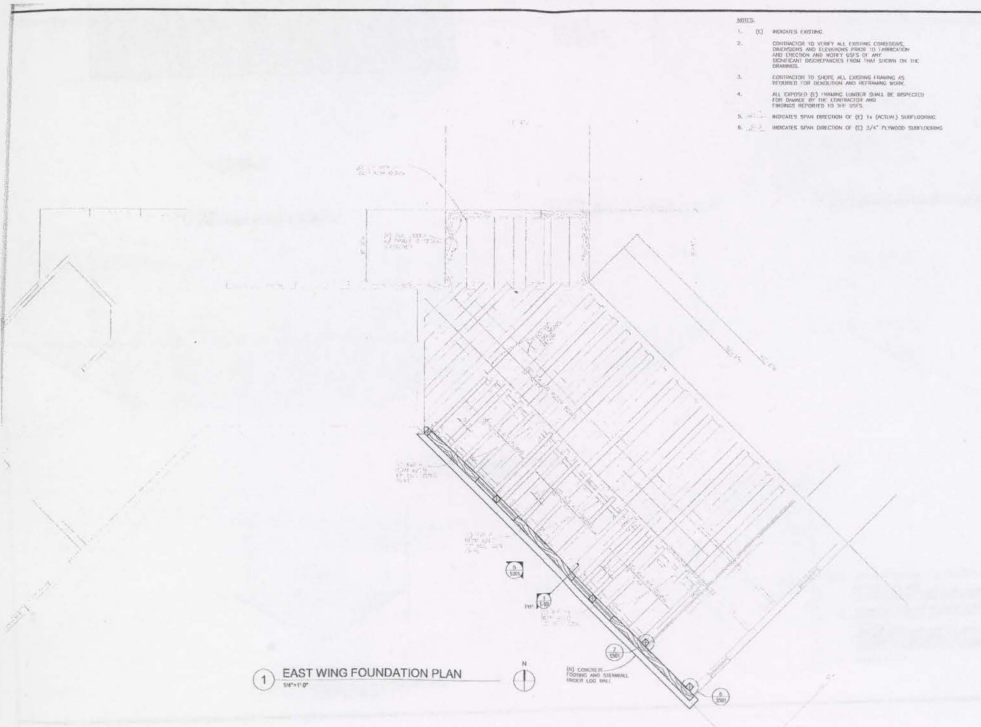
- NOTES:
1. INDICATES CENTER.
 2. CONTRACTOR TO VERIFY ALL EXISTING CONDITIONS, DIMENSIONS AND ELEVATIONS PRIOR TO CONSTRUCTION AND RECORD ALL NOTES HEREON IN THE DRAWINGS.
 3. CONTRACTOR TO VERIFY ALL EXISTING FOUNDING IS BEING USED FOR REPAIRS AND RECONSTRUCTION.
 4. ALL EXISTING (3) CHIMNEY LINERS SHALL BE REPLICATED FOR SERVICE ON THE EXISTING AND FINISHED REPAIRS TO THE STACK.
 5. --- INDICATES SPIN DIRECTION OF (3) 3/4" PLYWOOD SHEATHING.
 6. - - - - - INDICATES SPIN DIRECTION OF (3) 3/4" PLYWOOD SHEATHING.

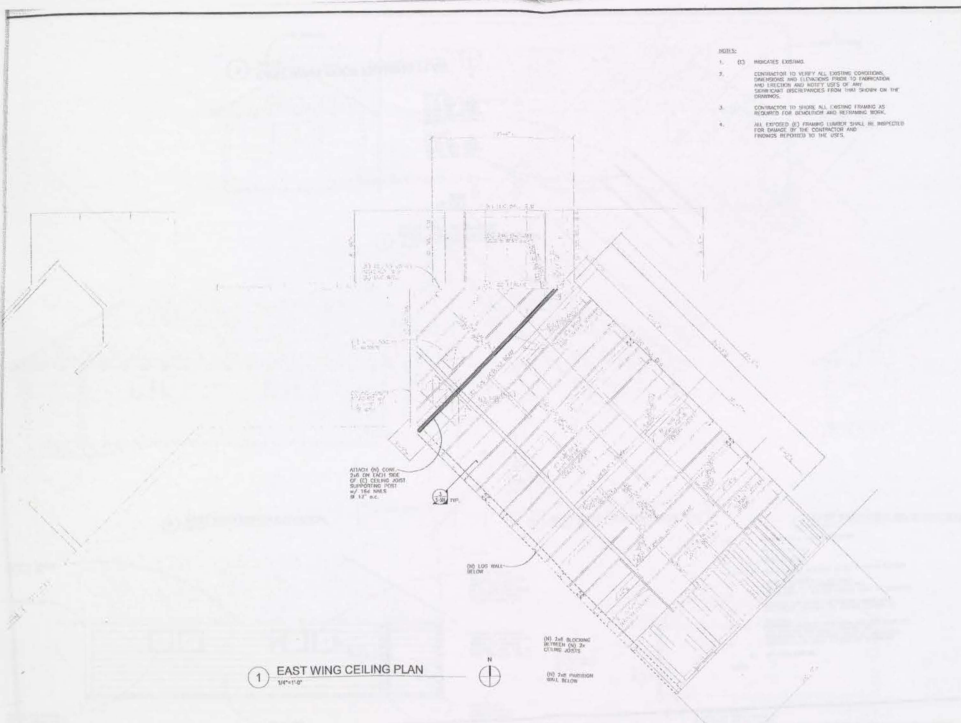
1 EAST WING CEILING PLAN
SP-172

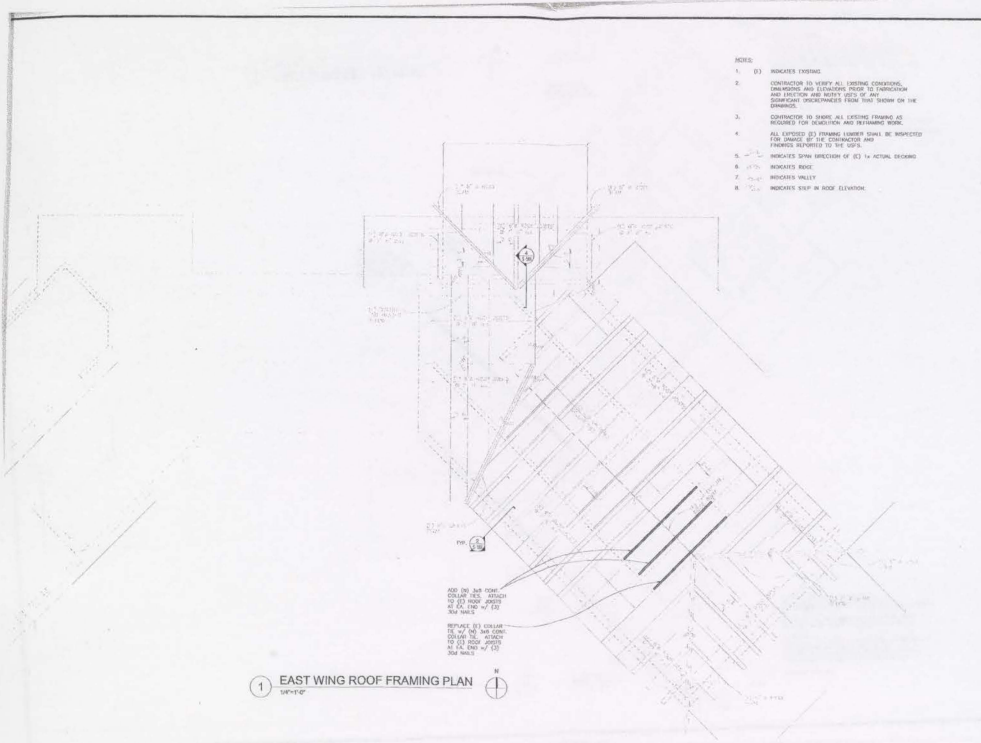
- NOTES:
1. (D) INDICATES EXISTING
 2. CONSTRUCTION TO VERIFY ALL EXISTING CONDITIONS, DIMENSIONS AND ELEVATIONS PRIOR TO CONSTRUCTION AND SPECIFICATIONS ARE NOTED SPEC. 01 AND SUPPLEMENTARY SPECIFICATIONS FROM THAT SECTION ON THE DRAWINGS.
 3. CONTRACTOR TO MAKE ALL EXISTING FRAMING AS REQUIRED FOR REPAIRS AND REFRAMING WORK.
 4. ALL EXISTING (D) FRAMING ELEMENTS SHALL BE INSPECTED FOR DAMAGE BY THE CONTRACTOR AND FINDINGS REPORTED TO THE USFS.
 5. INDICATES DOWN DIRECTION OF (D) IN ACTUAL DRAWING
 6. (R) INDICATES RISE
 7. (V) INDICATES VALLEY
 8. (E) INDICATES ELEVATION

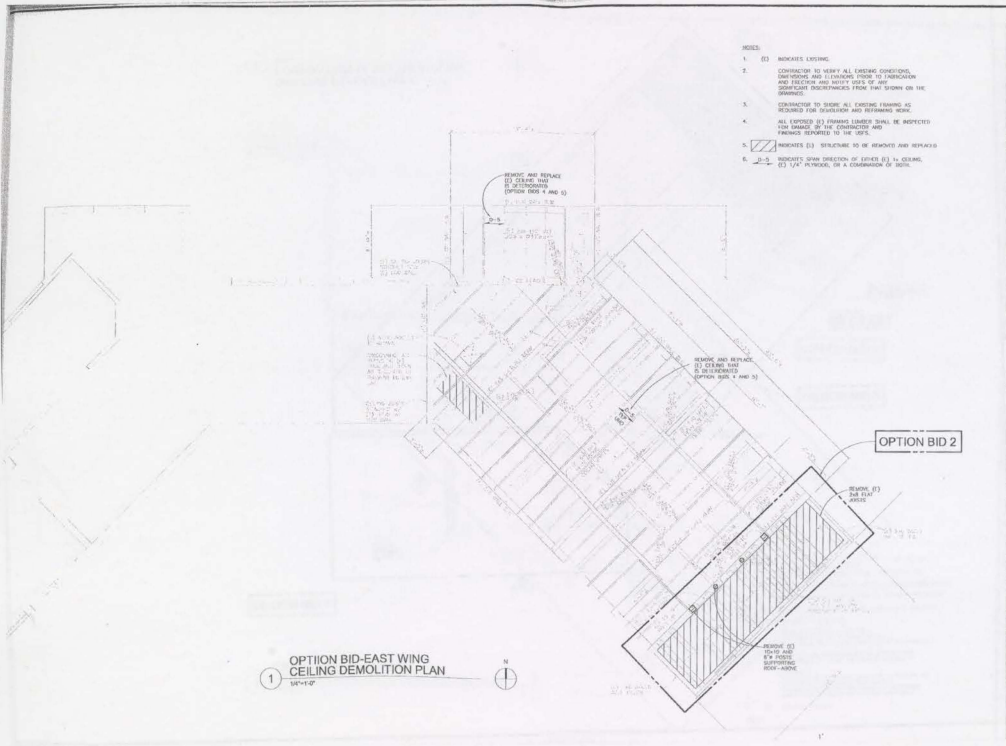
- NOTES:
1. (E) INDICATES EXISTING.
 2. CONTRACTOR TO VERIFY ALL EXISTING DIMENSIONS, DIMENSIONS AND CONDITIONS PRIOR TO DEMOLITION AND RECORD AND NOTIFY OWNER OF ANY DISCREPANCIES IMMEDIATELY FROM THE BEGINS ON THE PROJECT.
 3. CONTRACTOR TO VERIFY ALL EXISTING FRAMING AS BEING THE ORIGINAL AND REPAIRING WORK.
 4. ALL EXISTING (E) DIMENSIONS SHOWN SHALL BE INDICATED THE GRANTOR OF THE CONTRACTOR AND FINISHED DIMENSIONS TO BE SHOWN.
 5. [Hatched Area] INDICATES (E) STRUCTURE TO BE REPAIRED AND REPLACED.
 6. [Hatched Area] INDICATES DEMOLITION OF EXISTING (E) IN GENERAL. (E) 1/4" MINIMUM, OR A COMBINATION OF BOTH.

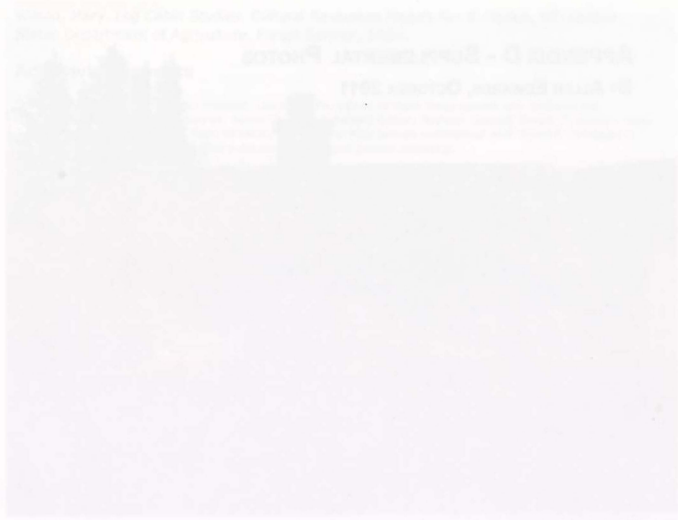
View of the farm buildings from the road

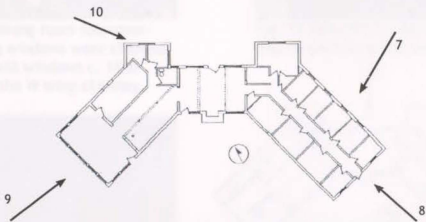
Fig. 10 Wood retaining wall outside basement wood storage area with north deck above.

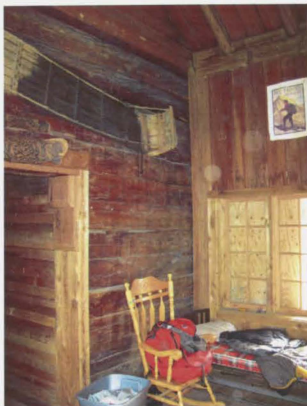
Fig. 19 Central hall, note adz and broad axe tool makings on timber wall. CCC era 8-lite casement windows in central hall were replaced in kind in 1997. Originals were 4-over-4 double-hung wood sash windows.

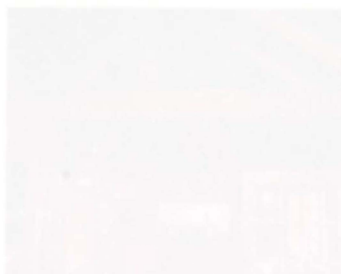
Faint, illegible text caption located below the top-left photograph.
