Stressed Skin Insulating Core Panel Demonstration House Thermal Testing Report

**Stressed Skin Insulating Core Panel
Demonstration House Thermal Testing Report**

**Energy Studies in Buildings Laboratory
Center for Housing Innovation
University of Oregon
Eugene, OR 97403**

December 1995

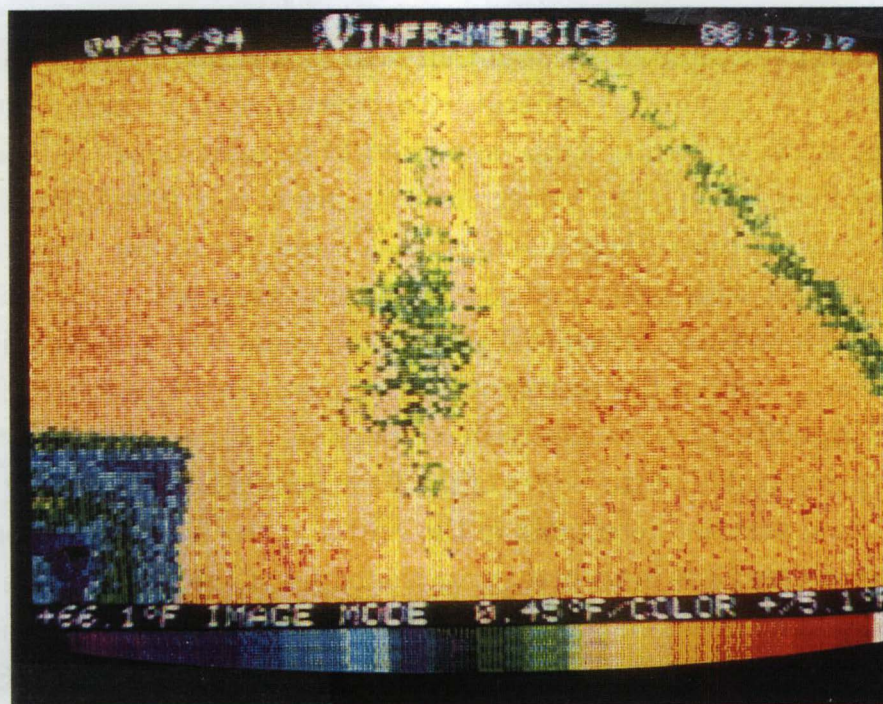
Figure 4-8
Heat Loss at SSIC Panel Panel to Panel Joint,
Heat Loss is More Extensive than Typical of Panel Joints

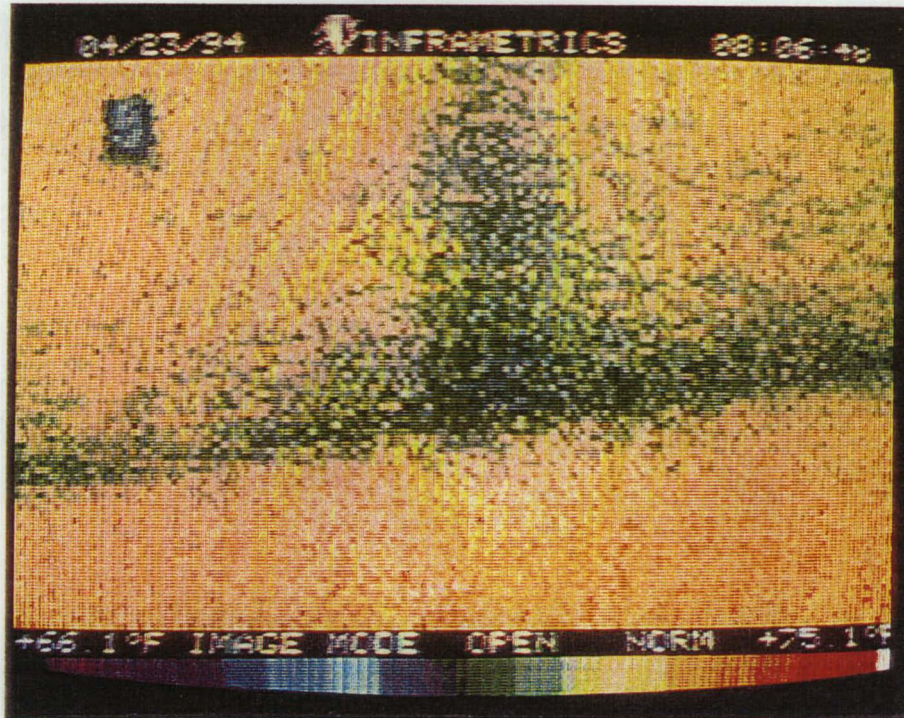
Figure 4-9
Heat Loss at Panel to Panel Joint and Wall to Floor Plant Joint,
Heat Loss through Electrical Outlet also Visible

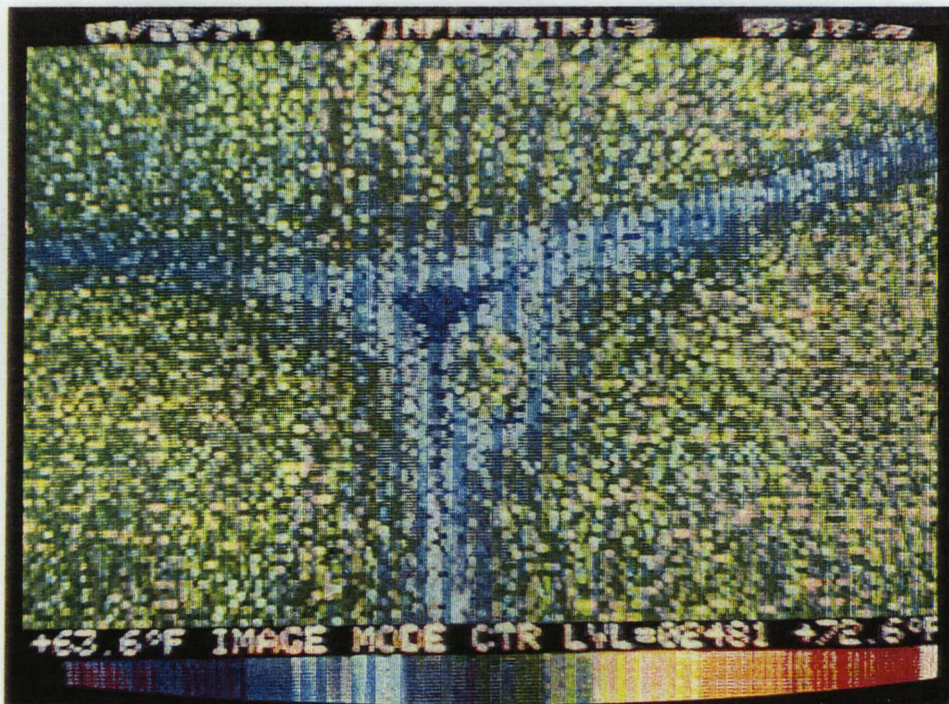
Figure 4-10
Heat Loss at Intersection of Panels and 2nd Floor Framing,
Heat Loss through Fresh Air Vent also Visible

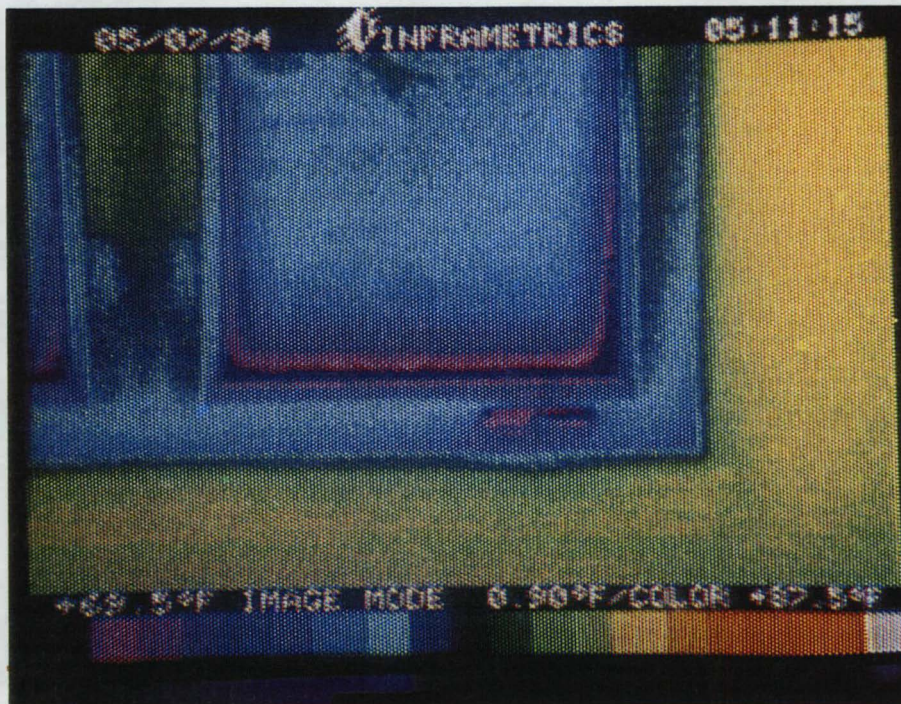
Figure 4-11
Heat Loss through Window Opening and Window Frame,
Heat Loss through Window Operating Mechanism

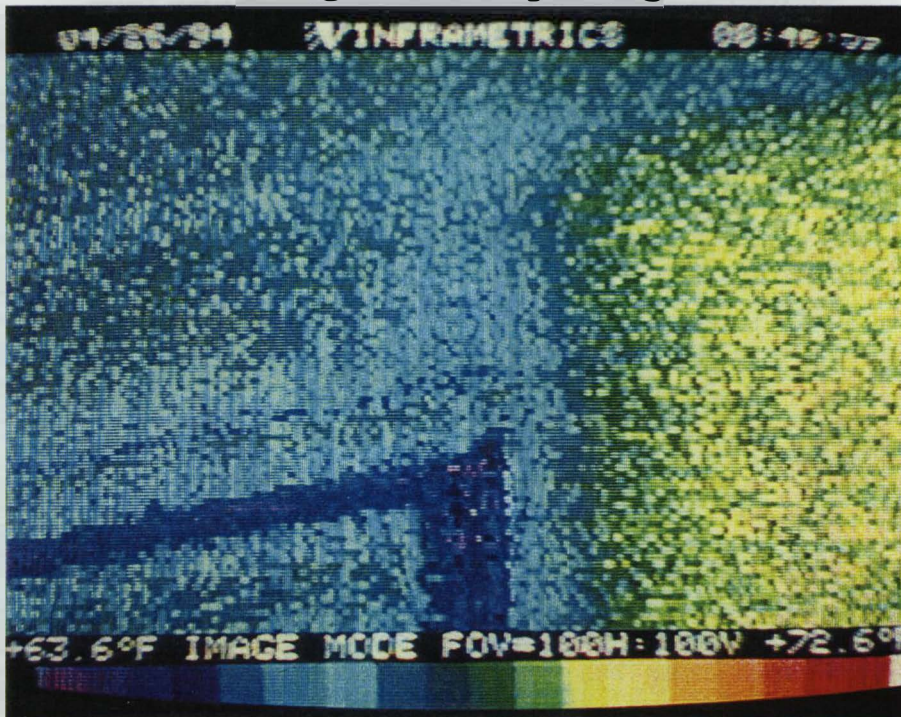
Figure 4-12
Heat Loss through Header above North Door

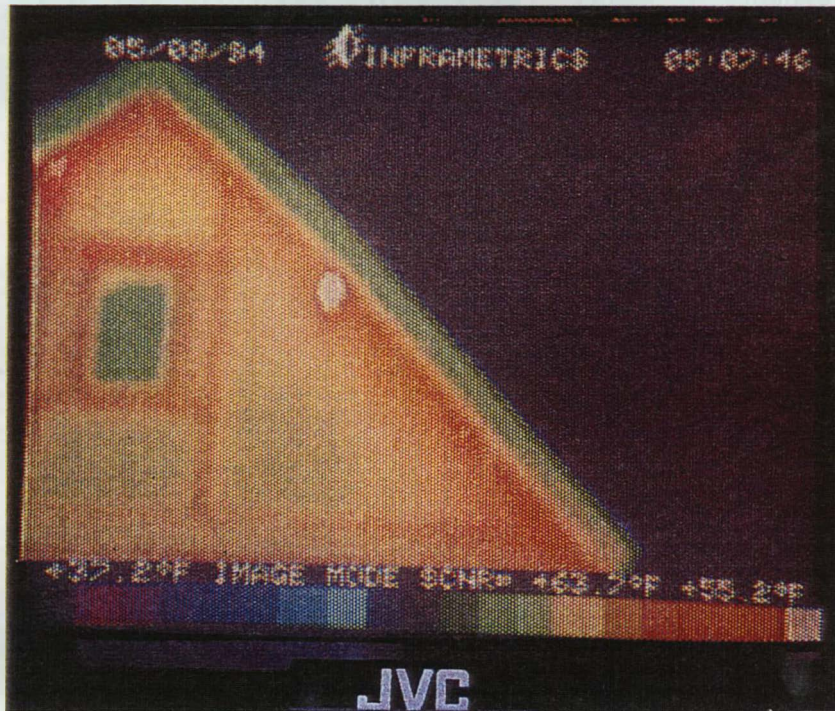
Figure 4-13
Exterior View of Heat Loss through Panel to Panel Joints, Fresh Air 80 Vents,
and 2nd Floor Framing

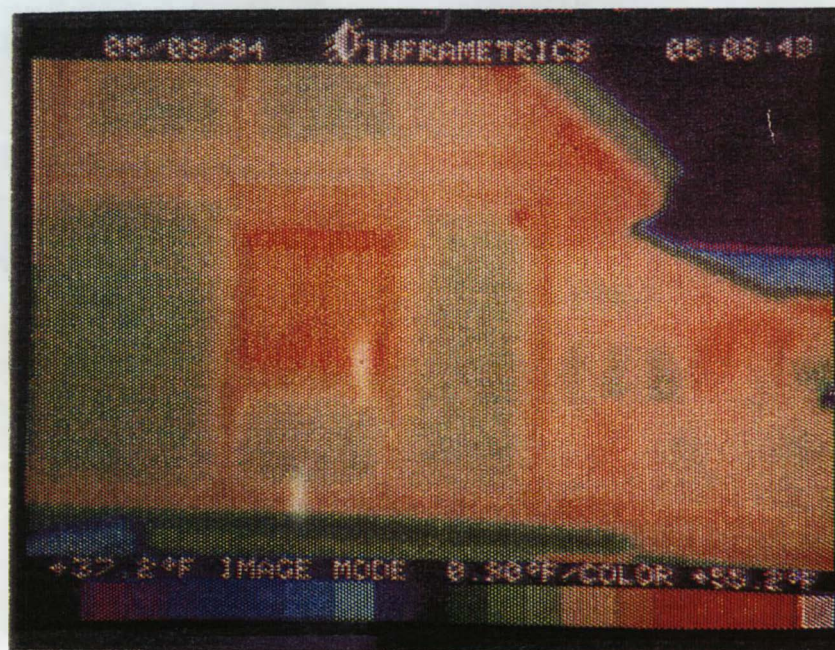
Figure 4-14
Exterior View of Heat Loss, East Elevation of Demonstration House.
Heat Loss is Visible through Panel to Panel Joints, 2nd Floor Framing, Fresh Air
80 Vents and Window Openings

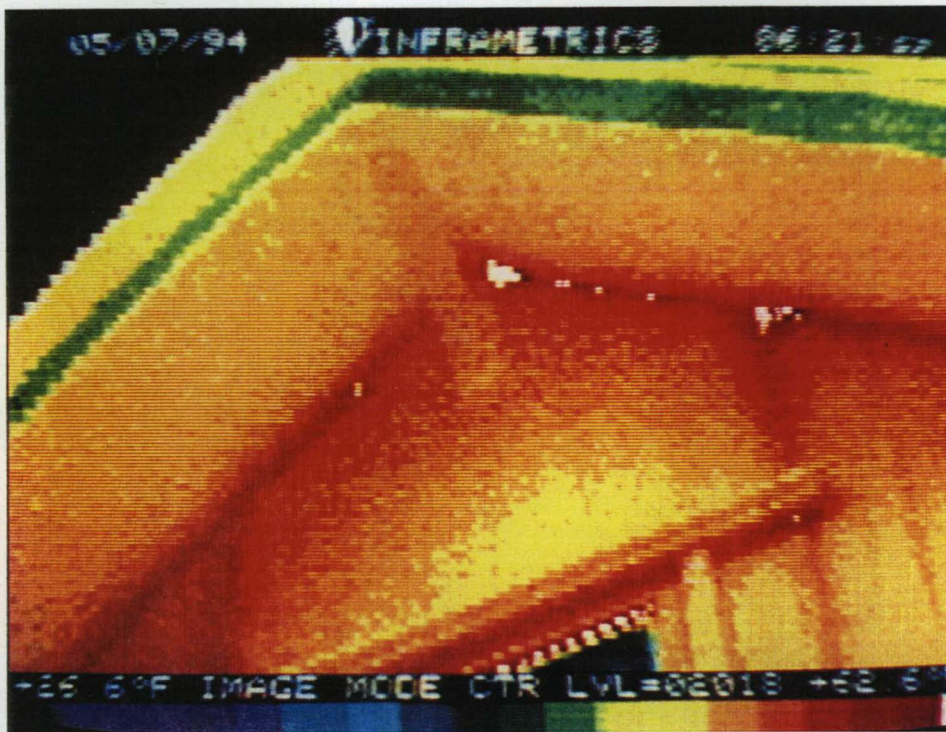
Figure 4-15
Heat Loss under Eaves on West Elevation of Demonstration House.
Heat Loss is More Extensive at Gable and Intersection of Panel Joints and Roof

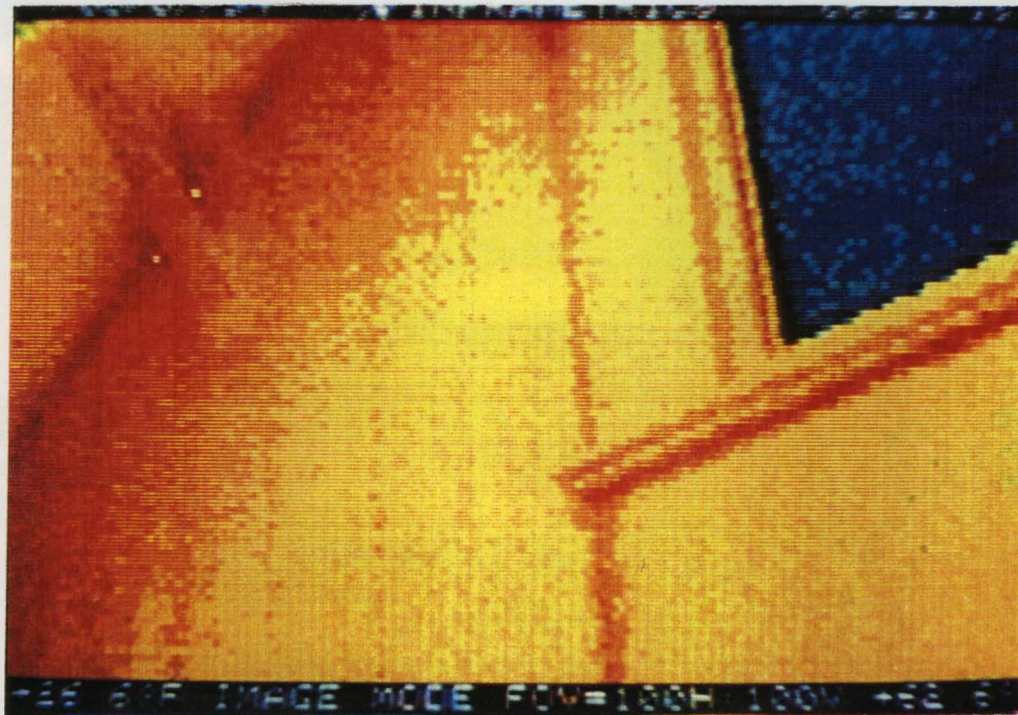
Figure 4-16
Heat Loss on West Elevation of Demonstration House at Panel Joints around 2nd
Story Window and Around Overlook under Eaves
