HISTORIC STRUCTURES REPORT: LONE PINE INDIAN SHAKER VILLAGE,
A NINETEENTH CENTURY FISHING SETTLEMENT IN
THE DALLES, WASCOCOUNTY, OREGON

A THESIS

Presented to the Interdisciplinary Studies Program: Historic Preservation
and the Graduate School of the University of Oregon
in partial fulfillment of the requirements
for the degree of
Master of Science

December 1996

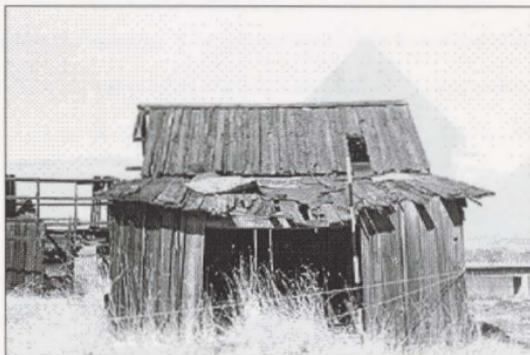
Figure 24. Visitor's House, East Elevation, Showing the Ridge Cap.

The lean-to is in poor condition. On the east elevation more than half of the exterior wall is missing and the beam supporting the roof is deflecting as much as six inches, causing the roof to cave in and the wall to bow (Figure 24). A horizontal board is missing from the south elevation. The north elevation is in good condition. Only half of the floor still remains on the interior of the lean-to.

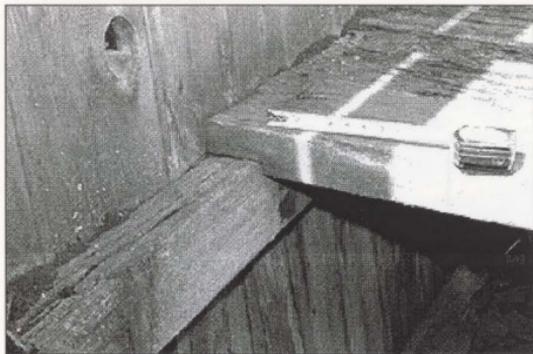
Figure 40. Barn (Small), Detail Showing Floor in the Upper Level.

The overall condition of the Barn (Small) is poor. The structure is leaning significantly to the southeast. Wall boards are missing in a small area on the east elevation and have come loose in several places on the west elevation (Figure 65). The floor in the upper portion is beginning to deteriorate in the center, exposing the drop-off

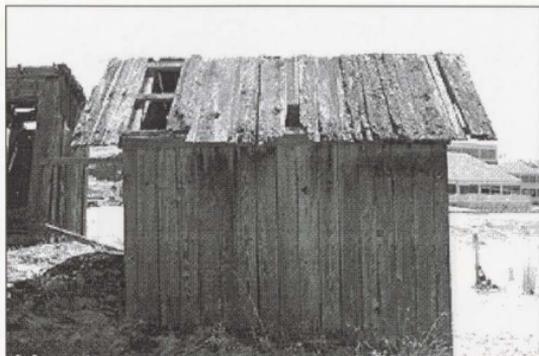
Figure 60. Chicken Coop, North Elevation.

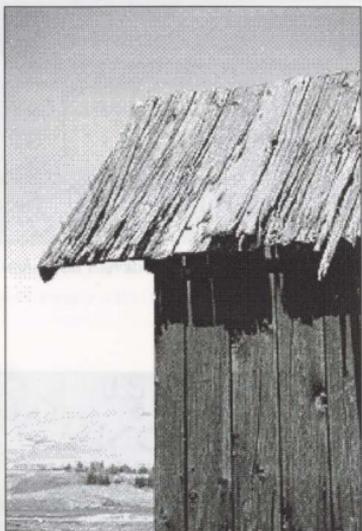
Figure 61. Chicken Coop, Detail of Roof at the Southwest Corner.

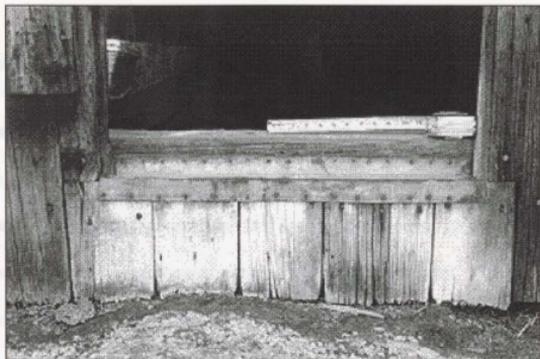
This building seems to have withstood the test of time, but it is beginning to show signs of neglect. The stain on the front is caused by the metal flashing but does not appear to be damaging the material. The graffiti is a result of vandalism by contemporary visitors to the site. The deterioration at the ends of the wall boards is caused by the proximity to the grass and the moisture that results. The deterioration of the roof is simply a result of weathering. The missing bargeboard may have been recycled for use in building fishing platforms.

Figure 62. Chicken Coop, West Elevation, Detail Showing Metal Discoloration.

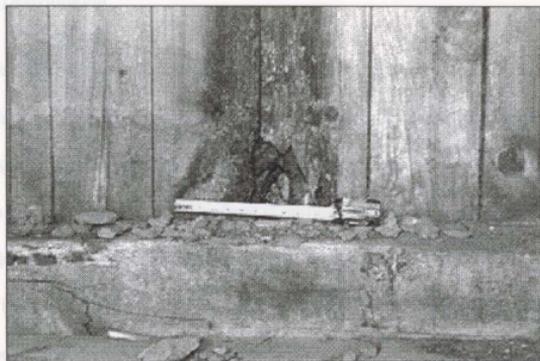
Because of its double wall construction the Chicken Coop is very sturdy and in good condition. Most problems are related to the roof or are isolated phenomena. There is some evidence of decay of the board ends at the ground, especially on the north elevation (Figure 60). The walls are in excellent condition on the outside, except for some graffiti on the north elevation. There is a hole and lichen growth on the north side of the roof. The south side of the roof is showing deterioration, especially the upper layer (Figure 61). One of the bargeboards on the west elevation is missing. The metal flashing used on the lip of the door is depositing a white chalky substance on the wood below (Figure 62). The interior is in fairly good condition, with evidence of a small fire on the back wall (Figure 63).

Figure 63. Chicken Coop, Interior, Fire Damage on the Rear Wall.

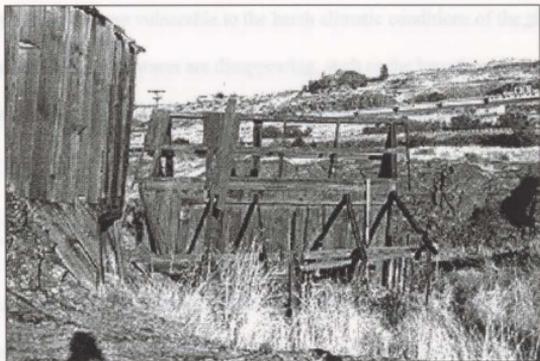
Figure 64. Barn (Small), West Elevation, Addition.

of the basalt ledge (Figure 40). The floor in the lower area is overgrown with vegetation, which can be four to five feet tall in the summer. The roof is over 90 percent gone, leaving the entire structure vulnerable to the harsh climatic conditions of the site. Several of the character-defining features are disappearing, such as the bargeboards on the south gable. The addition has no roofing and is completely exposed and overgrown with tall grass.

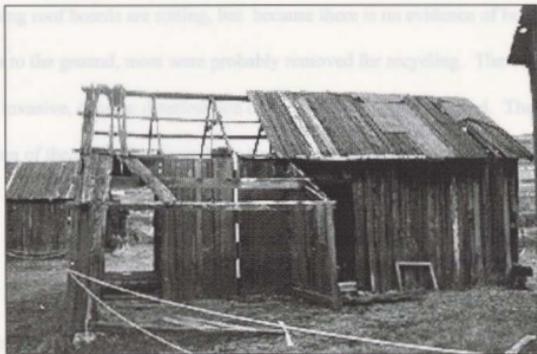
Figure 65. Barn (Small), East Elevation.

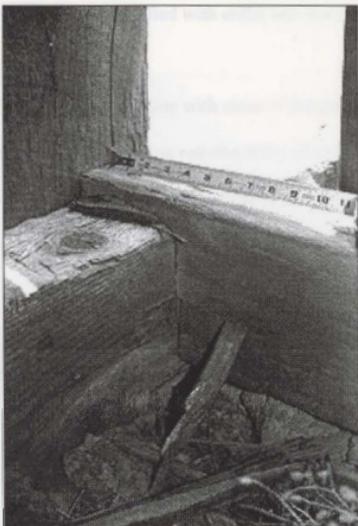
The main cause of deterioration for the Horse Barn is the diminishing roof and wall material. Although there is some evidence of rot at the ends of roof boards and the sill, most likely due to exposure to the harsh climatic elements, the primary reason for losing material appears to be the recycling of historic fabric for construction of fishing platforms.

Figure 67. Horse Barn, Detail Showing the Sill in the Southwest Corner.

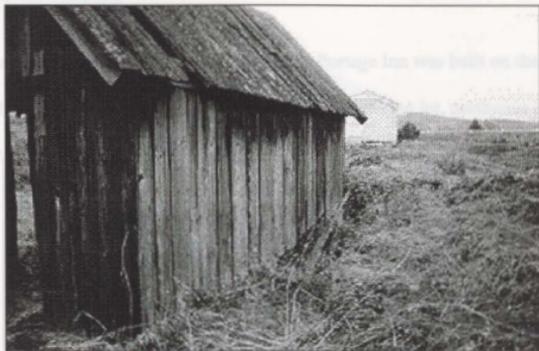
Figure 69. Storage Shed, Detail Showing Lichen Growth and Siting into the Basalt Outcrop.
