THE GEORGE C. COOLEY COTTAGE  
BROWNSVILLE, OREGON  
A HISTORIC STRUCTURE REPORT

A TERMINAL PROJECT

June 1983

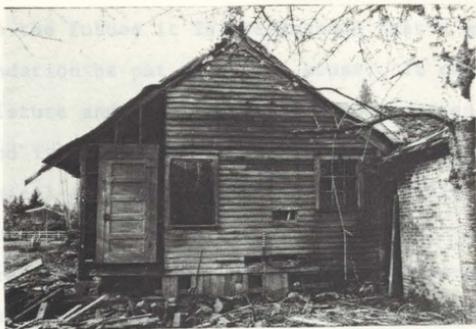
between foundation and sills, and the west wall has had mortar applied to the joints between the stones. Support for the joists in this section is provided for by the addition of a 6 x 8 beam at their mid-point, with stone piers for support. However, the stones in the pier at the southern end of the beam have slipped and the pier has failed. This has left the beam supported by the 1" thick boards of the skirting at the rear of the house, and by a short length of 2 x 4 material that has been nailed to the east side of the beam. Because the bottoms of both the skirting and the 2 x 4 are in contact with the ground they have rotted, resulted in the effective shortening of these members and subsequent sagging of the 6 x 8 beam (see Figure 10).

Fig. 10. South elevation of Cooley Cottage showing skirting in contact with ground.

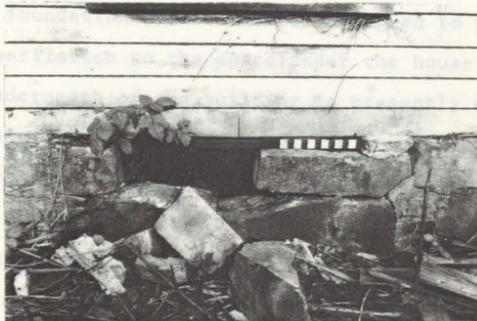
The foundation wall on the west side has failed under the kitchen window, and shows signs of deterioration elsewhere along its length (see Figure 11).

Fig. 11. West side foundation wall.

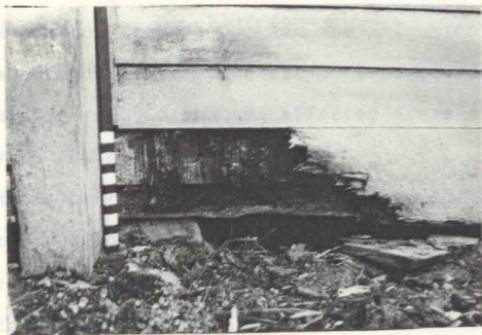
Wood ashes piled against the house on the east side have kept the sill, ledger, and wall planks wet, resulting in the deterioration of these members (see Figure 12). The deteriorated areas of these members should be repaired with new material to match.

Fig. 12. Deteriorated area of sill, ledger, water table on east side of house.

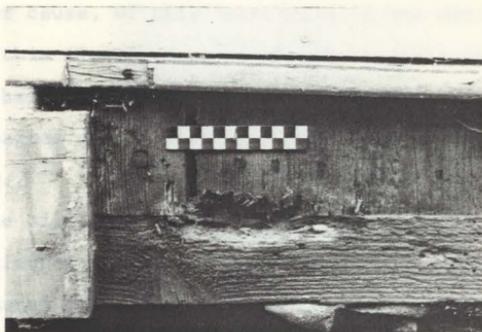
Fig. 13. Termite damage, northeast corner of house.

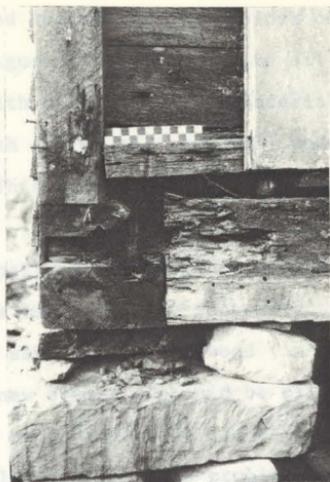
Fig. 14. Deteriorated sills at southwest corner.

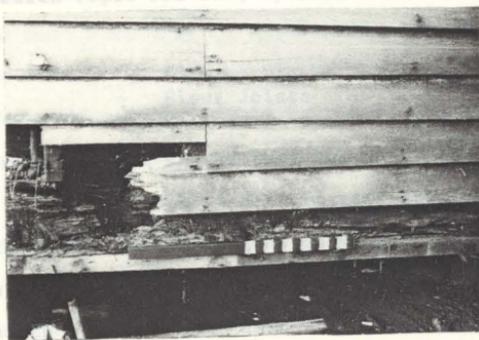
Fig. 15. Deterioration in the sill under the south end of the house.

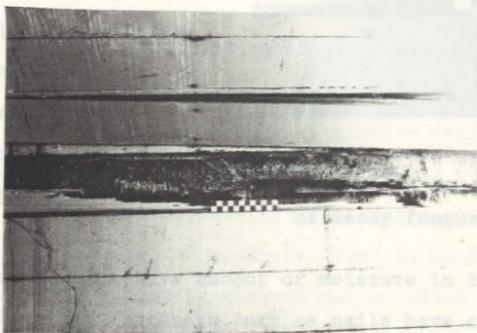
fungus can be seen in Figure 16. Figure 17 is a close-up of the area and shows the fruiting bodies of this particular fungus, an indication that the attack is in an advanced stage.

Fig. 16. Deterioration of ribbon strip and other members caused by decay fungus. (scale = 6")

roof and sealing possible water entry points in the siding and trim will prevent future water infiltration. Ant colonies should be destroyed and nesting areas treated to prevent reinfestation. For advice on treatments contact the Extension Entomology Service at Oregon State University.

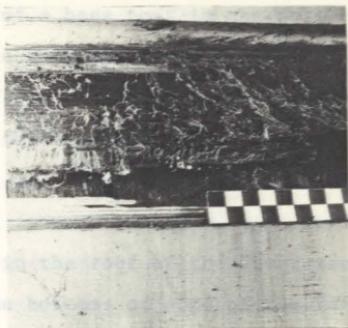
Fig. 17. Close-up showing hyphae and fruiting bodies of decay fungus. (scale=6")

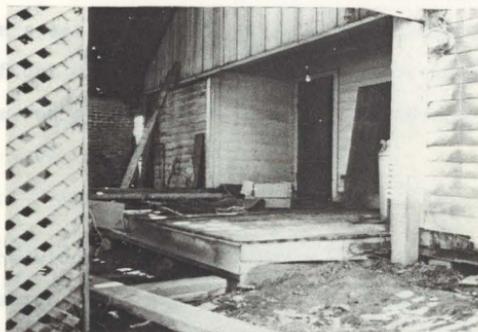
The trim boards on the north end of the porch have rotted due to wood to earth contact, and by the effects of moisture that was held in the large pile of ashes that had been deposited at the end of the porch (see Figure 18).

Fig. 18. East side porch showing earth to wood contact and deteriorated trim boards.

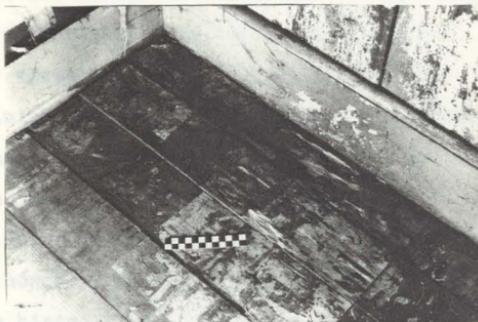
The parlor floor has a rotted area in the southwest corner of the room. The rot is contained in the first two floorboards from the west wall, beginning at the south wall and running approximately 3' to the north (see Figure 19).

Fig. 19. Deteriorated area in southwest corner of parlor floor. (scale = 6")

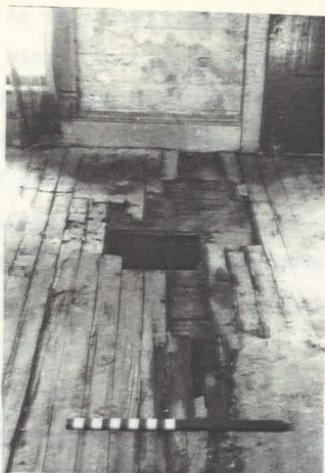
Fig. 22. Deterioration on the west half of the kitchen floor.

The new floor should then be covered with a vinyl

floor covering. As mentioned earlier, linoleum is no longer produced, but if vinyl flooring is available in reproduction patterns this would be the best alternative. It is believed that when the new tongue-and-groove floor was installed c. 1930, it was, and always has been, covered with linoleum. Therefore it would be inaccurate to leave the floor uncovered, or to install a new tongue-and-groove floor and apply a clear finish.

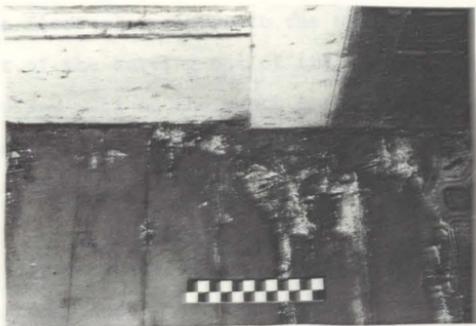
Fig. 23. Hyphae and white surface growth of a decay fungus along the east side of the kitchen floor. (scale = 6")

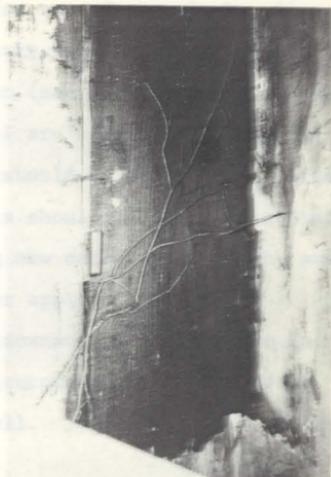
Fig. 24. Northwest corner of the parlor wall. Vine is growing up the inside of the wall.

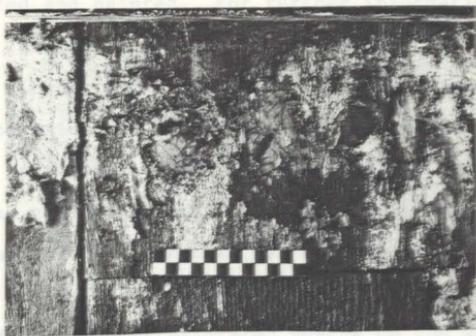
Fig. 25. Fungal growth on the east wall of the entry hall. (scale = 6")

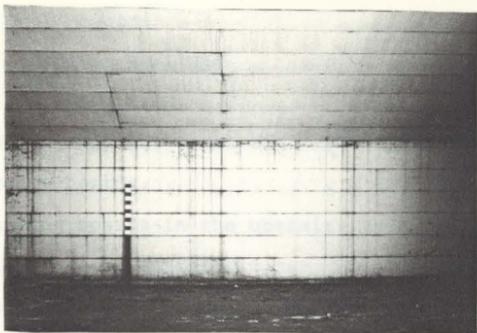
Fig. 26. West wall of north bedroom upstairs showing extensive water stains.

It is recommended that while wallboards are removed for repair, further inspection of the tops of the wall planks, upper ribbon strip, and wall furring strips be carried out. The top wall boards on the east wall should also be removed for this reason, taking care to do as little damage as possible to them. Any deteriorated members that are found should be repaired or replaced using new materials to

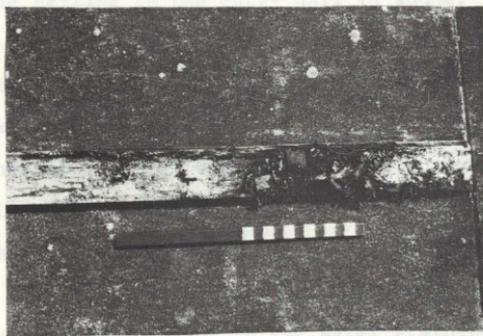
The ceiling boards in the upstairs bedrooms are water stained, indicating the entry of water. One ceiling board on the west side of the south bedroom was removed and was found to be covered with a thick layer of white surface growth, leaves, and other organic matter (see Figure 27) which has entered through the failed roof over a long period of time.

Fig. 27. Ceiling board taken from the west side of the south bedroom upstairs. Note the large amount of white surface growth and leaves.

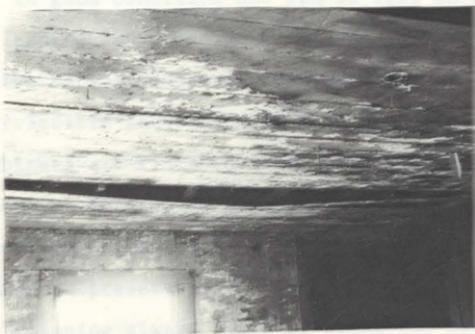
As is the case with the floors, the kitchen ceiling is in the worst condition of all the ceilings. Water entering through the failed kitchen roof over a long period of time has resulted in the deterioration and failure of several of the ceiling boards on the west side of the kitchen (see Figure 28). These boards should be removed and replaced with new boards using new material to match.

Fig. 28. Deteriorated ceiling boards on the west side of the kitchen ceiling.

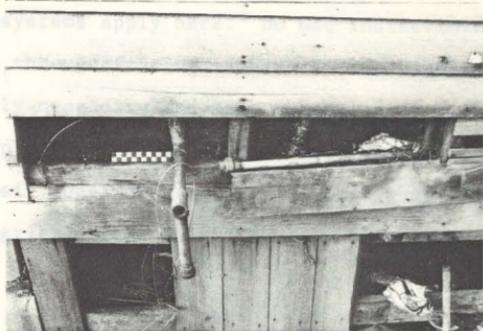
Fig. 30. Deteriorated condition of the plumbing which runs through the south wall of the house.

A new water heater needs to be installed as there is presently no system in the house. The new water heater should not be installed in the attic over the kitchen unless additional structural support is added to the attic framing system. A better location for the water heater is in the crawl space or cellar which is created by the new foundation, or in the new bathroom addition. These locations will not take up valuable space inside the house, and are much less likely to disturb the historical integrity of the house.

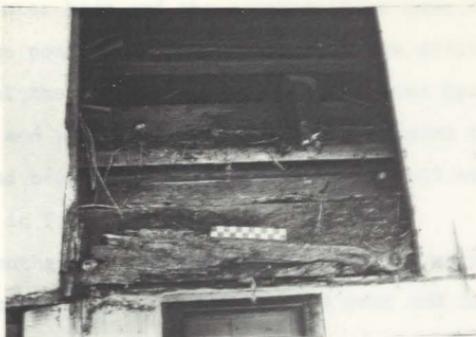
Fig. 31. Deteriorated beam at the north end of the woodshed.

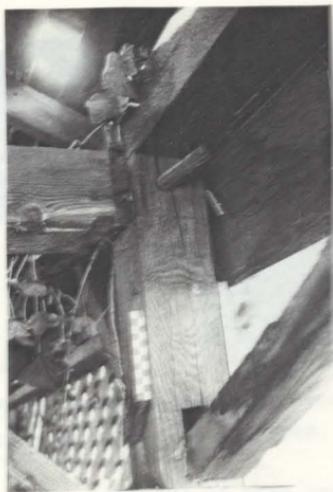
Fig. 32. Deteriorated mortise and tenon joint on the north side of the woodshed.

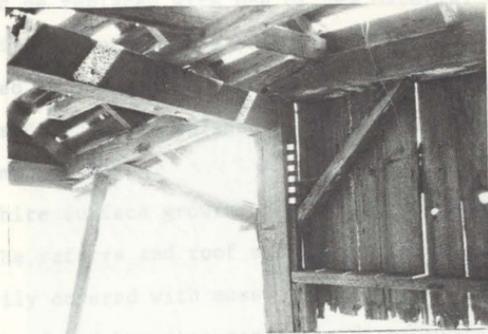
Fig. 33. Photo shows broken top plate and poor connection between post and beam.

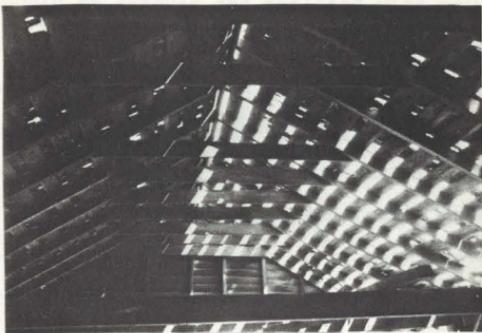
Fig. 34. View looking up at inside of woodshed roof. Note the number of shingles that are missing.

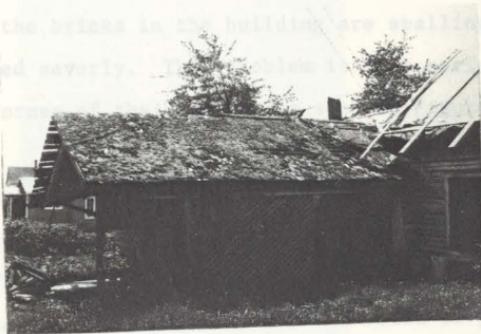
Fig. 35. View of north side of woodshed roof showing thick layer of moss.

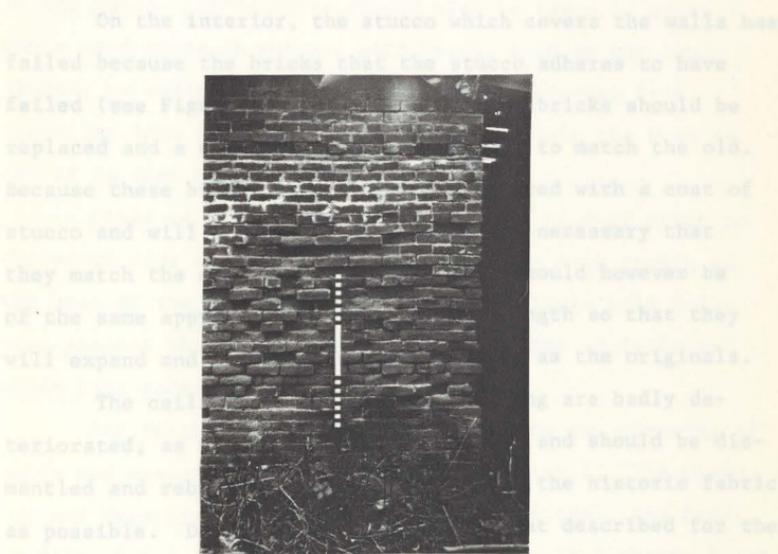
Fig. 37. Close up of east wall shows severity of spalling.
