WILD NOTIONS:
PRESERVATION OF HISTORIC BUILDINGS IN OREGON WILDERNESS

by
CHARLOTTE M. HELMER

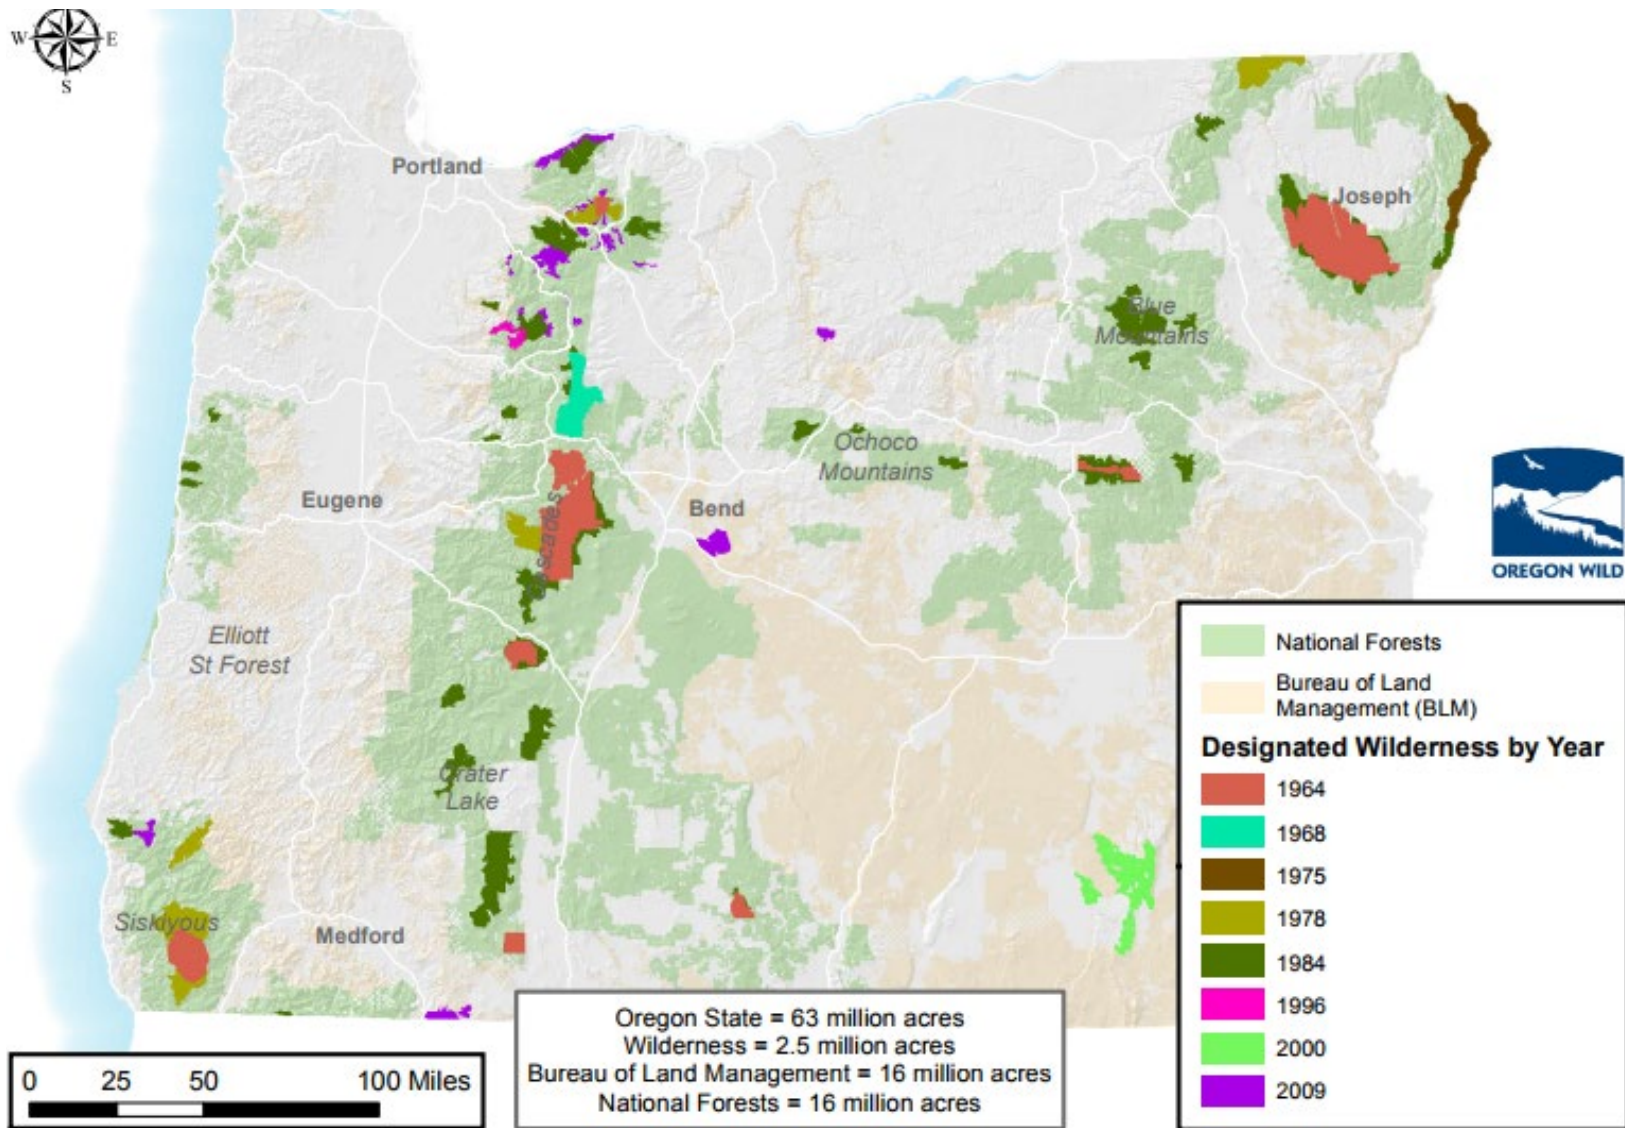
Figure 3.1. Chronological wilderness designations in Oregon (Oregon Wild, 2009).

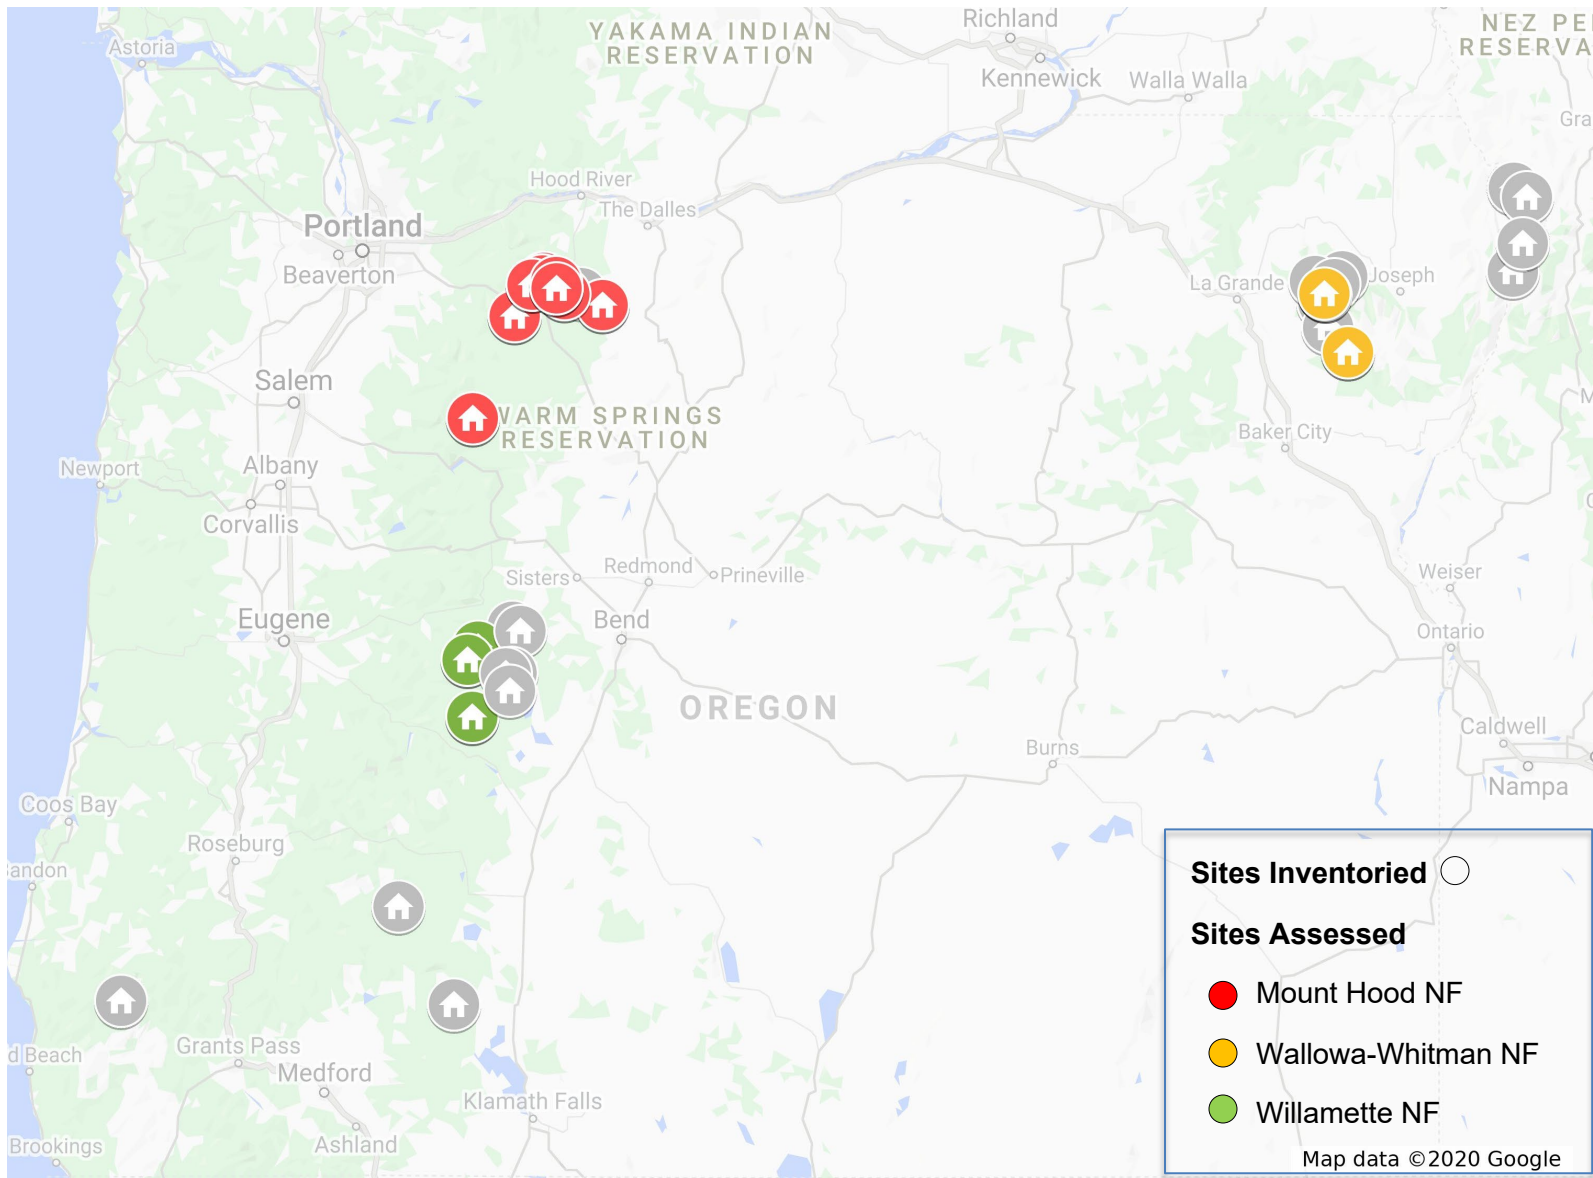
Figure 4.1. Historic sites inventoried and assessed during this study.

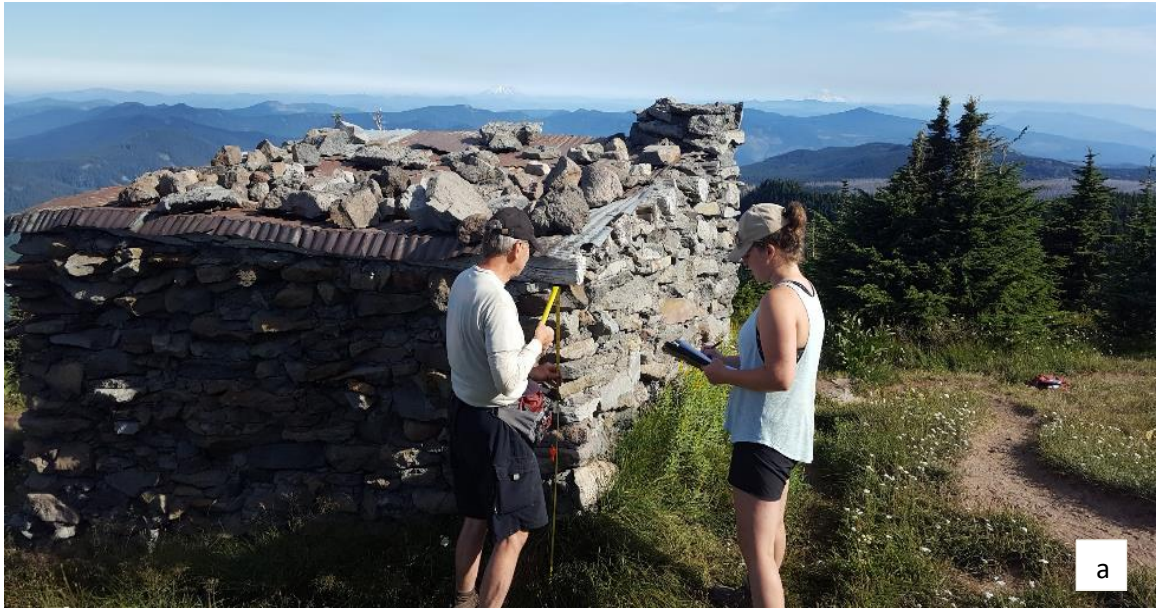
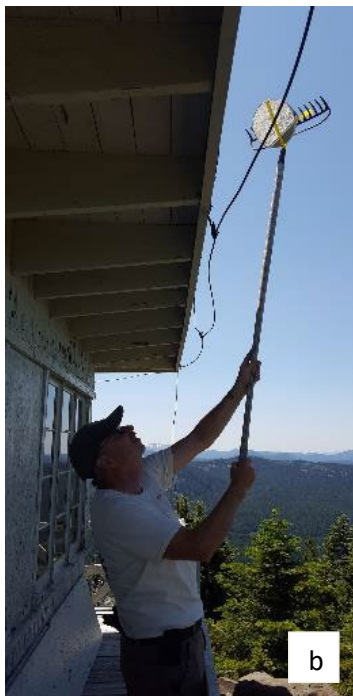
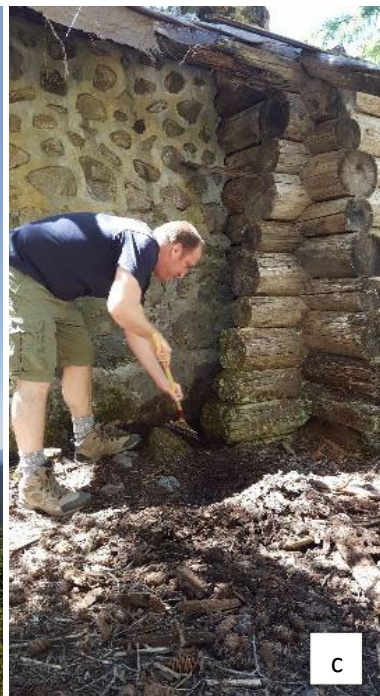
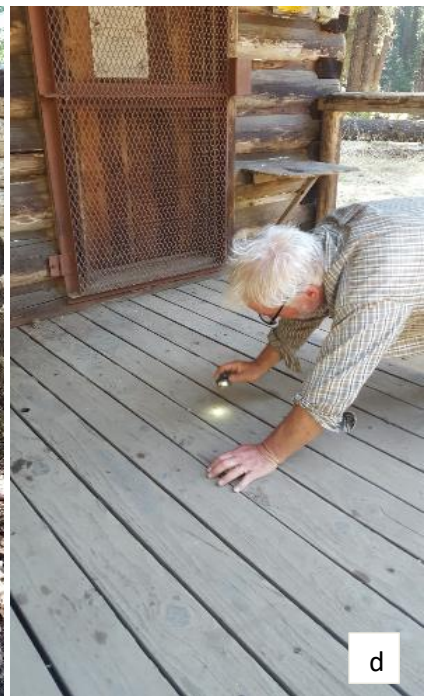
Figure 4.6. Volunteers use tools to investigate and record conditions at historic sites in wilderness during the course of this study: (a) John Milliken and the author use tools to measure and record conditions at McNeil Point Shelter (Jonas Landes, 2017); (b) Milliken engineers a device to inspect the roof of Waldo Mountain Lookout; (c) Dan Everhart of Restore Oregon uses a hand rake to inspect sill logs at the Upper Sandy Guard Station; and (d) John Helmer uses a headlamp to investigate floor joists at the Millard Ranger Station.

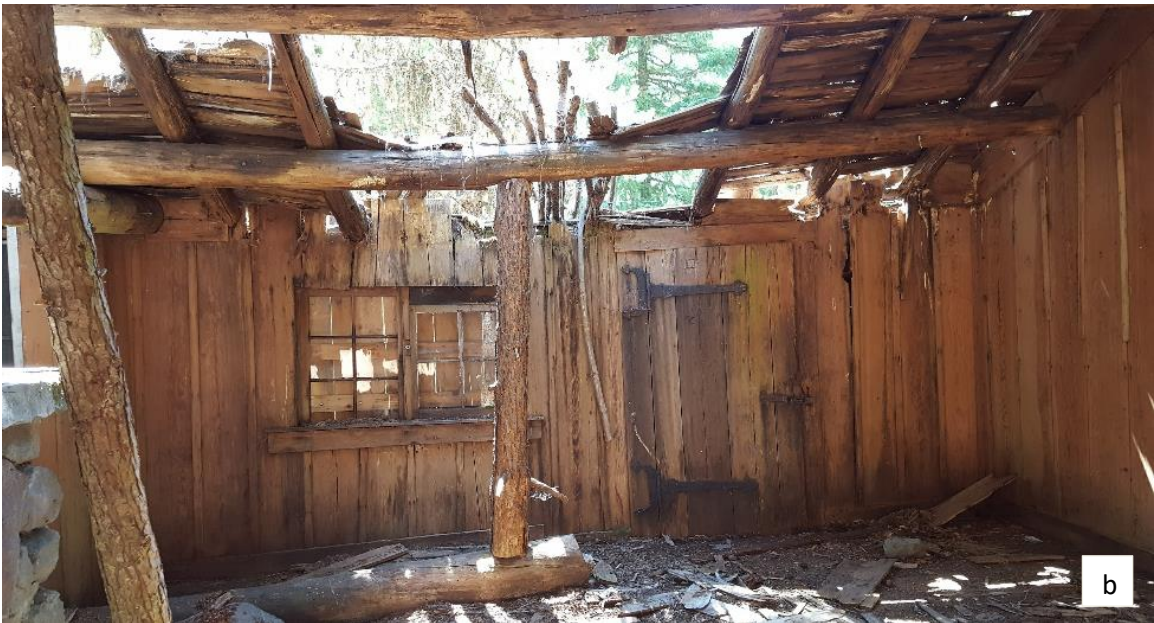
Figure 5.3. Exterior (a) and interior (b) views of the Upper Sandy Guard Station in the Mount Hood Wilderness, Mount Hood National Forest in July 2017. This building exemplifies the correlation between no active use (administrative or otherwise), no maintenance, and poor conditions.

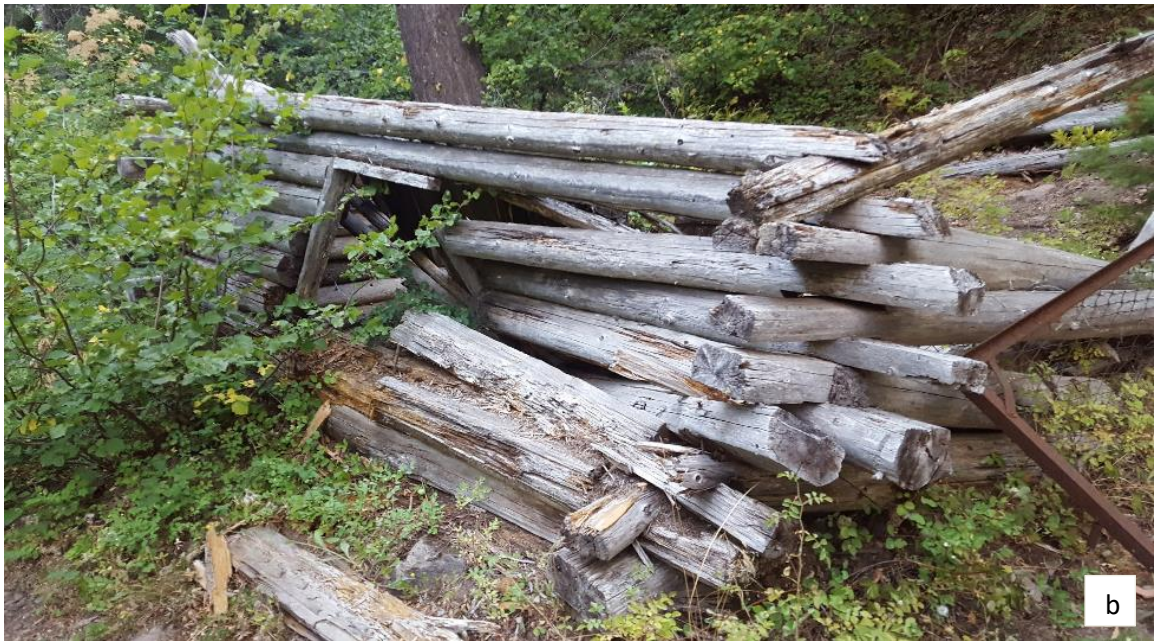
Figure 5.4. Preservation opportunities represented by (a) Waldo Mountain Lookout, which needs roof repairs in order to sustain its otherwise good conditions and high integrity, versus (b) Kinzel Cabin, which is in poor condition, require no urgent work items, and is a ruin.

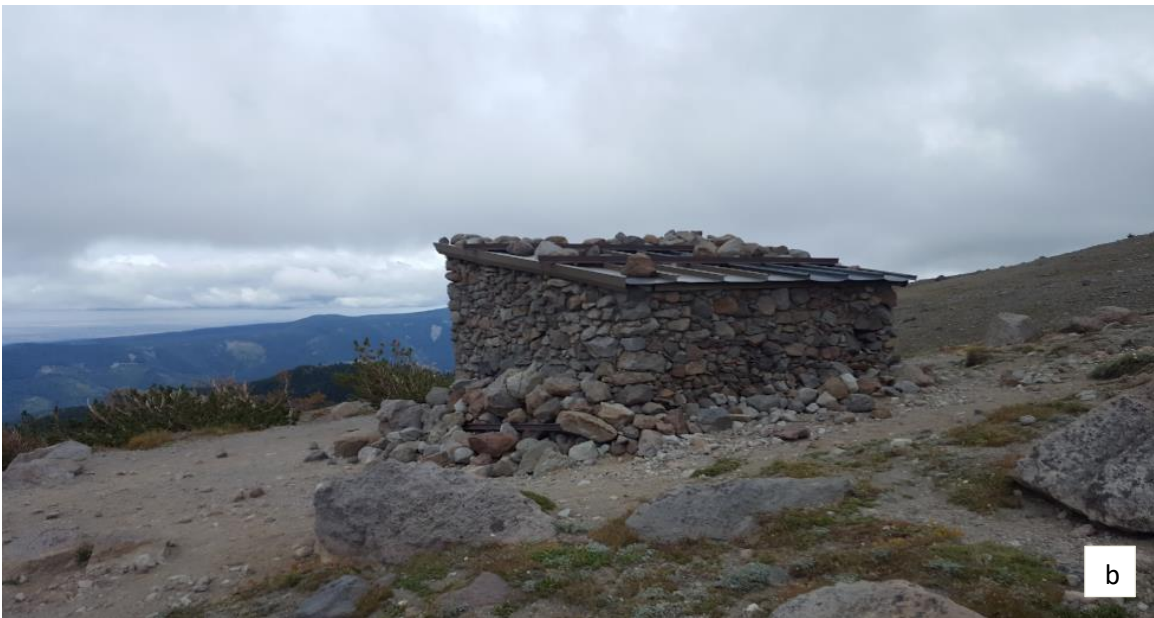
Figure 5.5. Preservation opportunities represented by (a) McNeil Point Shelter which is in fair condition, requires urgent roof repairs, but retains its integrity, versus (b) Cooper Spur Shelter which is in good condition, has no urgent needs, and has fair integrity impacted by the addition of a non-historic standing seam roof, rubber curtain, and orange spray foam insulation.

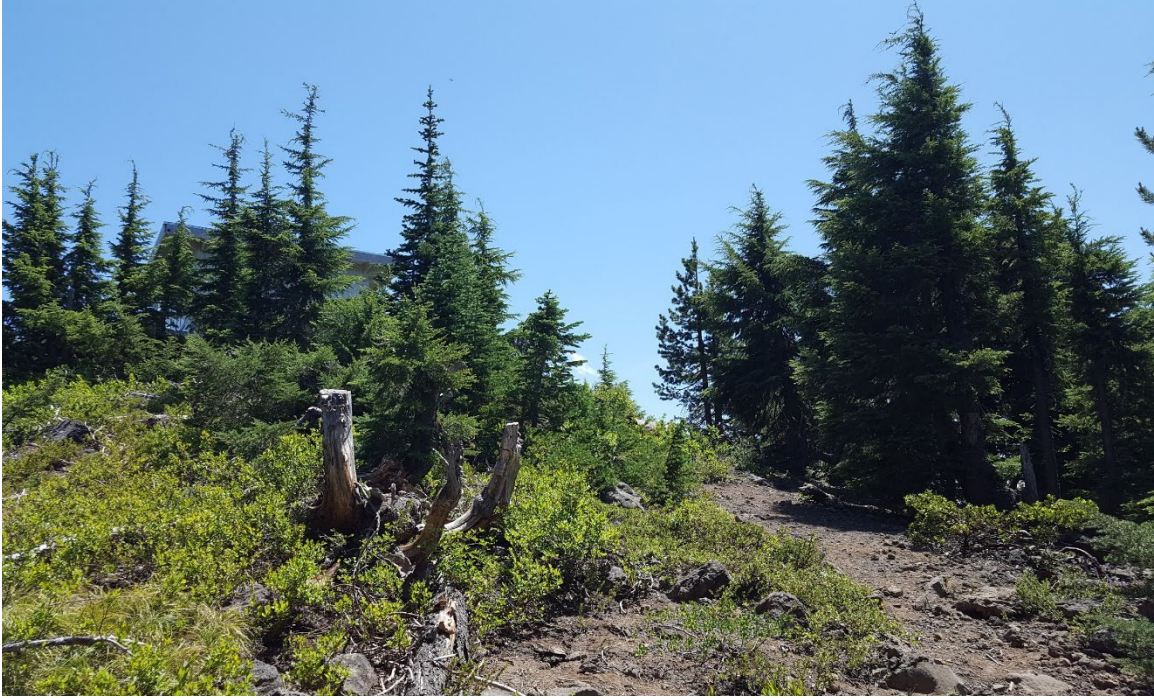
Figure 1. Record of trail conditions on the route to Waldo Mountain Lookout

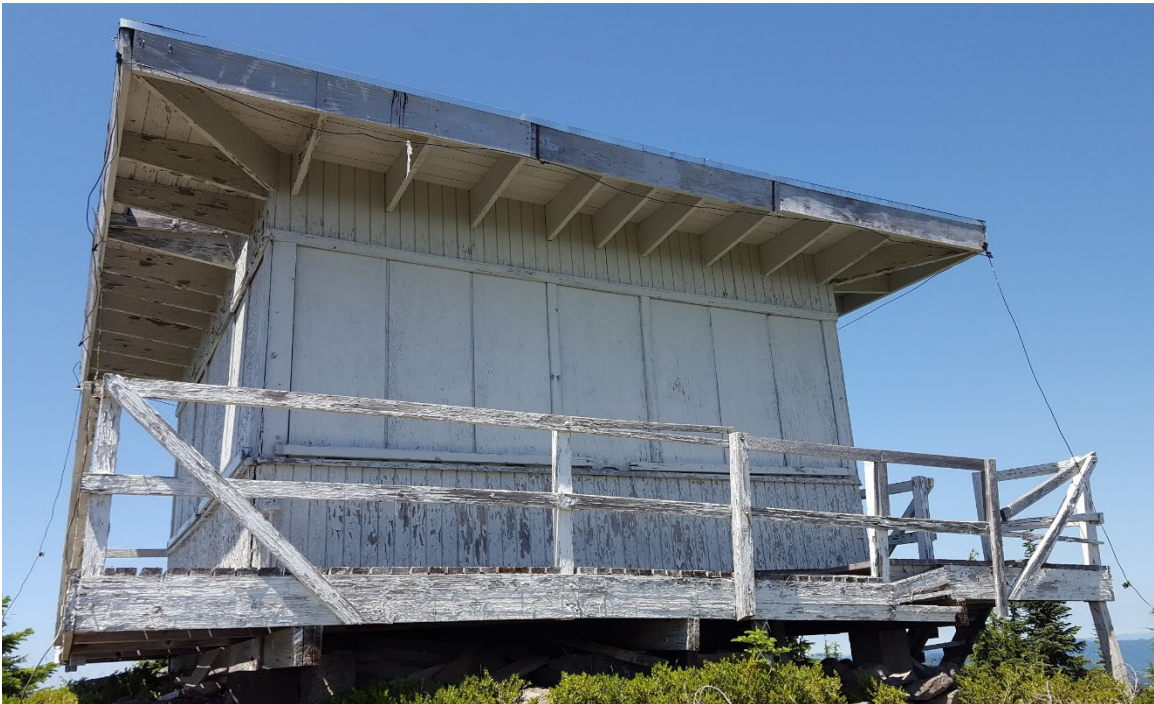
Figure 2. Photo of overall form and conditions, Waldo Mountain Lookout

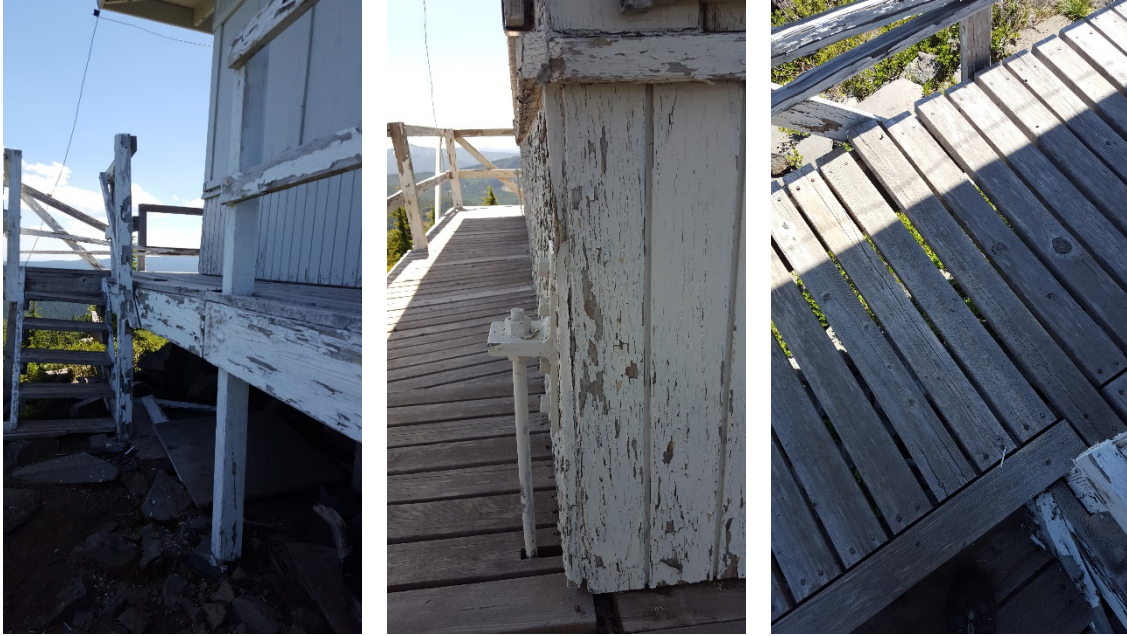
Figure 3. Photo tour of exterior features

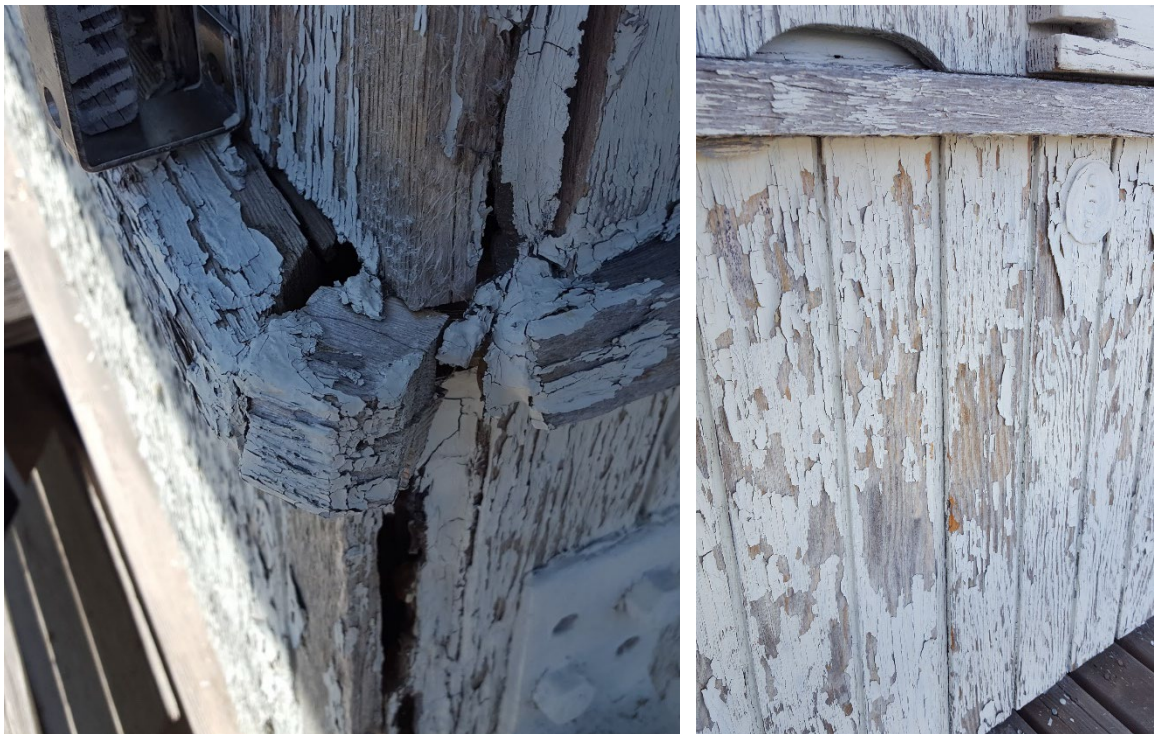
Figure 8. Photos of specific damage versus typical conditions

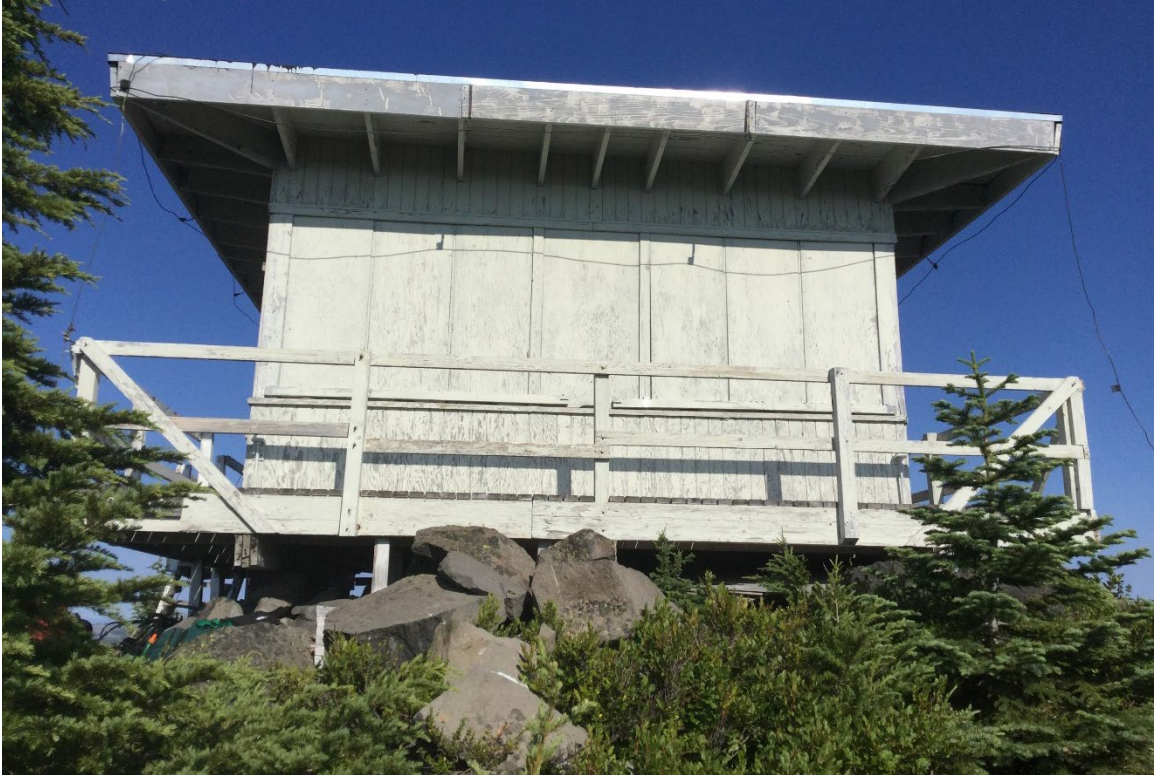
Figure 9. Lookout locked and shuttered at end of assessment (John Millikin, 2017)

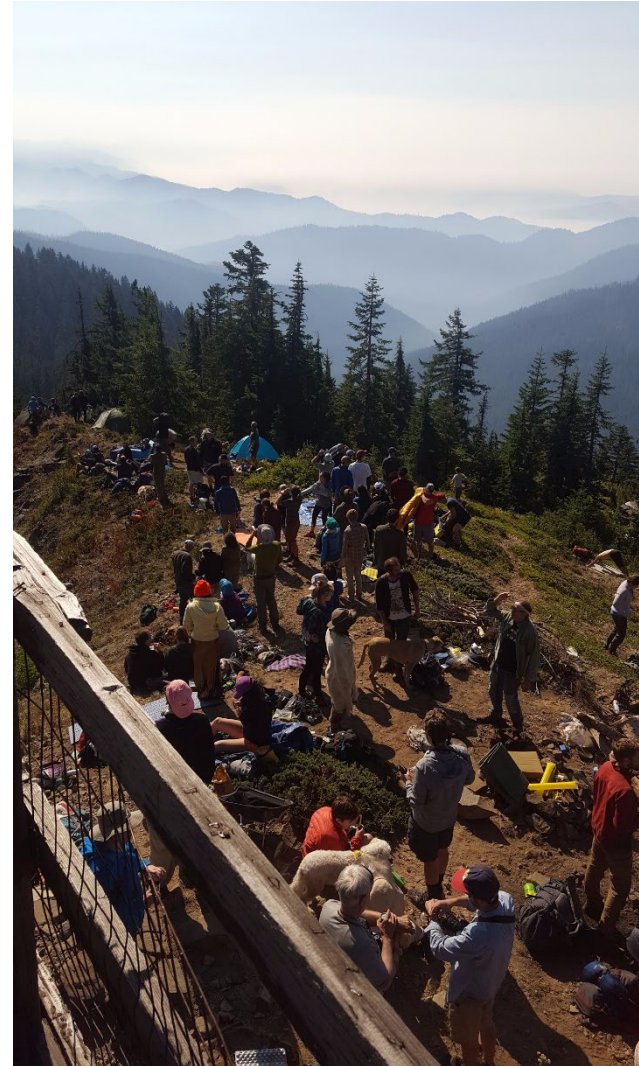
Bull of the Woods Peak during a solar eclipse, July 2017

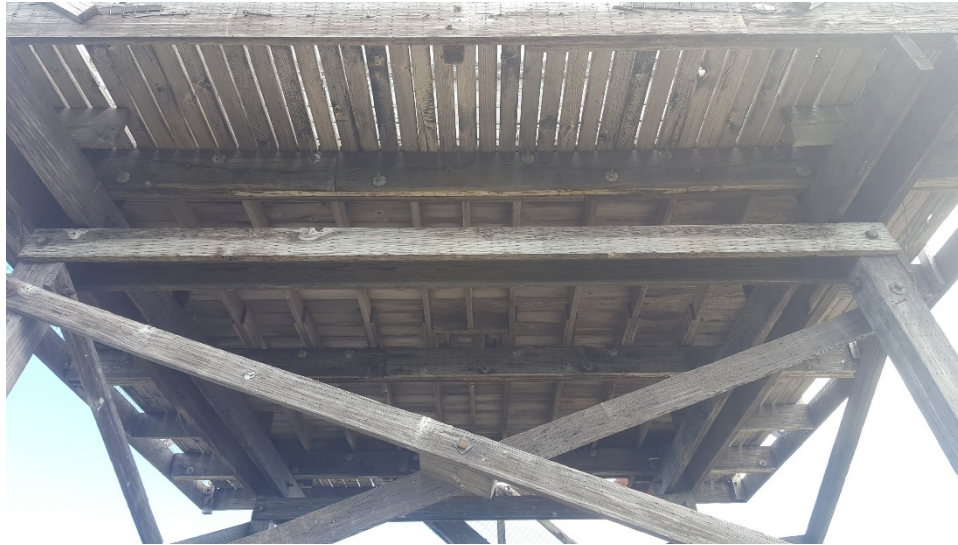
Tower and floor structure

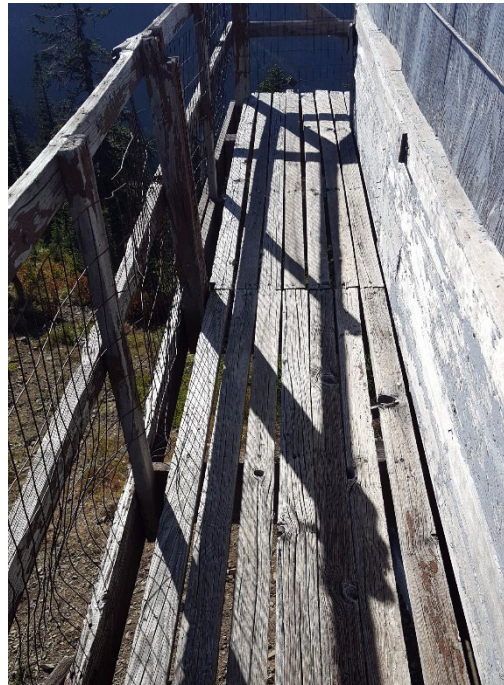
Deck condition, south side

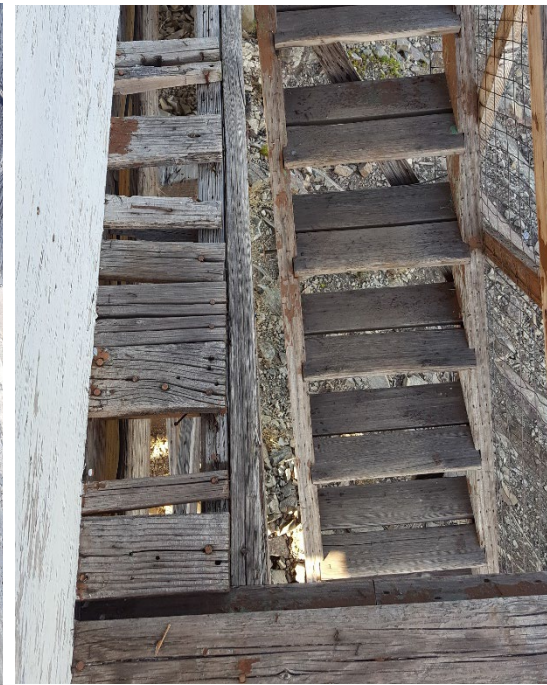
Deck condition, east side

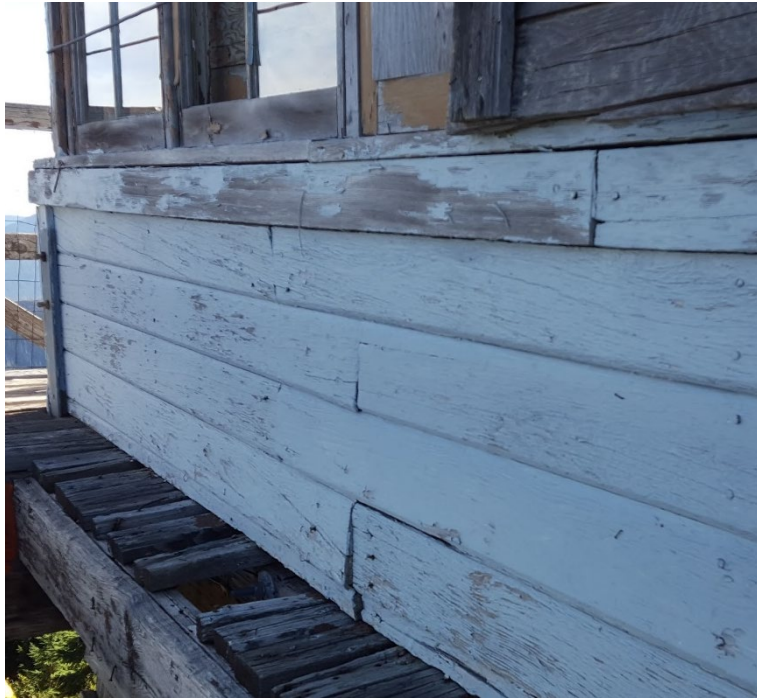
Typical wall condition

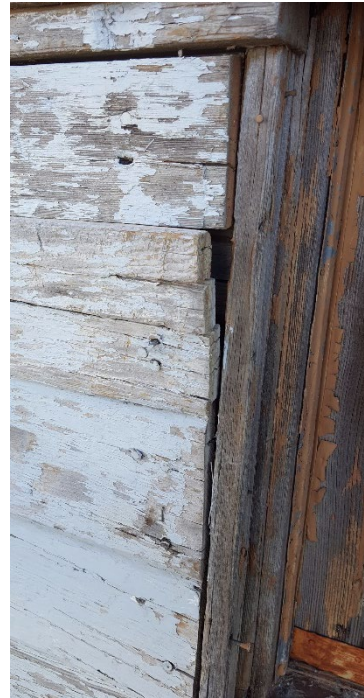
Typical siding condition

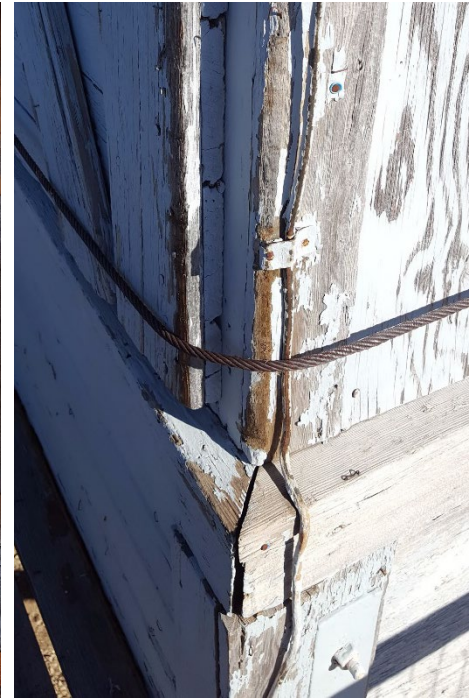
Typical trim condition

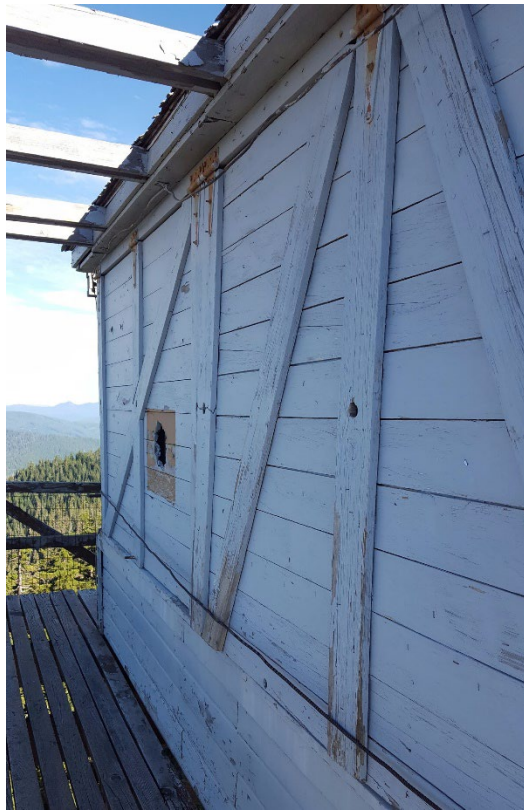
Typical condition, north elevation

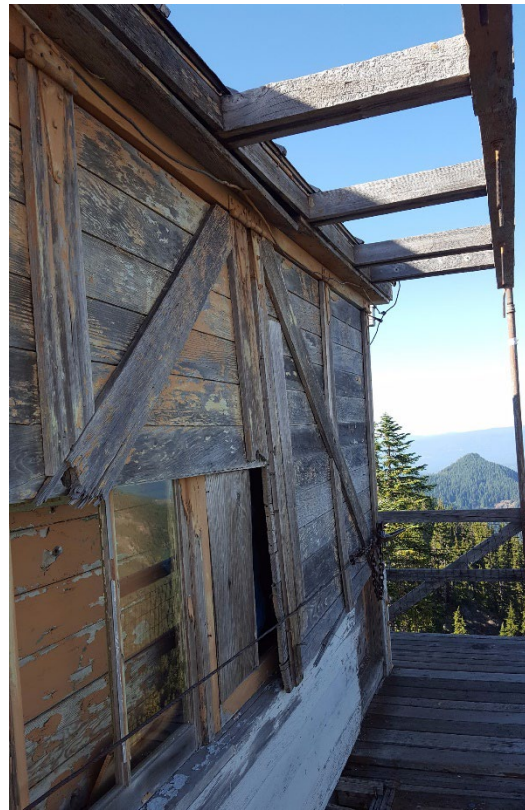
Typical condition, east elevation

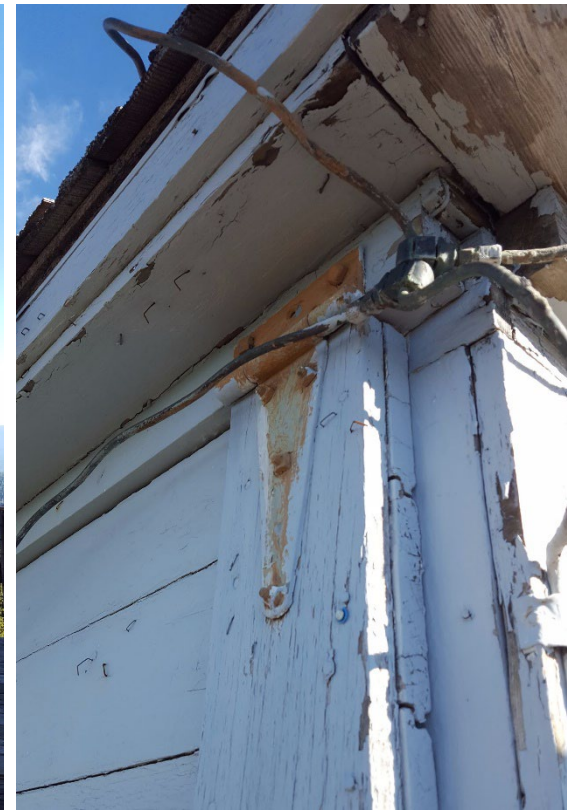
Construction and hardware

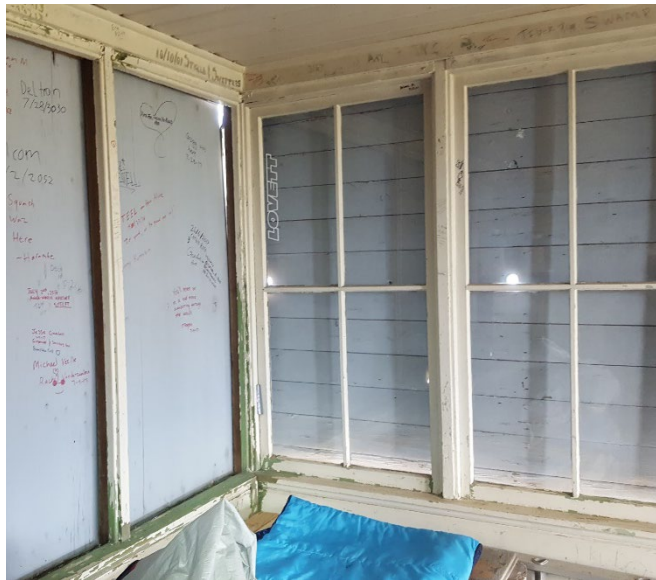
Door - The lookout's single door is on the east elevation, at the top of the stairs. It appears to be original and is in poor condition. The glass panes, muntin, and hardware are worn but intact, however, the bottom of the door is broken as if it has been kicked open and repaired numerous times. The door does not lock. *Recommended treatment:* repair or replace the door (this may require further, more detailed assessment).

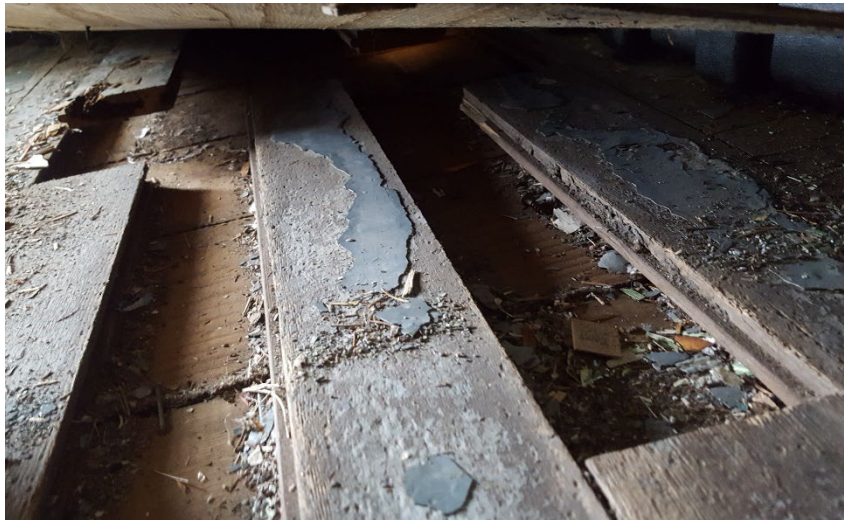
Interior finishes - The interior was previously treated with latex-based paint. The floor was finished with grey-over-white which is now in poor condition. The walls and ceiling were finished with white-over- green, which is in fair condition. *Recommended treatment:* test for lead content, scrape failing paint, and apply primer and paint.

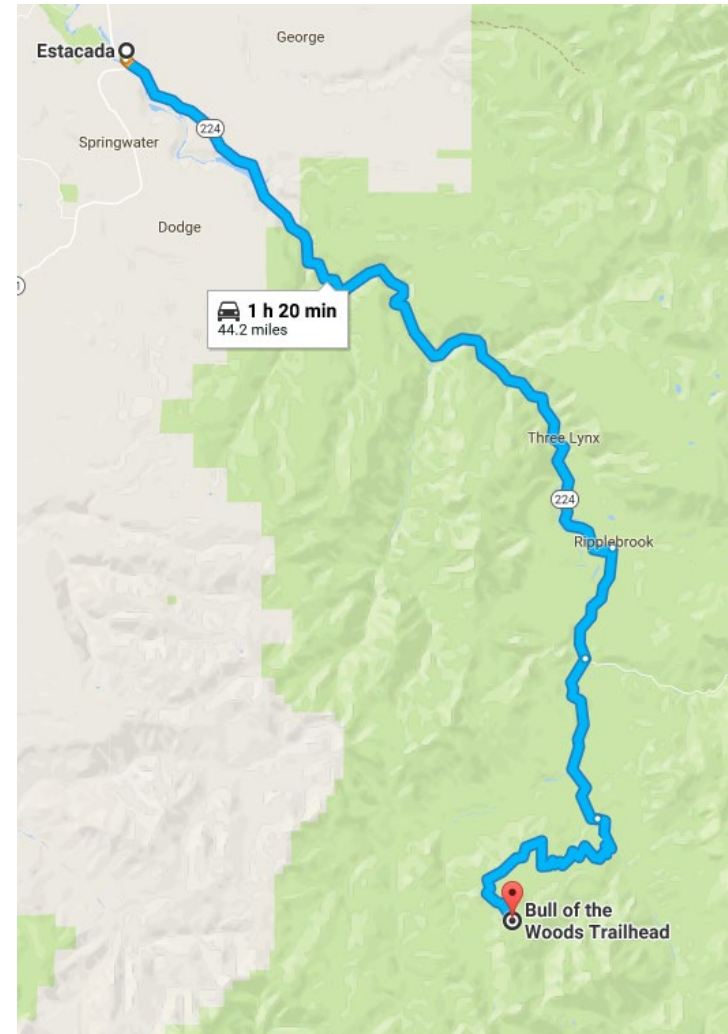
Route to Bull of the Woods Trailhead. Google Maps.

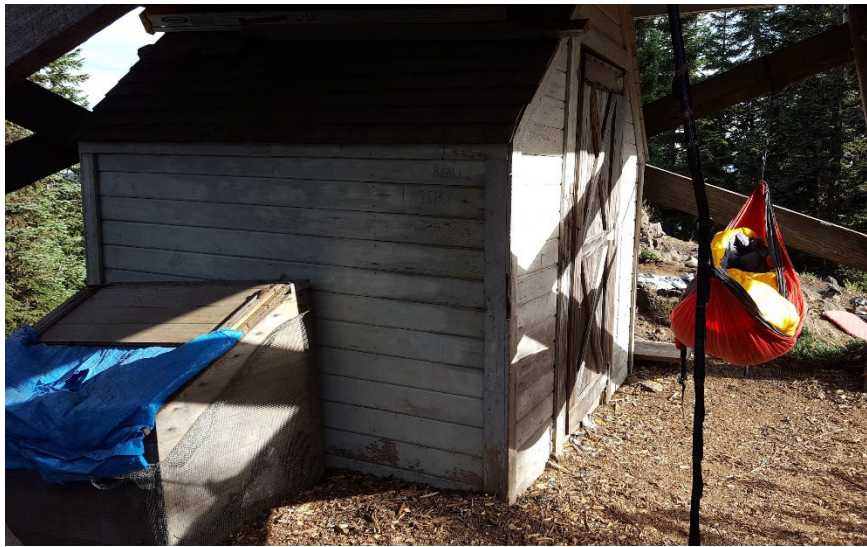
An 8’3” by 8’4” front gable storage shed is located directly beneath the lookout cab. It has a log footing and is clad in the same shiplap siding used on the lookout. The shed door faces south and is unlocked. A single window is located on the north elevation. The shed is in good condition but occupied by animals that have damaged the gear stored inside. A wood box located at the shed’s north elevation is in poor condition. It is probably not original but it serves a useful purpose. The lid has broken and is covered with a tarp. The sides were previously wrapped in wire to keep animal out. *Recommended Treatment:* clean out the shed and secure holes that have allowed animals inside. Repair the wood box with three 4’ long 1x5 tongue and groove boards and re-secure the wire wrapping.

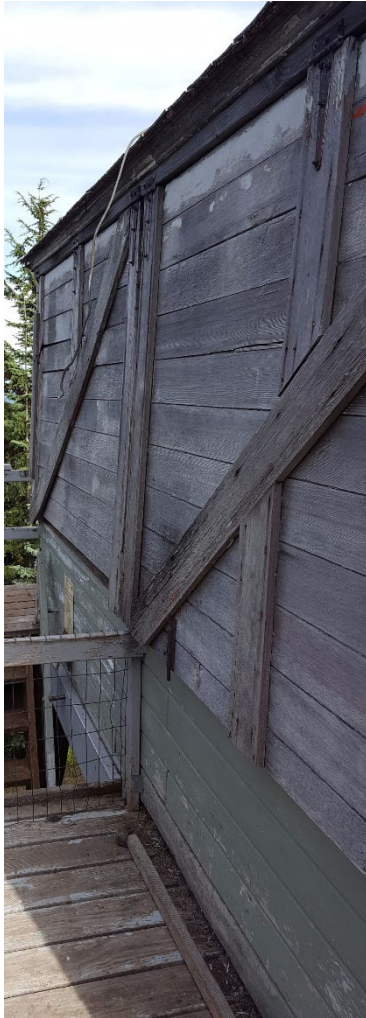
Condition of north shutters

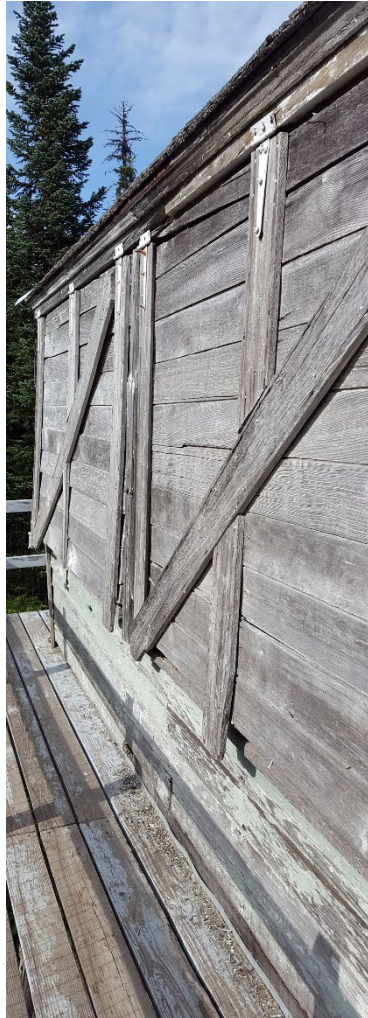
Condition of the west shutters

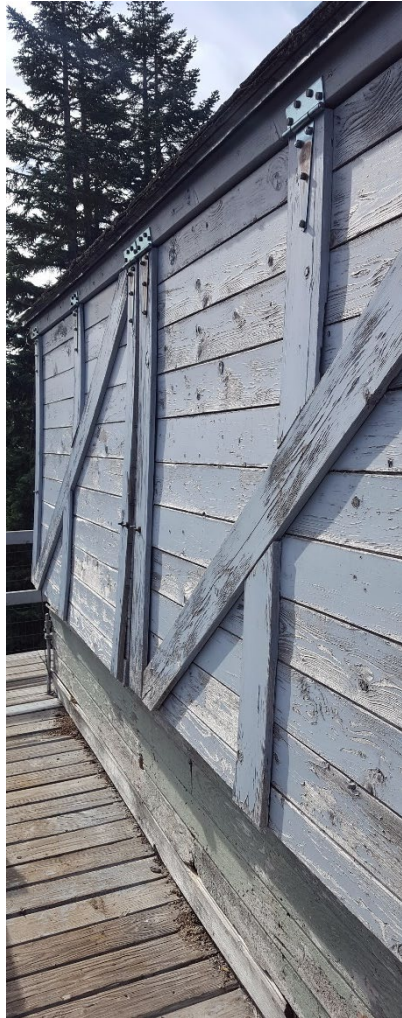
Condition of south shutters

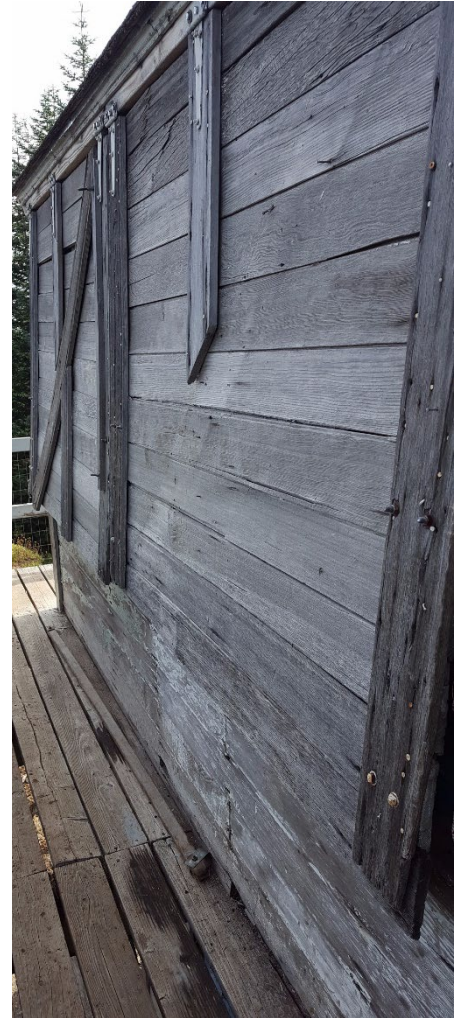
Condition of east shutters

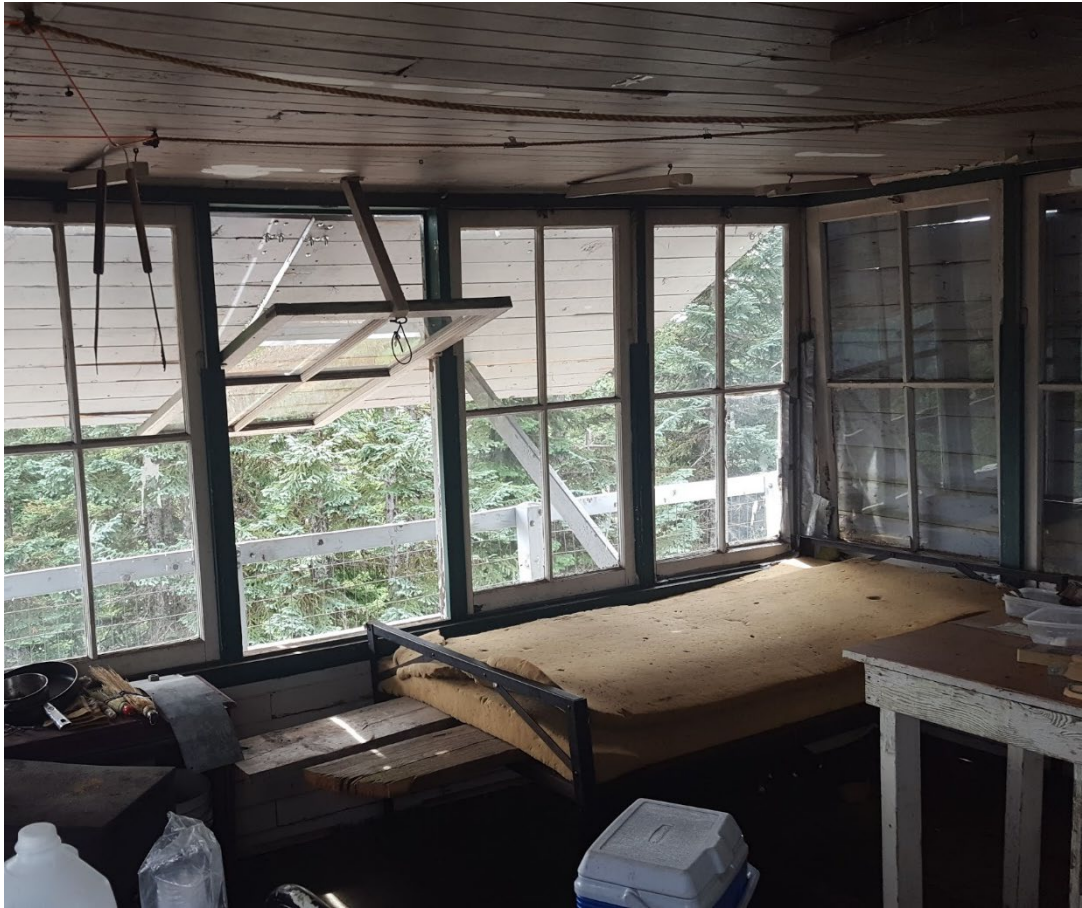
Typical window construction

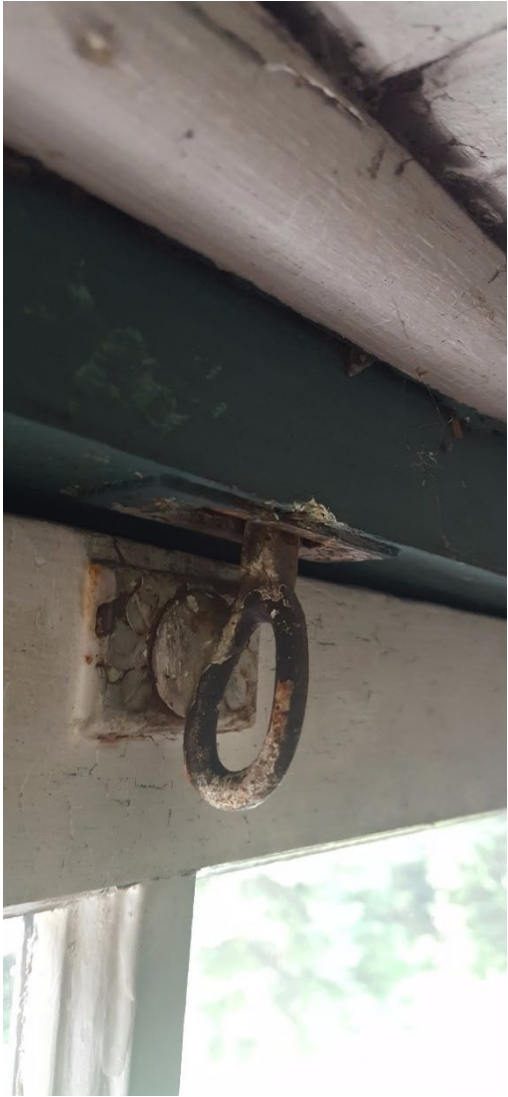
Typical condition, hardware

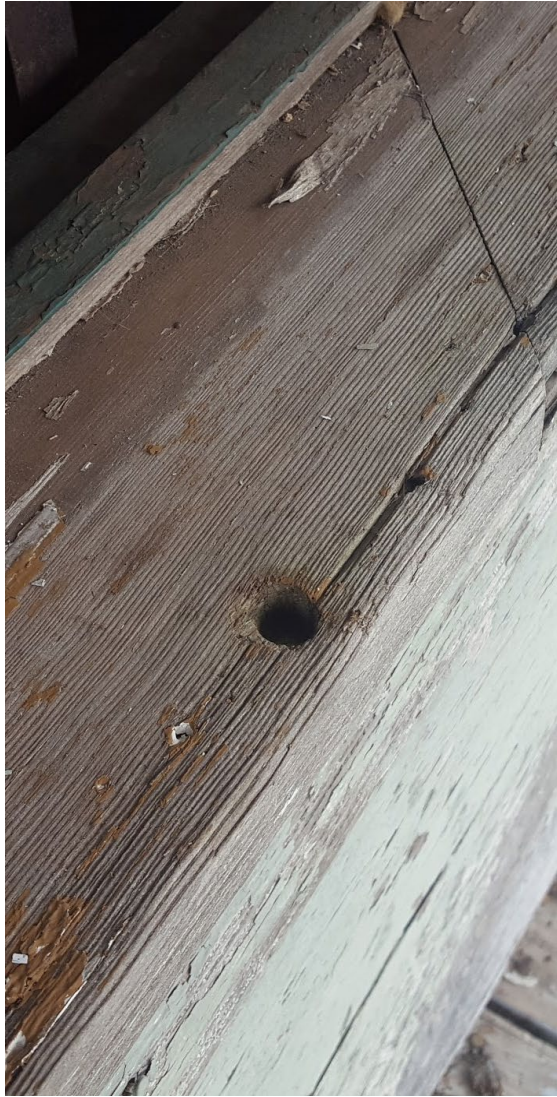
Typical condition, window sills
