WILD NOTIONS:
PRESERVATION OF HISTORIC BUILDINGS IN OREGON WILDERNESS

by
CHARLOTTE M. HELMER

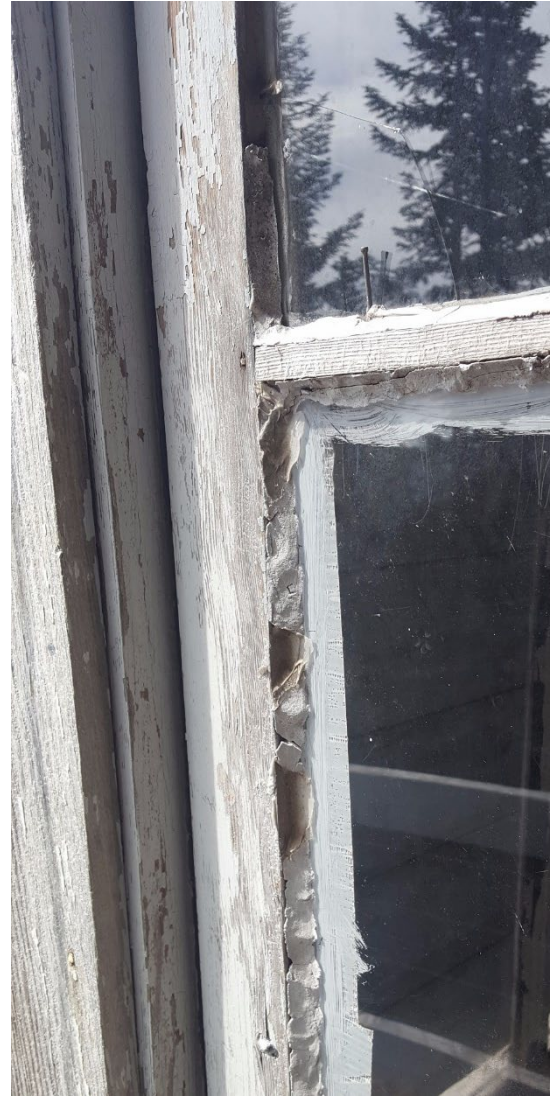
Typical condition, sash and glazing

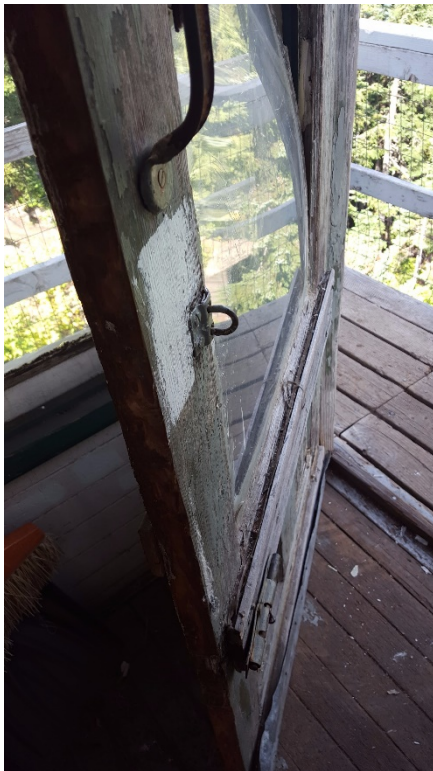
Typical condition, door

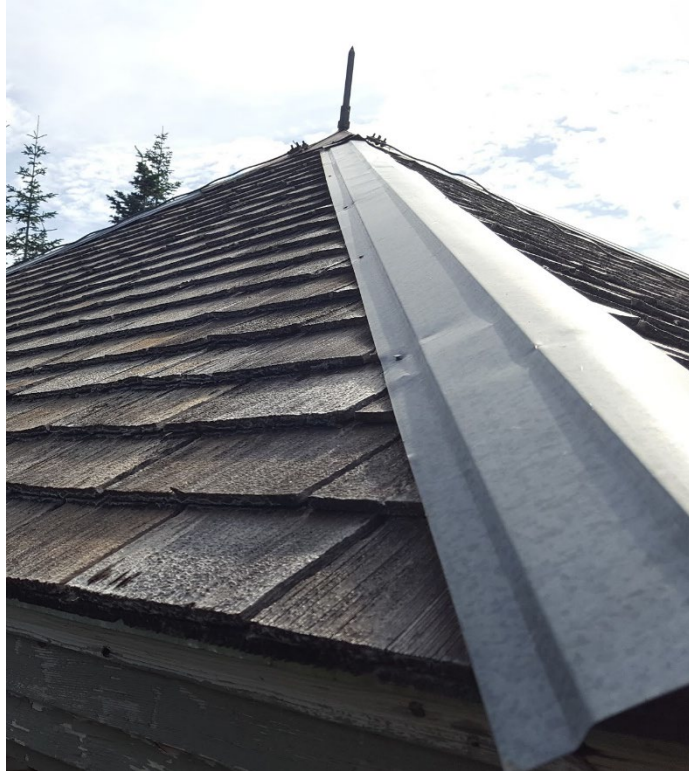
Typical condition, roof

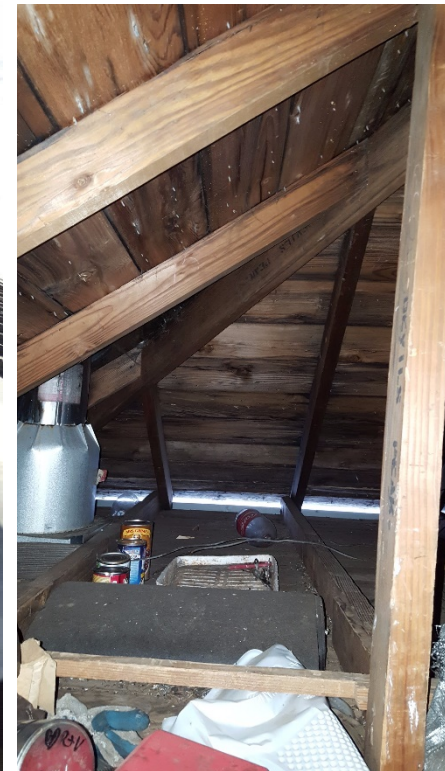
Typical condition, attic

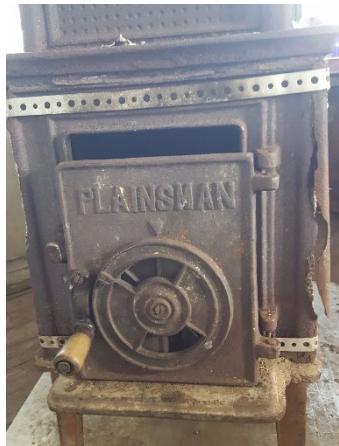
Security and Safety - The building is not secured against animals or trespassers, but it has been adopted by visitors and could remain unlocked. The lookout is safe for visitors, but fire is a concern. *Recommended Treatment:* provide a fire extinguisher and discourage visitors from lighting candles, burning incense, and using the current wood stove. The front door could be annotated with a sign that explains the lookout's significance, invites visitors to use it, and asks them to treat the building with respect.

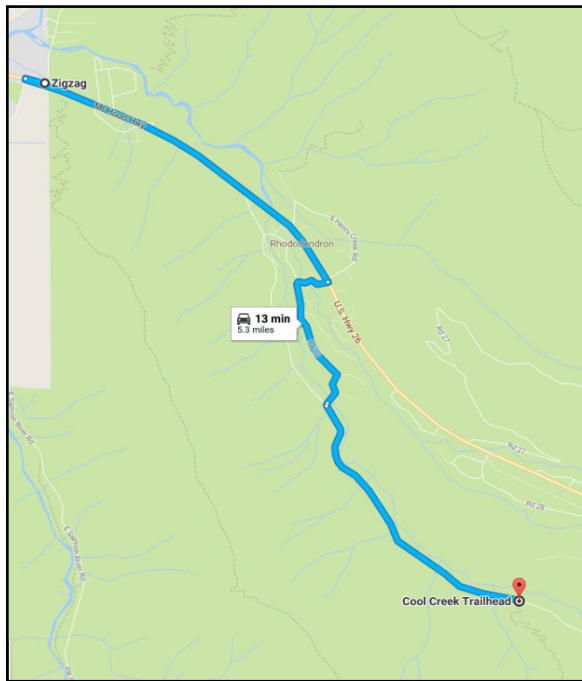
Routes from Zigzag to Cool Creek Trailhead.

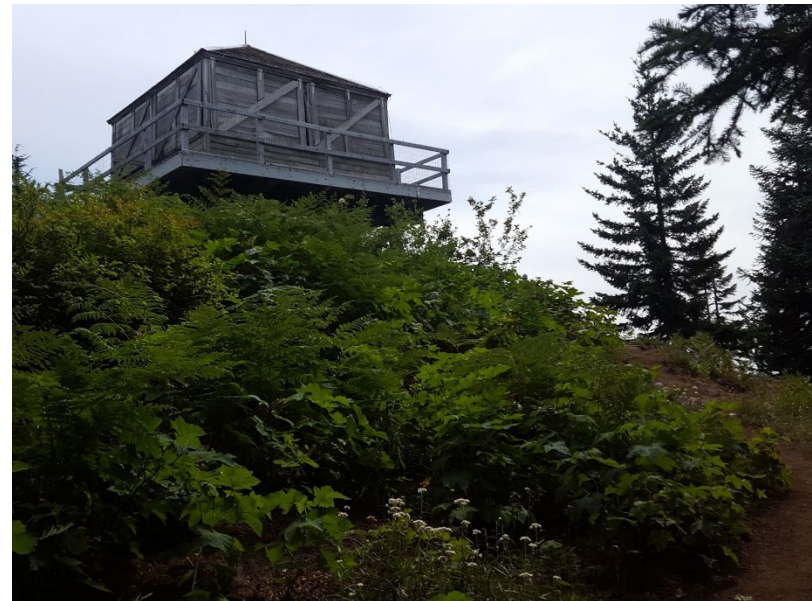
First view of Devil's Peak Lookout from the spur trail

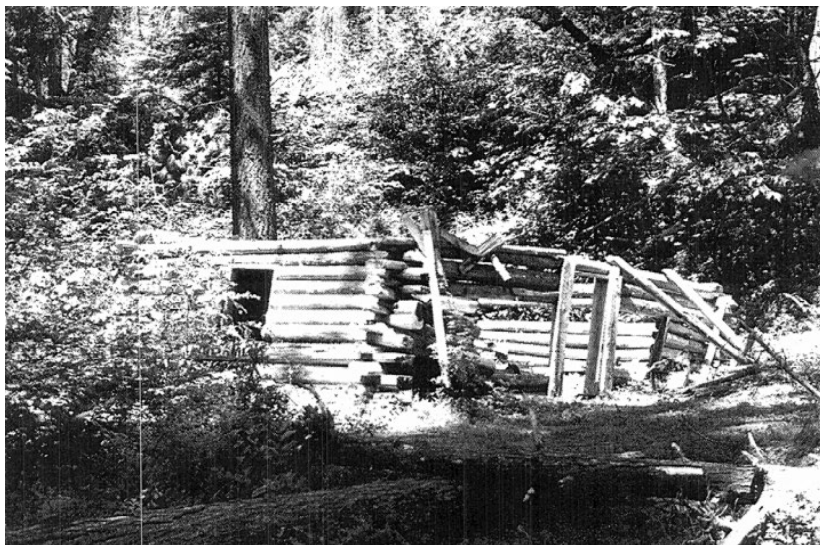
South and east elevations in 1997. Courtesy of USFS.

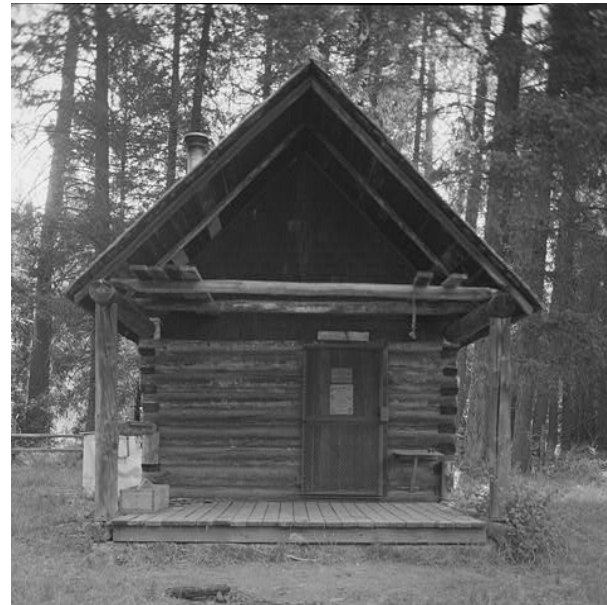
Millard Ranger Station, 1997. Library of Congress.

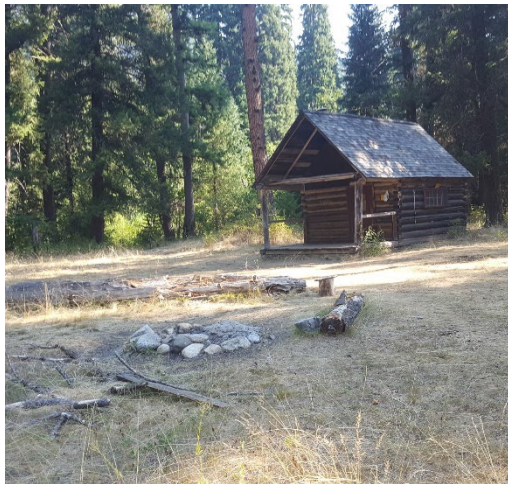
Southwest corner and fire pit

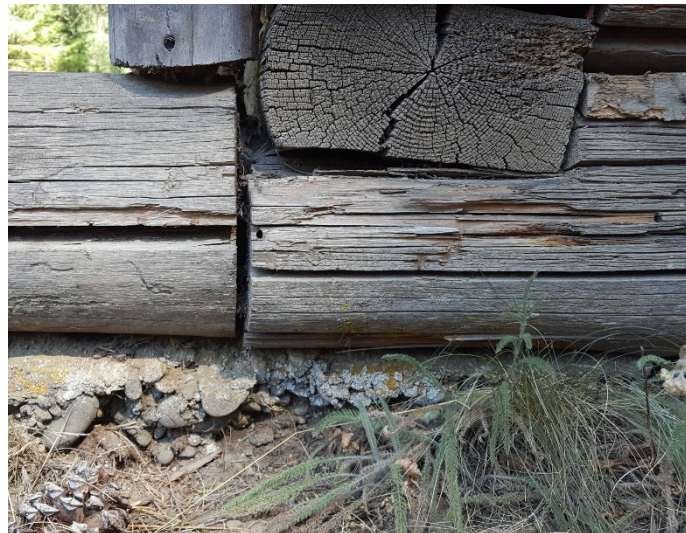
Foundation and sill construction

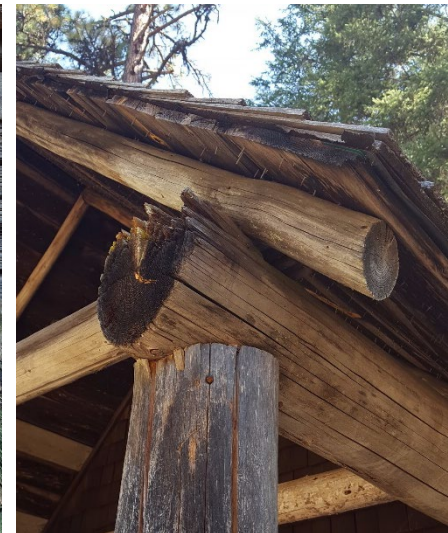
Condition at southwest corner

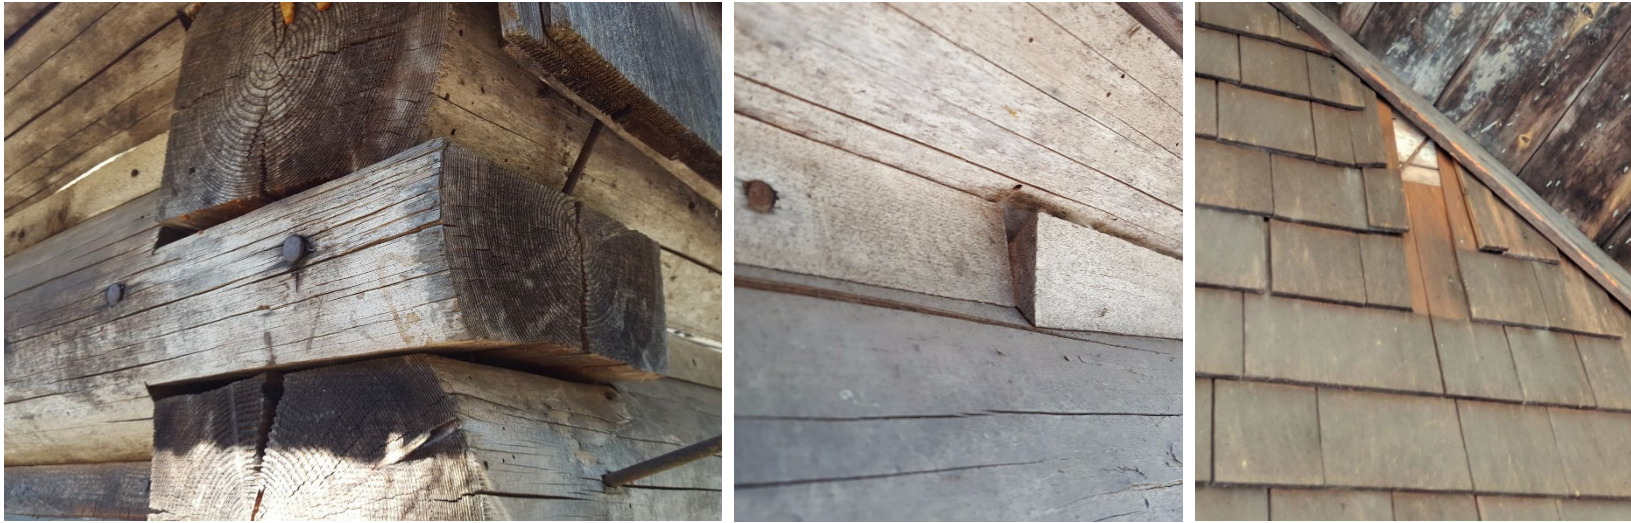
Wall construction details: joinery, chinking, shingles

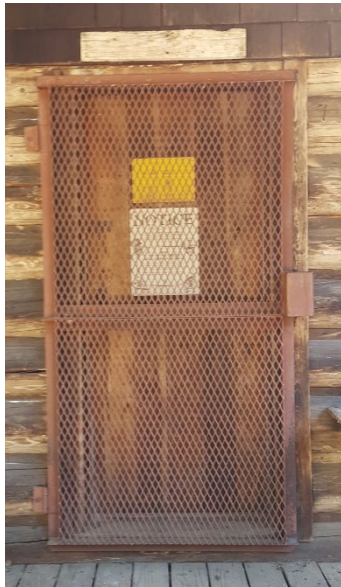
Roof - The roof structure was only partially accessible during this assessment but appears to be in good condition. It a steep gable framed in poles and clad in a cedar shingles on top of wide sheathing boards. Rafter tails feature stains and surface rot but are all intact. One damaged tail has been ‘fixed’ with orange spray foam. This repair is sufficient as a temporary measure but could eventually be replaced with a spliced rafter tail. A stovepipe protrudes from the north side of the roof and appears to have been previously damaged and reinstalled.

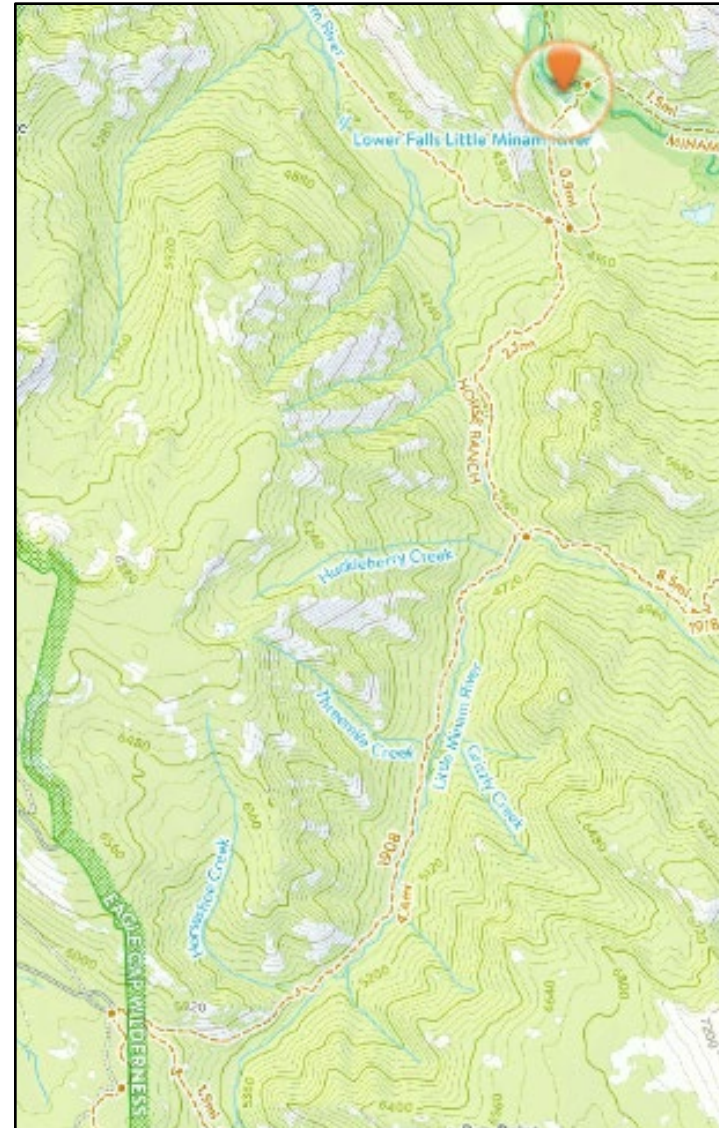
Stock - The Horse Ranch trail is frequently used for stock, and there is sufficient water all along the route. Stock can graze in the meadows around Red's Horse Ranch. The trail is steep and narrow, which makes it easy for heavy-laden animals to slip, but the trail is frequently used nonetheless.

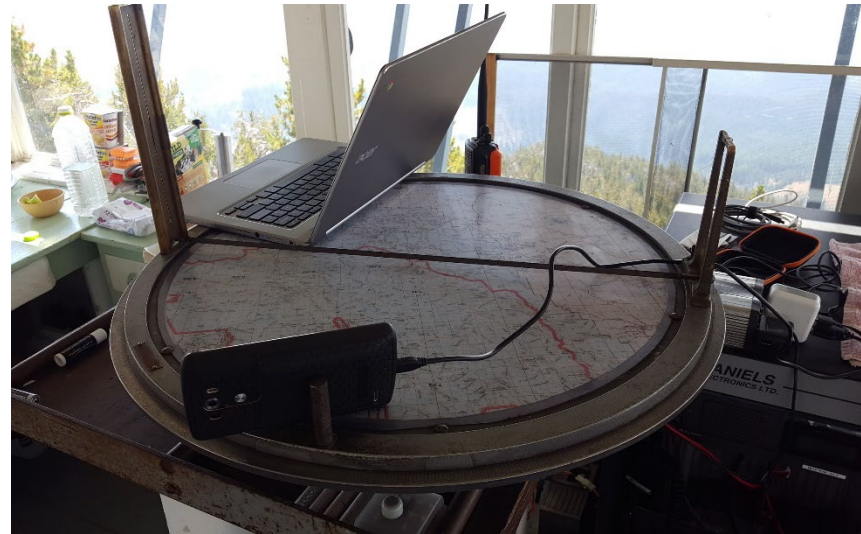
Technologies used to monitor fire activity from Mule Peak

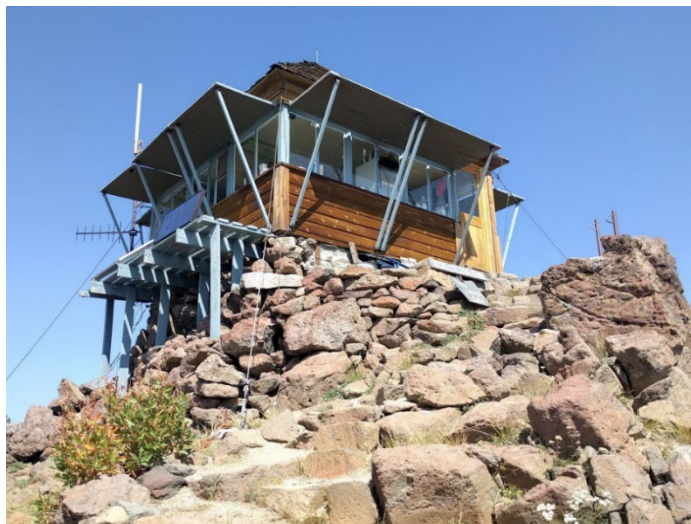
Southwest and southeast elevations and site

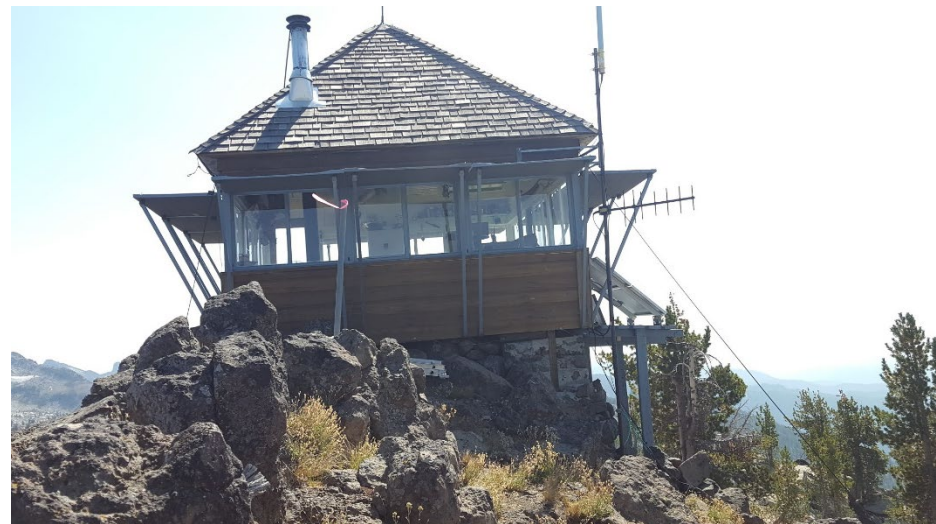
Northwest elevation and site

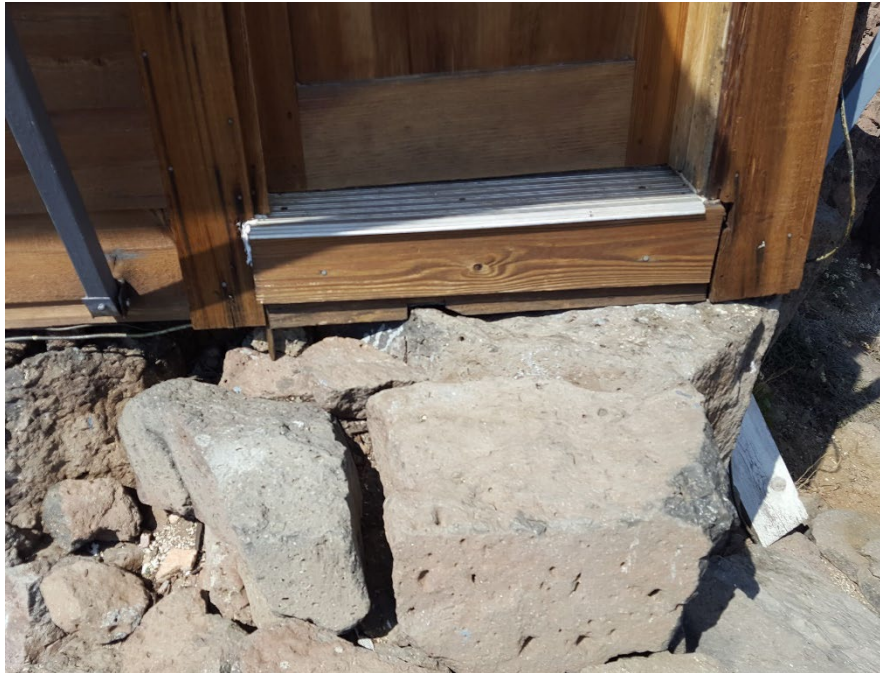
Typical construction and condition of dry-laid stone steps

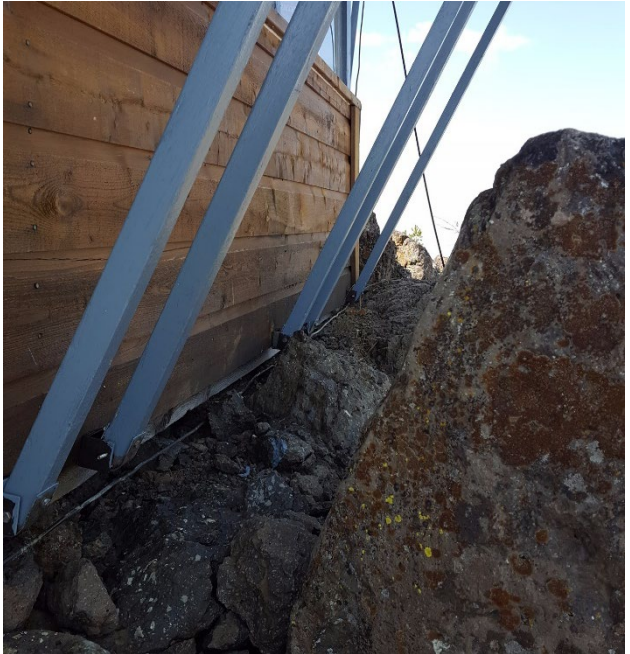
Basalt foundation, northeast side

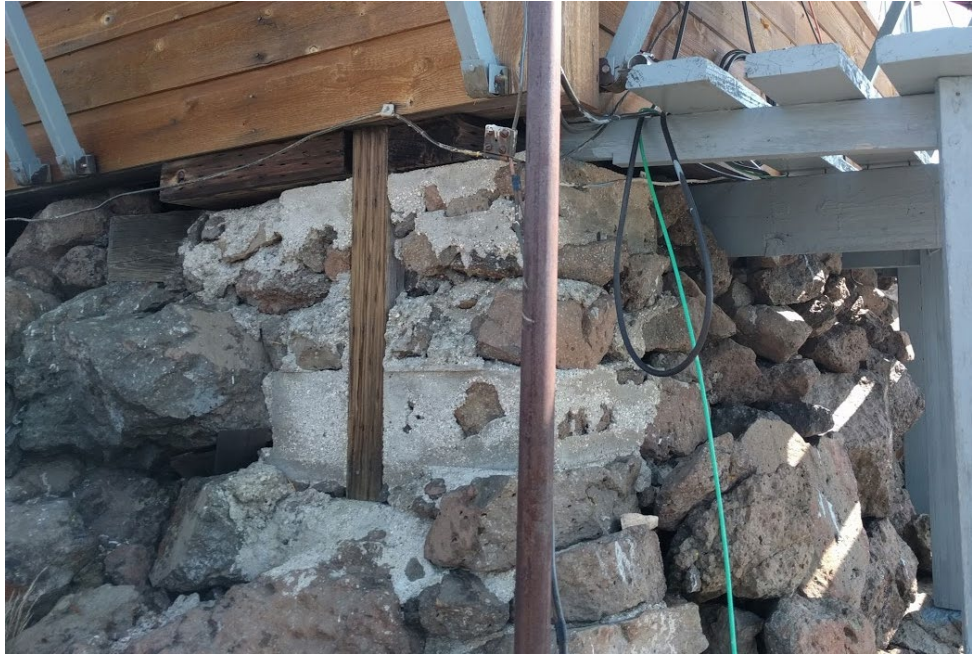
Reinforced foundation, west corner

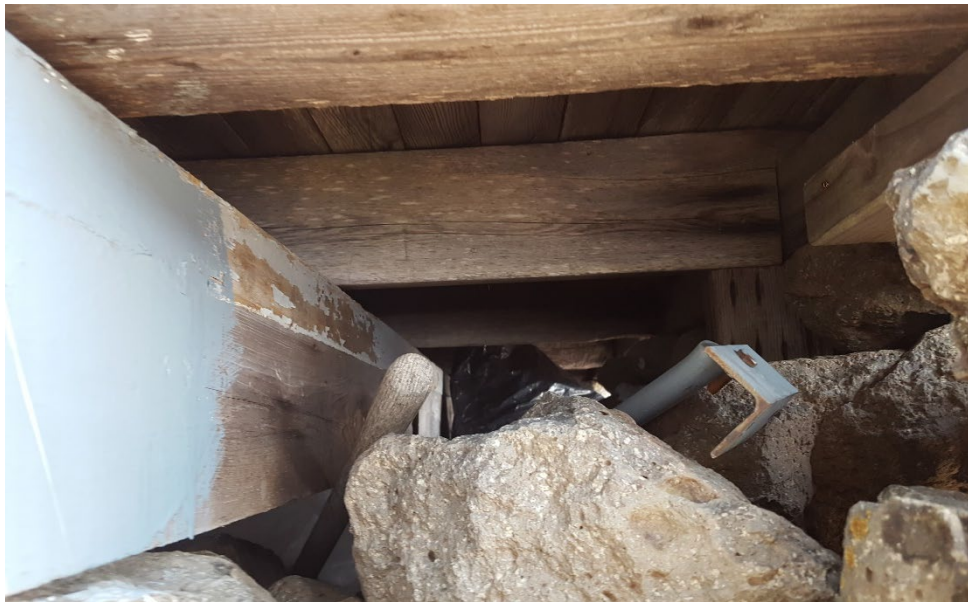
Typical construction of floor joists and subfloor

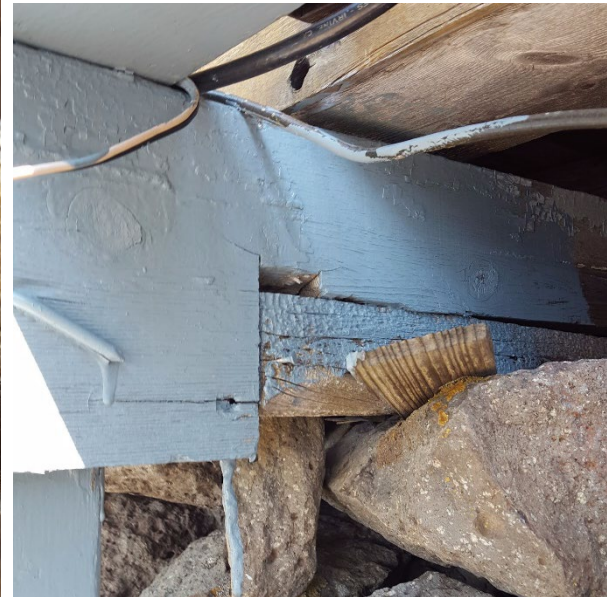
Typical rough construction of solar panel deck

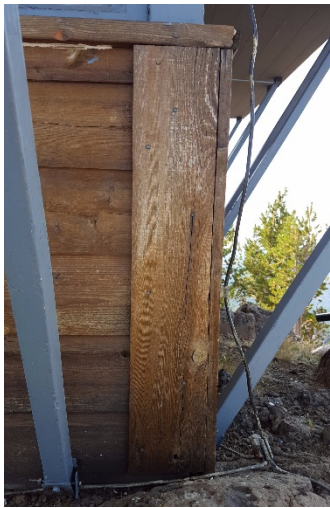
Finishes – Painted surfaces are in good condition. Unpainted surfaces of the lookout were previously painted with a grey latex-based paint. *Recommended Treatment:* treat all unpainted wood with primer and paint. This will restore the lookout’s traditional appearance but, more importantly, it is a necessary measure that will extend the lifetime of the siding which protects the wall structure underneath.

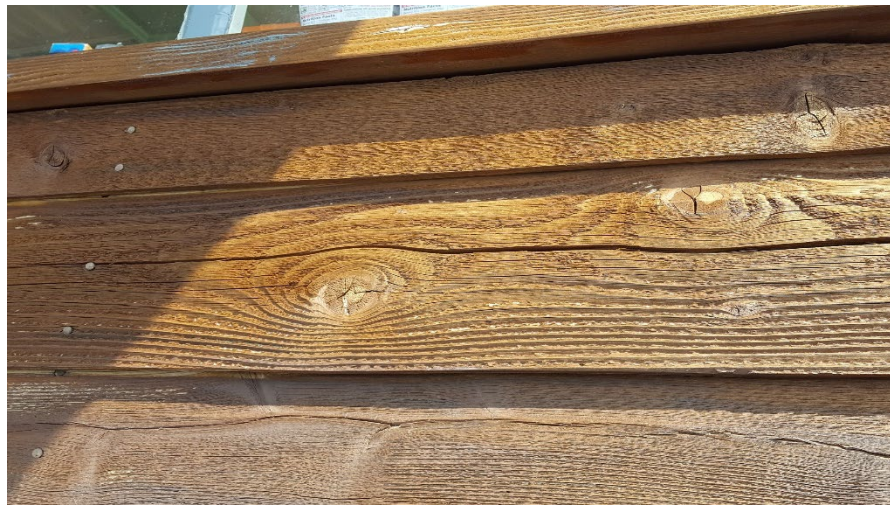
Typical condition of shiplap siding

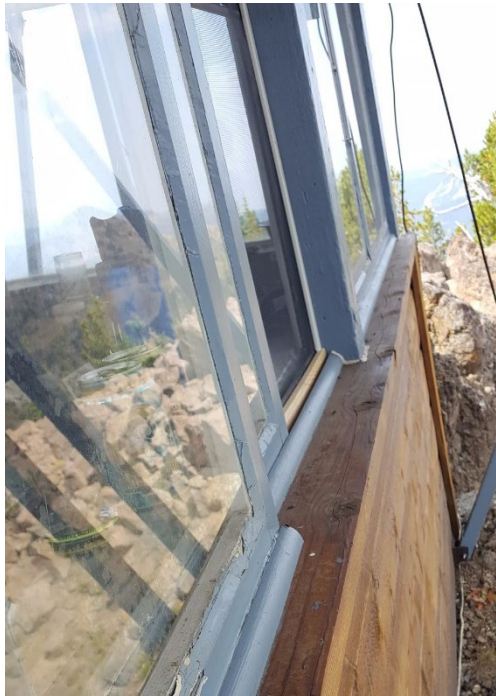
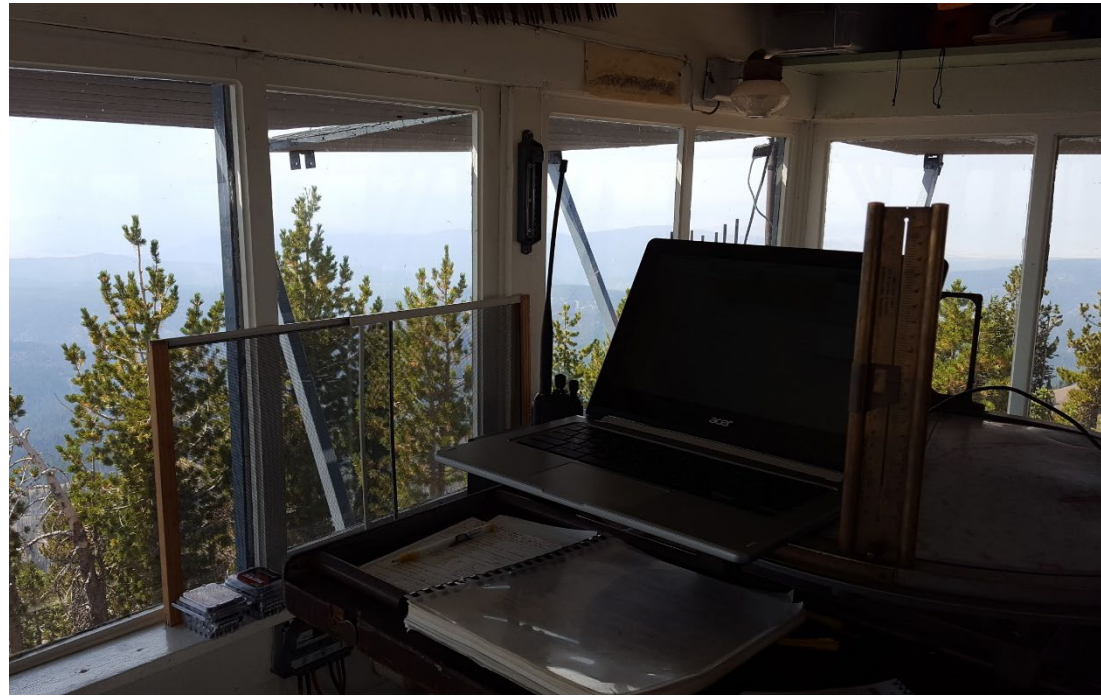
Construction of fixed and sliding sash

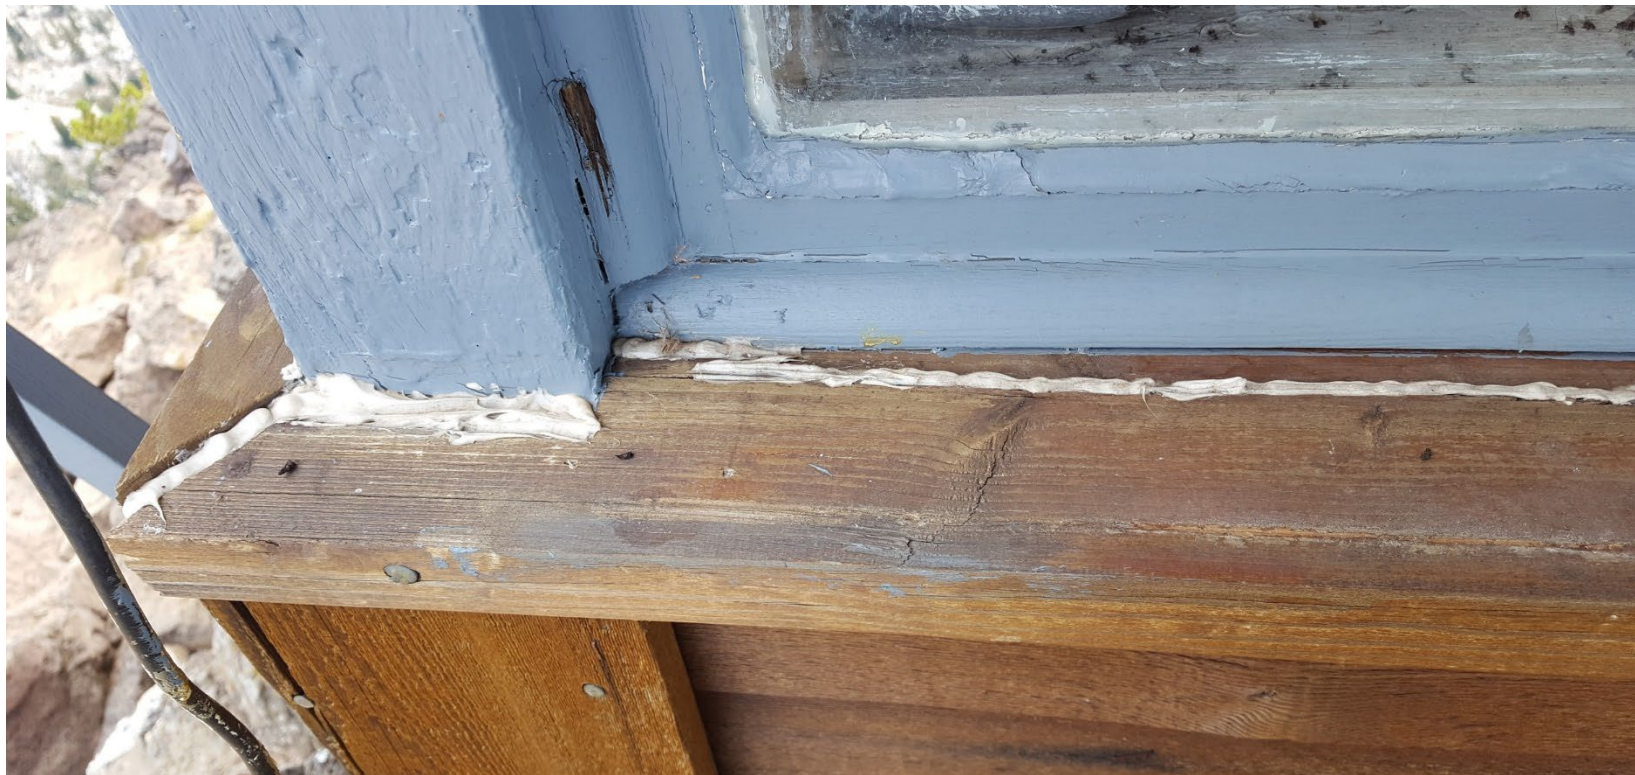
Typical condition of window sills, unpainted and caulked

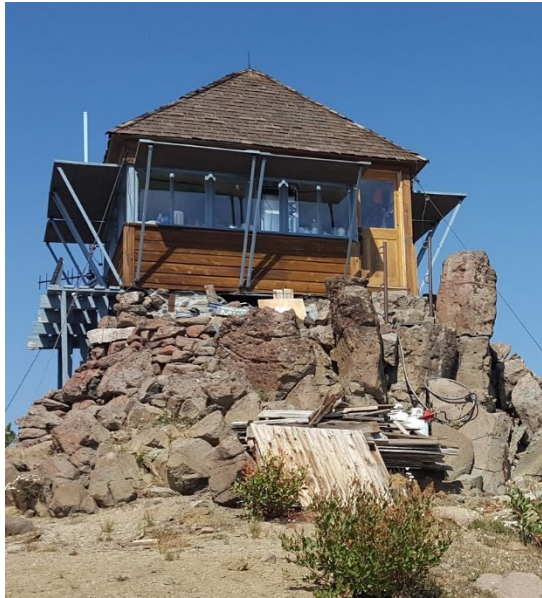
Roof - The hipped roof was not accessible during this assessment but both the structure and the cladding appear to be in good condition. The roof is treated with cedar shingles that have a standard 5" reveal. Shingles along the ridges are cupping and will likely fail first. The resident reported that the roof leaks around the stove pipe and may need to be reflashed. *Recommended Treatment:* inspect the chimney to verify that it is flashed effectively.

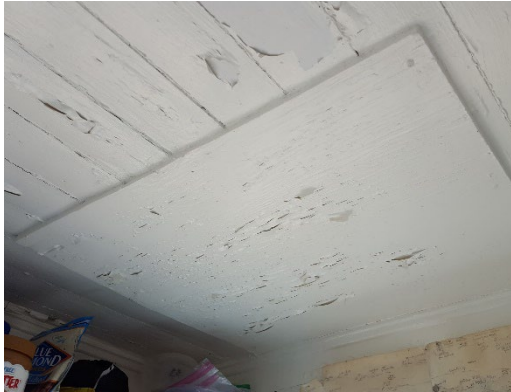
Security - A cable is run through the eye bolts and fastened with a griphoist to hold the shutters closed. This system is probably not original and the cable is scarring the lookout's corners. However, the system is effective and could be continued. *Recommended Treatment:* reinforce the corners with small pieces of aluminum flashing or a similar protective layer to prevent more damage.

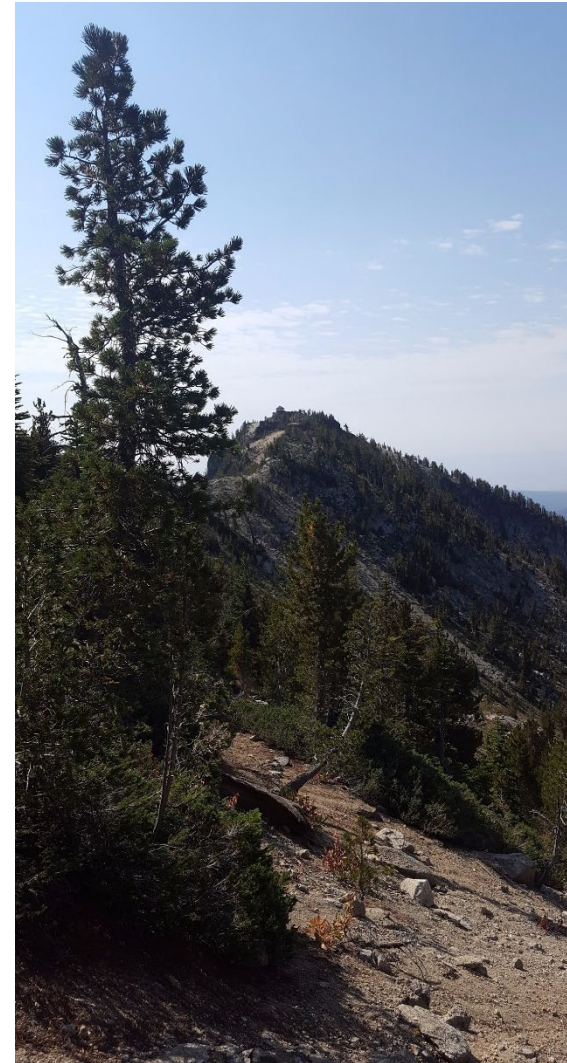
Mule Peak Lookout seen from Sand Pass

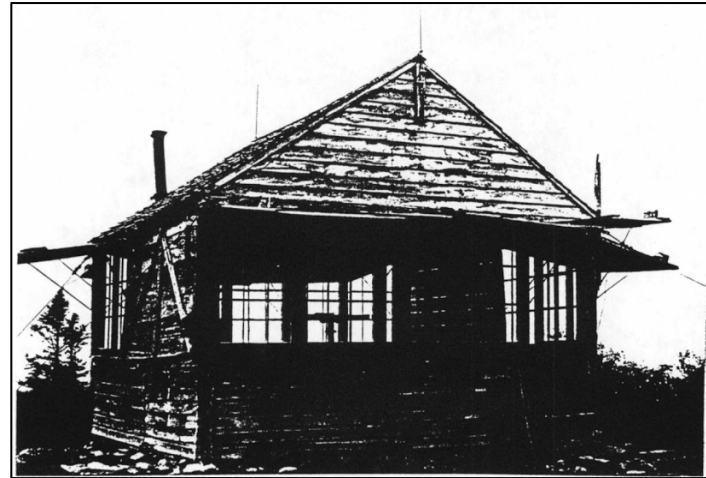
Olallie Mountain Lookout, ca 1990. USFS.

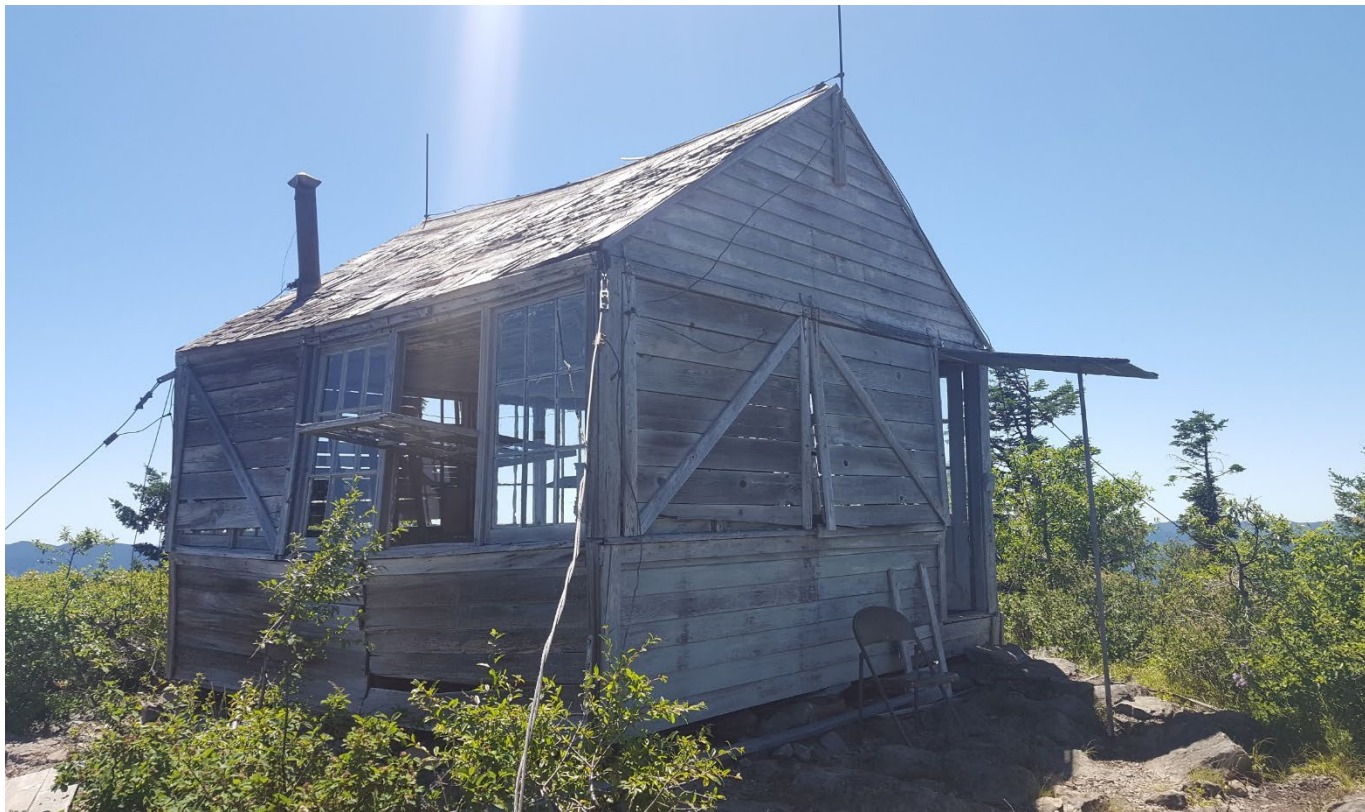
West and north elevations

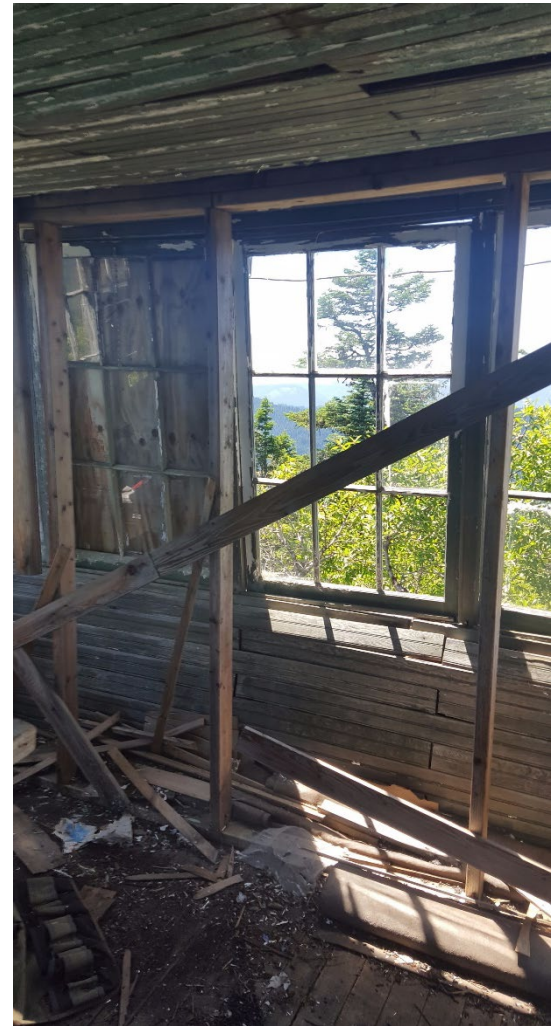
Temporary interior wall

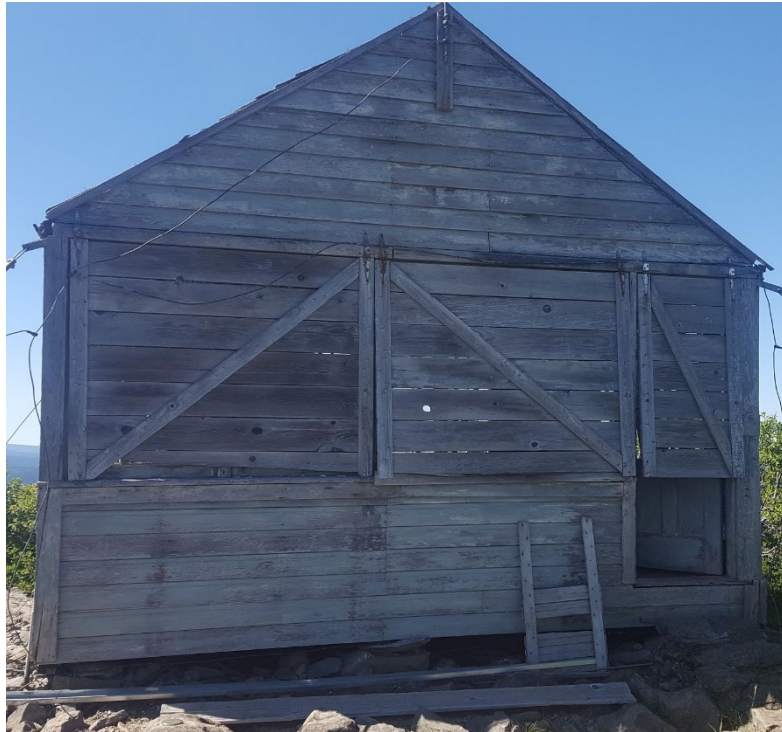
Typical construction

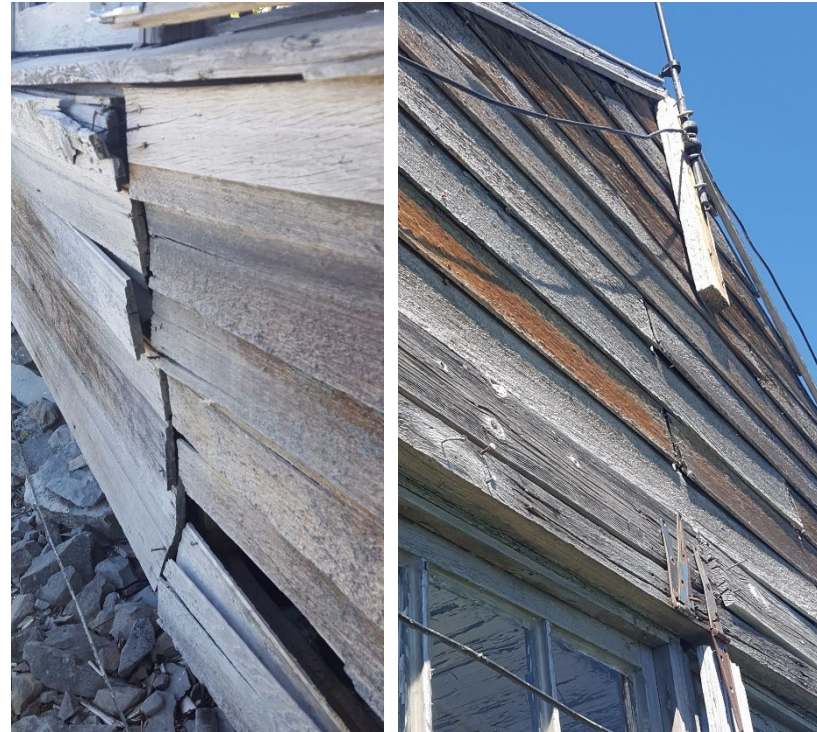
Typical condition below and above windows

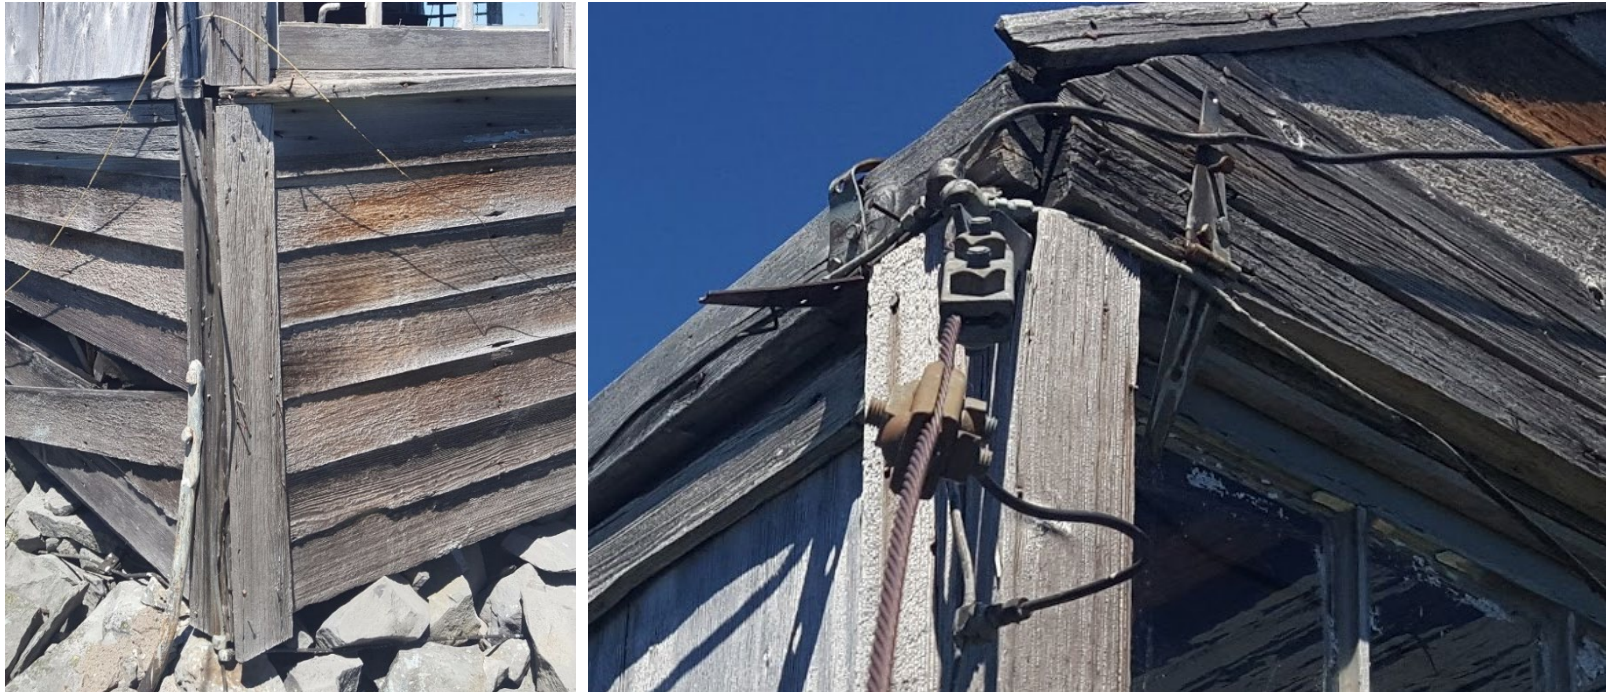
Typical trim construction below and above

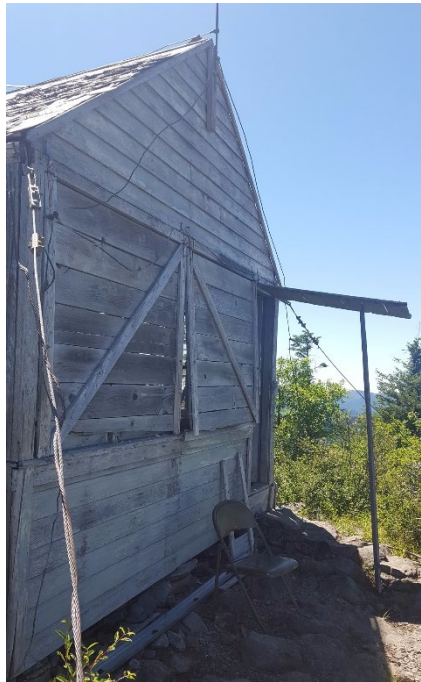
Typical construction

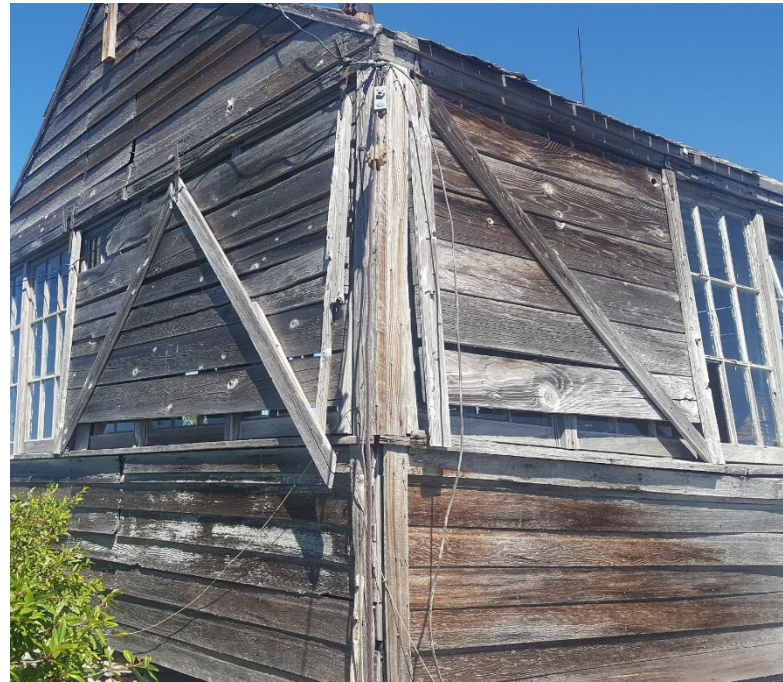
Typical condition of large and medium-sized shutters

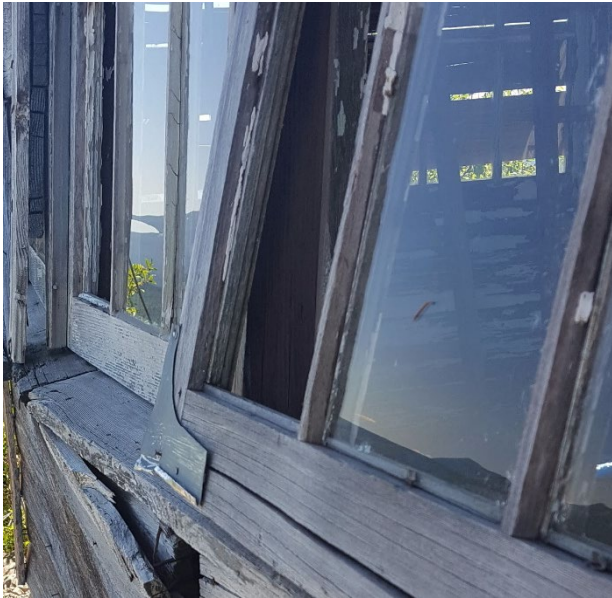
Door - The lookout's single door is on the north elevation. It is in good condition with panes, muntins, and panels intact. A small amount of damage to the woodwork could be patched with wood filler and the door could be repainted. The threshold dripline has broken off and could be repaired. The padlock and hasp have been removed. *Recommended Treatment:* repair the threshold and patch minor damage to the door's surfaces with woodfiller.

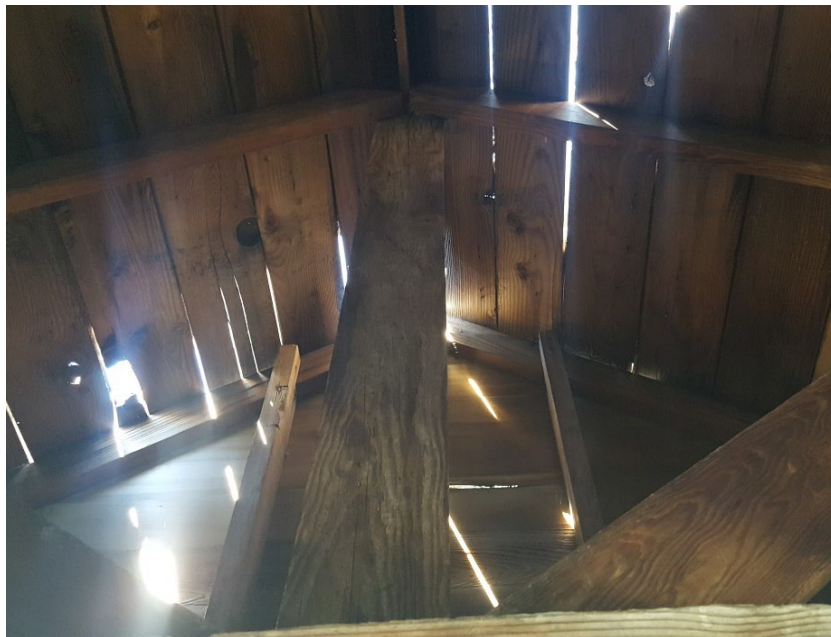
Roof structure construction and condition

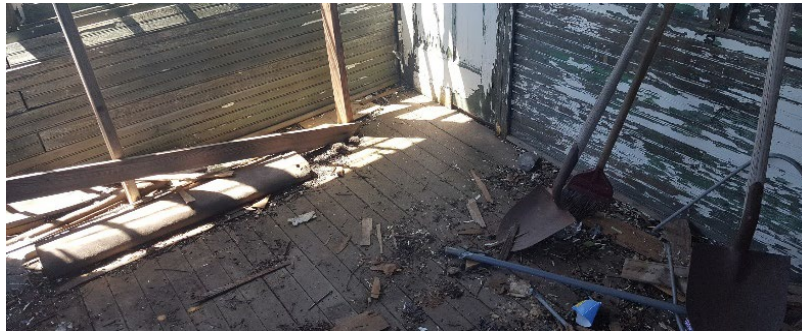
Floor and wall condition

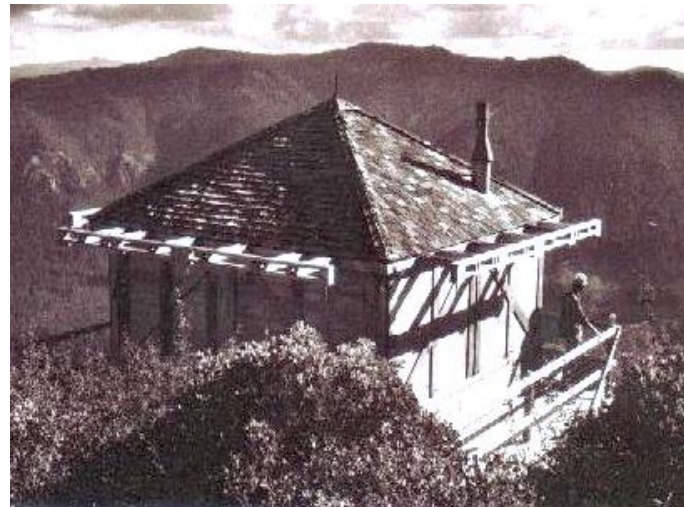
Rebel Rock Lookout, no date. USFS.

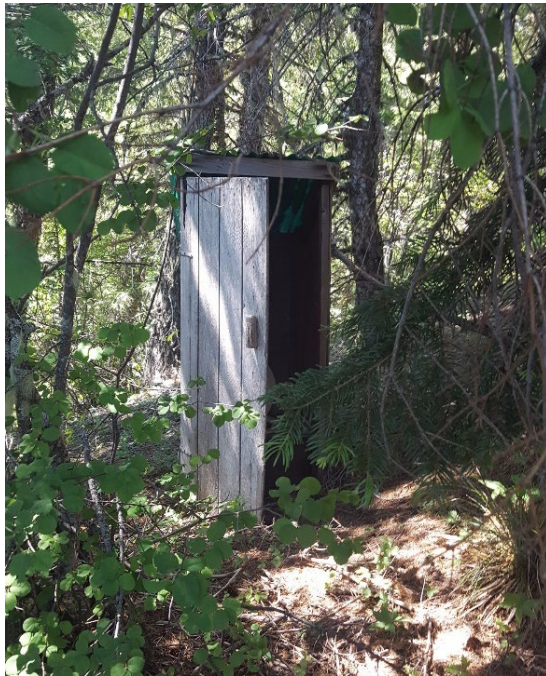
Overall, the site is in good condition; common concerns such as overhanging branches, water runoff, erosion, and duff are not an issue. The site provides excellent drainage and ventilation for the lookout. Historical view-sheds are intact. No other built interventions are visible from the lookout. The only signs of alteration are old clear-cuts and an occasional airplane. Exposure is significant but not extreme and it primarily affects the southwest and southeast sides of the building.
