WILD NOTIONS:
PRESERVATION OF HISTORIC BUILDINGS IN OREGON WILDERNESS

by
CHARLOTTE M. HELMER

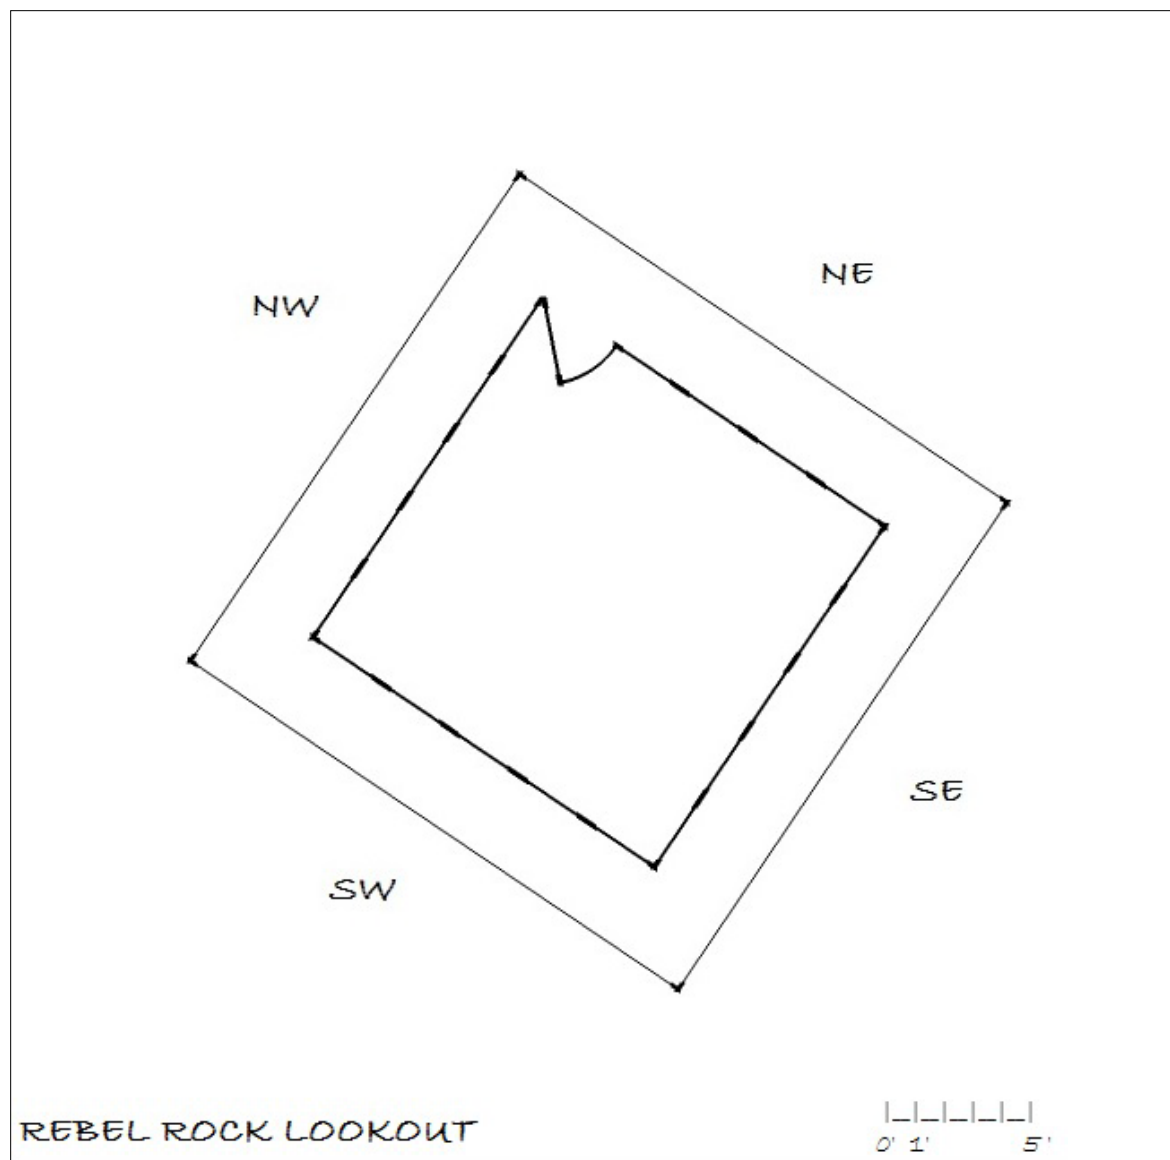
Small clearing and trail connection at the front door

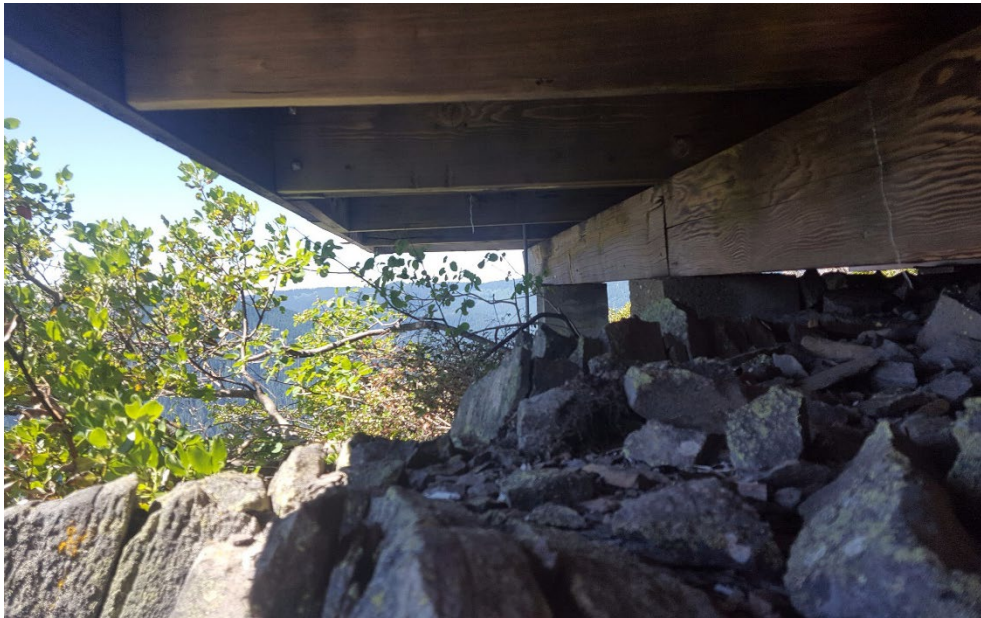
Typical construction and condition, southeast elevation

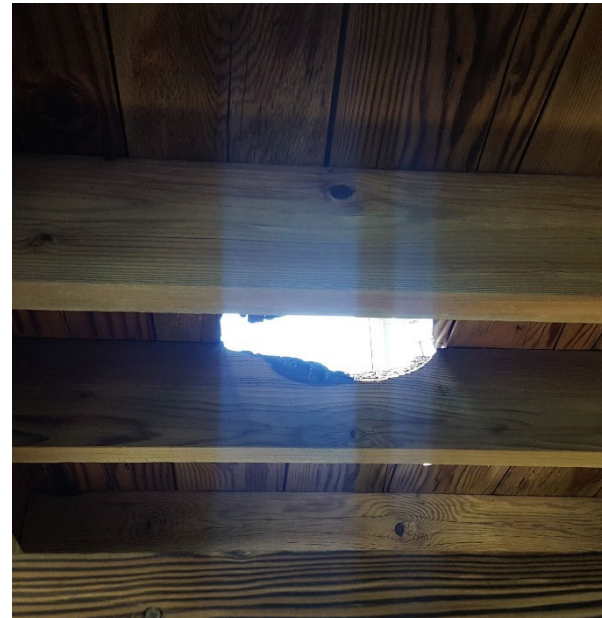
Burn damage, southwest corner

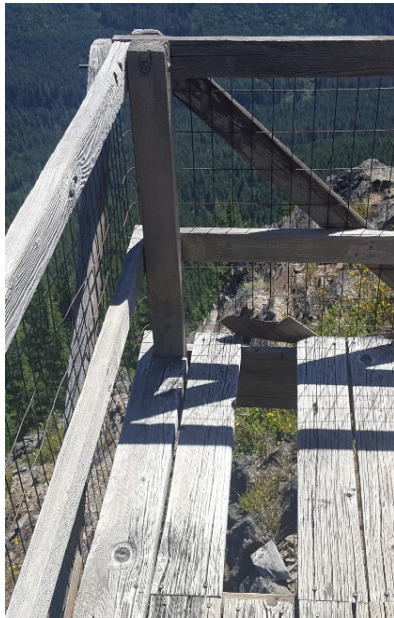
Missing deck boards, south corner

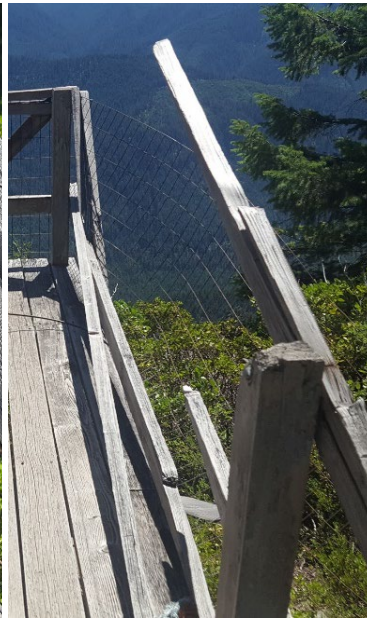
Broken northwest railing

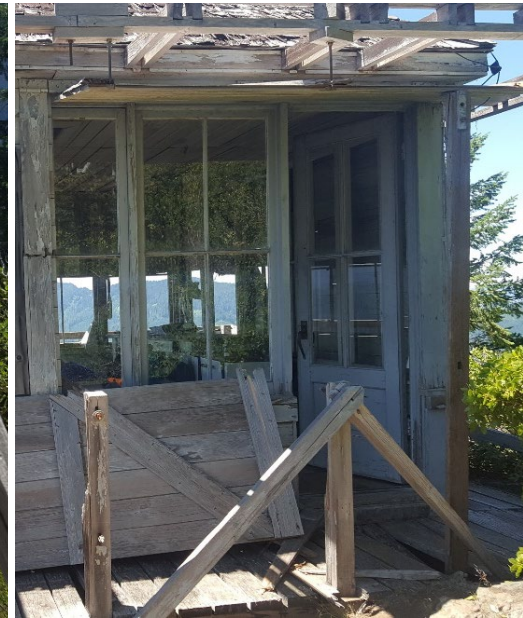
Altered northeast railing

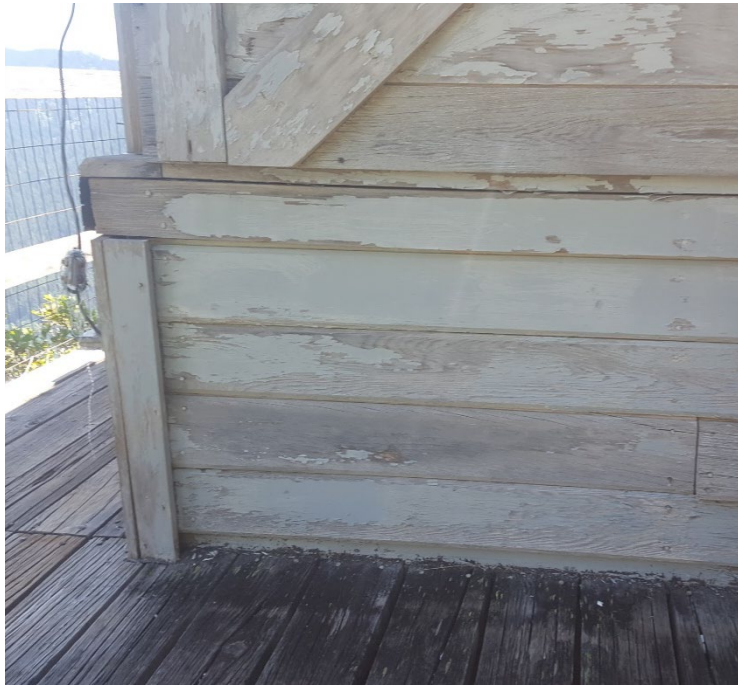
Typical construction

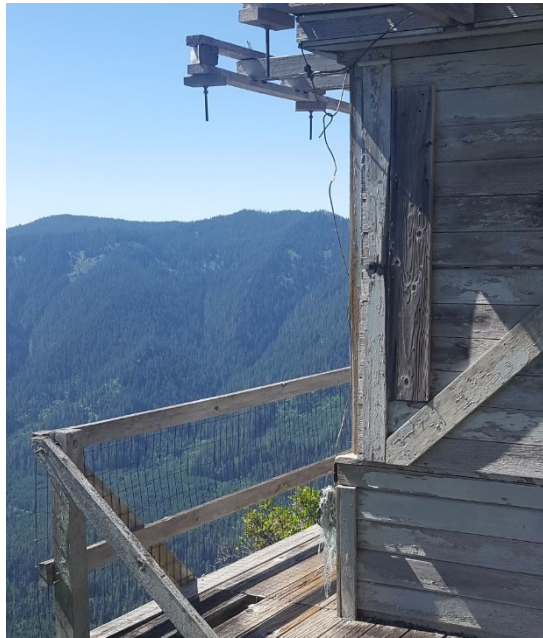
Typical construction

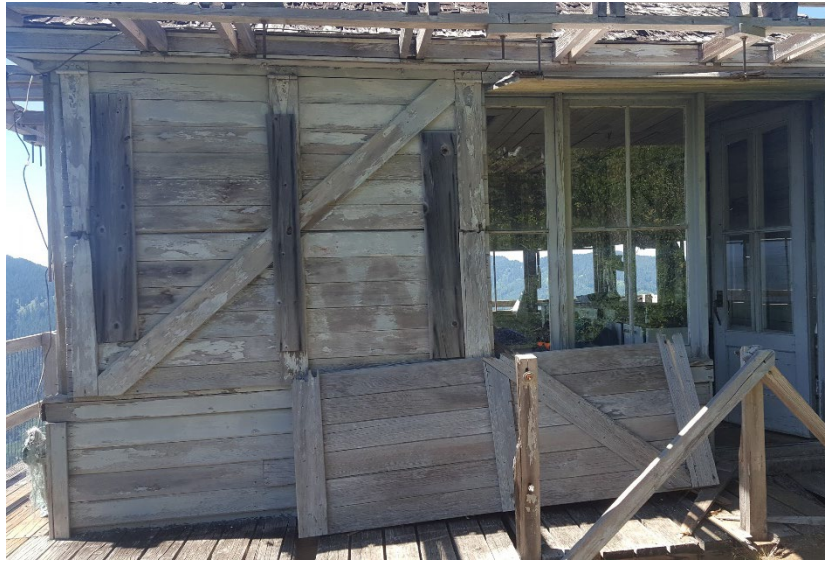
Typical construction (reinforced), northeast elevation

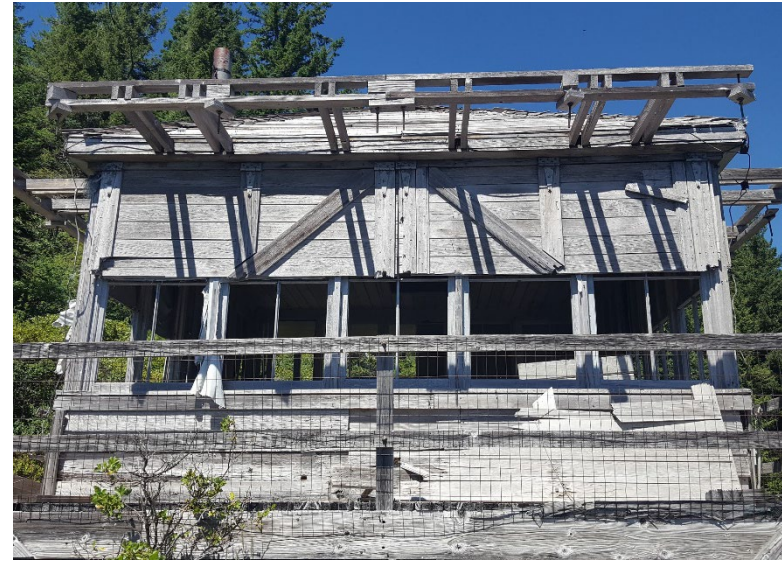
Typical condition, southwest elevation

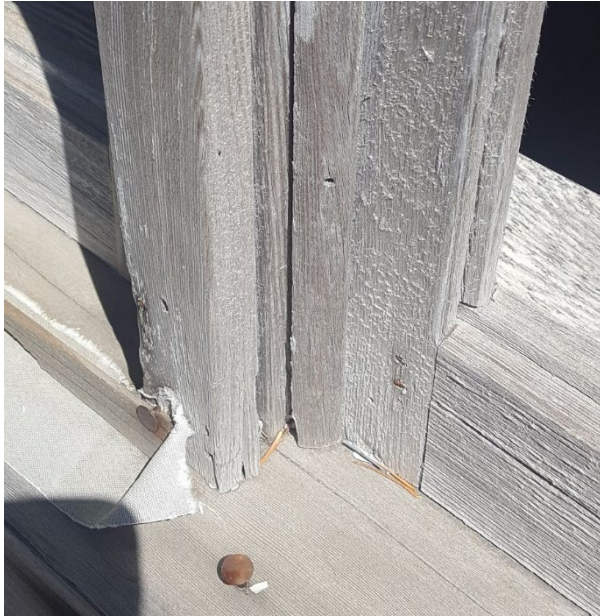
Exterior mullion and sash profiles

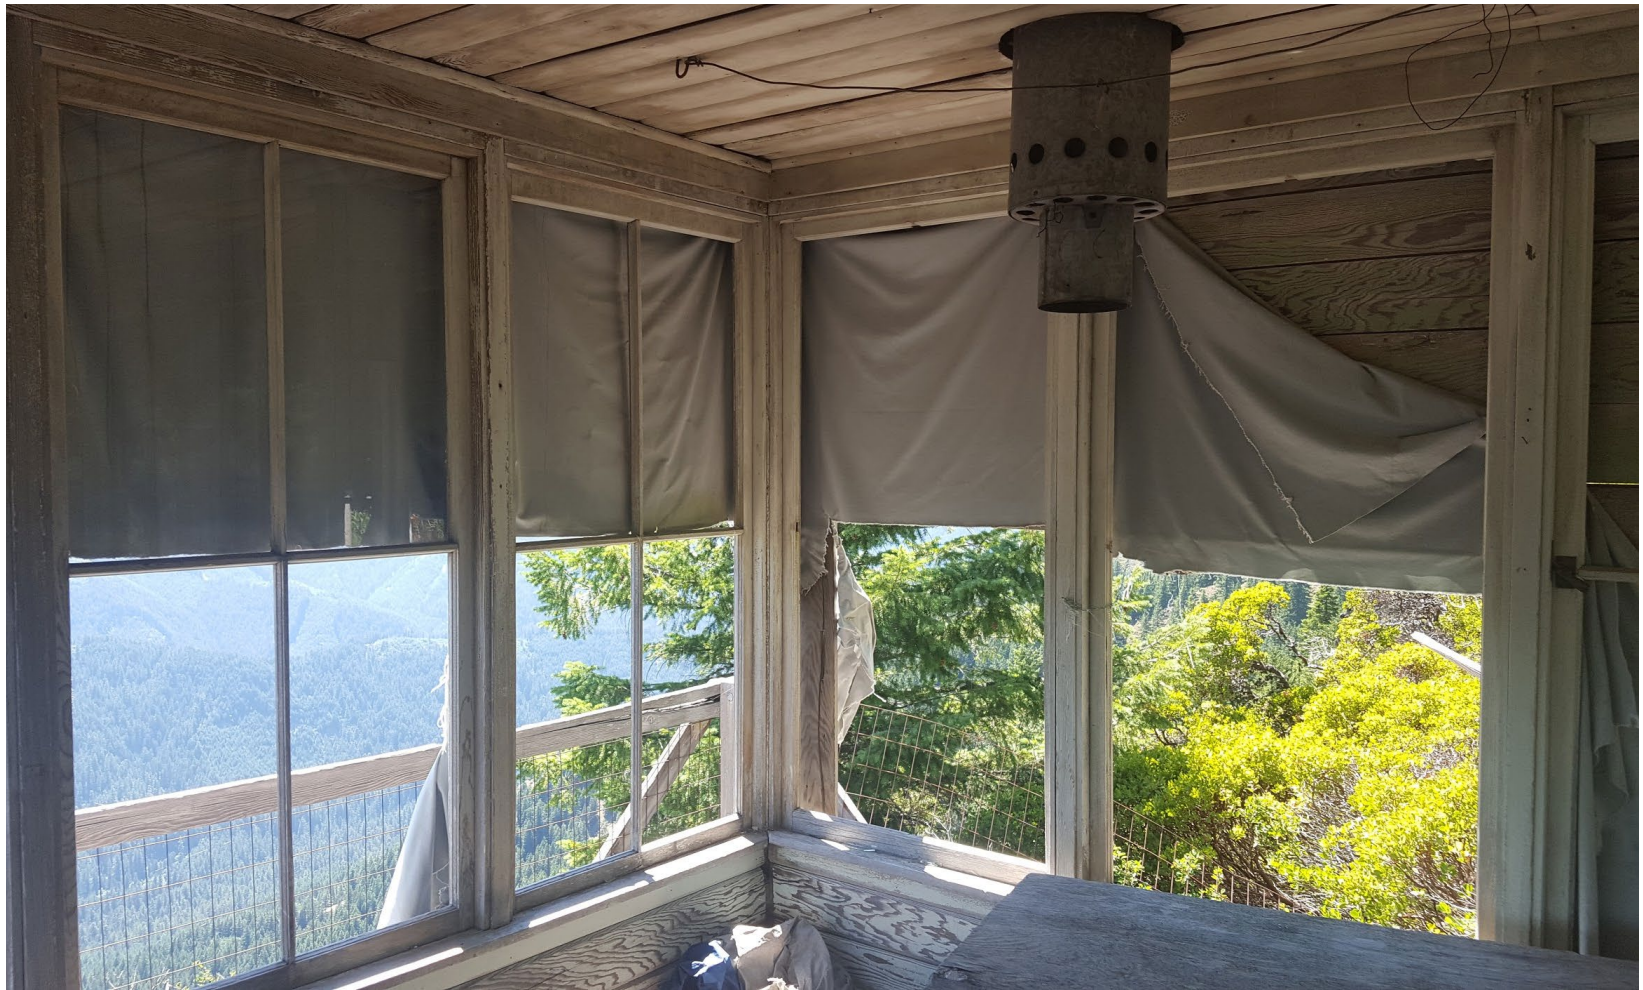
Windows in poor condition, with broken panes and muntins

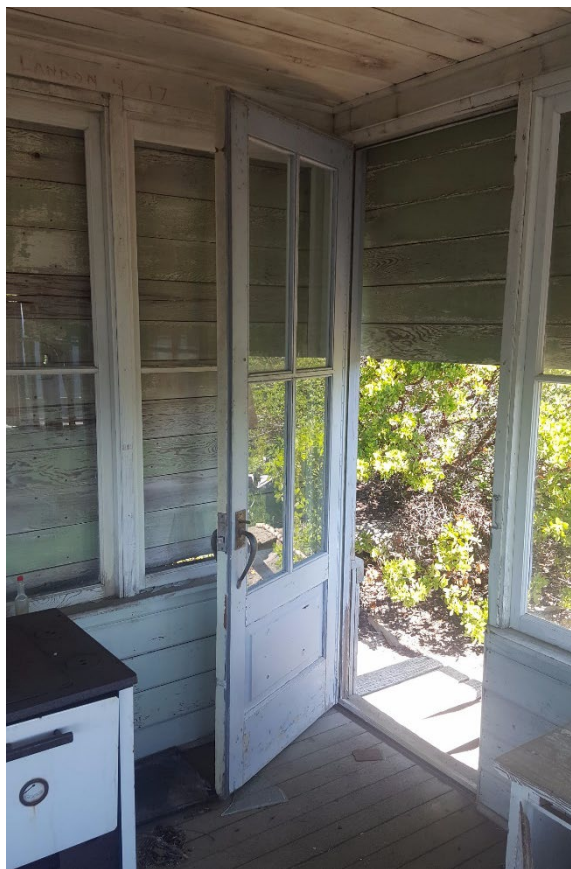
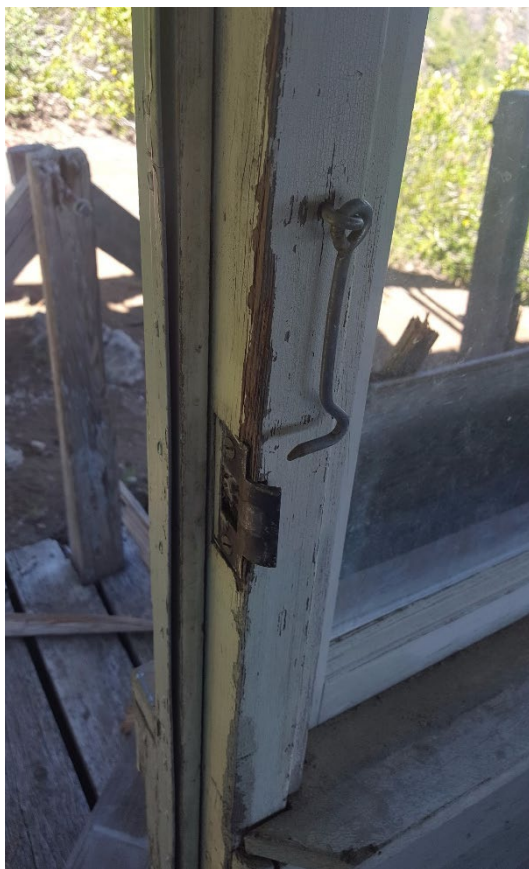
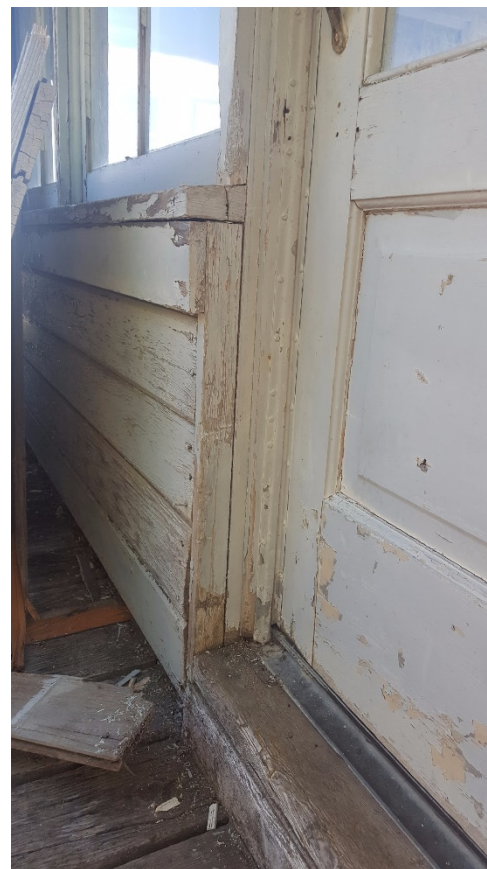
Construction, hardware, and condition

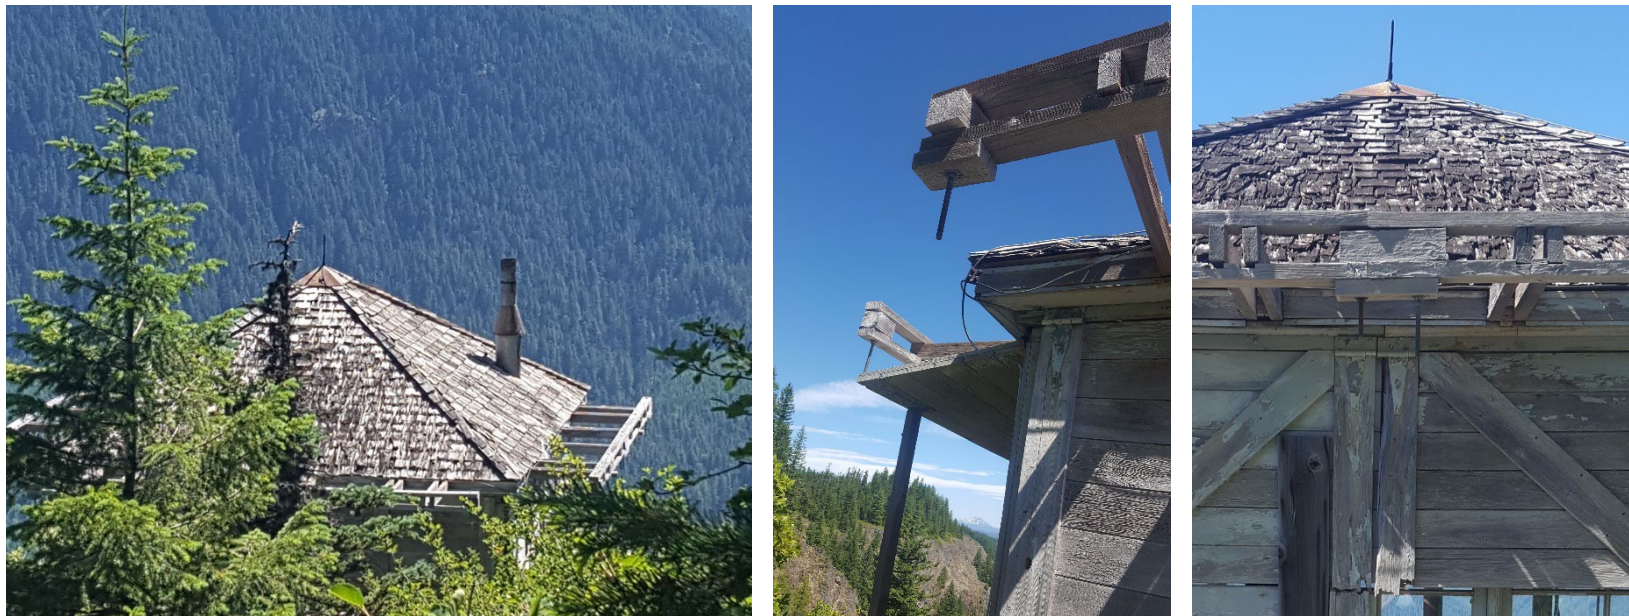
Typical construction and condition of external rafters and shingle roof.

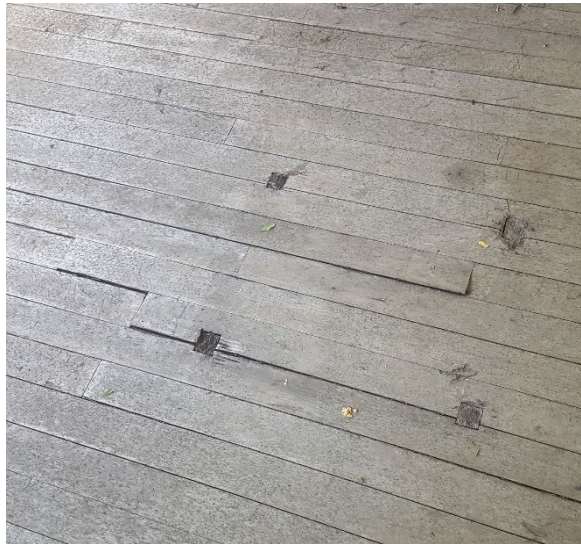
Typical construction and condition, absent Fire Finder

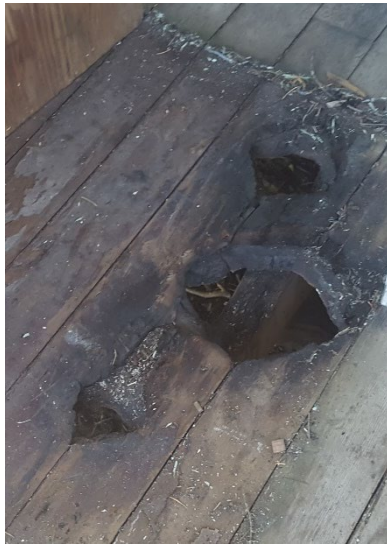
Burn damage (1' x 3')

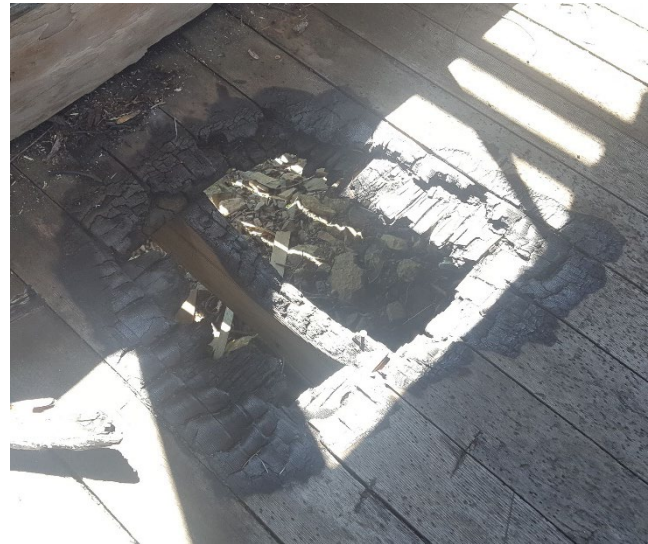
Burn damage (2' x 2')

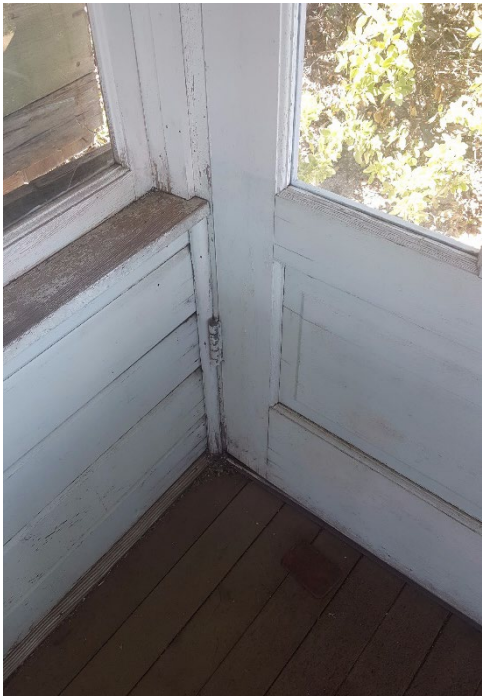
Typical construction

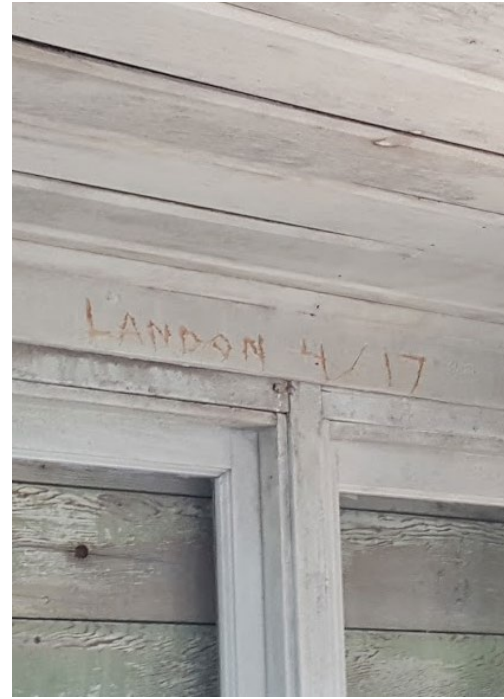
Carved graffiti damage

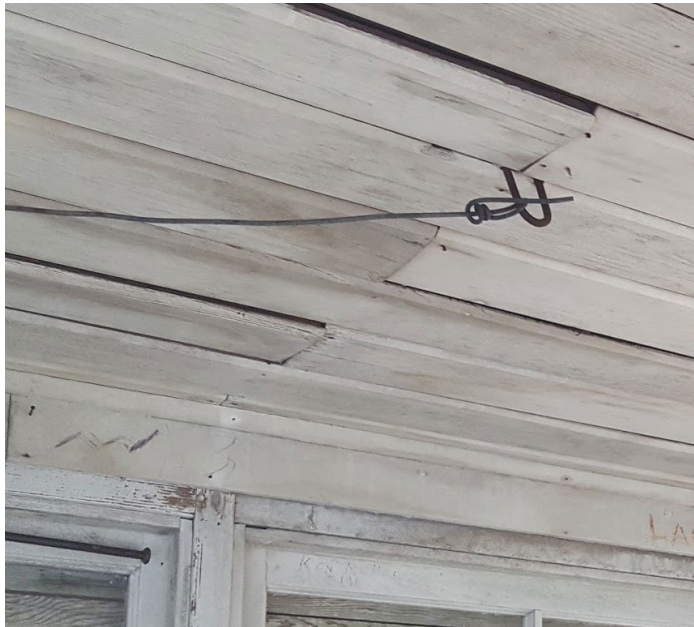
Typical ceiling construction and condition

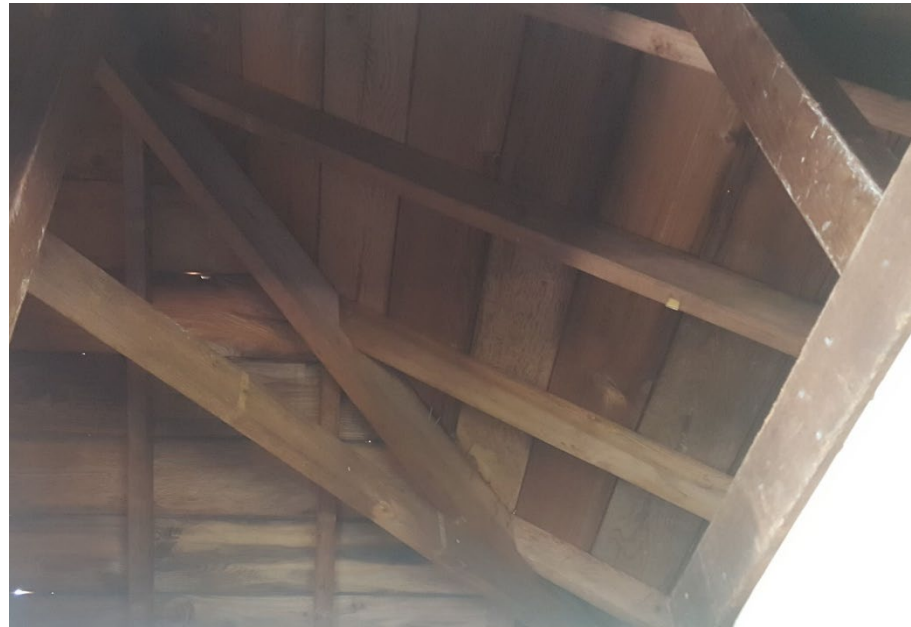
Roof construction and condition

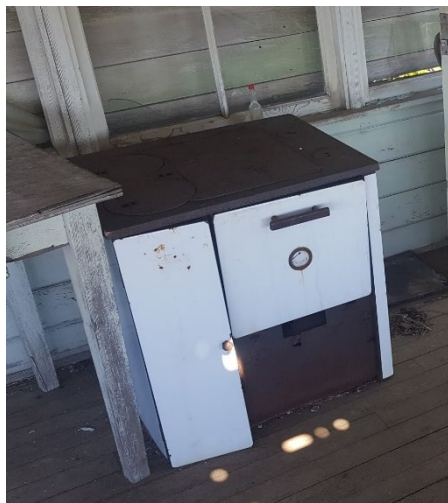
Trash - The site and interior are strewn with branches, broken glass, tarps, canvas sheets, a broom, a broken bow saw, a damaged tent, and other trash. This condition encourages other visitors to leave their trash behind and/or damage the interior. It also encourages animals and insects to occupy the building. Finally, this debris traps moisture, stains and scratches the interior. Trail reports and public photographs indicate that the interior was clean and tidy five years ago.

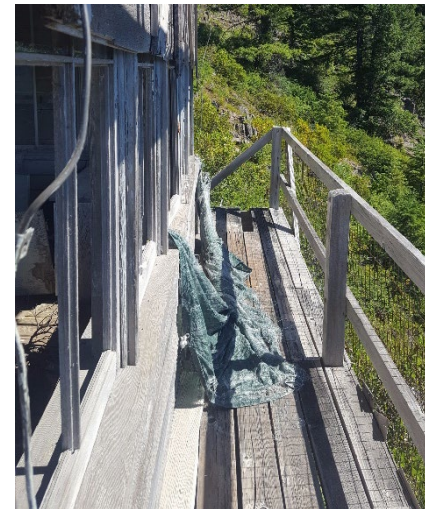
Furniture and debris

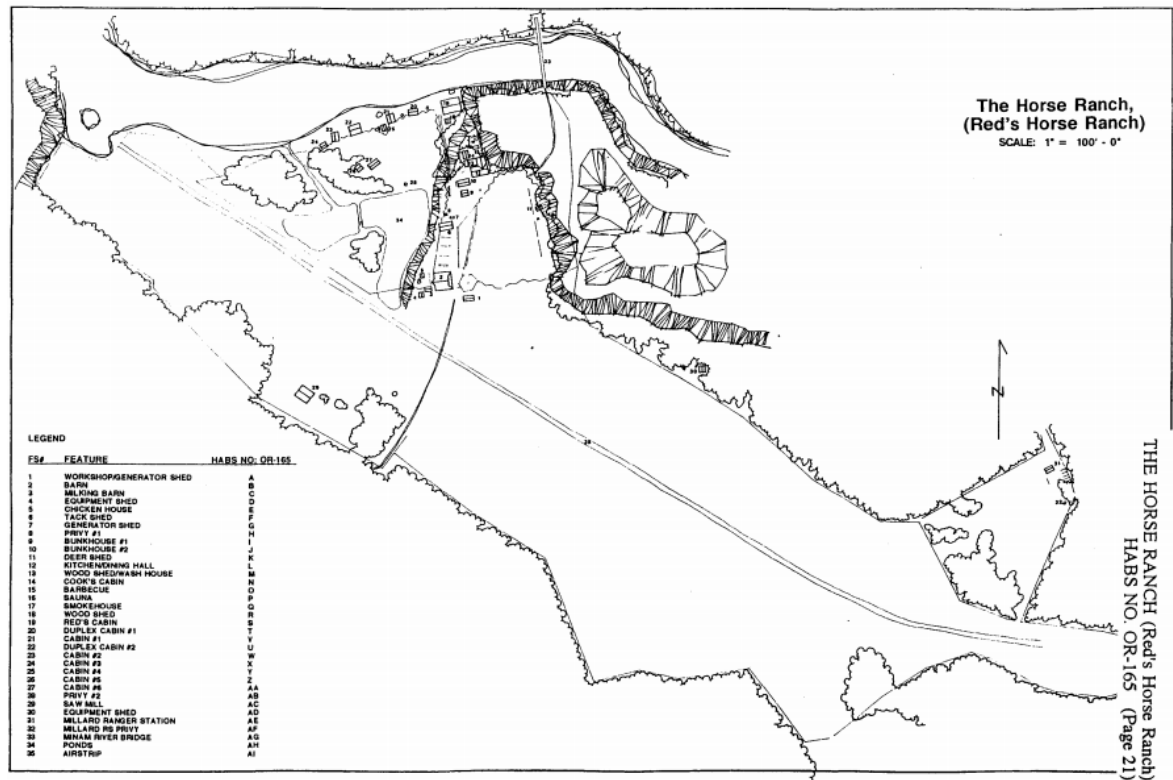
Site plan of Red's Horse Ranch, 1994. Library of Congress.

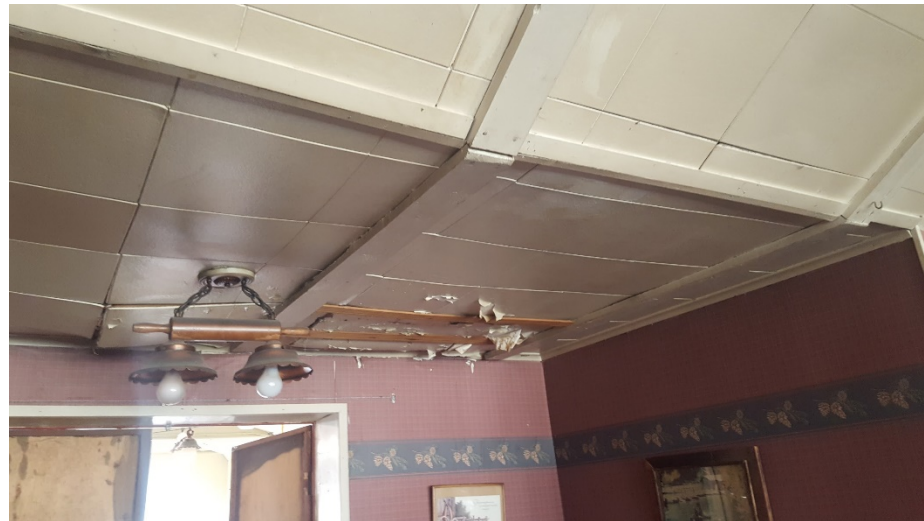
Dining hall ceiling condition

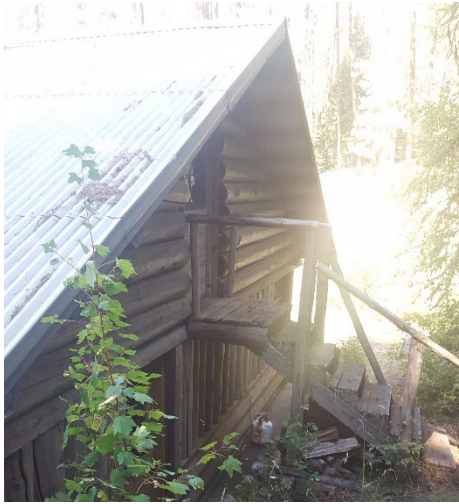
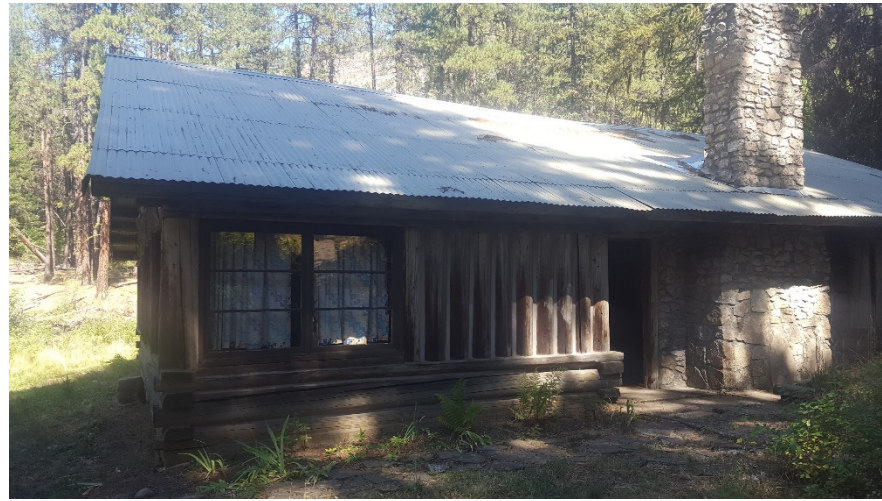
Red's Cabin: exterior

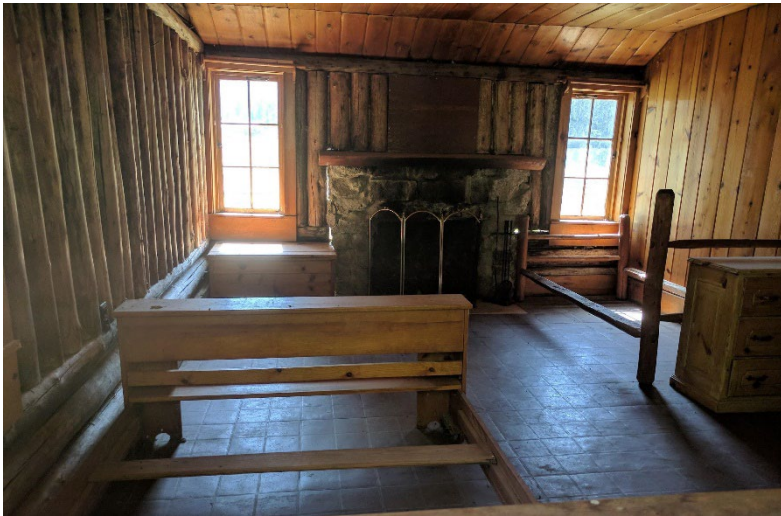
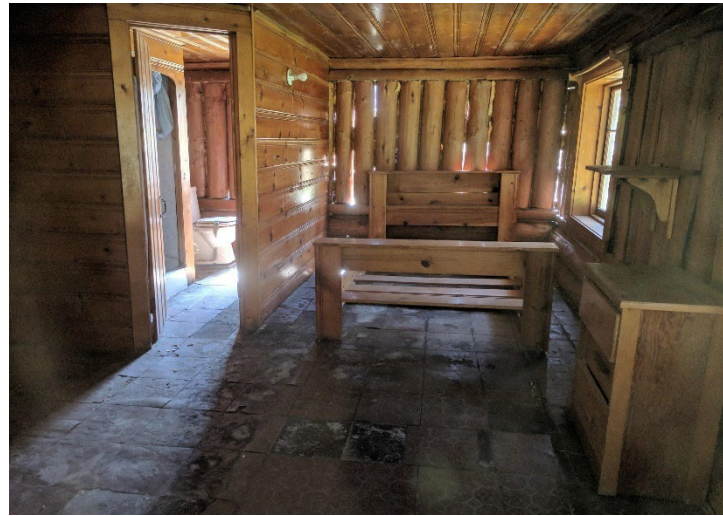
Guest cabins: interior

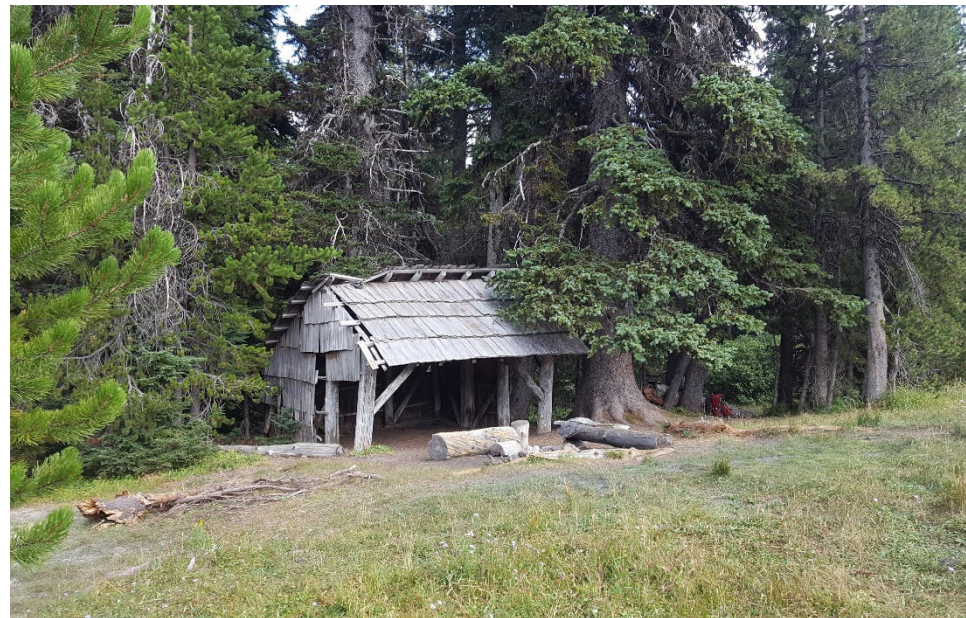
Site conditions, north and west elevations

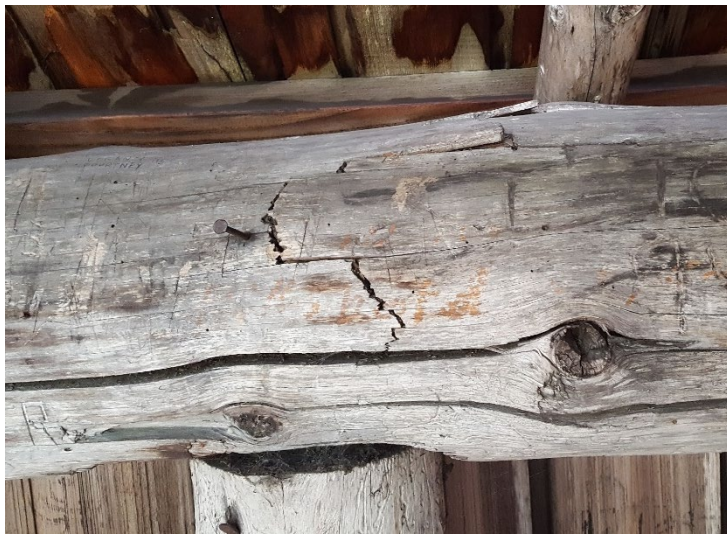
Condition of cracked rear beam

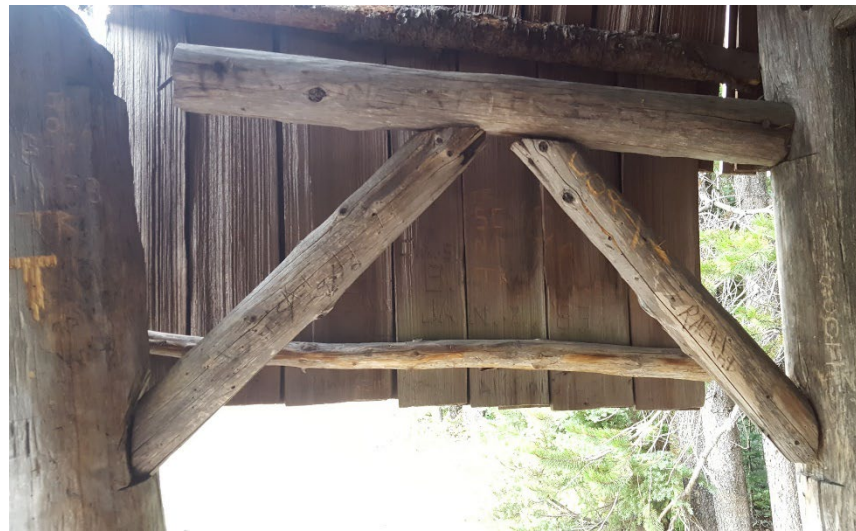
Condition of north wall braces

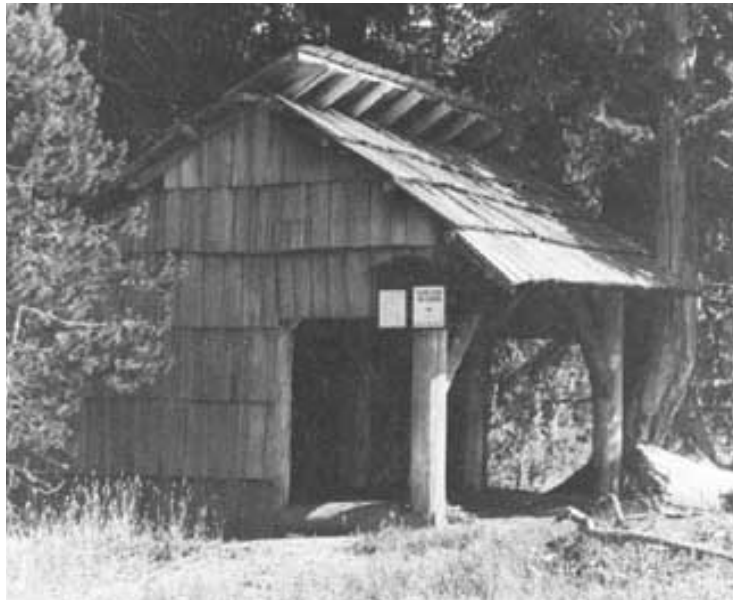
Construction and condition, 1978. Courtesy of USFS.

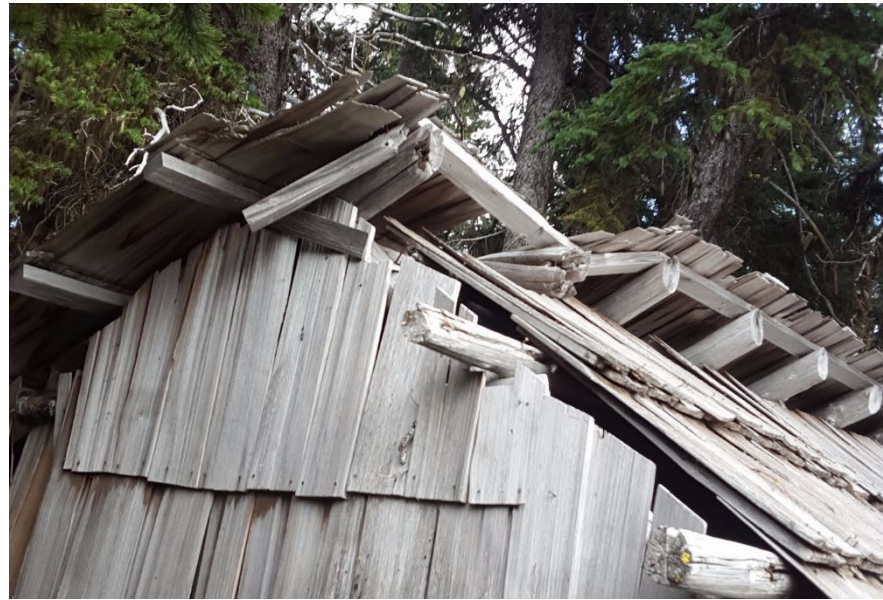
Roof construction and condition

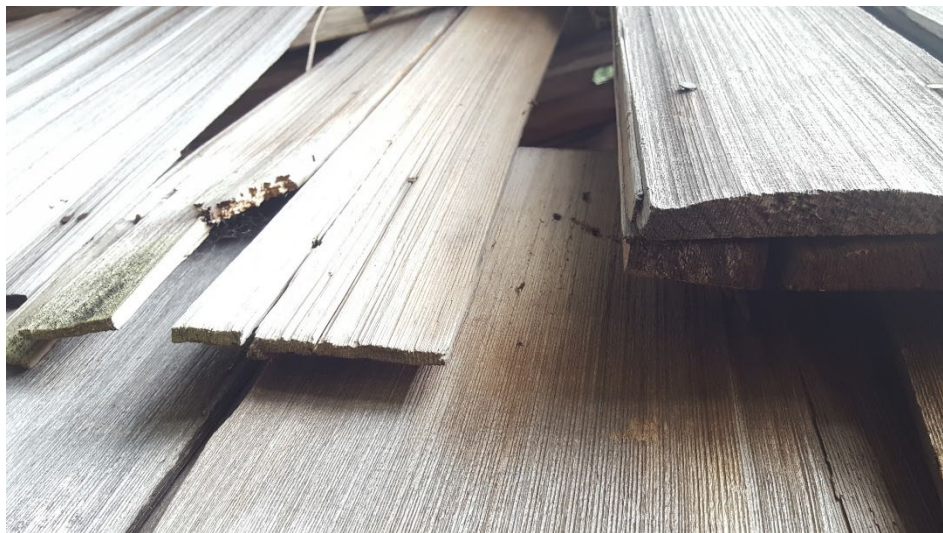
Shingles and shakes, south wall

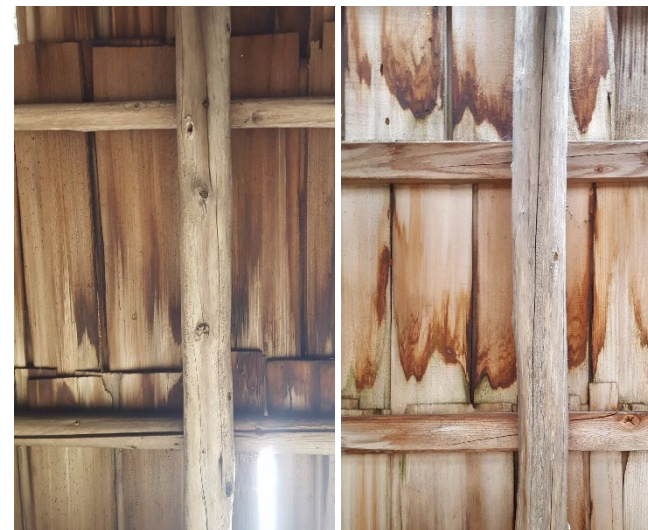
Roof construction: poles, replaced 2x4s, courses

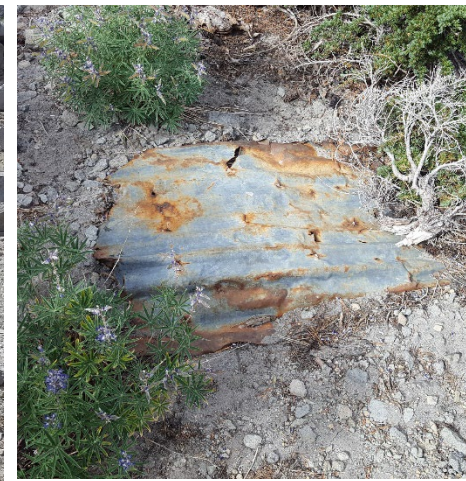
Corrugated steel roof panel

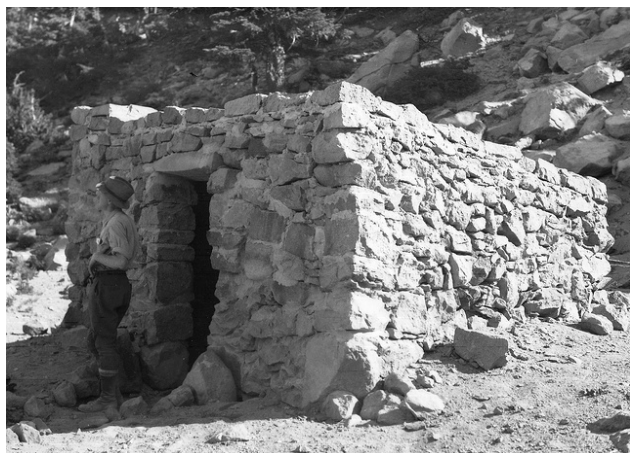
Gnarl Ridge Shelter, no date. OregonHikers.org.

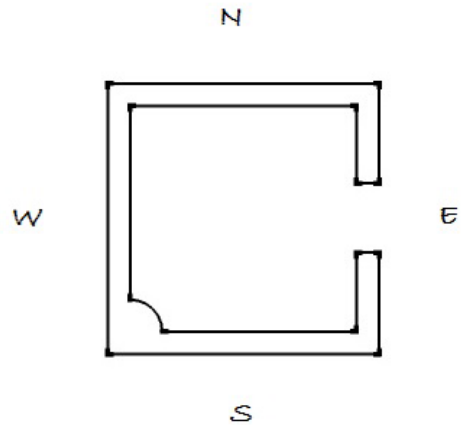
Site - Cairn Basin Shelter is sited below the timberline at the edge of a small clearing slightly east of the Timberline Trail. It is visible from the main trail and easily reached via a short spur trail. Overall, the site is in good condition. Dirt and duff have built up to a height of roughly 6” - 1’ on each elevation which will trap moisture against the masonry walls. Small plants are growing against the building. Large trees are close enough to fall on the building but they appear to be in good health. Otherwise there are no issues related to exposure, erosion, drainage, etc. The interior room is roughly square and measures approximately 10’ x 10’. The dirt floor has risen at least 6”. There is no evidence of floor below. *Recommended Treatment:* rake duff and vegetation away from walls to create a 2’ wide perimeter; rake out roughly 6” of dirt from inside the shelter.

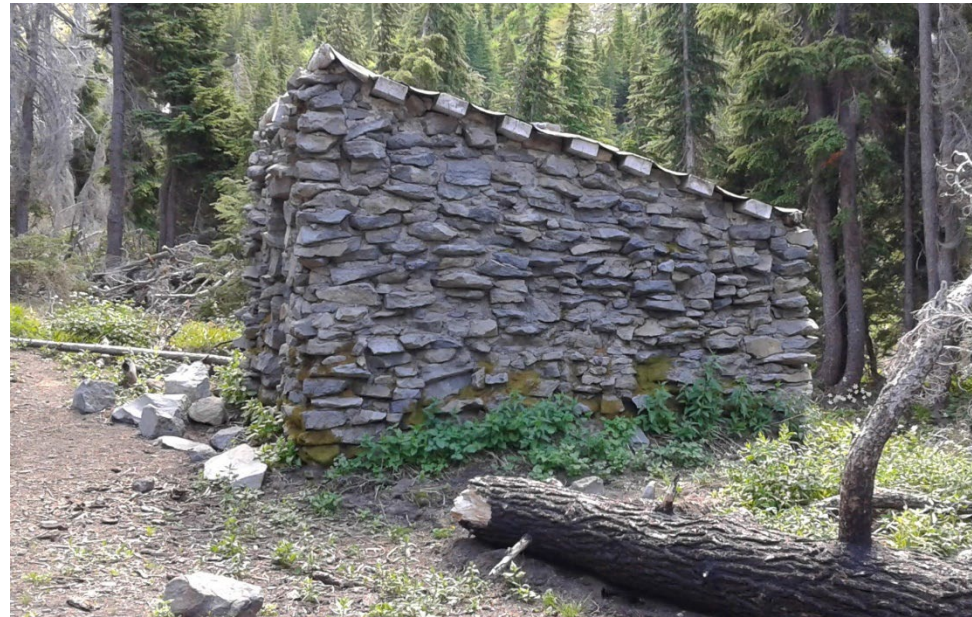
Site, north elevation

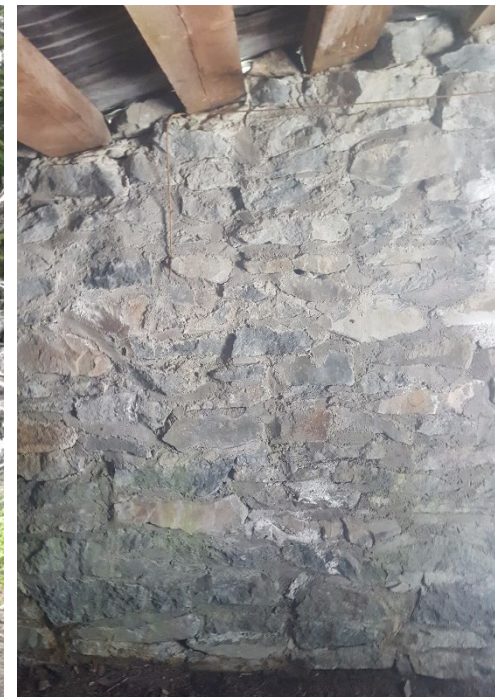
Typical interior construction and condition

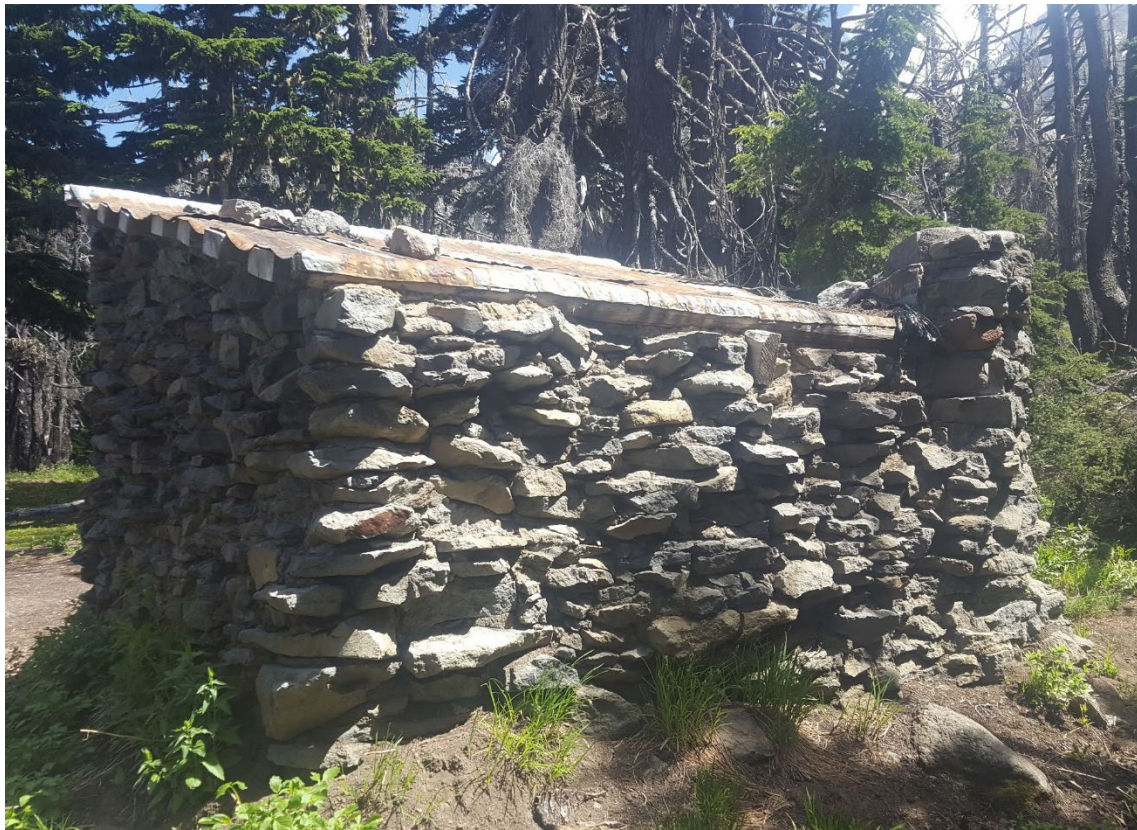
Rear elevation and chimney

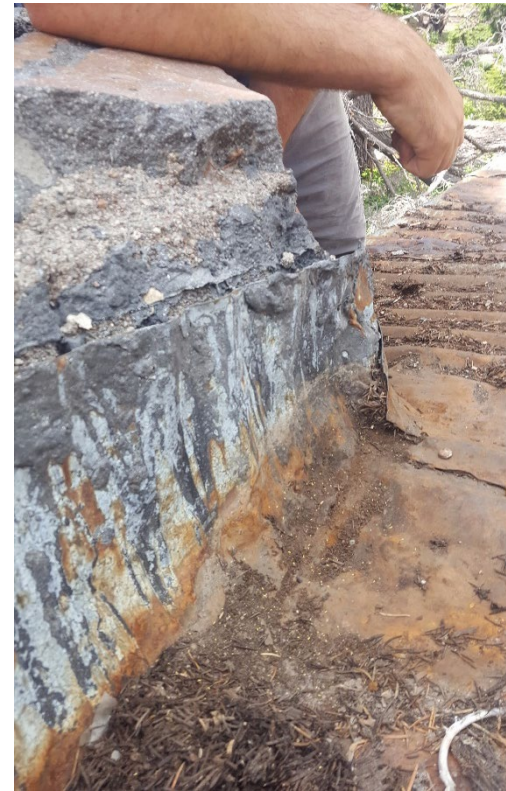
Failed seam at chimney

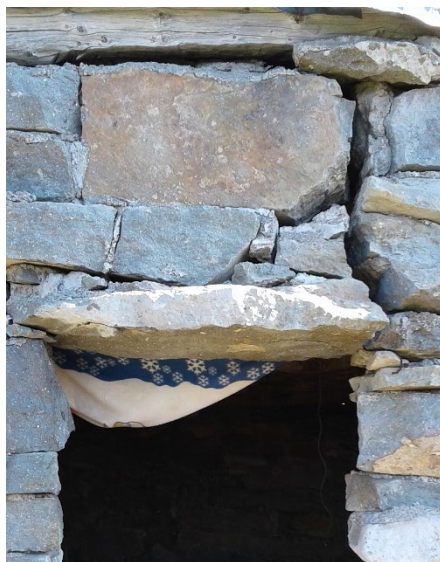
Condition in north elevation

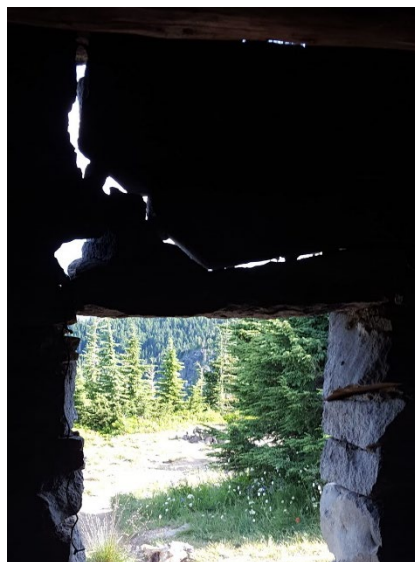
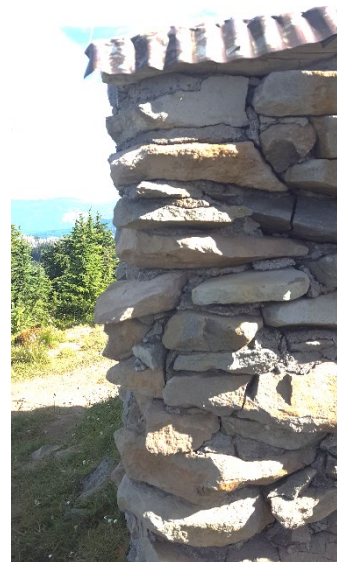
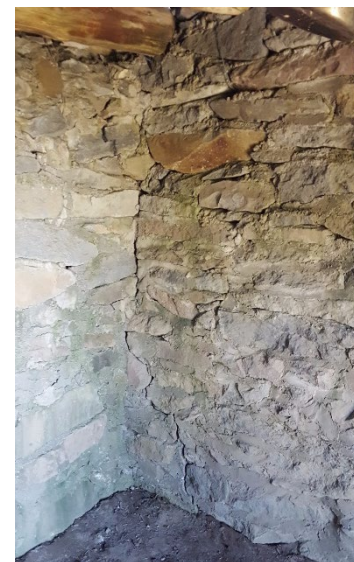
Condition at southwest corner
