WILD NOTIONS:
PRESERVATION OF HISTORIC BUILDINGS IN OREGON WILDERNESS

by
CHARLOTTE M. HELMER

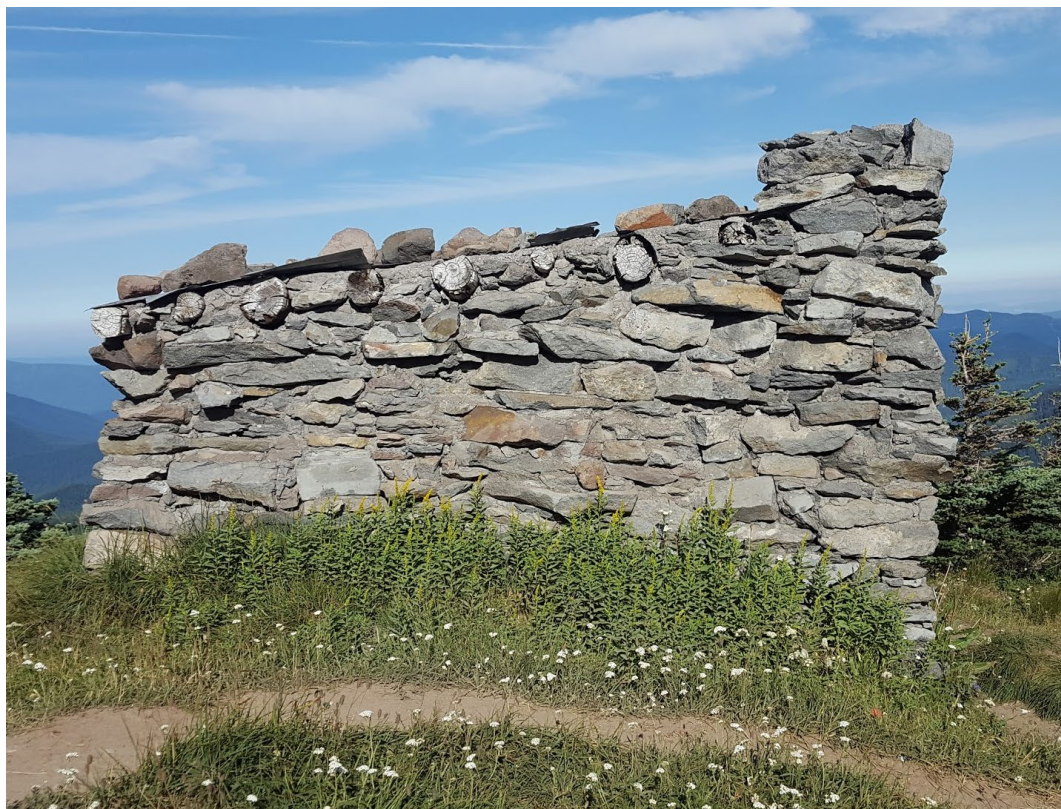
West elevation and chimney

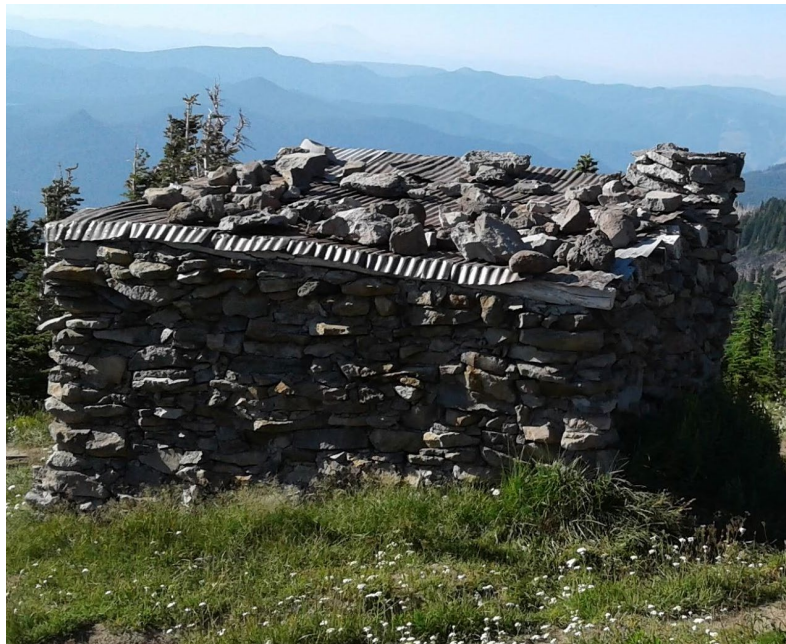
South elevation and roof construction. John Milliken.

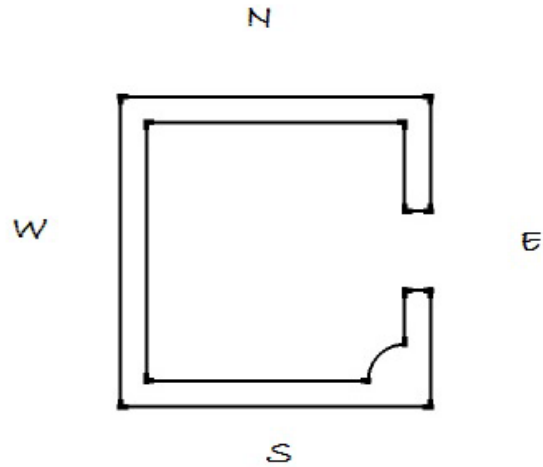
Site - Cooper Spur Shelter is sited well above the timberline on the shoulder of Cooper Spur with sweeping views of the Columbia River Gorge and Mount Adams to the north, Mount Hood to the west, and the Deschutes River to the east. Exposure and erosion have caused an issue in front of the north elevation where sandy soil has worn away on the downhill side of the building. Stones have been piled against the south, east, and north elevations to anchor I-beams cabled to the roof and prevent erosion at the base of the walls. A thick rubber mat hung in the doorway may also help prevent the floor from eroding, because it blocks wind and weather. *Recommended Treatment:* slight erosion could be addressed by installing a rough threshold of dry-laid stones in the doorway. This would reduce erosion that will otherwise undermine the walls. This work could be done by a trail crew.

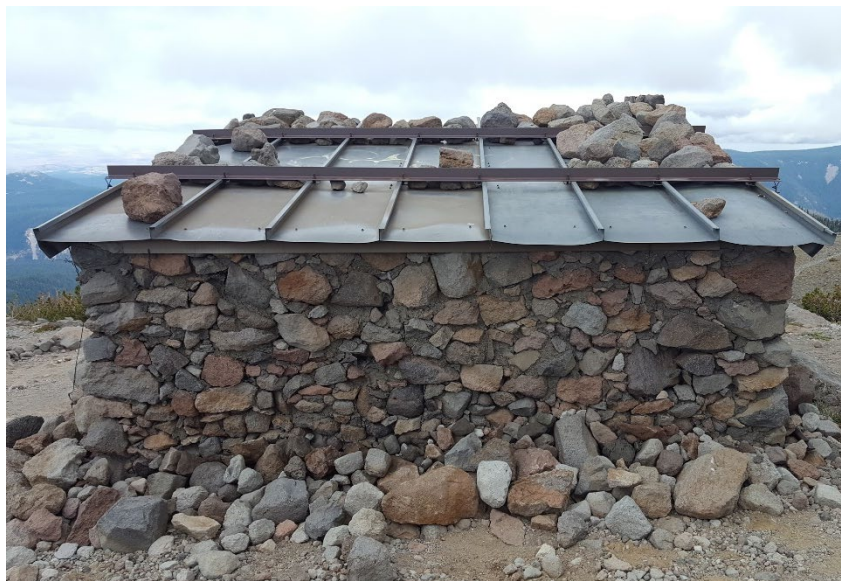
Rear wall condition and missing stones, 2017

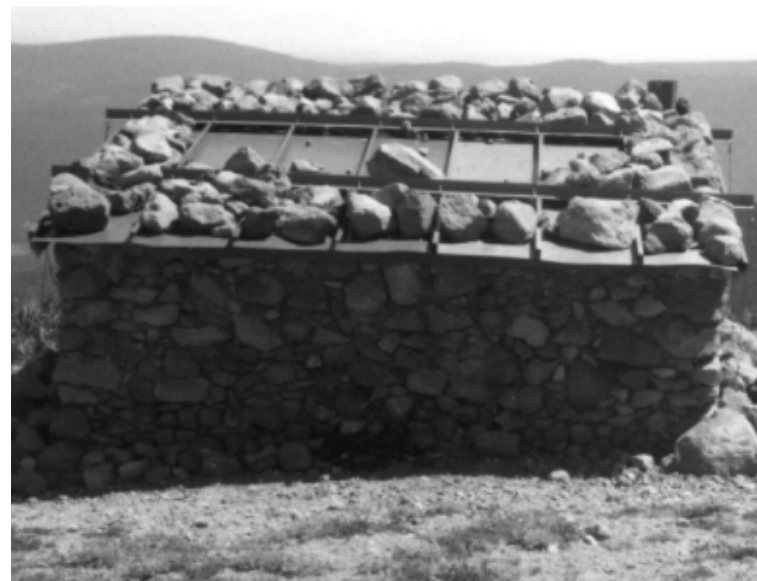
Rear wall condition, 1978. Courtesy of USFS

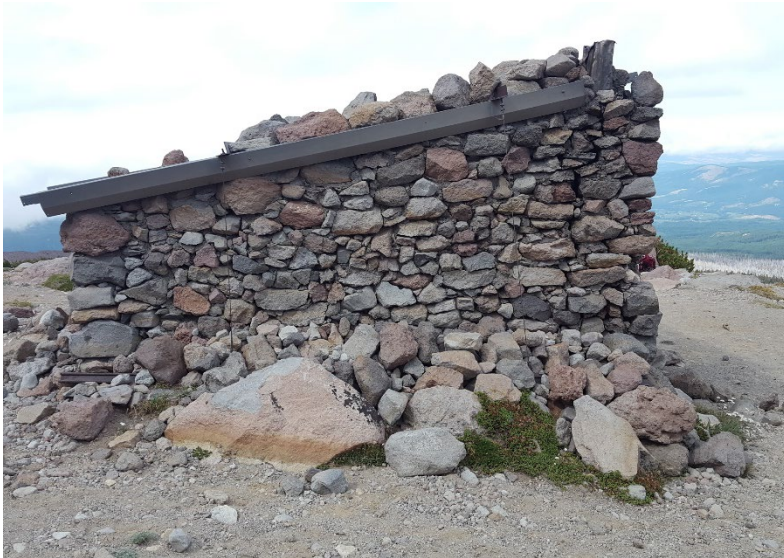
South wall condition and vertical crack, 2017

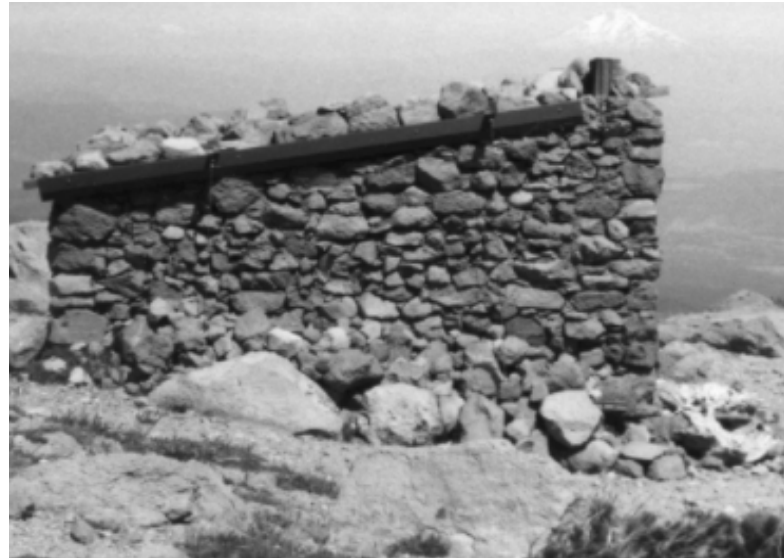
South wall condition, 1978. Courtesy of USFS

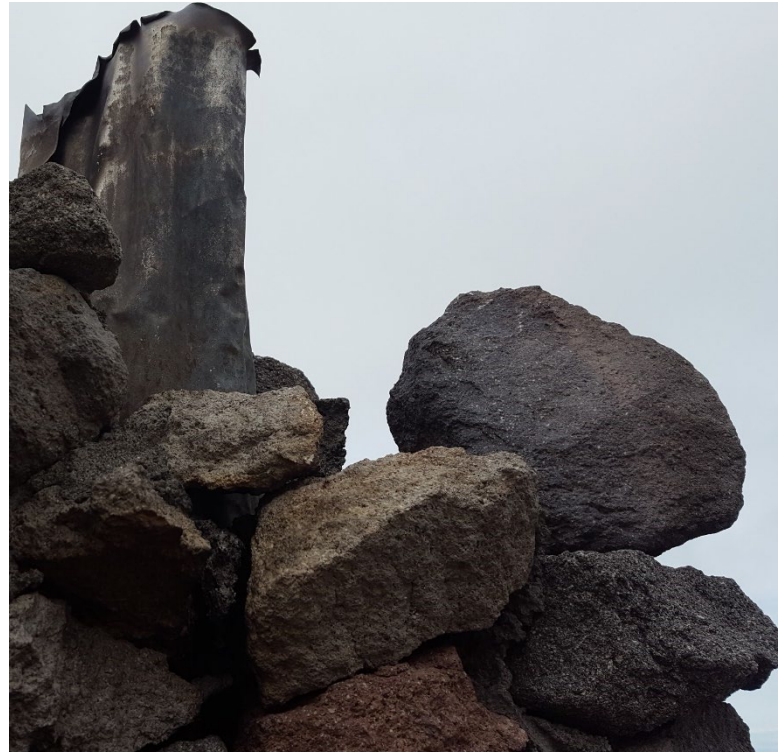
Corrugated steel stovepipe and loose stones

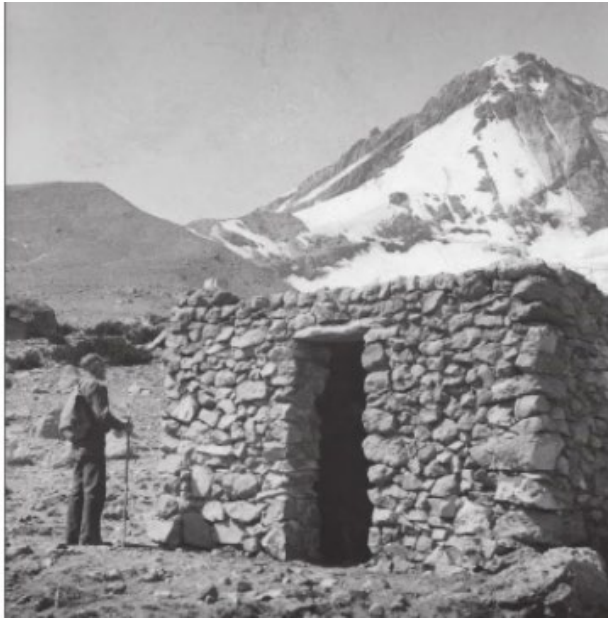
Original doorway, date unknown. Courtesy of USFS.

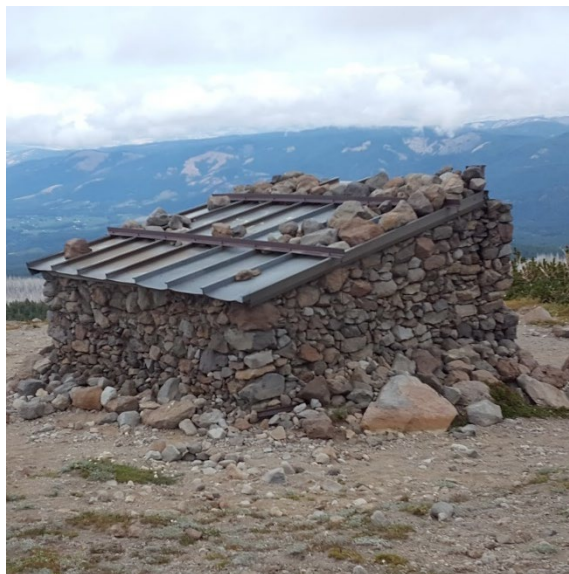
Five iron rafters run from east-to-west and are in good condition. The standing seam roof is comprised of seven panels, all in good condition except for graffiti scrawled on the undersides which are accessible from inside the shelter. All wires that anchor the roof are in good condition; three out of the four wires are under slight tension. Photos from 1978 show that the roof was once covered in a layer of stones; roughly half of these stones are still in place. Orange spray foam fills small gaps between the metal roof and the masonry walls. The foam probably makes the shelter more comfortable when it is used in emergencies. It can be retained if heritage resource managers believe that it serves a useful purpose. However, it is another intervention that has altered the integrity of this historic resource.

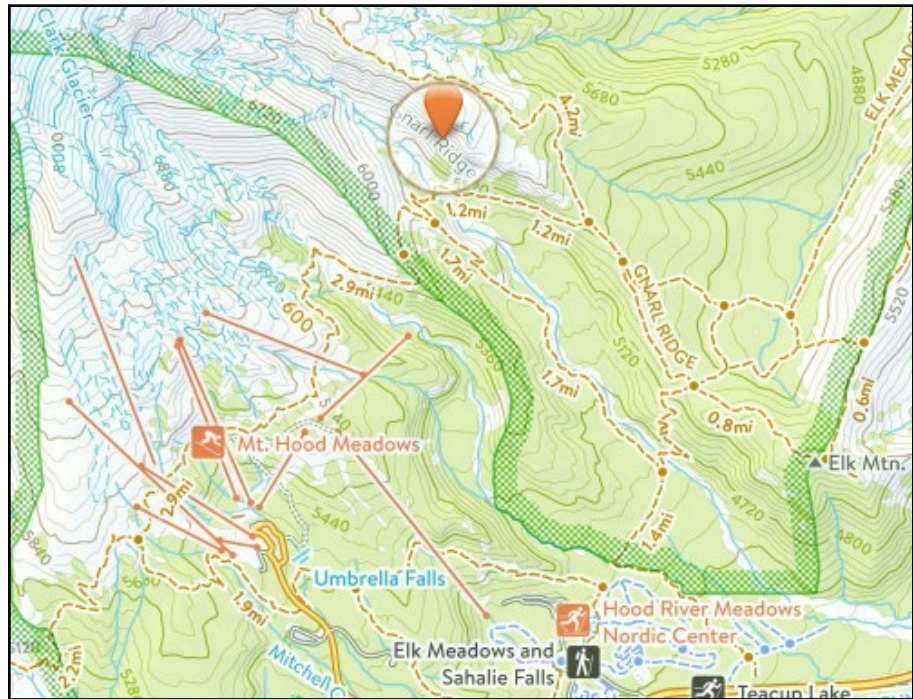
Trail to Gnarl Ridge Shelter. www.naturalatlas.com.

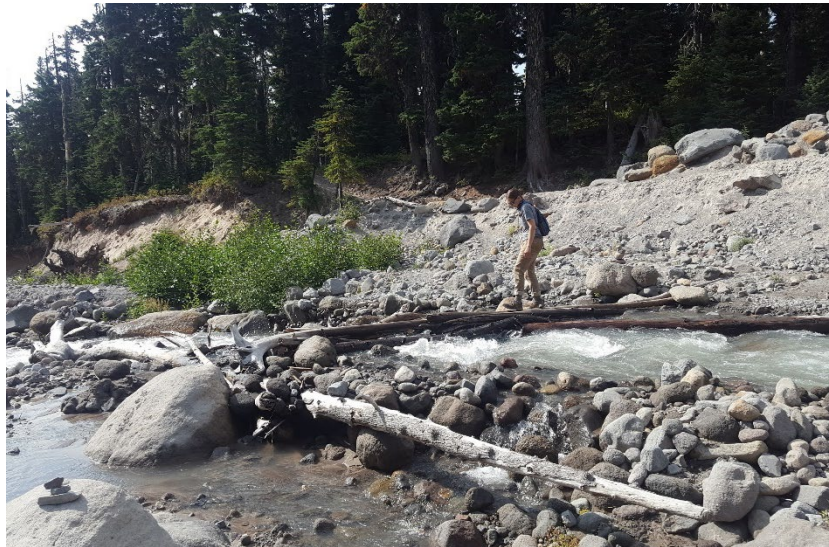
The recommended method for future work at Elk Meadows would be a) a pack train or b) helicopter flights. Stock can access Elk Meadows via the Elk Meadows trail. The trailhead provides sufficient room for trailers, and the route provides many creeks where stock can be watered. It does not provide any places to graze. The switchbacks above Newton Creek and the ford across Newton Creek may be difficult for a heavy-laden pack string. Staging areas were not identified during this assessment but several parking areas along OR-35 could provide enough room. The Elk Meadows - Sahalie Falls Trailhead is not a feasible staging area. Elk Meadows may be an appropriate place to drop-off or retrieve supplies near the shelter, but the meadows are saturated with water even in late August.

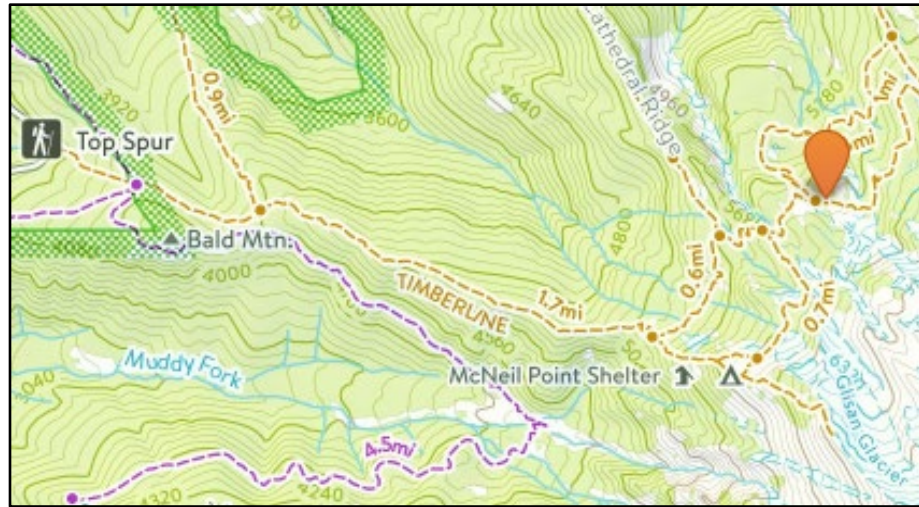
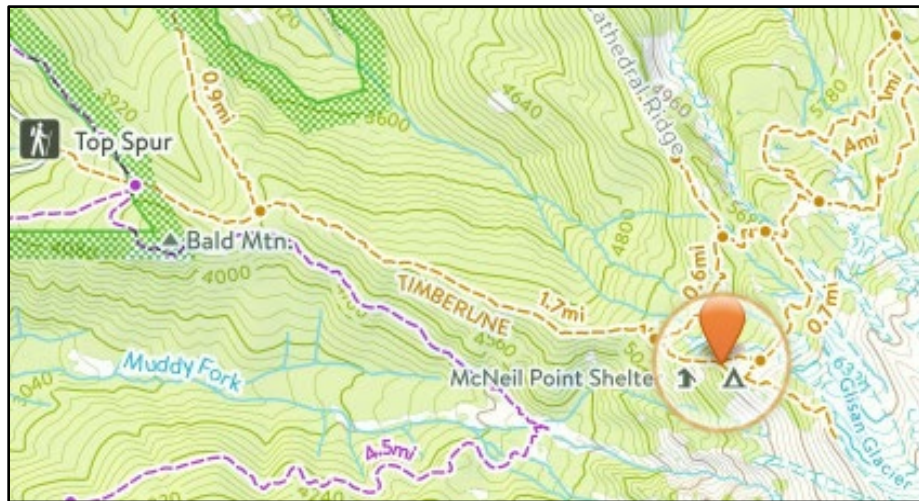
Trails to Cairn Basin Shelter [above] and McNeil Point Shelter [below]. www.naturalatlas.com.

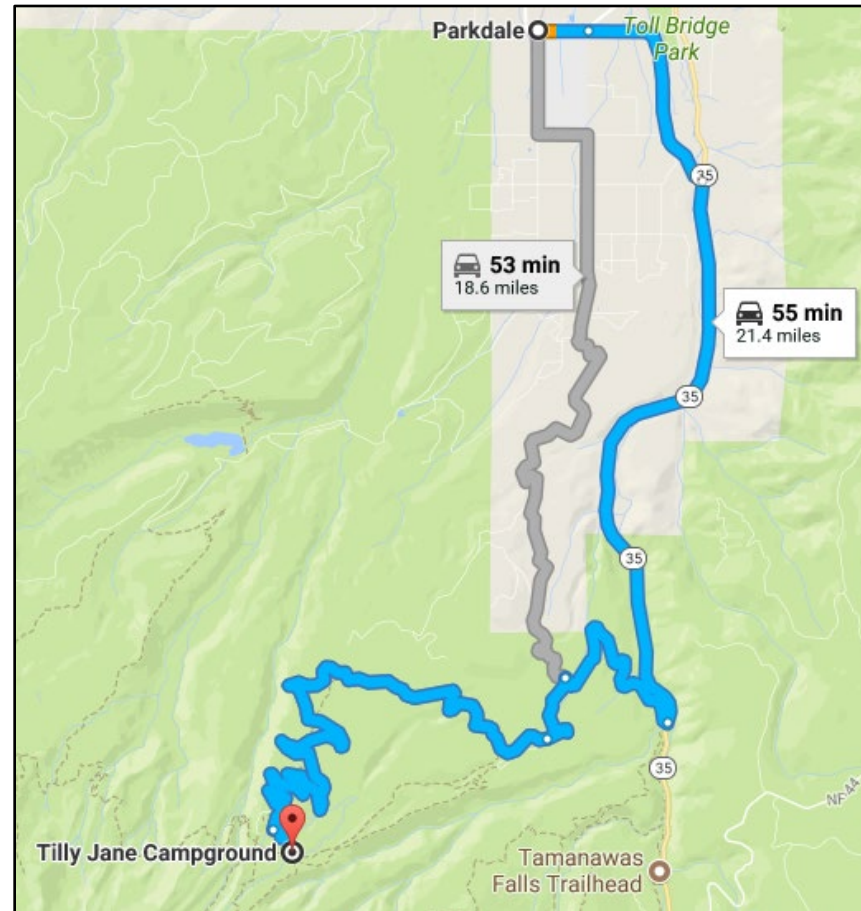
From the day-use parking area at Tilly Jane Campground the trailhead can be found by heading towards the old Tilly Jane Guard Station, which is visible from the parking area. Veer right of the ranger station to pick up the Tilly Jane Trail (#600A), which is signed. The Tilly Jane Trail climbs steeply for 1.0 mile, rising from an elevation of 5,740' to 6,650' to end at a four-way junction with the Timberline Trail (#600). Cross the Timberline Trail at this intersection and proceed straight on the Cooper Spur Trail (#600B) for 0.1 mile to reach Cooper Spur Shelter.

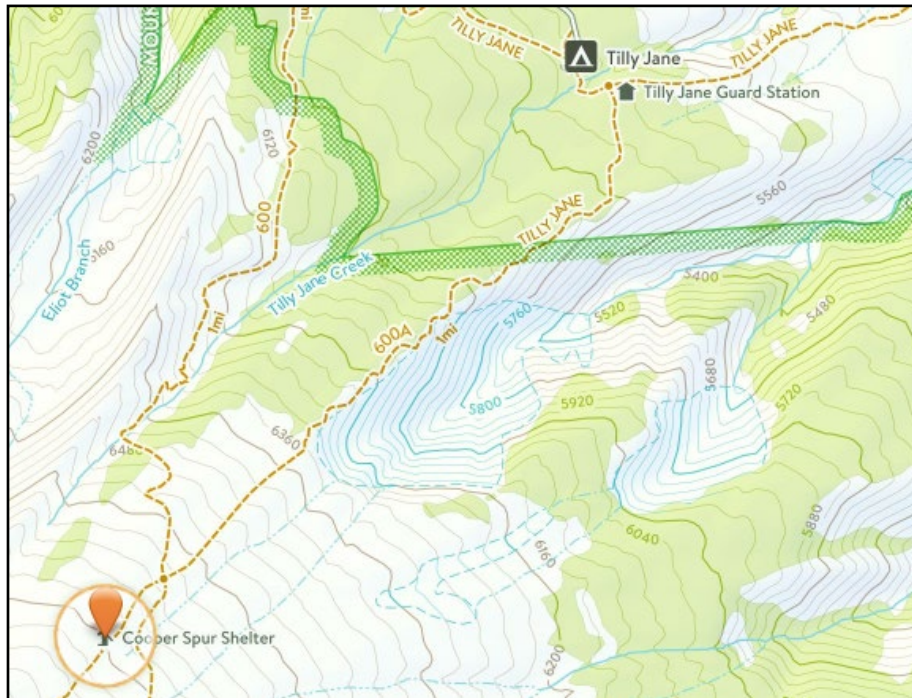
Trails to Cooper Spur Shelter. www.naturalatlas.com.

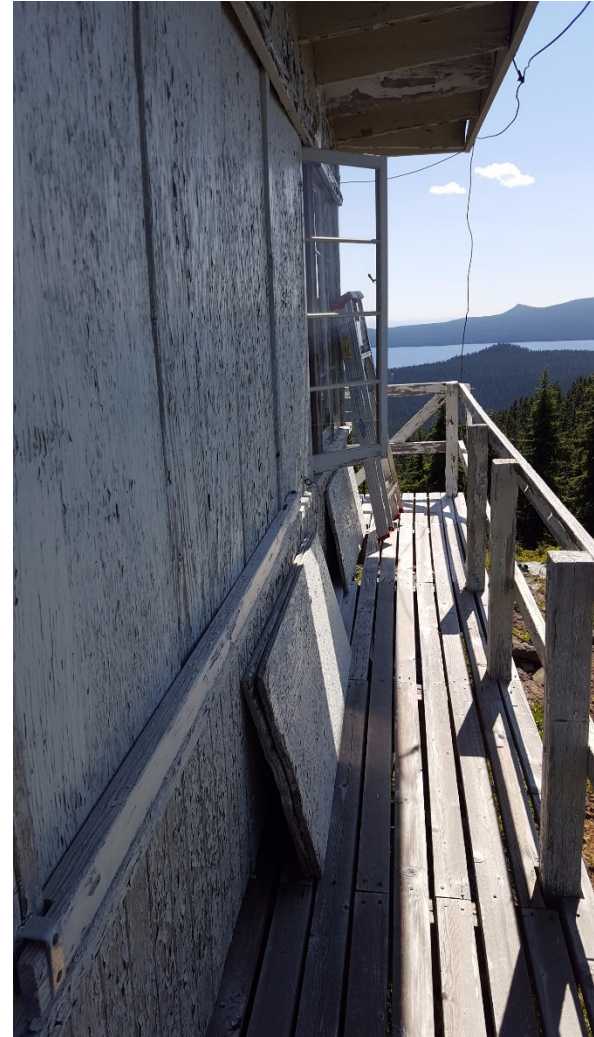
Waldo Lake see from Waldo Mountain Lookout

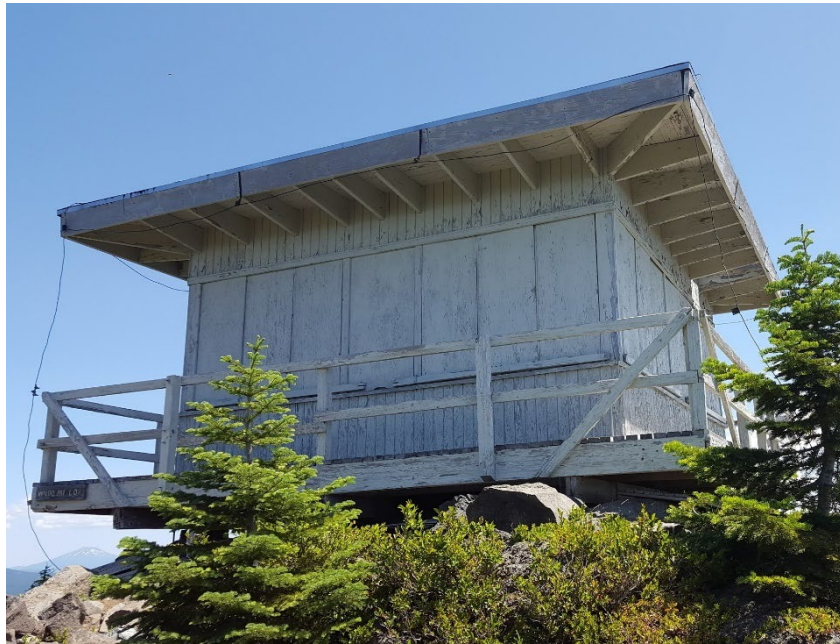
West and south elevations and south

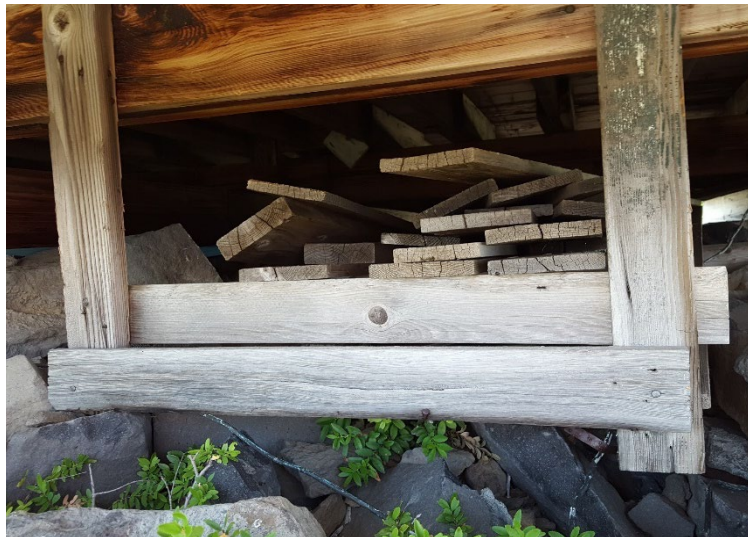
Lumber rack suspended from west side catwalk

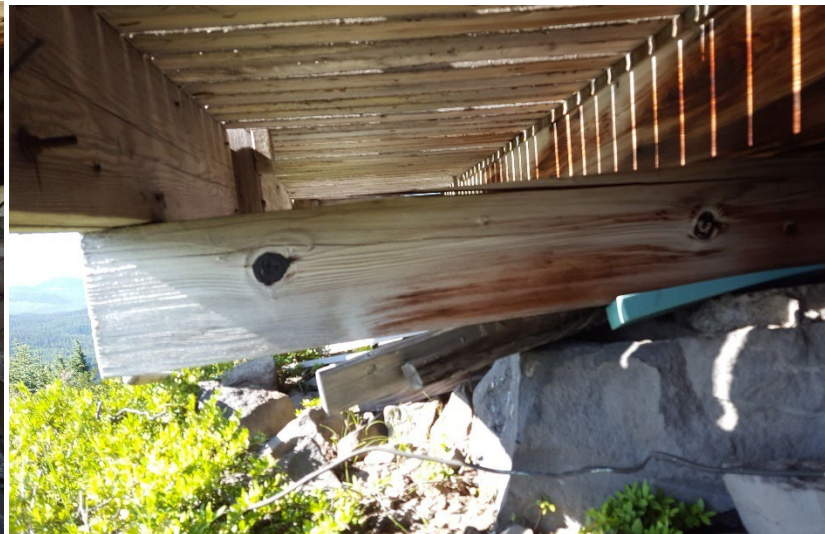
Cracked joist below east side catwalk

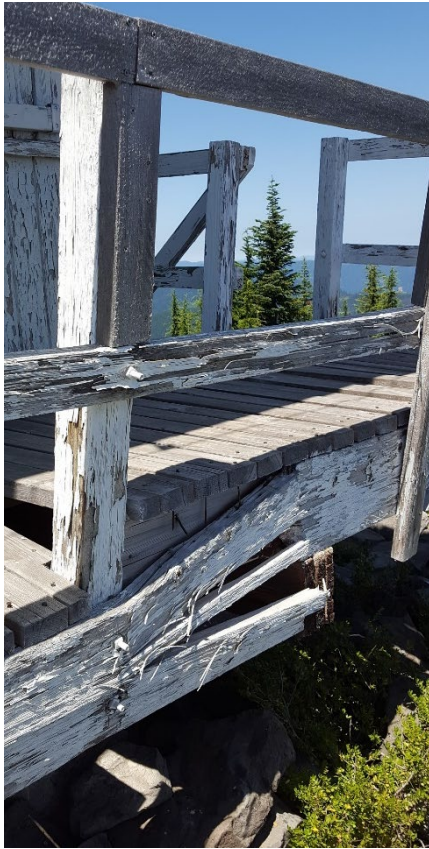
Damaged section of the catwalk on the east elevation

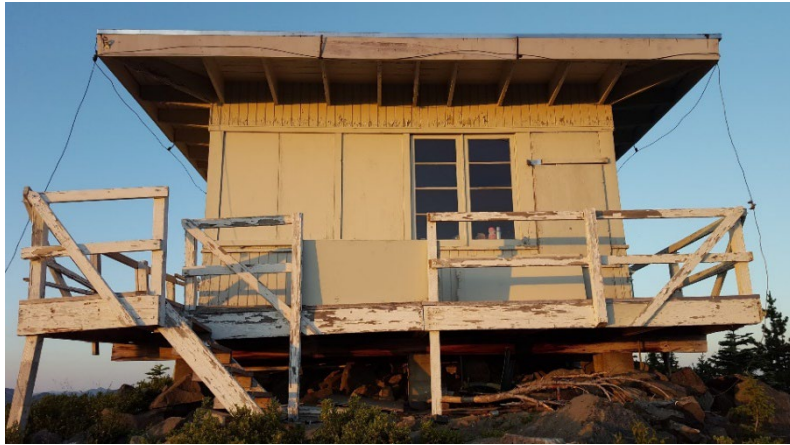
North elevation, railing design

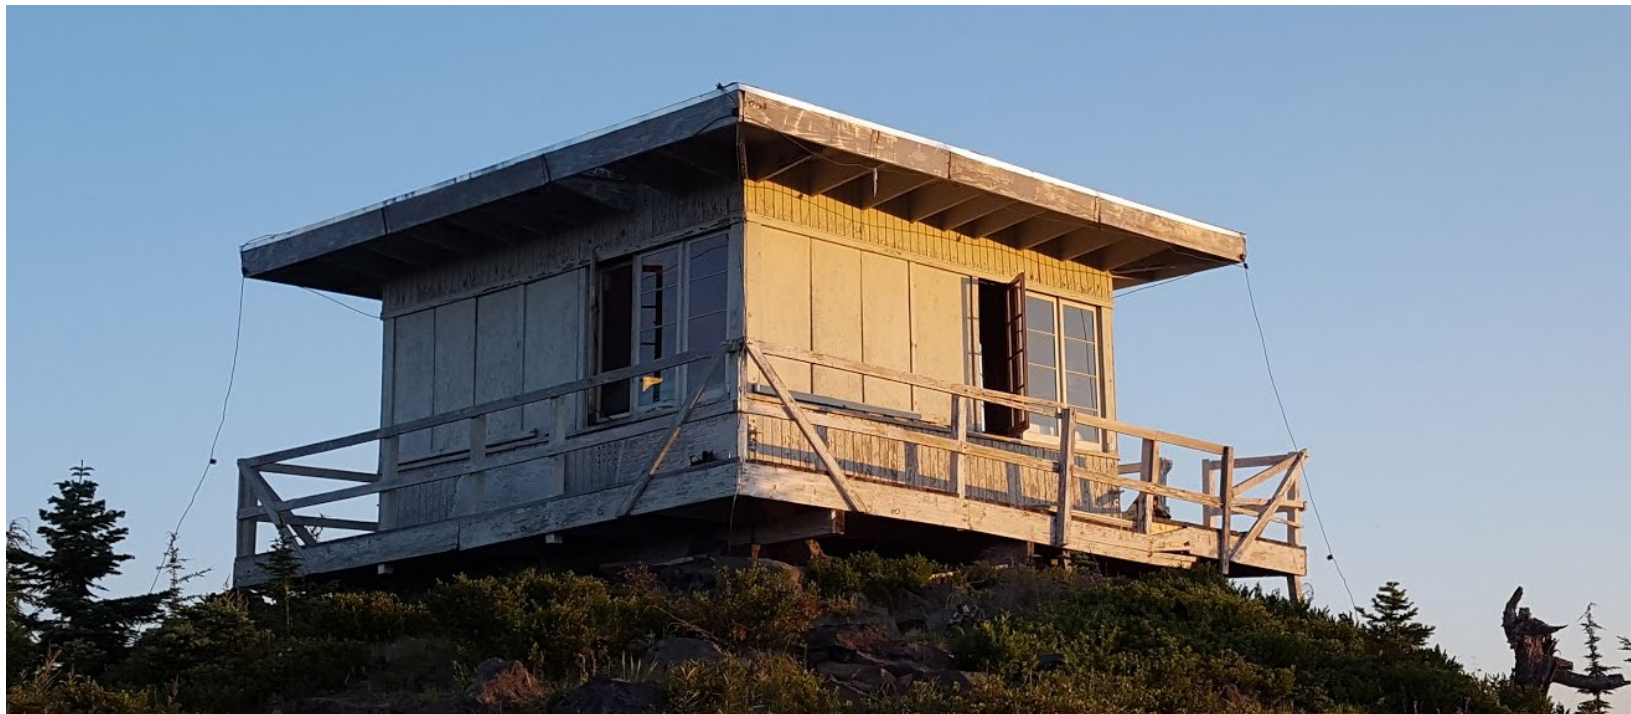
South and east elevations, railing design

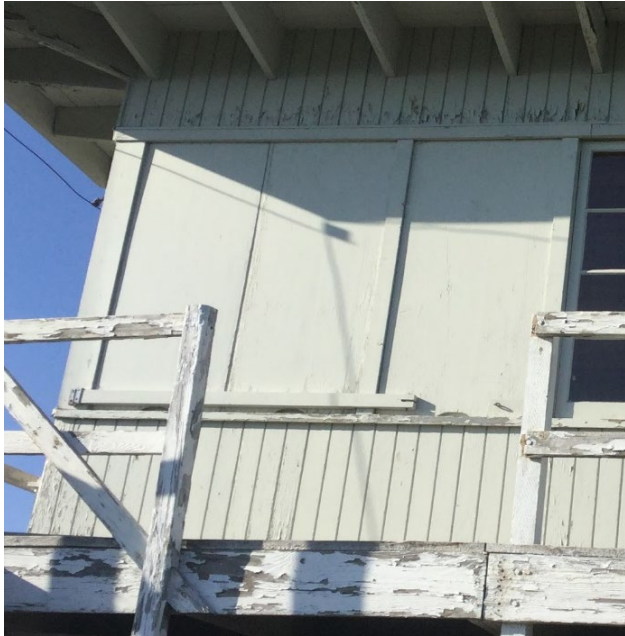
Typical shutter construction and condition

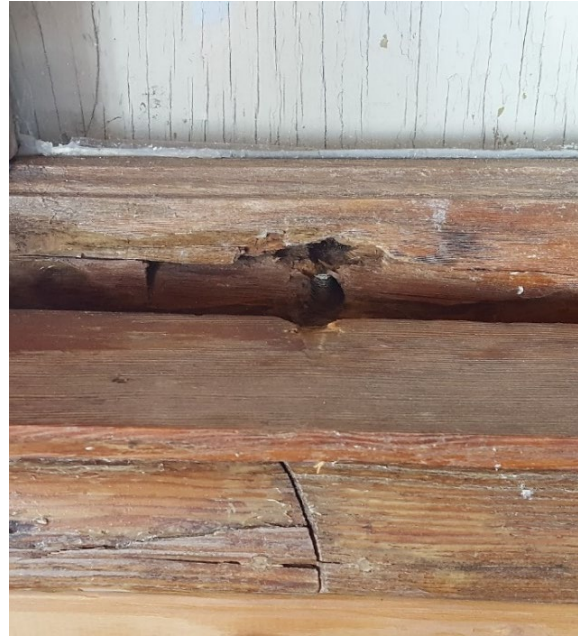
Condition caused by eyebolt installed through sash

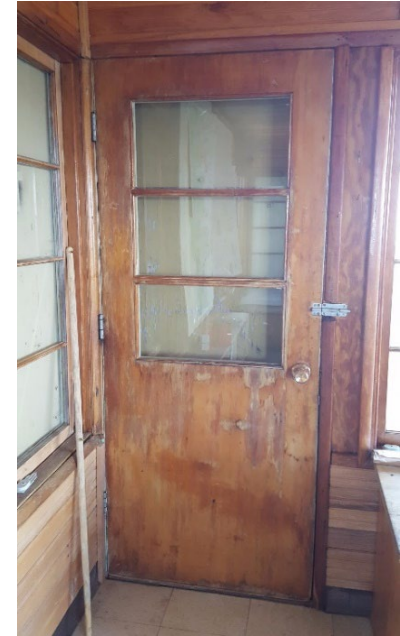
Door construction and condition

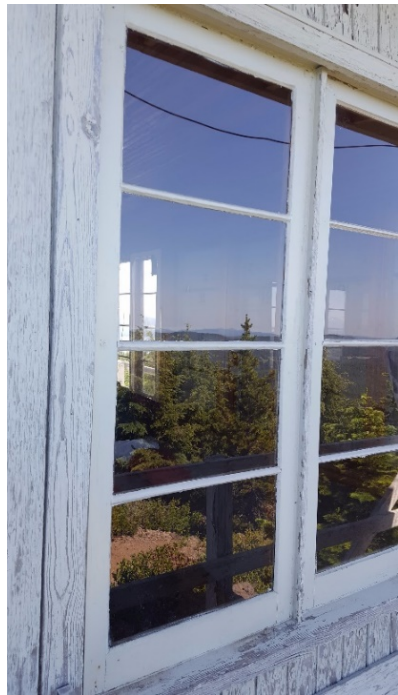
Typical window construction and condition

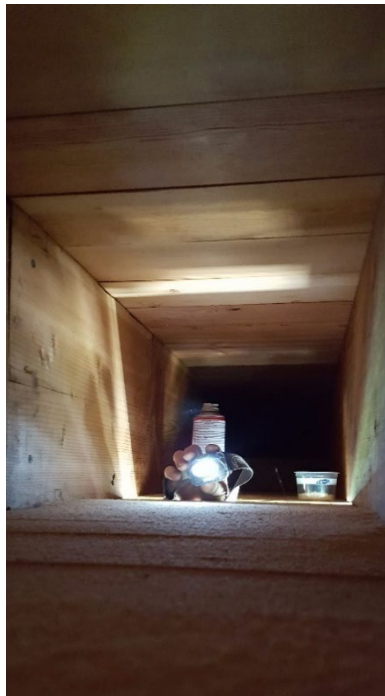
Roof - A section of rolled roofing on the south side is missing and has exposed the wood sheathing below. The patch measures approximately 8' x 10' and is a critical concern that has the potential to accelerate damage throughout the structure if it remains unrepaired through winter. Roofing nails are already on site inside the lookout. *Recommended Treatment:* replace roofing.

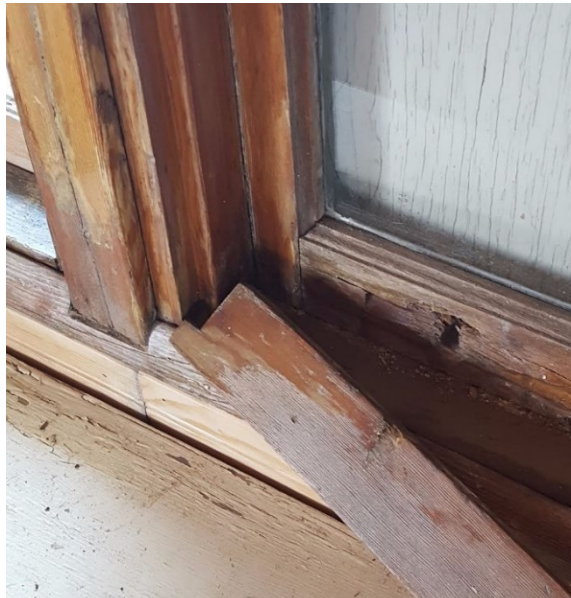
Window sill condition

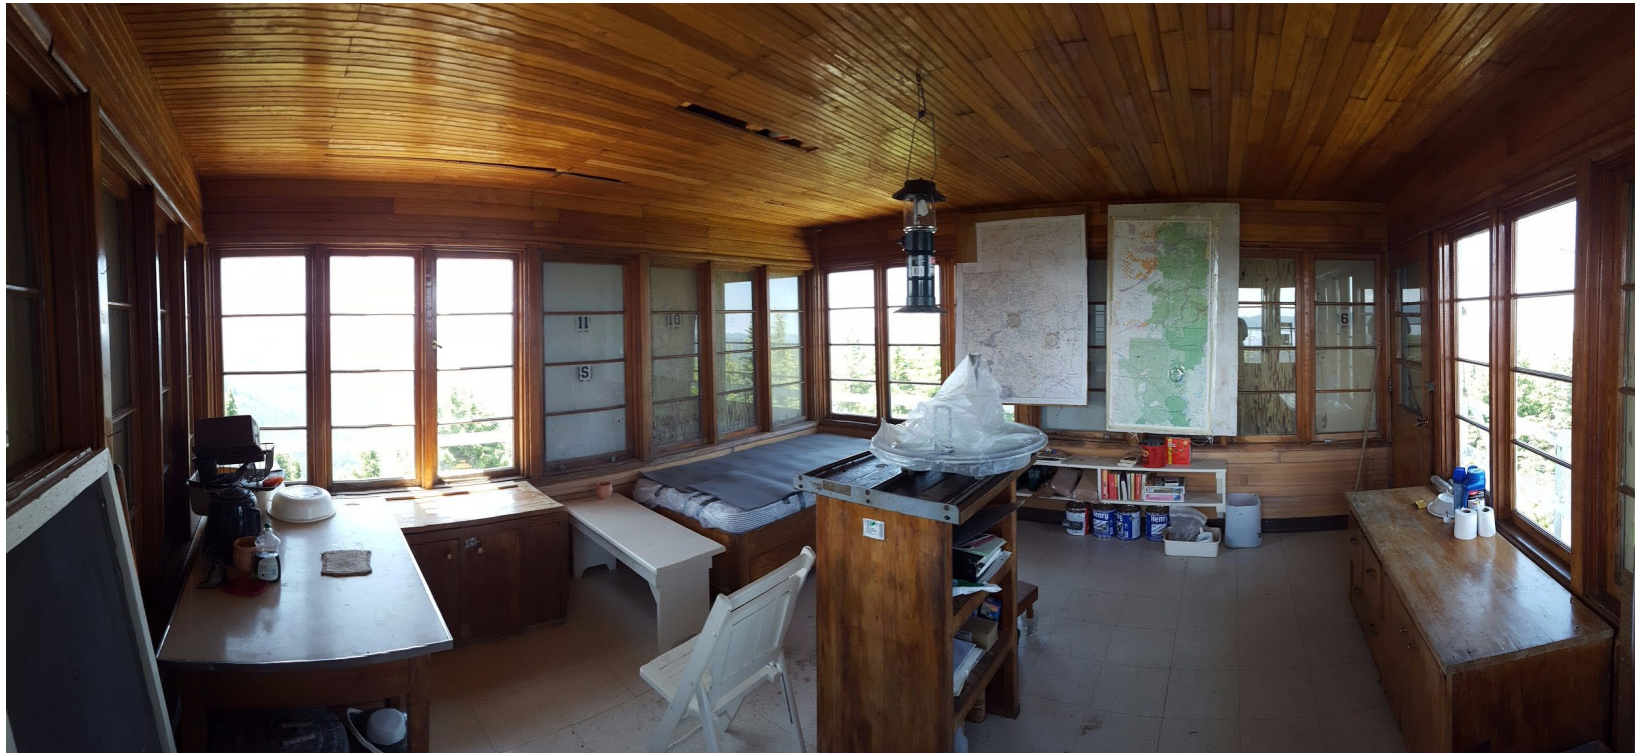
Panorama photo of the lookout interior (distorted)

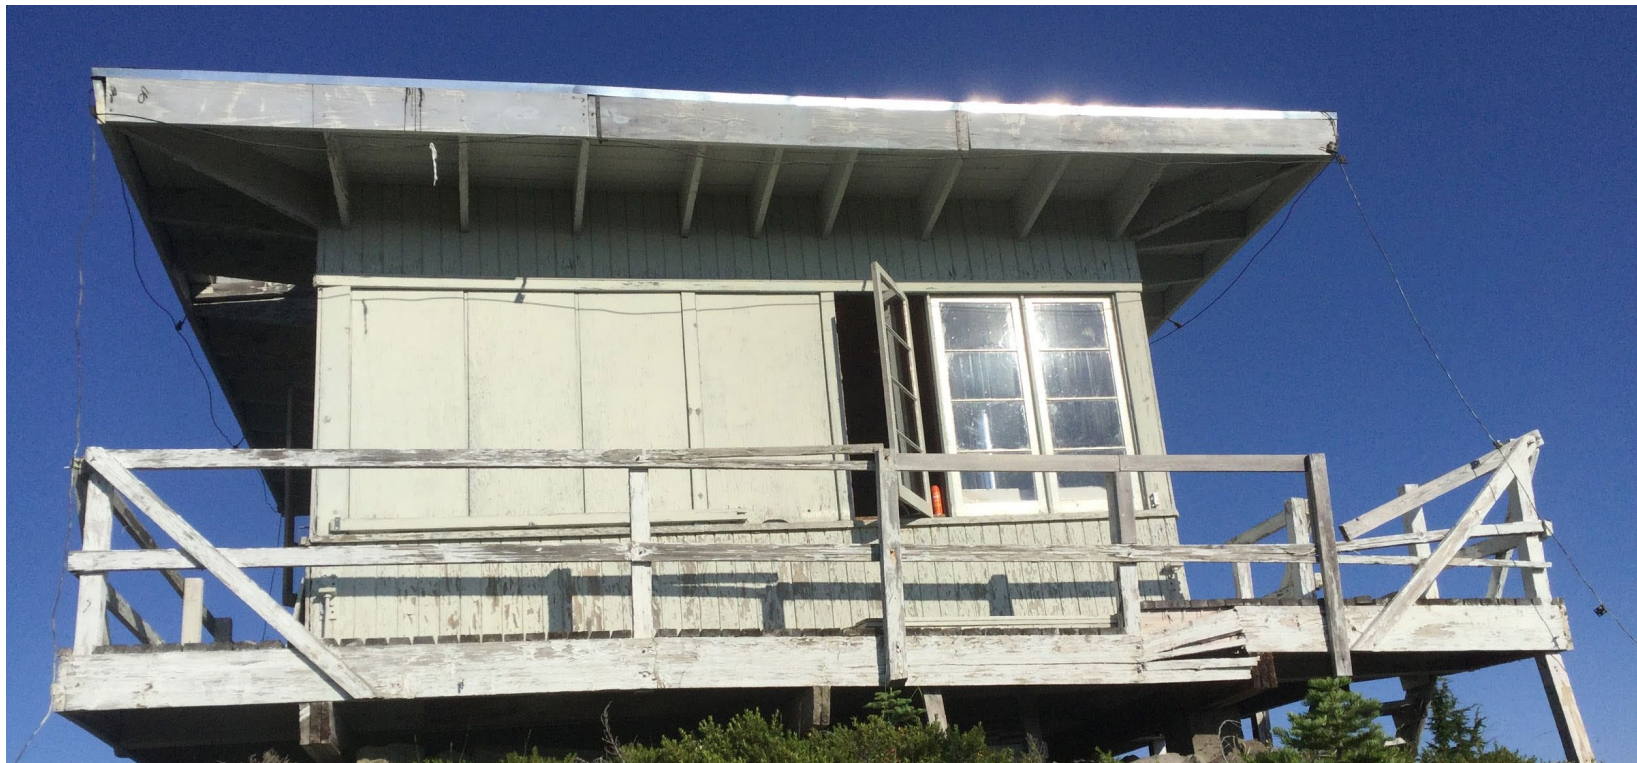
Unsecured window and broken catwalk on the east elevation present concerns about safety and security. Courtesy of John Milliken.
