WHIDBY ISLAND LODGE #15, F. & A.M., COUPEVILLE, WASHINGTON :

A HISTORIC STRUCTURES REPORT

by
KRISTIN GAYLE MONAHAN

A TERMINAL PROJECT

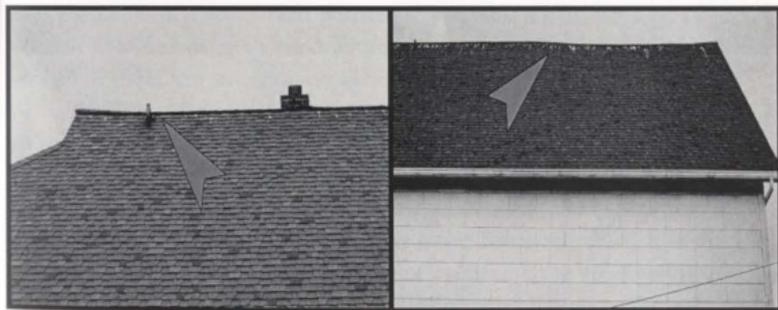
Figure 21: Deflection on western end of Temple roof. View looking north.

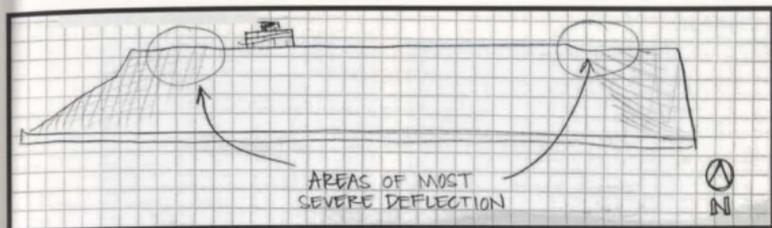
Figure 23: Sketch of Temple roof as seen from the south, showing areas of most severe deflection.

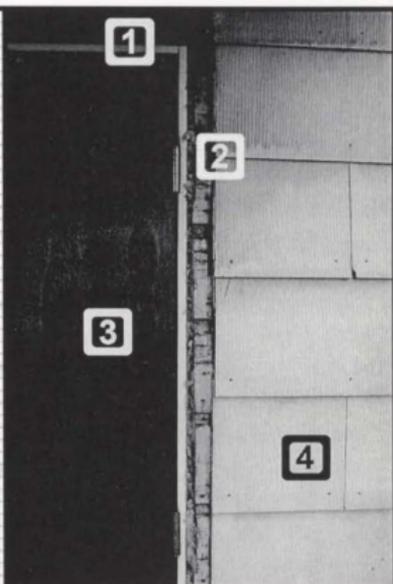
Figure 44: Photograph showing (1) the missing door trim piece, (2) exposed historic siding, (3) door, and (4) the cement-astbestos siding.

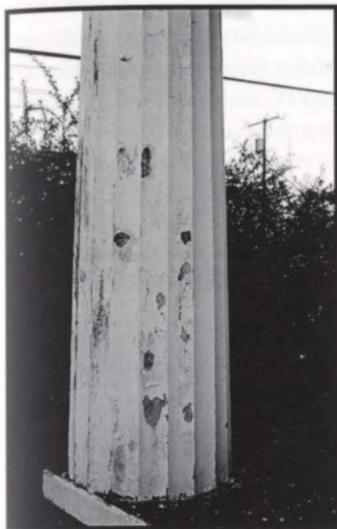
Figure 50: Detail of northern elevation column showing extent of paint degradation and loss.

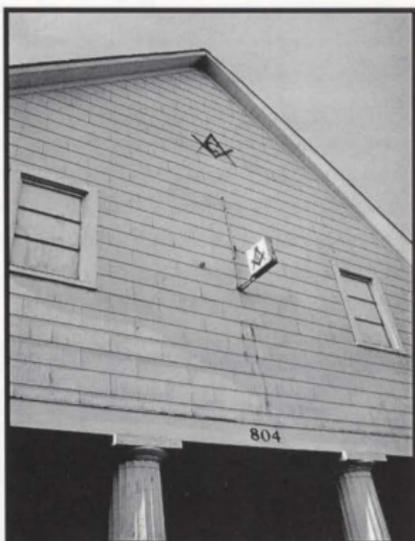
Figure 62: Photograph showing the various emblems located in the eastern elevation's gabled second story projection. Corrosion stains suggest where the second lighted element was once located.

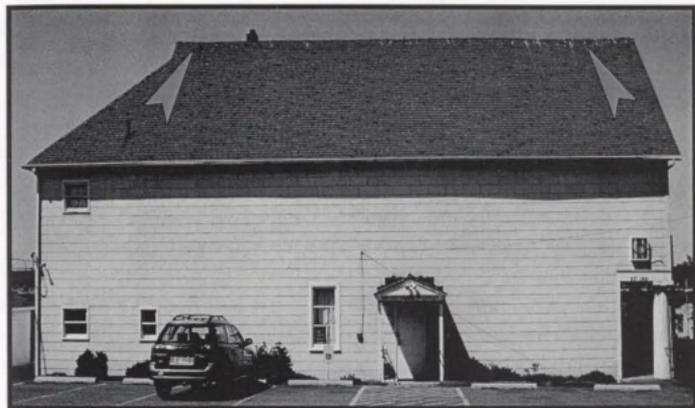
Figure 1: South elevation of the Temple showing roof deflection on the eastern and western ends.

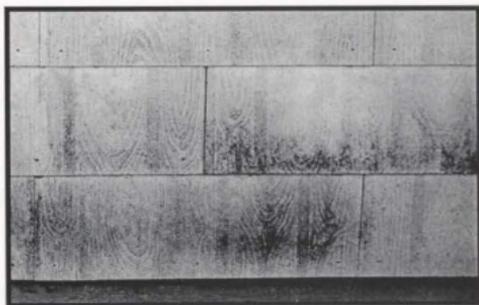
Figure 2: Mold and mildew growth on the shingles of the northern elevation.

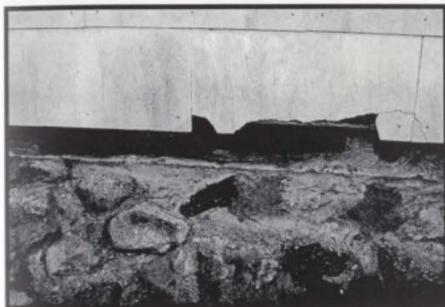
Figure 3: Breakage on the lowest course of shingles, north elevation.

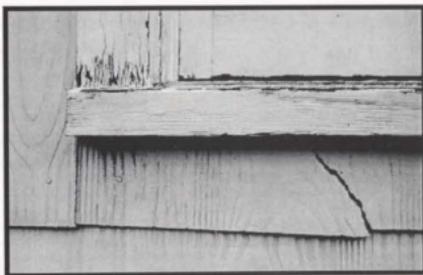
Figure 4: Breakage to shingle under window north side, west elevation.

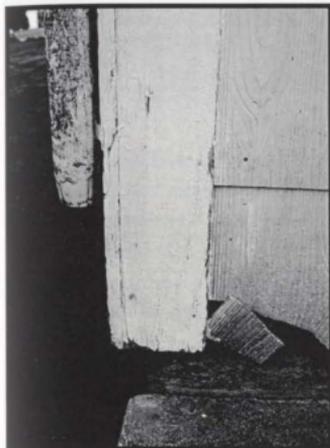
Figure 5: Broken tile, moldy gutter, and mildew growth on corner trim, western elevation.

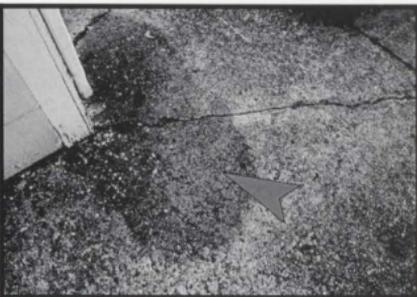
Figure 6: Water retention on the concrete elevation, southwest corner.

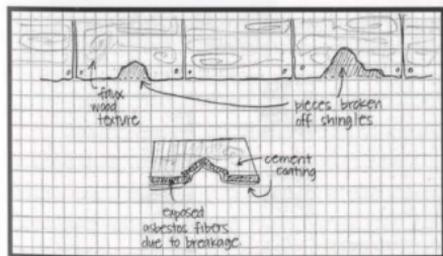
Figure 7: Sketch showing shingle degradation on southern elevation.

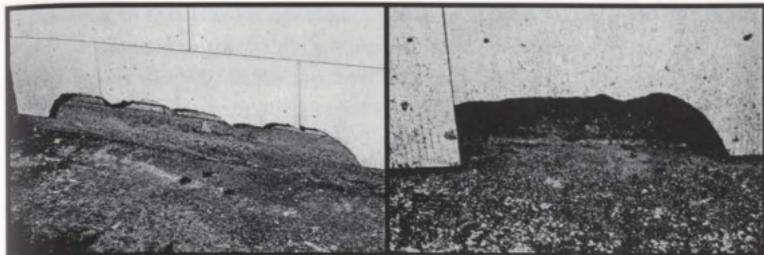
Figures 8 (Left) and 9 (Right): Photographs showing the extent of the breakage which has occurred to the shingles on the southern elevation. Broken pieces in Figure 8 measure three feet in length.

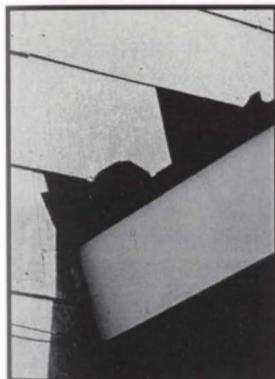
Figure 10: Missing shingles and discoloration over the gable roofed projection, southern elevation.

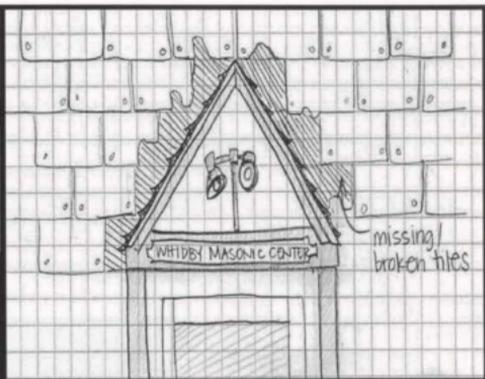
Figure 11: Sketch showing the shingle condition over the gabled projection. Note how large the area of missing and broken tiles is.

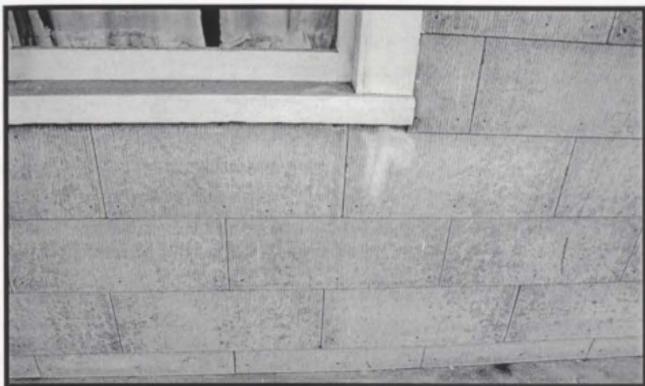
Figure 12: Prolonged exposure to car exhaust from Main Street has heavily soiled the shingles on the eastern elevation.

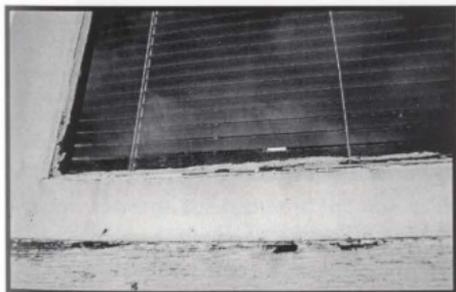
Figure 13: Mold growth on window sill and paint on glass lights, northern elevation.

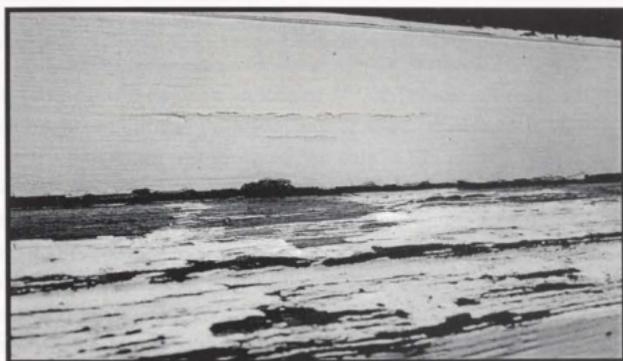
Figure 14: Mold growth and paint loss on the window sill of the first floor window, western elevation.

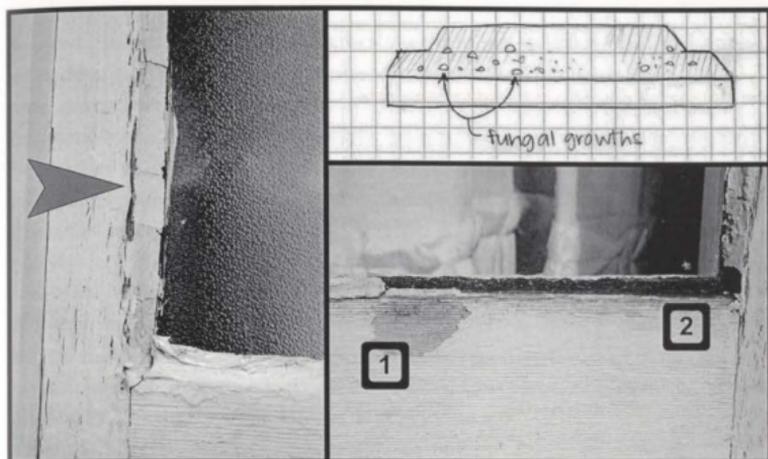
Figures 15 (Left), 16 (Top Right), and 17 (Bottom Right): Heavily cracked glazing on the western window, first floor; sketch showing the fungal growths on the window sill of the same window; and photograph showing (1) flaking paint which has exposed the wood structure of the window frame and (2) missing glazing in the large three light window on the first floor of the southern elevation.

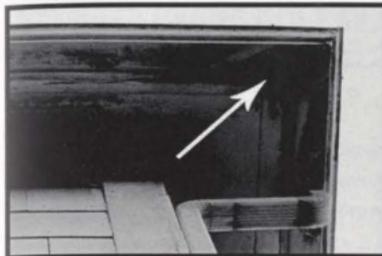
Figure 18: Mold growth, corrosion, and rot on the gutter and eaves, southwest corner, western elevation.

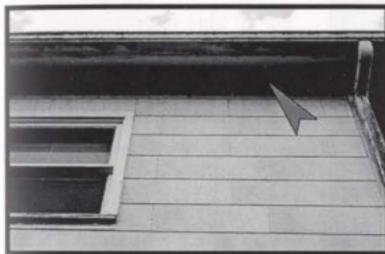
Figure 20: Missing fascia piece west side northern elevation.

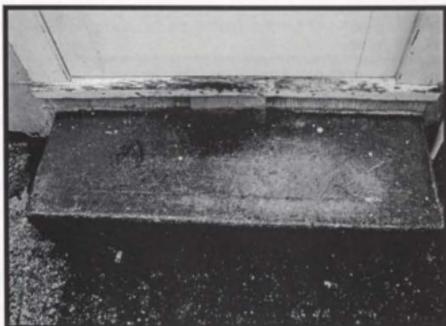
Figure 23: Wear to paint on tread and fungal growth, concrete step, western elevation.

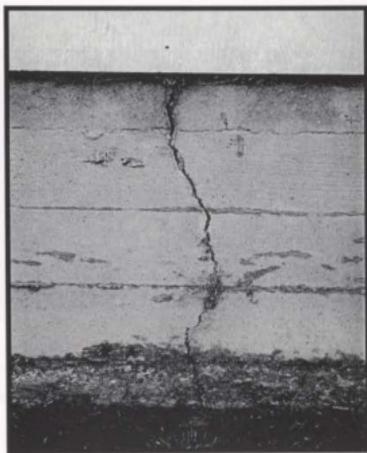
Figure 24: Crack in the board-formed concrete foundations on the eastern end of the northern elevation.

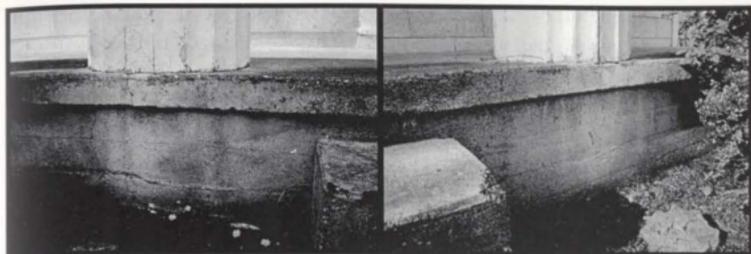
Figure 25: Minor cracks are apparent in the board-formed concrete foundation on the southern side of the eastern elevation.

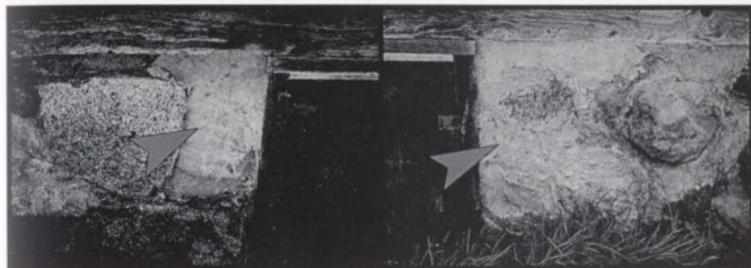
Figures 27 (Left) and 28 (Right): Re-pointing of the historic mortar on the stone foundation, northern elevation, does not match the historic fabric either in color or application. The mortar covers large sections of the historic stones.

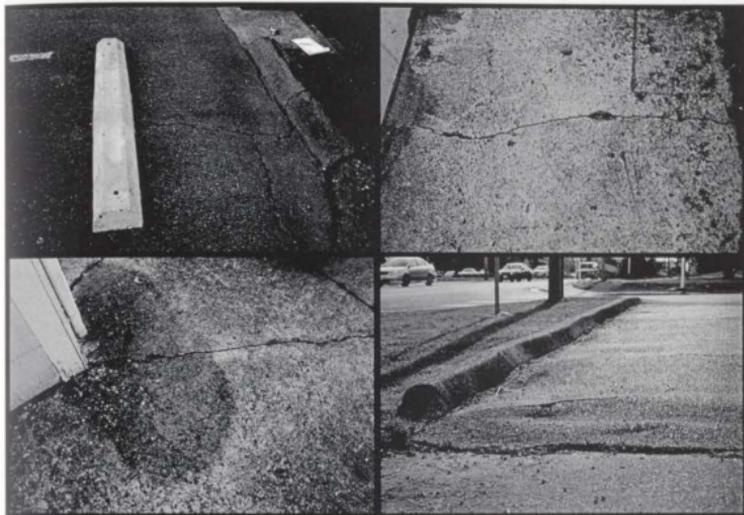
Figures 29 (Top Left), 30 (Top Right), 31 (Bottom Right), and 32 (Bottom Left): Photographs showing cracking and buckling due to freeze/thaw cycles in the Temple's concrete apron and parking lots

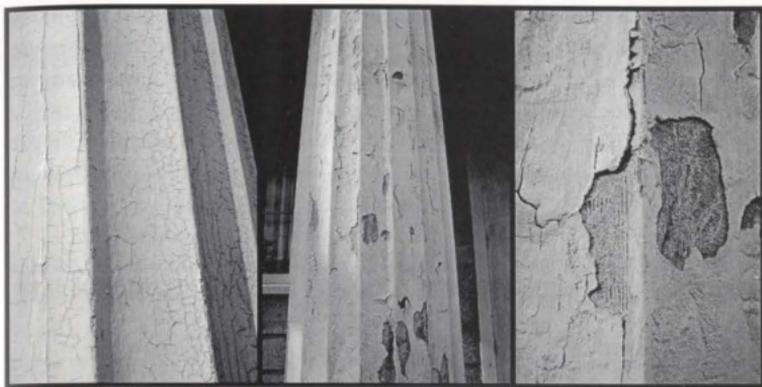
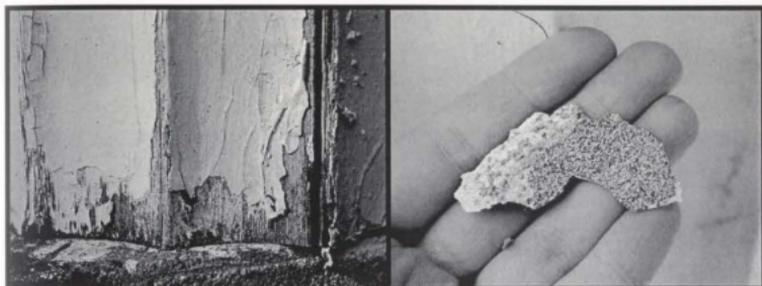
Figures (Clockwise from top left) 33, 34, 35, 36, and 37: Photographs showing extensive damage to the surface treatment of the eastern elevation's four Doric columns.

The columns need to be treated immediately in order to prevent any damage from occurring to their historic wood sub-structure and to prevent the loss of any historic fabric. The columns were built circa 1910, and their replacement would not be either easy or inexpensive. Fortunately, re-finishing the columns is a simple and relatively inexpensive way protect them from further damage. For guidance on re-finishing these and other wood elements on the Temple, refer to *Preservation Brief 10: Exterior Paint Problems on Historic Woodwork*, which is published by the National Parks Service, and has been included in the appendix of this document.

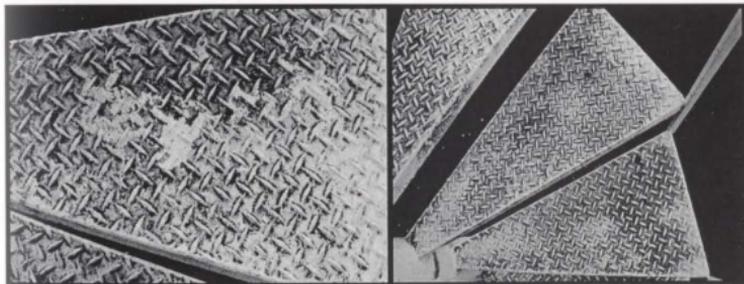
Figures 38 (Right) and 39 (Left): Photographs showing the rampant mold growth on the treads of the steel fire escape. This condition has left the stairs very slick and unsafe to use.

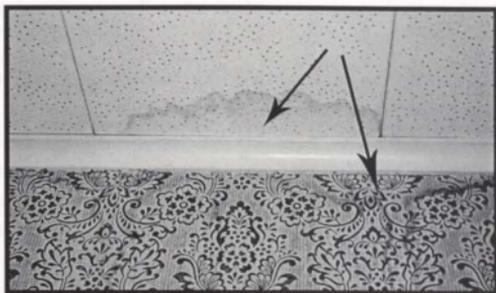
Figure 40: Discoloration on the wallpaper of the first floor Women's Restroom has occurred due to water infiltration through its western wall.
