A DOCUMENTATION AND RESTORATION PLAN FOR  
THE FIRST CHRISTIAN ADVENT CHURCH  
IN JOHN DAY, OREGON

A THESIS

Presented to the Interdisciplinary Studies Program:  
Historic Preservation  
and the Graduate School of the University of Oregon  
in partial fulfillment of the requirements  
for the degree of  
Master of Science

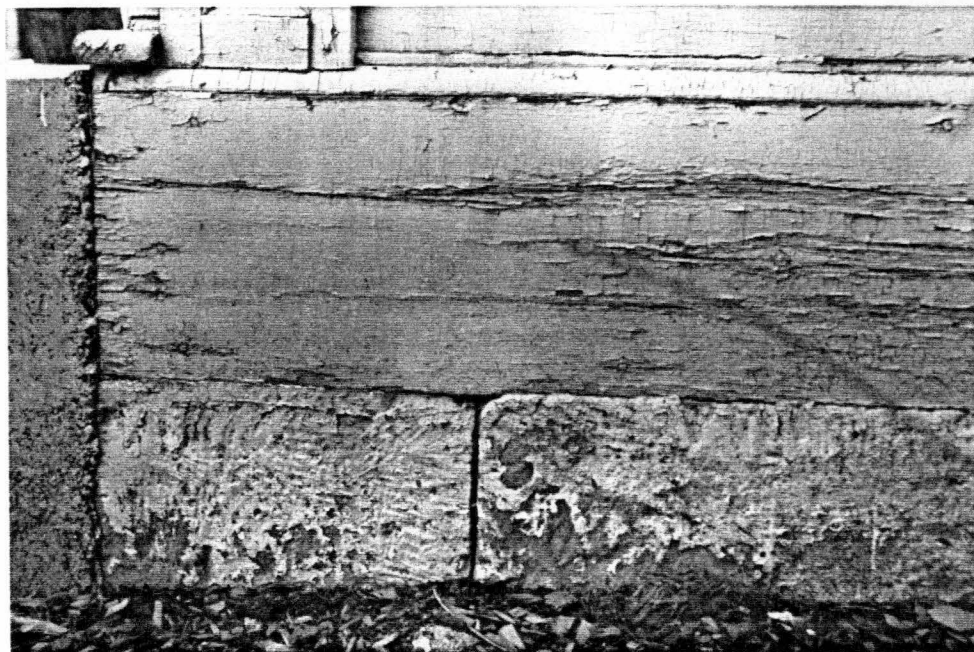
FIGURE 11. Foundation Wall. Entrance tower east elevation.

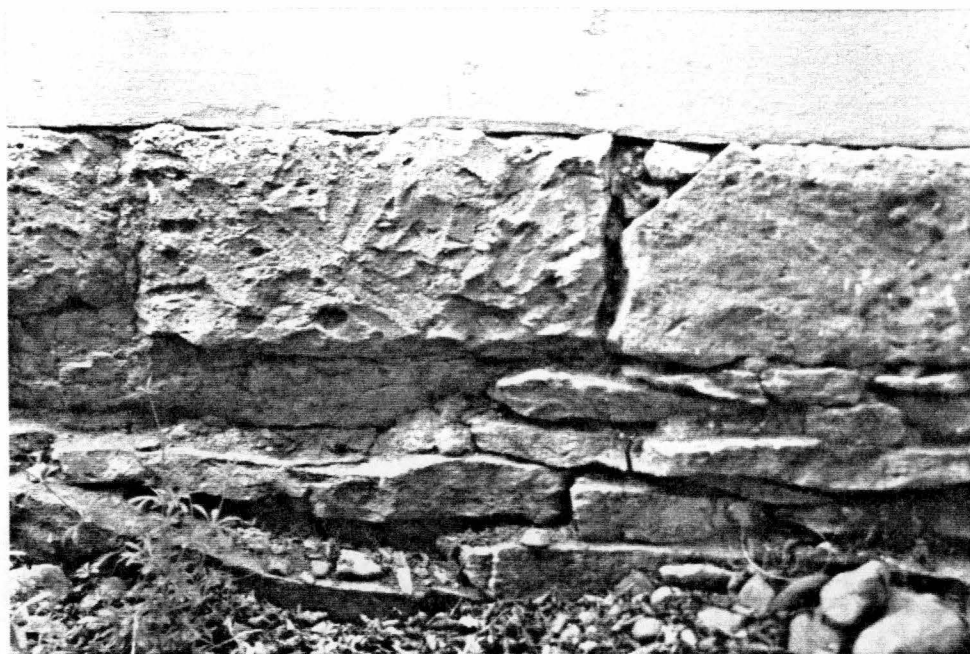
The foundation walls and footing have remained fairly true. The only significant problem occurs at the northeast corner of the building. Here, at the east end of the north elevation, the wall is  $1\frac{1}{16}$ " above the norm where it abuts the apse. It is  $1\frac{1}{4}$ " below normal at the corner itself. The problem is attributable mostly to the  $10'3\frac{1}{2}$ " crawl space access at the north end of the east foundation. The break in the wall means that the sill has to carry the weight of the entire corner of the building over to the end-wall. The problem is exacerbated by the poorer quality of the end-wall masonry, and by a section of the north sill which was cut out. Church records from the early 1960s indicate that the problem is not new.<sup>1</sup>

FIGURE 12. Foundation wall. North end of east elevation.

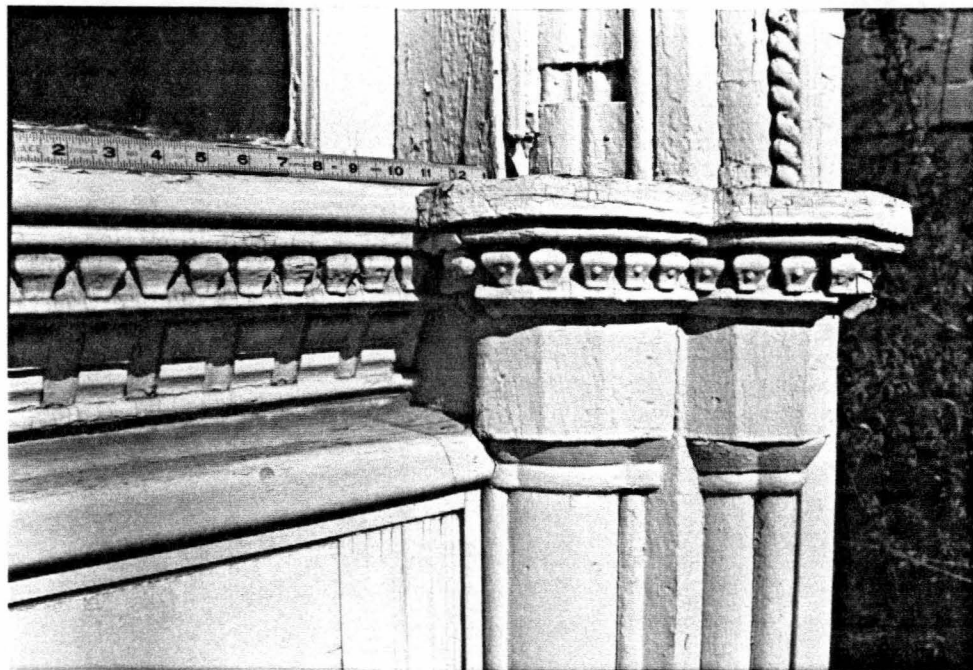
Inherent in the design of such ornament are some fairly fragile construction details. Figure 23 shows where single nails, with which the dentils are attached, have begun to work themselves loose. Indeed, no dentils at all remain on the opposite set of capitals. Inevitably, such ornament requires some maintenance to protect it from the elements.

FIGURE 23. Capitals of entrance pilasters. South elevation.

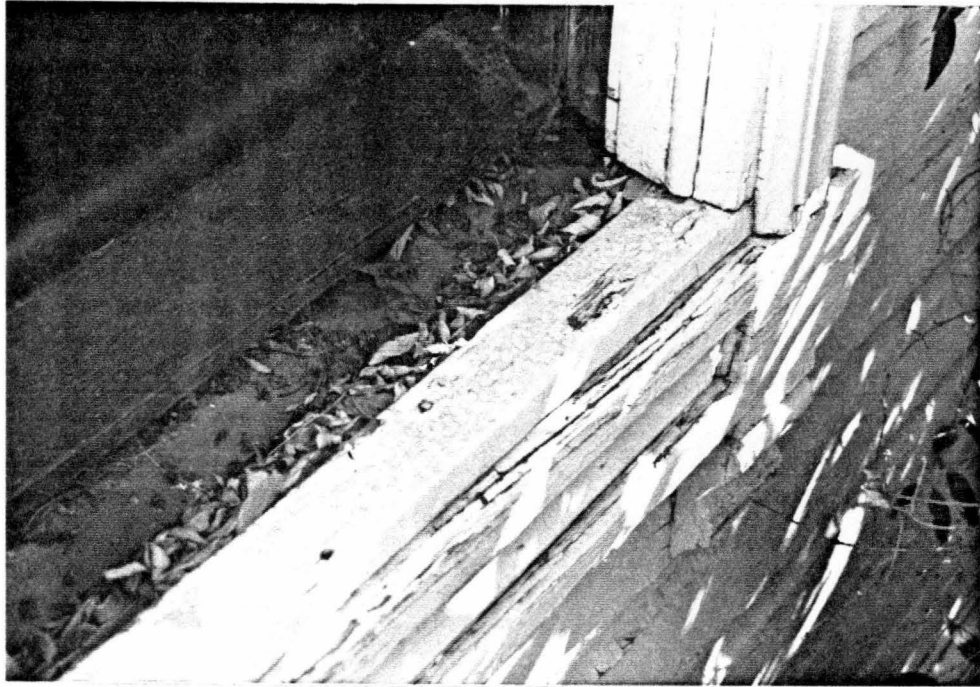
Exterior window sills exhibit a construction problem as well. The west window on the south elevation, and the two middle windows on the west elevation have sills which have split along their entire lengths (Figure 54). Subsequently, the sills have collapsed. Exposure to the elements and poor maintenance are two factors which have contributed to the damage. Also significant is the shallow pitch of the sills. They tend to hold water and collect debris.

FIGURE 54. Split window sill. West elevation.

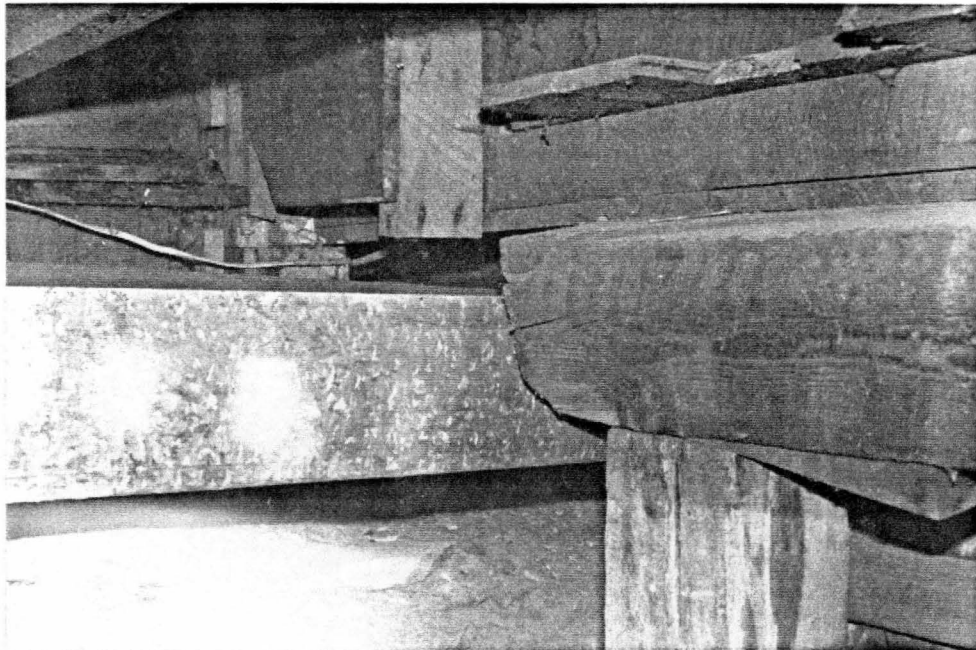
The installation of a propane heater in the apse in has caused more problems than any other alteration. Where it spans the apse in the crawl space, a 2'3" section sill was cut out to make room for duct work (Figure 55) (a hole was also cut in the floor of the apse for ducts). The sill break has exacerbated differential settlement at the northeast corner.

FIGURE 55. Sill at apse (north end of the building).

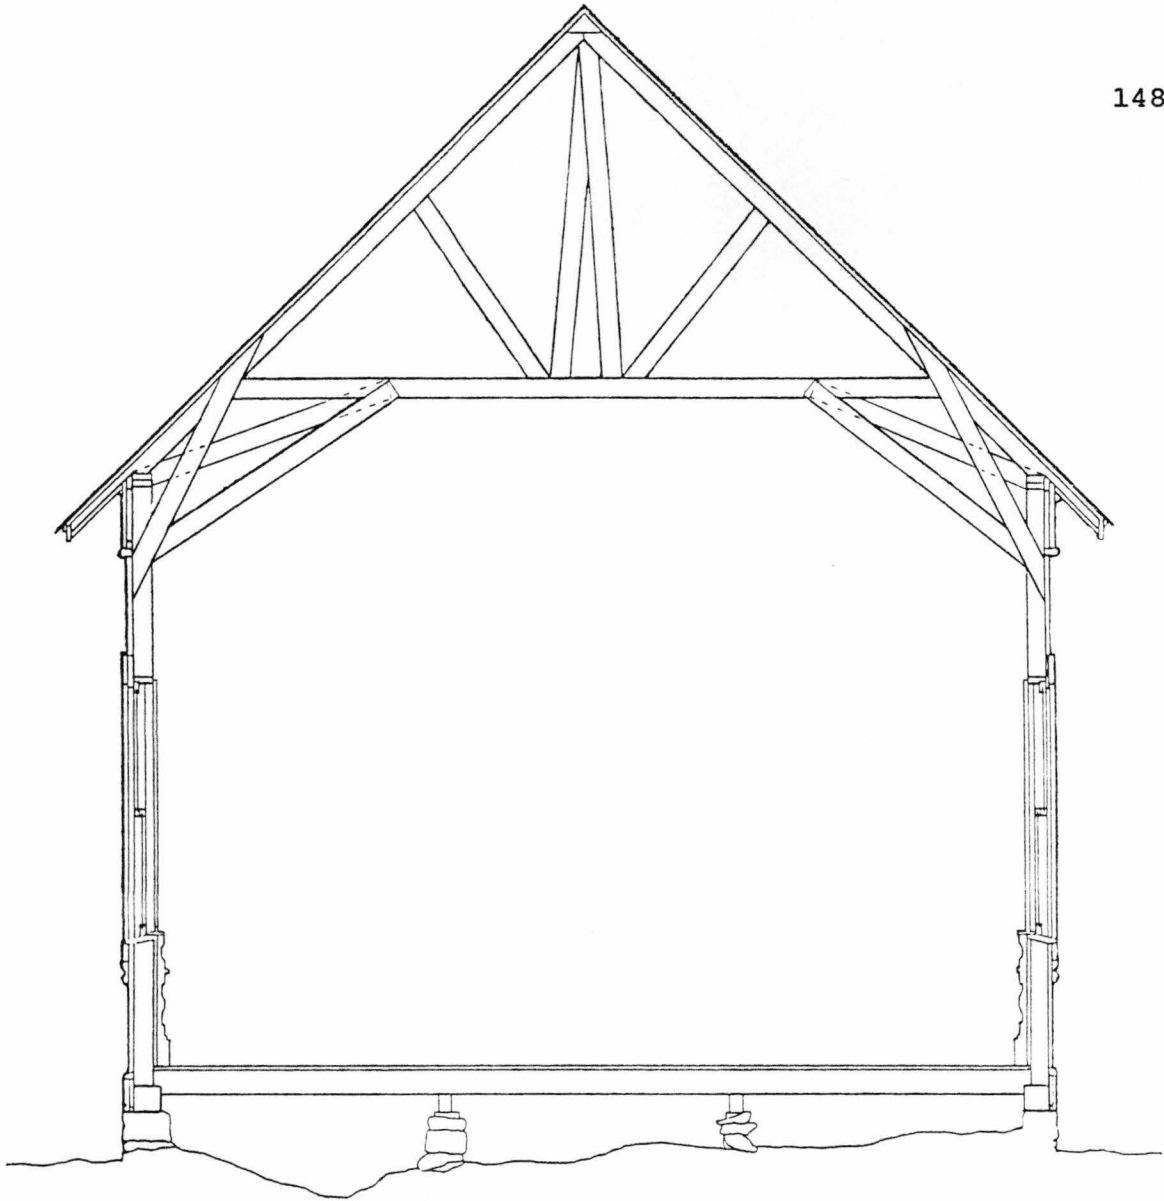
The most important consequence is that the east wall has begun to lean out by 1" at the south end, and by 2" at the north end. This has occurred because the rafters have spread and exerted lateral pressure on the tops of the walls. The leaning alone would not be any cause for concern if the building did not also creak and groan in the wind as it does. This circumstance illustrates the instability of the roof structure.

FIGURE 62. Sketch of roof structure reinforcement scheme.  
Add X-bracing. No scale.
