NEVADA FALL CORRIDOR:  
A CULTURAL LANDSCAPE  
REPORT

A THESIS

This study describes existing conditions, evaluates significance and historic integrity, and recommends treatment strategies to preserve historic elements of the Nevada Fall Corridor cultural landscape in Yosemite National Park.

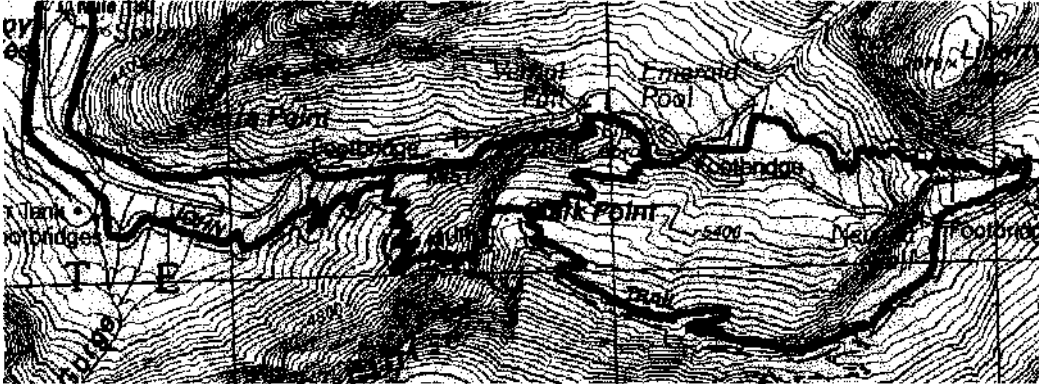
**Figure T.4** – This map shows locations of trail that have been so heavily used and frequently repaired that all original surfacing has been replaced, leaving little if any historic integrity of surface tread (USGS Half Dome Quadrangle, 1997).
