Environmental Disturbances

E5, E6 and E7 Investigations

Locking Difficulties in High Wind

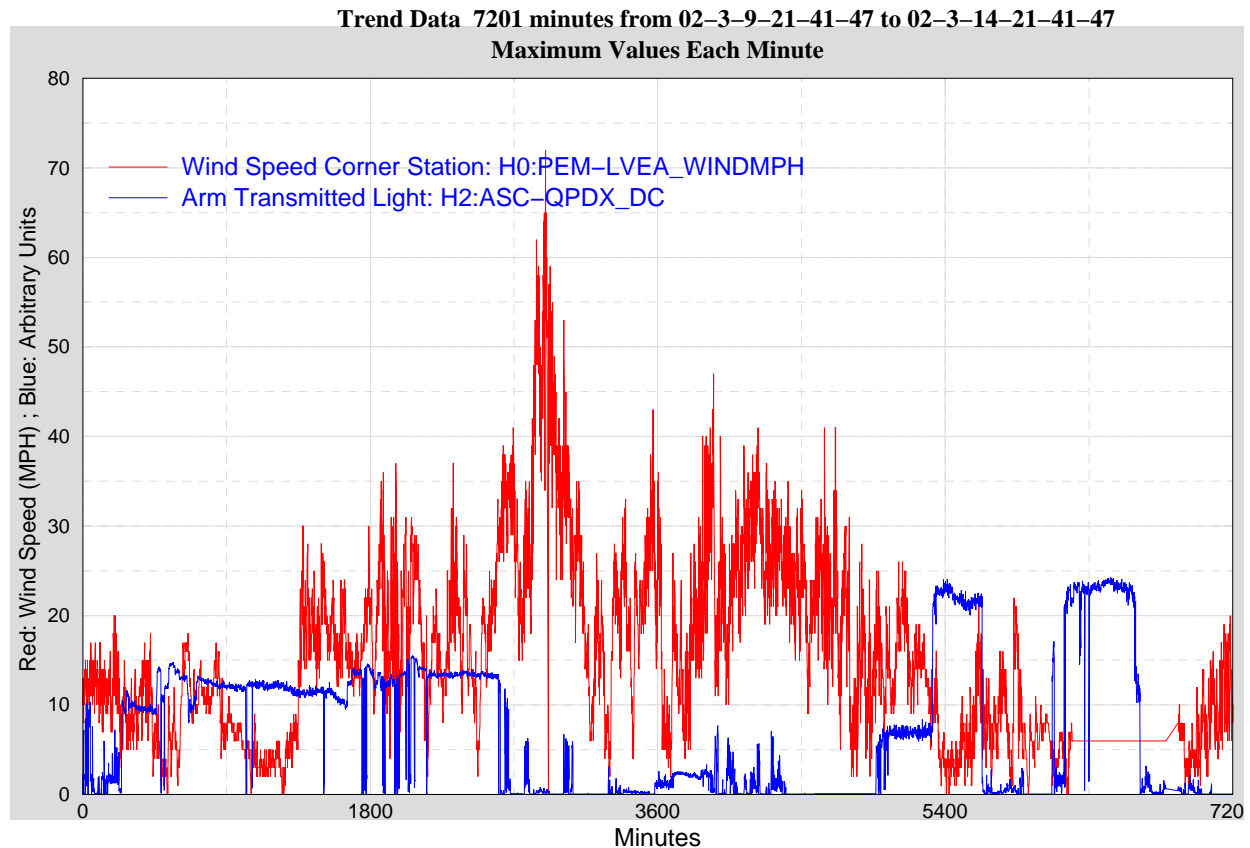
LHO 2k March 12, 2002 wind storm

Fully recycled, with common-mode servo and 1 WFS.

Difficulties regaining or holding lock when corner station wind speeds exceeded 25 or 30 mph

This was also the rough threshold during E7 for the LHO 4k in recombined mode (elog 1/11/02).

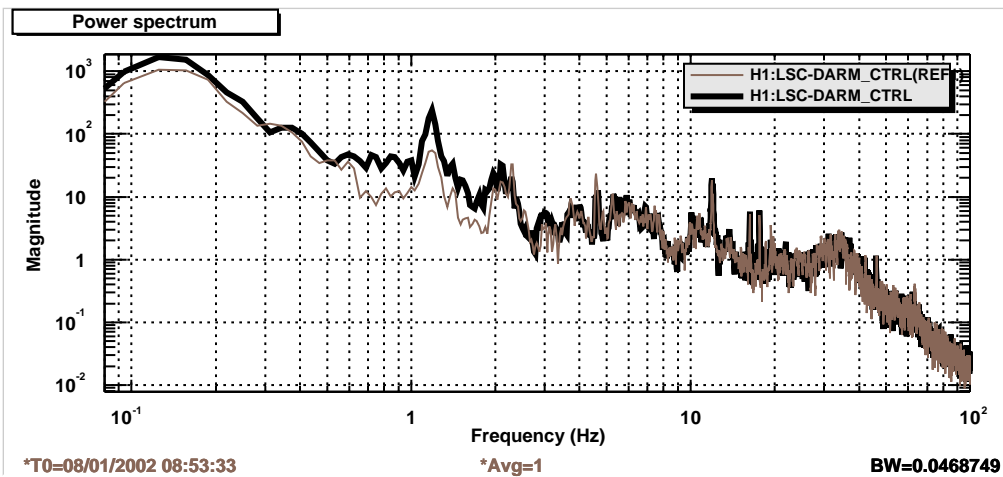
Differential Arm Control (thin reference line: 12 mph)

BSC Coupling: 33 MPH Y-end Wind

Lower wind speed elsewhere (X-end: 16 mph; Corn.: 18 mph)

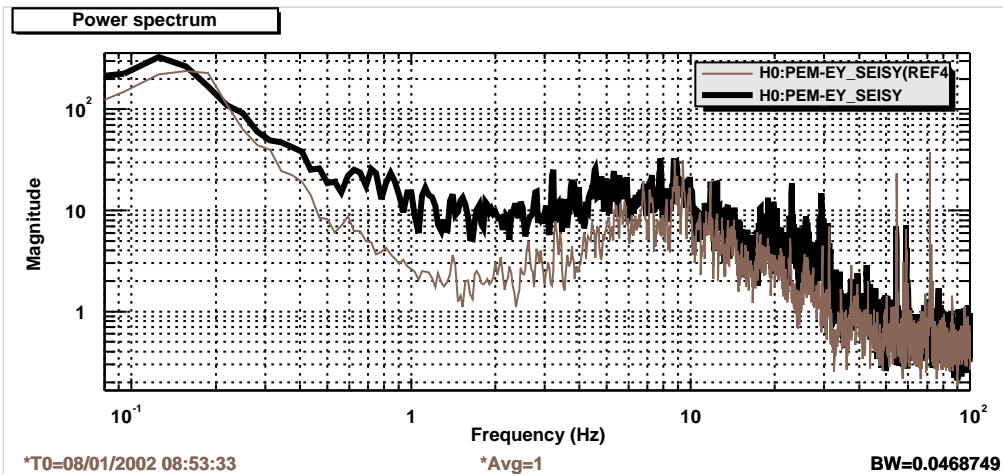
Y-end seismometer

~1.2 Hz BSC modes

MC_F and seismometers at other stations deviated little from reference spectra (elog: 01/11/02)

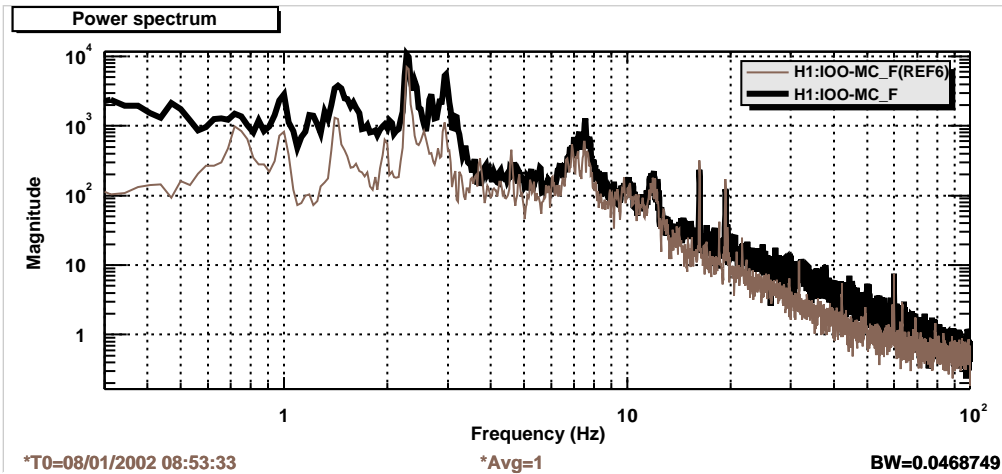
Mode cleaner control (thin reference line: 5 mph)

HAM Coupling: 40 MPH Corner Station Wind

Difference above 10 Hz does not appear in 2k MC and is consistent with signal distortion.

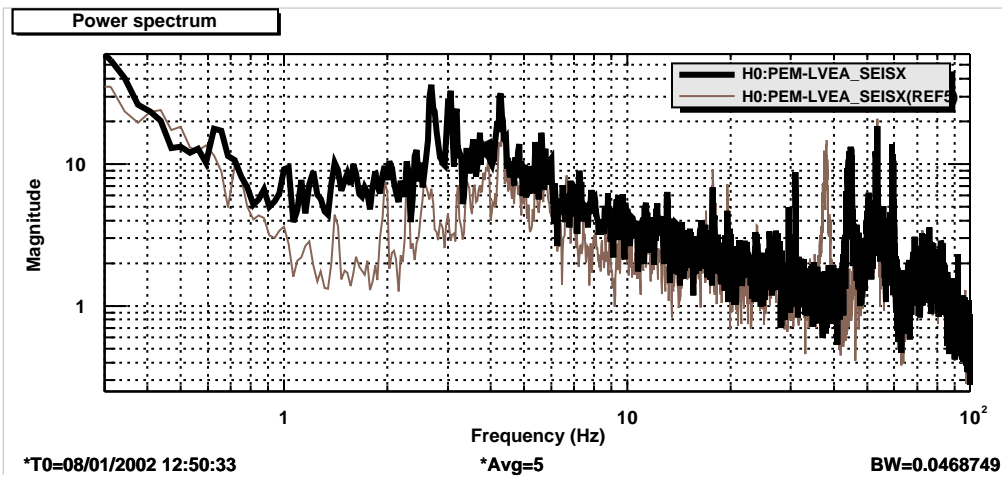
LVEA seismometer

Sub 5 Hz HAM modes

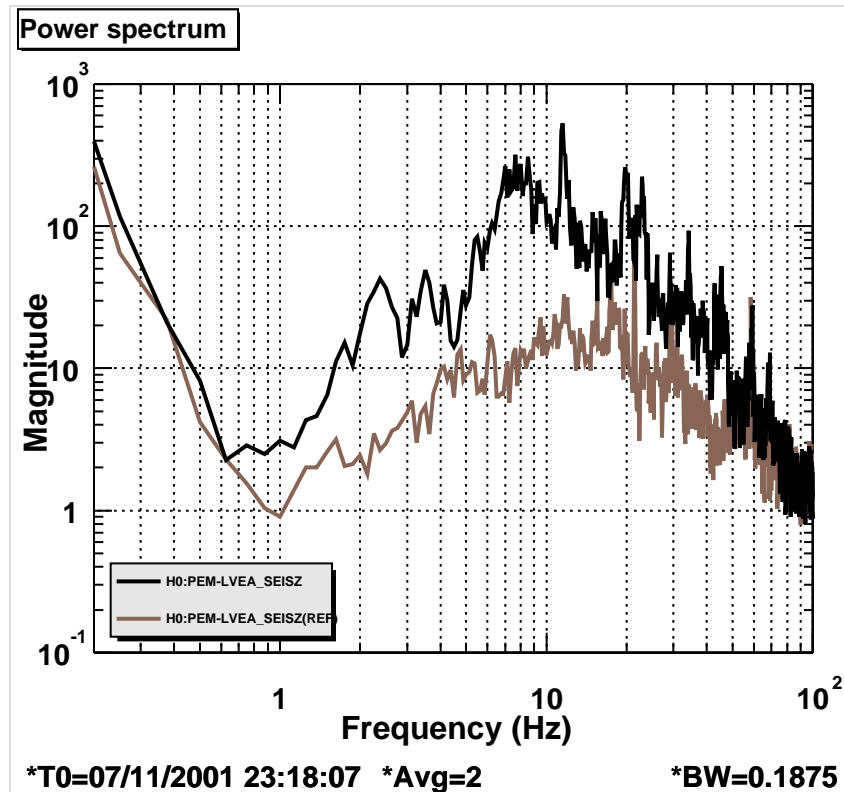
Seismic Noise Increase With Construction Near Corner Station

Could not lock with this factor of 10 increase (could hold 1 arm at factor of 5 increase)

Construction spectrum has shape of non-construction spectrum: evidence for “ground resonance” of about 10 Hz

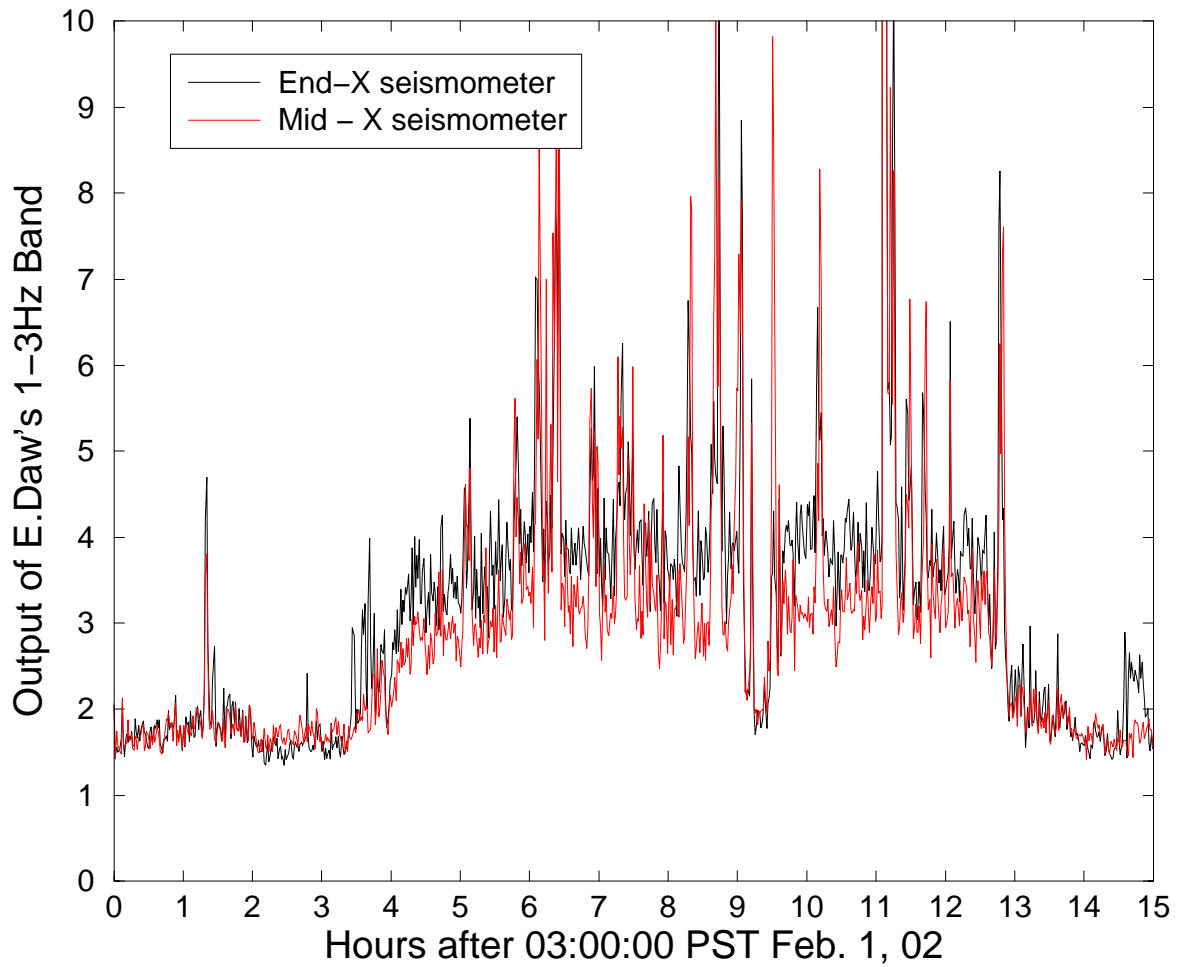
Anthropogenic Seismic Signal

Spikes are probably trucks on Route 2

Traced to Vitrification Plant Project

10 km from X-end, up to 5000 workers expected during 5 year project
