**Dawson Park Gazebo
Assessment
2004**

May 6, 2004

**Subject: Visual Structural Site Observation of the Dawson Park Gazebo
MCE Project No.: 040208**

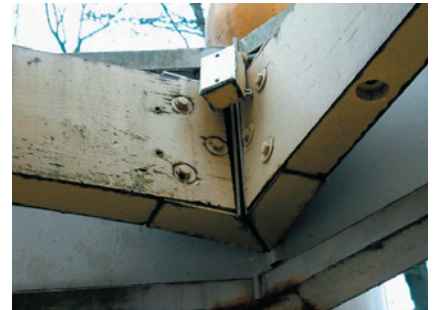
Existing 4 x 12" Beam Joint

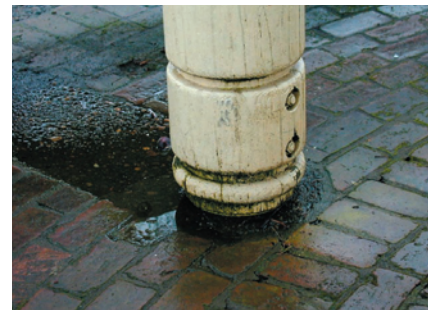
Existing Post

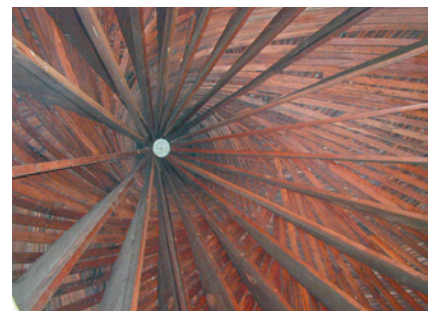
Existing Dome Ceiling Interior

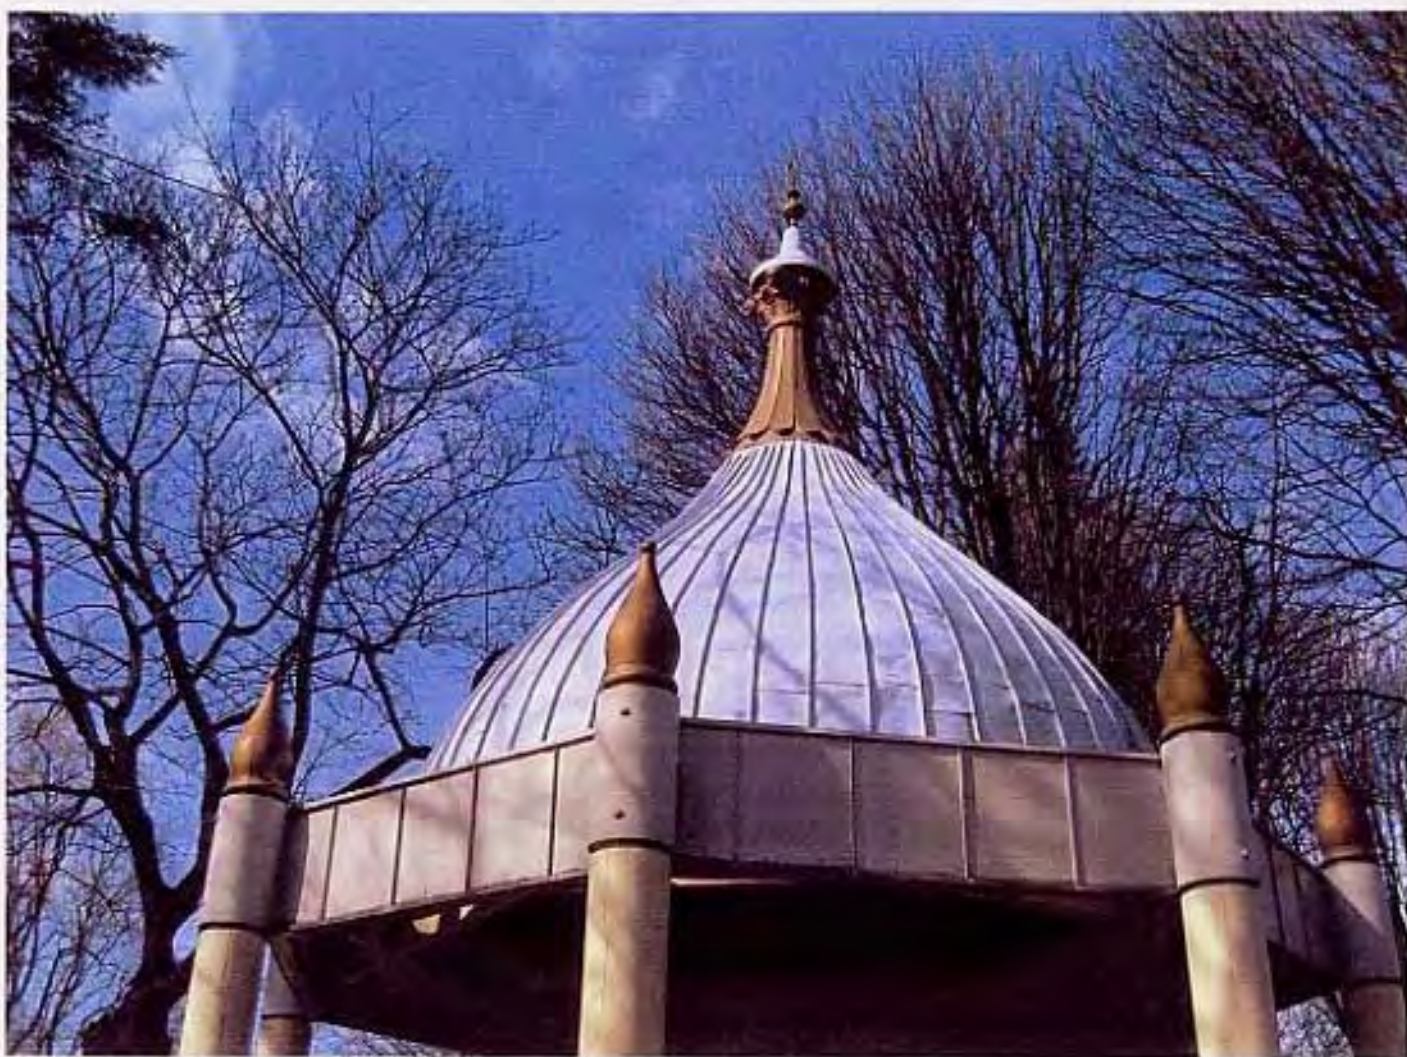
This structure is an open gazebo that combines eight (8) columns that are on a 20'-6" diameter circle which has internal beams carrying a round roof that is about 13 feet in diameter (photo #1). Both the vertical and lateral loads are carried by the 8 columns supporting the roof. The lateral loading (wind) is resisted by the way that the connection at the top of the column operates. These connections consist of a steel pipe section that is about 24-inches in length and has a snug, tight fit to the wood column. Between these column pipe collars there is a built-up steel member that uses a steel channel shape for the top and bottom flanges (photo #2).

PHOTO #1: DAWSON PARK GAZBO

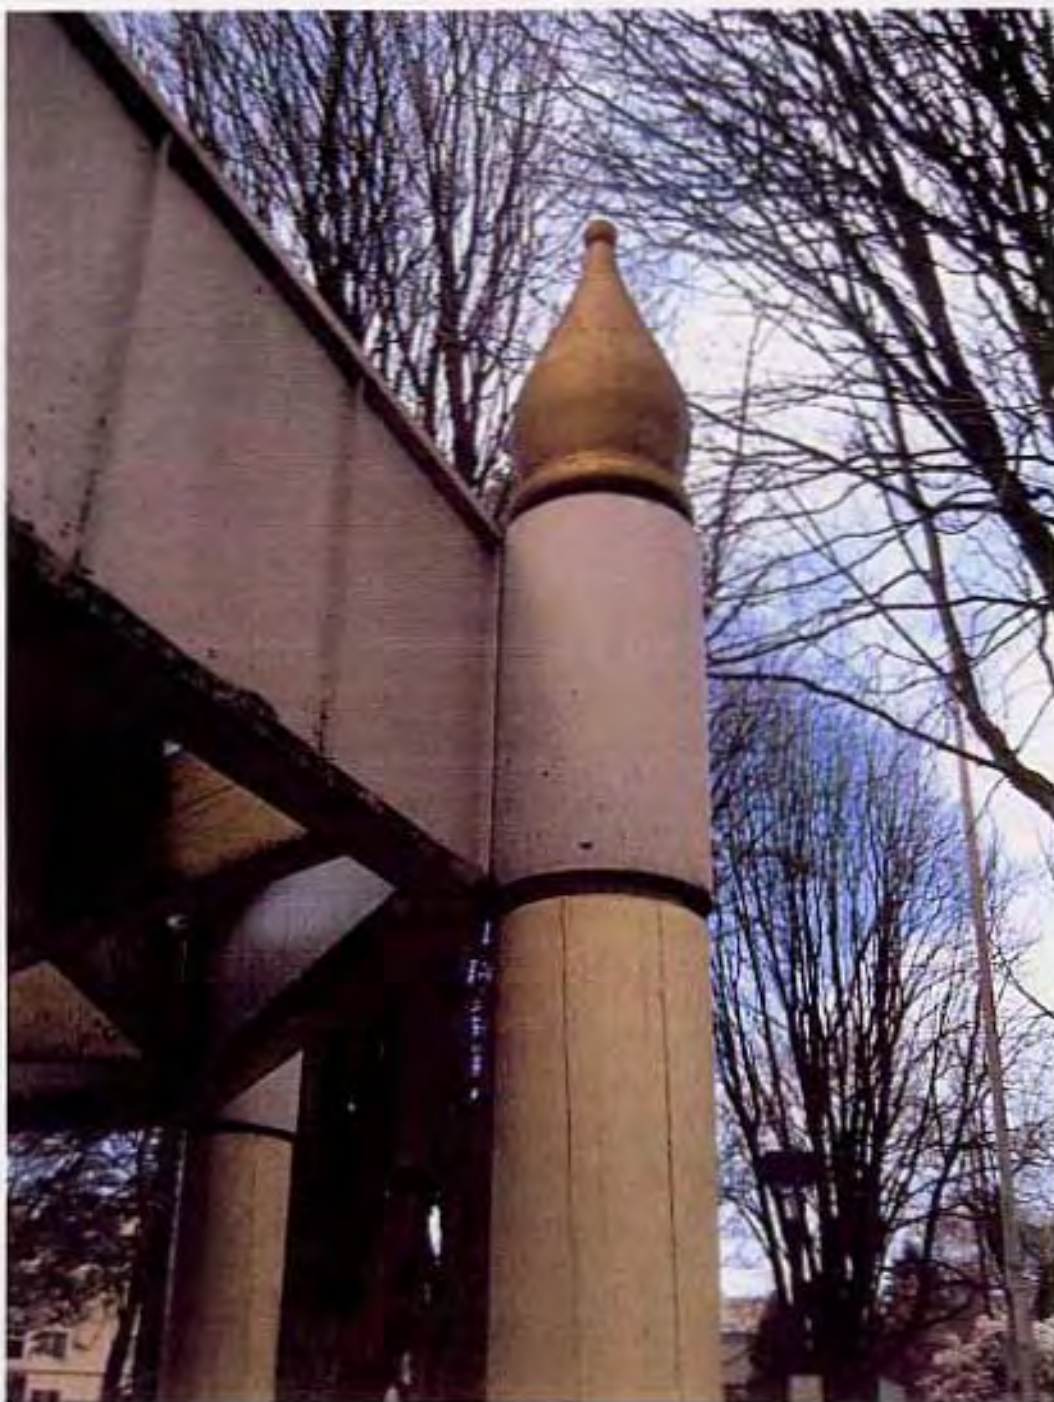
PHOTO #2: FRAME TO POST CONNECTION

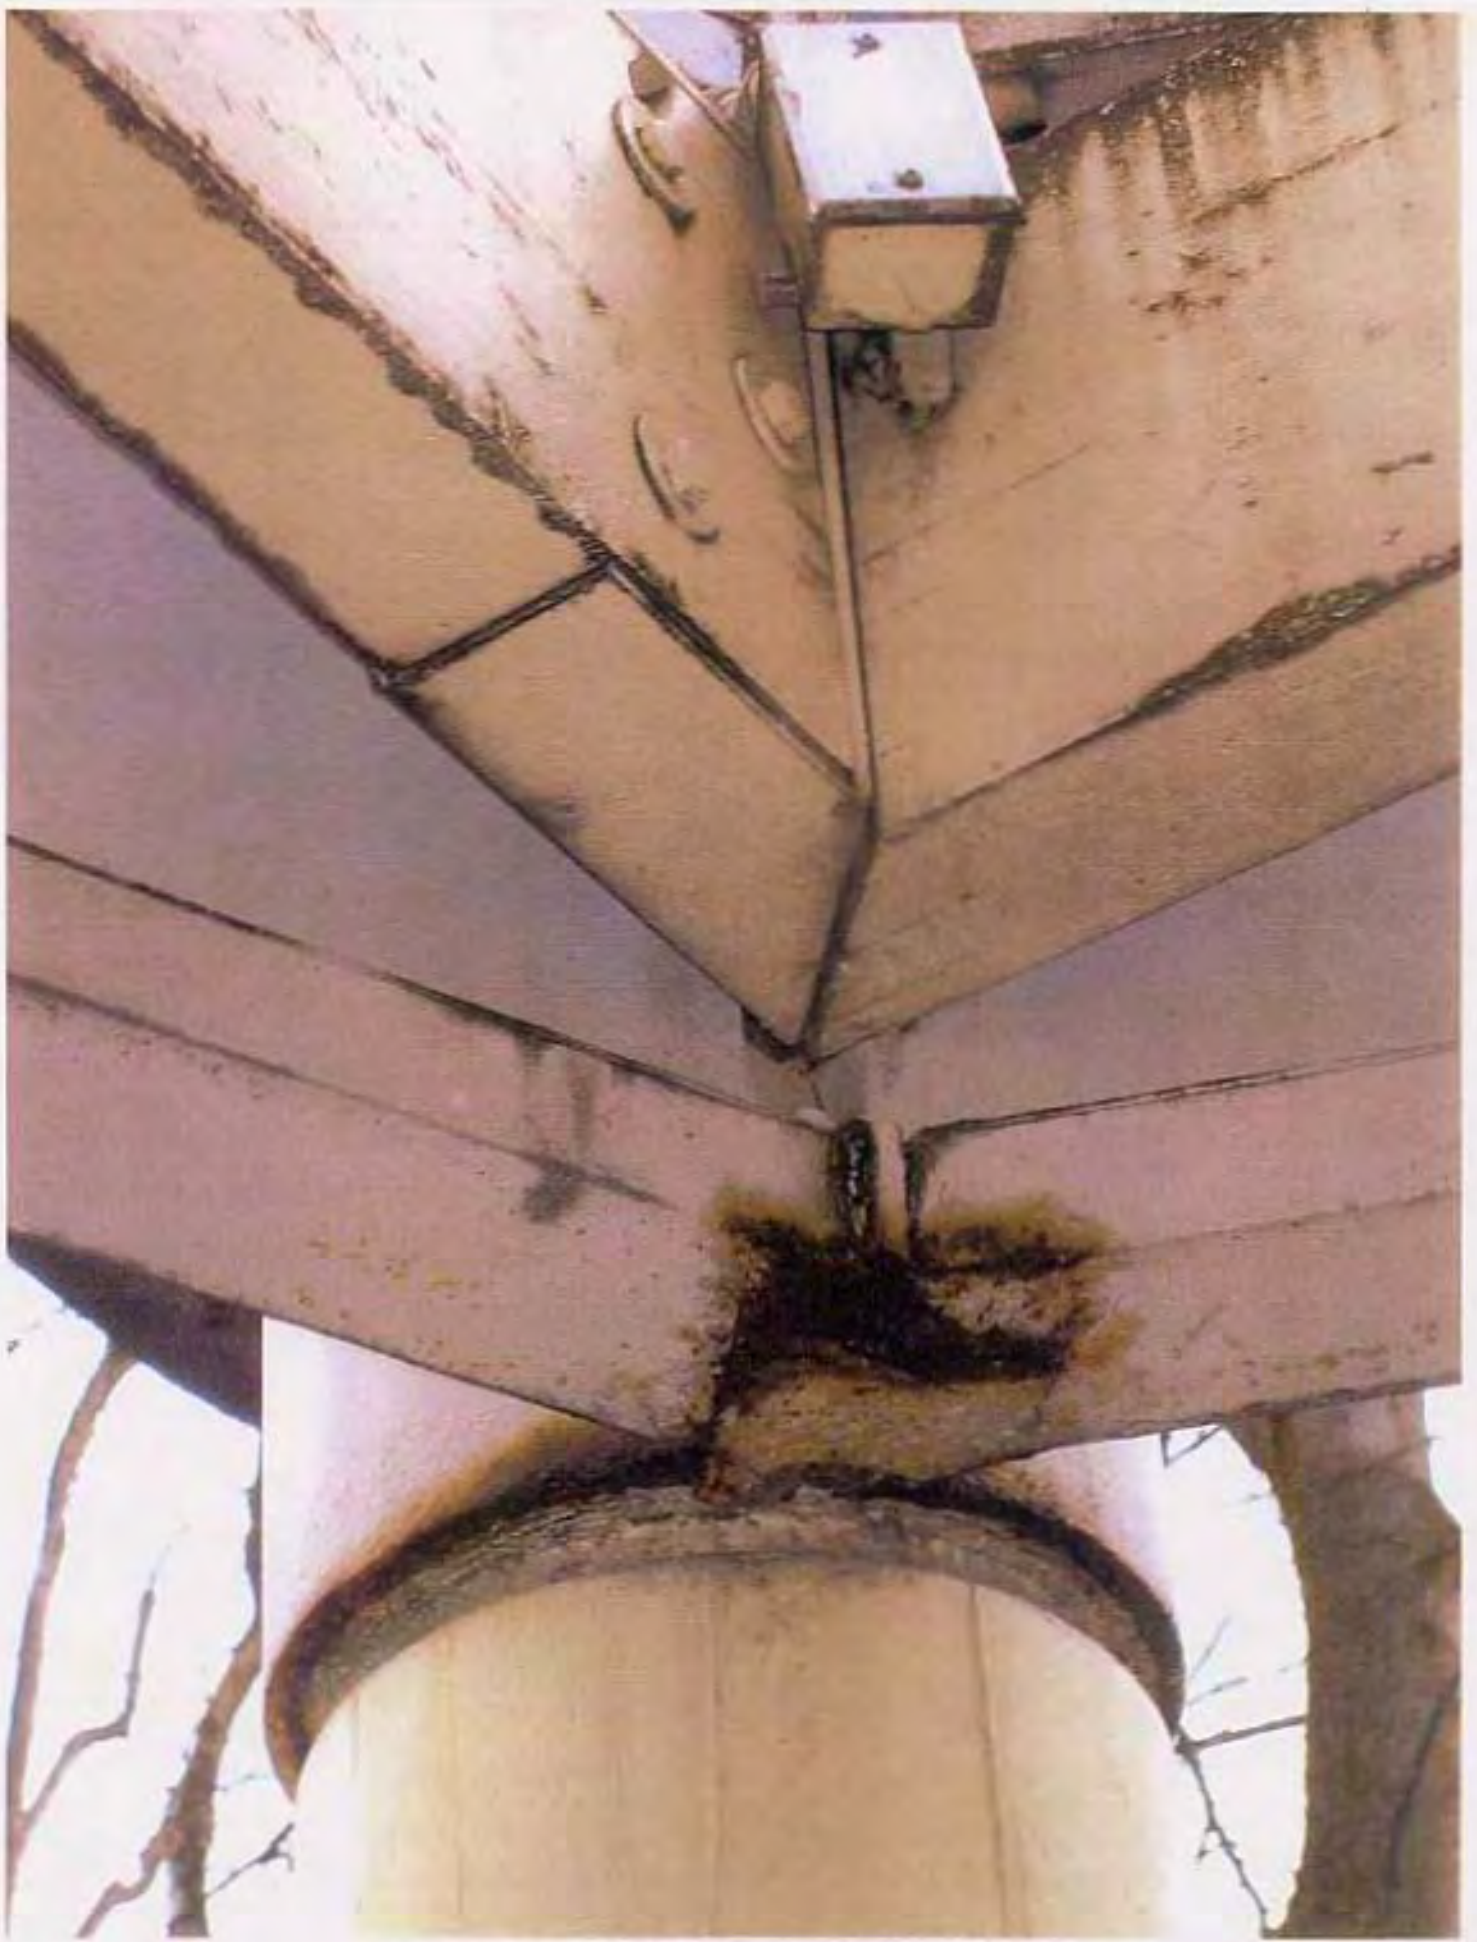
The bottom channel has its flanges turned upward forming a rain gutter and, as a result, has promoted the corrosion seen in photograph #3. The open design of the support framing allows the unprotected wood beam to be exposed to the elements. Four of the wood beams form a square with the four corners connected to every other column. Then a second set of beams form a second square with its members starting and stopping at each of the eight intersection points of the primary frame (see the "ceiling plan" drawing enclosed).

PHOTO #3: RUST DETERIORATION

3. Treat the cut ends and bolt holes of the new 4x12 members with two saturated coats of "Wood Life" preservative;
4. Before the new 4x12's are placed, the perimeter steel needs to have all rust removed and these bare spots primed with zinc-rich paint. Then the perimeter steel should be re-painted;

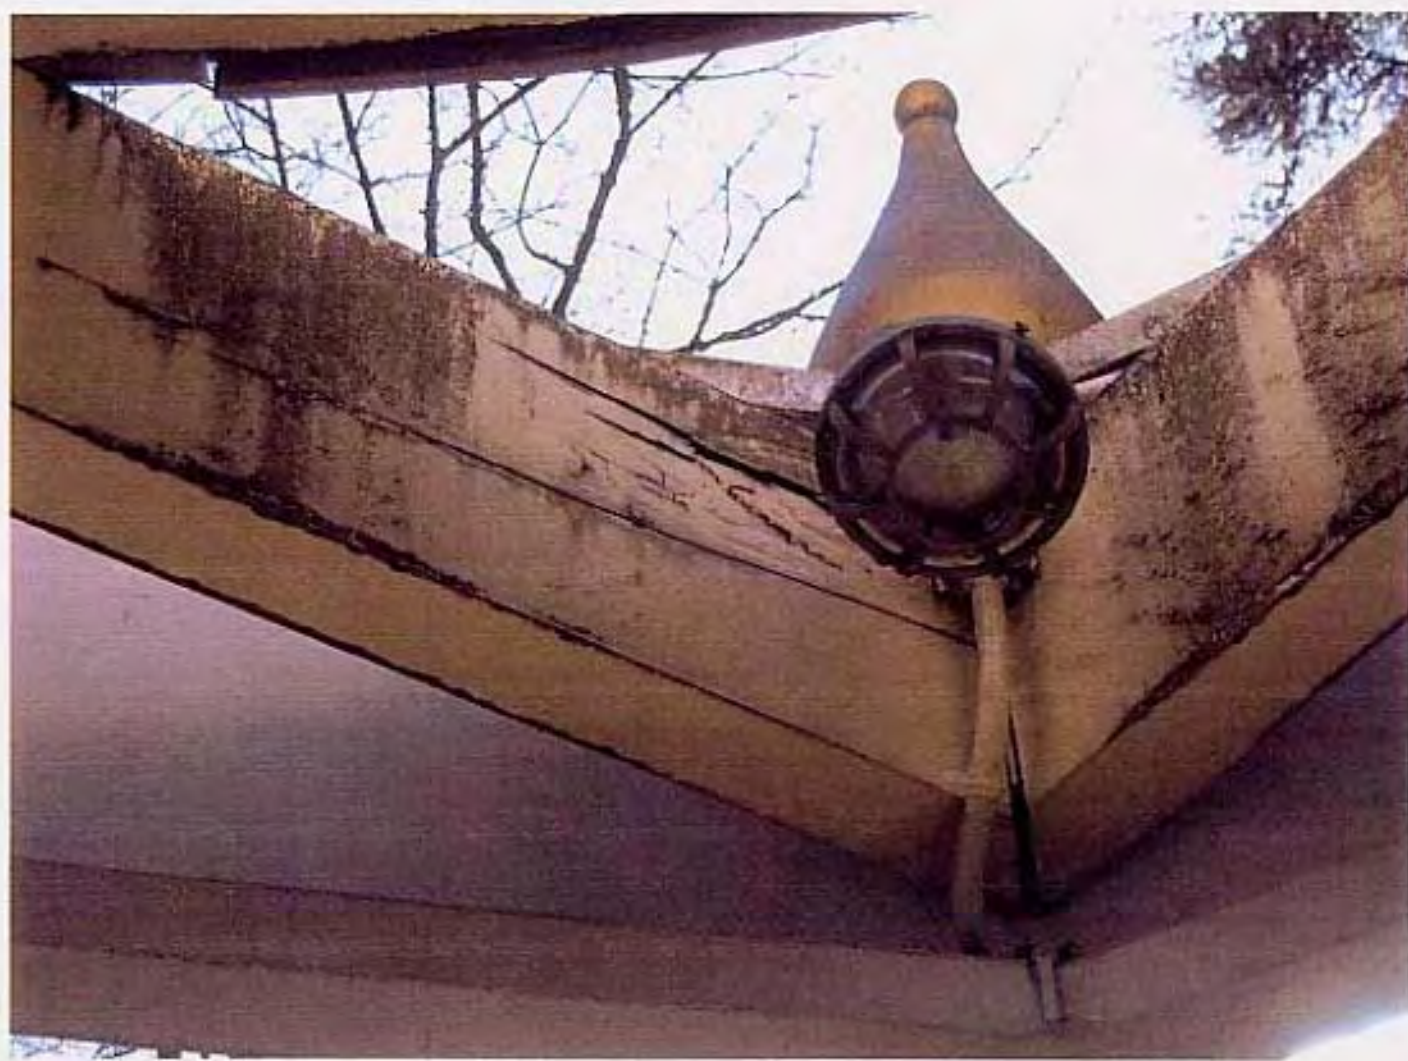
The original 4 x 12 wood members are un-treated and half of them have been replaced. Photograph number 4 shows two of the original members coming together at a column, connected to a "knife" plate that has been welded to the pipe collar. The surface condition to the left of the light is typical of wood that has deteriorated due to water intrusion. This condition is commonly referred to as "dry rot" and this condition slowly eats away at the cellular structure of the wood until it can no longer carry any load.

PHOTO #4: EXISTING 4X12 DETERIORATION

1. Replace all 4x12 members with new pressure treated material. This will require the "onion shaped" top to be removed or shored in place;
2. Modify the existing knife plate connections so that they have the base plate added, per photo #5;

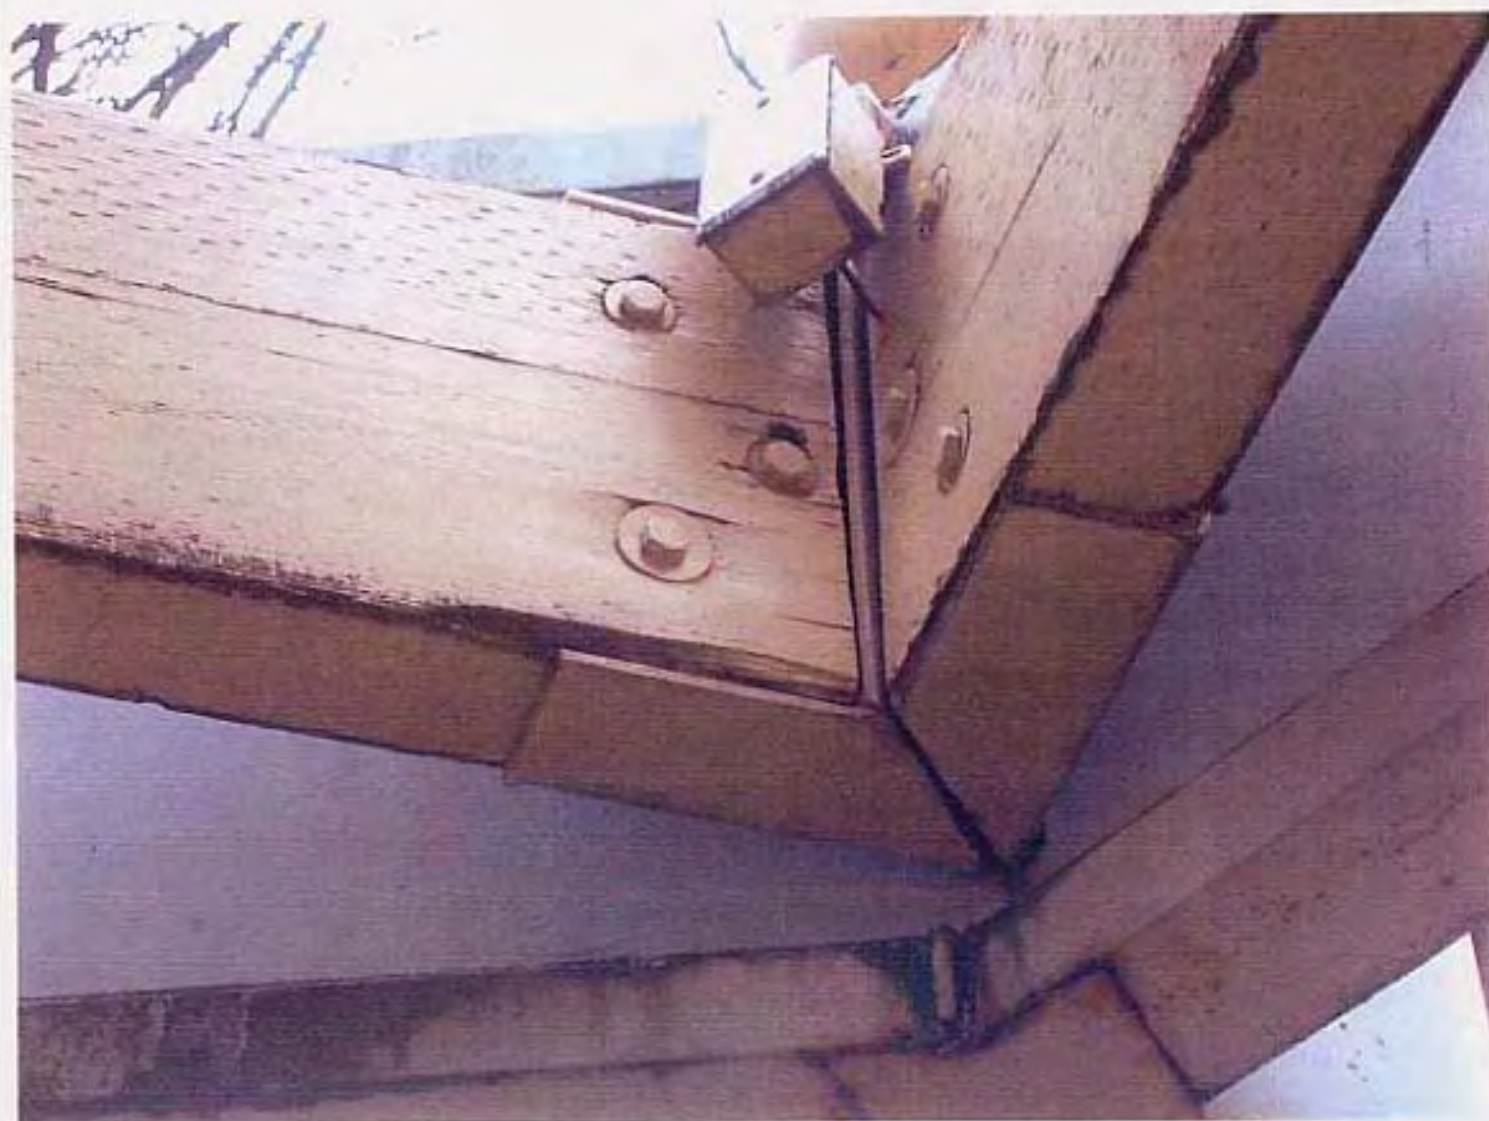
About one half of the 4x12's have been replaced with pressure treated 4x12's. The pressure treated 4x12's have little slits or incising marks that are used to increase the depth of penetration of the pressure treating chemicals. Unfortunately, even pressure treated material is not exempt from "dry rot" as seen in photograph # 5. The bulging seen below the lowest bolt on the left is caused by swelling of the wood from deterioration. Also, note the bottom bearing plates of this modified connector in this photo compared to the original knife plate only in photograph #4. It is suspected that the end grain cut of the 4x12 beam did not get treated with a wood preservative.

PHOTO #5: NEW 4X12 DETERIORATION

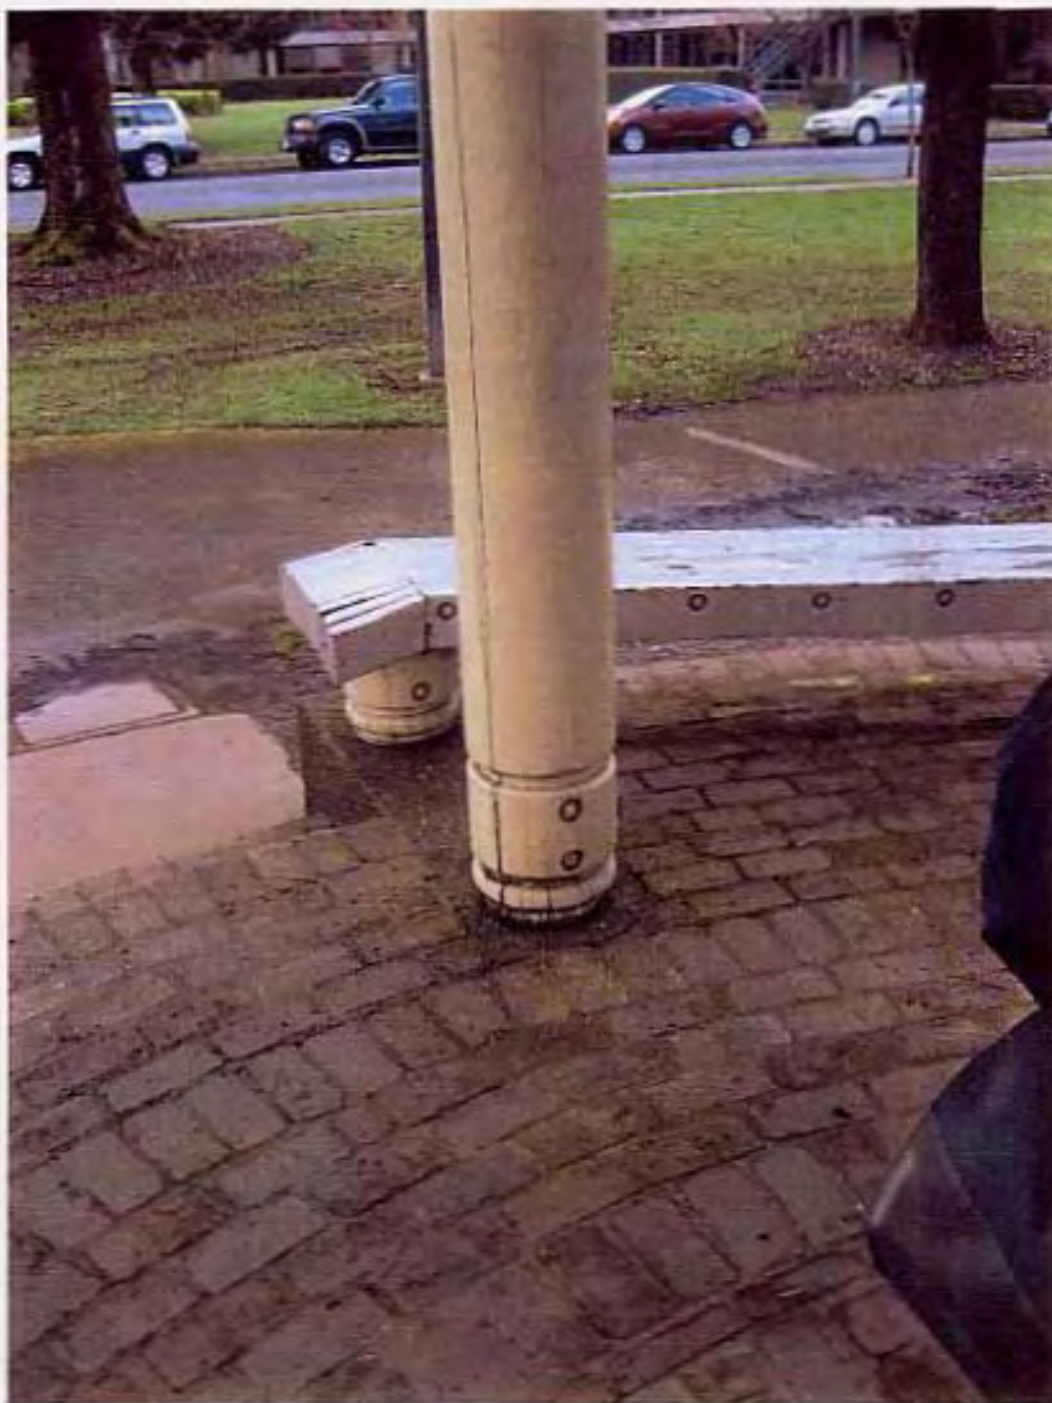
The 8 posts appear to be in surprisingly good shape at their base connections. They were "sounded" to see if they had "dry rot". "Sounding" is simply tapping on the wood with the side of a hammer to see if the wood sounds solid or hollow. If the wood has a "rattle" sound or goes "thud", instead of having a firm bounce, deterioration is present. See photograph #6 for a view of the post base connection. In the background of photograph #6, you will notice the edge of the bench is falling apart.

PHOTO #6: TYPICAL POST BASE

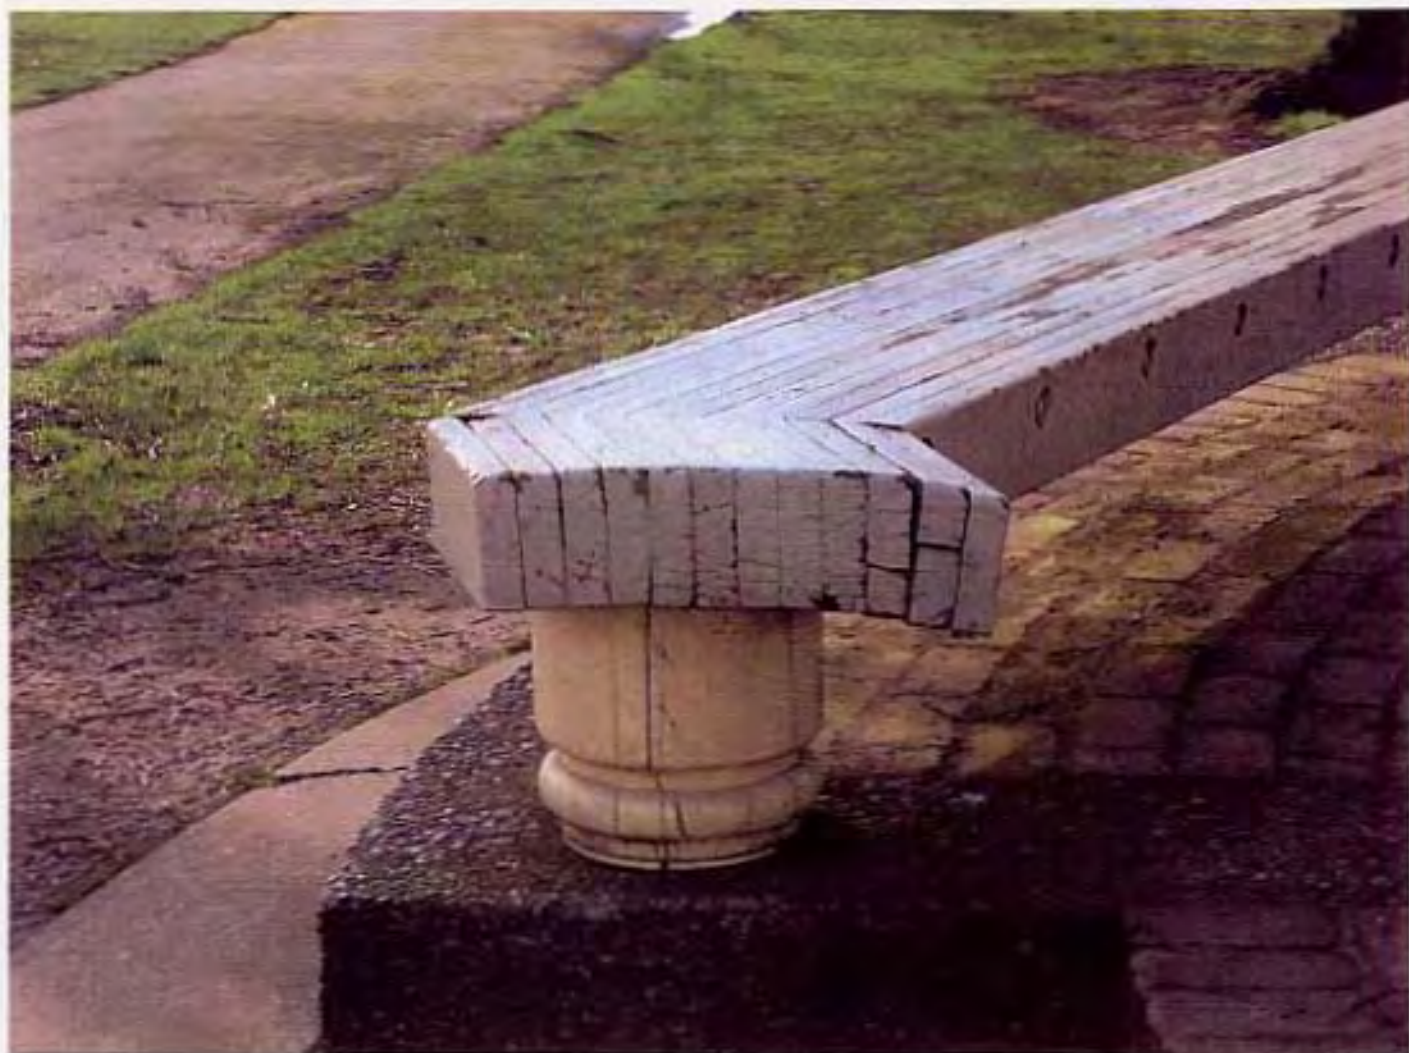
PHOTO #7: BENCH PROBLEM

6. Another location of water intrusion is between the column finial and the top of the pipe collar ring. This needs to be re-caulked or flashed;
7. Repair the bench corner by adding another bolt though the entire assembly, similar to the rest of the bench (see photo #7). A long drill bit will be required and a length of galvanized all-thread rod can be used for the bolt. Nut and washer each end will match the existing.
