SUSTAINABLE HISTORIC PRESERVATION: A REHABILITATION PLAN FOR
THE JEFF. SMITH'S PARLOR MUSEUM IN SKAGWAY, ALASKA

Presented to the Interdisciplinary Studies Program:
Historic Preservation
and the Graduate School of the University of Oregon
in partial fulfillment of the requirements
for the degree of
Master of Science

June 2009

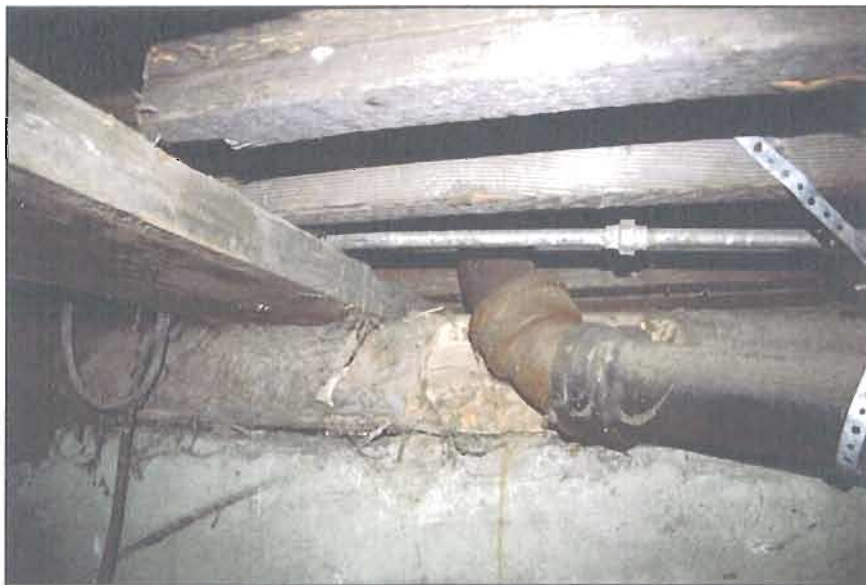
Under section A-2 is the second foundation type which has a deeper cellar (see figure 16). Here the building sits on logs resting atop two sides of the concrete walls of the cellar. A 5'2" tall 1 1/2" diameter post supports the floor joists in the center of the cellar. There is a large opening and cave-in exposing the west side of the cellar to the outside.

Figure 16. Log foundation along west wall of section A-2. *Source:* National Park Service/Alaska Regional Office, July 2008.

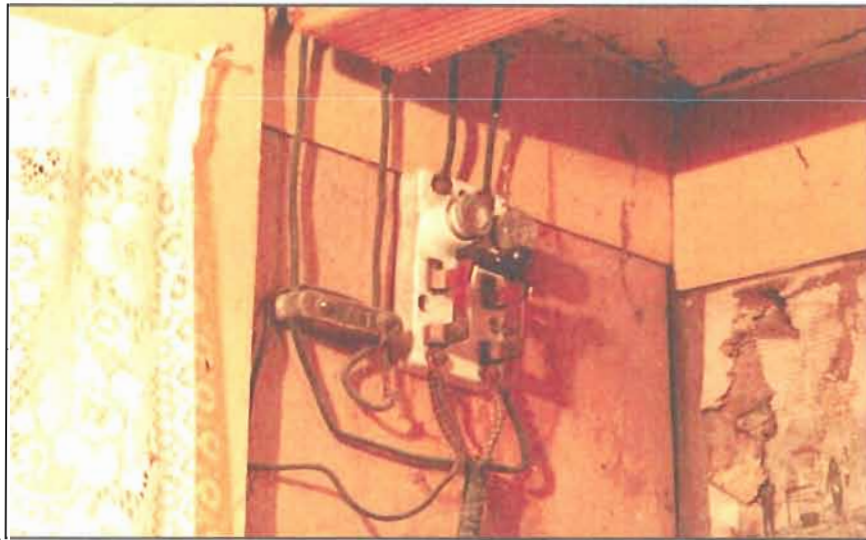
Figure 26. Knob and tube electric wiring in northeast corner of Room A-1. *Source:* National Park Service/Alaska Regional Office, July 2008.

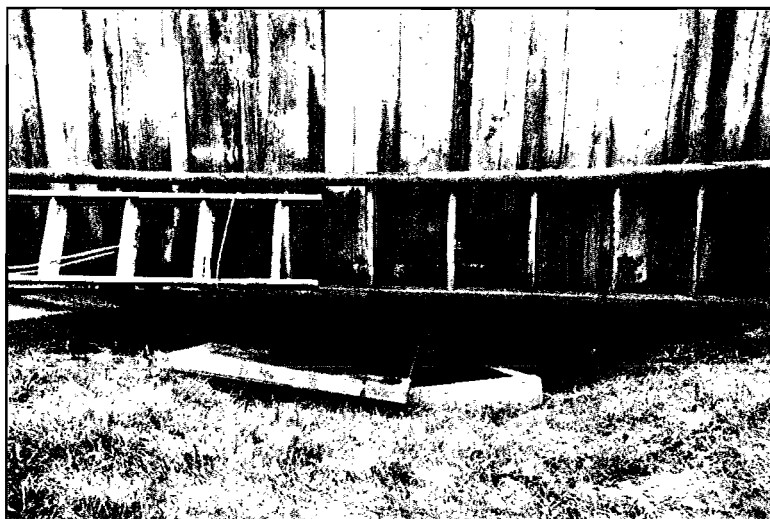
Figure 3. Cave-in along west side beneath section A-2.
Source: National Park Service/Alaska Regional Office,
July 2008.

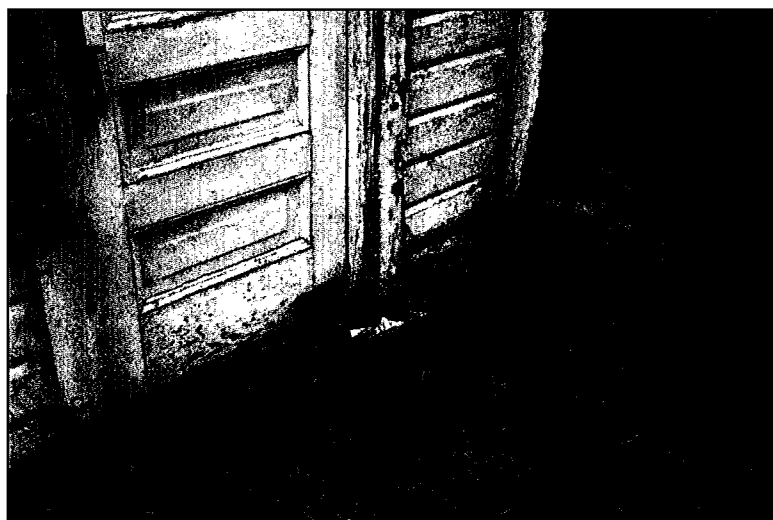
Figure 10. Northwest corner sinking into grade with grass covering the watertable. *Source:* National Park Service/Alaska Regional Office, July 2008.

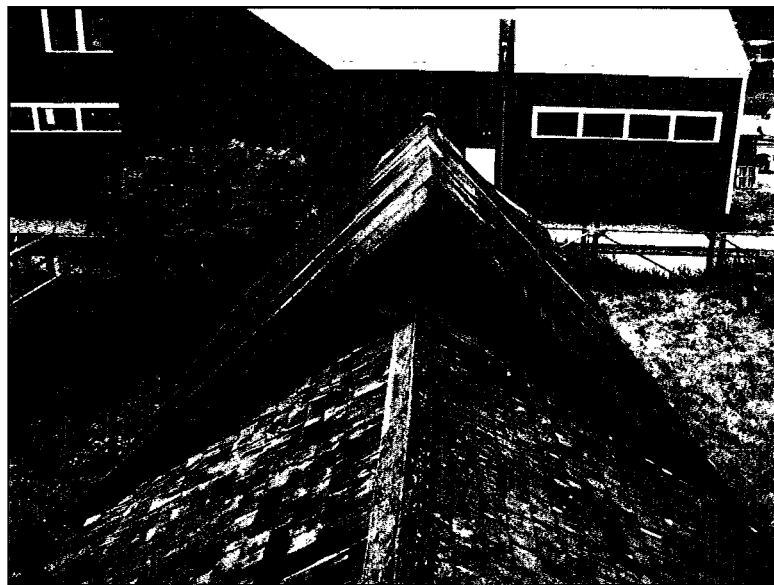
Figure 18. North peak and gable of roof section B. Ridge covered with sheet metal. *Source:* National Park Service/Alaska Regional Office, July 2008.

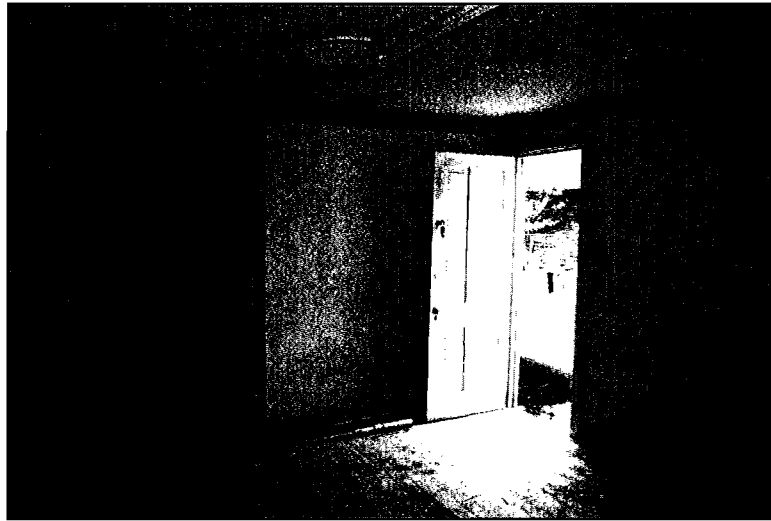
Figure 31. Southeast corner of room A-2. Note opening doorway to exterior and doorway to room B. Also visible is the inoperable ceiling fan and gramophone in ceiling.
Source: National Park Service/Alaska Regional Office, July 2008.
