# University Hall

## Preliminary Historic Assessment

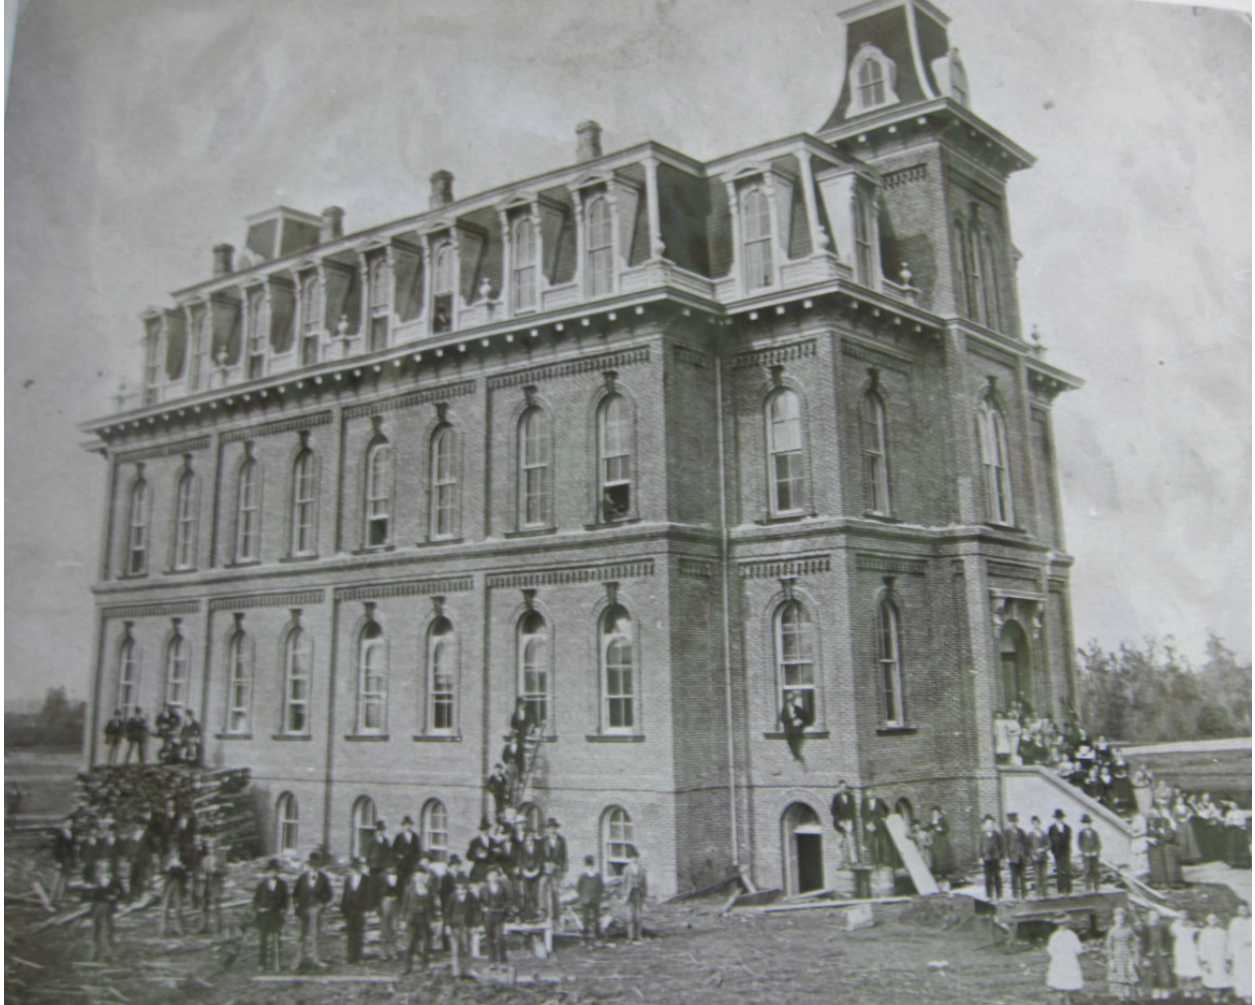
University Hall  
Inception Era

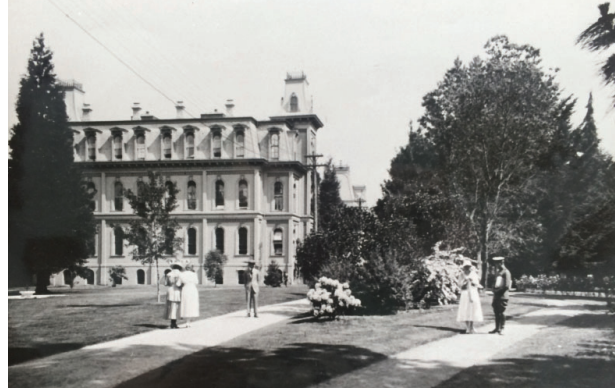
University Hall, 1901

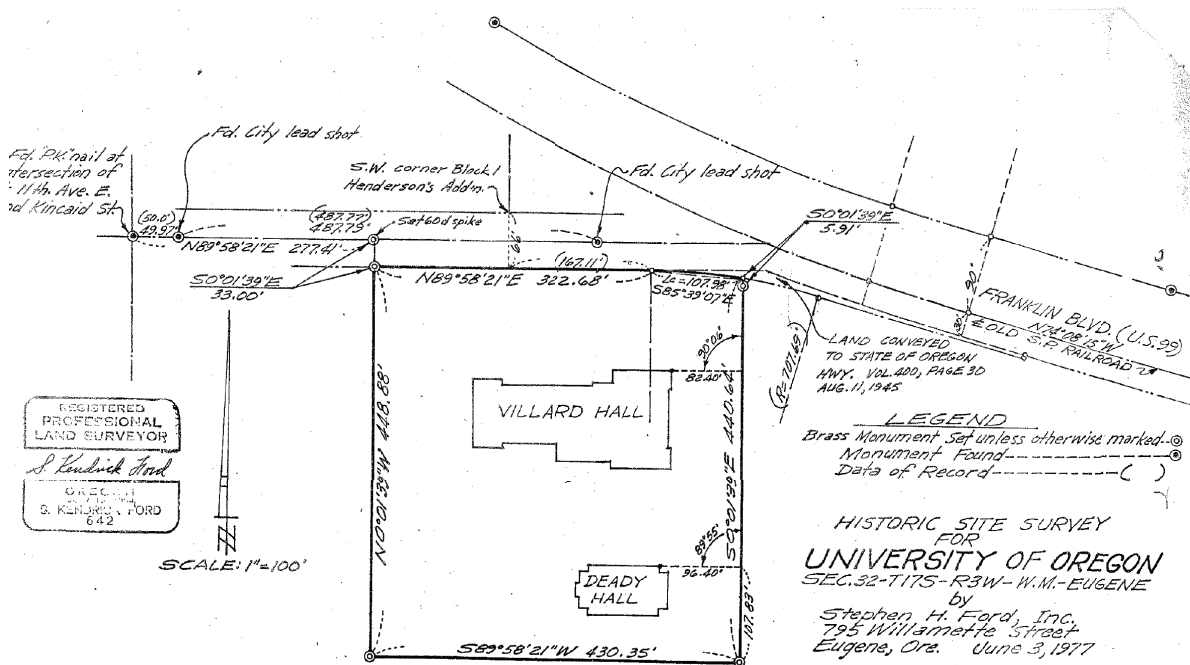
National Historic Landmark Boundary, 1977

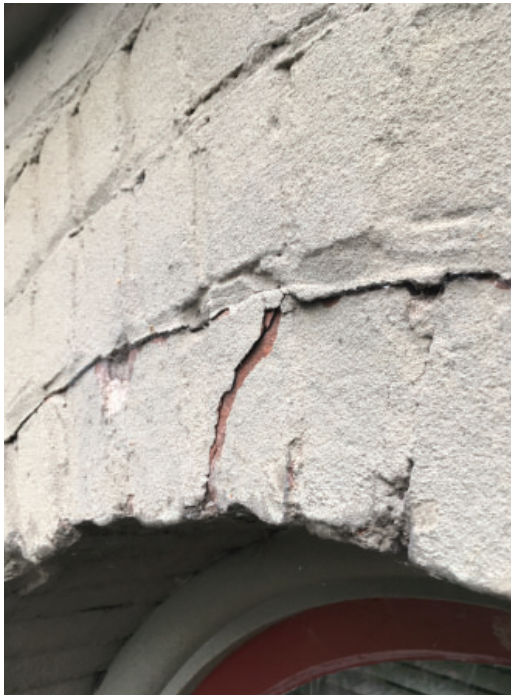
Finishes deteriorating around entryway

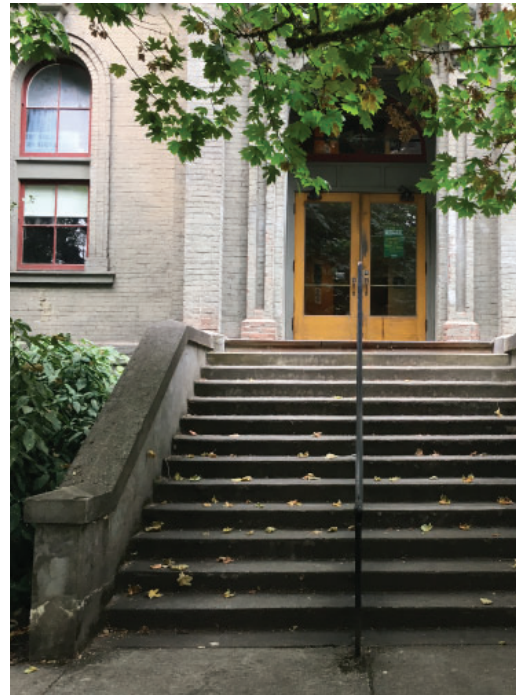
Stairs are in original locations and configuration but were replaced (as recorded in historic documents)

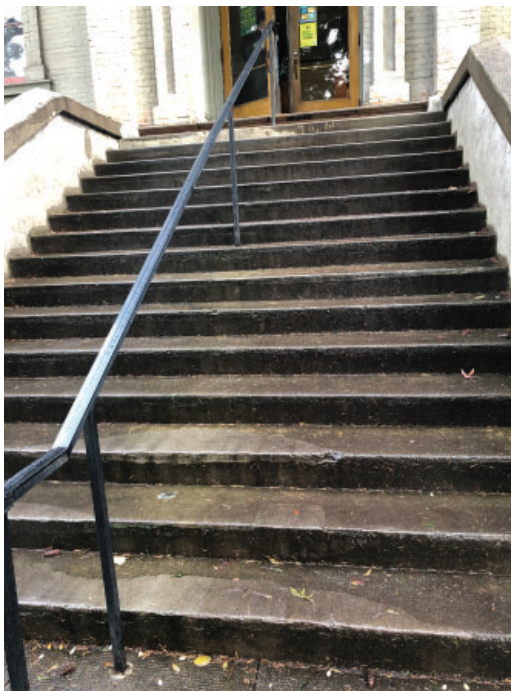
Stair treads are wider than at West Entrance, historically this entrance was designated for women

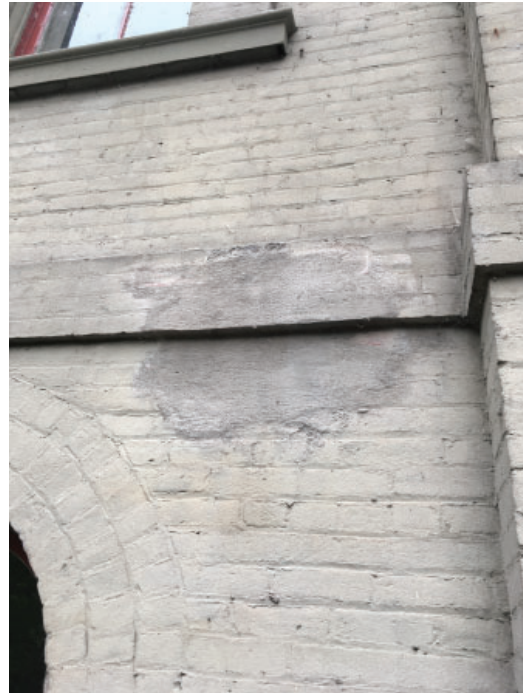
Prior repairs of infill brick do not match original color, texture or composition

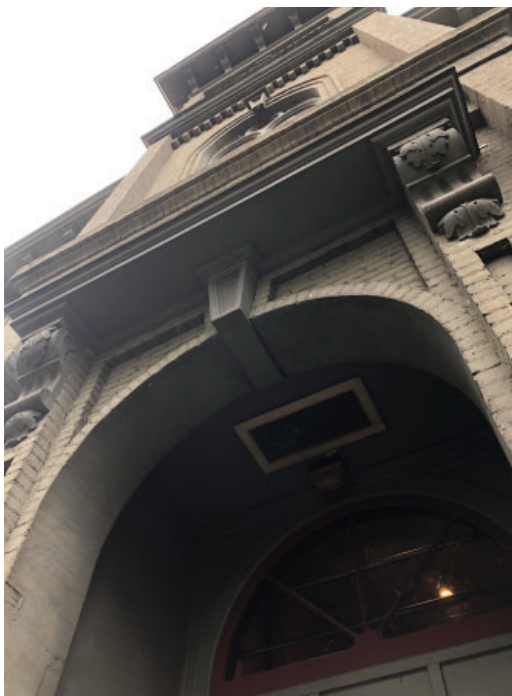
Air vent and exterior light above East entrance, not original

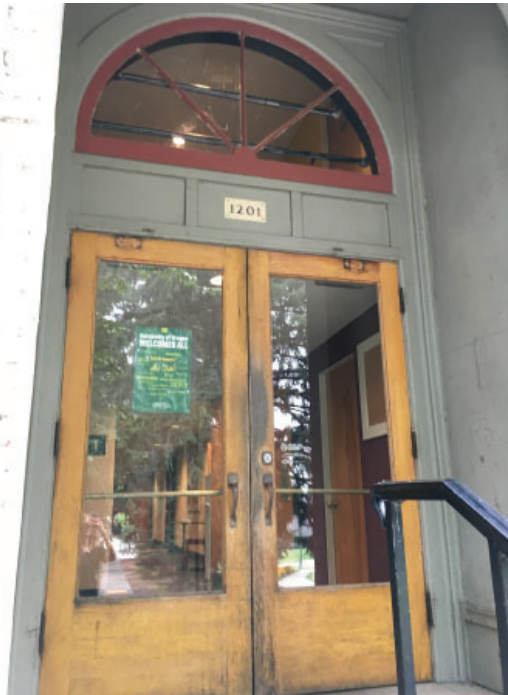
Original wooden door, with older looking hardware. Doors were stained and are weathering.

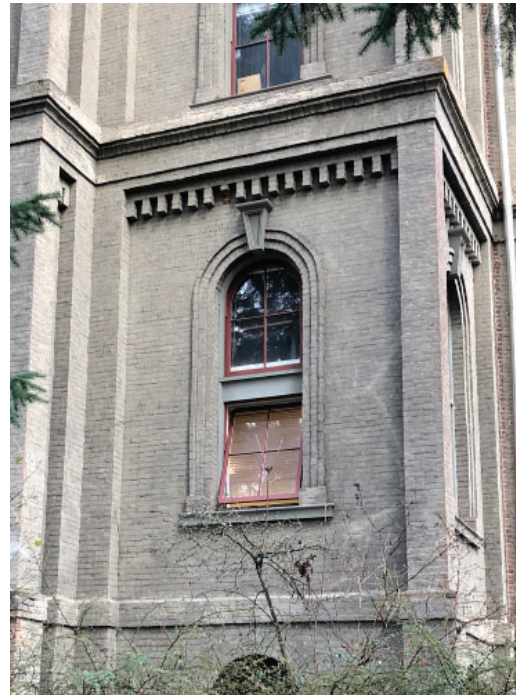
Window sills were painted from original color

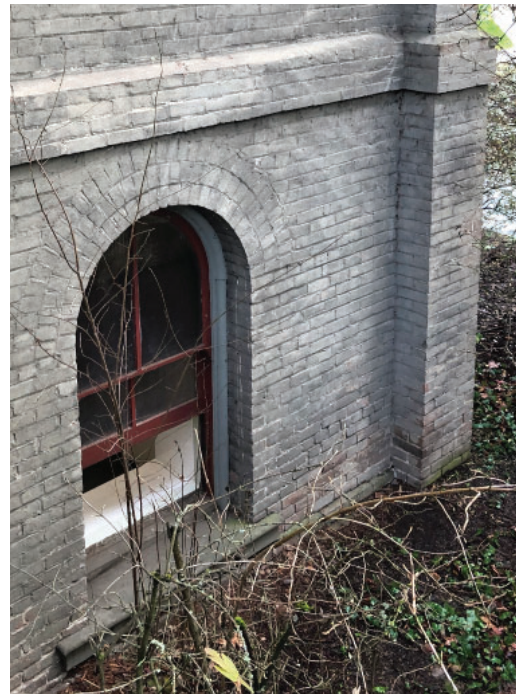
Facade finishes are deteriorating where facade meets the ground.

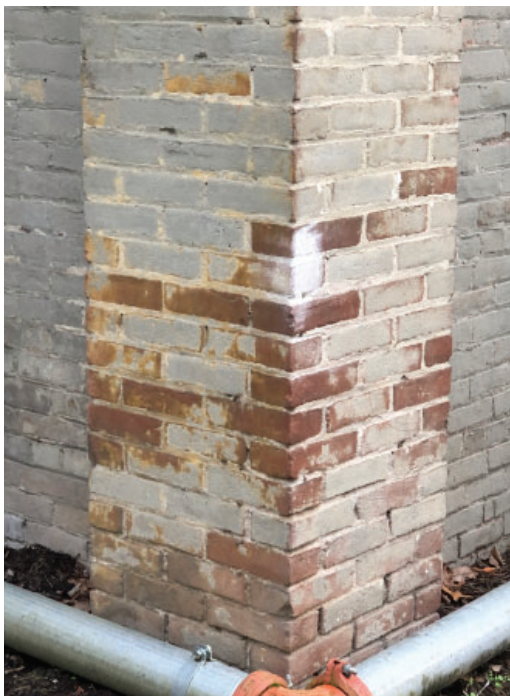
Exterior finishes deteriorating around northeast corner

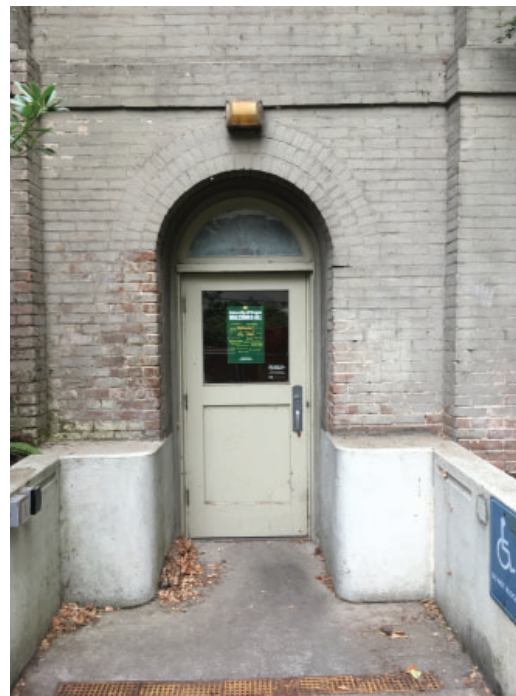
ADA entrance through basement level located at northwest corner, incompatible light fixture

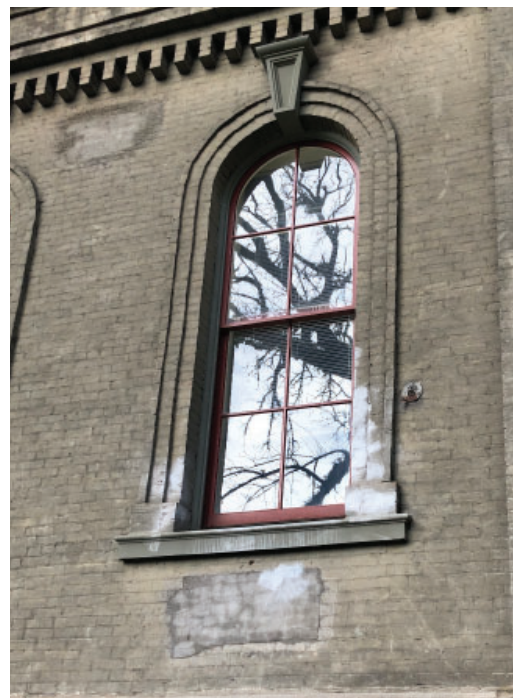
Previous brick repair does not match original facade

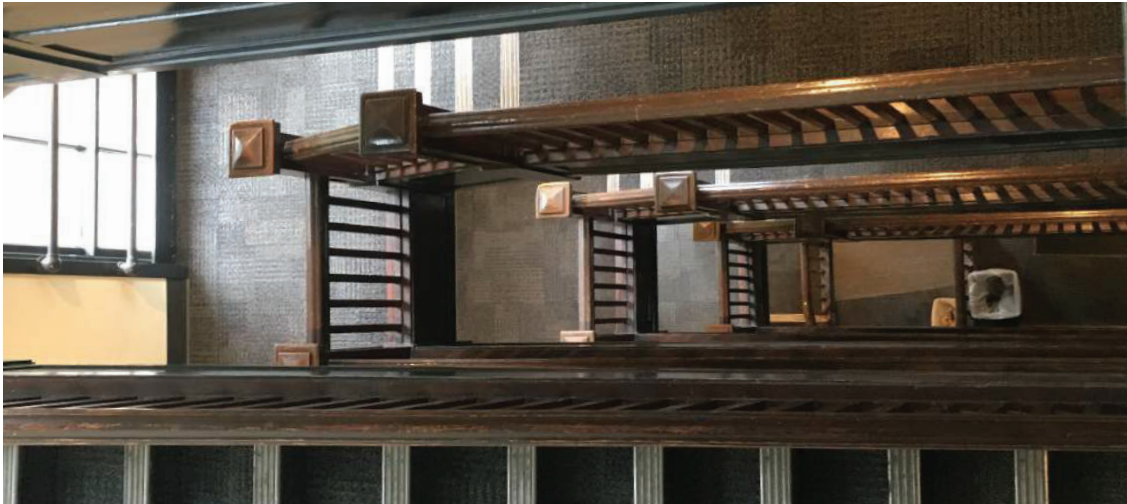
Following the major interior alterations in the 20th century, remaining historic materials and small scale features are minimal. However many spatial qualities and some classroom and office locations dating back to both 1876 and 1914 remain intact. This section provides an assessment of the interior program and finishes with recommendations for an interior rehabilitation that combines features from both historic periods.

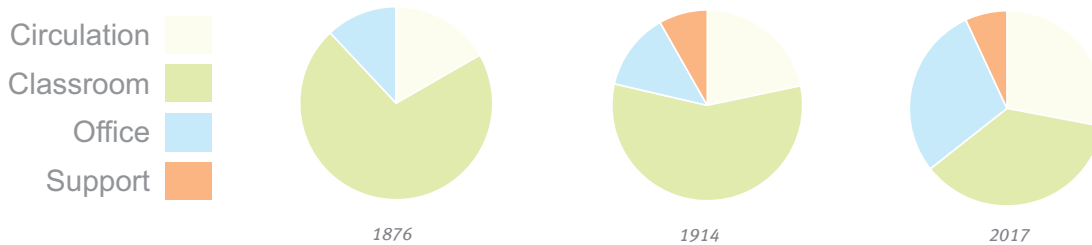
**Existing Conditions**

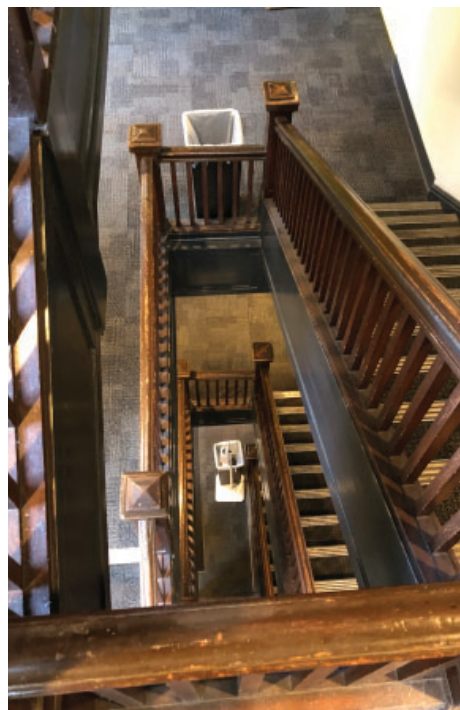
Main stairwell configuration is not original, however, unchanged since the 1914 renovation

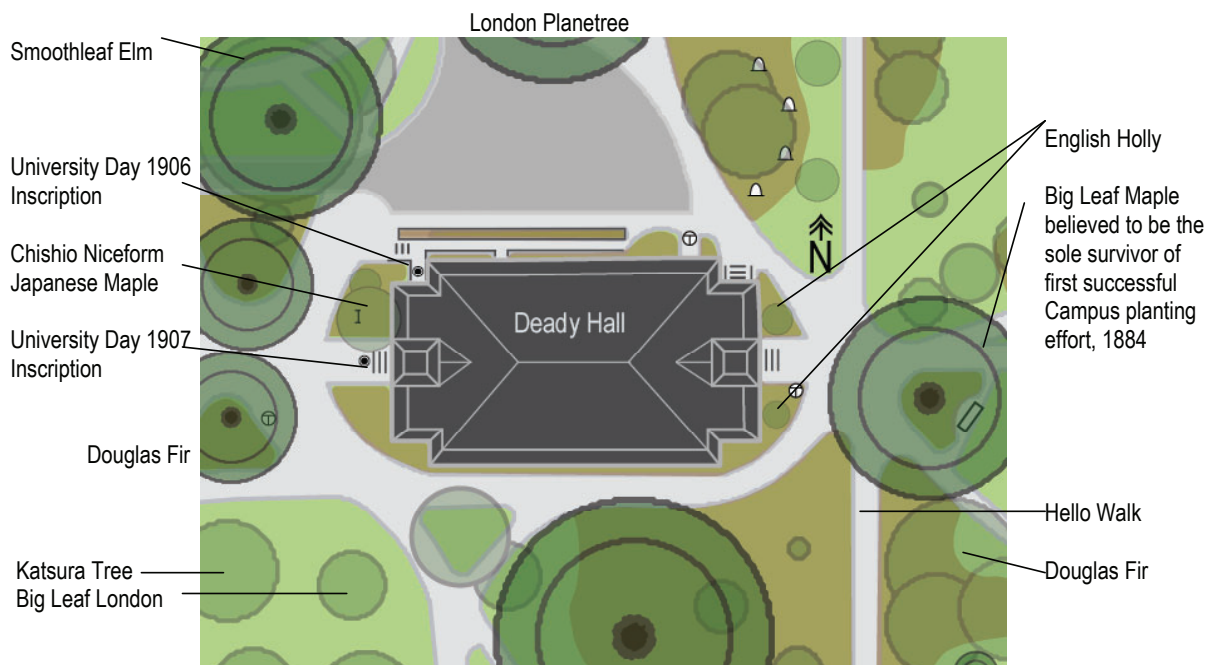
## **APPENDIX D - SECRETARY OF THE INTERIOR'S STANDARDS FOR REHABILITATION**

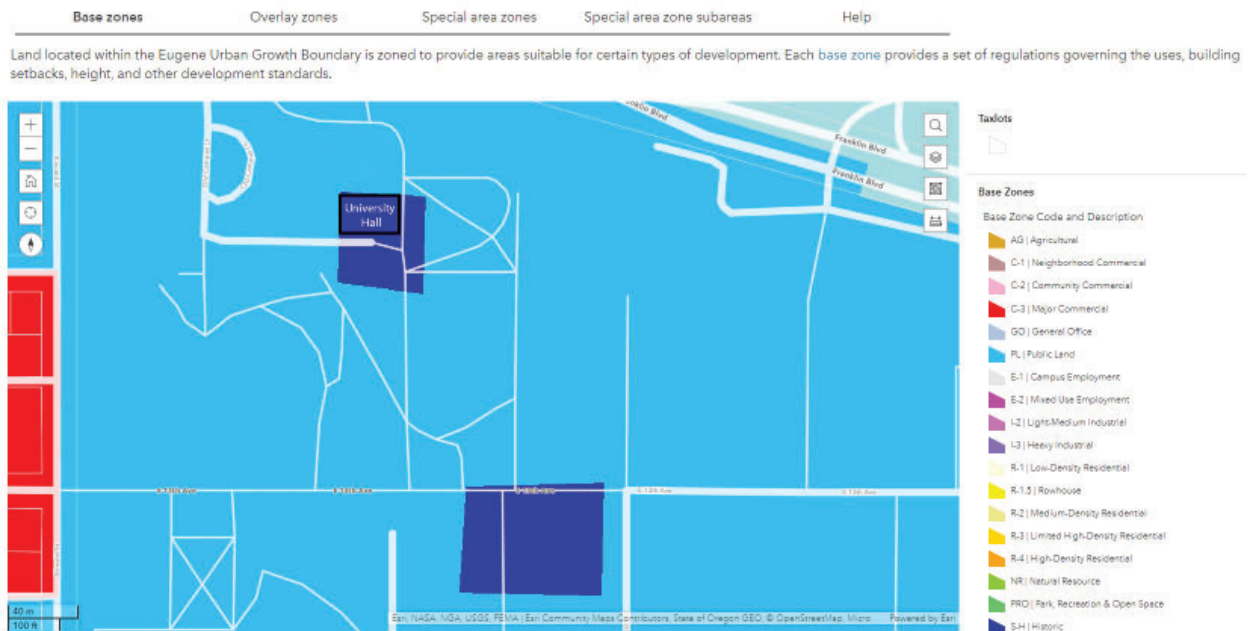
University Hall is located within the following City of Eugene zones:  
PL - Public Land, and  
S-H - Historic

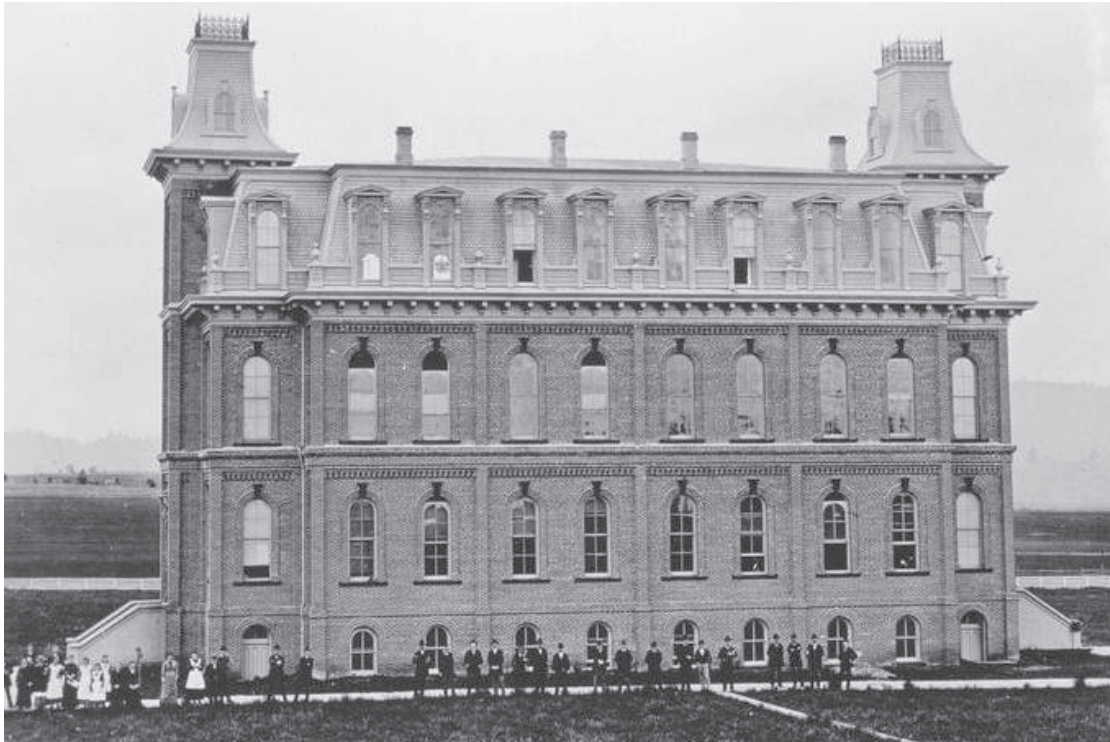
Deady Hall is most recognized for its exterior Italianate design comprised of brick masonry construction capped with a mansard roof. Most of the original exterior historic fabric remains, including brick walls, wood windows with decorative cast zinc trim, wood doors at the east and west entrances, a bracketed wood cornice, and tall crested towers. Other items have been replaced in kind on the exterior, such as the wood shingled roof and wood parapet with urns. A protective grey sand-painted finish coat covering the brick, originally applied in the 1890s to match neighboring Villard Hall in appearance, is extant, although deteriorating.
