**ON-GRADE PANEL FLOOR SYSTEM
REPORT #2**

**ENERGY EFFICIENT INDUSTRIALIZED HOUSING
RESEARCH PROGRAM**

**ENERGY STUDIES IN BUILDINGS LABORATORY
CENTER FOR HOUSING INNOVATION
DEPARTMENT OF ARCHITECTURE
UNIVERSITY OF OREGON
EUGENE, OREGON 97403**

September 1997

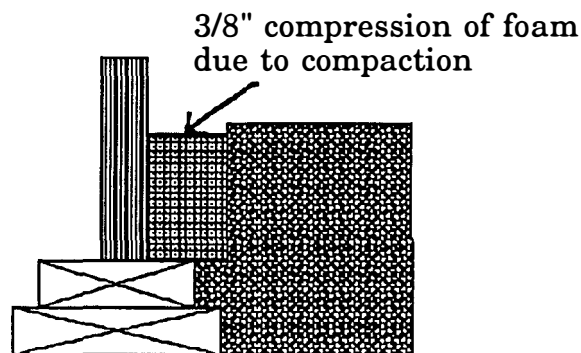
After the floor was constructed, a visual accuracy test was performed. It was discovered that the footer beam joint at the south-east corner of the floor had separated approximately 1/8" at the top due to the pressure of the gravel during the slinging and compacting process. This could be remedied by supporting the corners of the footer beams with stakes or utilizing a more effective corner detail. It was also discovered that the floor had a "Bounce" of approximately 1/8" around some parts of the perimeter. One solution for this is to use a finer grade of gravel in the top lift, making the final leveling of the surface easier and more accurate. Finally since the perimeter insulation was installed with the perimeter beam and before the compaction process, the compactor was run over the insulation during the edge compaction resulting in an approximately 3/8" gap between the perimeter insulation and the floor panel insulation. To prevent this, an increase of 3/8" in the foam elevation should be built into the design.

Figure 3-10, Compaction of the Perimeter Insulation

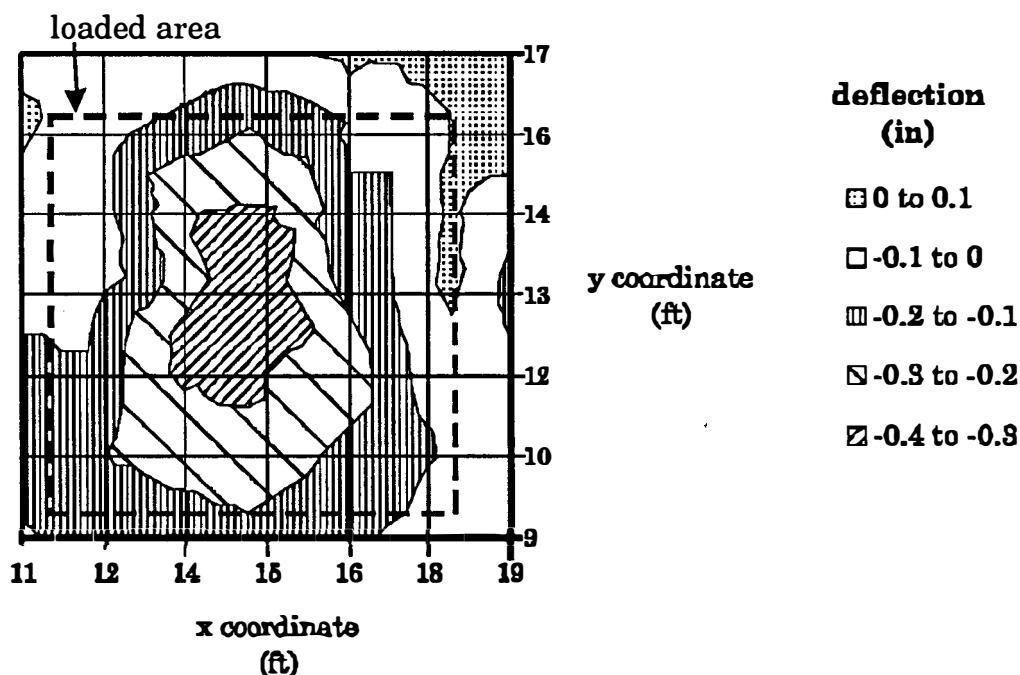
concrete blocks were placed in a 6' by 6' area, resulting in a final load of 125 lbs/ft². The maximum deflection was 0.40 inches in the center of the distributed load. The average deflection was 0.07 inches. with a floor design load of 40 lb/ft², the maximum deflection was 0.25 inches and the average was 0.05 inches.

Figure 4-2, Distributed Load Deflection Results (125 lbs/ft²)

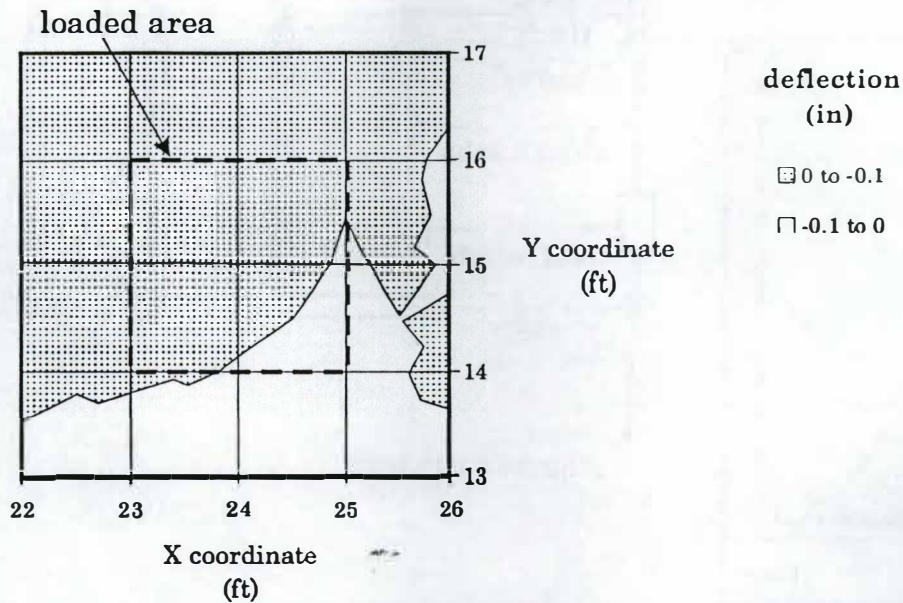
Total deflections of the floor within one foot of the compactor were measured. The maximum deflection after the compactor had been running for one hour was 0.08 inches and the average deflection was 0.01 inches. Soil compaction tests were done under both test areas and untested areas to identify possible results of running the compactor. There was no measurable difference in compaction between the tested and untested areas.

Figure 4-3, Dynamic Load Deflection Results (after 1 hour)

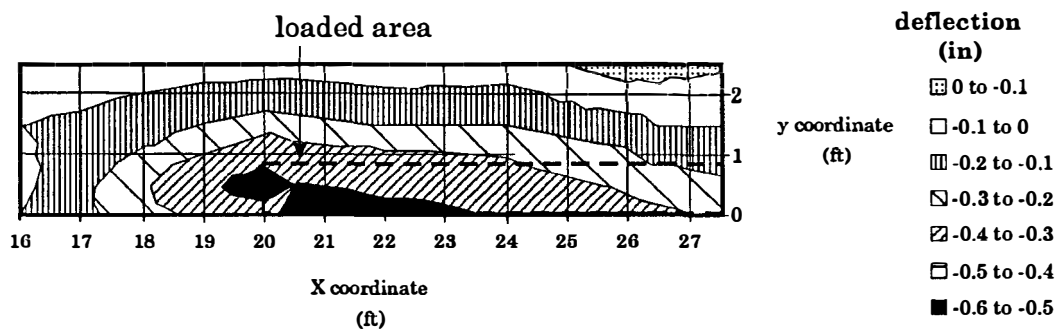
Larger loads were planned, but it is unclear how large a load the testing device would have supported due to the splitting of the 2 x 8 used as a header supporting the pipe, which was used to ensure the equal distribution of the load over the top of the wall.

Figure 4-6, Floor at Exterior Bearing Wall
Deflection Results (1446 lbs/ft)

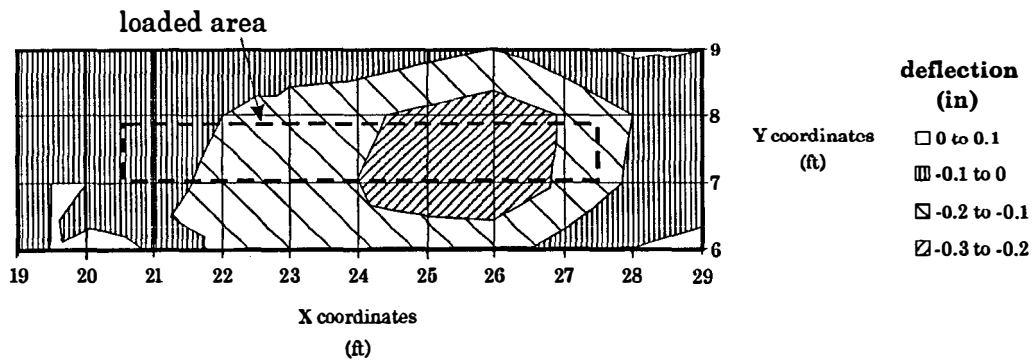
The maximum deflection reached for the interior wall was 0.28 inches at a load of 3880 lbs (485 lbs per foot). The maximum occurred in two places, both of which were the middle of a panel in the upper layer of OSB. Recall that the middle of the upper layer of OSB corresponds to the seam in the insulated panels. The average deflection was 0.7 inches. At the design load of 380 lbs/ft the maximum deflection was 0.25 inches and the average was 0.05 inches.

**Figure 4-8, Floor at Interior Partition
Deflection Results (485 lbs/ft)**

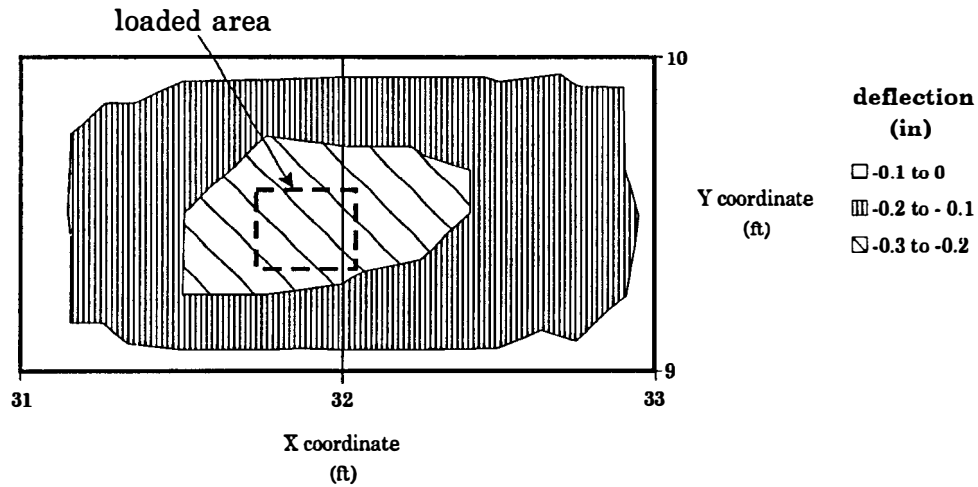
To test the deflection of floor under a smaller interior point load, a 4 x 4 post was loaded to 3700 pounds. The maximum deflection was 0.7 inches and the average was 0.13 inches.

Figure 4-9, Floor at Interior Post Deflection Results (3700 lbs)

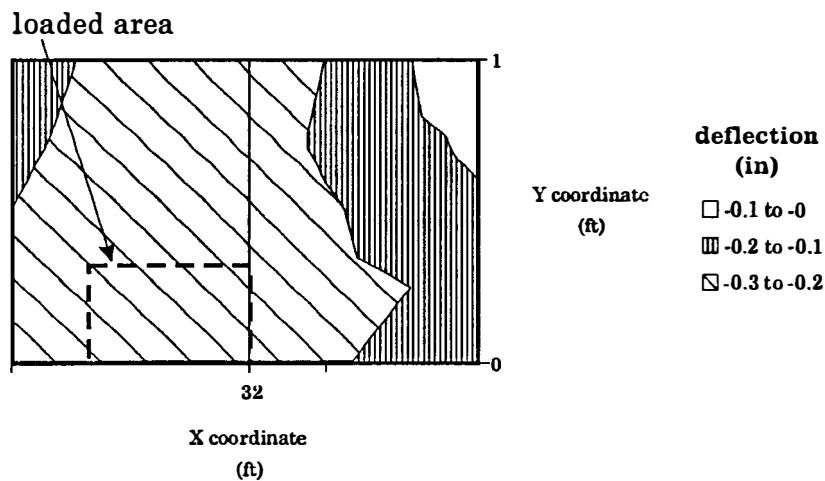
The deflection and performance of the perimeter beam under a structural post were tested using a 4 x 6 post. The post was loaded to 7700 pounds and the maximum deflection was 0.75 inches, the average deflection 0.19 inches. At the approximate design load, 2900 lbs, the maximum deflection was 0.18 inches and the average was 0.10 inches.

Figure 4-10, Floor at Exterior Post Deflection Results (7700 lbs)

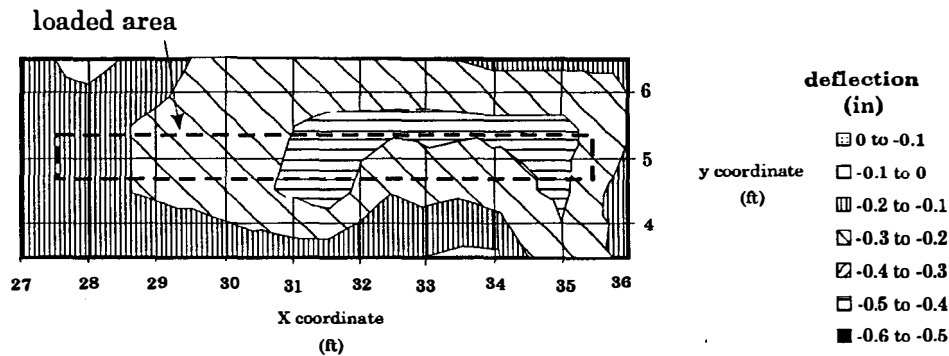
To recreate the effect of an interior partition resting on the perimeter beam, the lower interior partition wall was used. The laminated LVLs were loaded to 750 pounds per foot. The maximum deflection was 0.7 inches and the average was 0.10 inches. At the design load of 380 lbs/ft, the maximum deflection was 0.15 inches and the average was 0.05 inches.

**Figure 4-11, Floor at Interior Partition(Terminating in Exterior Wall)
Deflection Results (750 lbs/ft)**

One concern with the design was that a uniform load on a partition wall could possibly result in the buckling or rotation of the perimeter beam. This did not occur during the testing.

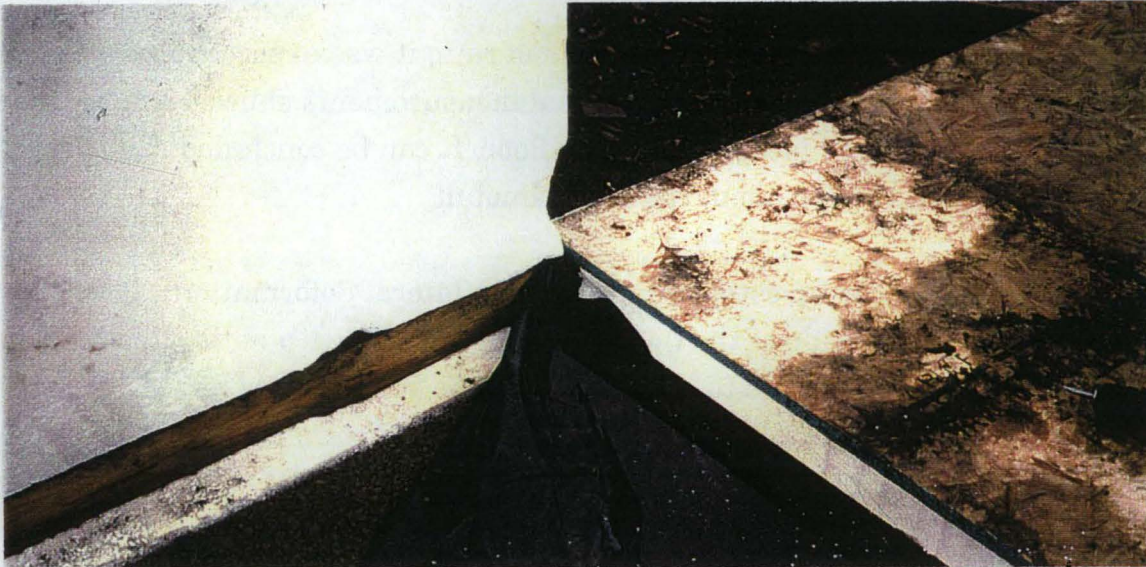
The most important finding was the chemical deformation of the perimeter foam as well as the panel foam in isolated locations as shown in Figure 6-1.

Figure 6-1, Chemical Deformation of Insulation and Panel Foam

The pressure-treated Microlam (or laminated veneer lumber, LVL) beams used in the footer were treated with an oil-borne solvent that dissolved the foam where it came in contact with it. The solvent probably came into greater contact with the foam because of the increase in water flow from rain due to the unprotected nature of the floor. A further discussion of this is included in Section 7: LVL Alternatives.

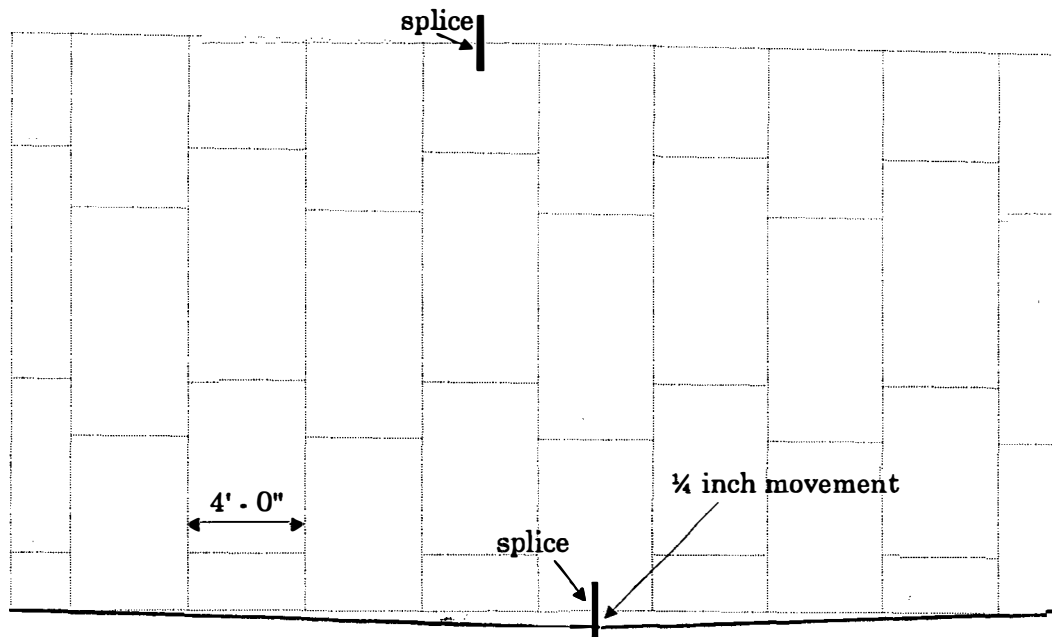
The perimeter beam was investigated for bowing (lateral deformation). It was observed that the south side of the floor was the only side with noticeable bowing. This deformation corresponded to the location of the splice where testing of the SSIC panel was conducted, 1/2" south of the SE and SW corners.

Figure 6-2, Lateral Deformation of the Perimeter Beam

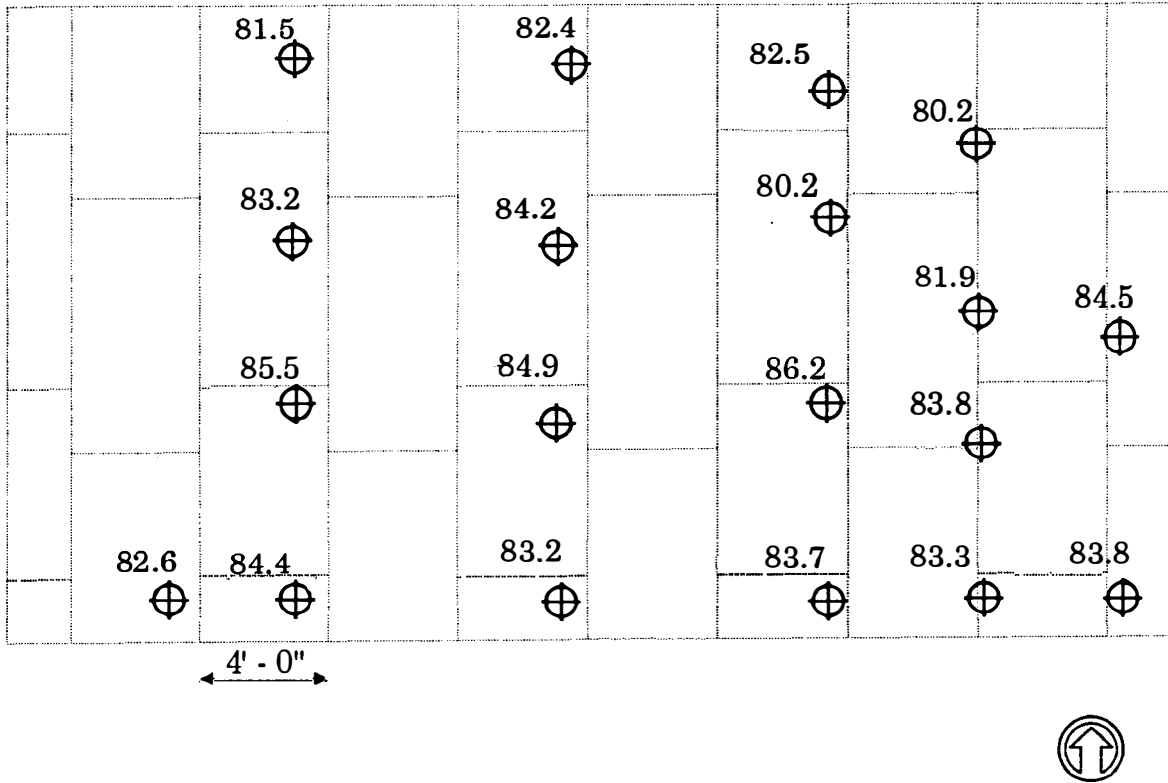
Compaction Results

The gravel fill was tested for compaction by Braun Intertec Corporation, a local testing agency, using a nuclear densimeter. The results showed a range in compactions from 80.2% to 86.2%. This is low compared to similar fill conditions. Adequate compaction was not achieved due to the large lift size and lightweight vibrating compactor used. The compaction was relatively consistent throughout the floor and did not vary under the dynamic loading test area. Appendix D contains a testing layout including results.

Values represent modified proctor compaction test results at test location as a percentage. 10" depths were used for most tests. The two east tests represent an average of the 6" and 12" test results. Tests were conducted by Braun Intertec from Eugene, OR.
