*The***ASHP**

**Journal***Associated Students for Historic Preservation**University of Oregon***The Preservation Gamble***By Christy Fockler*

A one-room rural schoolhouse in Clatsop County, Oregon

Pressed Metal Ceilings

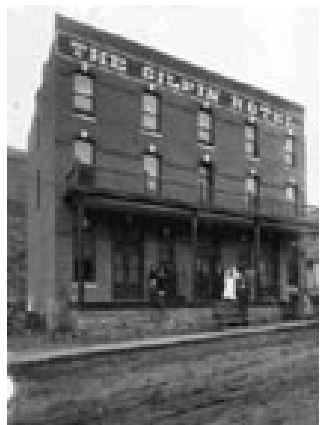
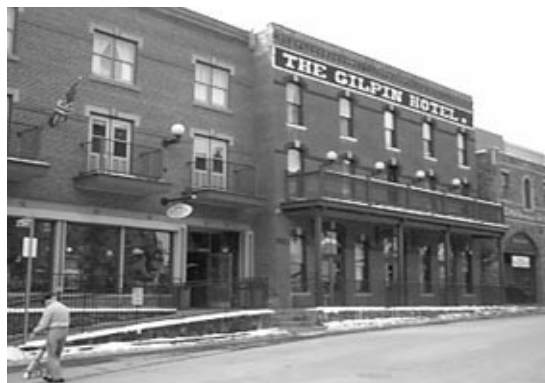
*The Gilpin Hotel, Black Hawk, CO., then and now.*

Owners of historic structures were encouraged to retain their original businesses and an attempt was made at preventing them from filling their buildings with gaming devices by limiting gaming square footage to 35 percent of the building footprint. The result was a creative manipulation of the rules by casino owners combined with a very loose interpretation from the gaming commission, ultimately allowing for entire floors full of gaming devices.

Architectural style has become the most loosely interpreted section of the amendment. The architectural style of Black Hawk and Central City was to conform to a style common in those areas prior to World War I. However, the amendment gives the individual governing bodies the power to determine the styles. In the early stages of gaming, both Central City and Black Hawk utilized the expertise of the State Historic Preservation Office (SHPO) in an attempt to retain their historical fabric. Over time, however, the casino developers and Gaming Commission stopped seeking the advice of the SHPO.

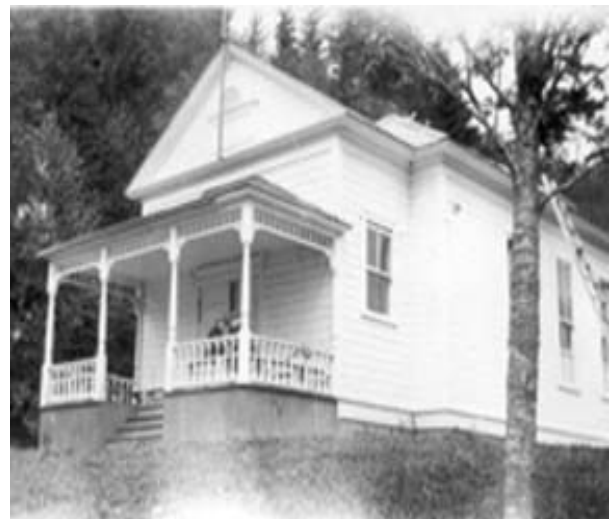
Sylvandale School is a rectangular building with three windows on each side and a hipped roof. The center vestibule, which was used as a coatroom, was entered through double doors. Above these is a transom and a full pediment pierced by a lunette vent in the gable. Rough sawn timbers, thirty-five feet long, run the length of the foundation, while horizontal weatherboard clads the building's exterior. A carpenter Gothic porch was added sometime during its first decade.

The Sylvandale School. (Photo supplied by R. Nielson)

The Greek Revival style was thought to be a good style for school buildings and is generally found in Oregon buildings from the 1850s-1870s. Yet this circa 1900 schoolhouse exhibits simplified vernacular elements of this style, including a low pitched hipped roof, a main roof cornice line and porch emphasized with a wide band of trim representing a classical entablature, a traditional classical pediment above the entry porch, a front door with transom, and elaborate door and window surrounds.

An original photo of what is believed to be opening day of the school shows no porch, a chimney on the north side, a flagpole, and no hawthorn tree. A carpenter Gothic full width porch was added between 1909-1911. Student, Oney Oja (my grandfather), born in 1902, appears to be about 7-9 years old in a photo showing him standing on the porch.

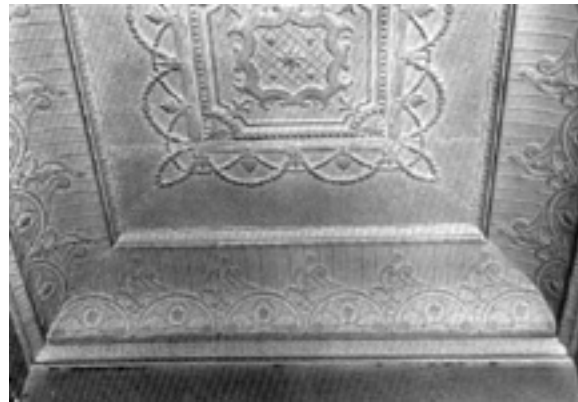
Pressed ceilings, walls, and ornament were made from very thin sheets of metal, less than one sixty-fourth of an inch thick. Panels were individually hammered out on rope drop hammer presses. To emboss the sheet metal with a design, it was placed on the die, or stamp, fastened to the bed of the press. By releasing a three-inch diameter rope, the operator dropped a giant hammer on the die to produce the decorative panel.

The repetition of a single pattern is the main characteristic of stamped metal ceiling and wall panels. In the early days of production, patterns were few and fairly simple, with flat, shallow embossing. As the industry progressed, more patterns were offered. Their designs were more complex and the stamping became deeper-up to three inches deep for some ceiling panels.

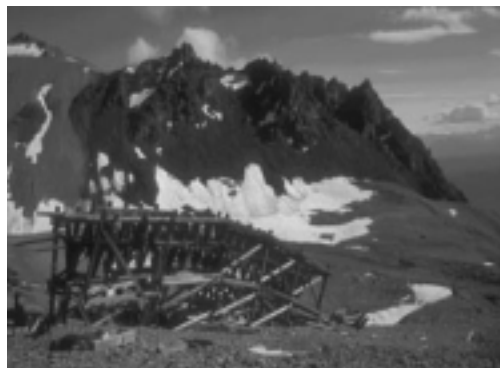
Top of the Jumbo Ariel Tramway (Photo by J. Weinstein)

The mine is located in the Wrangell-St. Elias National Park, the largest park in North America. The National Park Service purchased much of the property around the small mining town of Kennecott in 1998. Slowly, funding has become available for work on the structures in the mill town and most buildings have been recorded and condition assessments made, although it was just this summer that funds were available for work on the aerial tramway structures. The tramway system includes timber-frame towers, breakovers and stations supporting lengths of wire ropes that carry ore from the mountains into the mill town for processing.

At this point in the project, NPS has focused on prioritizing structures according to decay rates and historic importance. Some structures will be restored, rehabilitated or reconstructed, while others are left to decay. The fate of the tramway has yet to be decided. When the operation at the mines was shut down in 1938, the corporation removed only small amounts of the expensive equipment and much of the remains as it existed in the 1930's. Surprisingly, much of the tramway system also remains intact, towers and support cables still stand, machinery is greased and ready for a long awaited ~~start up~~ start up.

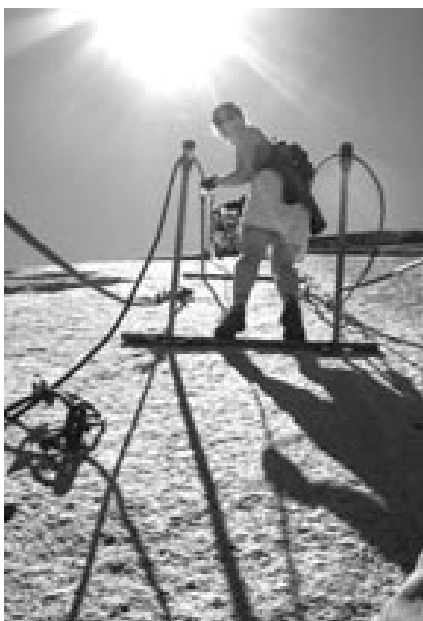
On the Half Dome trail. (Photo by J. Engeman)

In 1919, the Sierra Club also installed a wooden arch on stone piers at the base of the granite steps to commemorate Anderson's ascent. Only the retaining wall, steps, and arch piers remain today and the original granite steps on the lower dome have almost been entirely replaced.

The Half Dome Trail is significant as one of the earliest trails to a Yosemite Valley high mountain summit and as one of the most difficult trail-building projects in the park. It opened an inaccessible mountain peak to Yosemite visitors and became a principal point of interest for hiking and climbing enthusiasts all over the world. Though the climbing technique used with the double cable system is not much different from the use of a single rope or cable, this new system provided the average hiker a safer and more comfortable trip up the dome. The cable system can be likened to that of a gangplank on a steam ship. The metal posts are set into sockets drilled in the granite every ten feet. At intervals of one hundred feet, heavy chains are bolted into the rock to help strengthen the cables, and wooden footrests are placed at ten-foot intervals on the slope.
