RESEARCH, DOCUMENTATION AND RESTORATION GUIDELINES FOR  
DECORATIVE PLASTERWORK AT THE DAVENPORT HOTEL,  
SPOKANE, WASHINGTON

Presented to the Interdisciplinary Studies Program:  
Historic Preservation  
and the Graduate School of the University of Oregon  
in partial fulfillment of the requirements  
for the degree of Master of Science  
June 1988

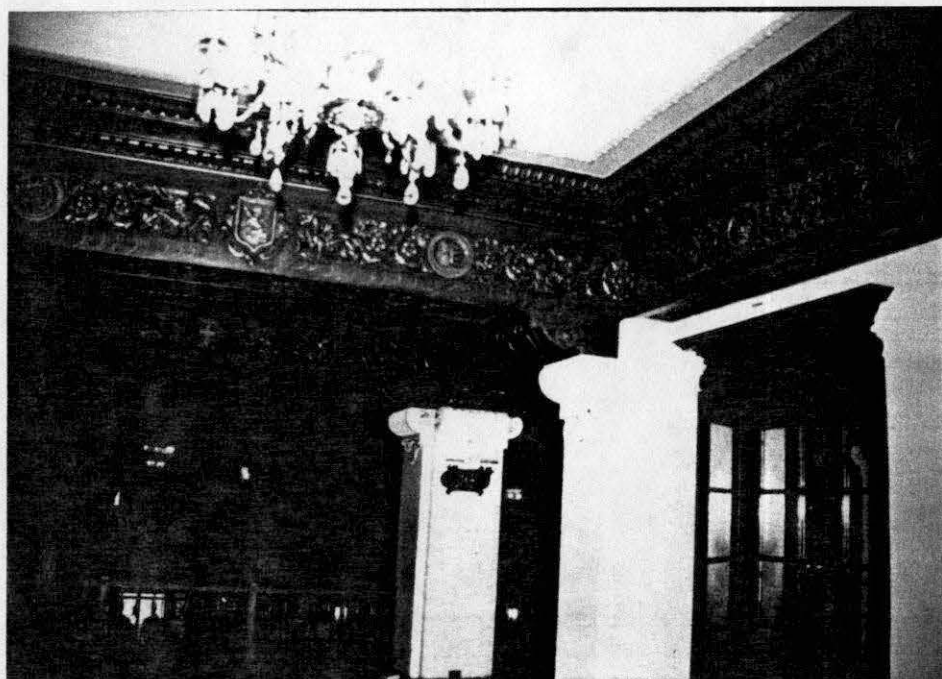
Fig. 5 Davenport Hotel, Lobby Mezzanine Friezes, Present. (Source: author's photograph.)

A surface of the beams which received a different plaster design is found on the underside of the shorter beams which span the second floor concourse. These areas compose foliate scrolls and interlaced strapwork with simulated nail heads. Overlying the principal friezes of the lobby beams are narrow paneled friezes of foliate scroll relief.

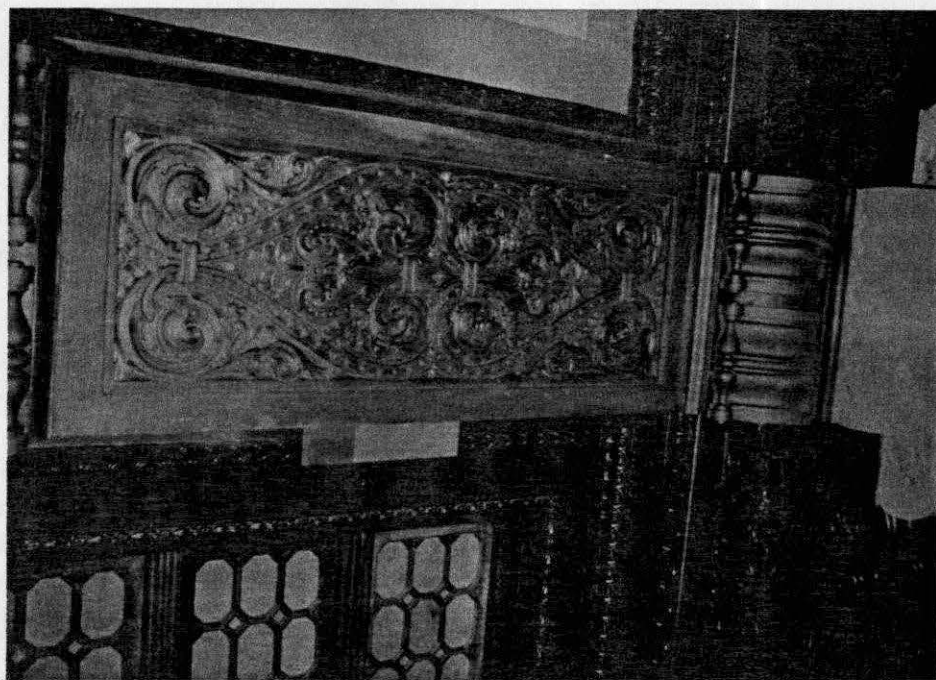
Fig. 7 Davenport Hotel, Underside of Beam, Present. (Source: author's photograph.)

Where pre-cast ornaments of previous years were often secured only by the keying action of one wet plaster surface against another, these large fibrous sections were affixed to beams and friezes with screws that passed through holes pre-drilled in the ornament. The location of these screws was later disguised with the application of small decorative devices such as the regularly placed rosettes and nail heads found on many of the Davenport panels.
