# ROOTS AND ROUTES

*Seeking an Accessible Path to Make Peace Between  
Street Trees and Sidewalks in The Whit*

An applied research project accepted and approved in partial  
fulfillment of the requirements for the degree of  
Master of Landscape Architecture

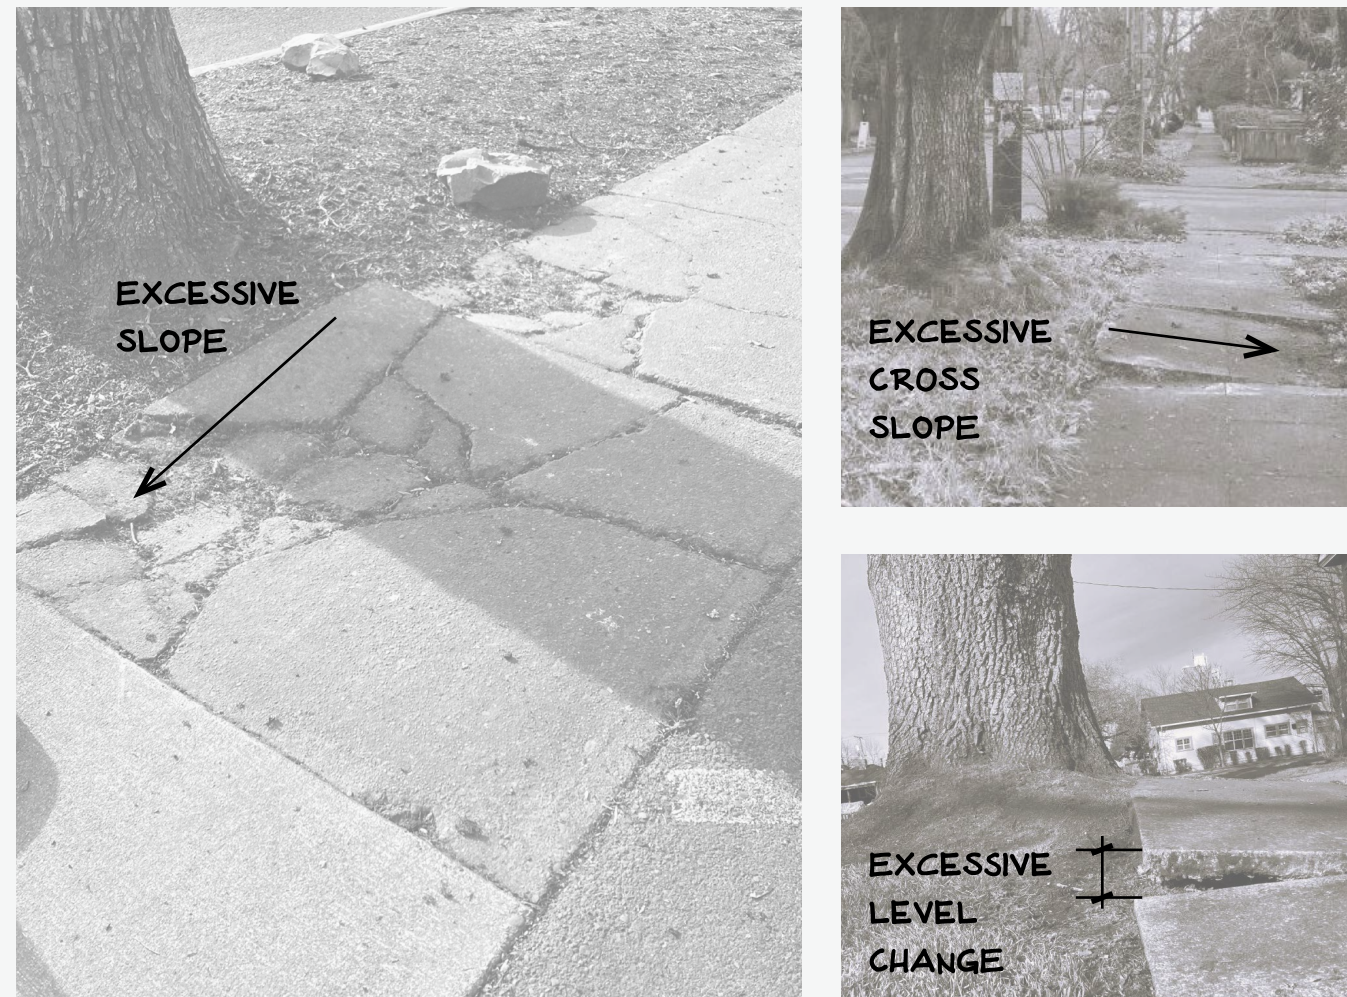
Figure I.1

**The Problem with Root Heave**

Sidewalk root heave is the phenomenon of **tree roots lifting sidewalks**, creating public hazards and obstructing disabled people's access to public space. This is because the pavement's surface is often lifted by the roots in excess of code-required slopes, cross slopes, and level changes (see figure I.1). The stable, level surface required for people to safely navigate over sidewalks has strict tolerances that do not have room for much, or any, root growth (see figure I.2). In other words, **roots lift sidewalks because sidewalks were constructed in a way that only remains accessible if roots do not grow beneath them.**

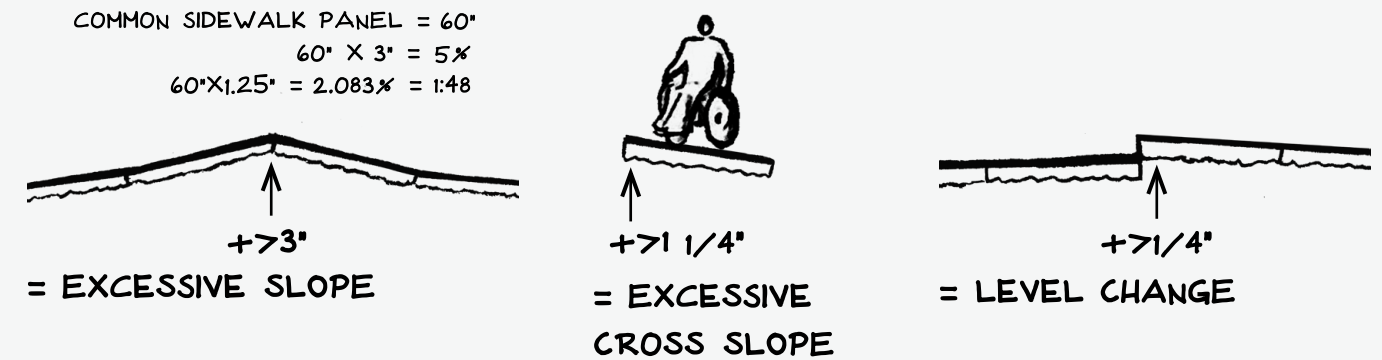
ROOTS GROW RADially (OUTWARDS) IN ALL DIRECTIONS, INCLUDING UP!  
 RADIAL GROWTH - (SOIL COMPACTION + LATERAL DISPLACEMENT) = ~ROOT HEAVE HEIGHT

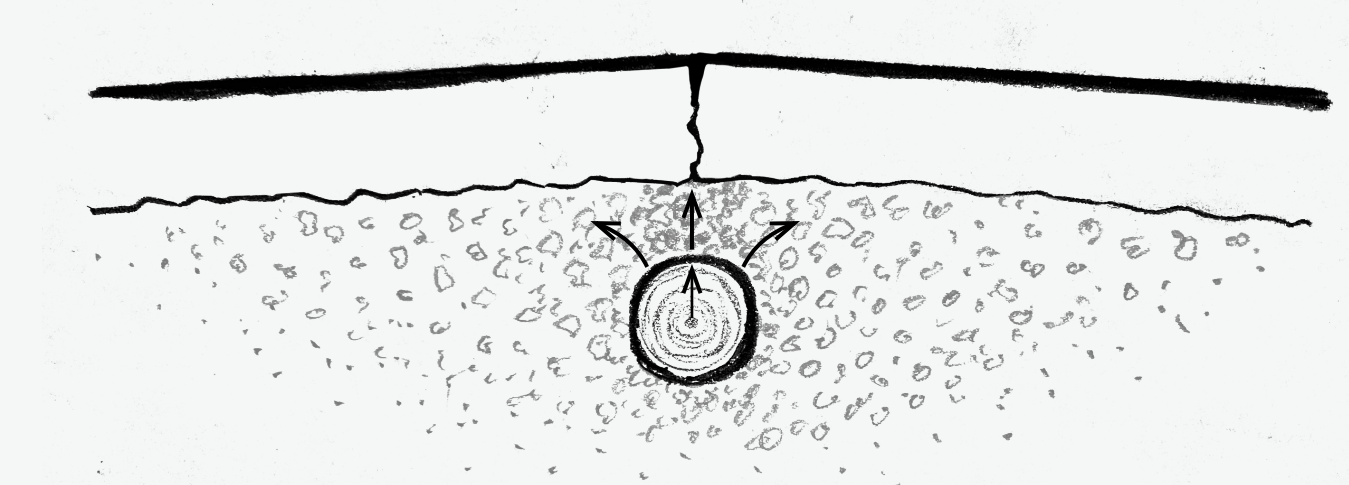
NOTE: WHEN TREES ARE CUT DOWN, ROOTS ROT, LEAVING VOIDS SIDEWALKS CAN SINK INTO.

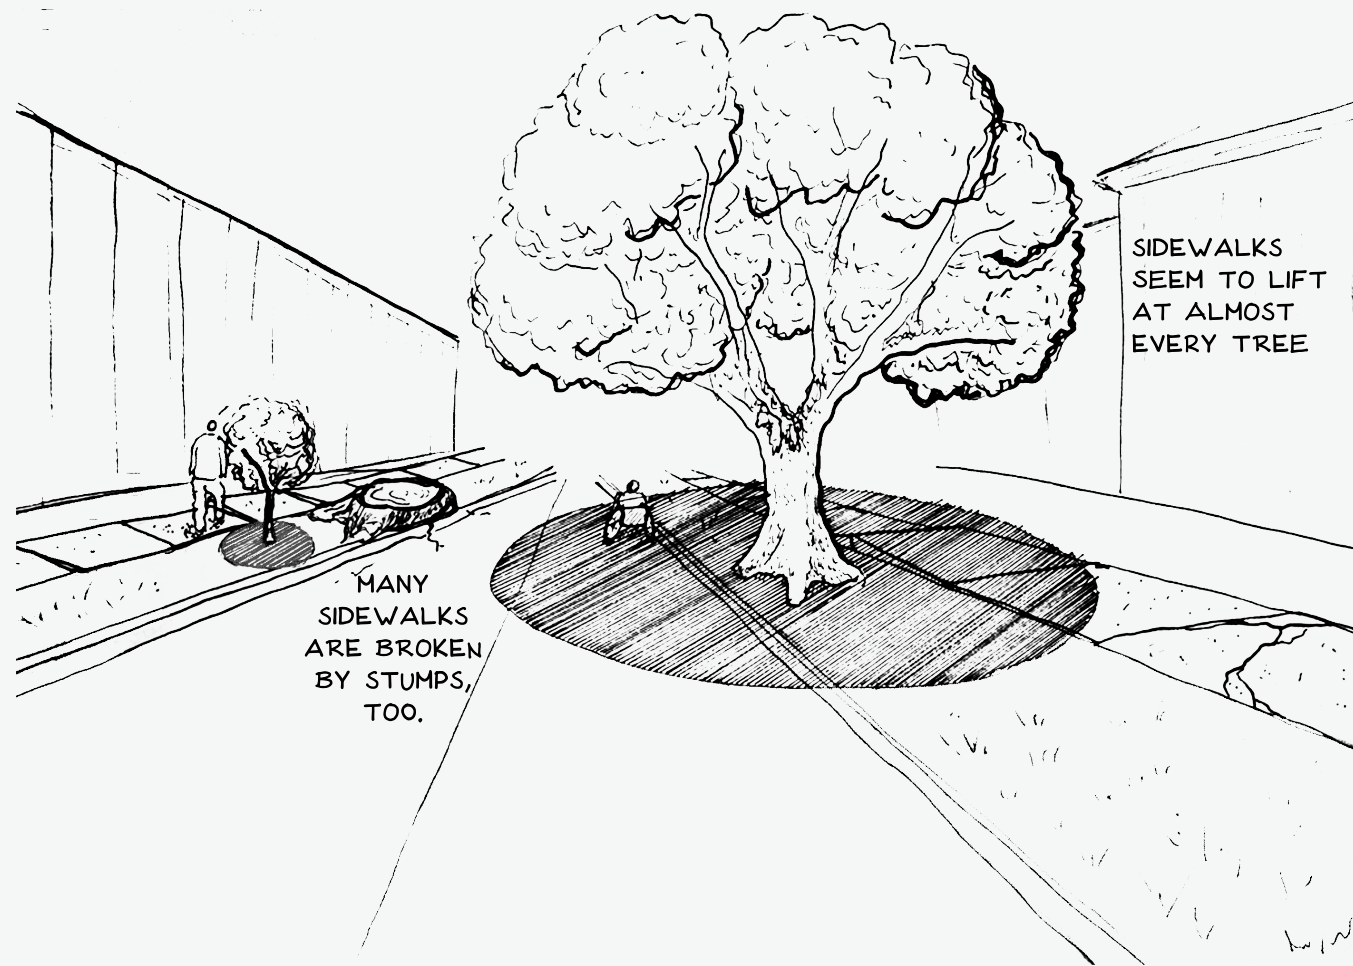
**Figure I.3**  
**The Root Heave We See**

Illustration of an urban street with a mature tree, a sapling, and a stump alongside broken sidewalks that are nonfunctional for many people with disabilities.

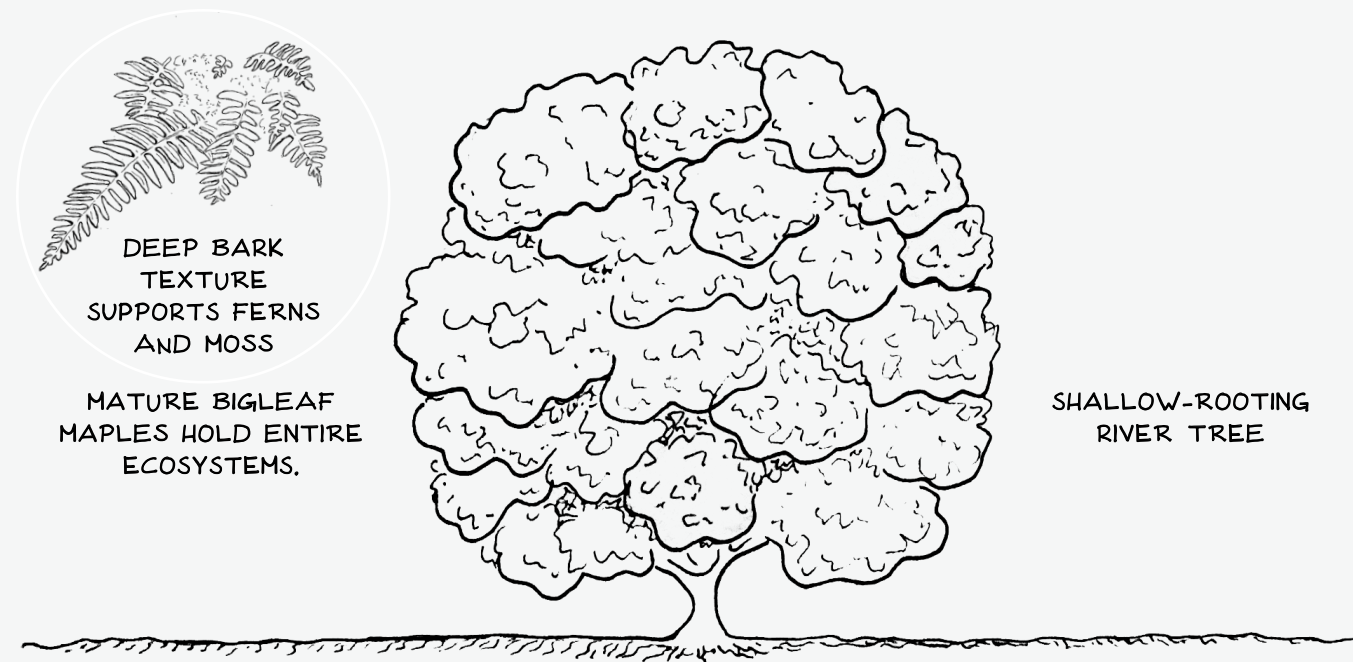
**Figure I.9**  
**Bigleaf Maple**

Illustration of a Bigleaf Maple tree in profile view, showing the proportional relationship between the crown and root span.

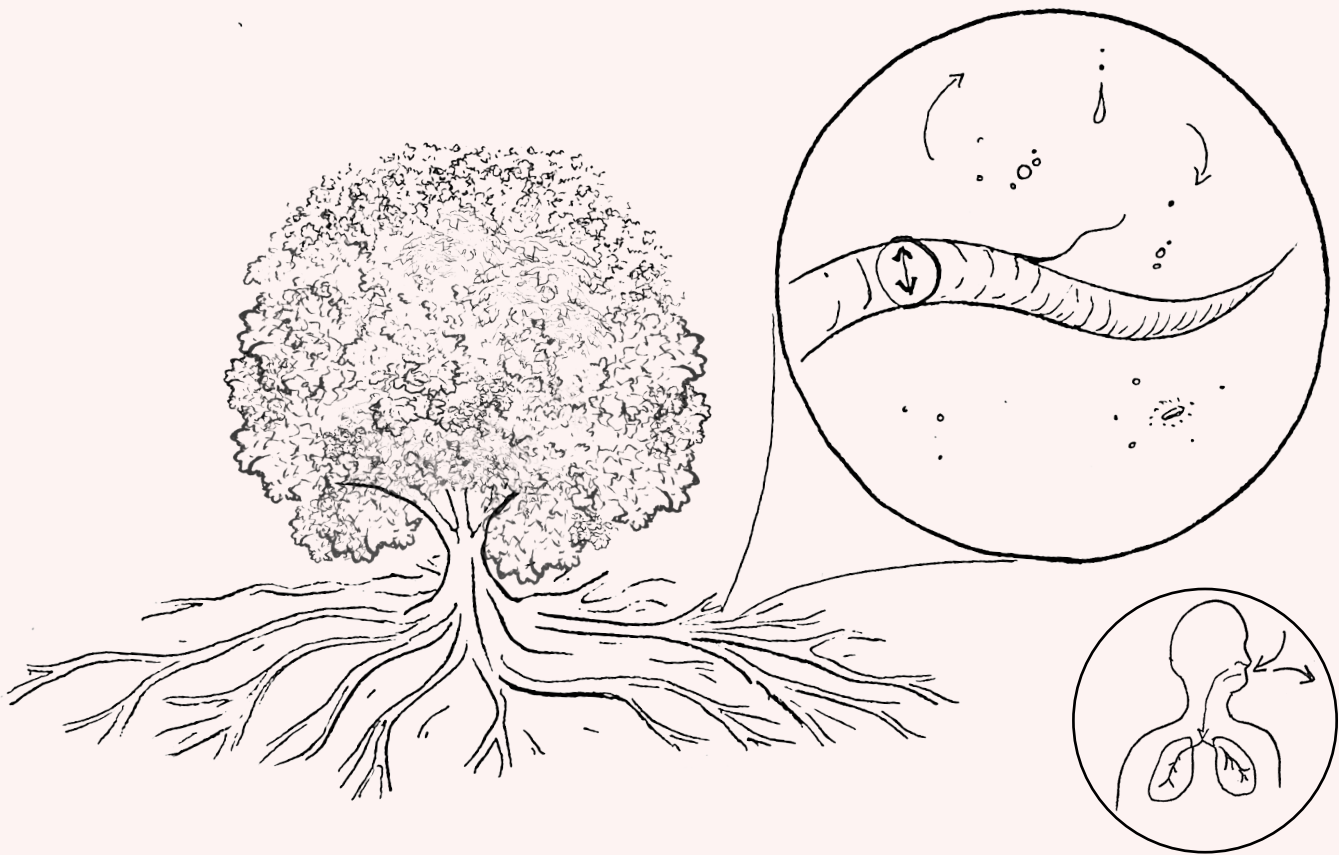
**Figure 1.1.1**  
**Tree Root Biology**  
Illustration of basic tree root growth patterns and needs.

As illustrated in figure 1.1.1, roots require oxygen because trees need to “breathe” but have no centralized lungs or gills, so their respiration is distributed across their biomass. Roots’ access to gas exchange is necessary for their survival and also allows them to deposit CO2 into the soil, which is part of how they sequester carbon (Trimble, 2021).

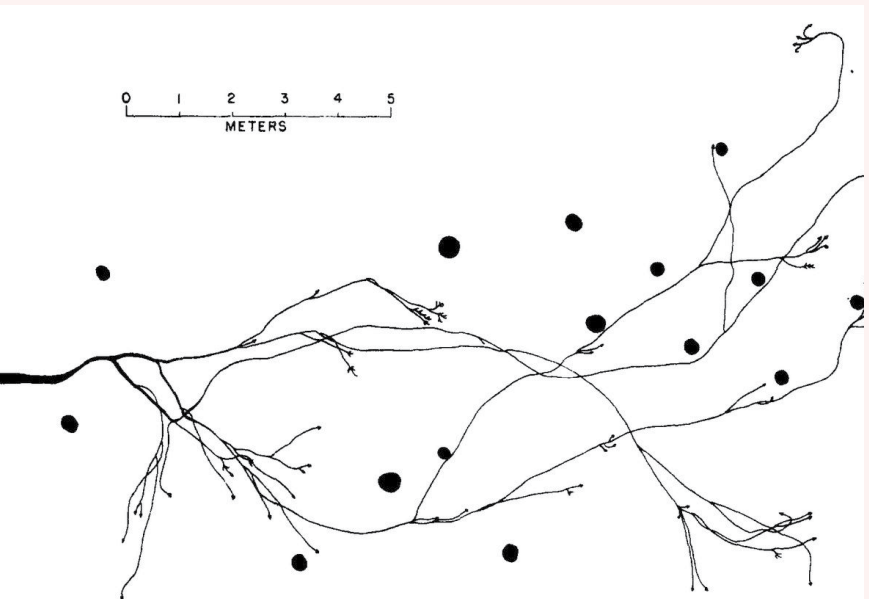
**Figure 1.1.2**  
**Tree Root Diagram**  
Plan view diagram of a single lateral Red Maple root in a stand of other trees, which are shown as black dots, representing other trunks (Perry, 1982).

To have greater access to oxygen, all trees have some roots near the surface, which spread laterally out from their trunks. These roots spread dozens of meters (see figure 1.1.2). The rooting patterns of different species vary, but most deciduous species, especially surface rooting species like Bigleaf Maples, grow their roots in a large, shallow mat that is often twice as wide as their canopy or more (oregon.edu; Perry, 1982). However, the majority of their roots are concentrated within their canopy dripline, and their most critical roots grow within a calculable radius around their trunks, which is known as the critical root zone or CRZ. Protecting this area is essential for the health and longevity of trees (virginiatreecare.com).

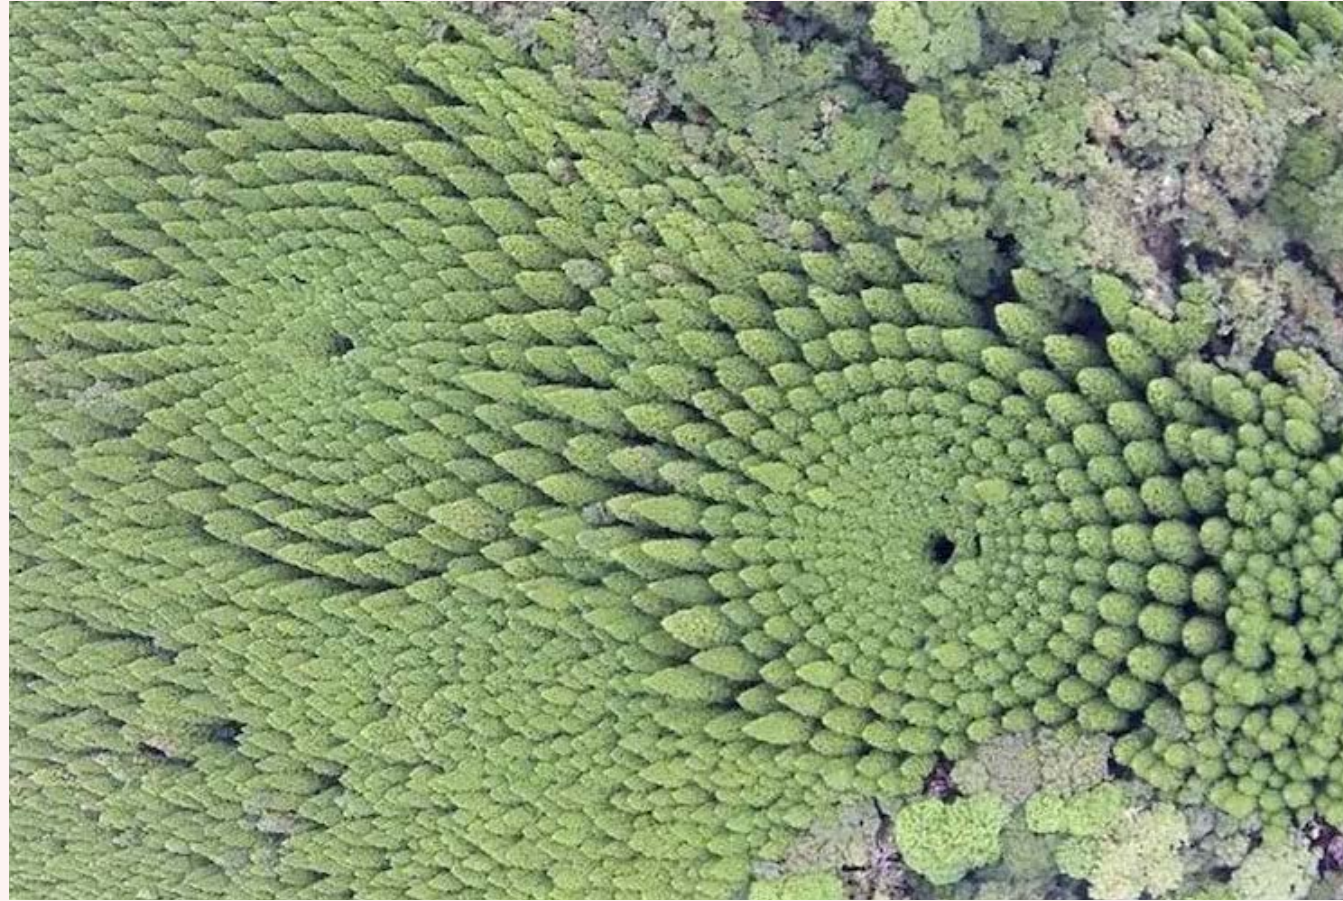
**Figure 1.1.3**  
**Experimental Forestry**  
**Showing Trees of the Same**  
**Species and Age**

Drone photo of the results from a post-clear-cutting experiment in 1973. This patch of forest in the Miyazaki Prefecture in Japan was planted uniformly with Japanese Cedar trees in concentric circles, increasing spacing between saplings in outer rings. This demonstrates how much larger trees of the same species and age grow when they have more room, thus access to resources (Varga, n.d.).

Japan. After forest clear-cutting, Japanese Cedar saplings of the same age were planted at the same time in concentric rings radiating out from a central clearing, which naturally resulted in wider spacing in the outer rings (Marchese, 2019). After about fifty years of growth, the growth advantage of wider spacing is clearly evident; see the aerial photo in figure 1.1.3. Because urban streets require significant spacing between trees, due to limited planting areas and visibility requirements, it is logical for trees to grow faster in urban environments, which has been demonstrated in existing literature (Thurston and Scott, 2025).

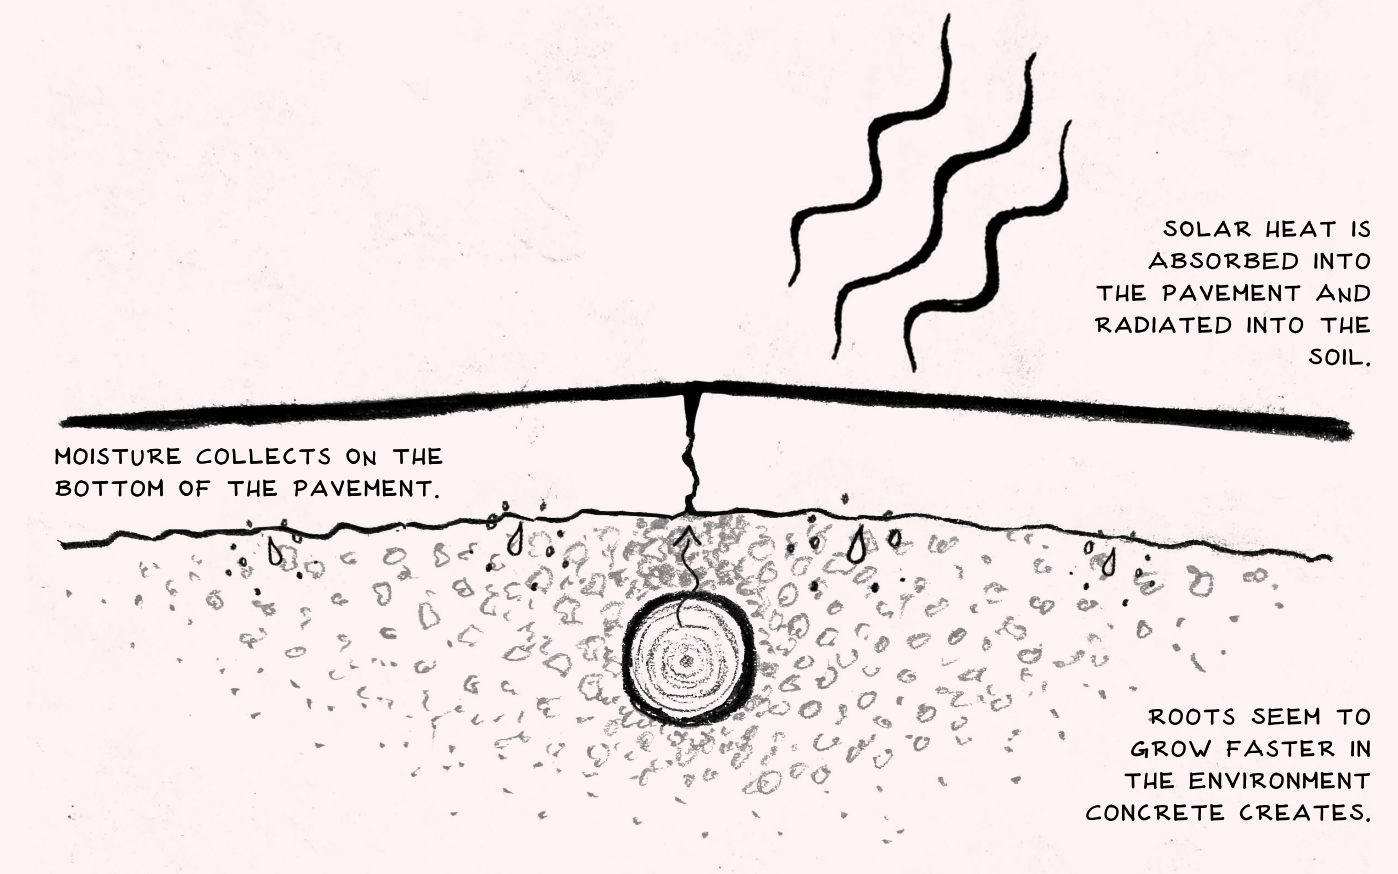
**Figure 1.1.4**  
**Concrete Physiology**  
Illustration of how on-grade concrete creates growing conditions that encourage tree root growth.

The specific micro-climatic growing environment beneath sidewalks may encourage and expedite root growth because of the physiology of concrete (see figure 1.1.4). Concrete, as an impermeable surface, prevents water from evaporating

in soil, trapping moisture and collecting condensation along the bottom of the pavement. Sidewalks then create an abnormal humidity gradient, which seems to stimulate rapid tree root growth specifically beneath the sidewalk (Randrup et al., 2001, p. 215). The concentration of water beneath and around sidewalks is further elevated in areas with adjacent irrigation, i.e. well-watered lawns, which may further encourage surface rooting (Randrup et al., 2001, p. 215). The solar energy absorbed into the pavement also elevates the soil temperature, which may correlate with rapid surface root growth.

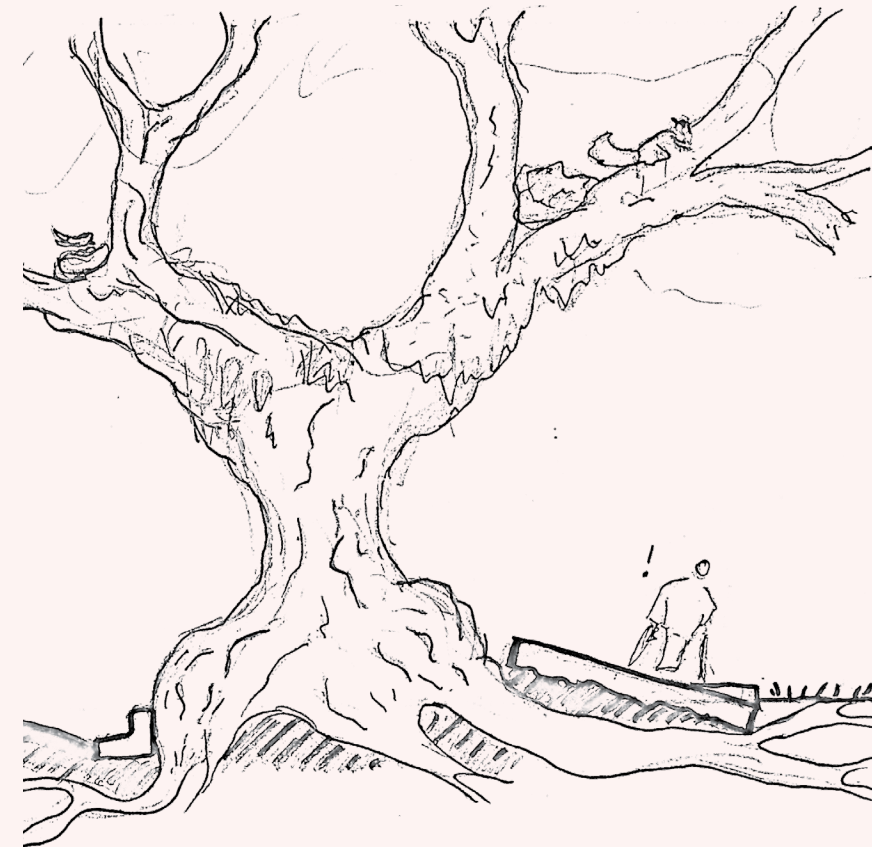
**Figure 1.2.1**  
**Root Growth vs. Safety and Welfare**

Illustration of a tree in cramped growing conditions lifting the sidewalk, creating a hazard for the public, especially people with disabilities.

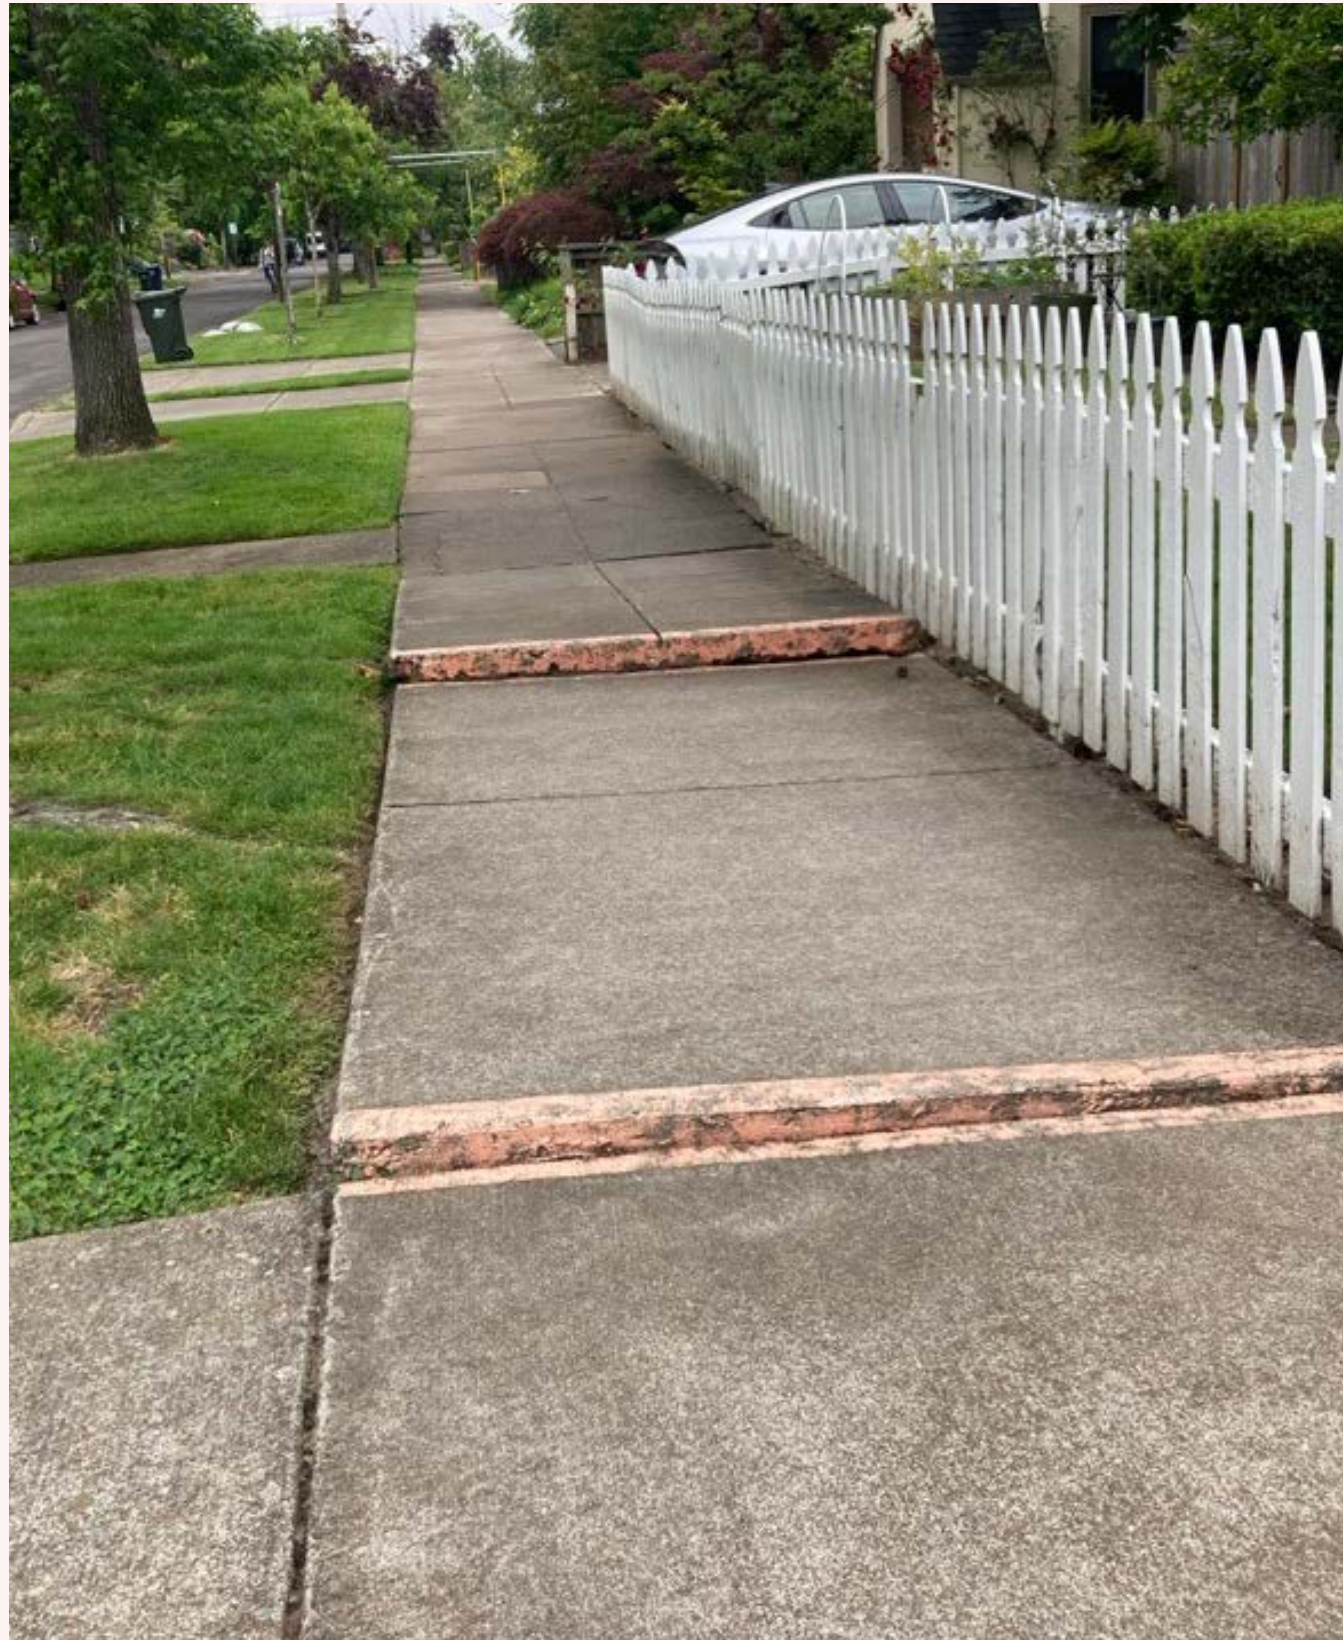
**Figure 1.2.3**  
***The Reality of Urban Sidewalks***

Photo of a non-compliant sidewalk in Eugene that has been spray-painted, which alerts pedestrians of the problem but does not remove the safety hazard or obstruction.

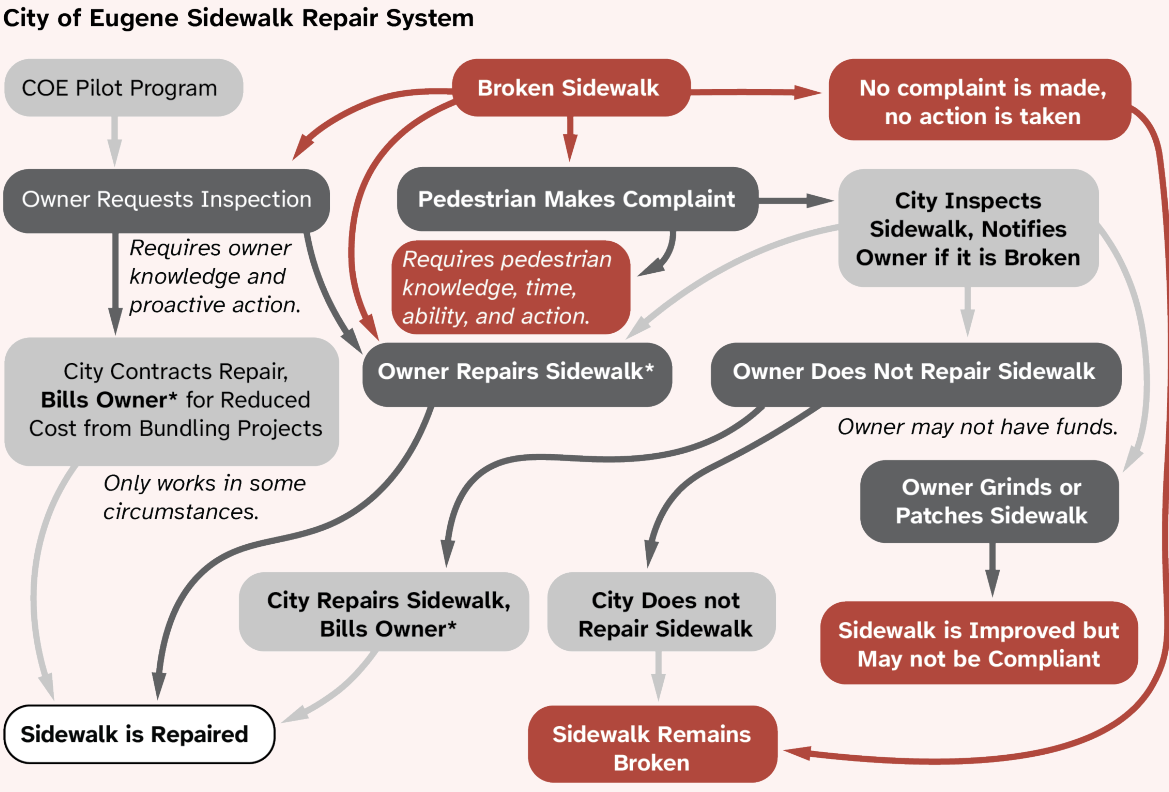
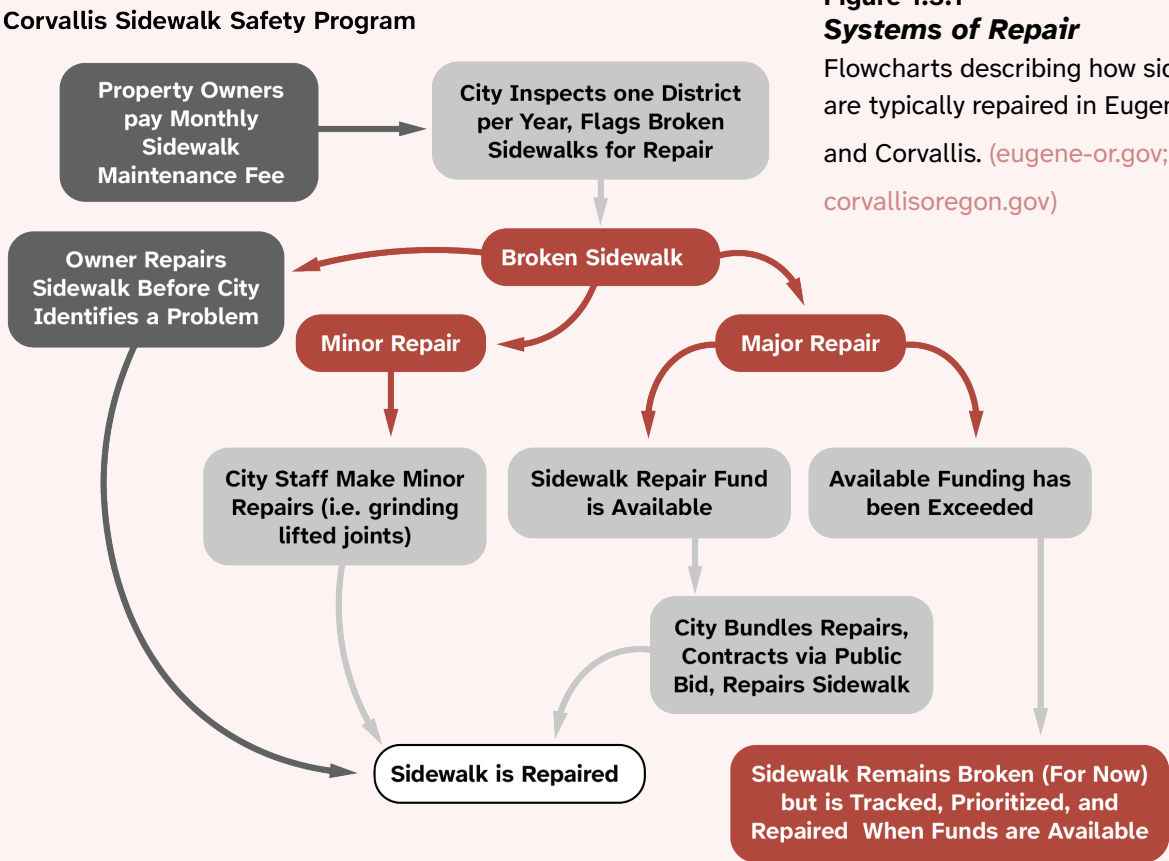
Figure 1.3.1  
Systems of Repair  
Flowcharts describing how sidewalks are typically repaired in Eugene and Corvallis. (eugene-or.gov; corvallisoregon.gov)

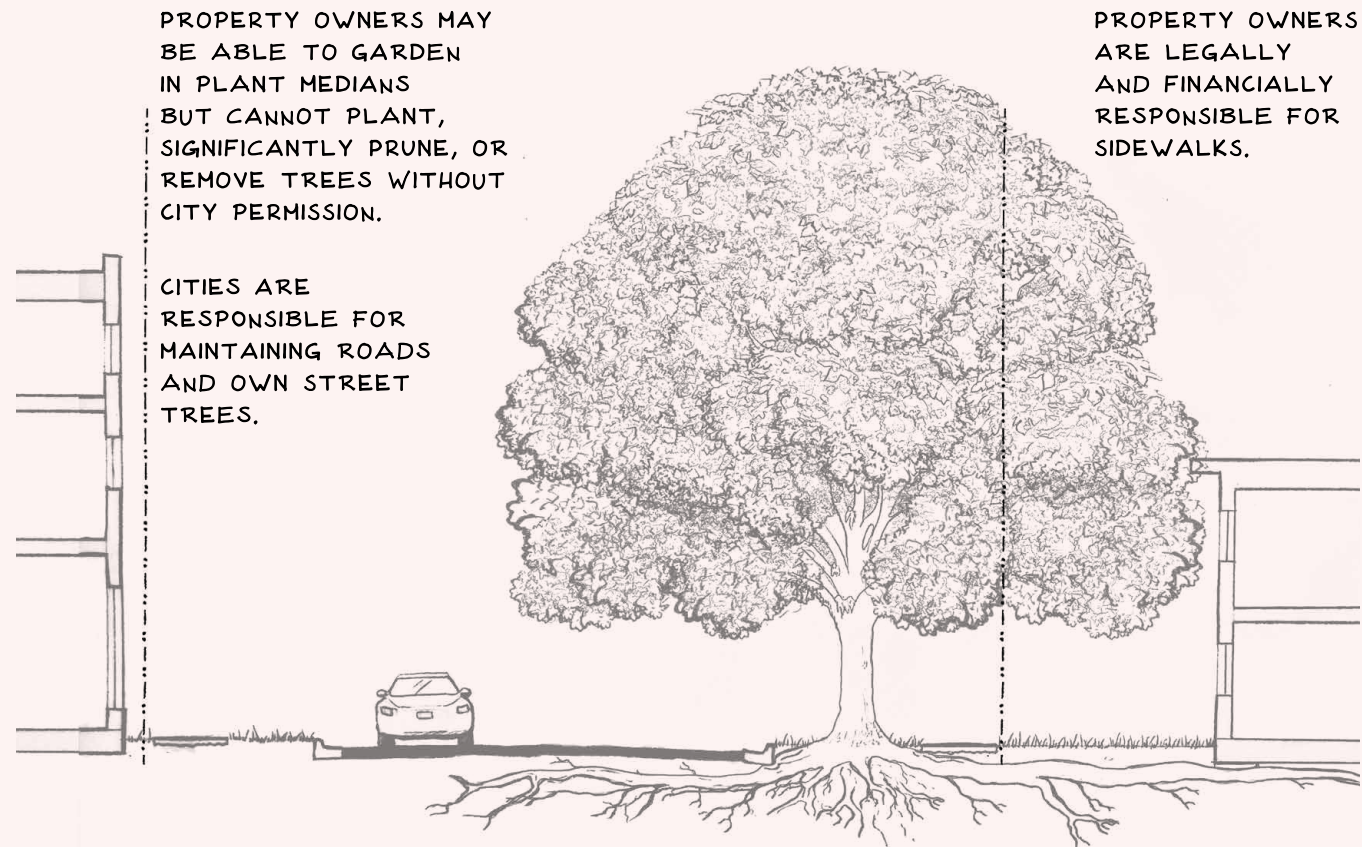
**Figure 1.3.2**  
**Ownership and Responsibility**  
**in an Urban Streetscape**

Cross section of an urban street spanning from the driving lane to private property, showing that the city is typically responsible for the street and tree but the property owner is responsible for sidewalk repair and maintenance. Illustration reflects the current policy in Eugene, Oregon but is representative of the majority of U.S. cities.

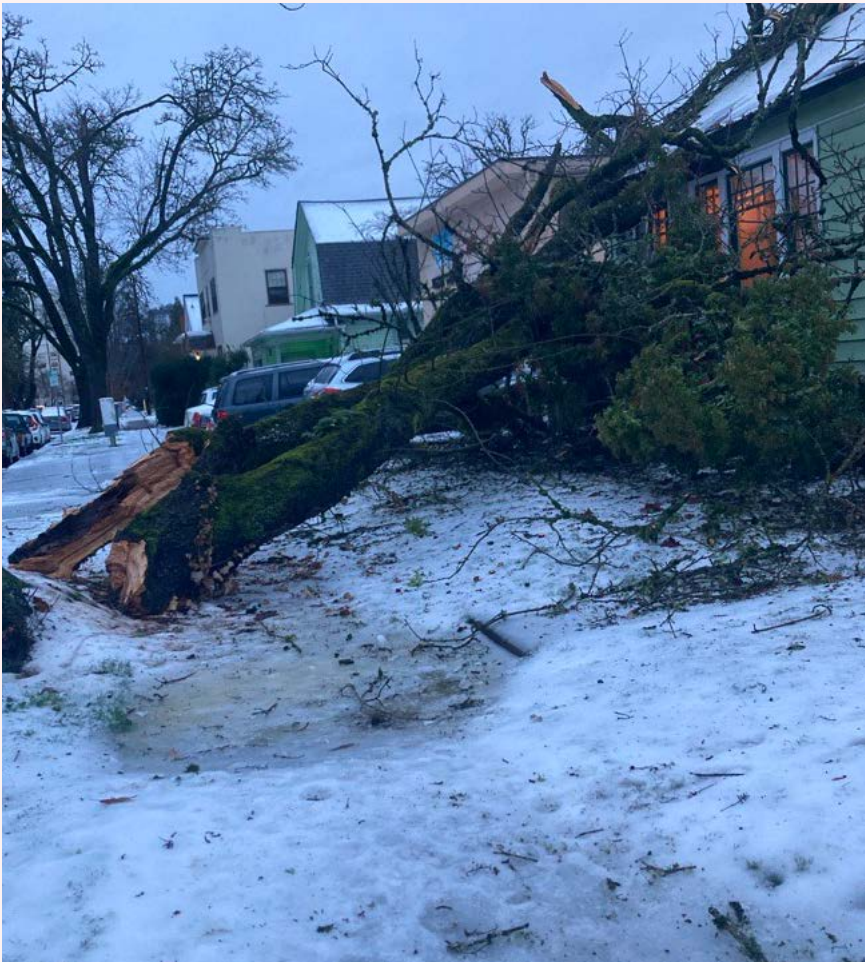
**Figure 1.3.4**  
**Risk of Urban Street Trees**  
Photo of an especially large tree branch that fell through the roof of a house taken in Eugene on January 17, 2024 during a major ice storm.

branch can cause serious damage, as pictured in figure 1.3.4, so risking an entire tree falling is not an option. Root pruning can also be a problem for specific species, even where there is no structural concern. **Bigleaf Maples are specifically at risk** because they often struggle to tolerate root pruning according to an experienced urban forester and certified arborist at the City of Eugene (Lakics, personal communication, January 16 2026).

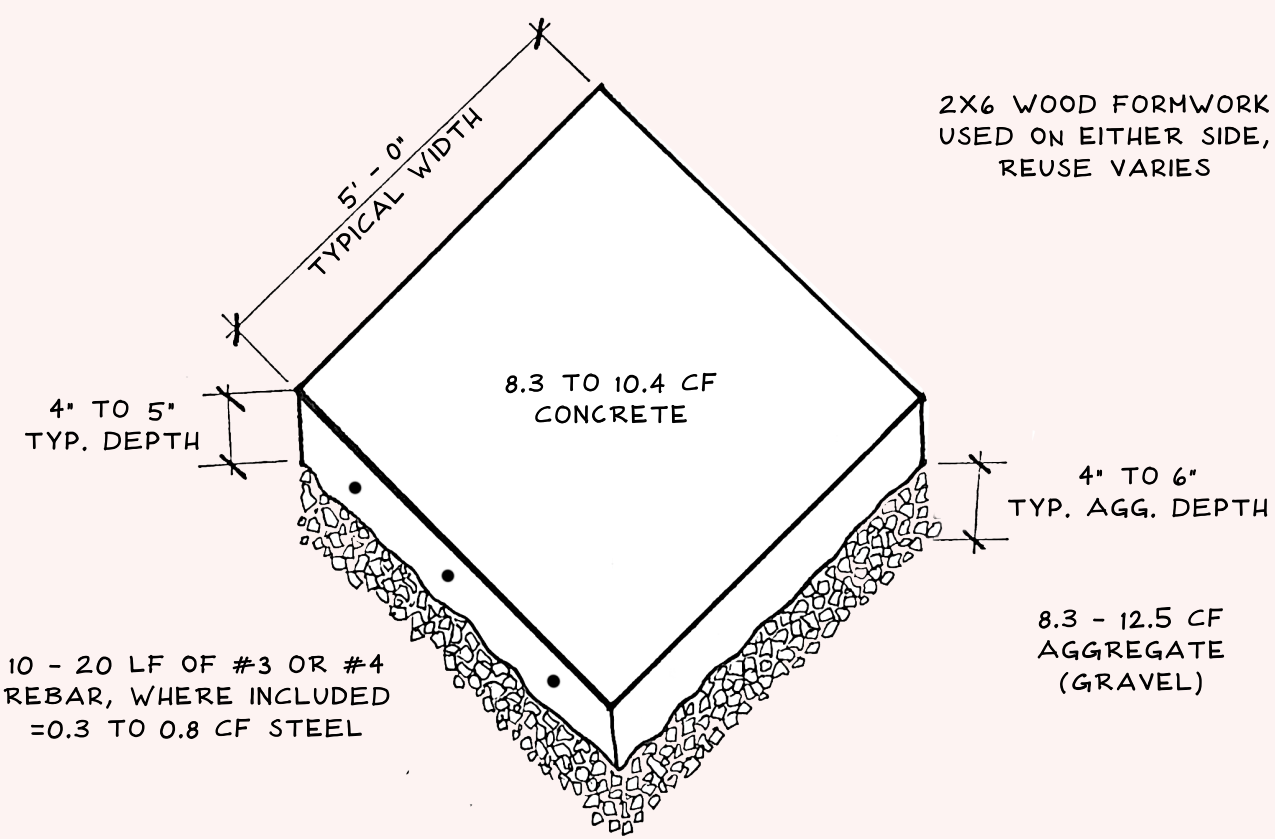
**Figure 1.3.5**  
**One Sidewalk Block**  
Simplified illustration of the material required for a typical 25 square foot block of sidewalk.

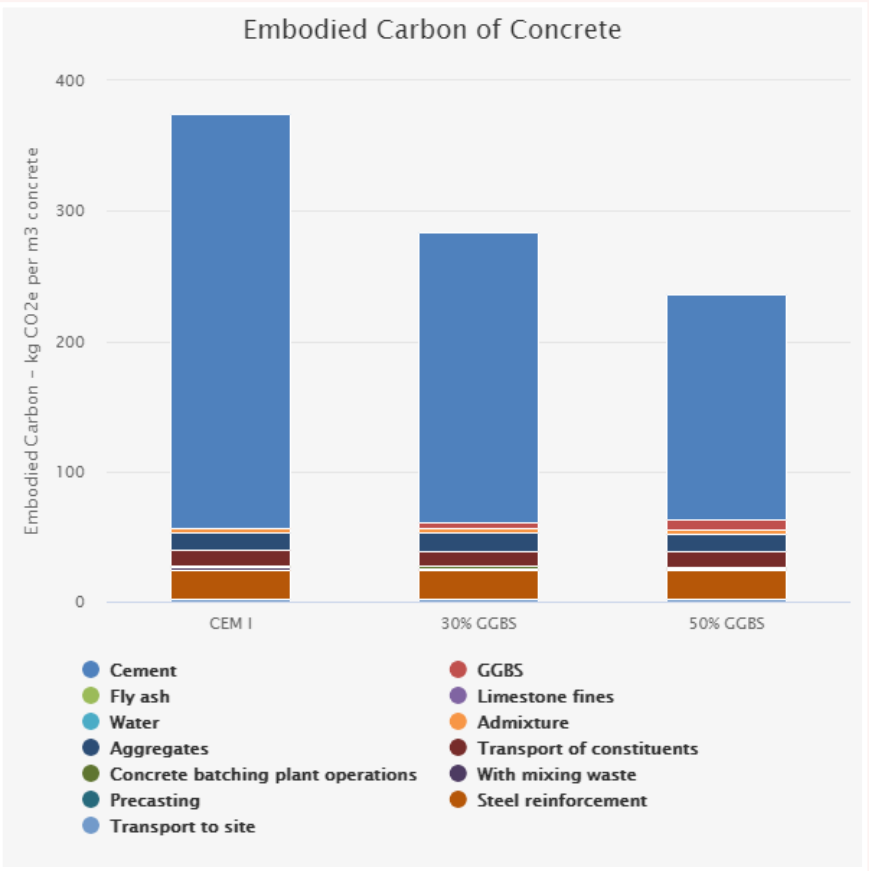
**Figure 1.3.6**  
**Embodied Carbon of Concrete**  
Example of common embodied carbon calculations for different mixes of concrete. Represents a range equivalent to 15lbs/cf to 24lbs/cf. This means a single block of sidewalk has 124 to 250 pounds of embodied carbon just from the concrete ([circularecology.com](https://circularecology.com)). This represents at least 3-6, possibly 6-12 mature trees’ annual carbon sequestration capacity ([Ross, 2023](#)).

sequestration capacity with generous estimates. More conservative estimates suggest trees may only sequester 22 pounds of carbon per year, meaning that square of concrete could take 6-12 trees one year to offset (Ross, 2023).

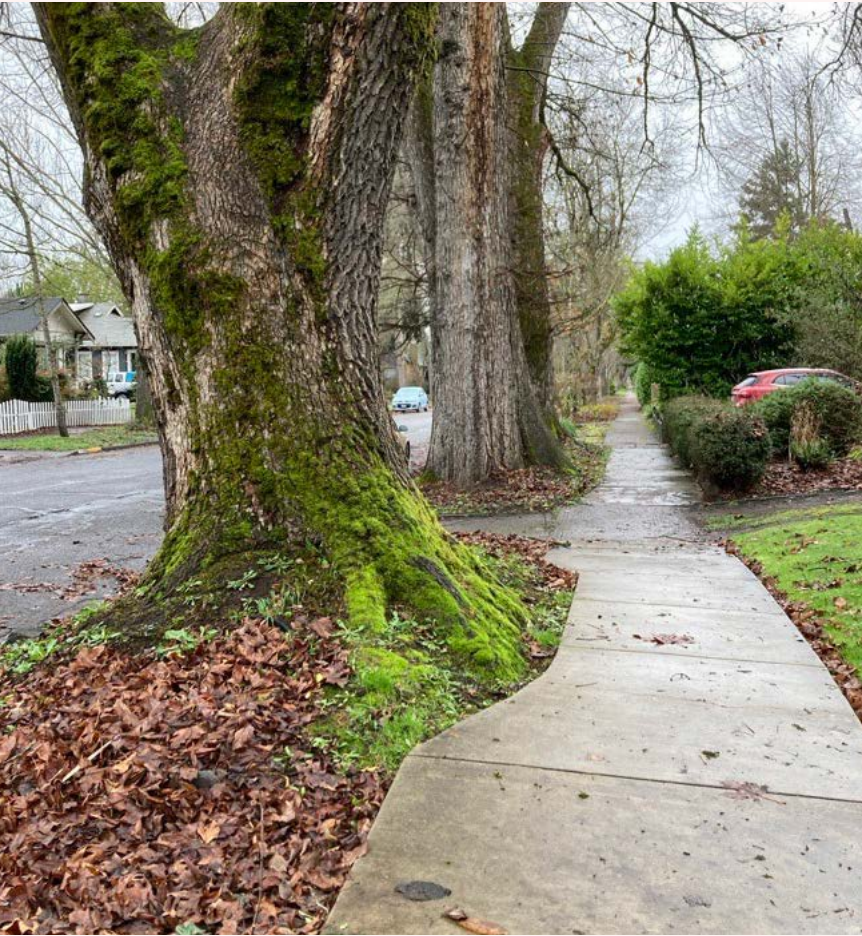
**Figure 1.3.10**  
**Sidewalk Width Adjustments**  
Photo of new sidewalk that is narrowed next to a mature Bigleaf Maple street tree in Eugene.

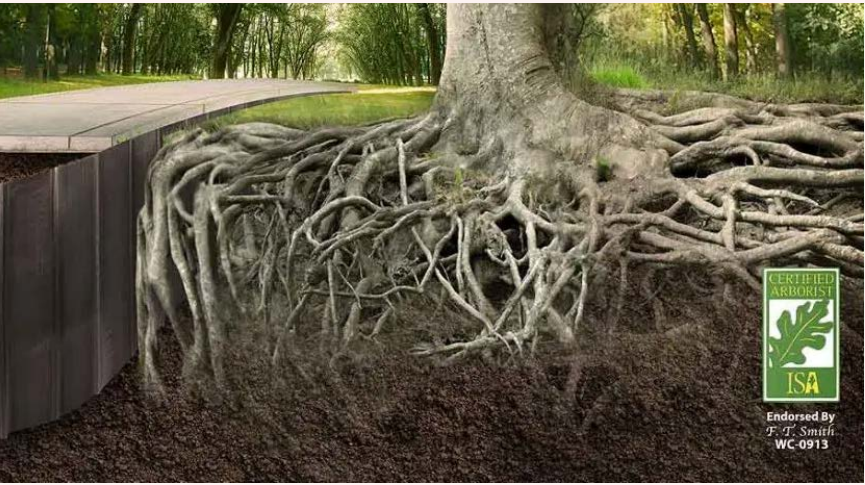
**Figure 1.3.11**  
**Root Protection**  
Illustration of vertical root protection, which at least one longterm study found to be the most effective root protection intervention compared to other options, such as horizontal layers of foam and increased aggregate depth (Smiley, 2008, greenindustrytrees.com)

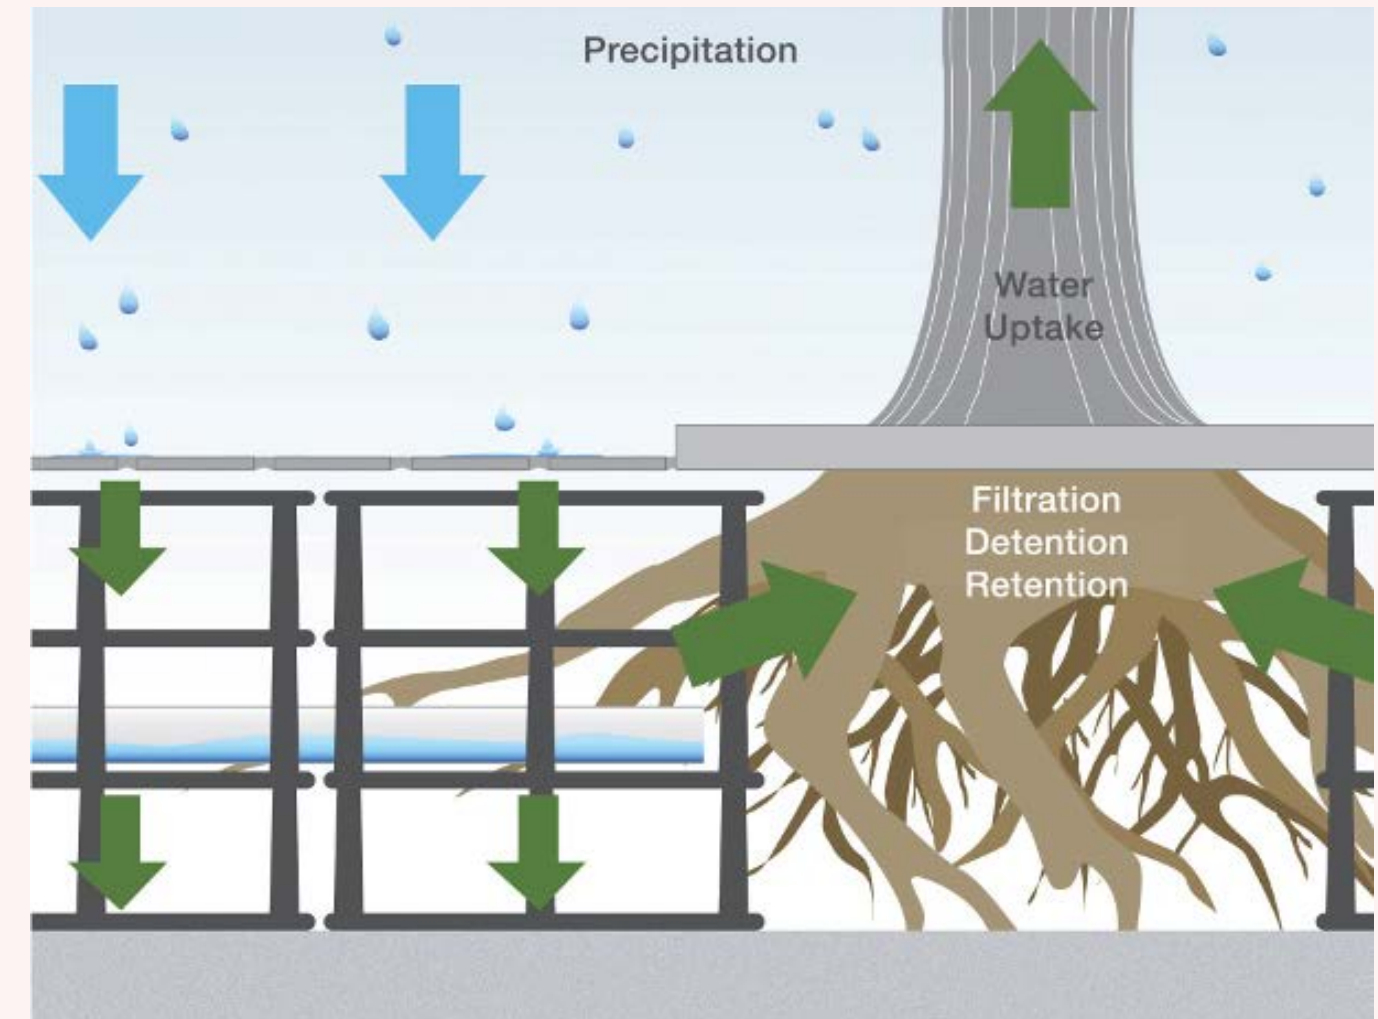
**Figure 1.3.12**  
**Root Accommodating**  
**Subgrade Construction**

suited for different use cases. Suspended grating systems seem to be most suitable for existing trees, while structural soils or modular box systems are more effective for new plantings (Wojnowska-Heciak et al., 2025, p. 11). Most options can be used at existing trees with the help of an air blade to remove compacted soil. The research comparing these solutions is limited because it focuses on synthesizing existing information to describe and compare methods of supporting tree roots alongside pedestrian paths, which does not include **original field research of actual installations**. Further research is needed to verify efficacy for preventing root heave.
