# ROOTS AND ROUTES

*Seeking an Accessible Path to Make Peace Between  
Street Trees and Sidewalks in The Whit*

An applied research project accepted and approved in partial  
fulfillment of the requirements for the degree of  
Master of Landscape Architecture

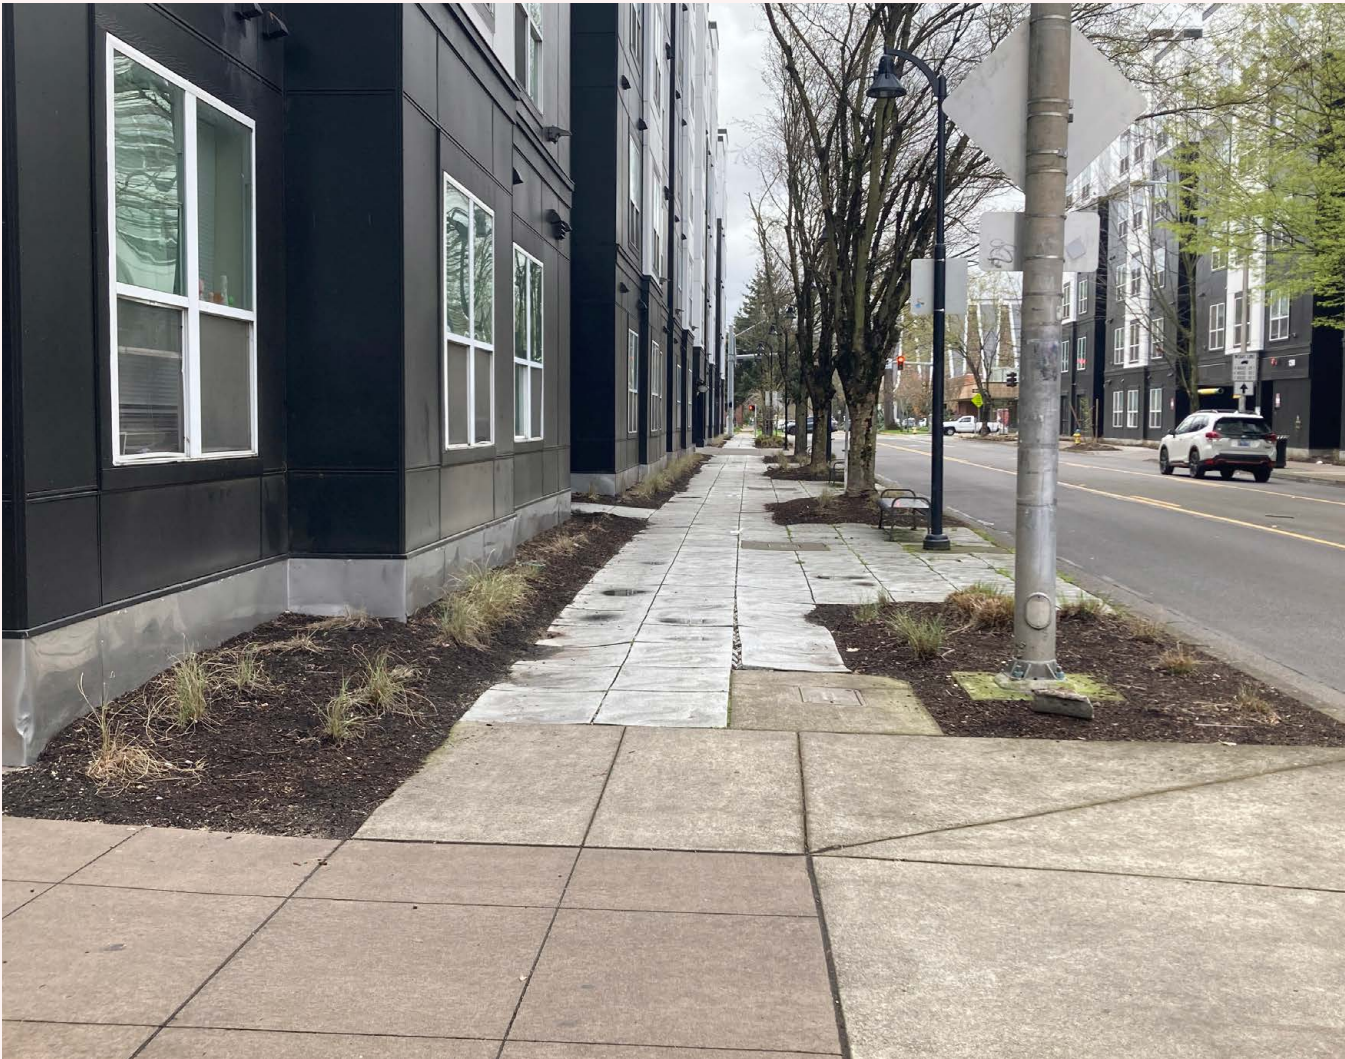
**Figure 1.3.15**  
**Terrewalk System Failure**

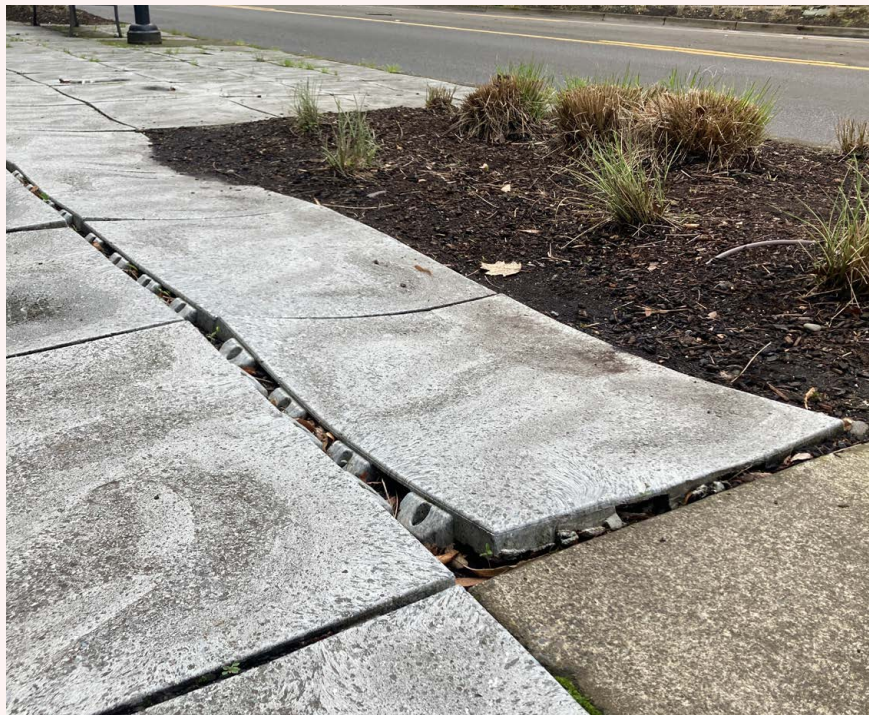
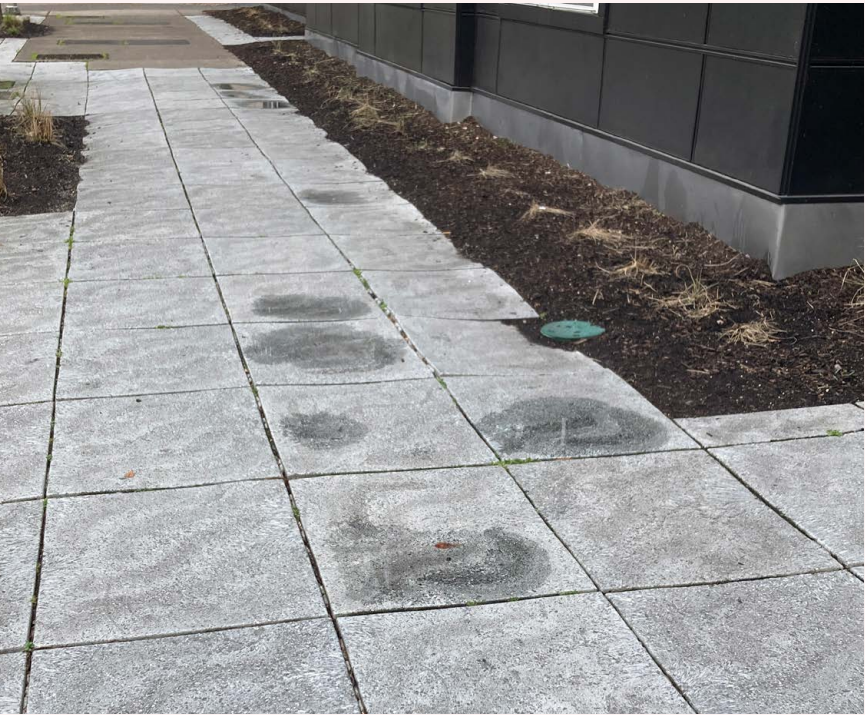
**Figure 1.3.14**  
**Water Pooling on Terrewalk System Panels**  
Photo of in-tact Terrewalk system panels with bowls holding water from adjacent irrigation.

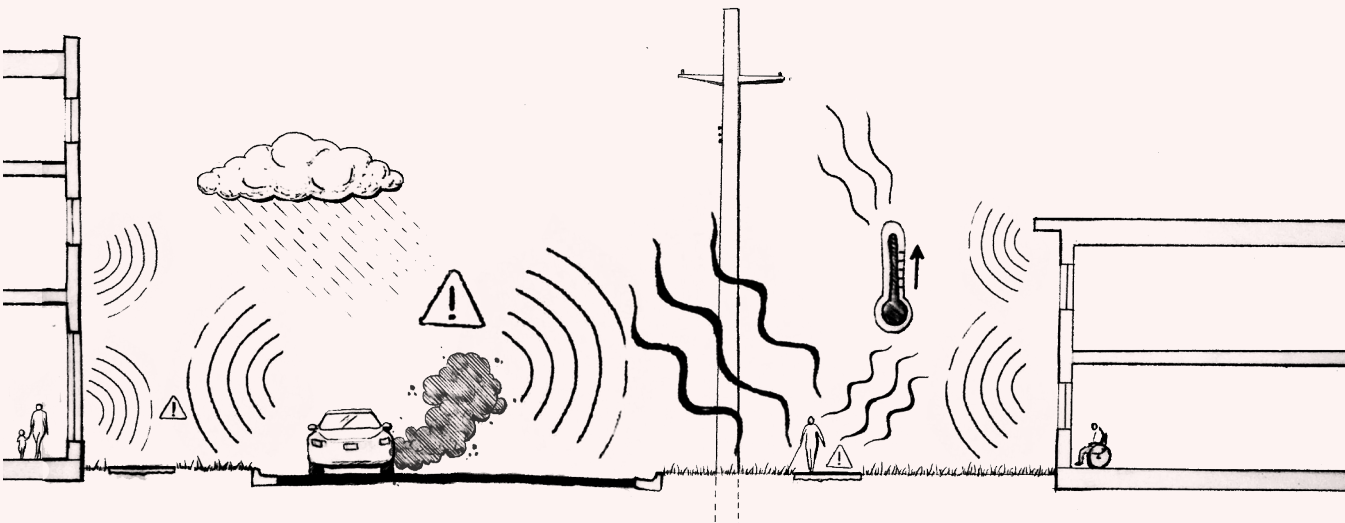
**Figure 1.4.2**  
**Our Streets without Trees**  
Illustrative diagram of the urban heat island effect and other negative aspects of the large amount of pavement in cities.

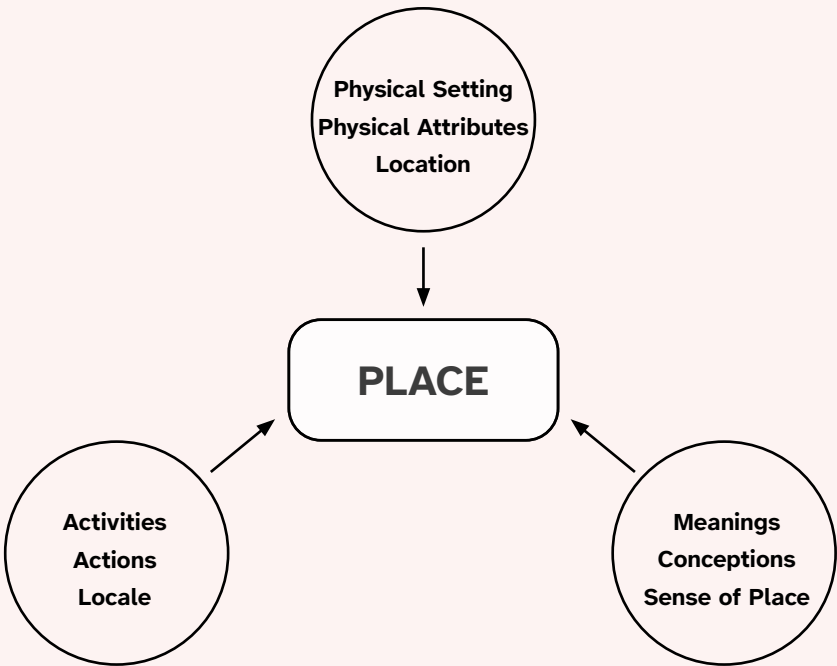
**Figure 1.4.4**  
**Trees as Place-makers through the Tripartite Model of Place**  
Adaptation of Dr. Stapleton’s diagram illustrating the cross-disciplinary tripartite model of place as defined by John Agnew. (Stapleton, 2022, pp. 24)

the connection between humans and their environment. This concept of place builds on decades of work interrogating the meaning and creation of “place,” including John Agnew’s tripartite model for place as the relationship between location and human experience (see figure 1.4.4). What this means is that a space becomes a “place” when people connect with it by making memories there, associating it with someone they love, or by appreciating its beauty (Stapleton, 2022, p. 25). Using Stapleton’s Place-Based Human-Environment framework (figure 1.4.5) which translates a concept of place from across disciplines into landscape architecture, **I argue that urban trees, particularly large mature trees, are an important part of place-making.**

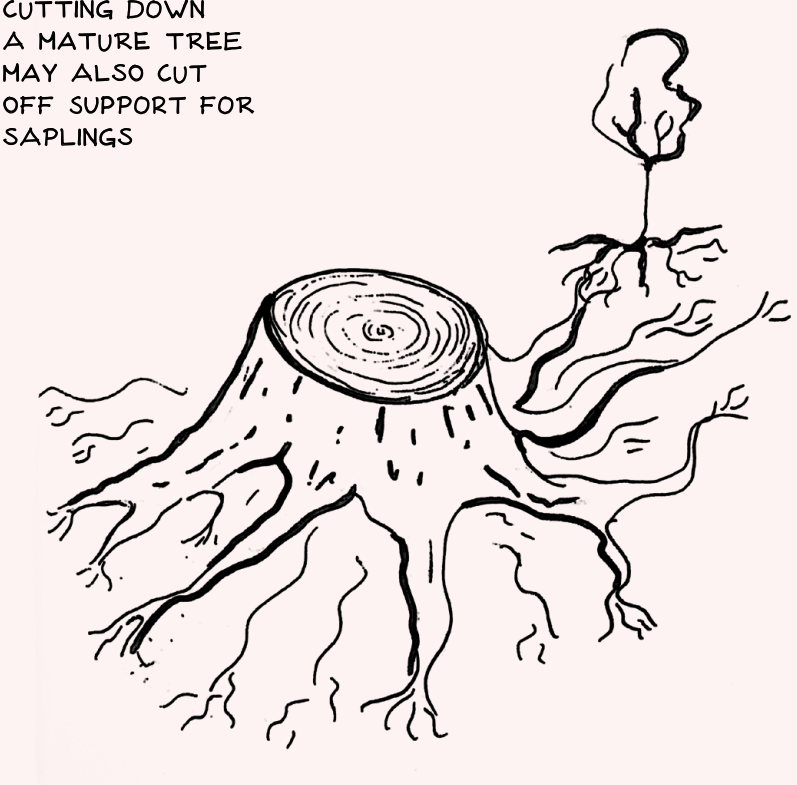
**Figure 1.4.8**  
**A Lost Mother**  
Illustration of a stump with its roots intertwined with a sapling, representing the sentiment of The Mother Tree Project in the context of mature tree removal.

Trees are also connected, especially beneath the surface. This has been long recognized by traditional indigenous ecological knowledge and has been demonstrated through empirical western research by *The Mother Tree Project*, which shows that trees not only protect one another but communicate and share resources ([mothertreeproject.org](https://mothertreeproject.org)). The relationship between trees in the urban forest warrants deeper research, especially understanding the impact mature tree removal has on surrounding saplings. As illustrated in figure 1.4.8, it is worth asking how stumps impact surrounding trees, if trees that have been cut down

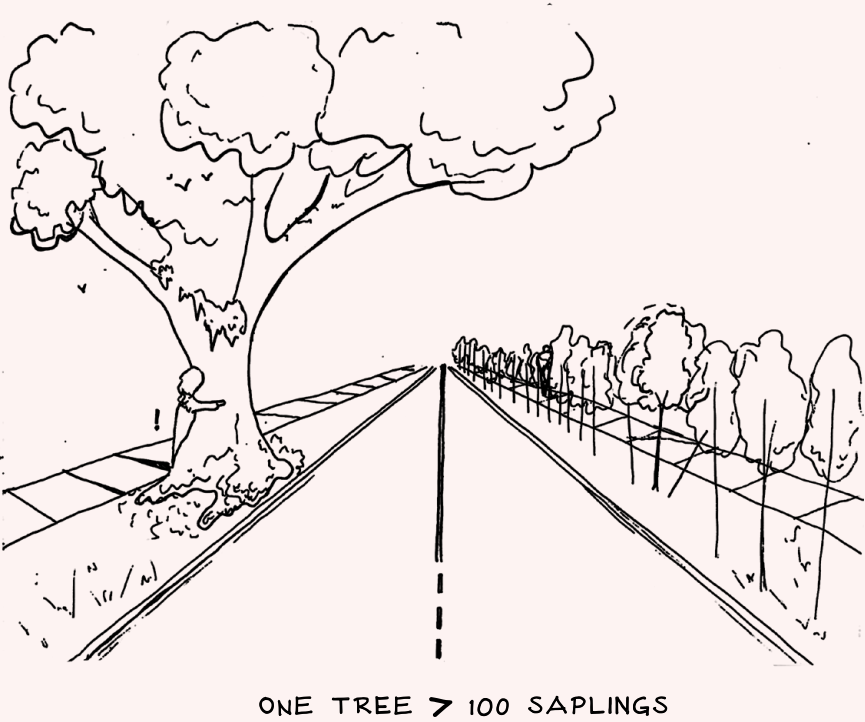
**Figure 1.4.9**  
**Saplings Cannot Replace a Tree until They Grow**  
Illustration of a mature tree across the street from a line of smaller saplings stretching out into the distance.

negative for an urban forest (figure 1.4.9).

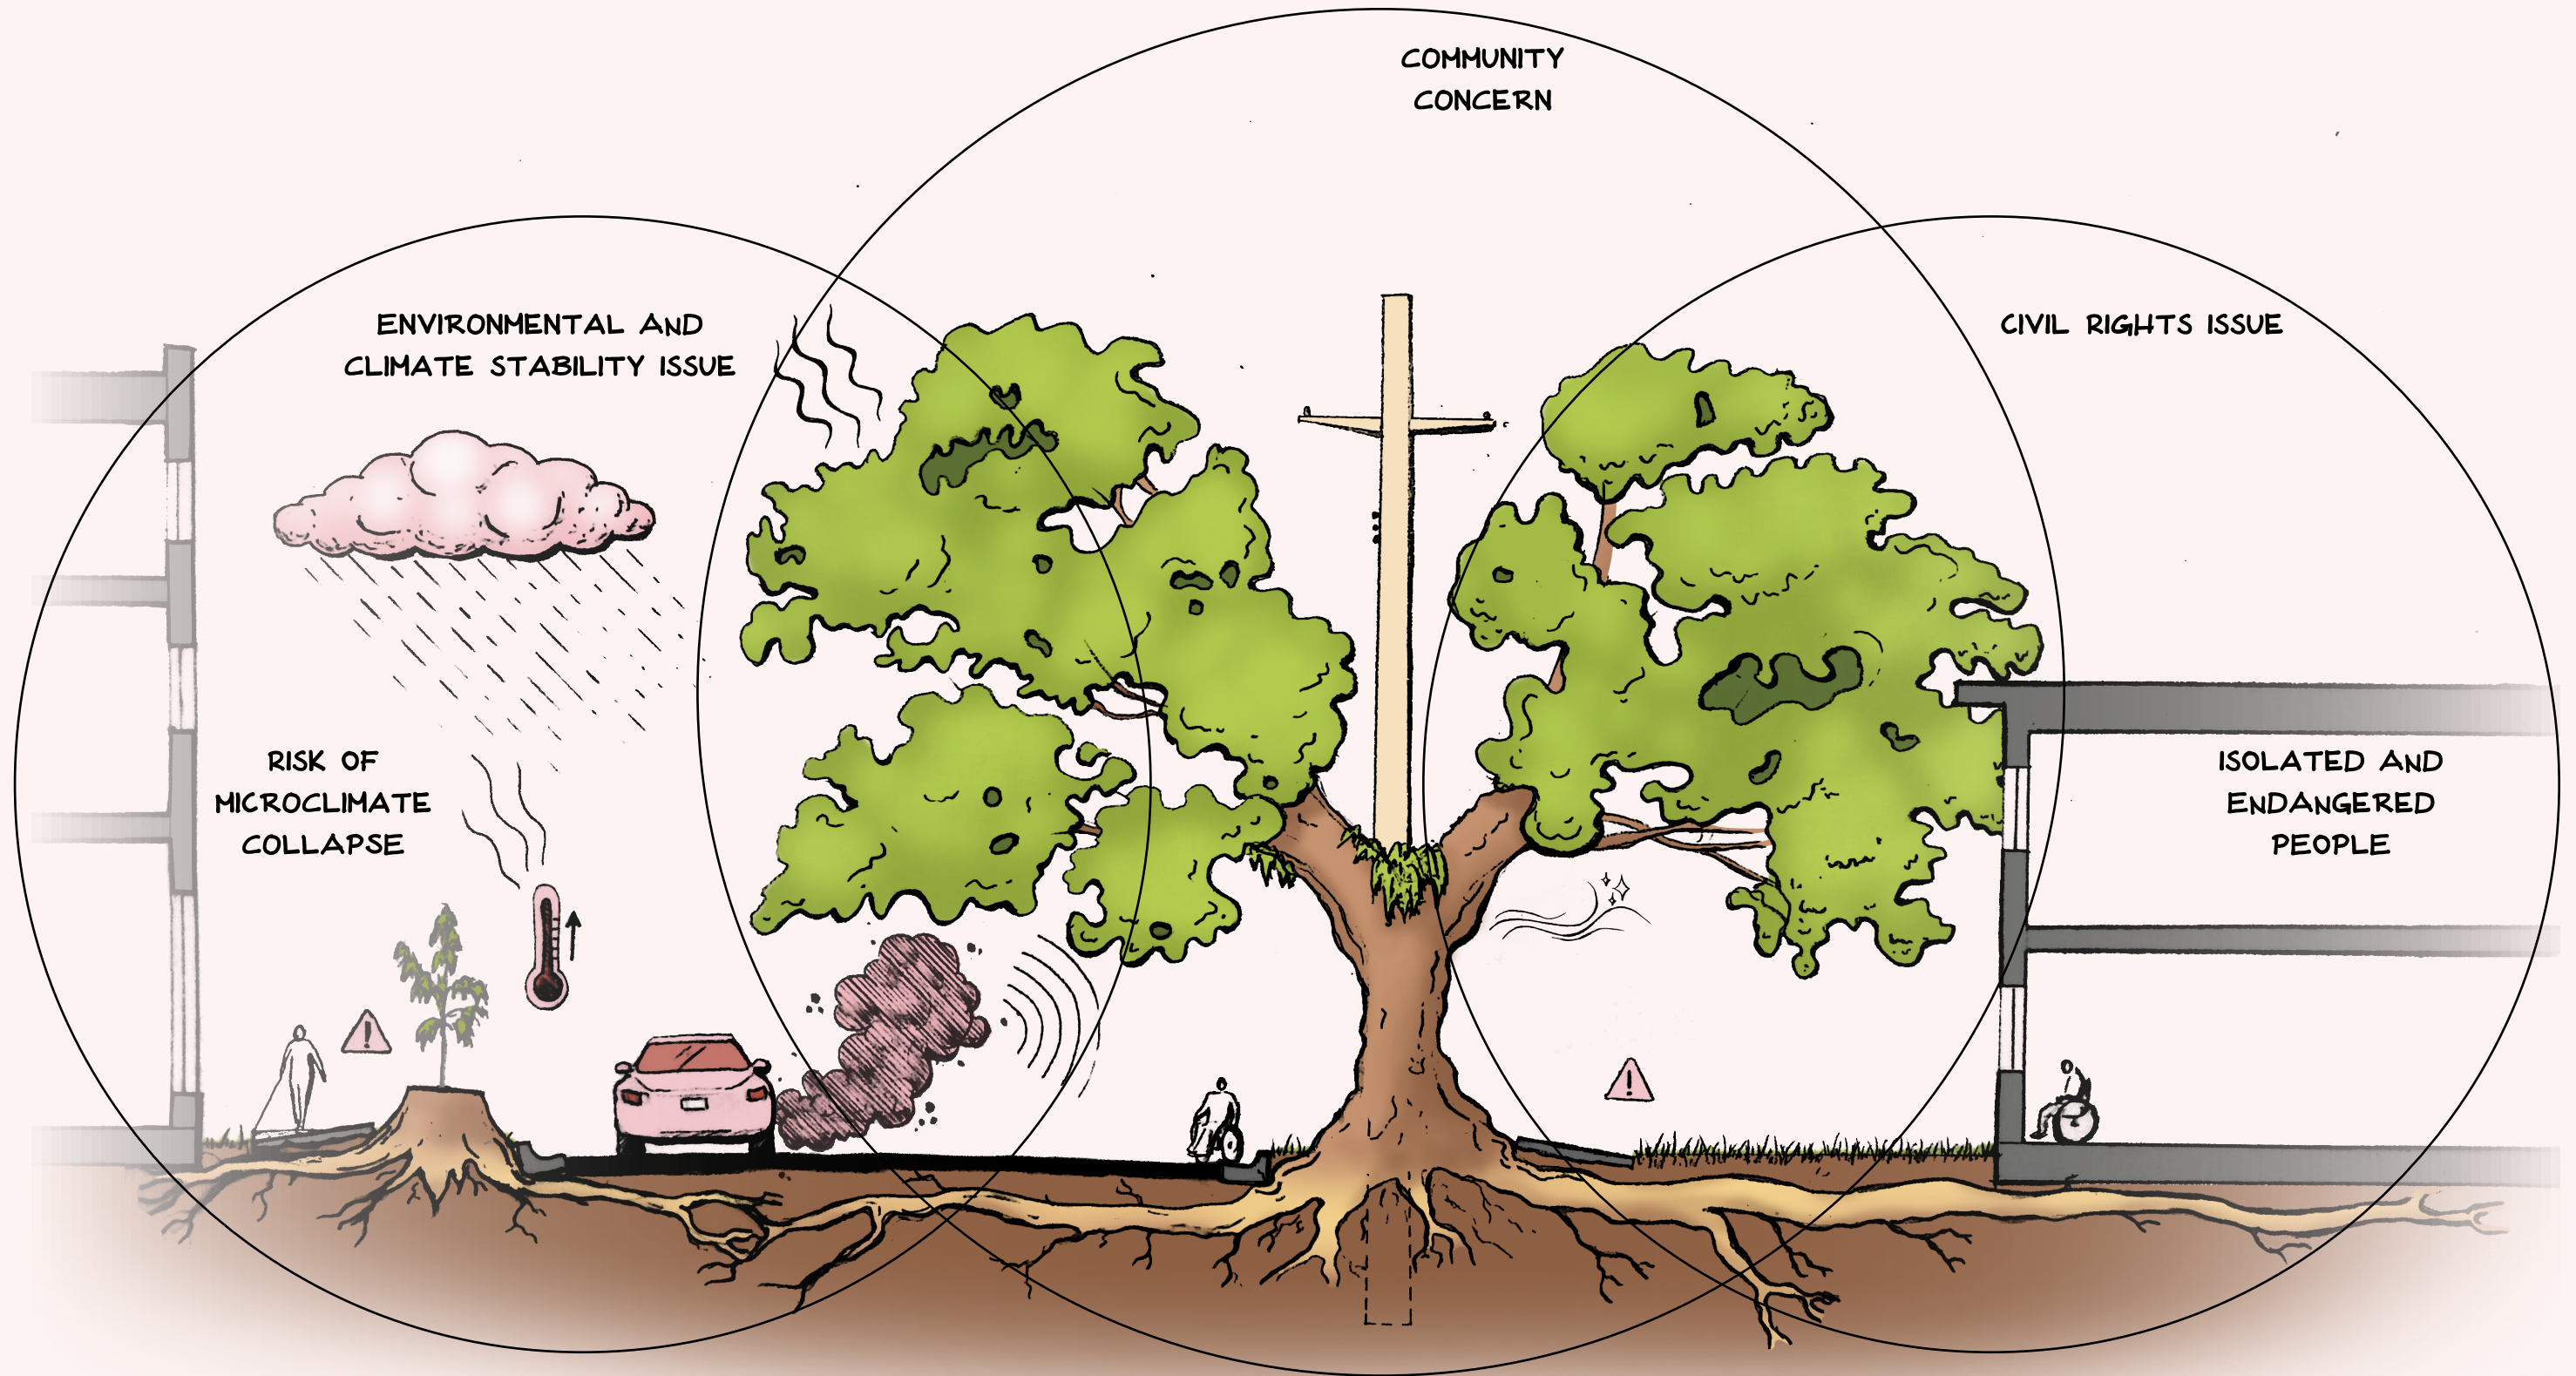
Figure 1.5.1  
Background Summary Diagram

Illustration of the complex concerns and constraints of urban street trees.

Sidewalk root heave often feels like an impossible problem with no “right” answer. It seems like an inevitable problem that sits at the **intersection between environmental and civil rights concerns** (see figure 1.5.1). Between unfortunate constraints of existing conditions and competing pressures in favor of leaving all mature trees alone or fixing all sidewalks, cities are left between a rock and a hard place. However, there are several avenues for new research that could reveal a more peaceful path forward.

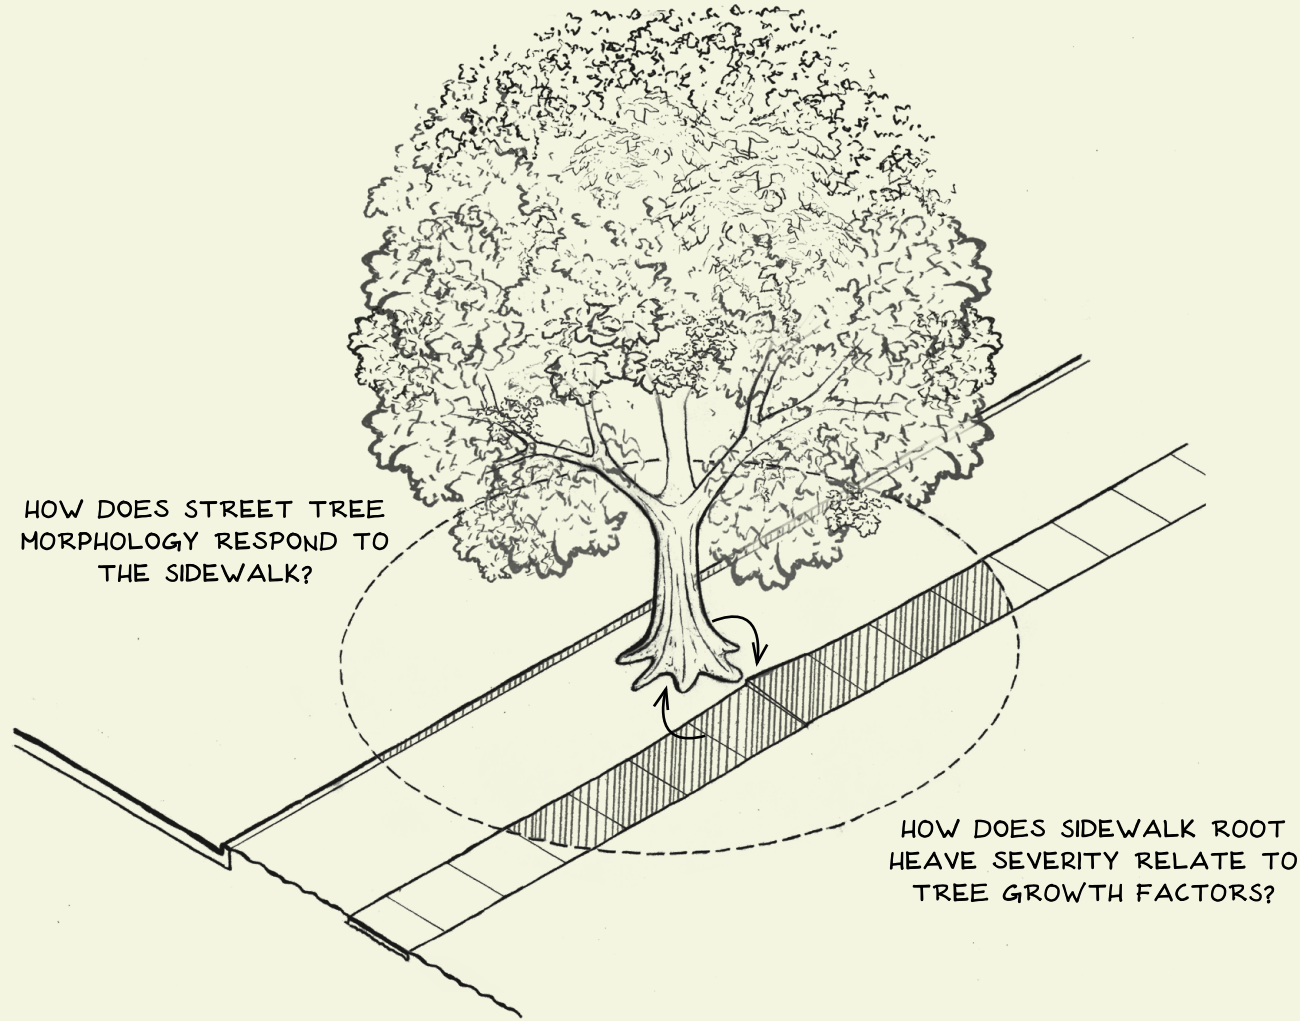
**Figure 2.1.1**  
**Research Questions**  
Isometric drawing of a street tree indicating a focus on the relationship between the base of the tree and the sidewalk.

By approaching these questions qualitatively and quantitatively, the study aimed to explore how the urban streetscape influences street tree root growth (see figure 2.1.1).

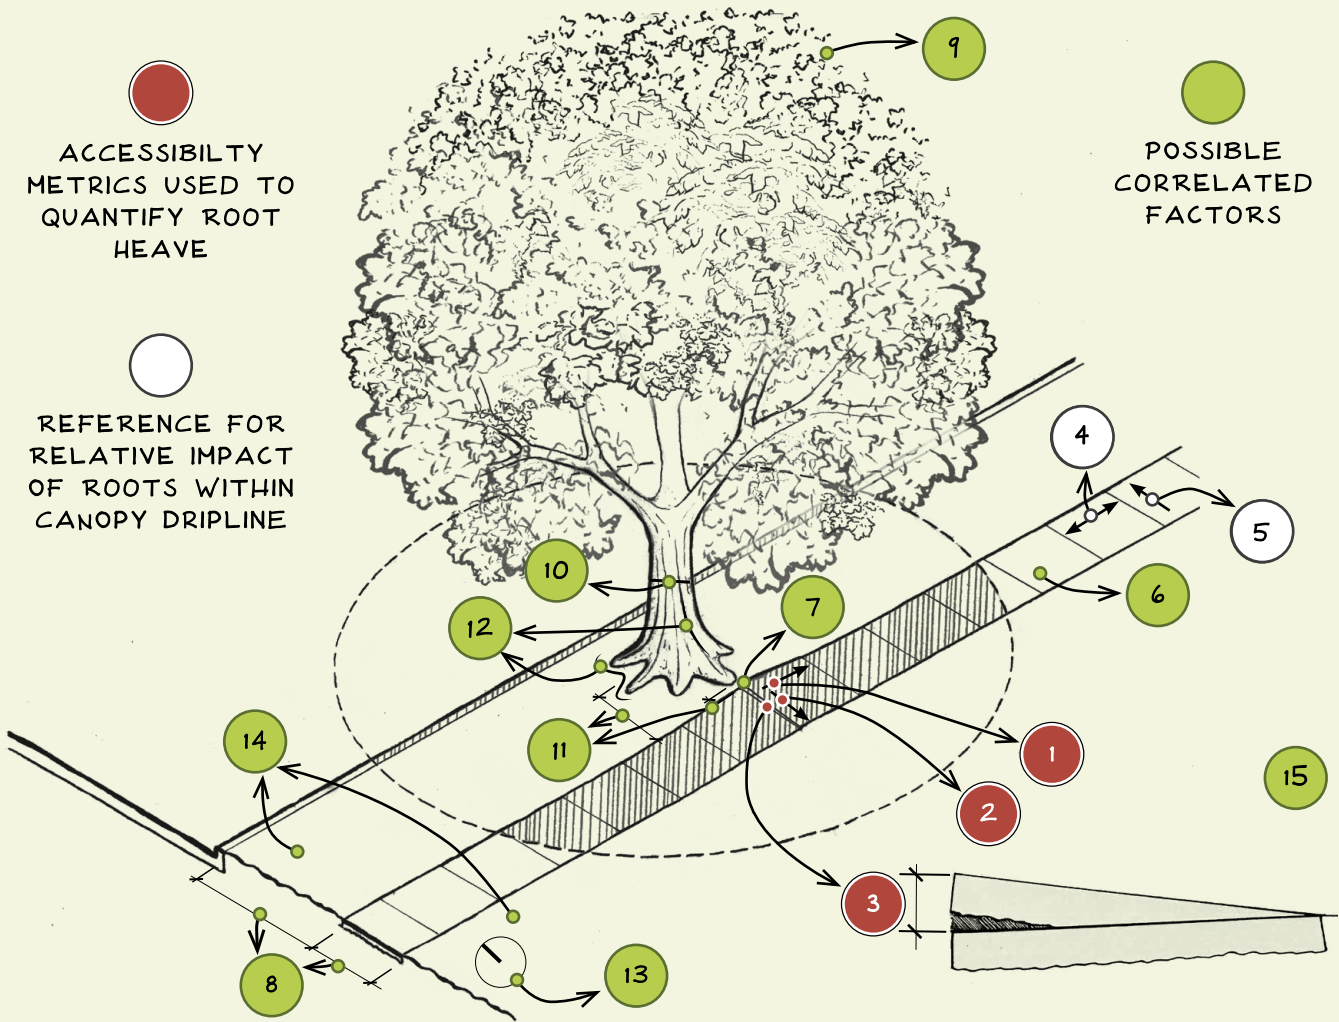
**Figure 2.1.2 Hypotheses**  
Isometric drawing of a street tree indicating a focus on the relationship between the base of the tree and the sidewalk.

among people who manage and observe street trees on a regular basis. The scope for this work can be best described by the metrics and possible correlated factors listed below and shown in figure 2.1.2.

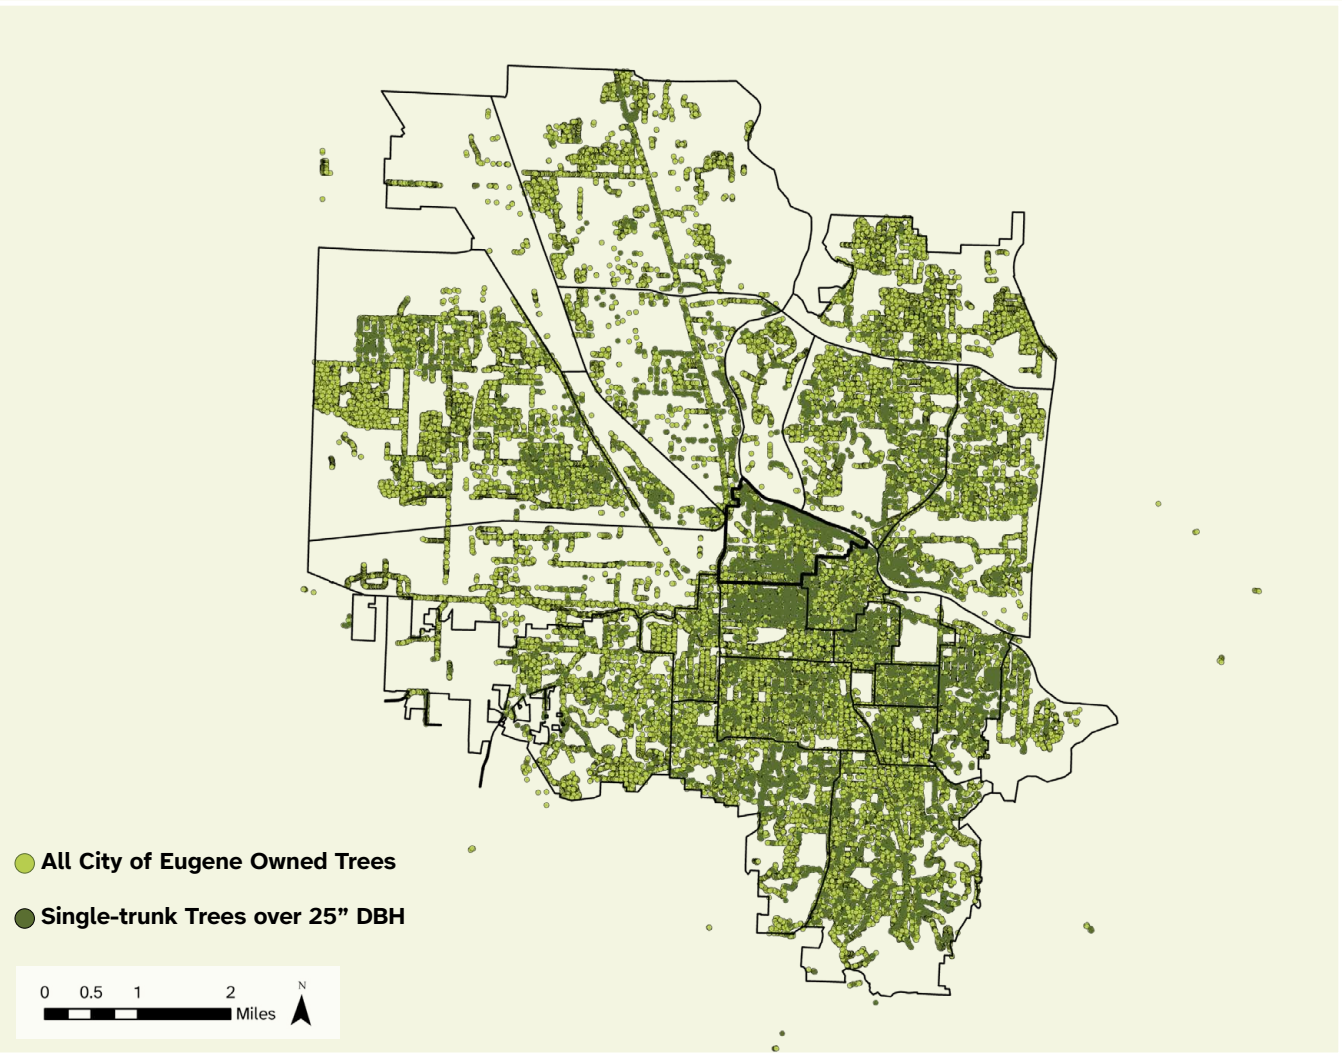
**Figure 2.2.1**  
**Scope within Eugene and Selection Process**  
Map of Eugene’s entire urban forest noting trees with one trunk over 25” in diameter with Whiteaker outlined.

To define the project scope, trees were first filtered by diameter and number of trunks. Whiteaker has a greater number of single-trunk trees over 25” in diameter than other neighborhoods (see figure 2.2.1). They were then filtered by site type to exclude stumps and planting sites, as well as.

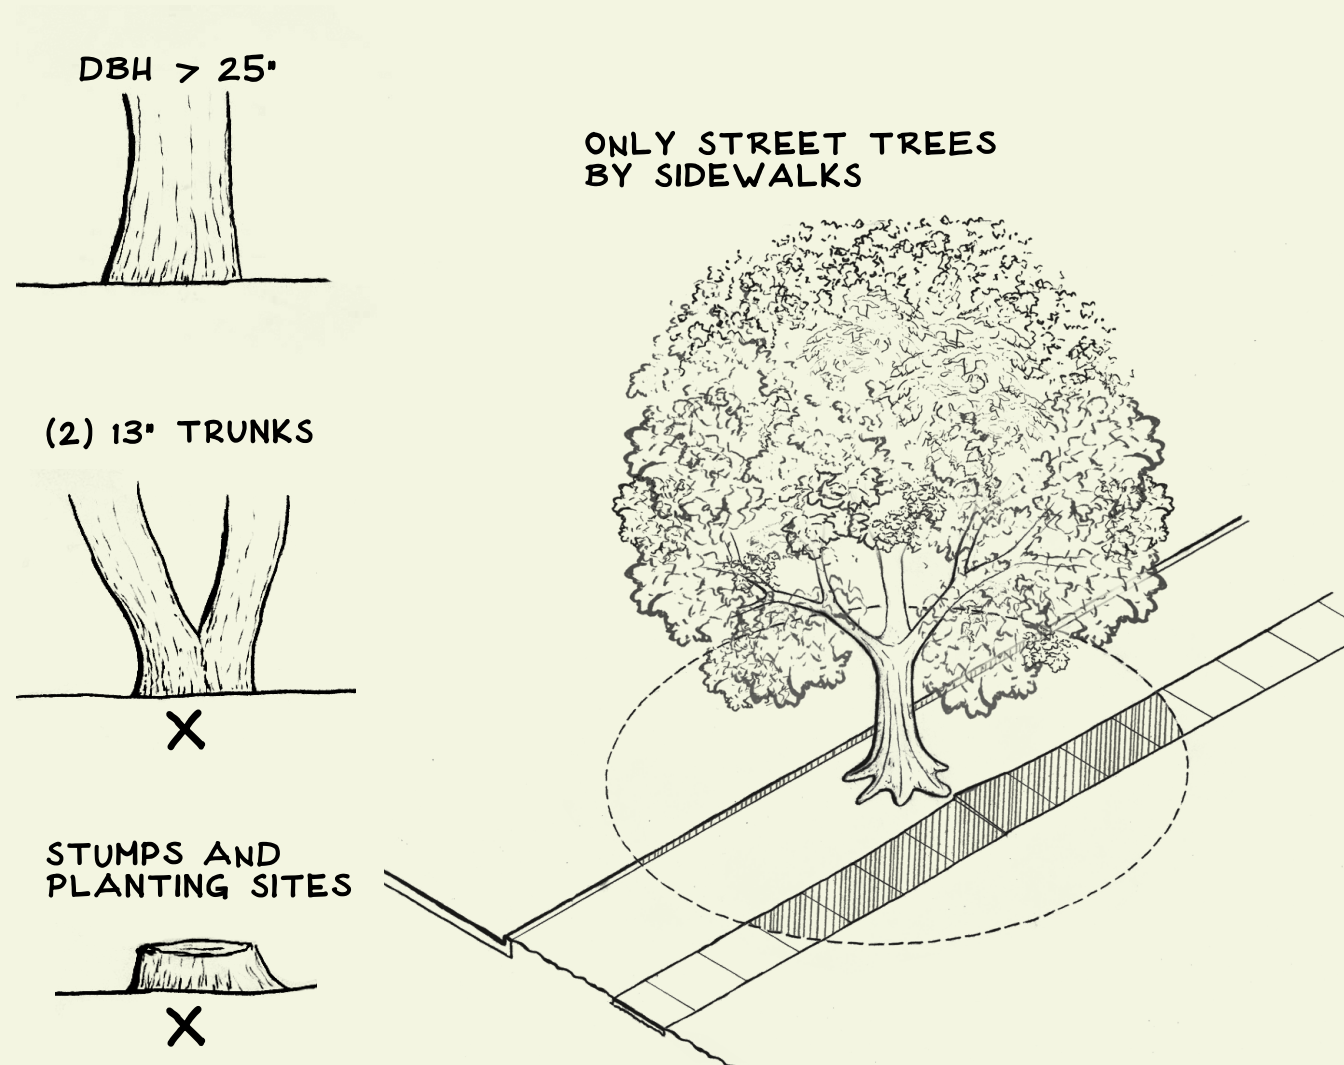
**Figure 2.2.2**  
***Scope Selection Process***  
Illustration of the factors that were filtered in and out of the city's tree database to define the project scope.

The resulting project scope is neatly defined as large street trees shading sidewalks in the Whiteaker neighborhood (see figure 2.2.2).

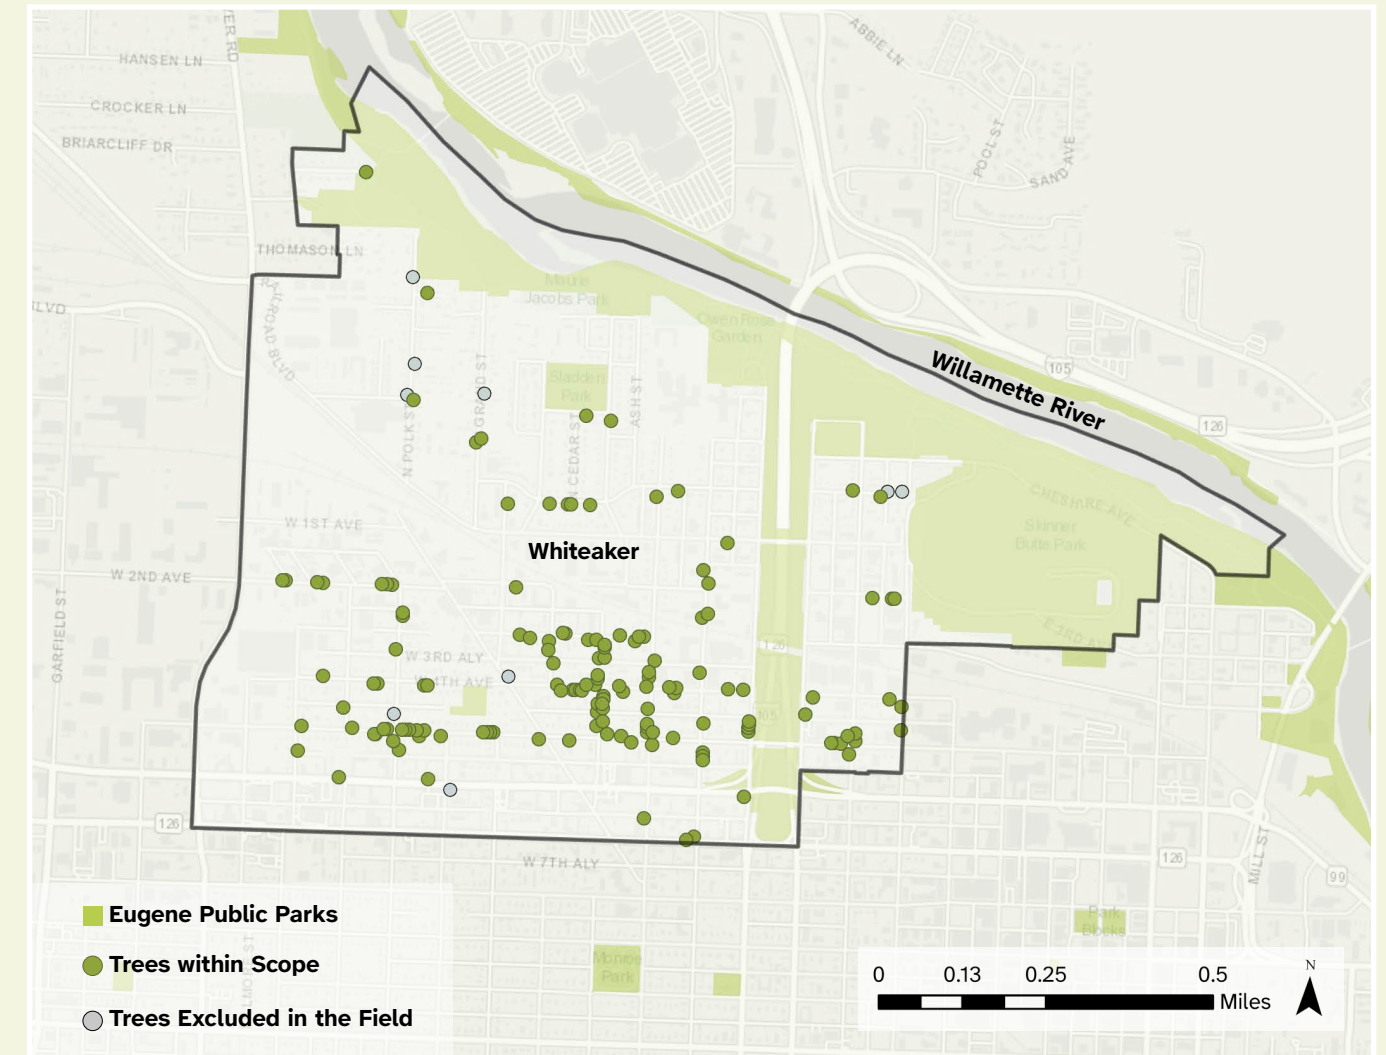
**Figure 2.2.3**  
***Selected Scope and***  
***Prevalence of Bigleaf Maple***  
Map of the 146 trees identified  
as fitting the project scope. Pie  
charts reflecting the relatively high  
prevalence of Bigleaf Maples.

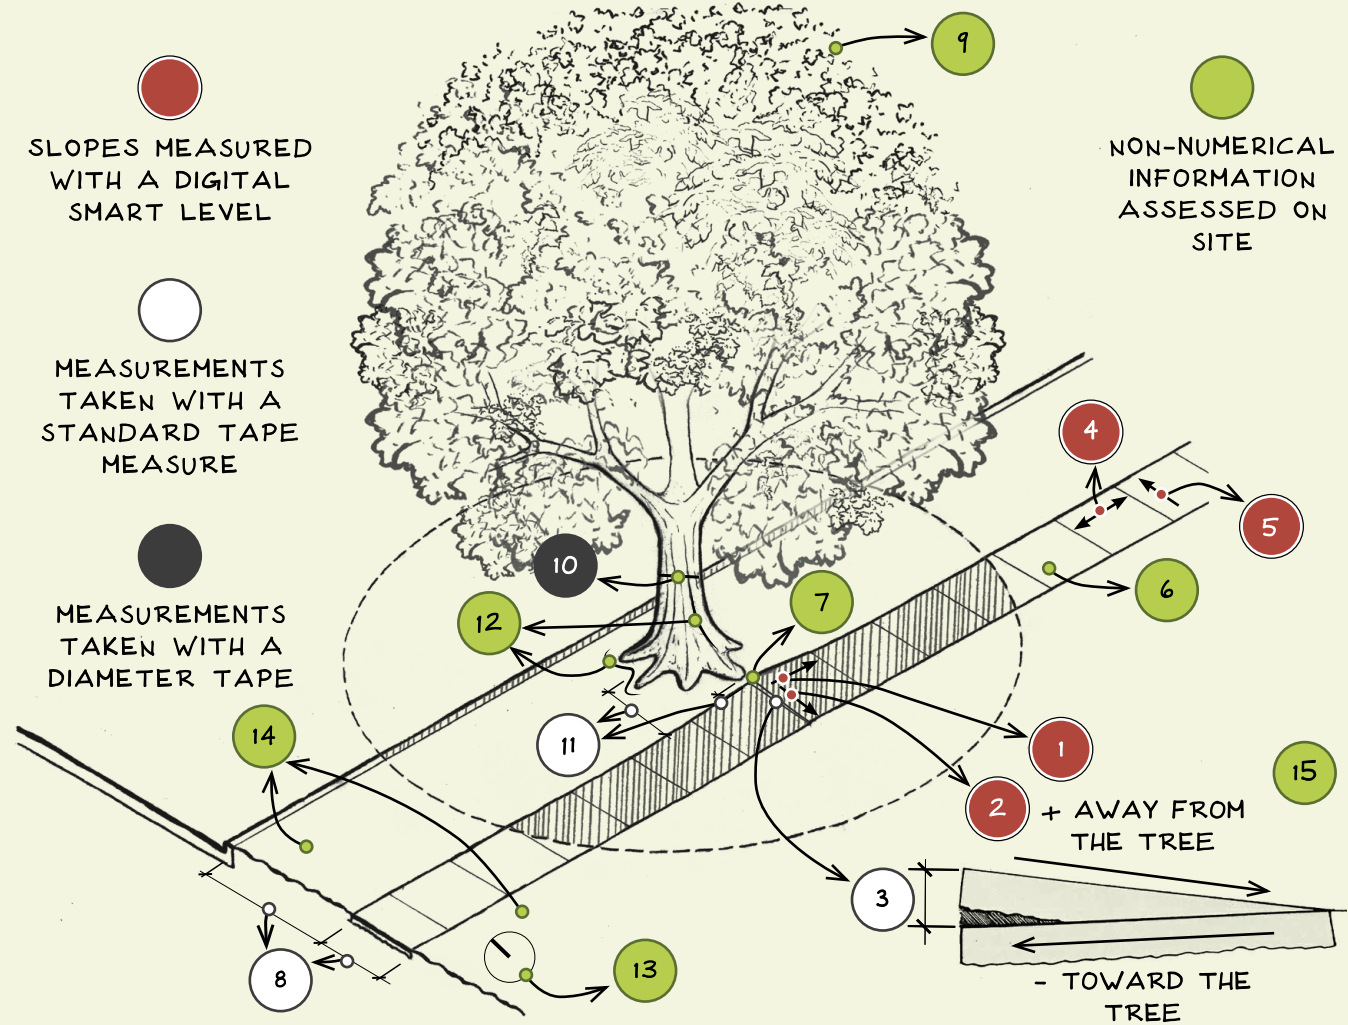
**Figure 2.3.1**  
**Methods**  
Isometric drawing of the measurements taken at each site.

**(2) maximum cross slope** was measured in the same manner for slopes perpendicular to the path of travel and assigned a positive value for slopes pointing away from the tree (see figure 2.3.1).

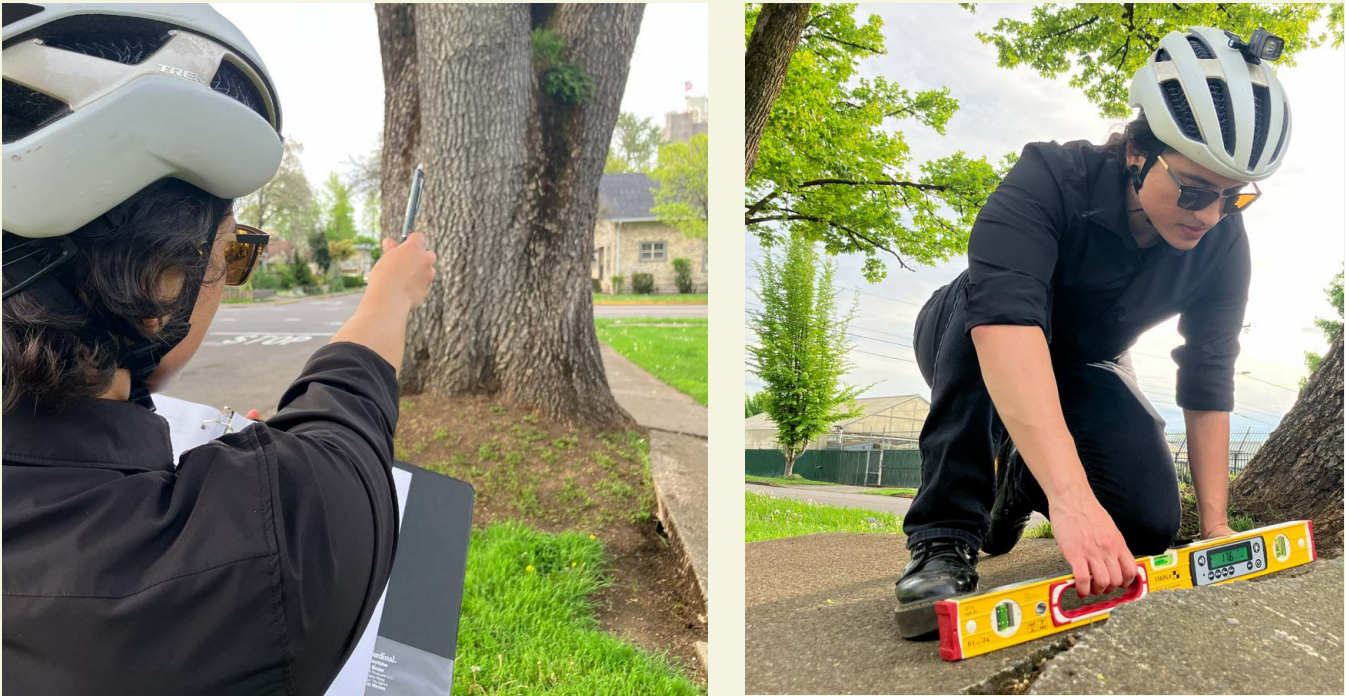
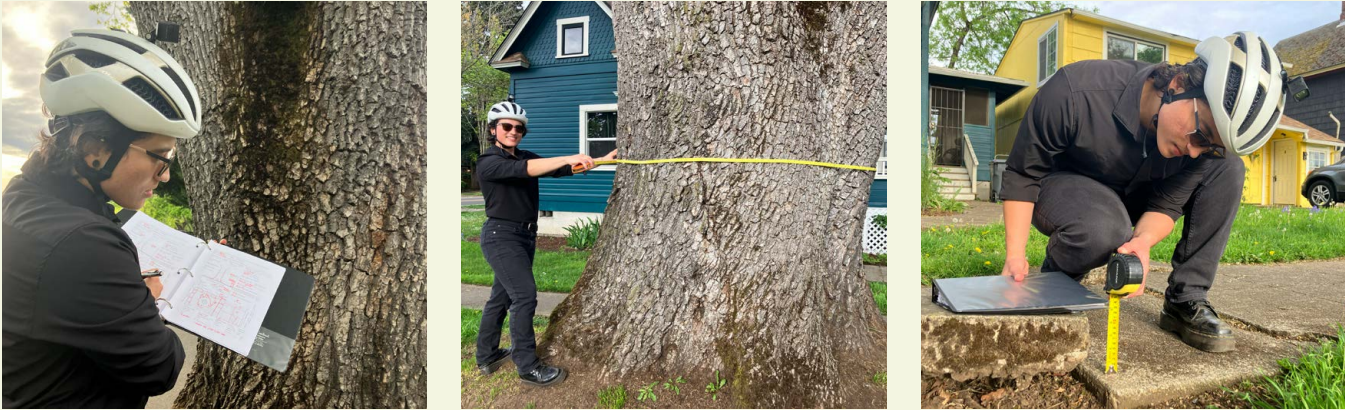
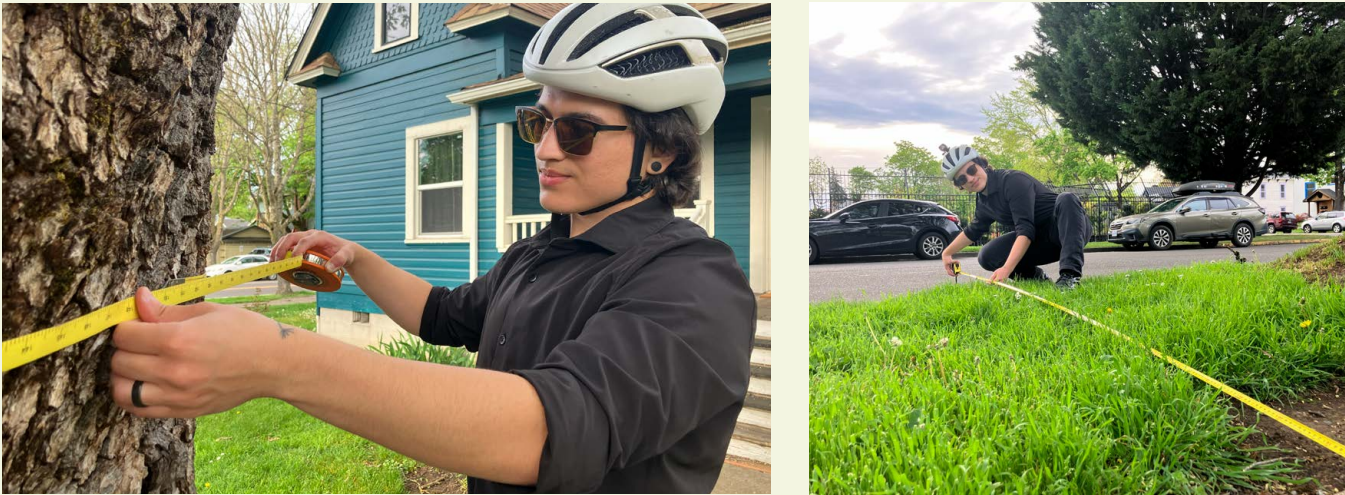
**Figure 2.3.3**  
**References for Sidewalk Age Estimation**  
Photos of sidewalks with approximately known ages used for reference when estimating the age/assessing the weathering of sidewalks evaluated in Whiteaker.

by taking simple field notes on sites and photos that were later compared to the references shown in figure 2.3.3. The “new” sidewalks resemble those known to be 5 years old or less, meaning they show no signs of weathering. “Young” sidewalks appear to be older than 5 years but younger than the “weathered” sidewalks, which had pitted or spalled surfaces and often featured a vintage pebble finish. Lastly, “historic” sidewalks match the jointing pattern, tone, and color of sidewalks known to be around one century old, including a local sidewalk stamped with the year 1914. Given that the age of most sidewalks is unknown, this was the best available means of estimating sidewalk age. However, this method was highly qualitative and somewhat subjective. “Young” is a notably broad category.

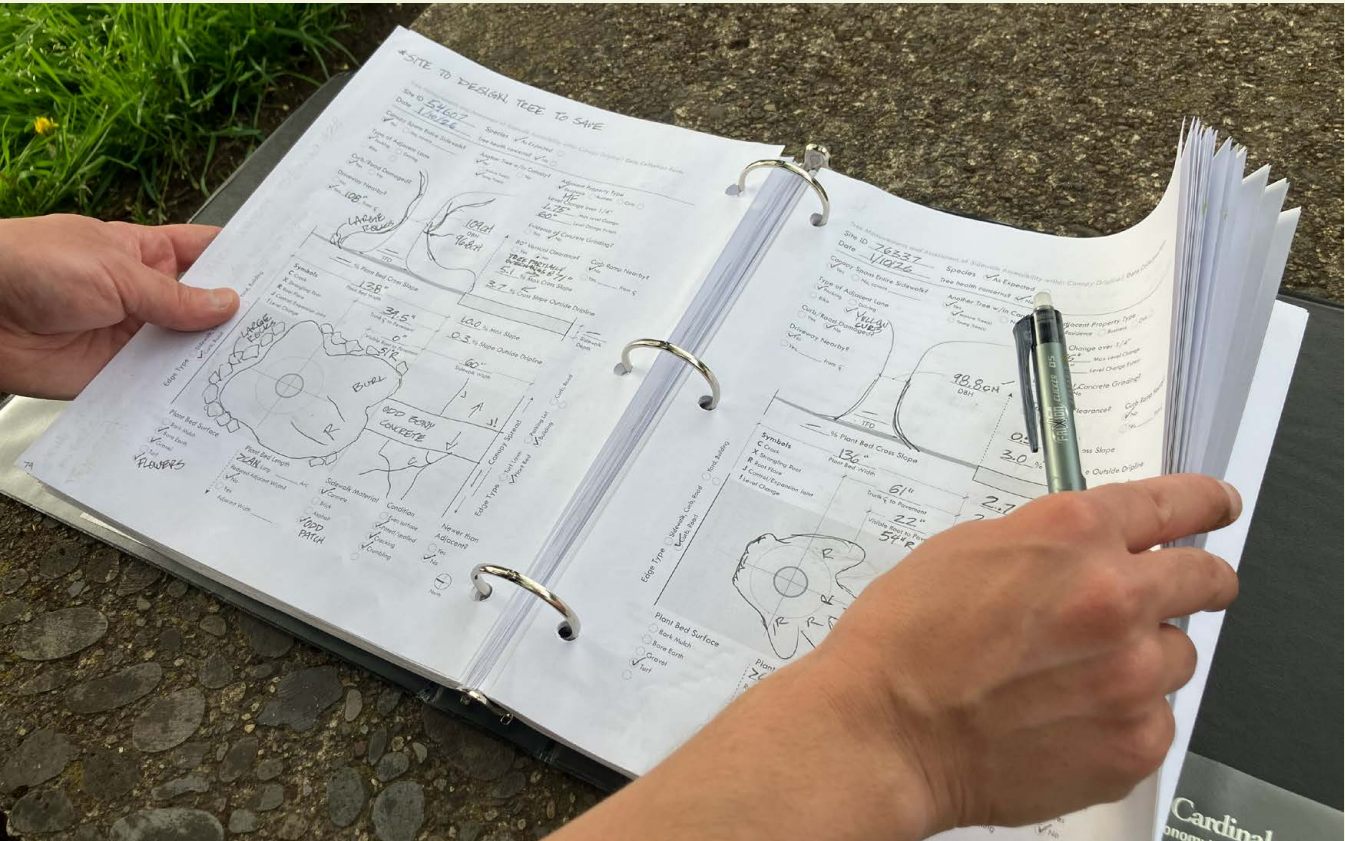
**Figure 2.3.4**  
**Methods in Action**  
Photos of research methods in the field, taken by Lilika Bechtle-Hanson.

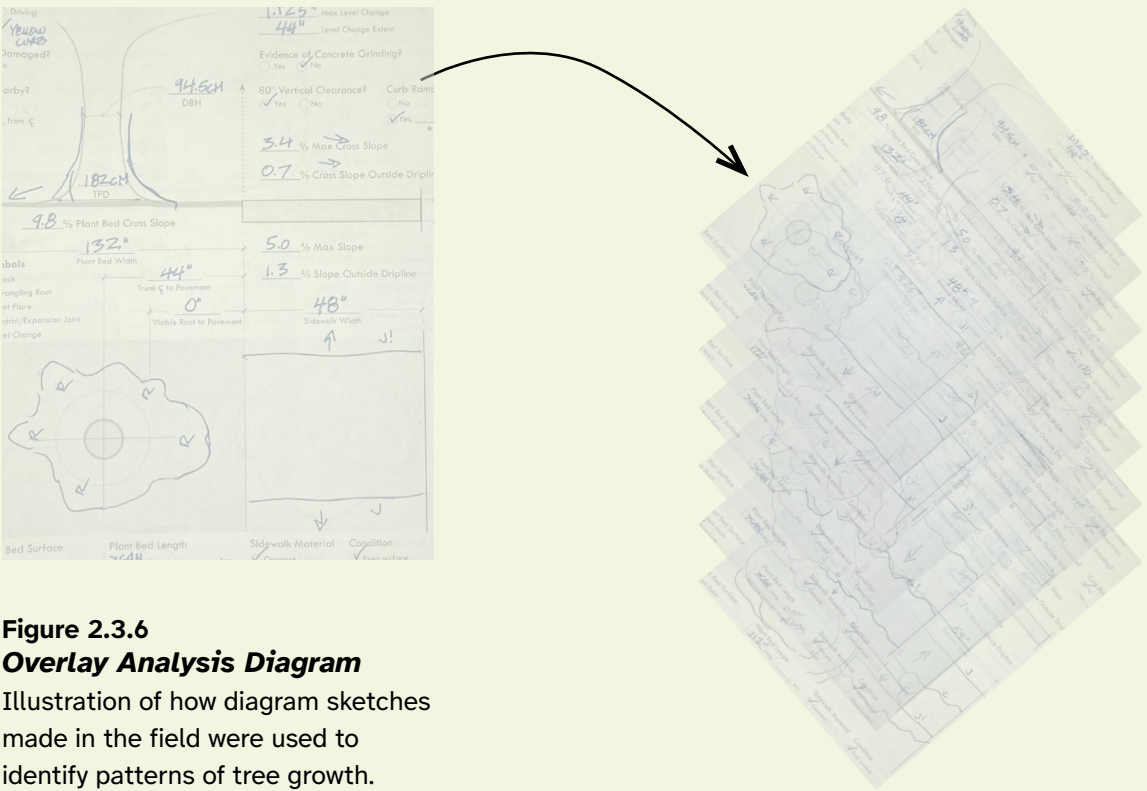
**Figure 2.3.6**  
**Overlay Analysis Diagram**  
Illustration of how diagram sketches made in the field were used to identify patterns of tree growth.
