# ROOTS AND ROUTES

*Seeking an Accessible Path to Make Peace Between  
Street Trees and Sidewalks in The Whit*

An applied research project accepted and approved in partial  
fulfillment of the requirements for the degree of  
Master of Landscape Architecture

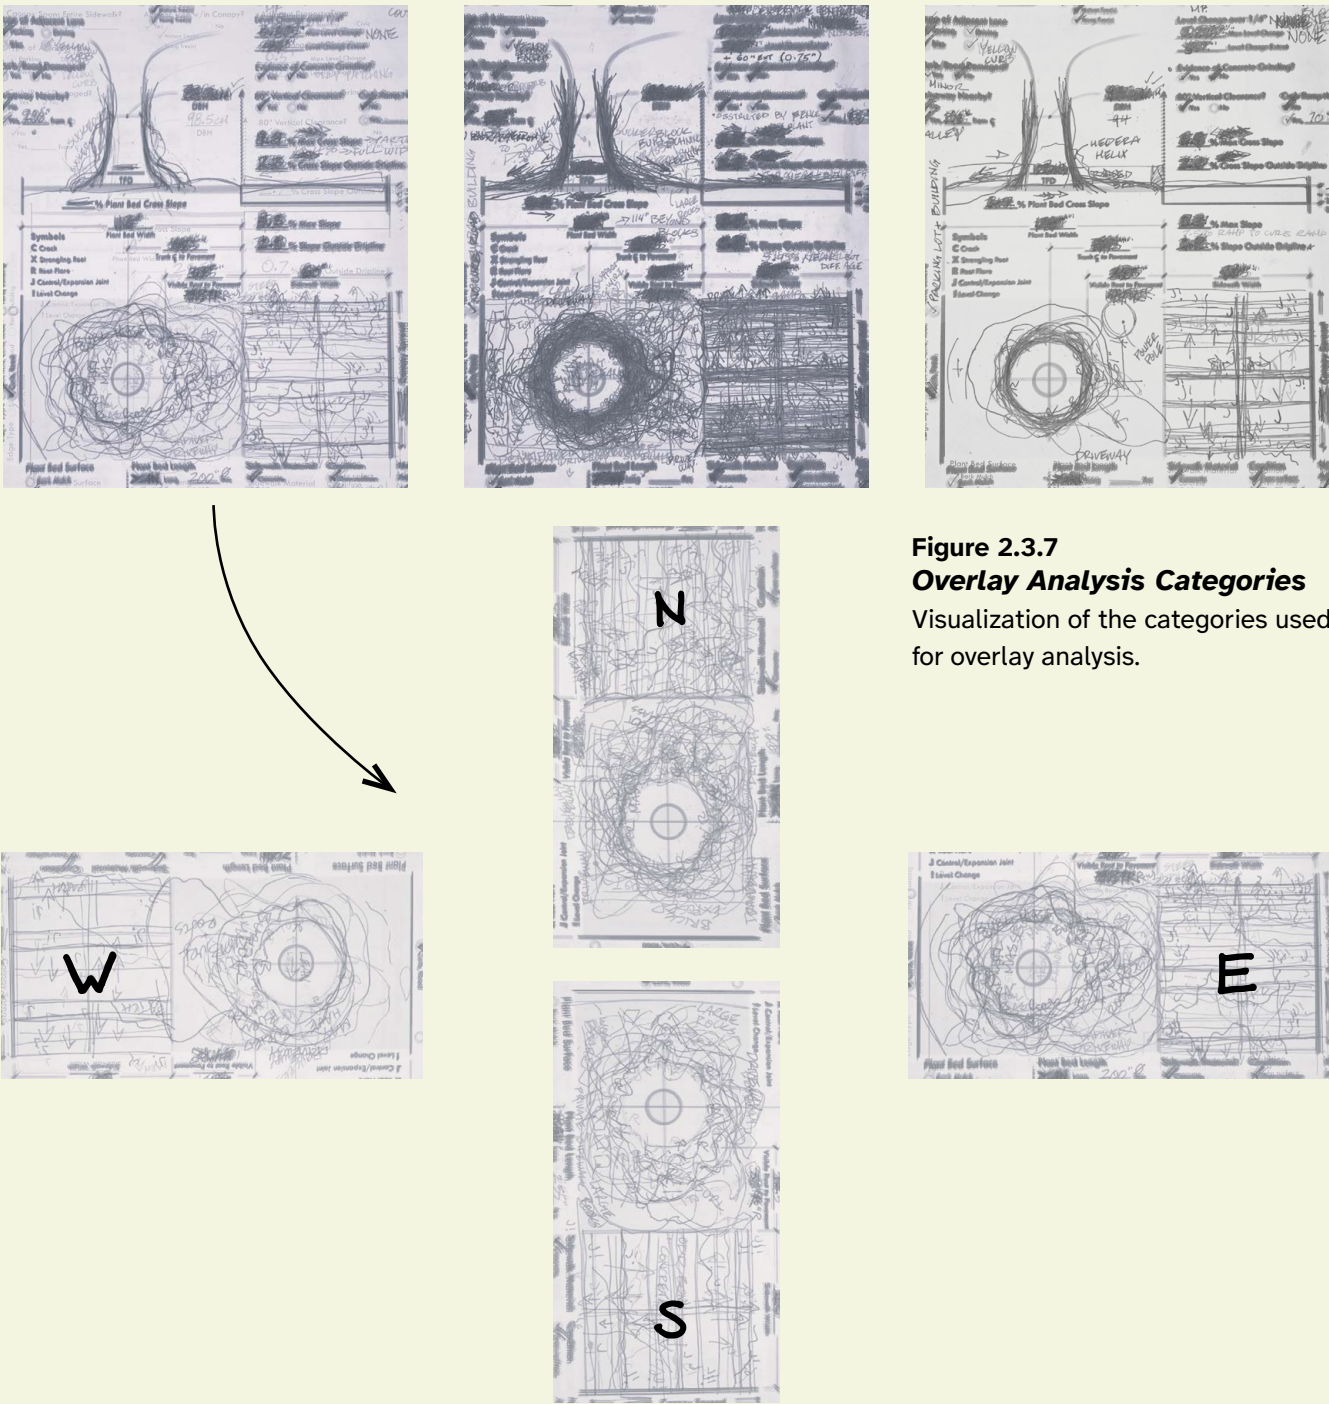
**58 BIGLEAF MAPLES      69 OTHER DECIDUOUS      19 EVERGREENS**

**Figure 2.3.7**  
**Overlay Analysis Categories**  
Visualization of the categories used for overlay analysis.

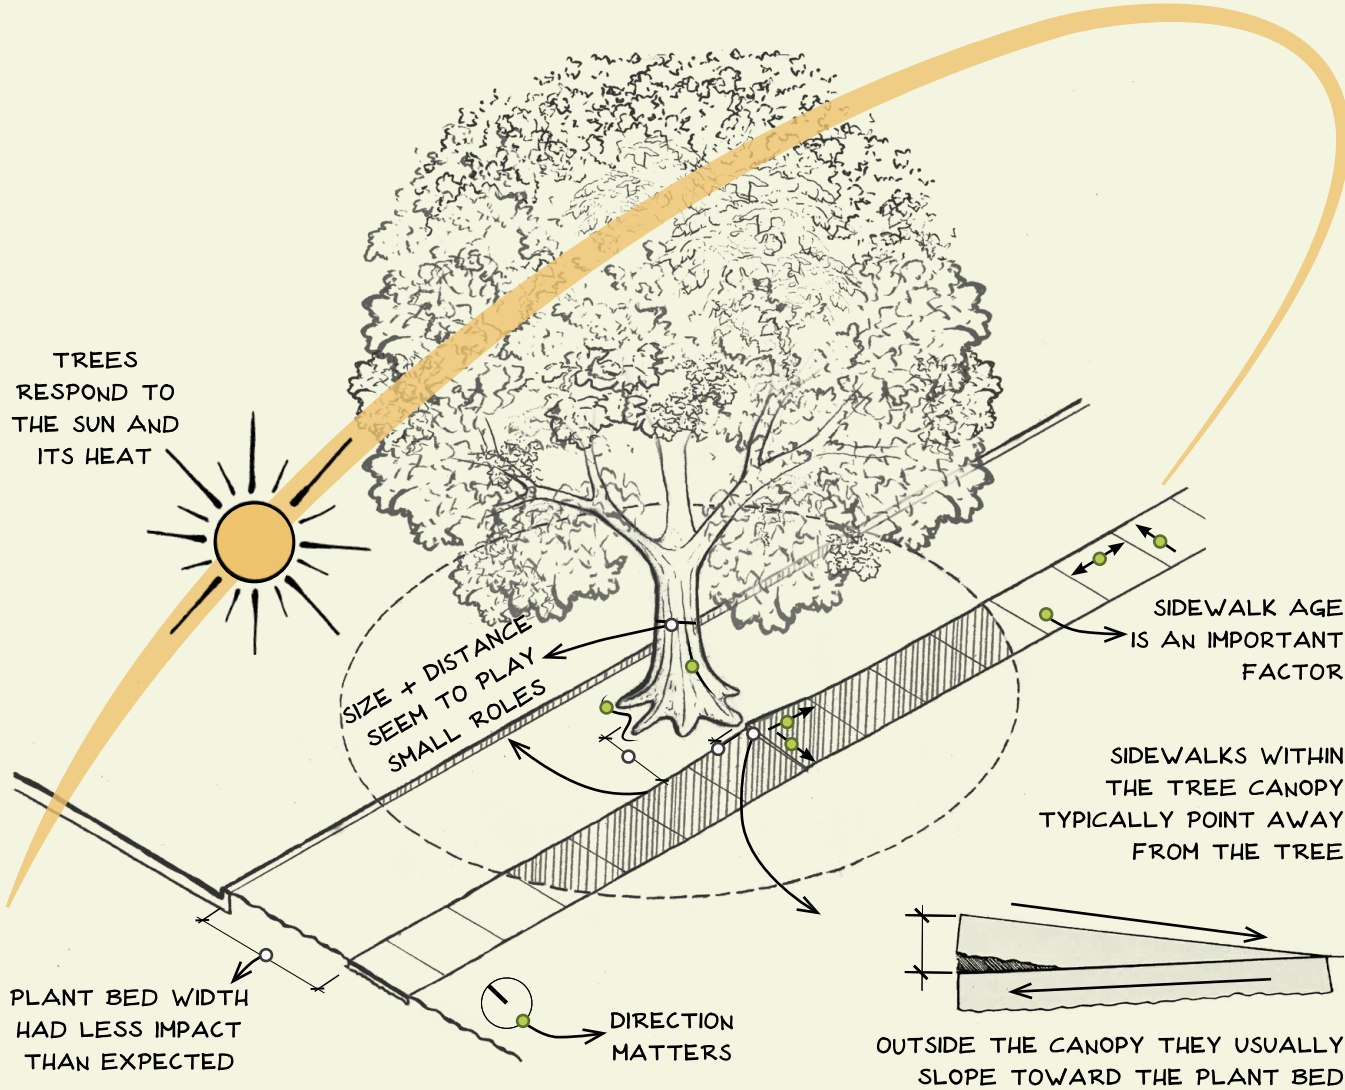
**Figure 2.4.1**  
**Overview of Results**  
Isometric drawing of the noted correlations identified in this study.

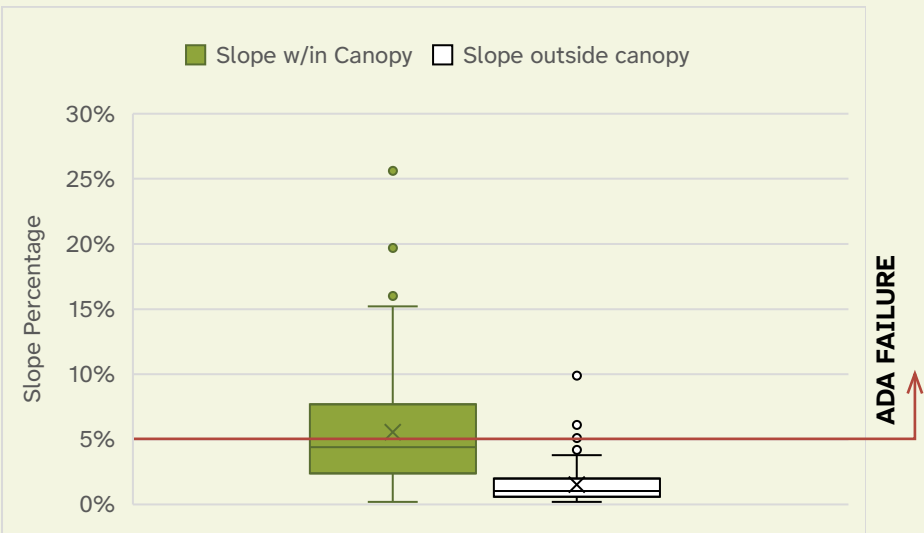
Figure 2.4.2  
**Slope Inside vs. Outside Canopy**

Box and whisker charts reflecting slope inside vs. outside the tree canopy.

The maximum measured slopes and cross slopes were higher within the tree canopy compared to outside the canopy dripline (see figures 2.4.2 and 2.4.3). The cross slope was typically positive, meaning pointing away from the tree, within the canopy and negative, or sloping toward the plant bed outside the canopy, indicating that the sidewalk is typically lifting away from the tree. This is most likely due to tree roots expanding radially, displacing soil upwards, thus lifting the pavement. Even locations where the sidewalk is tilted toward the tree may be influenced by root heave. As illustrated in figure 2.4.4, roots may not always grow straight out and can resurface after diving deep.

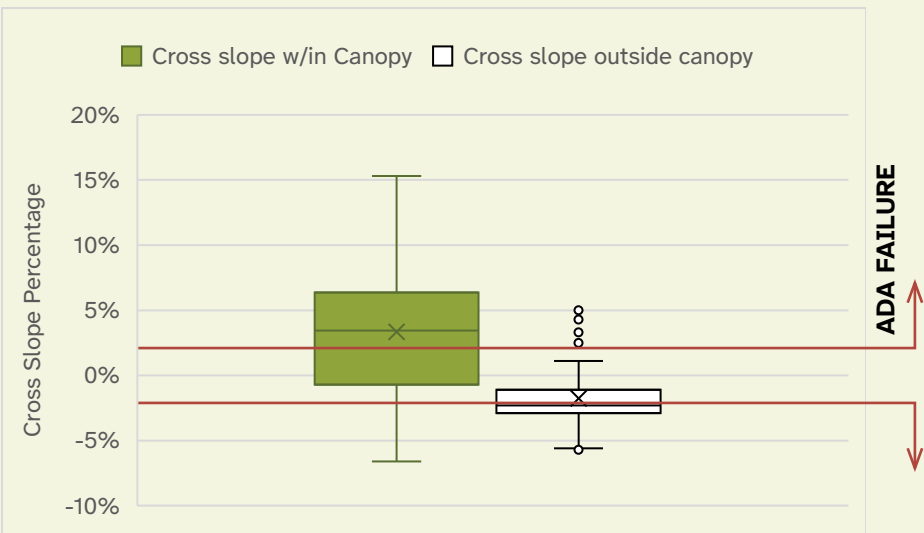
Figure 2.4.3  
**Cross Slope Inside vs. Outside Canopy**

Box and whisker charts reflecting cross slope inside vs. outside the tree canopy.

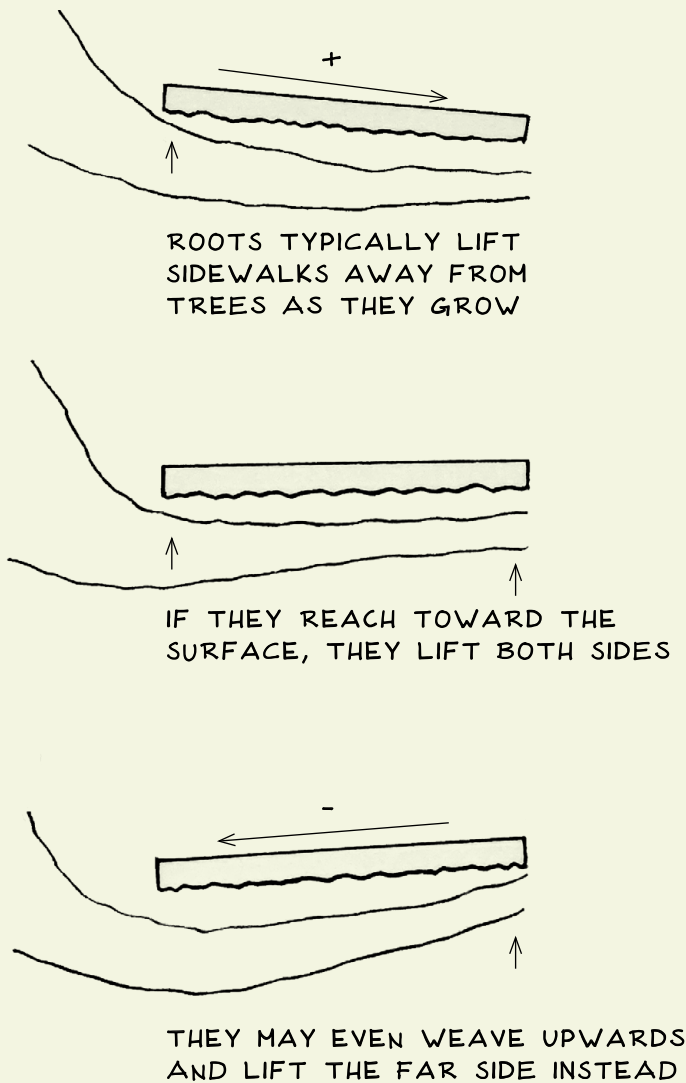
Figure 2.4.4  
**Overview of Sidewalk Cross Slope**

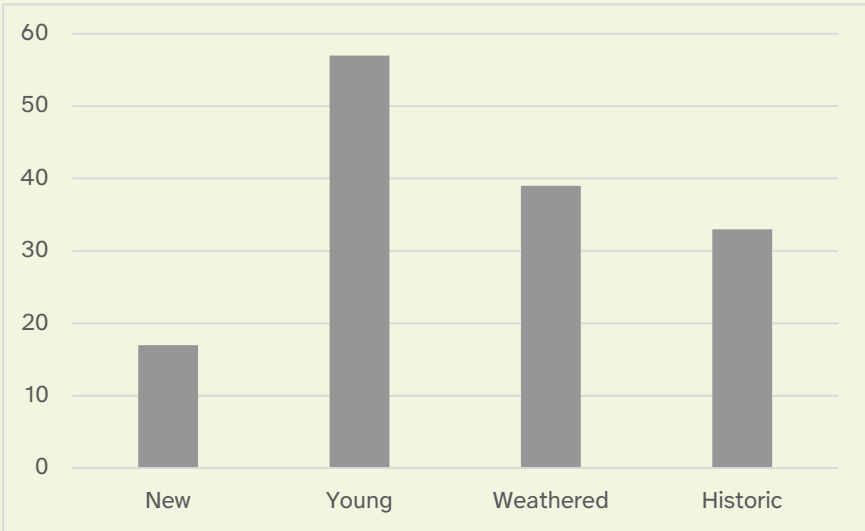
**Figure 2.4.5**  
**Representation of Estimated Sidewalk Age Categories**  
Bar chart reflecting the number of sidewalks estimated to fit each approximate age category.

Sidewalk age appears to play a substantial role in the rate and severity of sidewalk root heave, but sidewalks of any age can be lifted to the point of failure. As shown in figure 2.4.5, the most represented approximate sidewalk age category is “young,” especially near deciduous tree species (see figure 2.4.6). “Young” sidewalks include all sidewalks that did not appear to be “new,” meaning five years old or less, or “weathered” meaning pitted or spalled. The number of modes of failure is significantly related to the sidewalk’s approximate age (see figure 2.4.7.), but further research is required to determine a sidewalk’s actual lifespan and how that may be influenced by tree root growth.

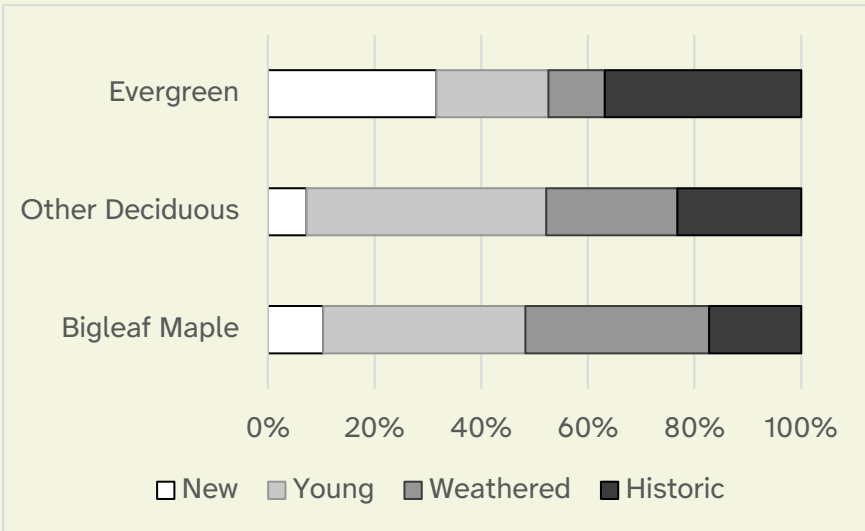
**Figure 2.4.6**  
**Estimated Sidewalk Age by Species Category**  
100% Stacked horizontal bar chart showing the proportion of sidewalks that appear to be new, young, weathered, or historic at trees in different species categories.

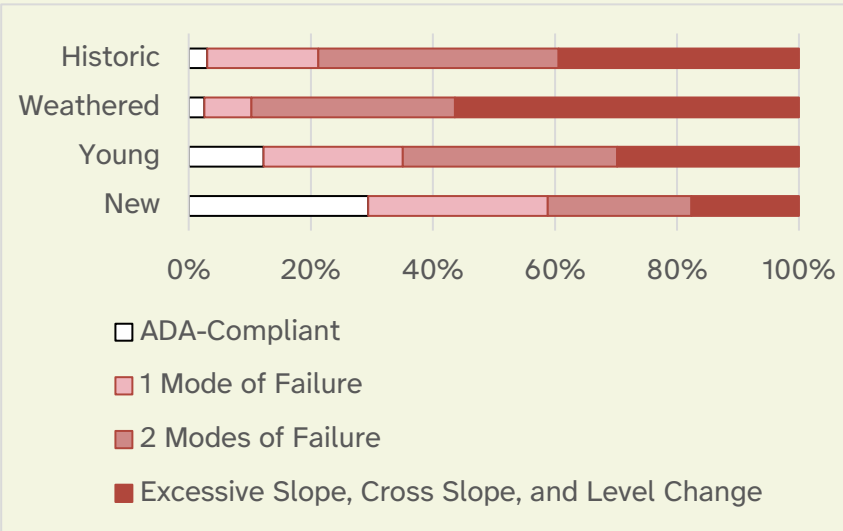
**Figure 2.4.7**  
**Number of Modes of Failure by Estimated Sidewalk Age**  
100% Stacked horizontal bar chart reflecting the number of modes of path failure at sites with sidewalks estimated to be new, young, weathered, or historic.

These results are important primarily because they show that **sidewalk age is likely a complicating factor that influences the severity of root heave adjacent to a tree**; this must be taken into account when considering all other results. The distribution of sidewalk age groups also provides interesting information, like the apparent increased sidewalk ages to the east of trees. Note that the direction of the sidewalk relative to the tree also likely changes the concrete’s surface quality and may have thus skewed age estimation. More research is needed into the site-specific factors that influence sidewalk age and failure rate, especially solar exposure.

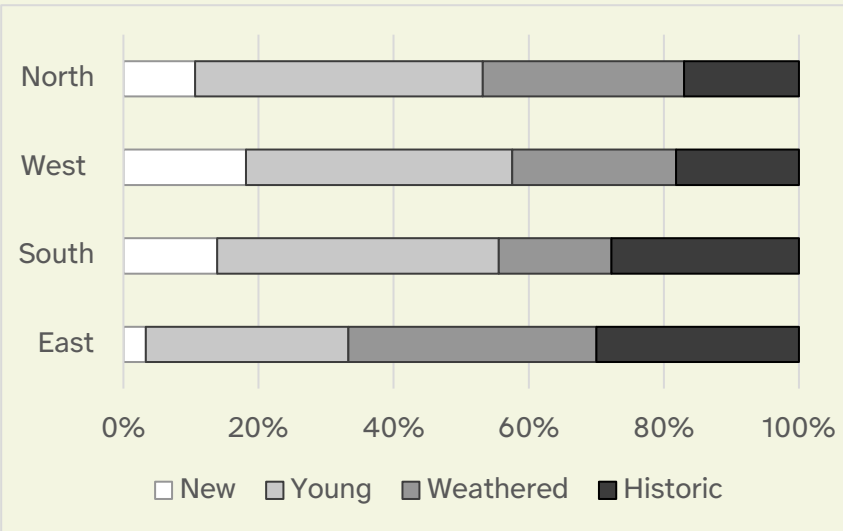
**Figure 2.4.8**  
**Estimated Sidewalk Age by Direction**  
100% Stacked horizontal bar chart showing the proportion of sidewalks that appear to be new, young, weathered, or historic at trees in different directions relative to their adjacent trees.

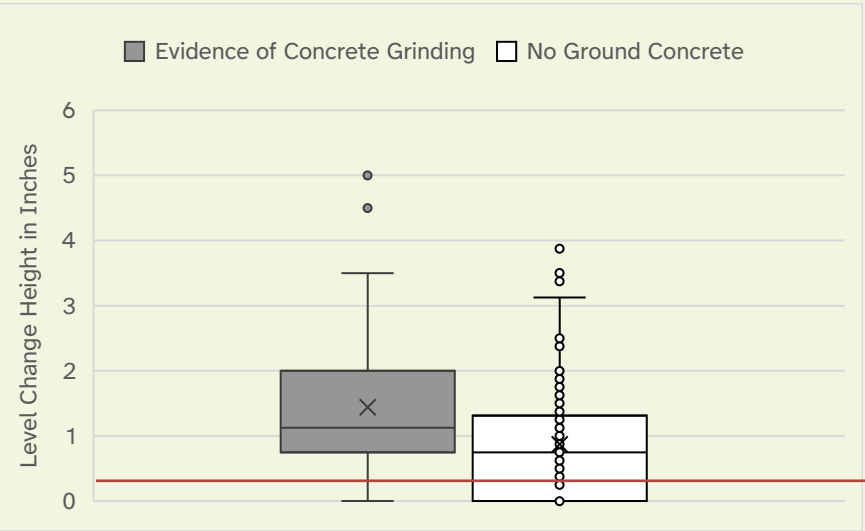
**Figure 2.4.11**  
**Accessibility of Sidewalks with and Without Evidence of Concrete Grinding**  
Box and Whisker Chart showing the height of level changes at sites with vs. without signs of concrete grinding, showing that sites with concrete grinding had notably higher level changes.

Higher level changes were measured at sites with signs of concrete grinding (see figure 2.4.11) and these sites had more modes of failure than sites without signs of concrete grinding (figure 2.4.12). These results do not imply that concrete grinding worsens accessibility in itself; it suggests that sidewalks continue to lift after concrete grinding, implying it is only a short-term solution to root heave. More research is required to confirm how long concrete grinding is effective at eliminating level changes, but few sites with concrete grinding were found without level changes, which often occurred where concrete had already been ground down.

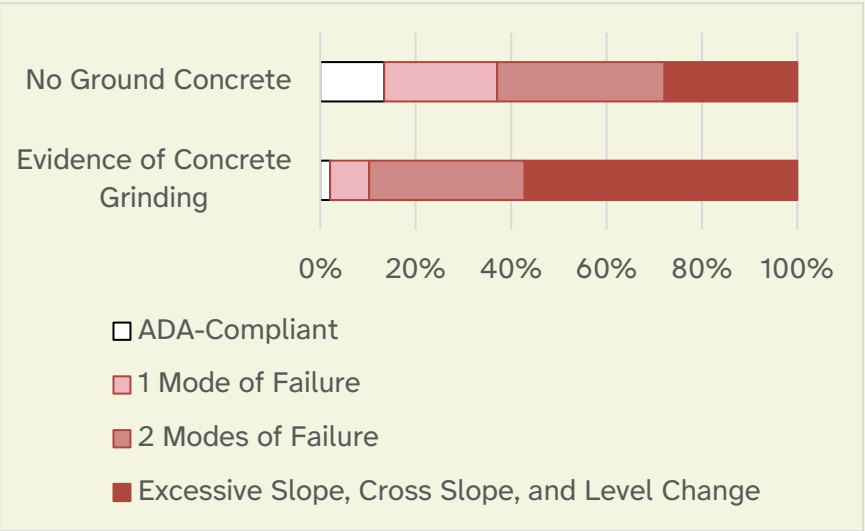
**Figure 2.4.12**  
**Accessibility of Sidewalks with and Without Evidence of Concrete Grinding**  
100% Stacked horizontal bar chart showing the accessibility of sidewalks with vs. out concrete grinding showing that sites with evidence of concrete grinding had substantially more accessibility failures.

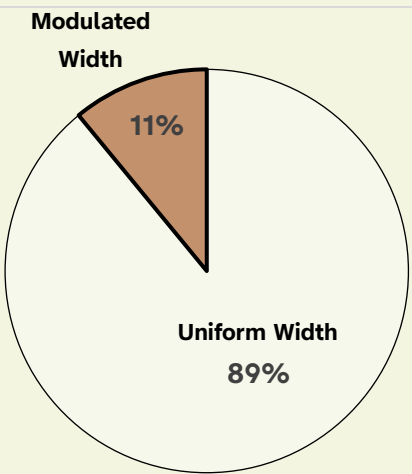
Figure 2.4.13  
*Prevalence of Modulated Width*

Pie chart showing the proportion of sites that had some widening of the plant bed at the tree.

Modulated width implies that the sidewalk was repaired near the tree, likely due to root heave, and the sidewalk’s footprint was modified to accommodate the tree (see figure 2.4.15). Modulated width was found at 11% of sites (see figure 2.4.13). Sites with modulated width had more modes of failure on average (see figure 2.4.14). While more research is needed to confirm these results with a wider sample size of modulated sidewalks, this evidence suggests that root heave is likely to recur after sidewalk repair.

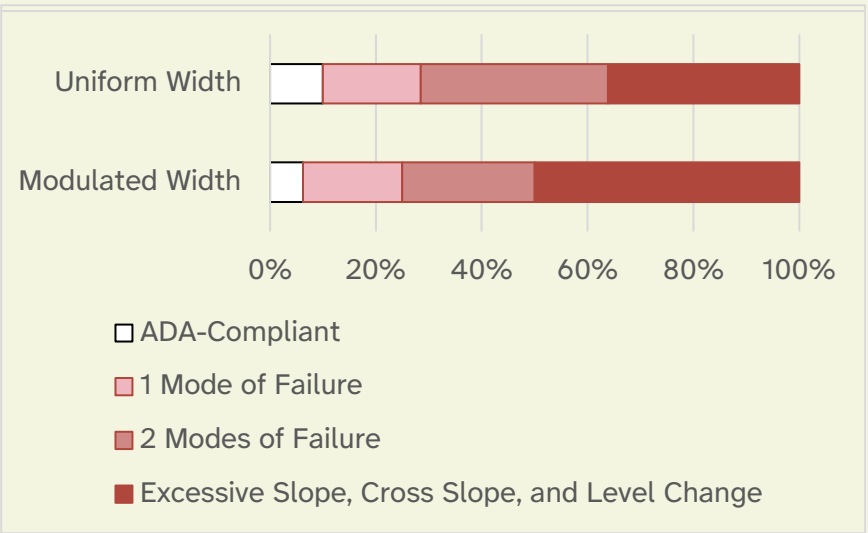
Figure 2.4.14  
*Accessibility of Sidewalks with and Without Modulated Width*

100% Stacked horizontal bar chart showing the accessibility of sidewalks with vs. out modulated width to widen the plant bed at the tree showing that sites with modulated width have slightly more accessibility failures, rather than less as may be expected.

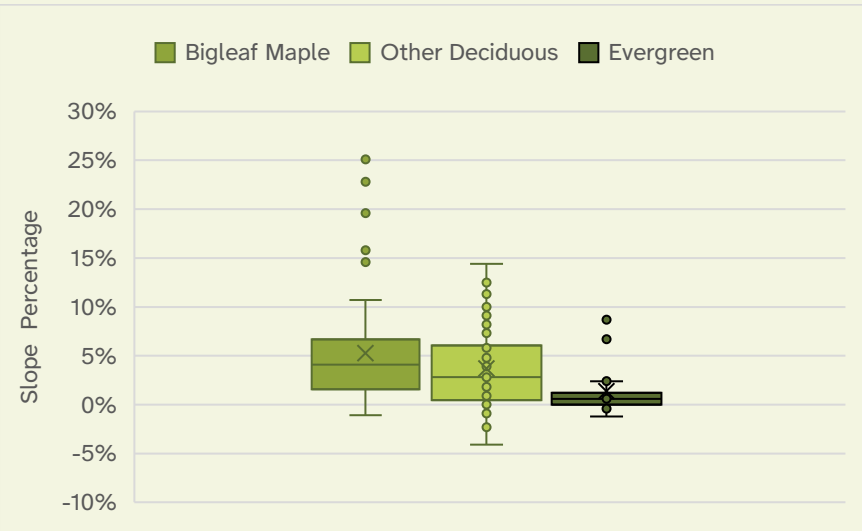
**Figure 2.4.16**  
**Difference in Max Slope In - Outside Canopy**  
Box and whisker charts reflecting the difference in slope within vs. outside the tree canopy by species category.

calculated by subtracting the slope outside the canopy from the slope within the canopy. Evergreen trees were found to have the least slope difference, with all deciduous species, including Bigleaf Maples, having a higher mean slope difference value and wider range. Bigleaf Maples appear to have an elevated impact on slope and more outliers than other deciduous species. Cross slope difference, shown in figure 2.4.17, shows similar results with a greater difference for Bigleaf Maples than other deciduous species and wider ranges for all three categories. Bigleaf Maples were also found to have higher mean level changes (see figure 2.4.18) and a wider range of variance. The result is that Bigleaf Maples had sidewalks with more modes of failure and fewer ADA-compliant sidewalks (see figure 2.4.19).

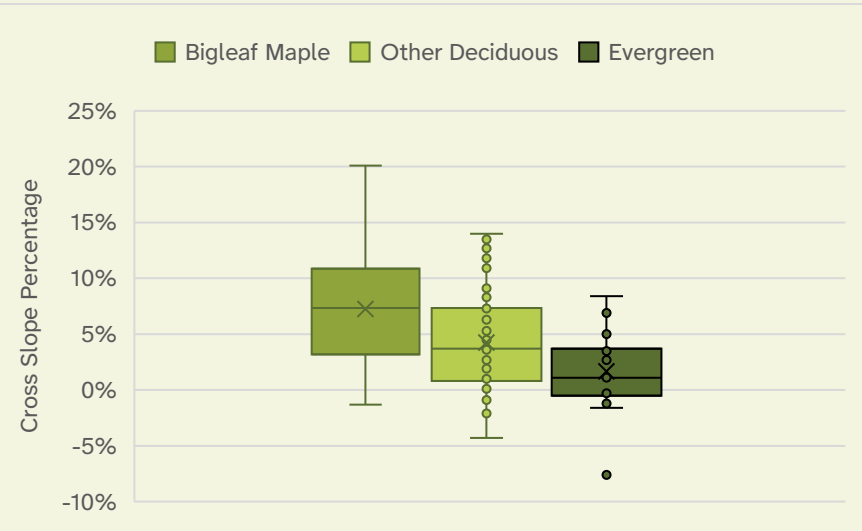
**Figure 2.4.17**  
**Difference in Max Slope In - Outside Canopy**  
Box and whisker charts reflecting the difference in slope within vs. outside the tree canopy by species category.

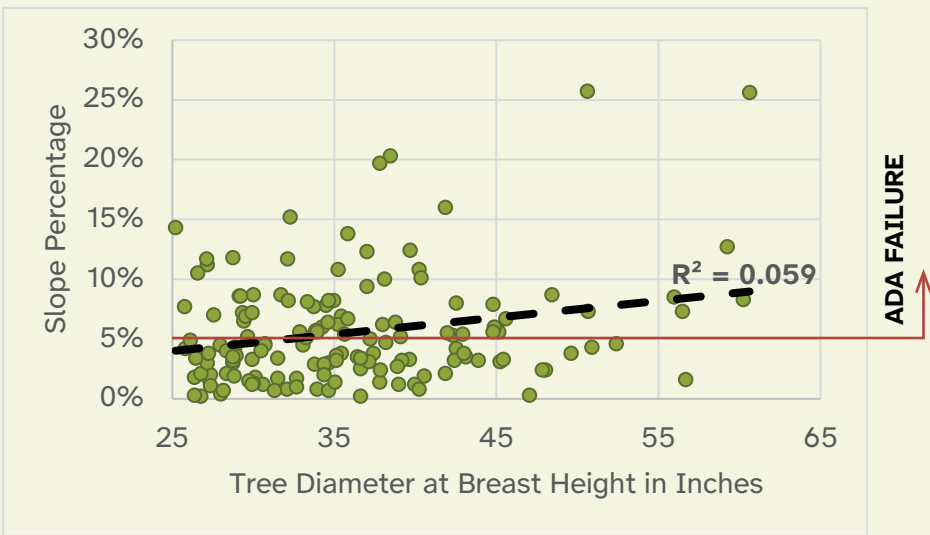
Figure 2.4.20  
**Relationship between Slope Within Canopy and Tree DBH Across All Species**

Scatterplot showing the relationship between trunk diameter at breast height and measured maximum slope within tree canopy.

The severity of root heave was expected to correlate with DBH, but this study found a very weak correlation between DBH and the maximum slope (figure 2.4.20), cross slope (figure 2.4.21), and level change (figure 2.4.22) within the tree’s canopy.

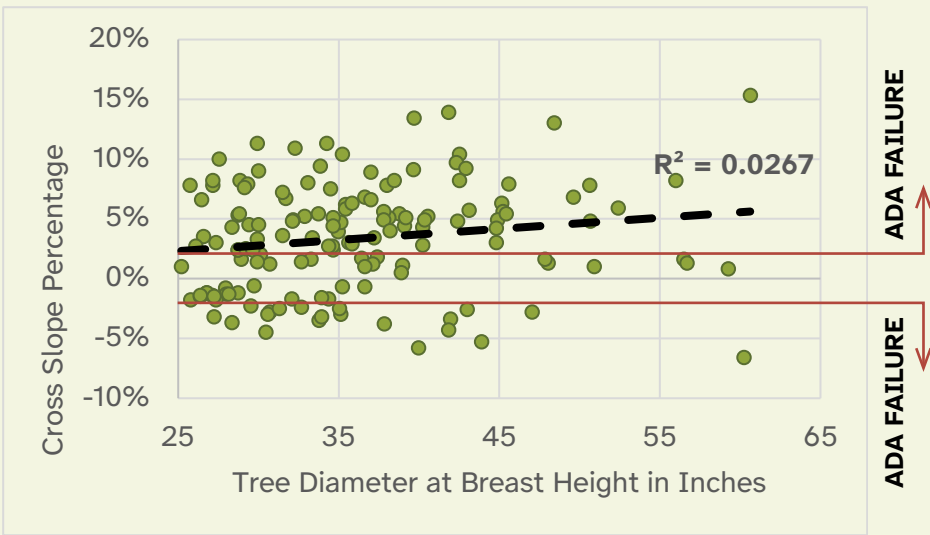
Figure 2.4.21  
**Relationship between Cross Slope Within Canopy and Tree DBH Across All Species**

Scatterplot showing the relationship between trunk diameter at breast height and measured maximum cross slope within tree canopy.

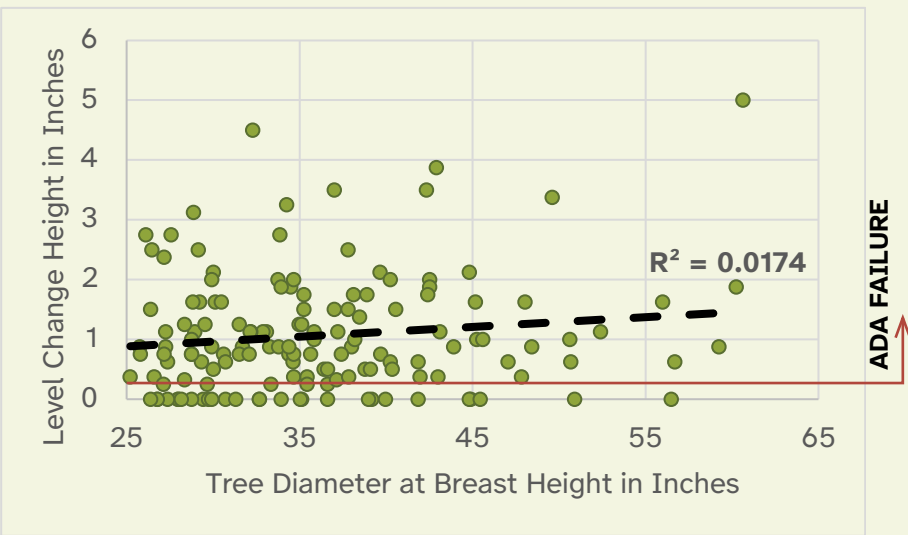
Figure 2.4.22  
**Relationship between Level Change Height and Tree DBH Across All Species**

Scatterplot showing the relationship between trunk diameter at breast height and measured maximum level change height within tree canopy.

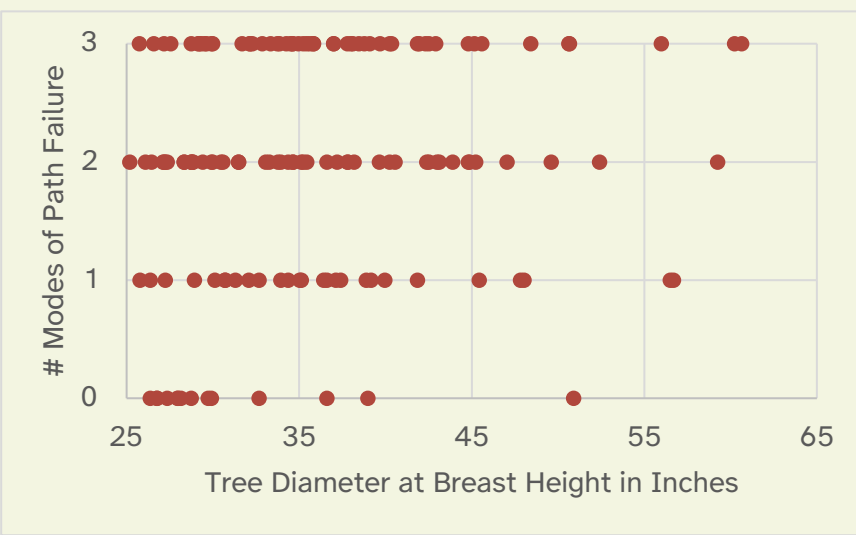
Figure 2.4.23  
**Number of Modes of Failure by Tree DBH**

Scatterplot showing the number of modes of accessibility failure by tree diameter at breast height.

based solely on its diameter. With  $R^2$  values below 0.1 it is **not possible to predict root heave severity based on tree size**. Figure 2.4.23 reflects an increased number of modes of failure at larger trees; this shows some connection between DBH and root heave, but the relationship is looser than expected. It appears that a 26” DBH tree could have an apparently similar degree of root heave to a 52” DBH tree.

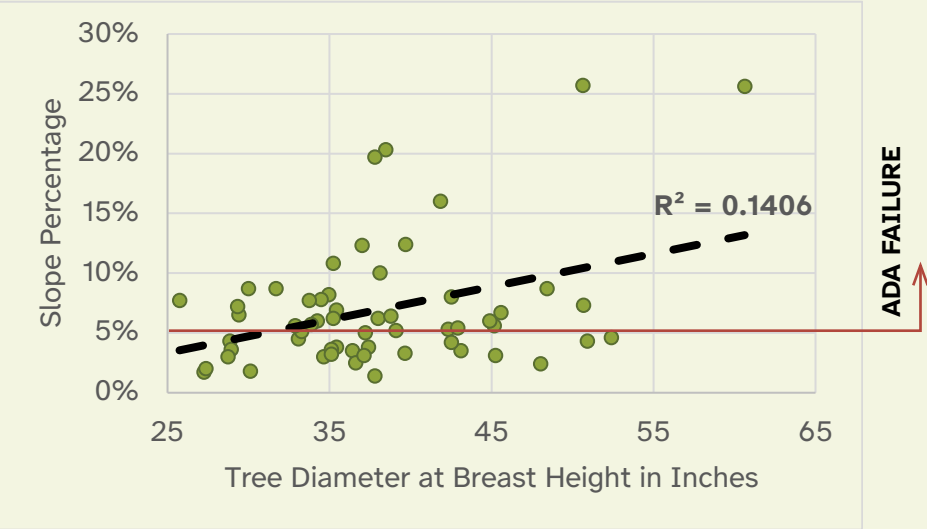
**Figure 2.4.24**  
*Relationship between Slope Within Canopy and Tree DBH for Bigleaf Maple*  
Scatterplot showing the relationship between trunk diameter at breast height and measured maximum slope within tree canopy.

One of the most expected variables at play is tree species, but controlling for species by solely analyzing results from Bigleaf Maples does yield increased R<sup>2</sup> values compared to analysis across species, but not to the degree expected. The relationship between Bigleaf Maple DBH and maximum slope within the tree canopy (figure 2.4.24) shows the strongest correlation, with an R<sup>2</sup> value of 0.1406. DBH and max cross slope (figure 2.4.25) appear to have a weaker relationship, with an R<sup>2</sup> value of 0.0997. And level change height had the weakest correlation with an R<sup>2</sup> value of 0.0339.

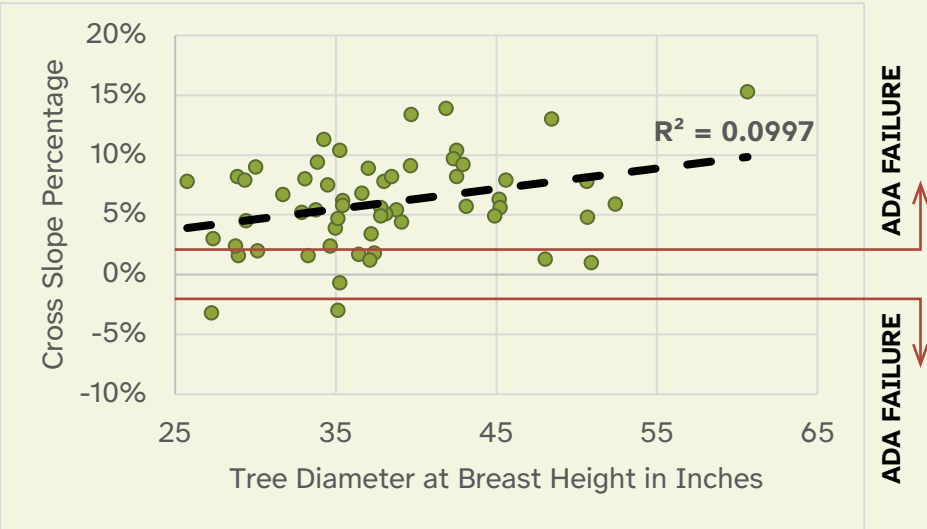
**Figure 2.4.25**  
*Relationship between Cross Slope Within Canopy and Tree DBH for Bigleaf Maple*  
Scatterplot showing the relationship between trunk diameter at breast height and measured maximum cross slope within tree canopy.

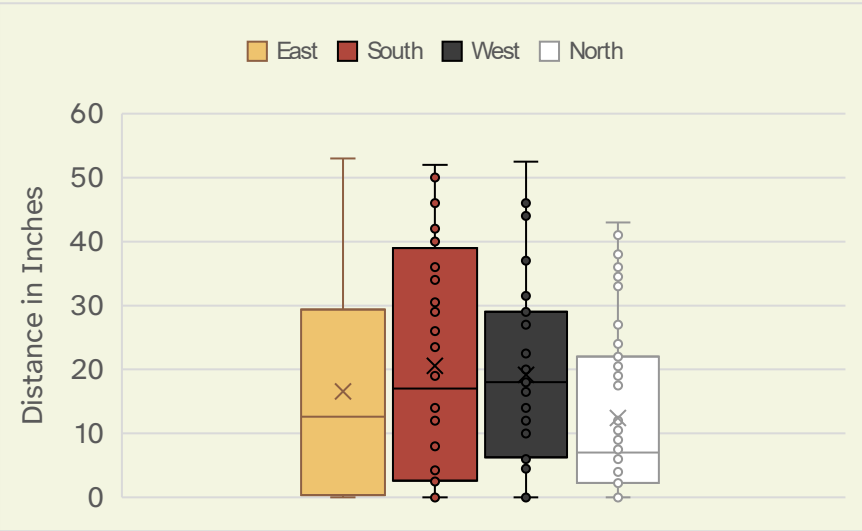
**Figure 2.4.32**  
*Distance from Roots to Sidewalk by Direction - All Species*  
Box and whisker chart showing the ranges of root-sidewalk distance measured across all sites within the research scope divided by the sidewalk's location relative to the tree.

In addition to species, root-sidewalk distance was found to have a significant relationship with the direction of the sidewalk relative to the tree. Figure 2.4.32 shows that trees appear to grow closer to sidewalks with eastern exposure, followed by north exposure. They seem to keep the most distance from sidewalks that face west, followed by sidewalks to the south. These patterns were not reflected as much by Bigleaf Maples, which appear to grow very close to the sidewalk except when it has western exposure (figure 2.4.33).

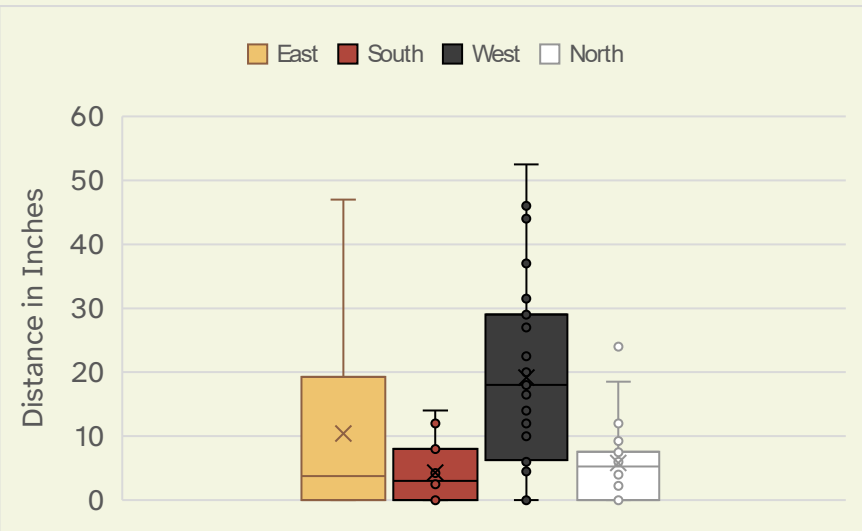
**Figure 2.4.33**  
*Distance from Roots to Sidewalk by Direction - Bigleaf Maples*  
Box and whisker chart showing the ranges of root-sidewalk distance measured across all Bigleaf Maples within the research scope divided by the sidewalk's location relative to the tree.

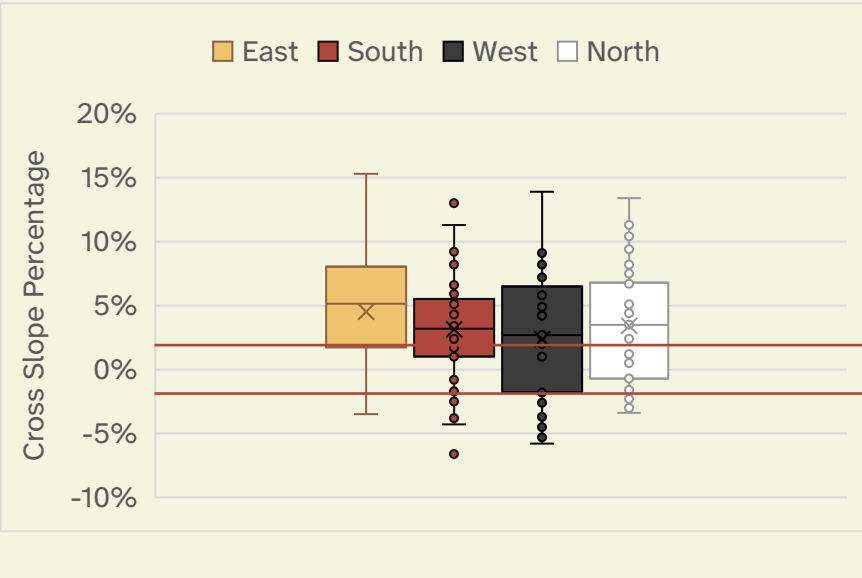
**Figure 2.4.34**  
*Maximum Cross Slope by Relative Sidewalk Direction*  
Box and whisker chart reflecting the range of maximum cross slopes measured at all sites within the research scope divided by the direction of the sidewalk relative to the tree.

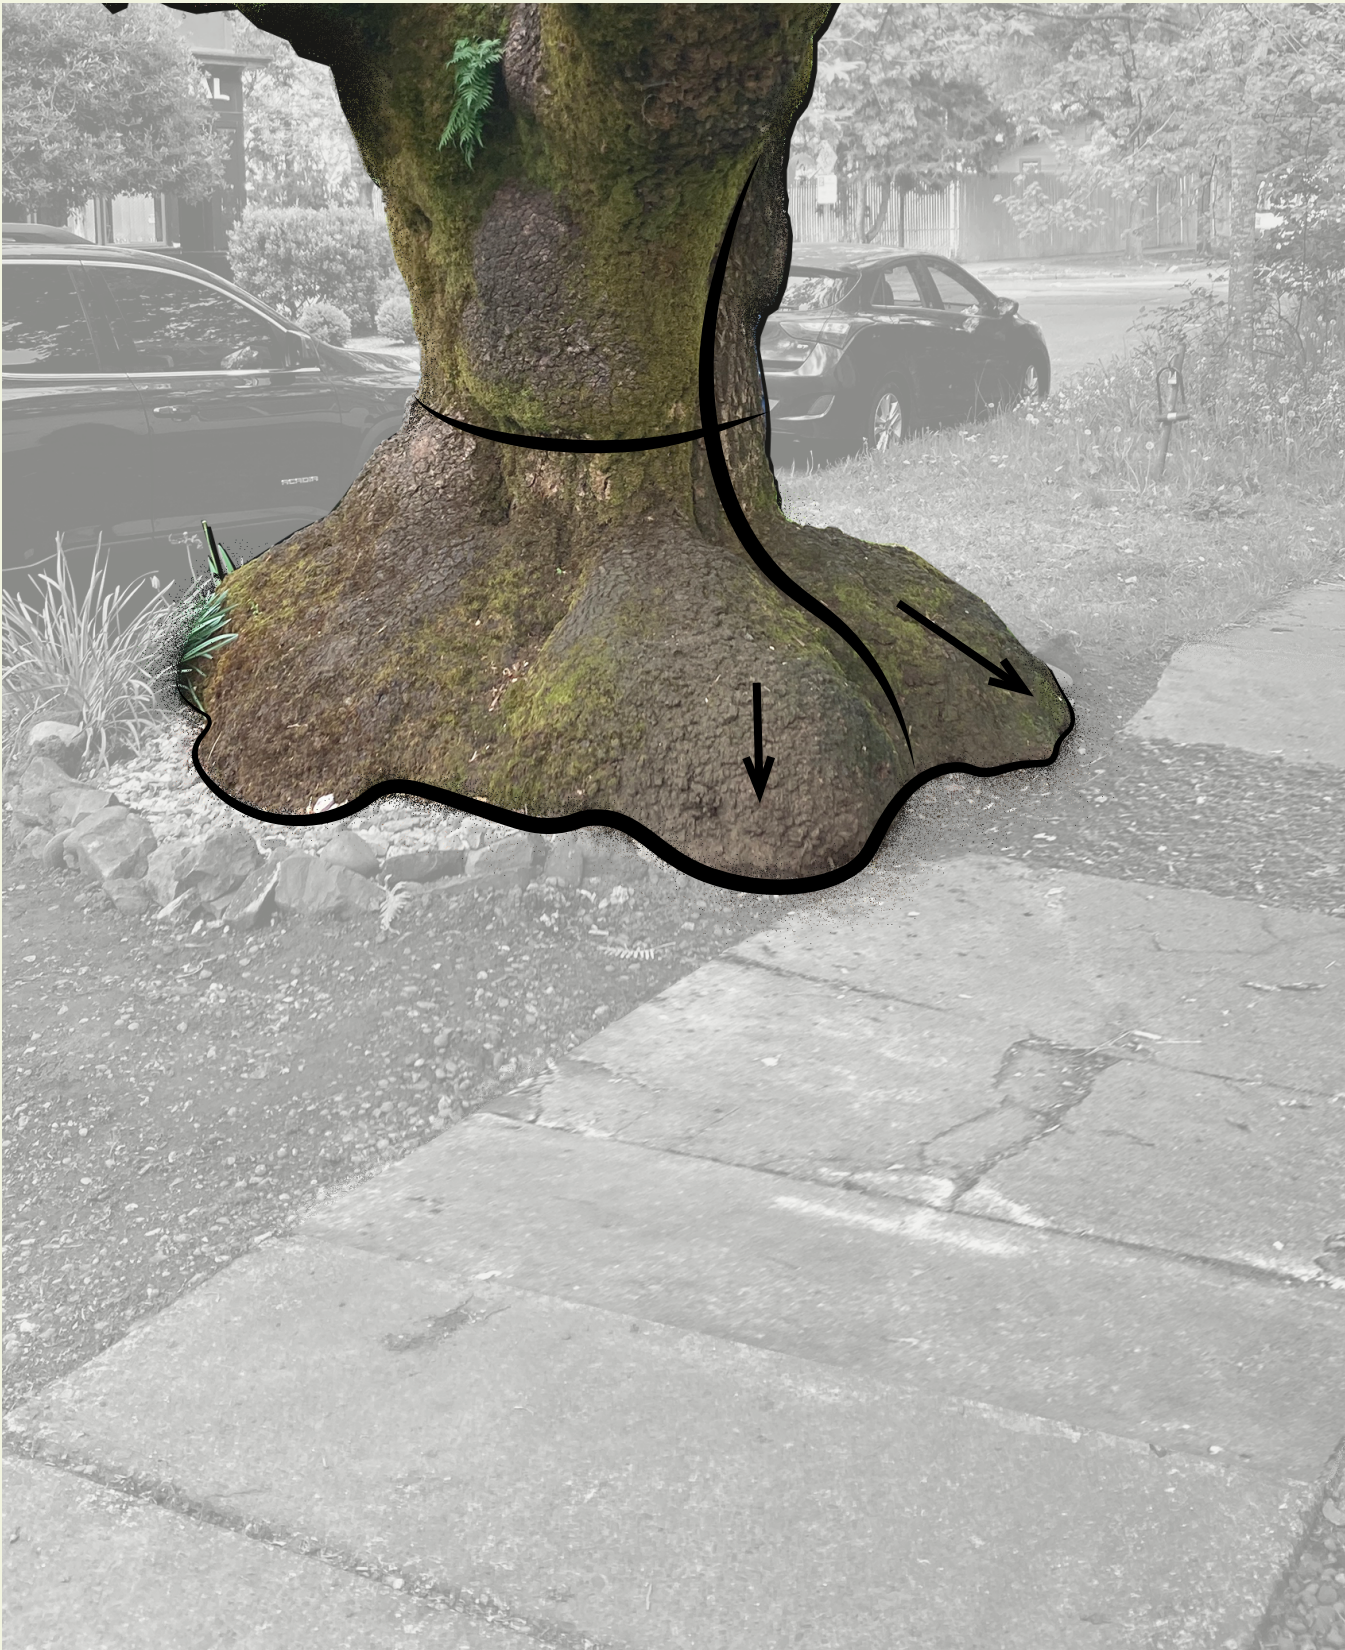
**Figure 2.4.36**  
***Illustration of Morphological Analysis***  
Annotated photo of a Bigleaf Maple street tree with a desaturated background and lines showing the aspects of each tree that were analyzed qualitatively in the field.

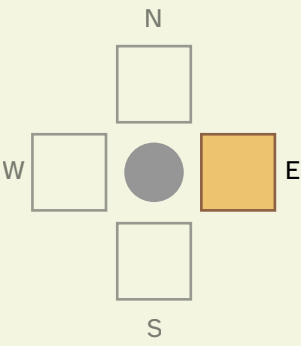
**Figure 2.4.37**  
**Observed Bigleaf Maple**  
**Morphological Trends with**  
**East-facing Sidewalks**  
Qualitative illustration of patterns observed in Bigleaf Maple morphology with east-facing sidewalks. Root flares appear to fan out in all directions, while more undefined burl masses reach toward the sidewalk. And more suckers appear on the street-facing (west) side.

Bigleaf Maple street trees were found to have distinctive morphological patterns characterized by basal burls as shown in figure 2.4.36. The qualitative overlay analysis of the field diagrams reflecting how Bigleaf Maples grew in response to the sidewalk in all four directions is reflected in the vector illustrations on the following page (see figures 2.4.37 - 2.4.40).

The overall result is that Bigleaf Maples appear to reach toward sidewalks and adjacent driveways, but in different ways and to different degrees depending on the relative direction of the sidewalk. More suckers, meaning sprouts shooting off from the trunk, were observed to the west, trees seemed more likely to lean toward the south, and they demonstrated the most sidewalk-reaching behavior to the north and east, where the sidewalk is likely cooler. This implies that sidewalks warrant site-based designs that consider solar exposure, which results in heat patterns in the soil on and around tree roots. This is particularly important for surface-rooting species like Bigleaf Maples but applies to all species.

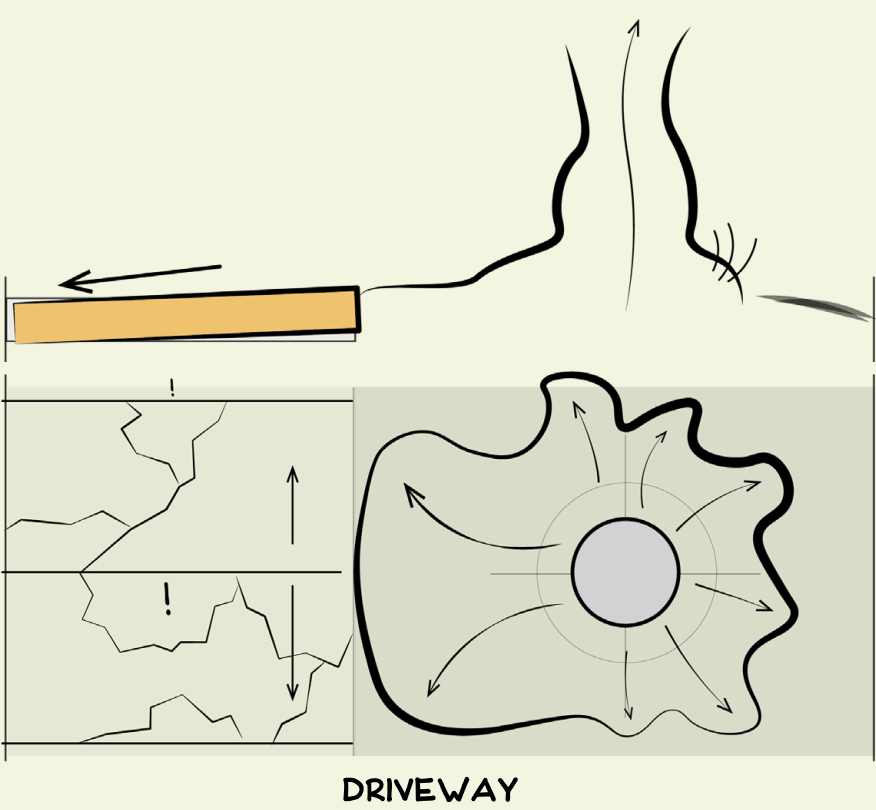
**Figure 2.4.38**  
**Observed Bigleaf Maple**  
**Morphological Trends with**  
**South-facing Sidewalks**  
Qualitative illustration of patterns observed in Bigleaf Maple morphology with south-facing sidewalks. Broad root flares and basal burls appear to form toward the sidewalk, reaching somewhat away from driveways. And trees seem to lean more toward the sidewalk-facing (south) side.

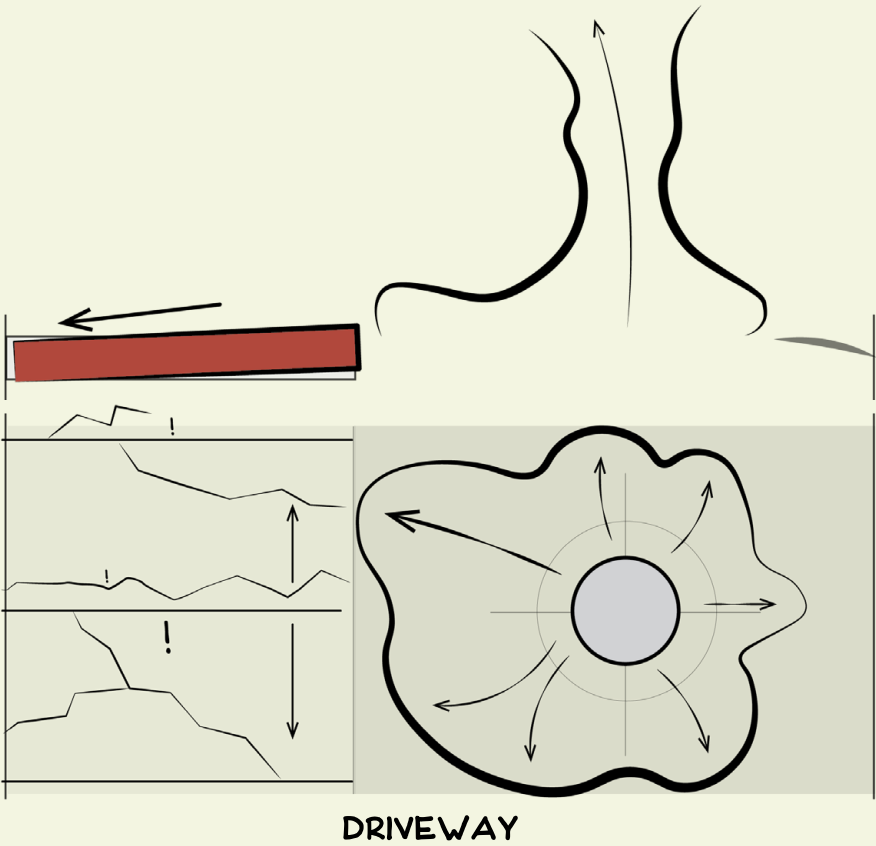
**Figure 2.4.39**  
**Observed Bigleaf Maple**  
**Morphological Trends with**  
**West-facing Sidewalks**  
Qualitative illustration of patterns observed in Bigleaf Maple morphology with west-facing sidewalks. Growth seems to follow a similar pattern to trees facing east, but there appear to be narrower stretches of burls reaching toward the sidewalk and more suckers seem to form on the sidewalk-facing (west) side.

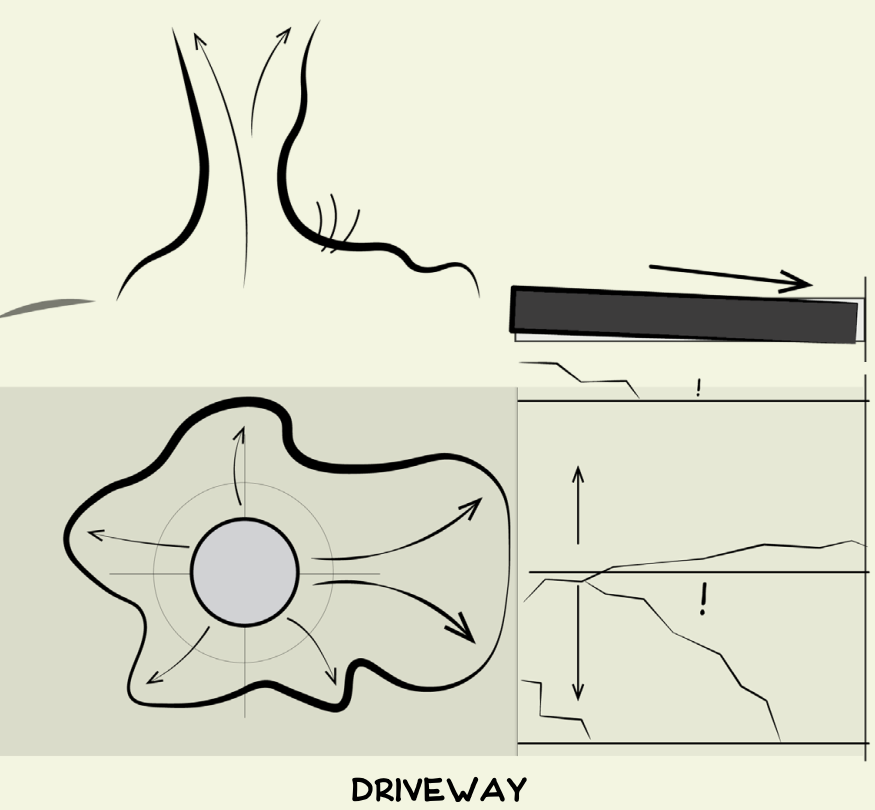
**Figure 2.4.40**  
**Observed Bigleaf Maple**  
**Morphological Trends with**  
**North-facing Sidewalks**  
Qualitative illustration of patterns observed in Bigleaf Maple morphology with north-facing sidewalks. Burls appear to form in all directions, root flares seem to have little definition, and trees seem to lean more toward the street-facing (south) side.
