# ROOTS AND ROUTES

*Seeking an Accessible Path to Make Peace Between  
Street Trees and Sidewalks in The Whit*

An applied research project accepted and approved in partial  
fulfillment of the requirements for the degree of  
Master of Landscape Architecture

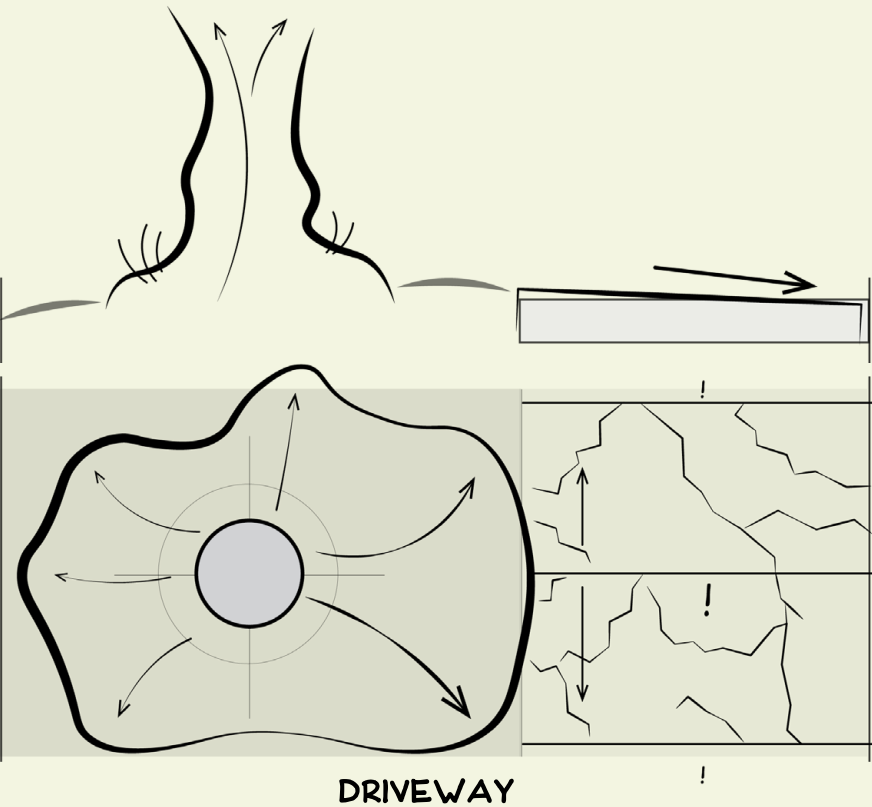
**Figure 2.4.41**  
**Bigleaf Maple Street Tree Morphology**

Qualitative illustration of growth patterns observed in the 58 documented Bigleaf Maples, summarizing the most common burl and root flare growth directions and common sidewalk cracking patterns across all four directions.

Across all three species categories and all four directions **street trees appear to reach toward sidewalks**. Figure 2.4.41 shows the overall common trend observed for Bigleaf Maples, which is burls spilling out at the base, particularly toward pavement. Figure 2.4.42 shows Other Deciduous species, which similarly reach toward the sidewalk and driveways, but also have a tendency to reach to the curb and show more defined root flares than Bigleaf Maples. Lastly, figure 2.4.43 shows that Evergreen trees appeared to have the fewest root flares and no burls or suckers, but they still had a tendency to reach toward the sidewalk and driveway, especially toward the corner where sidewalks and driveways intersect. While these results are highly qualitative and need further empirical research to make conclusive statements, they seem to align with sentiments from the pre-existing literature suggesting the conditions beneath concrete sidewalks are particularly attractive to tree roots and encourage expedited growth.

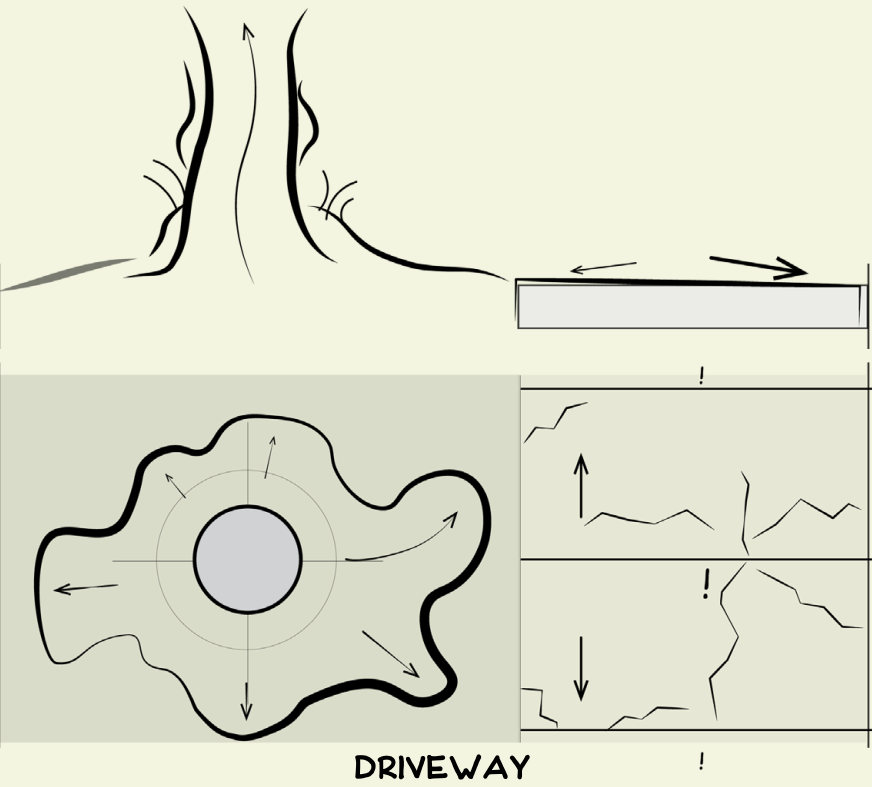
**Figure 2.4.42**  
**Other Deciduous Street Tree Morphology**

Qualitative illustration of growth patterns observed across the 69 specimens of Other Deciduous species. Growth was noticeably different for this group than Bigleaf Maples and unsurprisingly this category showed a wide range of variance.

All species appeared to show some degree of sidewalk-reaching behavior, but many also reached toward the curb. Burls were somewhat common, especially for Planetrees, which developed them along the entire trunk. And suckers were also typical, especially for Lindens.

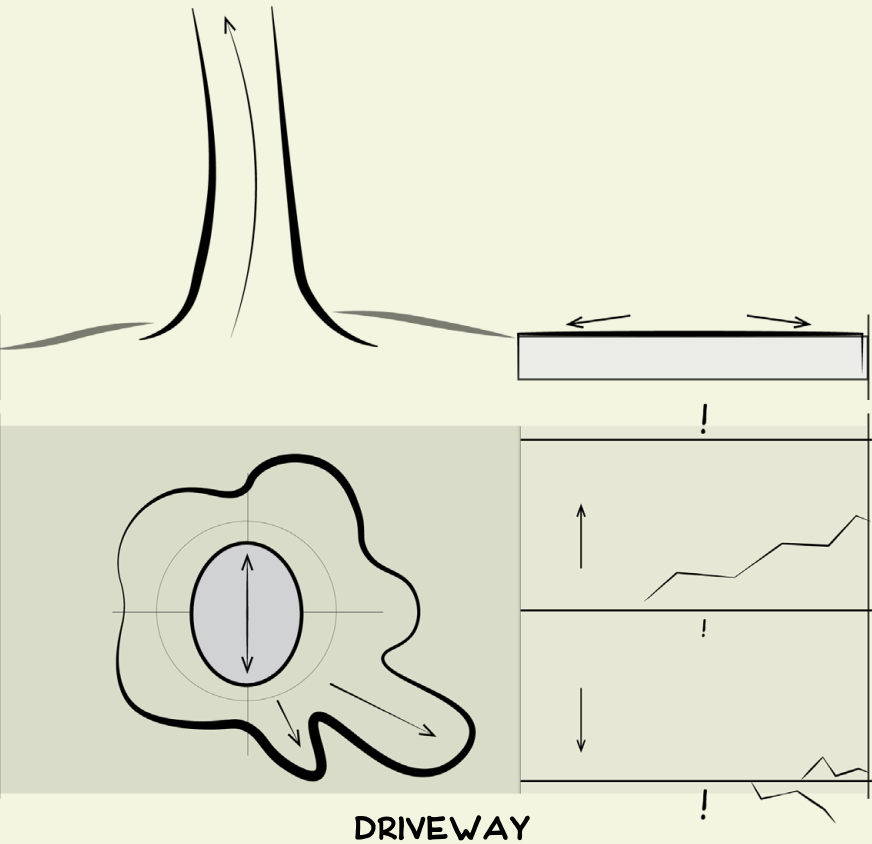
**Figure 2.4.43**  
**Evergreen Street Tree Morphology**

Qualitative illustration of growth patterns observed across Evergreen trees. This group was dominated by Douglas Firs and had a small sample size, but the patterns across these 19 trees shows a more minor sidewalk-reaching pattern than deciduous trees and suggests that Evergreen street trees react differently to sidewalks than their deciduous counterparts.

No basal burls or suckers were seen on evergreen trees, only root flares and fluted trunks, which often appeared to reach toward the sidewalk. Trunks were often elliptical in shape and wider in the direction parallel with the sidewalk.

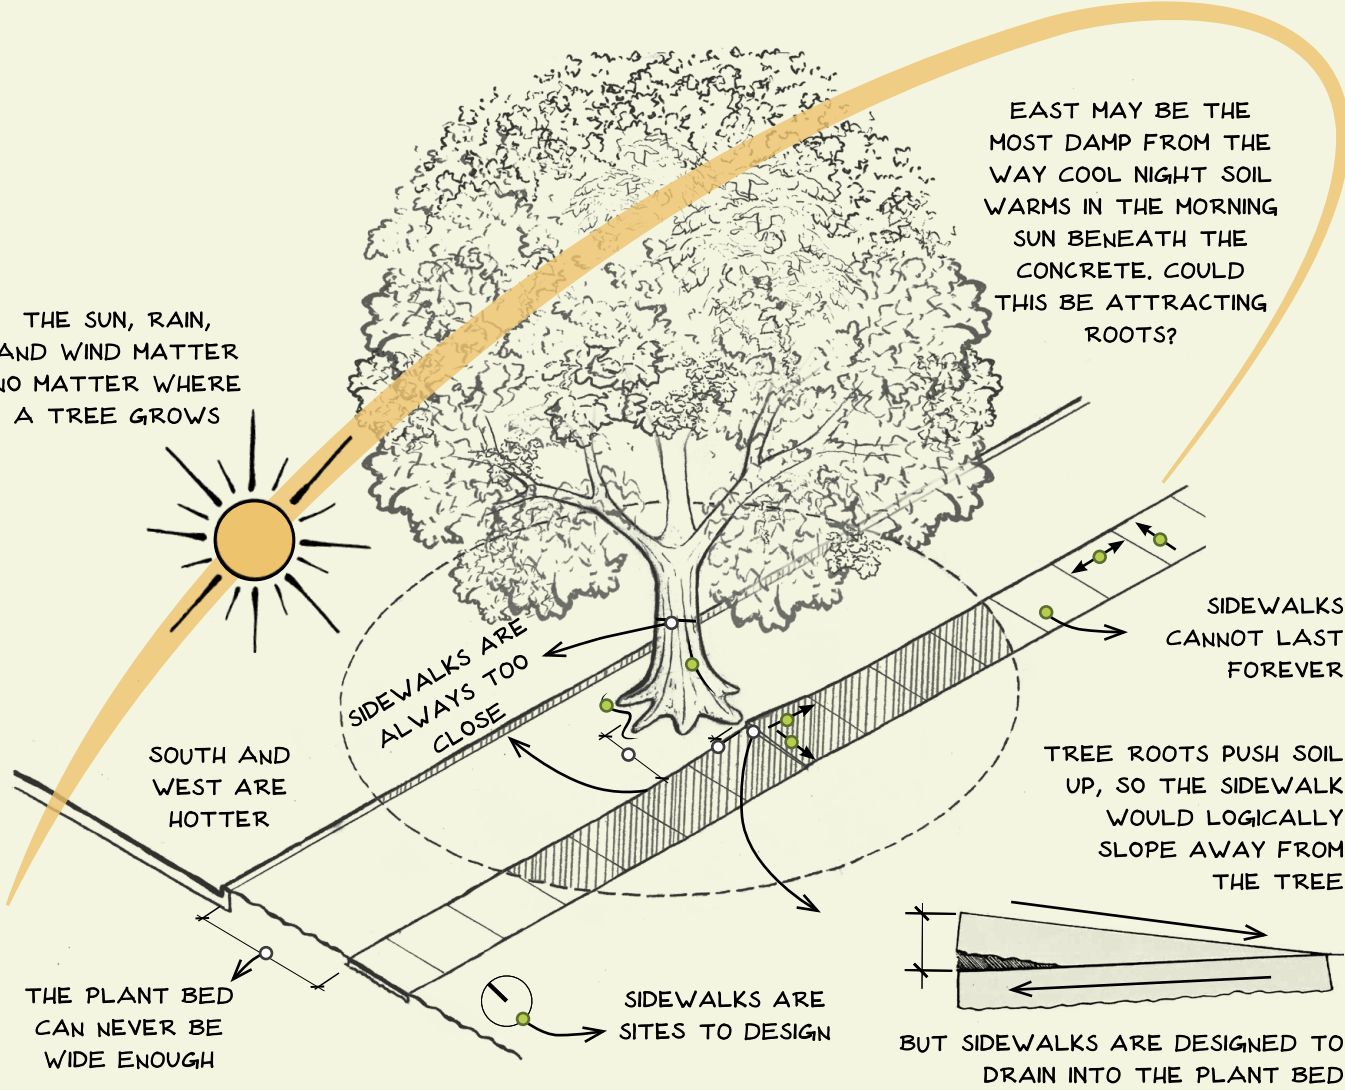
**Figure 2.4.44**  
**Summary of Results**  
Isometric drawing of the noted correlations identified in this study and speculation about why solar orientation appears to be influencing root growth.

- 9. **The direction of the sidewalk relative to the tree** has a significant effect on how the tree responds to the sidewalk and some effect on the degree of root heave that occurs. This is likely due to the heat patterns on the pavement from solar exposure.

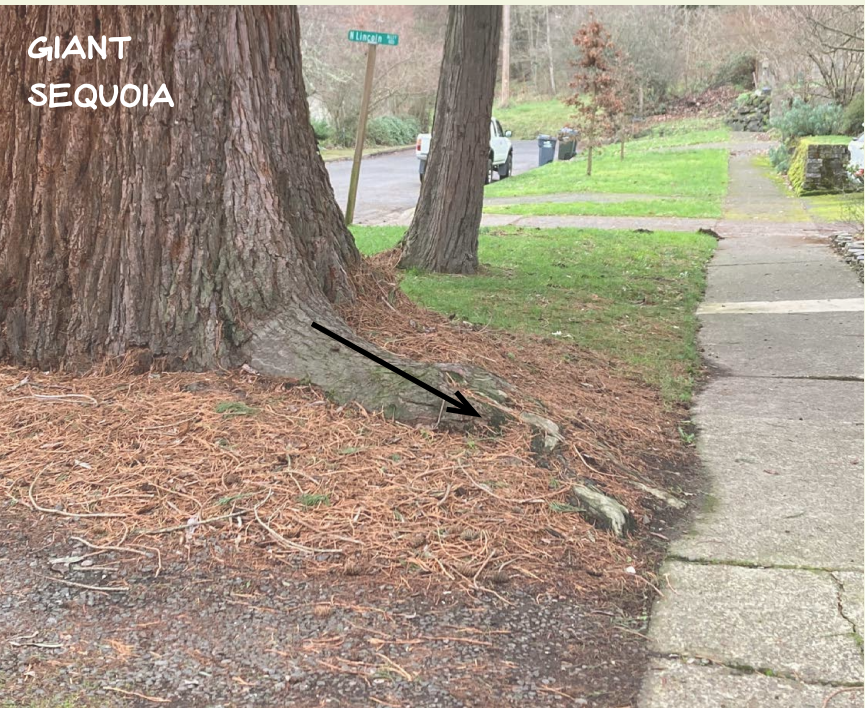
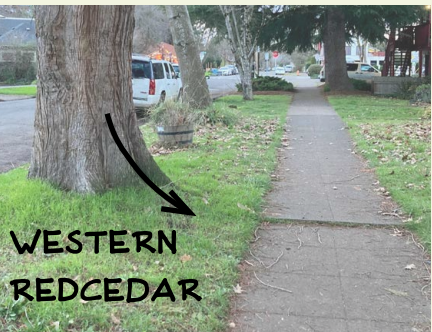
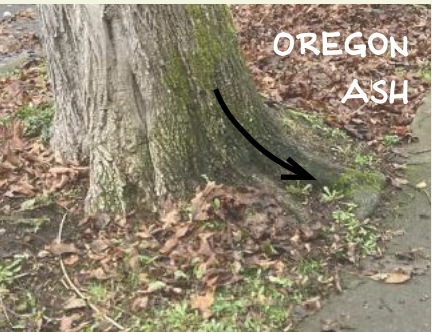
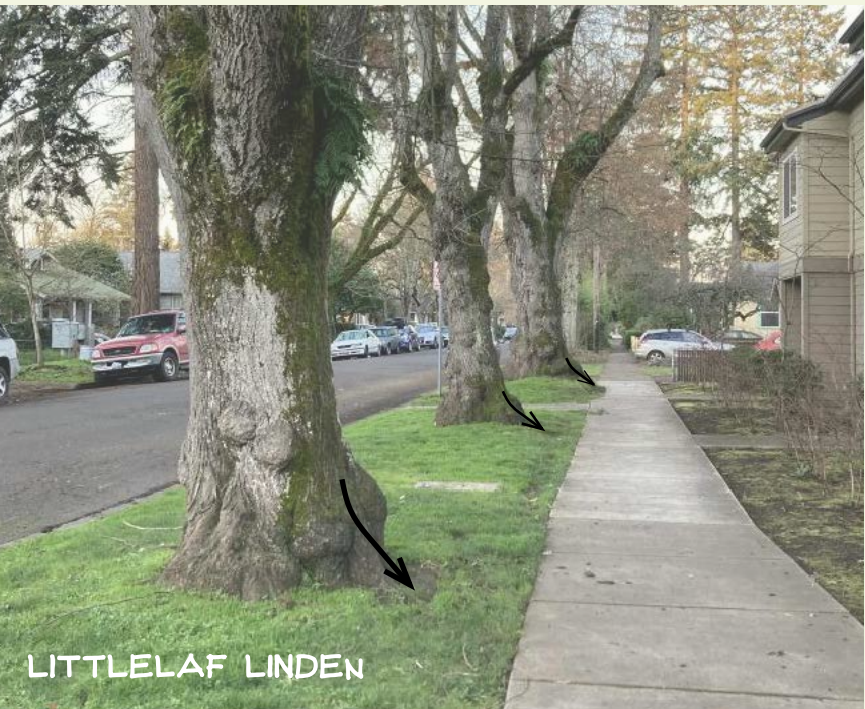
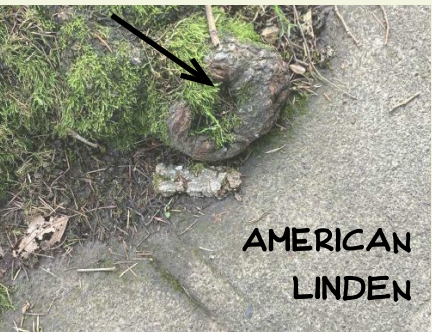
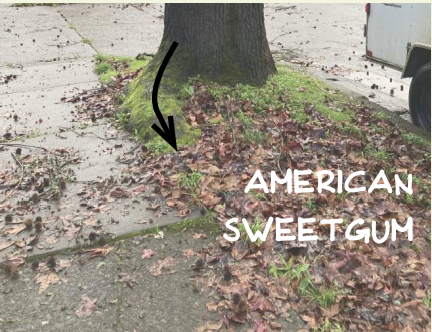
Figure 2.5.1  
**Sidewalk-Reaching Behavior Across Species**  
Example field photos illustrating sidewalk-reaching behavior.

The consistent pattern of many, if not most, street trees preferentially growing larger root flares and burls toward sidewalks shows that root heave is, at least in part, a **byproduct of trees' response to the growing conditions on-grade concrete sidewalks create**. The existing literature is consistent with these findings, noting how concrete creates a warm, moist environment that may invite roots and increases their growing speed (Randrup et al., 2001, p. 215).

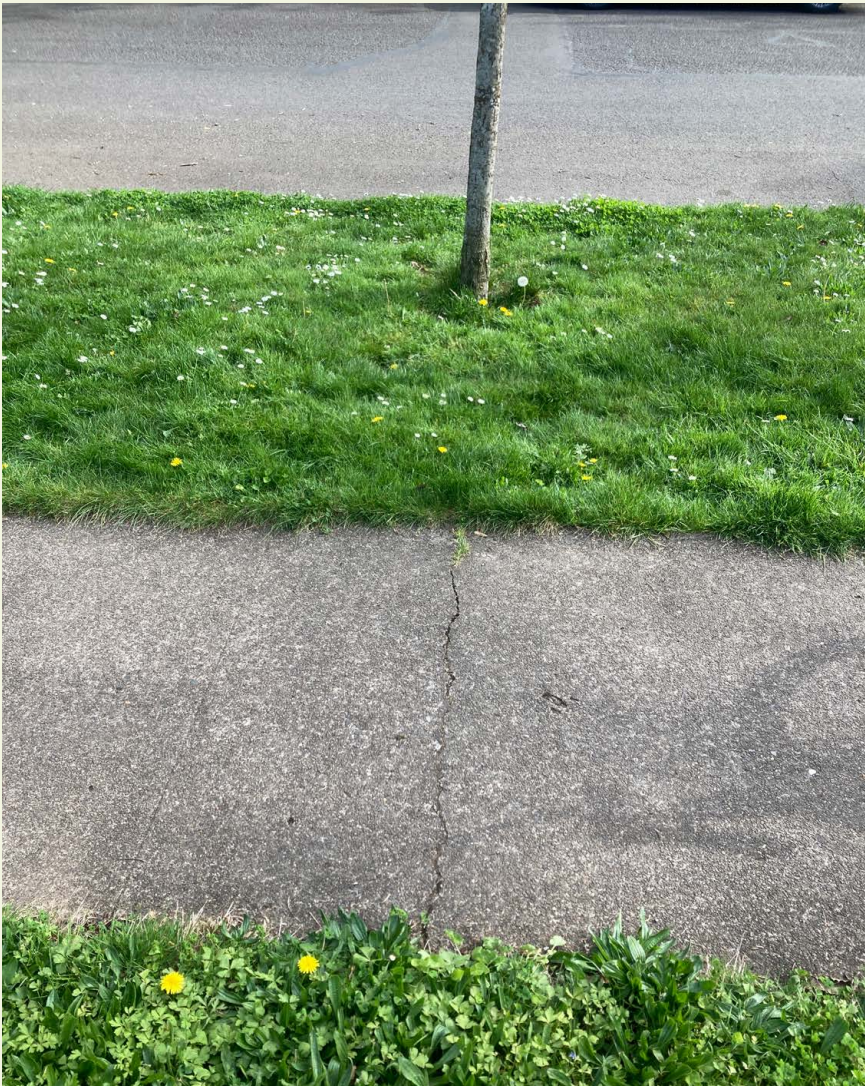
Figure 2.5.2  
**Small Bigleaf Maple Cracking  
Adjacent Sidewalk**

Photo of a Bigleaf Maple sapling in Whiteaker with a 3.6 inch diameter at breast height that appears to be cracking the adjacent sidewalk.

Notice the swollen base on the street tree, compare it to the swollen bases forming on the young trees pictured in figures 2.5.2 and 2.5.3. These basal burls signify distress. That may

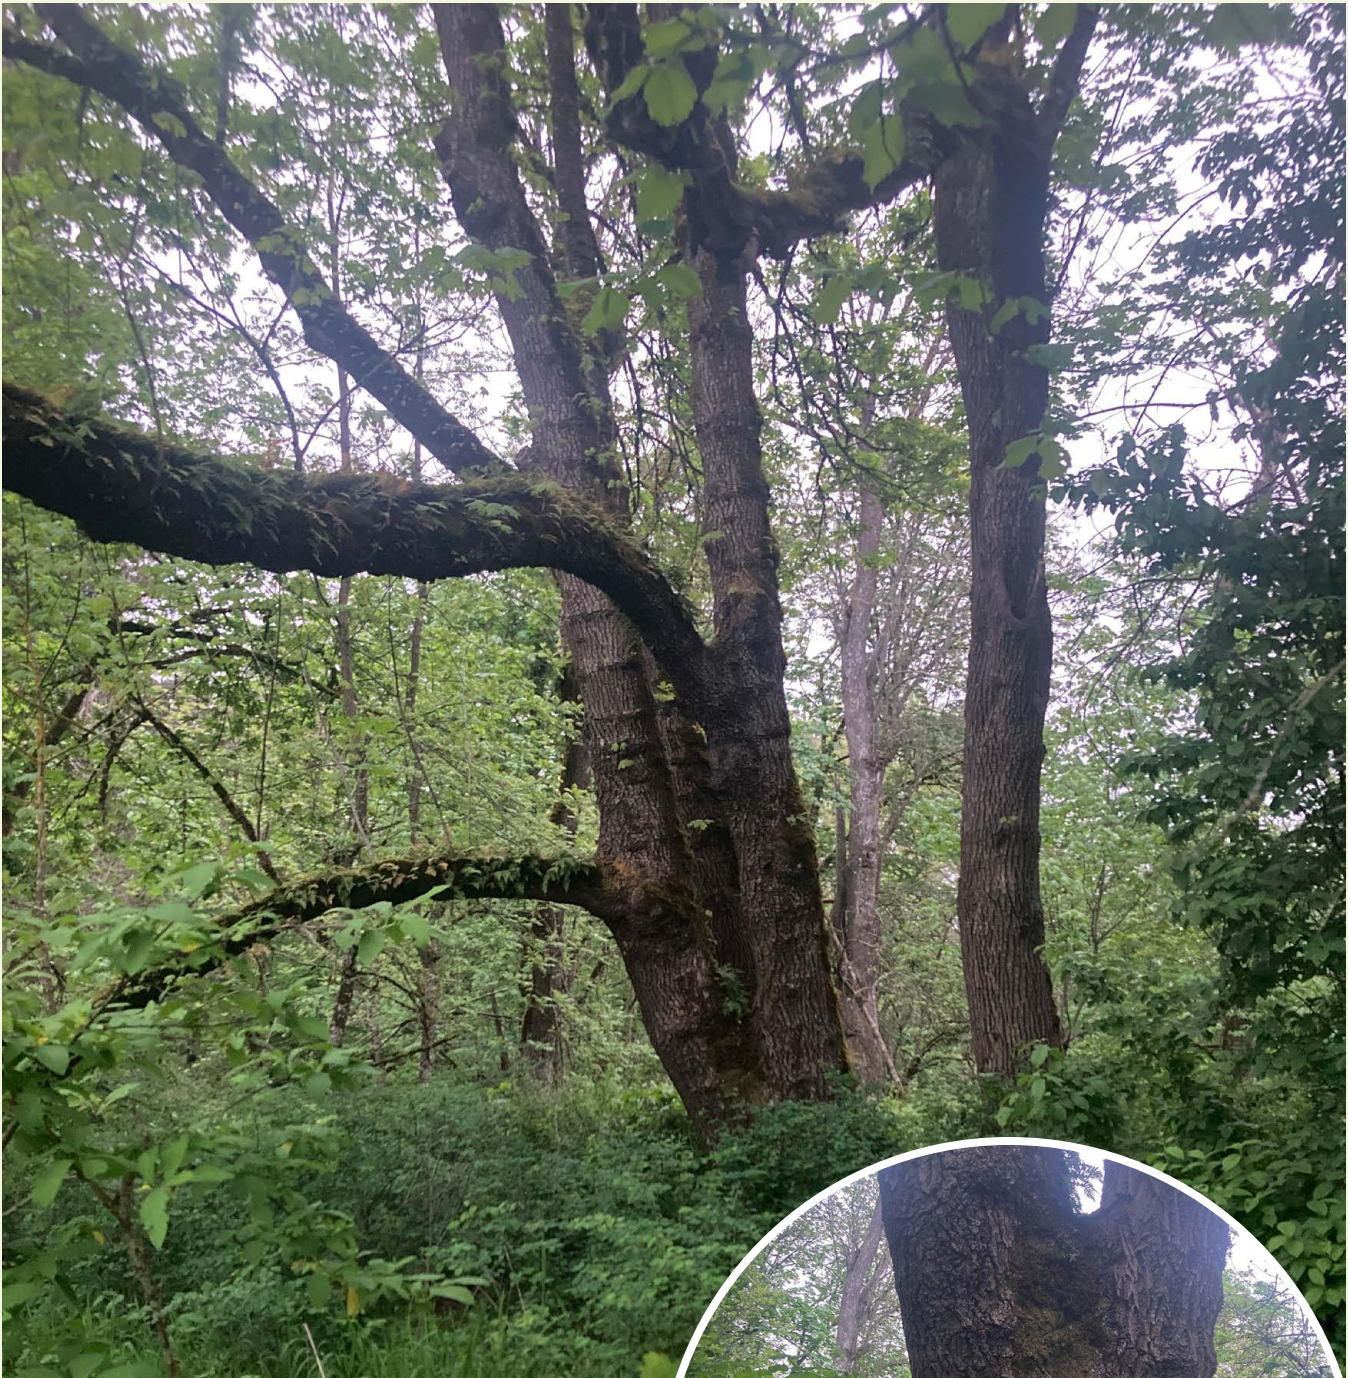
Figure 2.5.3  
**Small Bigleaf Maple Breaking  
Adjacent Sidewalk**

Photo of a Bigleaf Maple tree with a 7.6 inch diameter at breast height that appears to be breaking the adjacent sidewalk.

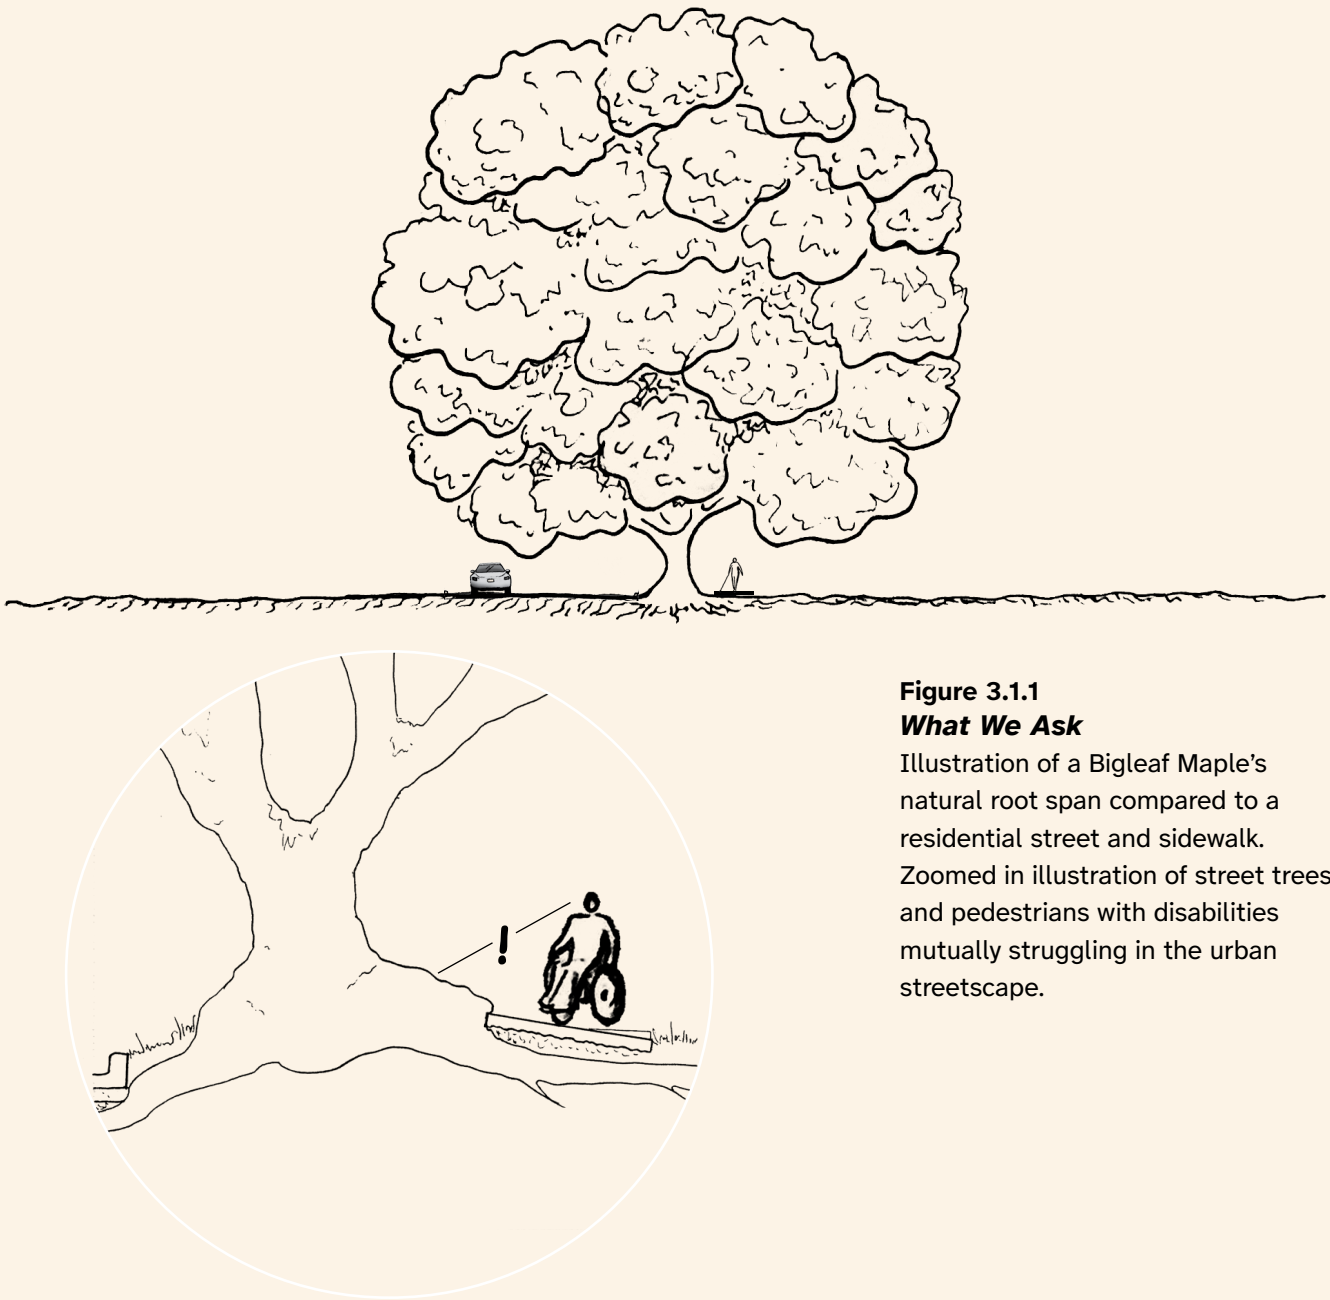
**Figure 3.1.1**  
**What We Ask**  
Illustration of a Bigleaf Maple's natural root span compared to a residential street and sidewalk. Zoomed in illustration of street trees and pedestrians with disabilities mutually struggling in the urban streetscape.

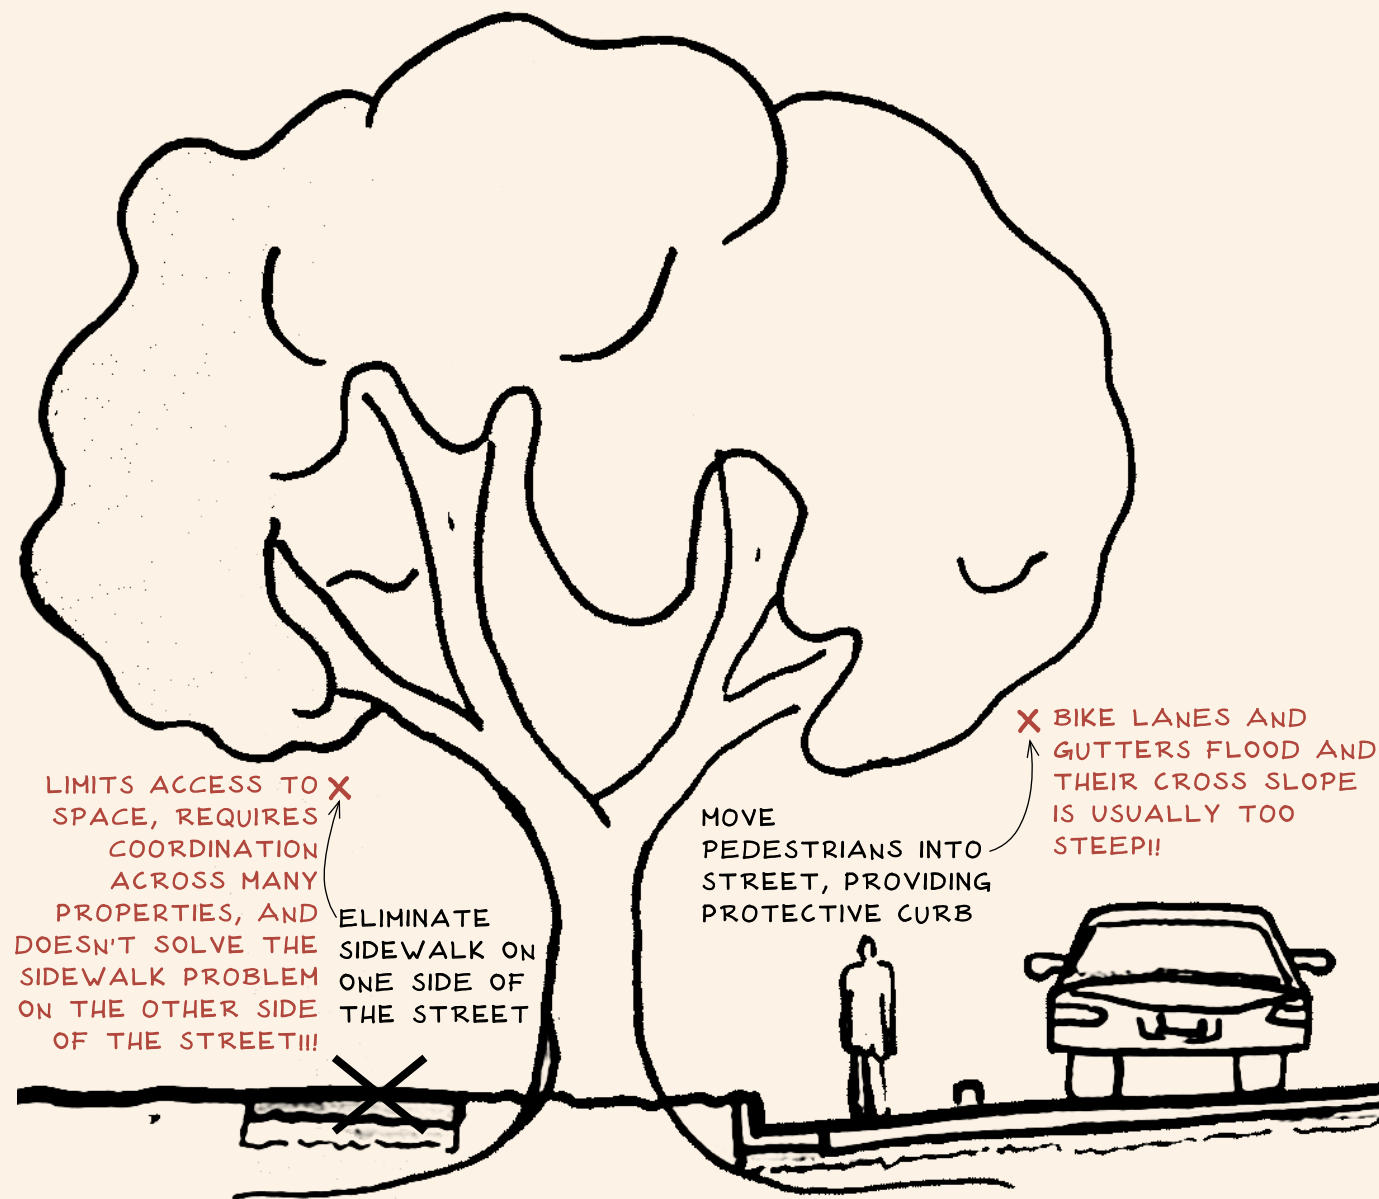
**Figure 3.1.2**  
**Other Places to Put the Sidewalk**

Illustration of options for laterally relocating the sidewalk, showing none of them address the core problem of root heave.

We have very limited options within reason besides lifting the sidewalk (see figure 3.1.2). Given that even a sidewalk across the street is almost certainly in a large tree’s critical root zone, there is nowhere to move it, and removing sidewalks

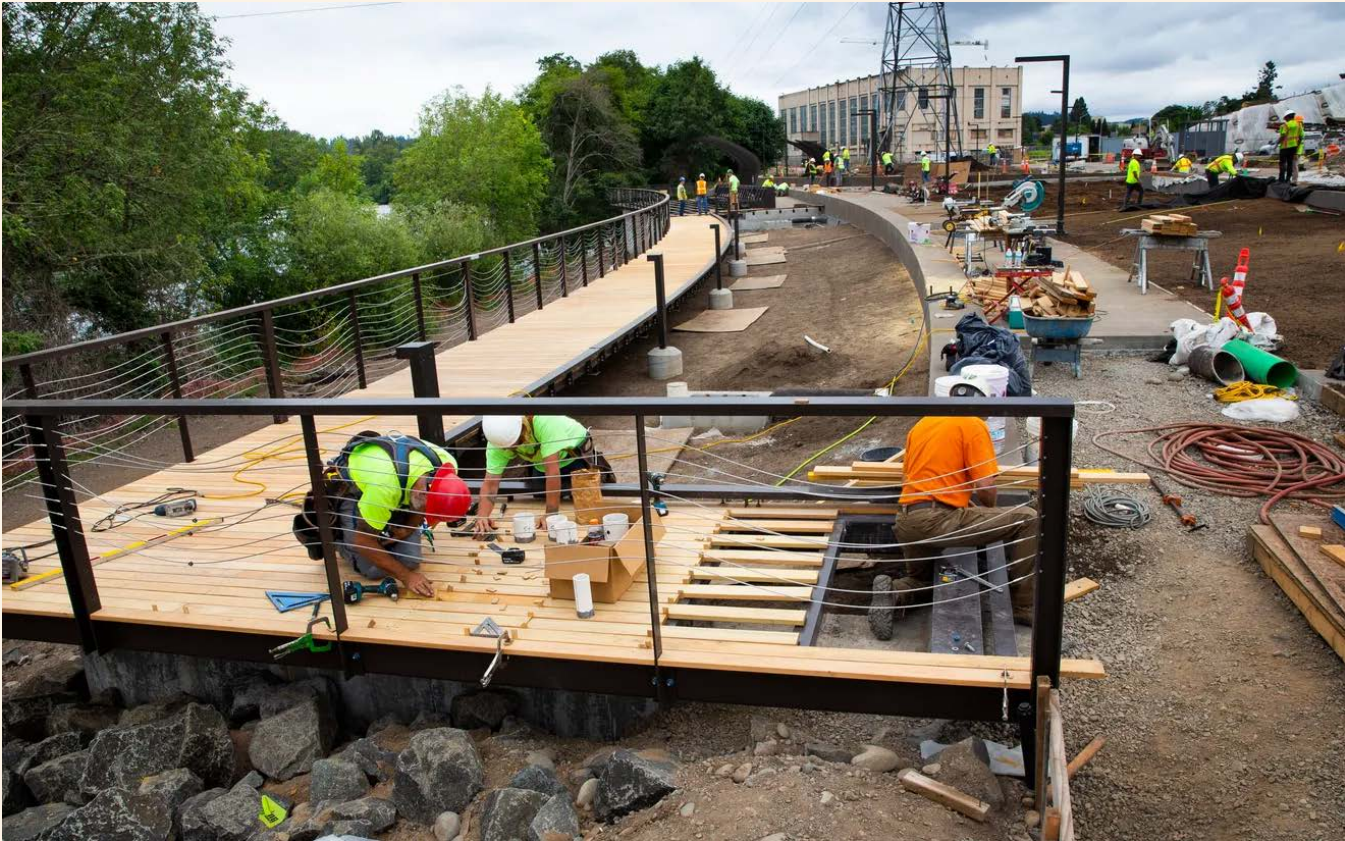
**Figure 3.2.2**  
**Downtown Riverfront Boardwalk**  
Photo of the boardwalk along the Eugene Riverfront under construction.  
(Pietsch, 2021)

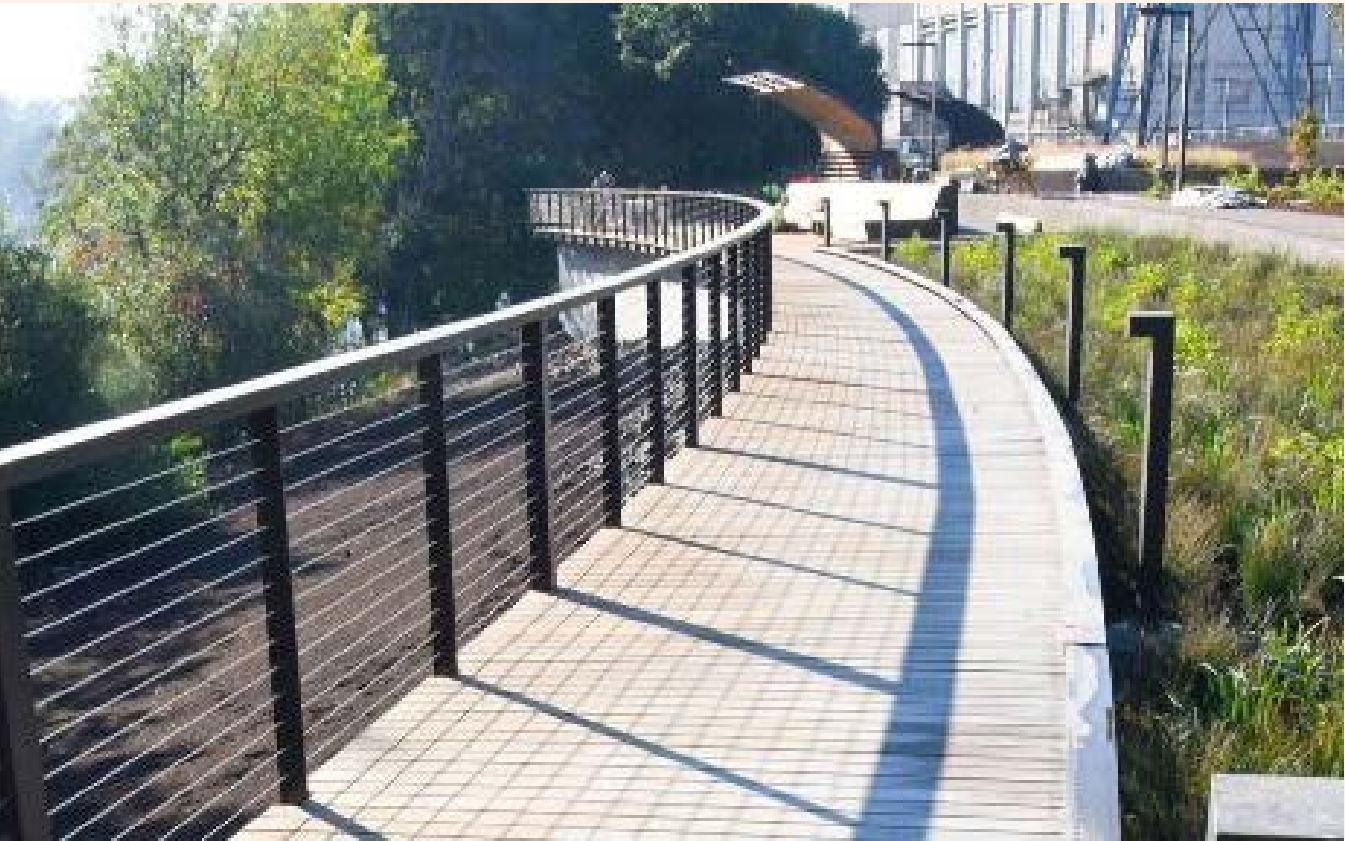
**Figure 3.2.3**  
**Modern Eugene Boardwalk**  
Photo of modern wooden boardwalk at the Downtown Riverfront in Eugene.  
(eugene-or.gov)

The boardwalk is substantially elevated, lit with closely spaced human-scale lights along the park edge and protected with a cabled guardrail on the side that overlooks the river. A wooden curb provides edge protection on the park-facing side and the boardwalk appears to slope toward the river, which has no curb to allow for drainage but meets edge protection requirements by including a fairly low bottom cable as a toe rail.

unnecessary and **too costly for a residential sidewalk**, but it could be scaled down. Given the boardwalk’s location along the Willamette River and short walking distance to the Whit, this precedent is also important design context. The sun-bleached wood decking appears to be withstanding Eugene weather, but it is unclear how long the boardwalk will maintain its rigid, stable surface without creaking or differential swelling across the boards.

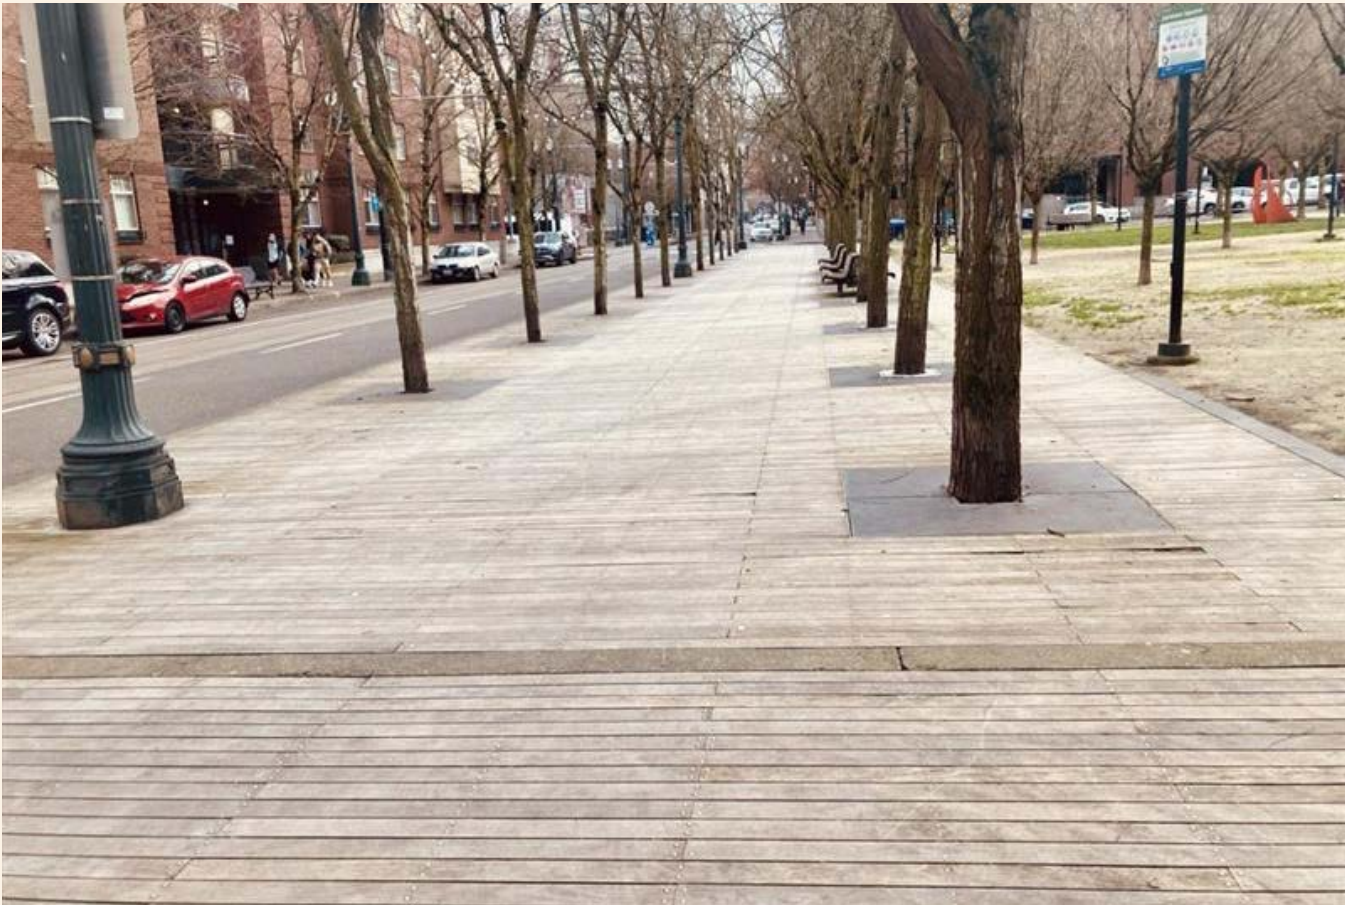
**Figure 3.2.4**  
**Jamison Square Boardwalk**  
Wide wooden boardwalk in Jamison Square in Portland, OR. Boardwalk is on-grade and encloses trees with grates. The main circulation route appears even and accessible, but there are some visible level changes along the sides, particularly between tree grates.

presence and a beautifully inviting historic revival aesthetic (figure 3.2.4). This boardwalk was inspired by Portland’s historic wooden sidewalks and docks along the Willamette River. The path connects three parks in Portland’s Pearl District that have a shared theme of water and incorporates an allée of honey locusts for shade and spatial definition (Helphand & Way, n.d.). This design provides a **gentler pedestrian experience and different sensory input than a standard concrete sidewalk** that may be especially pleasant for blind users. The airspace beneath the planks creates a soft echo reminiscent of a dock on a lake that subtly increases awareness of others walking nearby and the forgiving wooden surface reflects much less heat than concrete. The path also includes fully accessible curb ramps with the required tactile pavers (figure 3.2.6). Walker’s careful detailing is evident along the edge of these ramps, where the boards seamlessly transition into concrete with no level change, even after over twenty years of wear. The boards

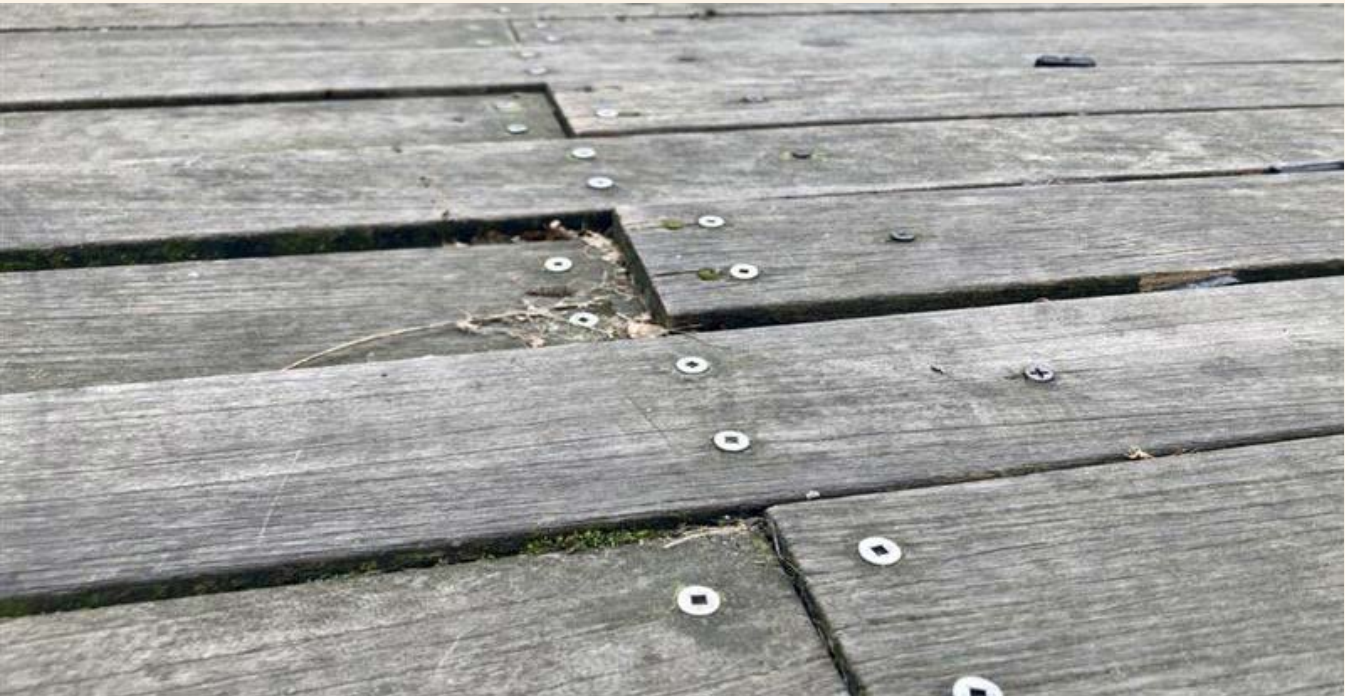
**Figure 3.2.5**  
**Jamison Square Wear and Tear**  
Close-up views of the boards at Jamison Square warping, likely through moisture/heat expansion and contraction, causing level changes, and images of sections with heterogeneous age, indicating recent repairs.

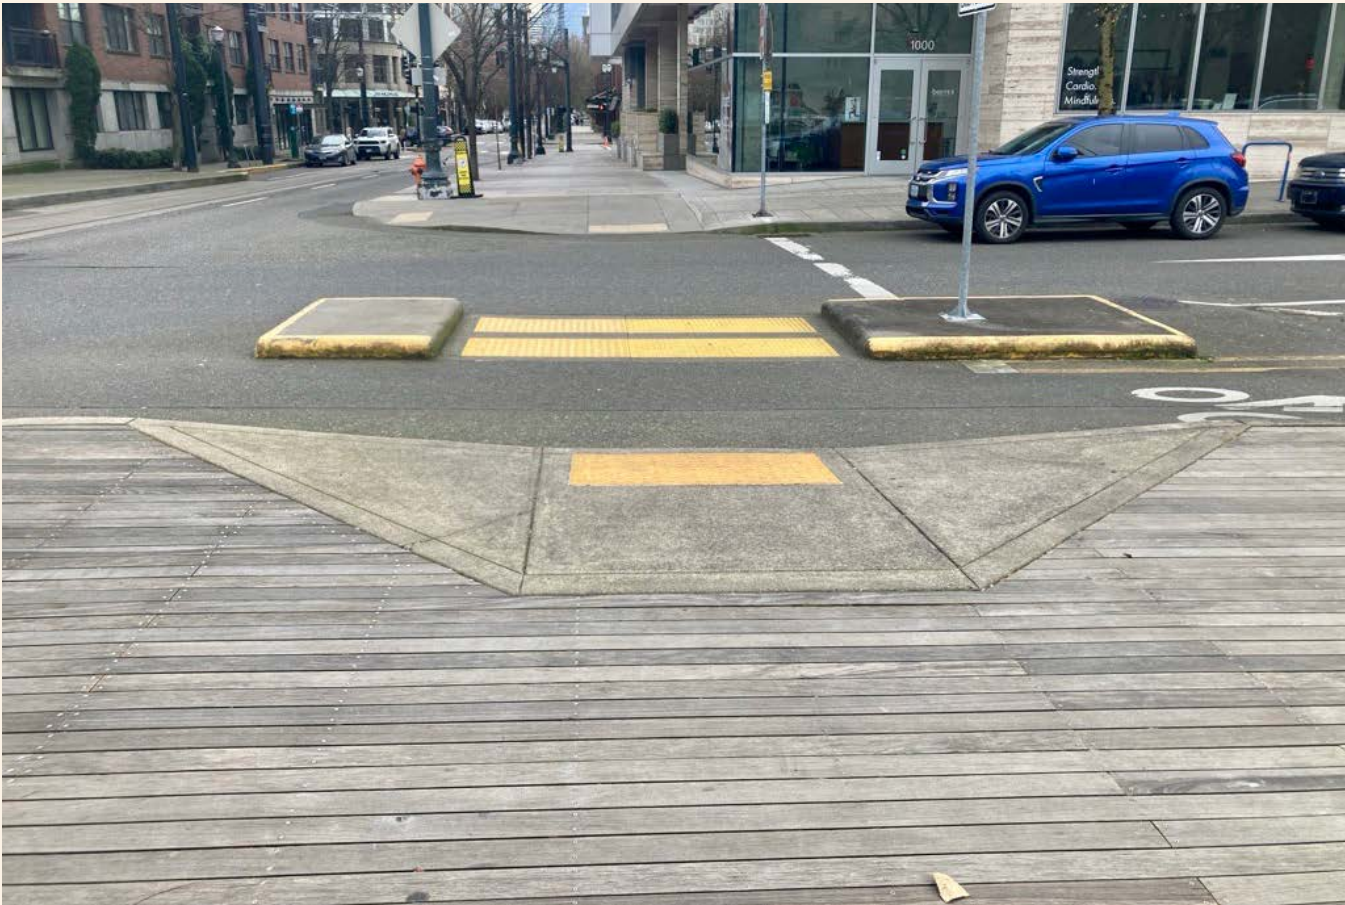
**Figure 3.2.6**  
**Jamison Square Curb Ramp**  
Photo demonstrating how the Jamison Square Boardwalk connects to curb cuts.

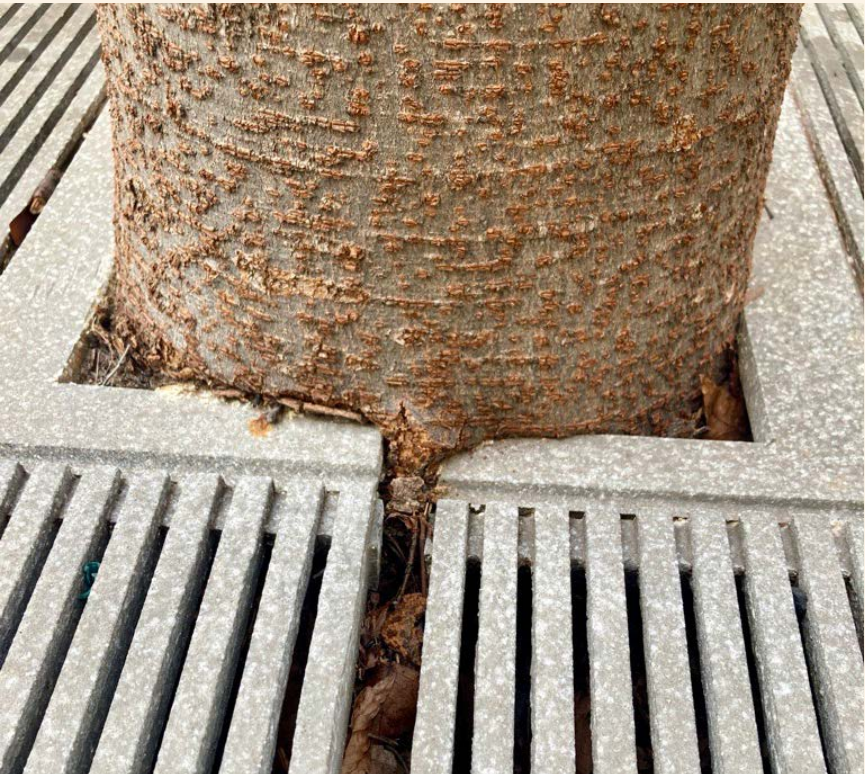
**Figure 3.2.7**  
**Jamison Square Tree Grate**  
Photo of a tree grate installed in Jamison Square, demonstrating how the product is constraining the tree’s base.

However, Walker’s tree well design does not appear especially inviting for the Honey Locusts planted within them (figures 3.2.7 and 3.2.8). While they have pockets of airspace, the sub-grade concrete beams surrounding them that are constructed within their critical root zones seem problematic for their health. The restrictive grates around the trees could be eliminated with curbs or rails as edge protection, but the sub-grade beams seem harder to avoid.

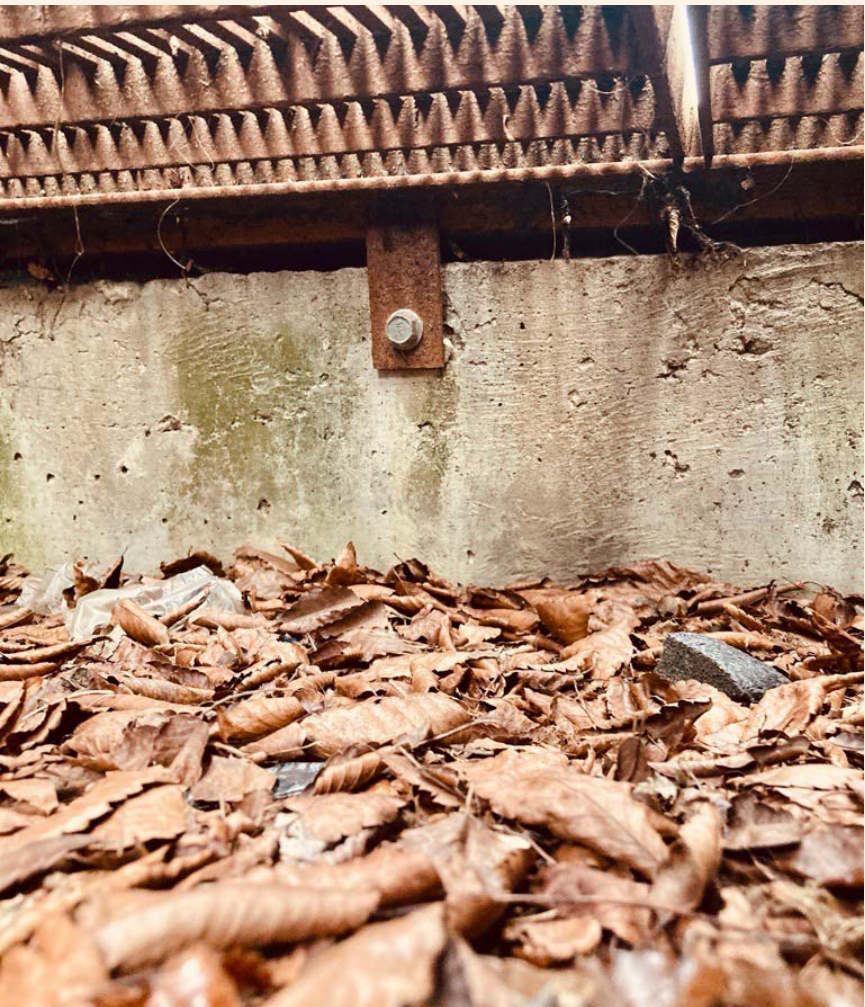
**Figure 3.2.8**  
**Inside Jamison Square Tree Grate**  
Photo taken below grade inside of a tree grate, showing that the grates and apparently the boardwalk itself are secured onto concrete beams, which provide some air space between them, but clearly occupy the space trees’ roots prefer to grow, enclosing the trees planted in Jamison Square.

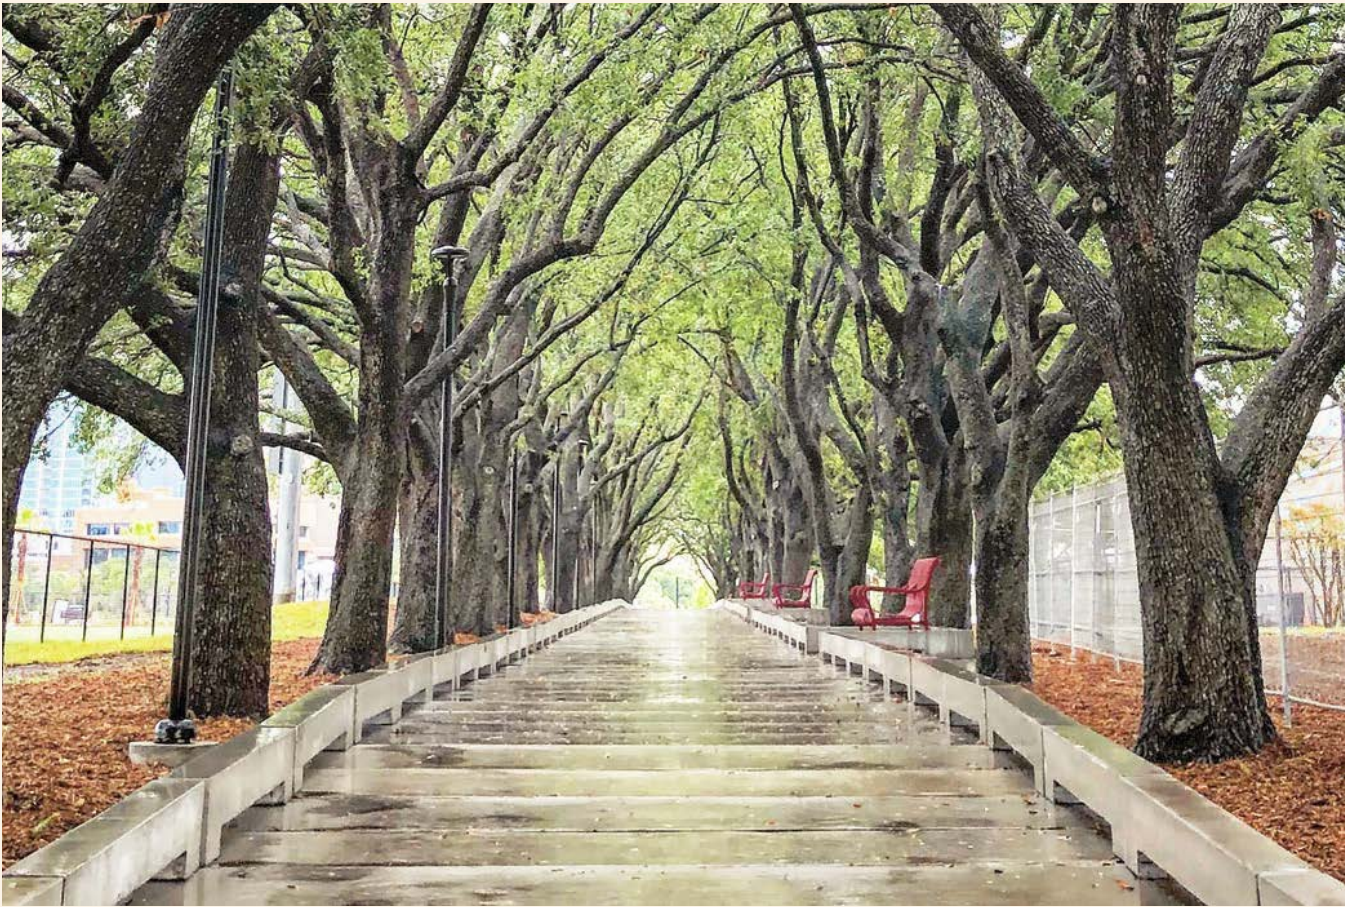
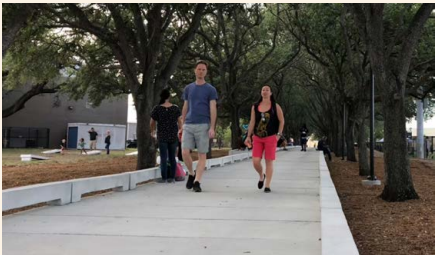
**Figure 3.2.9**  
**Julian B Lane**  
Precast concrete boardwalk project  
in Florida.  
([permatrak.com](http://permatrak.com))

The precast concrete boardwalk system by PermaTrak is a precedent that incorporates arborist insight and seems like a **fantastic design solution from the tree’s perspective**. This system was developed with the full recognition that trees need airspace above their roots, it is intended for the CRZ of trees that are especially significant, and highly durable ([permatrak.com](http://permatrak.com)).

As shown in figures 3.2.9 and 3.2.10, the PermaTrak precast boardwalk system treats existing tree roots with care while aesthetically elevating pedestrian spaces.

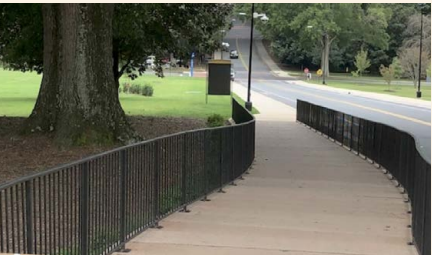
**Figure 3.2.10**  
**Davis Field Project at Wake Forest University**  
Precast concrete boardwalk project  
with a university in North Carolina.  
([permatrak.com](http://permatrak.com))
