# ROOTS AND ROUTES

*Seeking an Accessible Path to Make Peace Between  
Street Trees and Sidewalks in The Whit*

An applied research project accepted and approved in partial  
fulfillment of the requirements for the degree of  
Master of Landscape Architecture

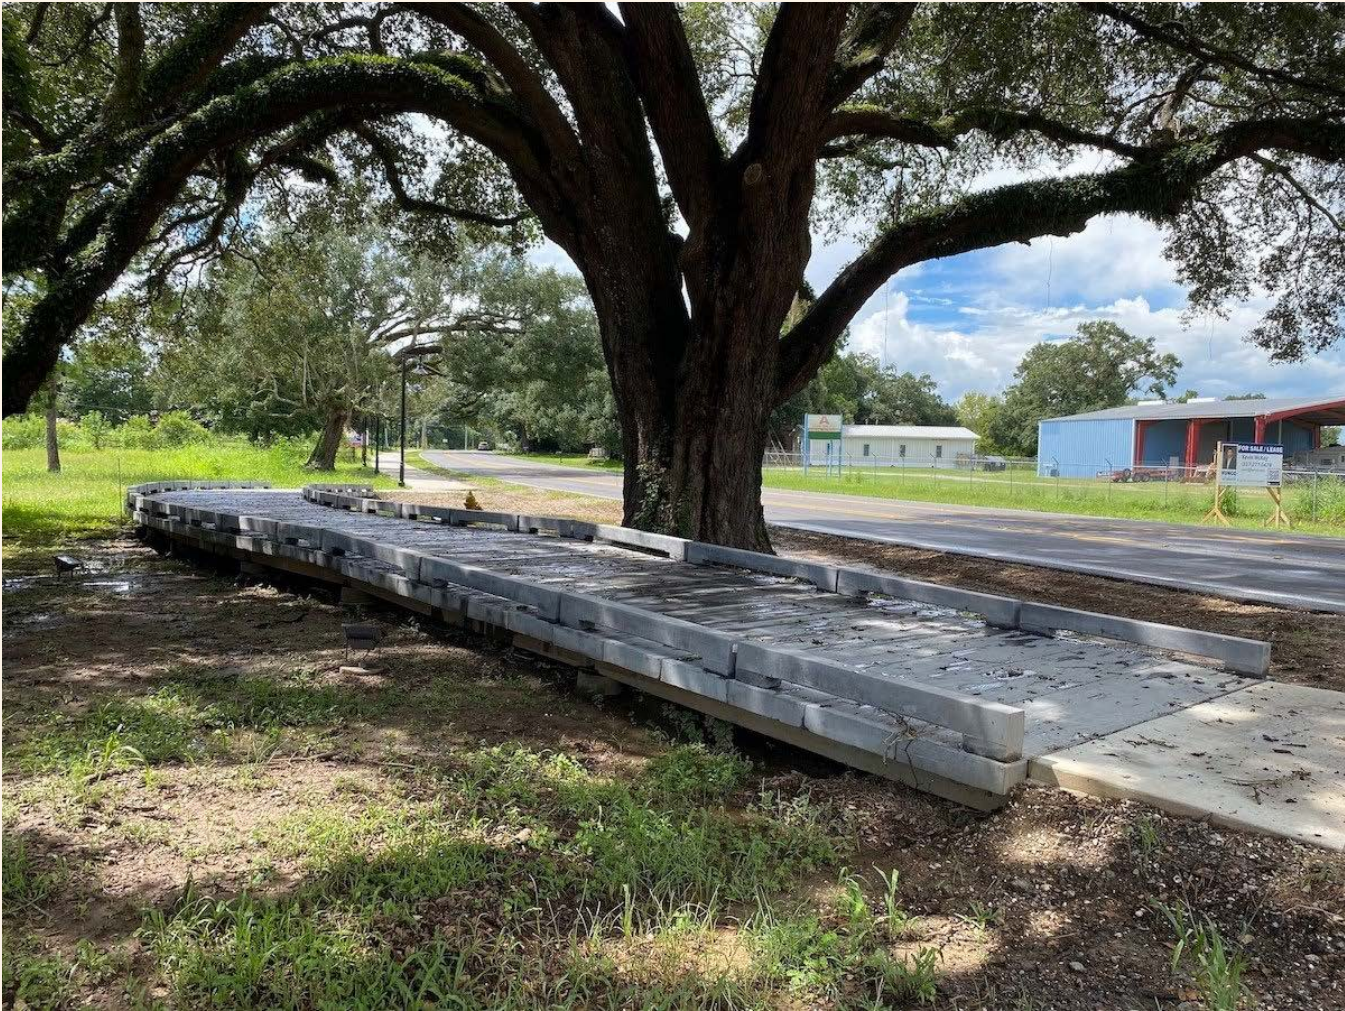
**Figure 3.2.11**  
**Davis Field Project at Wake Forest University**  
Project with a university in North Carolina.  
([permatrak.com](https://permatrak.com))

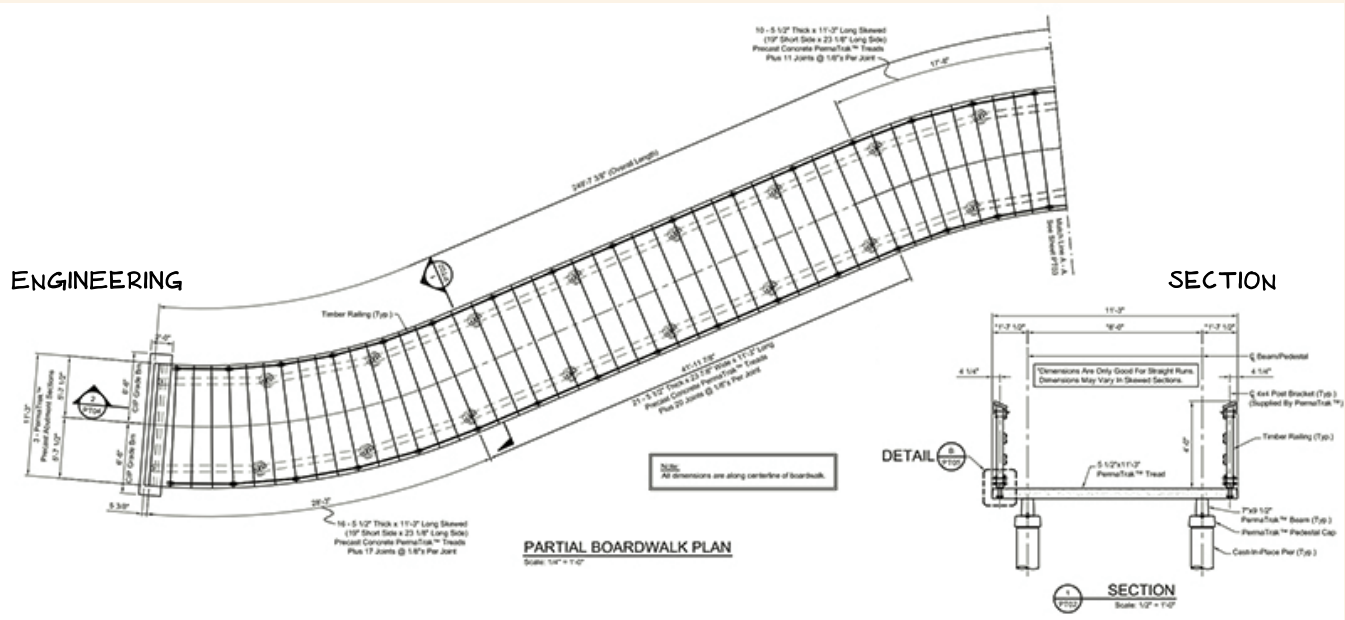
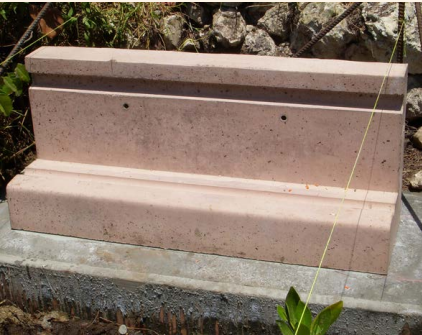
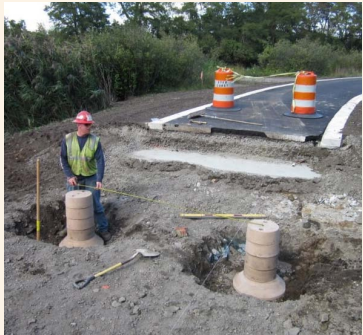
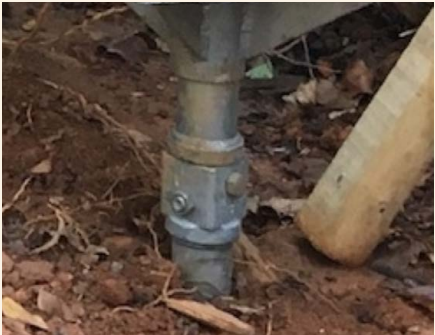
ABUTMENT

PRECAST CONCRETE

HELICAL PILE

**Figure 3.2.12**  
**PermaTrak Construction System**  
Screenshots of engineering drawings and construction photos of the PermaTrak precast concrete system with annotations noting design solutions to relevant problems.  
The system typically uses abutments at the connections between the boardwalk system and other path types and often uses precast or cast-in-place concrete pier foundations.  
([permatrak.com](https://permatrak.com))

1. Precast concrete boards are prohibitively expensive for many private homeowners and cities that manage sidewalk repairs cannot afford to install these systems broadly.
2. The weight of a precast concrete boardwalk is a substantial structural engineering challenge that necessitates substantial foundations, increasing tree root

- 3. The required thickness for edge protection with precast concrete is so large that there is often not space to accommodate it in addition to an accessible path width within the public right of way in residential areas. This is the likely reason PermaTrak projects are found in large urban areas and typical path widths are at least 8 feet.
- 4. All concrete has a significant carbon footprint. An elevated concrete boardwalk uses dramatically more concrete, increasing a city's carbon footprint.
- 5. Concrete acts as a thermal mass and contributes to the urban heat island effect; these drawbacks of concrete may not be altered by elevating the material, particularly if the assembly increases concrete mass.

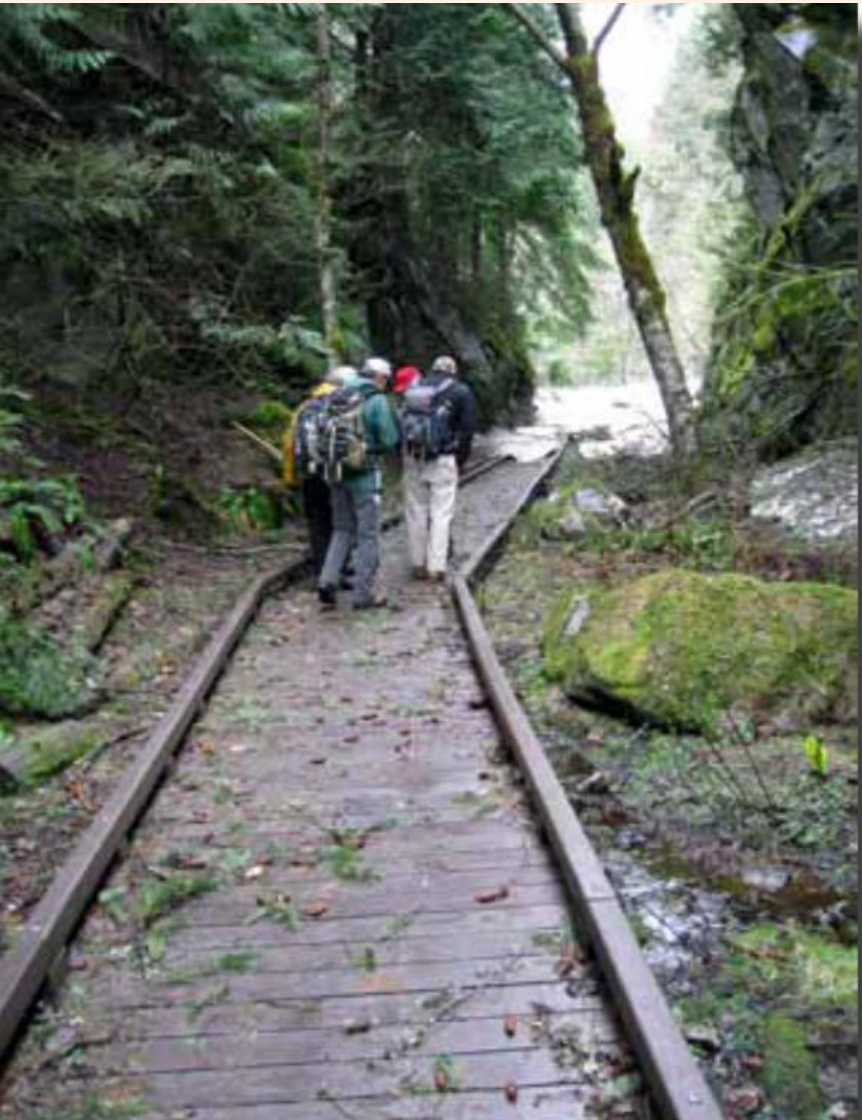
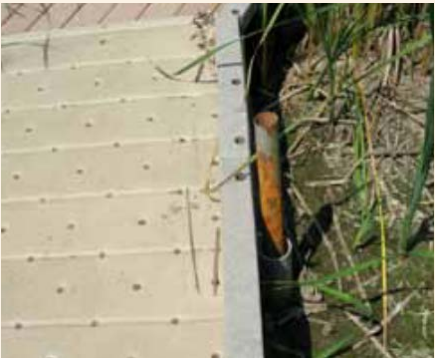
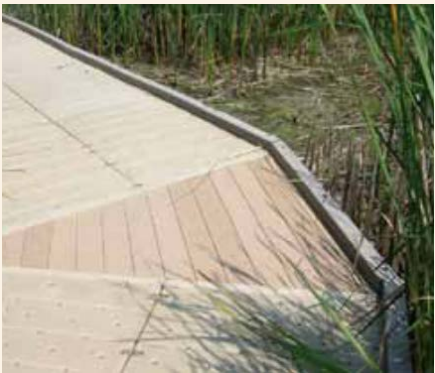
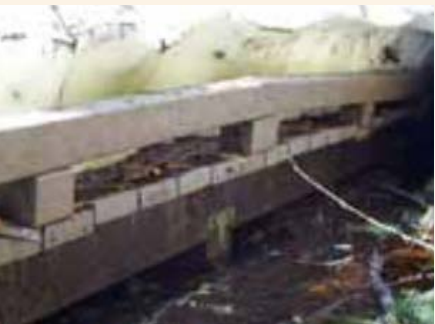
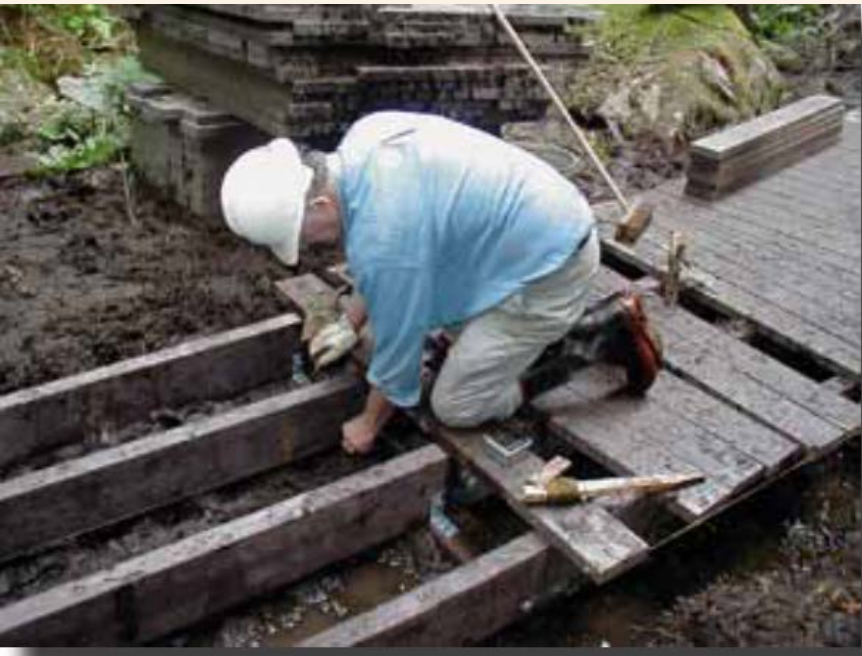
**Figure 3.2.13**  
**Plastic Lumber Boardwalks**  
Photo examples of plastic and rubber lumber options for boardwalks.  
(Willbee, 2011)

Luckily, there are many material alternatives to wood and concrete, ranging from FRP to the plastic and rubber lumber assemblies shown in figure 3.2.13. The main challenge these systems have is their **slip resistance**. Material specification must carefully consider integral material friction and avoid topical slip resistance that will wear down.

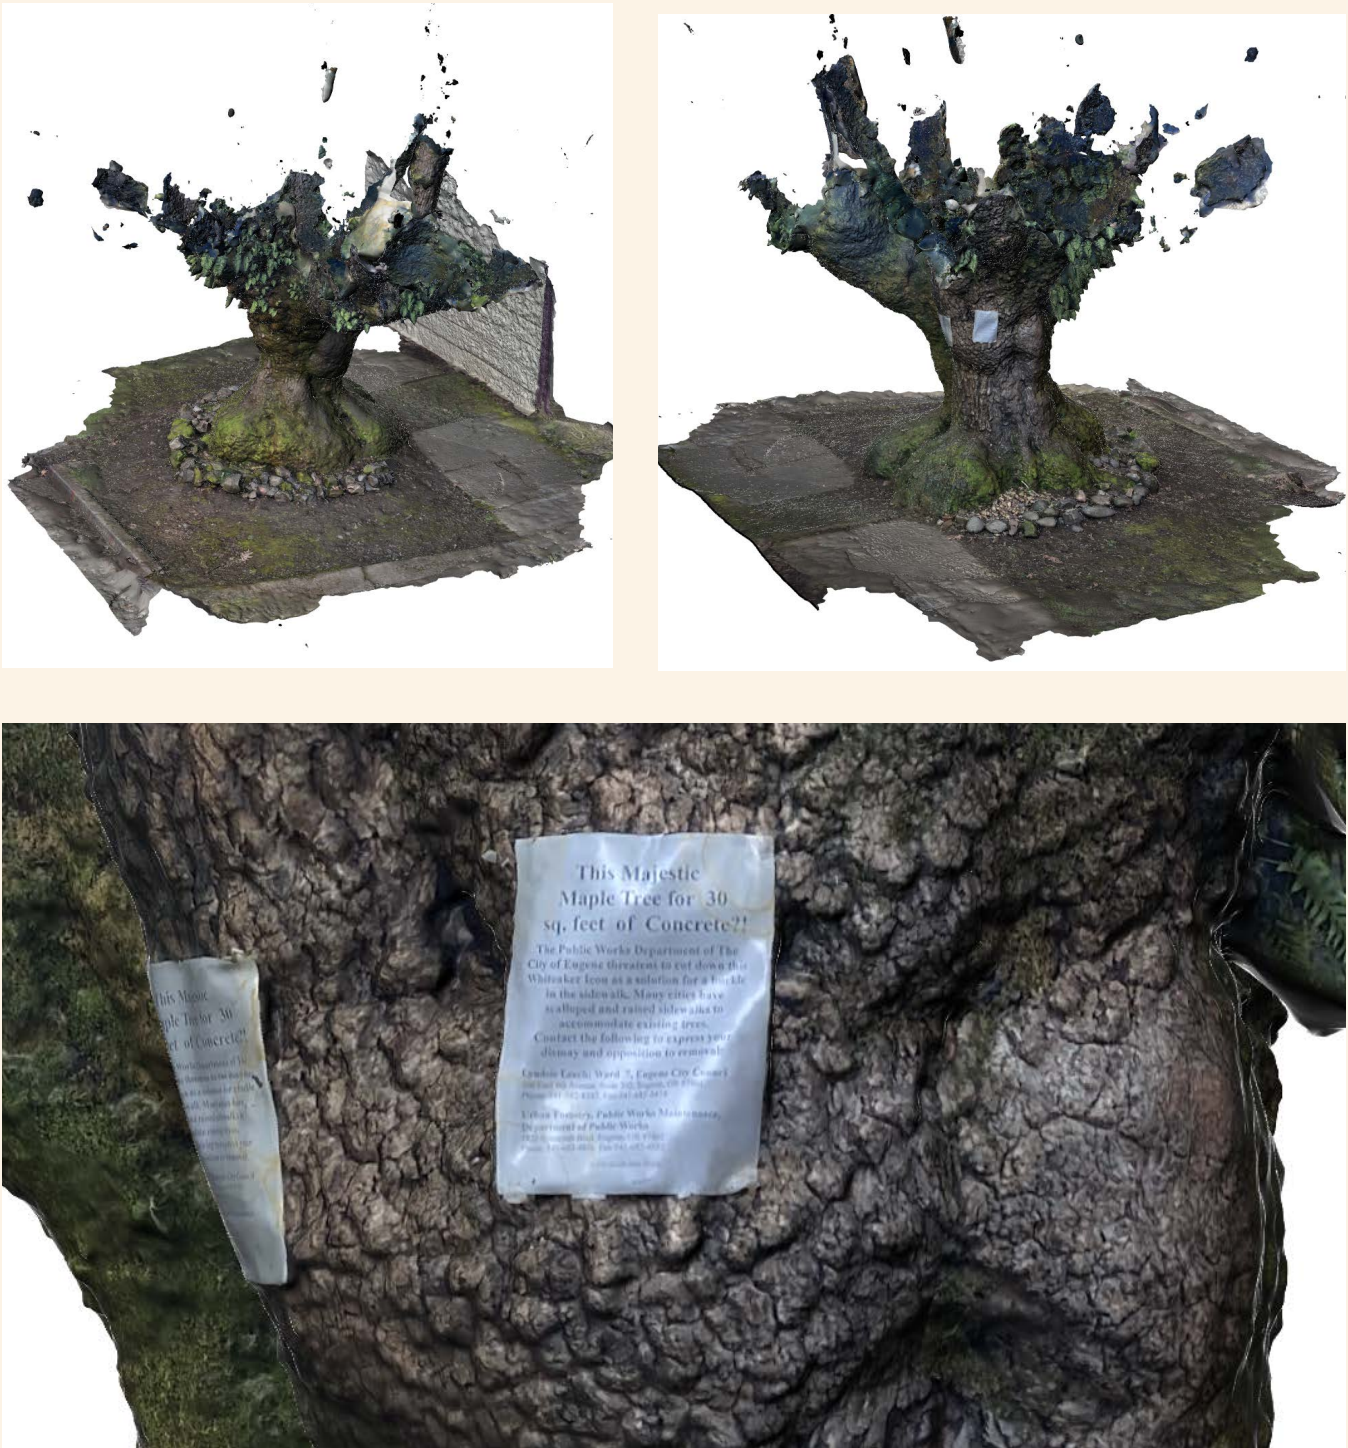
**Figure 3.3.6**  
**Initial Photometry Model**  
Image of the photogrammetry model of the Majestic Maple, courtesy of Ignacio Lopez Buson. Intended as either a memorial for or a realistic reference for designing around the tree’s burl’d base and low-hanging branch.

**SITE DOCUMENTATION**  
Out of particular care for this tree and a **desire to preserve its memory**, even if it hadn’t survived, it was documented through overlapping photos used to create the photogrammetry model (figure 3.3.6).  
Along the way this tree was examined in detail and

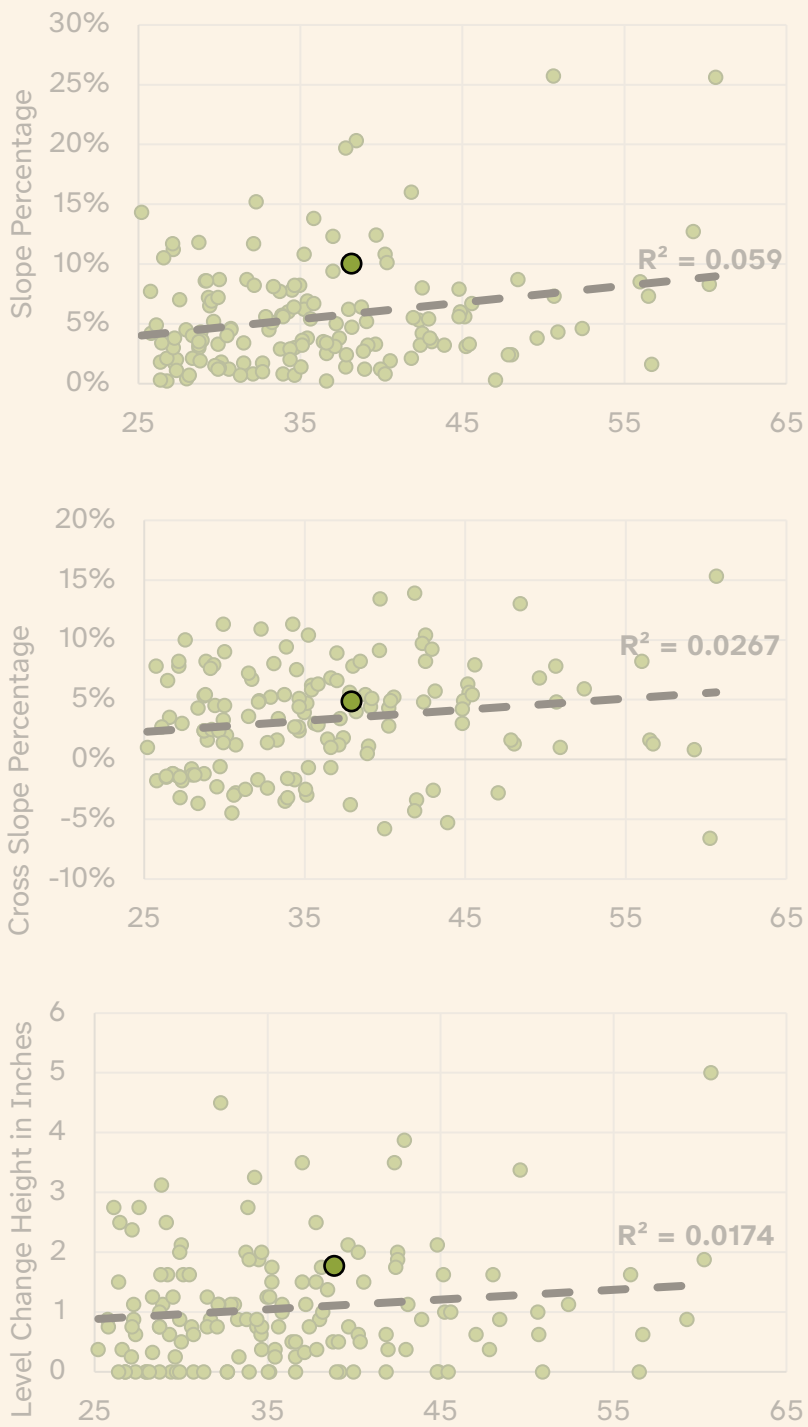
**Figure 3.3.7**  
**The Stakes at this Site**  
Scatterplots showing the relationship between tree DBH and root heave with this tree’s location noted, showing the local sidewalk obstruction relative to other trees within this project’s scope.

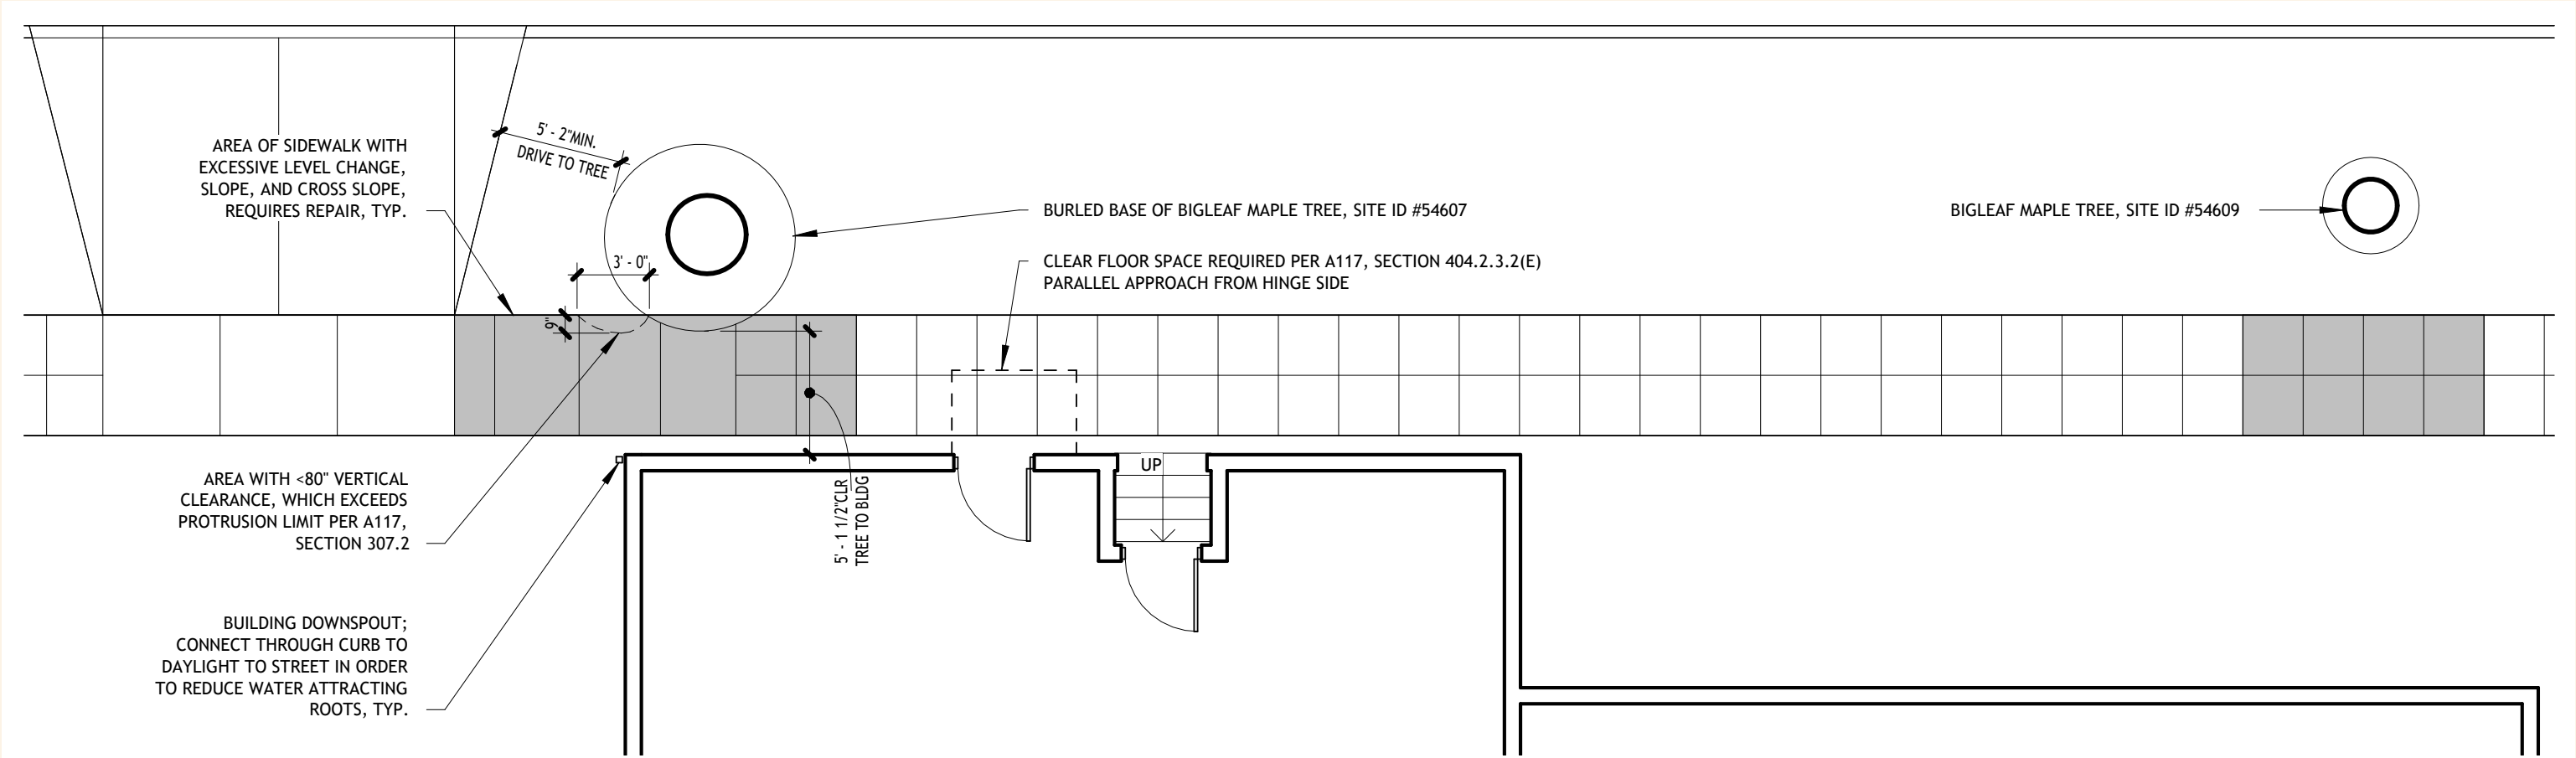
**Figure 3.4.8**  
**Conditions Measured in the Field**  
Drafted plan illustrating existing conditions surrounding the trees at this site.

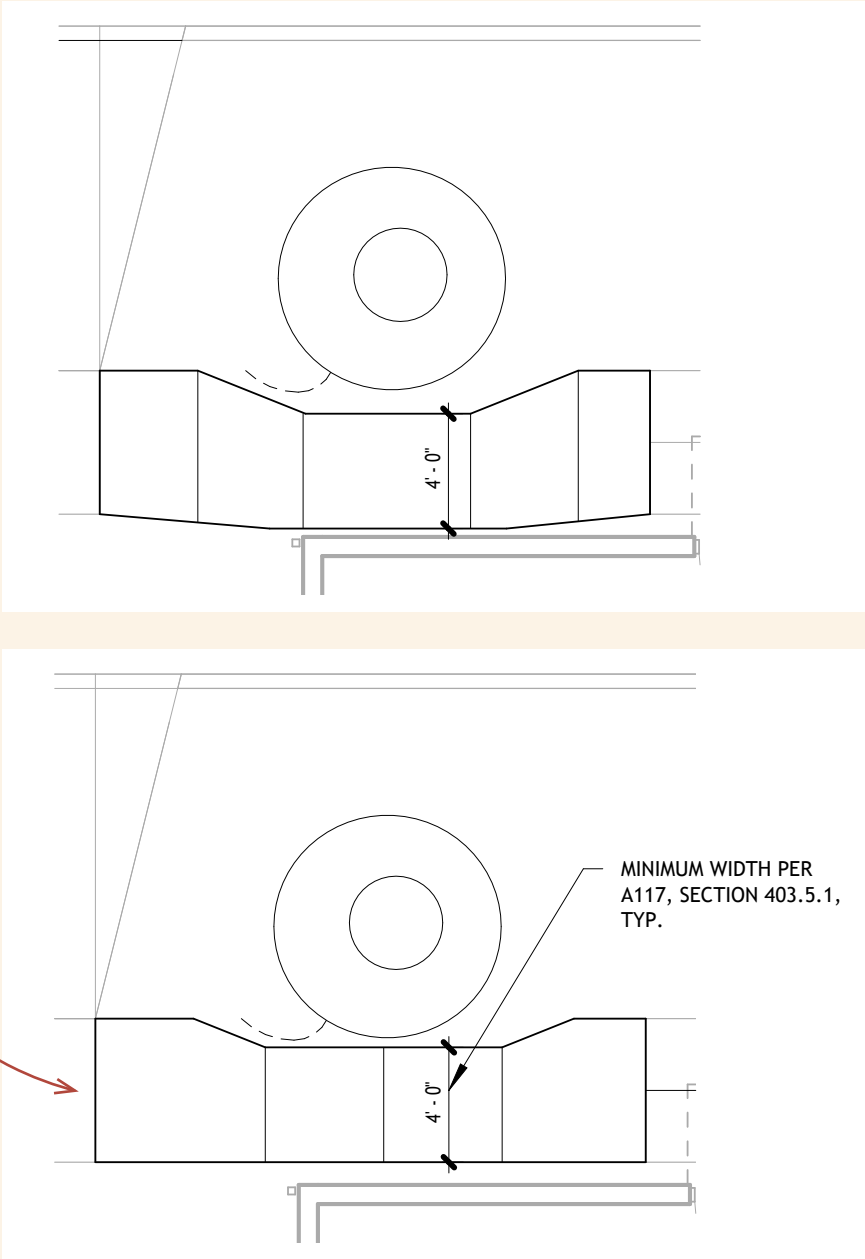
Figure 3.3.9  
**Possible Scalloped Walk Options for Repairing the Sidewalk within the Current System - Redlined Post Analysis**  
Drafted plans of ways to scallop the sidewalk illustrated January 2026 while waiting to hear the determined fate of the Majestic Maple with redlines added after data analysis.

THIS IS THE MOST WORKABLE OPTION - BUT IT'S NOT ALWAYS POSSIBLE AND REDUCES ACCESSIBILITY. AND WHAT IF IT JUST RESET THE CLOCK ON A RECURRING PROBLEM?

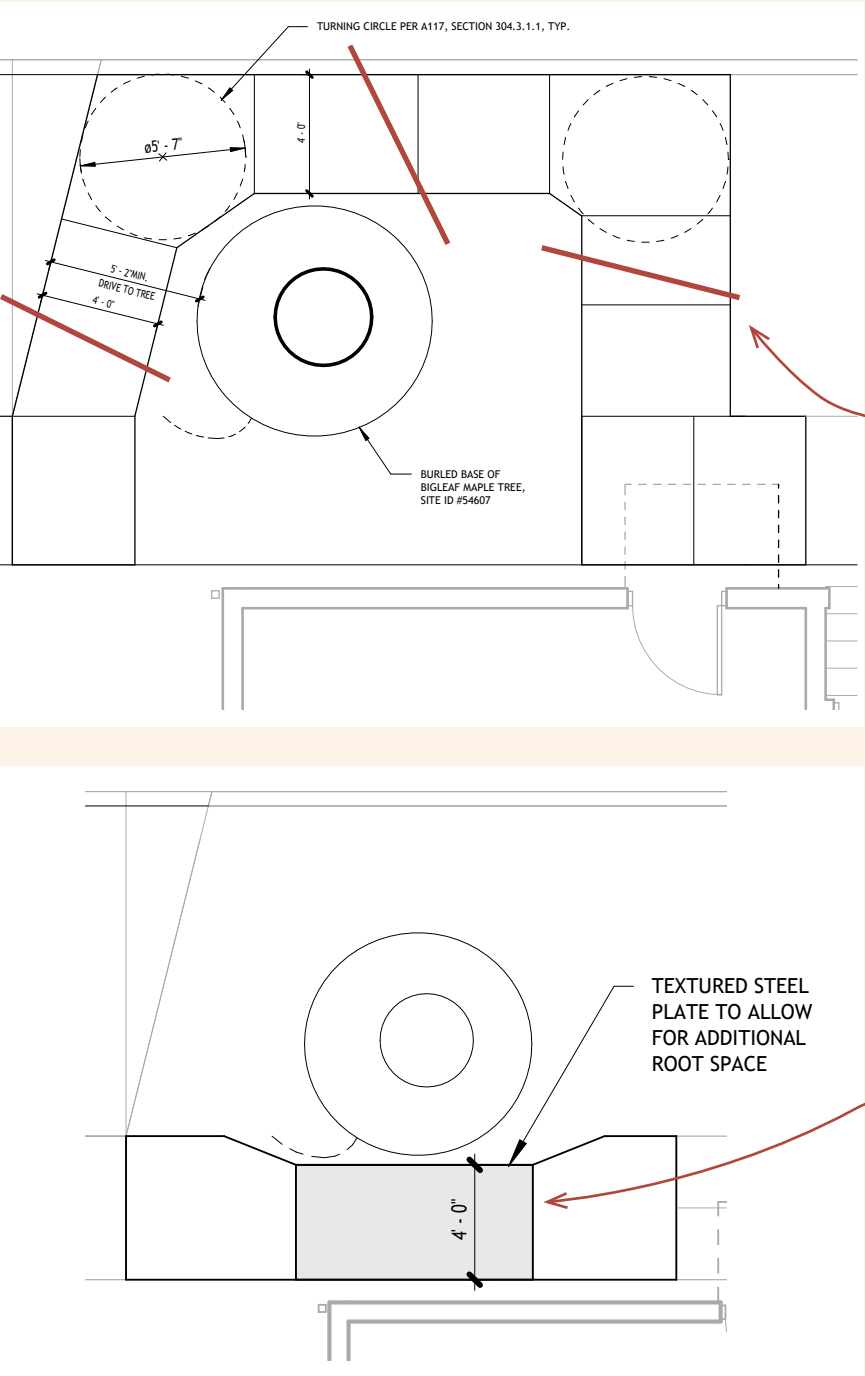
Figure 3.3.10  
**Theorized Radical Sidewalk Renovation Options- Redlined Post Analysis**  
Drafted plans of potential radical sidewalk changes illustrated January 2026 while waiting to hear the determined fate of the Majestic Maple with redlines added after data analysis.

WASTEFUL USE OF CONCRETE WITH NO MEANINGFUL ADDED ROOT SPACE!

HOW WOULD THIS BE SUPPORTED?  
WOULD IT REALLY PROVIDE MORE SPACE?

less realistic than relying on the existing sidewalk system to withstand root heave. The aluminum would need a supporting structure to span, which would have to be elevated significantly above tree roots and span across even a couple of feet, so there are some technical concerns. Aluminum is also slippery and reflective, thus suboptimal for a sidewalk walking surface.

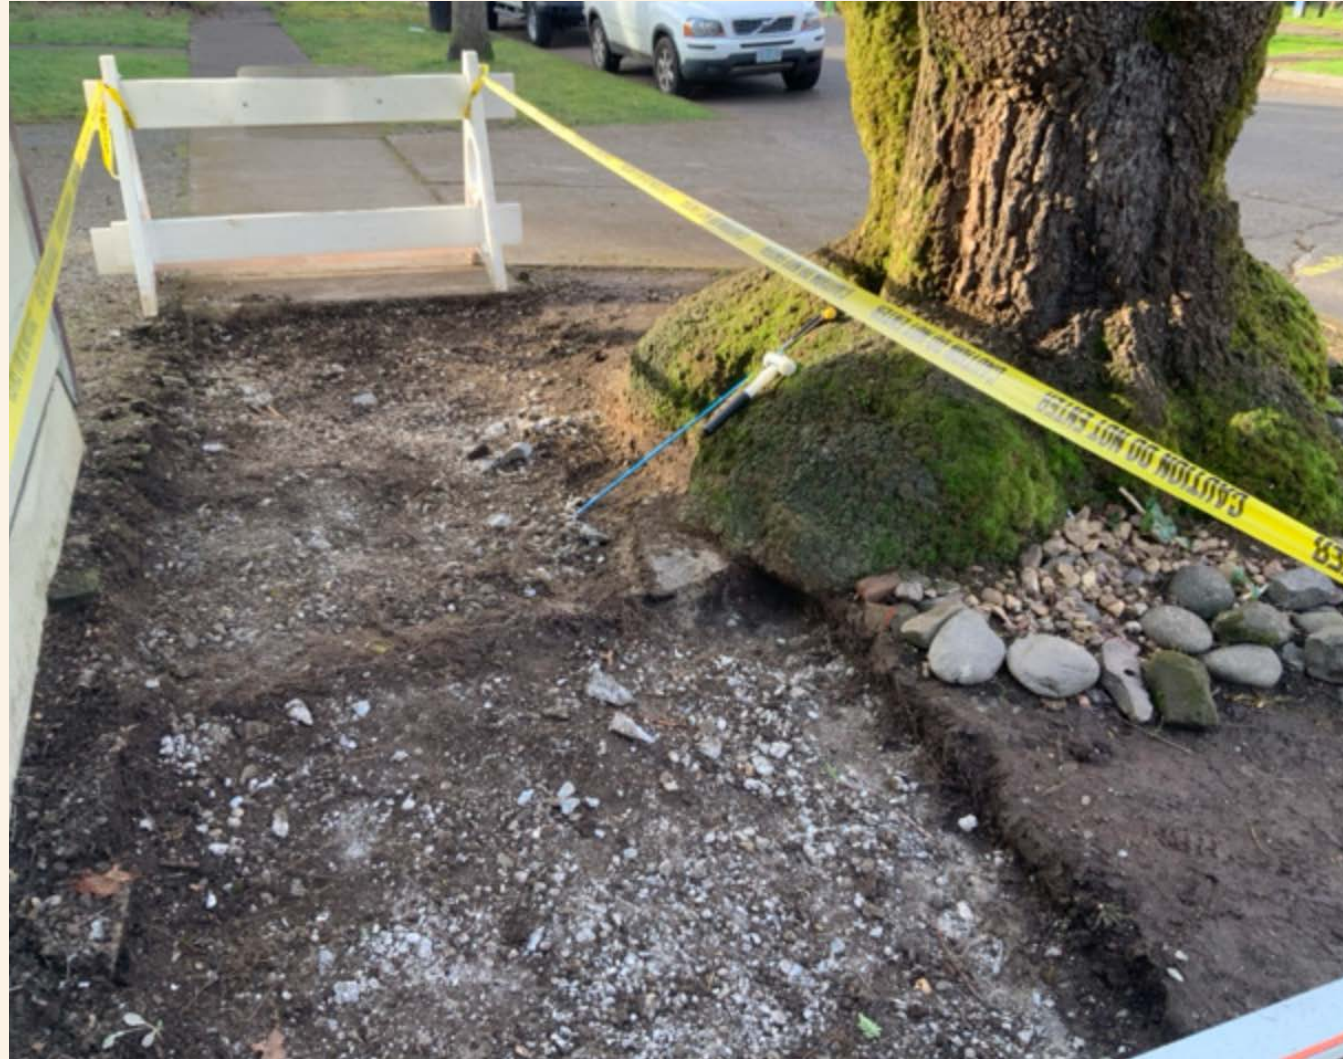
**Figure 3.3.11**  
***Schrödinger's Roots - The Majestic Maple Survived***

Photo from the City of Eugene Urban Forestry Department showing the Majestic Maple's roots before sidewalk reconstruction.

These roots were shaved down in a particular way to minimize regrowth vertically, toward the sidewalk, and rebar was used in the sidewalk to prevent root heave at the joints near the tree. In theory this will prevent recurrence.

According to the findings in this project's street tree study, it seems **highly possible the sidewalk will lift again at the joint between old and new concrete**, potentially putting these trees at risk again. Since this intervention uses almost the entire available toolkit within the current sidewalk system, it has to last as long as the trees have years left to live. Considering that accessibility tolerances allow for 3" of

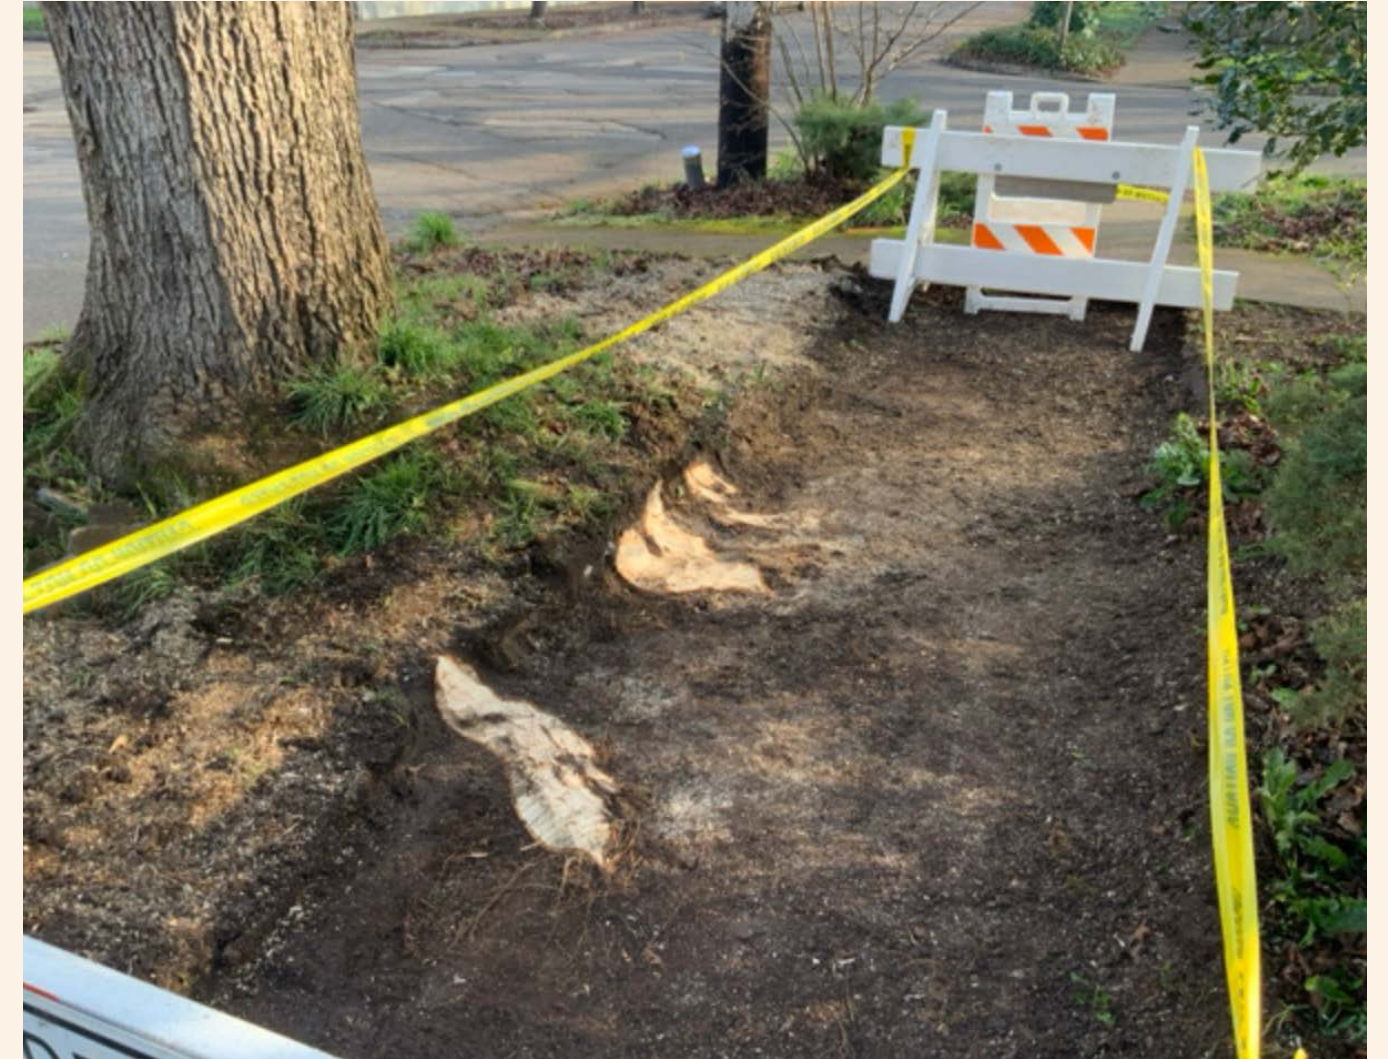
**Figure 3.3.12**  
***Root Pruning Required to Save the Smaller Majestic Maple***

Photo from the City of Eugene Urban Forestry Department showing the smaller Majestic Maple's roots before sidewalk reconstruction.

**OUTCOME**  
The city designed and constructed a new accessible sidewalk through their own means and were able to preserve both trees at this site (see figures 3.3.14 and 3.3.15), but the smaller tree had to endure significant root pruning to make sidewalk reconstruction possible (see figures 3.3.12 and 3.3.13). This is an example of how **urban forestry management requires a lot of compromise** to

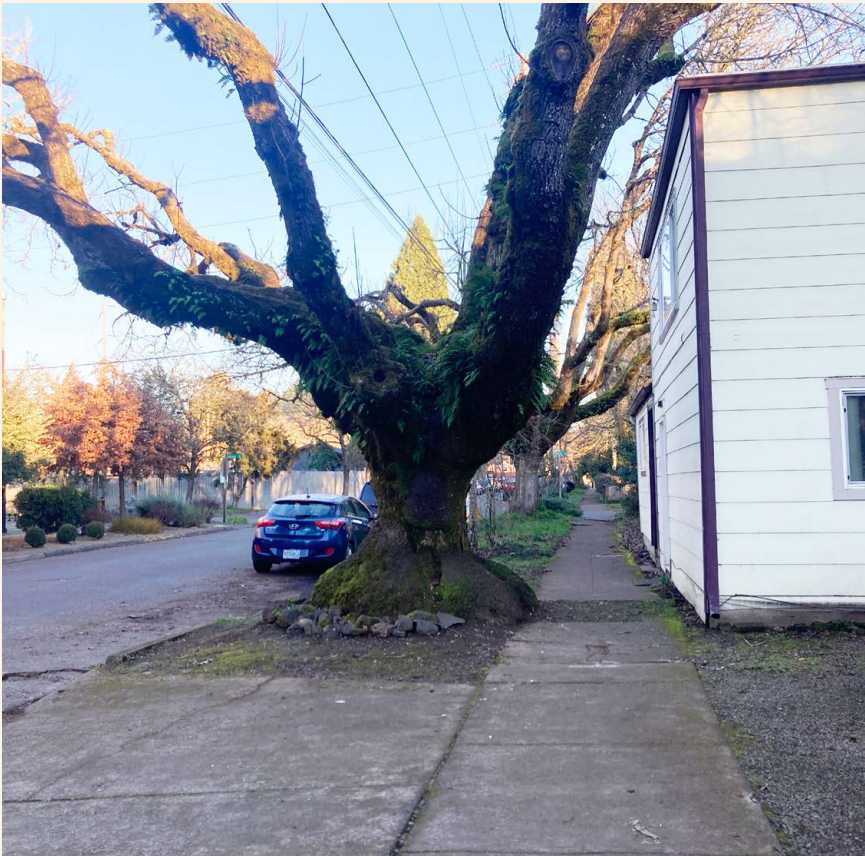
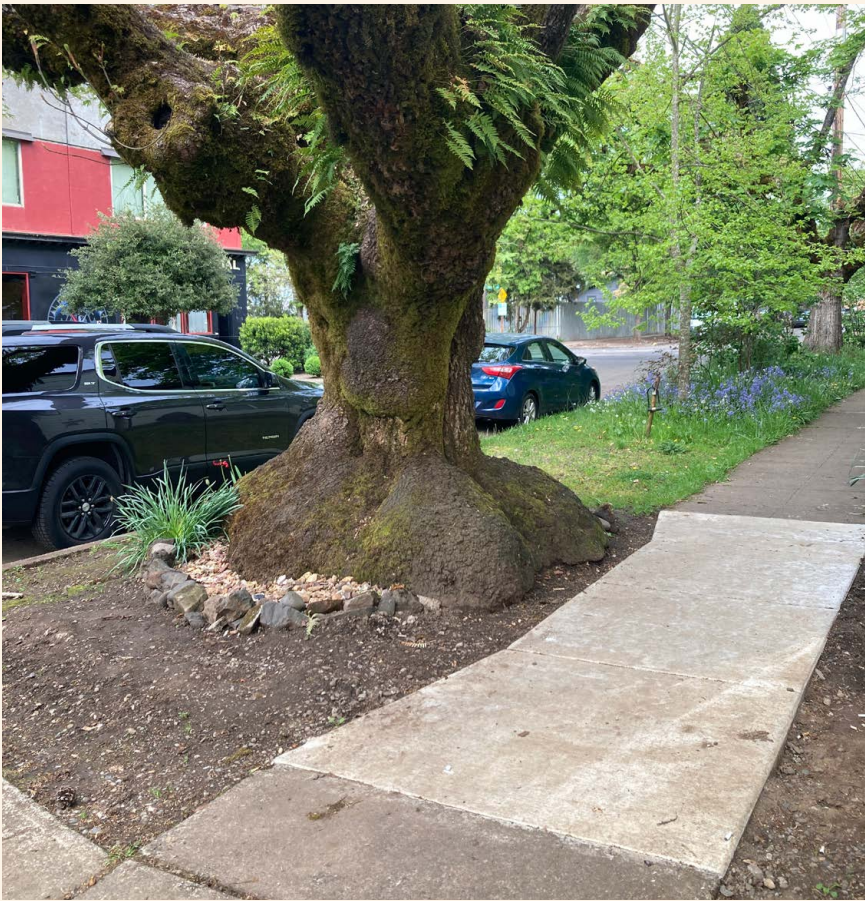
Figure 3.4.13  
***Majestic Maple - Before and After Construction***

Field photos taken before and after the Majestic Maple tree was preserved with minor root pruning.

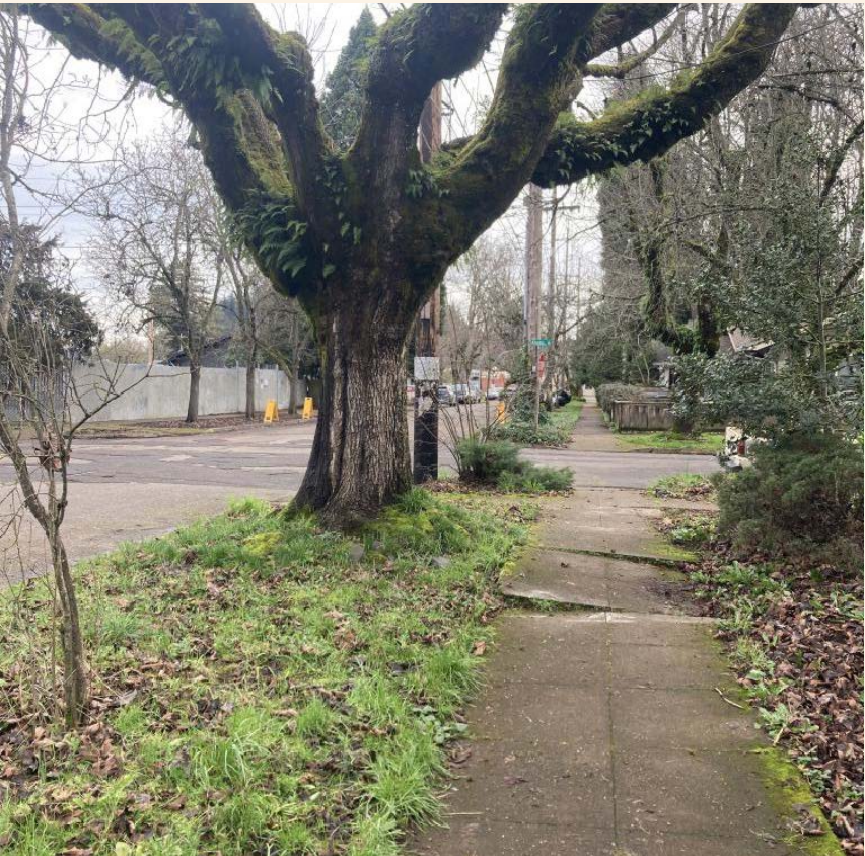
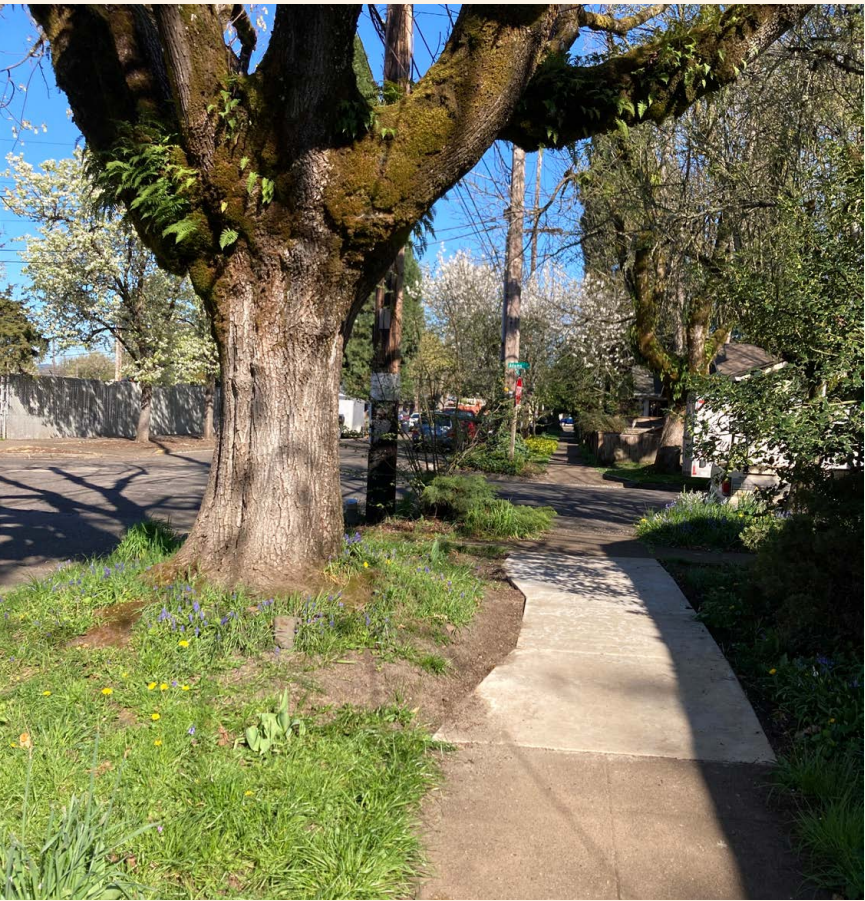
Figure 3.4.14  
***Majestic Maple - Before and After Construction***

Field photos taken before and after the smaller Majestic Maple was preserved with more significant root pruning.

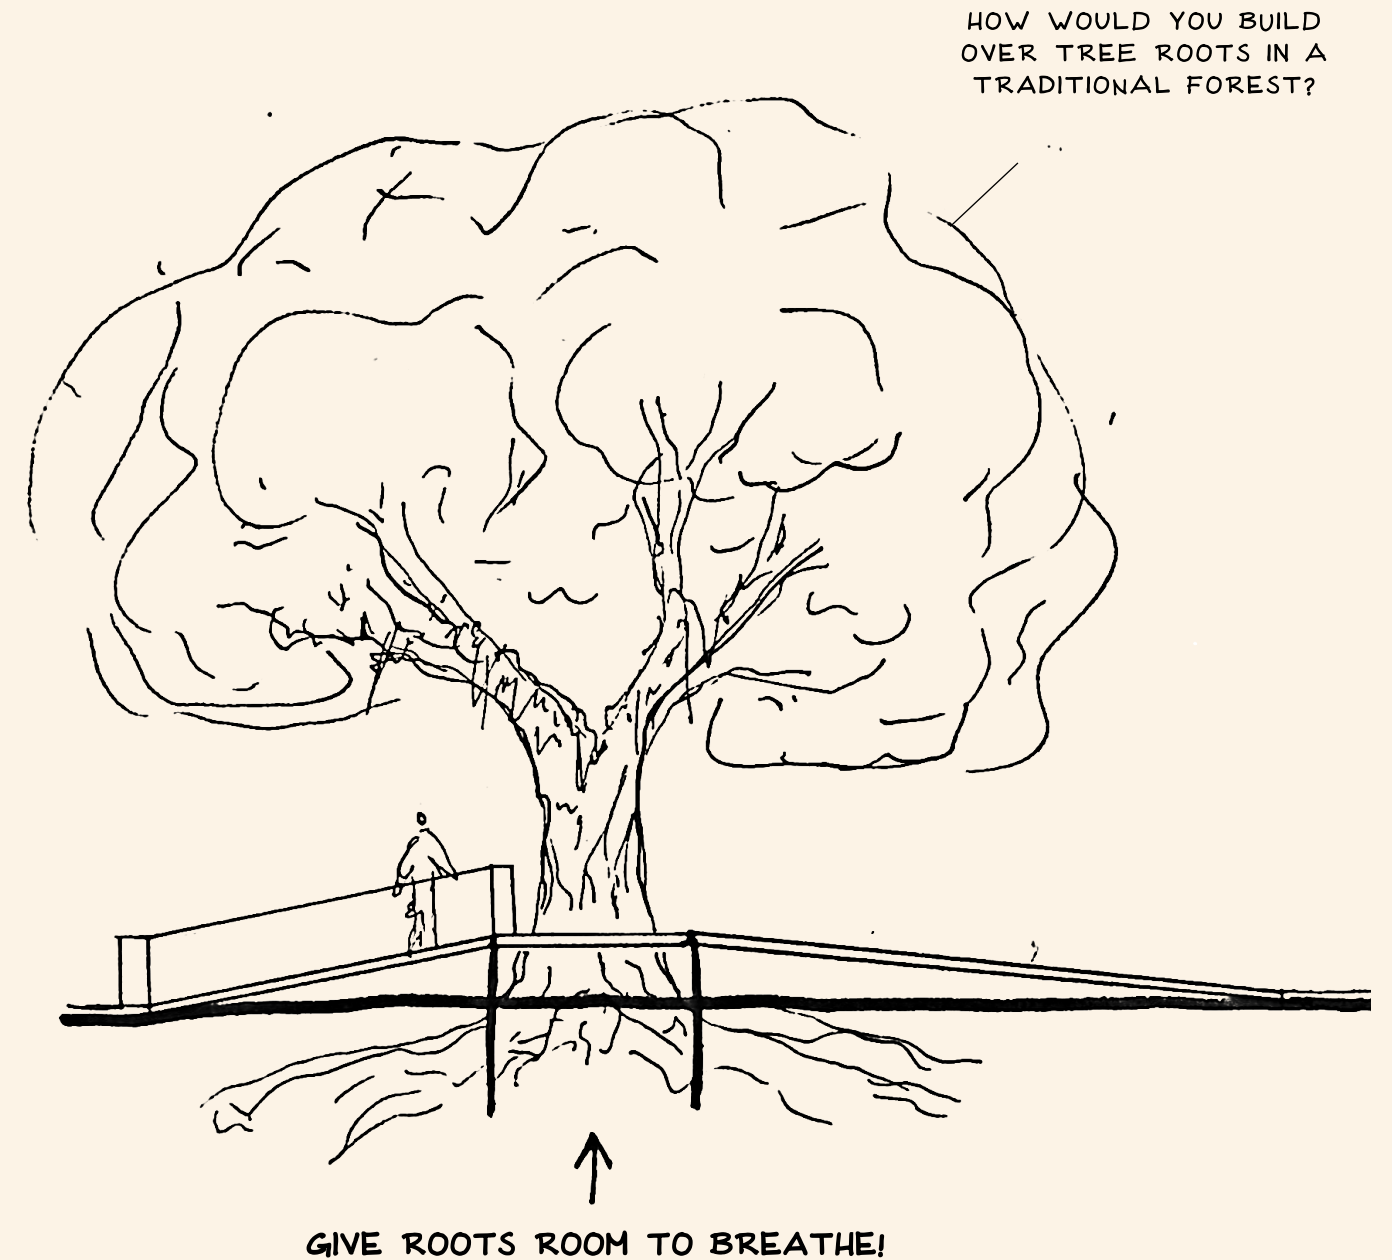
**Figure 3.4.1**  
**The Paddle Tree's Request**

Illustrative sketch of an exaggerated elevated boardwalk at the base of a Bigleaf Maple tree, which asks how we would build an accessible path through a traditional forest, in other words how we would treat the tree's roots if it were growing in its natural habitat.

The only design requirement, from the tree's perspective, is to **lift the sidewalk above the roots** (see figure 3.4.1). But the specific solution and aesthetic result presented is specifically suitable to Whiteaker because of how it responds to site context. The boardwalk appearance calls back to Eugene's historic wood sidewalks.
