# ROOTS AND ROUTES

*Seeking an Accessible Path to Make Peace Between  
Street Trees and Sidewalks in The Whit*

An applied research project accepted and approved in partial  
fulfillment of the requirements for the degree of  
Master of Landscape Architecture

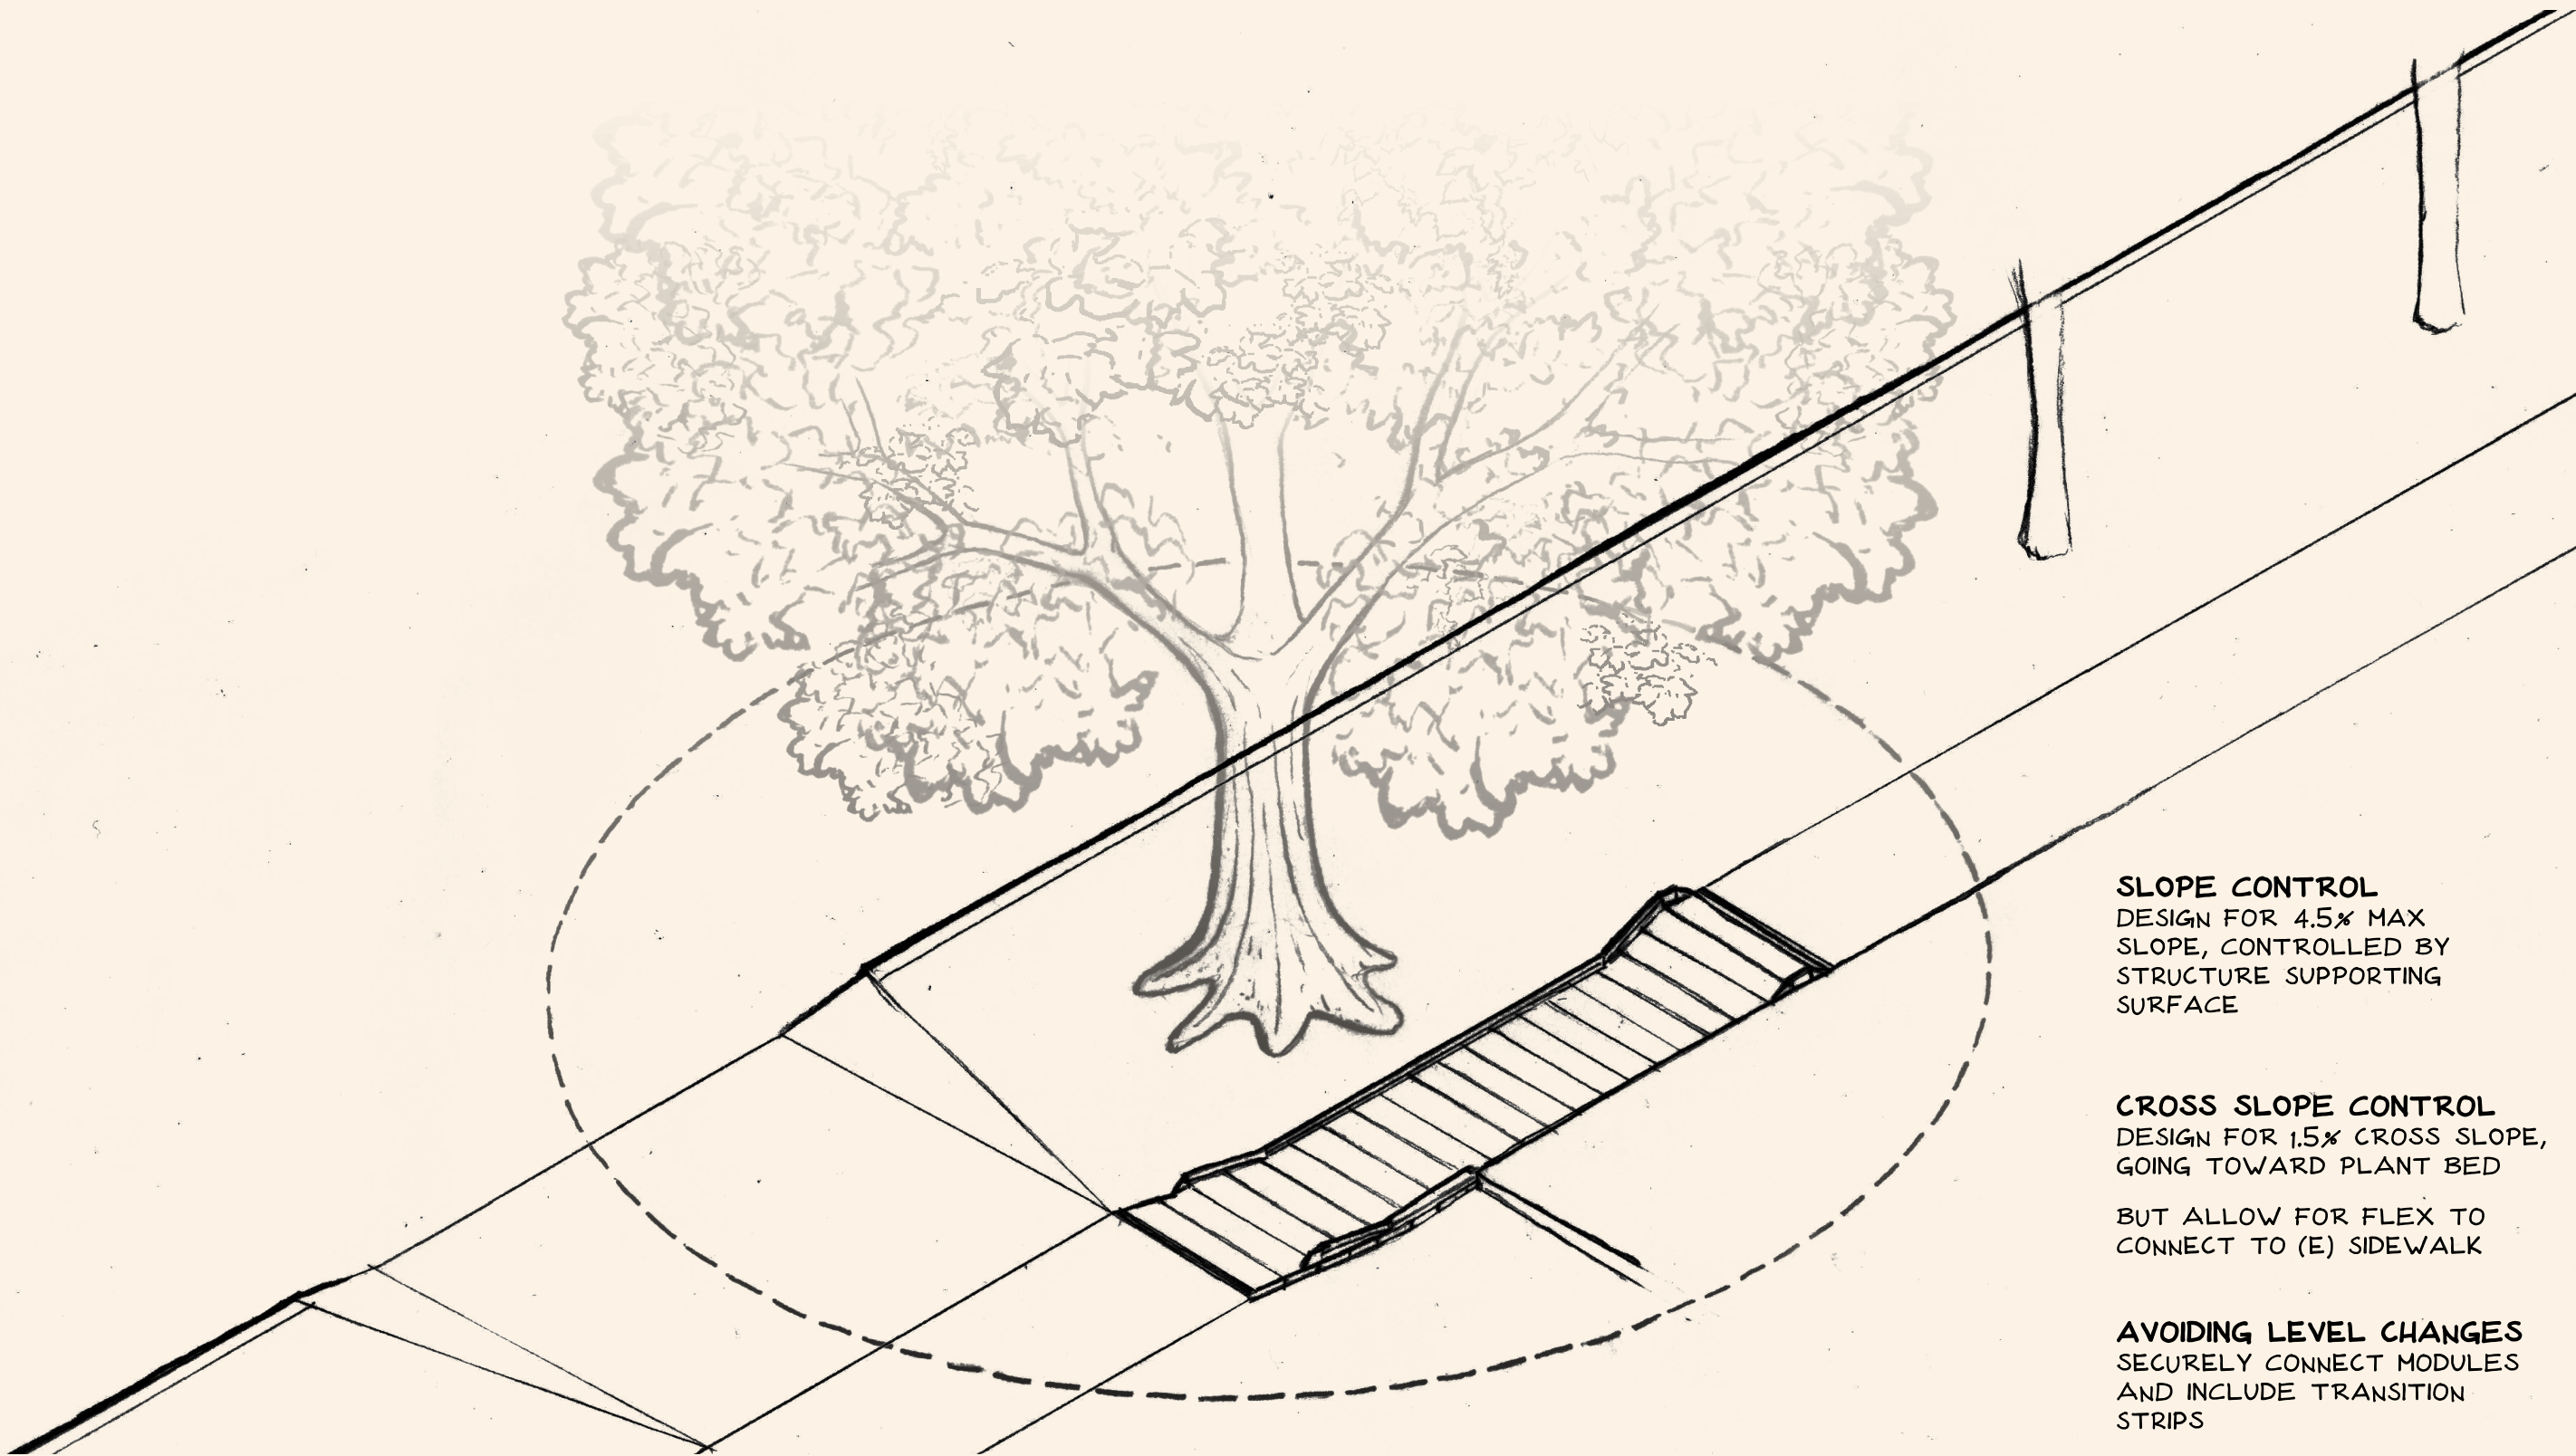
**Figure 3.4.2**  
**Minimum System**  
**Requirements**

**SLOPE CONTROL**  
DESIGN FOR 4.5% MAX  
SLOPE, CONTROLLED BY  
STRUCTURE SUPPORTING  
SURFACE

**CROSS SLOPE CONTROL**  
DESIGN FOR 1.5% CROSS SLOPE,  
GOING TOWARD PLANT BED

As shown in figure 3.4.2, this system is only really necessary where the sidewalk is being actively lifted. Whitwalks can serve as a bridge over tree roots, covering the most affected area of the sidewalk, and seamlessly transitioning to adjacent concrete.

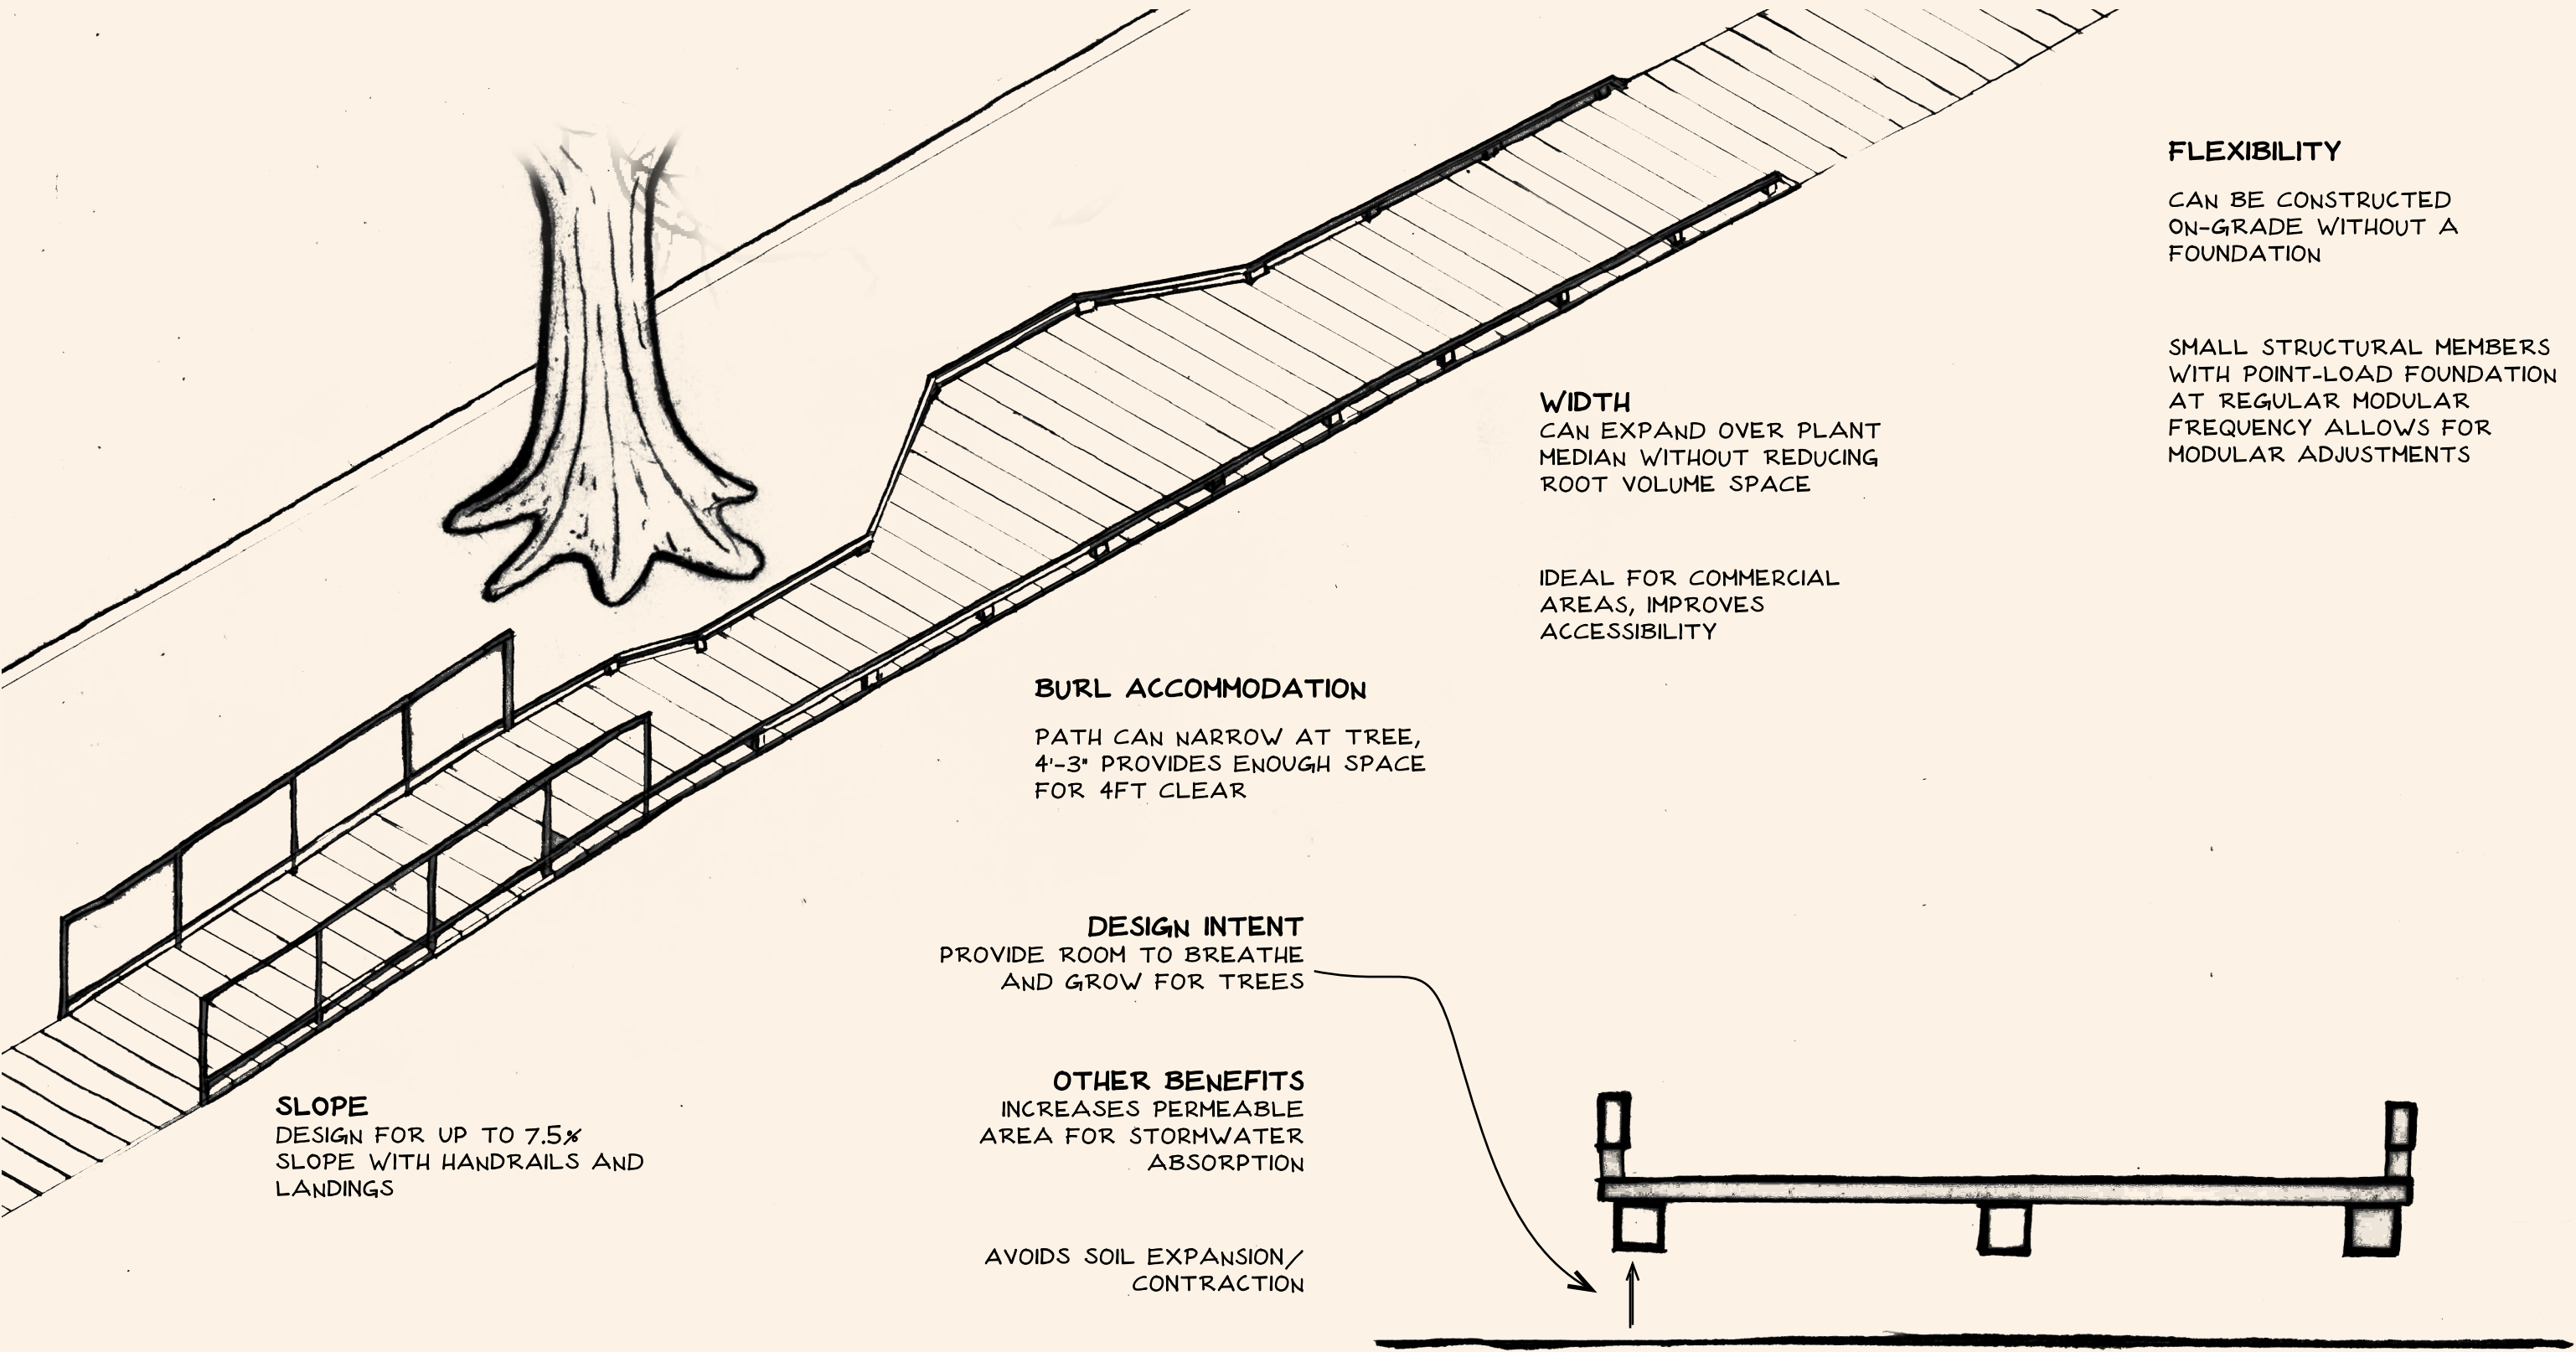
**Figure 3.4.3**  
**Potential for Expansion**  
Illustration of ways WhitWalks could  
expand and be modified to elevate  
sidewalks at various sites.

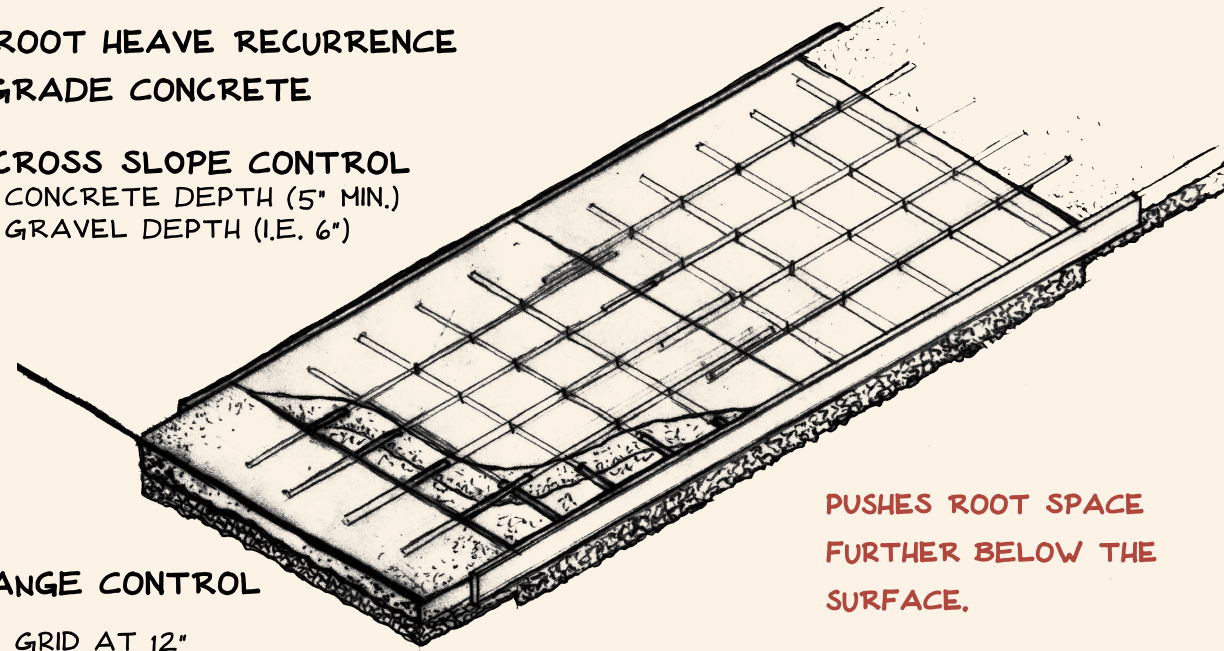
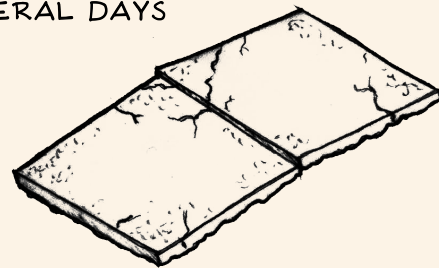
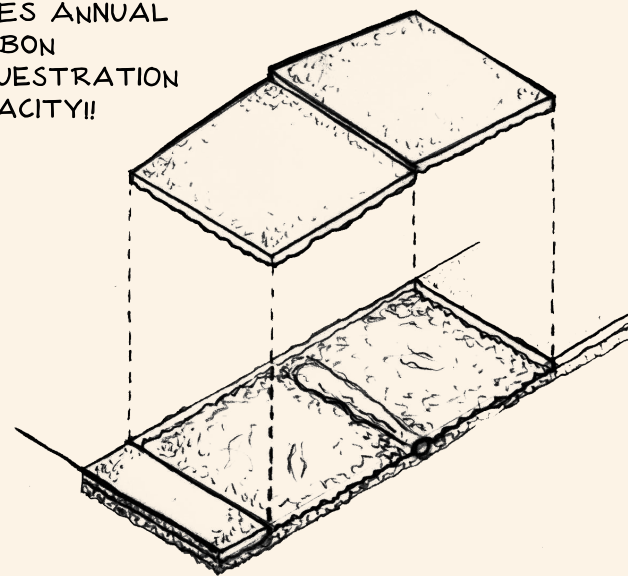
**Figure 3.4.4**  
**Means of Repair - Current System**

#### SLOPE / CROSS SLOPE CONTROL

INCREASED CONCRETE DEPTH (5" MIN.)  
INCREASED GRAVEL DEPTH (I.E. 6")

USE REBAR GRID AT 12" O.C., DRY DOWEL 12" INTO ADJACENT (E) SIDEWALK

POUR CONCRETE WITHIN REQUIRED TEMPERATURE RANGE, INTO WOOD FORM WORK, VIBRATE TO REMOVE AIR, WAIT SEVERAL DAYS TO SET.

ENTIRE BROKEN PANELS  
TYPICALLY BECOME WASTE  
THAT SITS IN A LANDFILL.

ON-GRADE CONCRETE IS  
BROKEN BY LEVEL CHANGES  
AT THE SOIL SURFACE.

Isometric illustration of repair required to prevent root heave with on-grade concrete sidewalks.

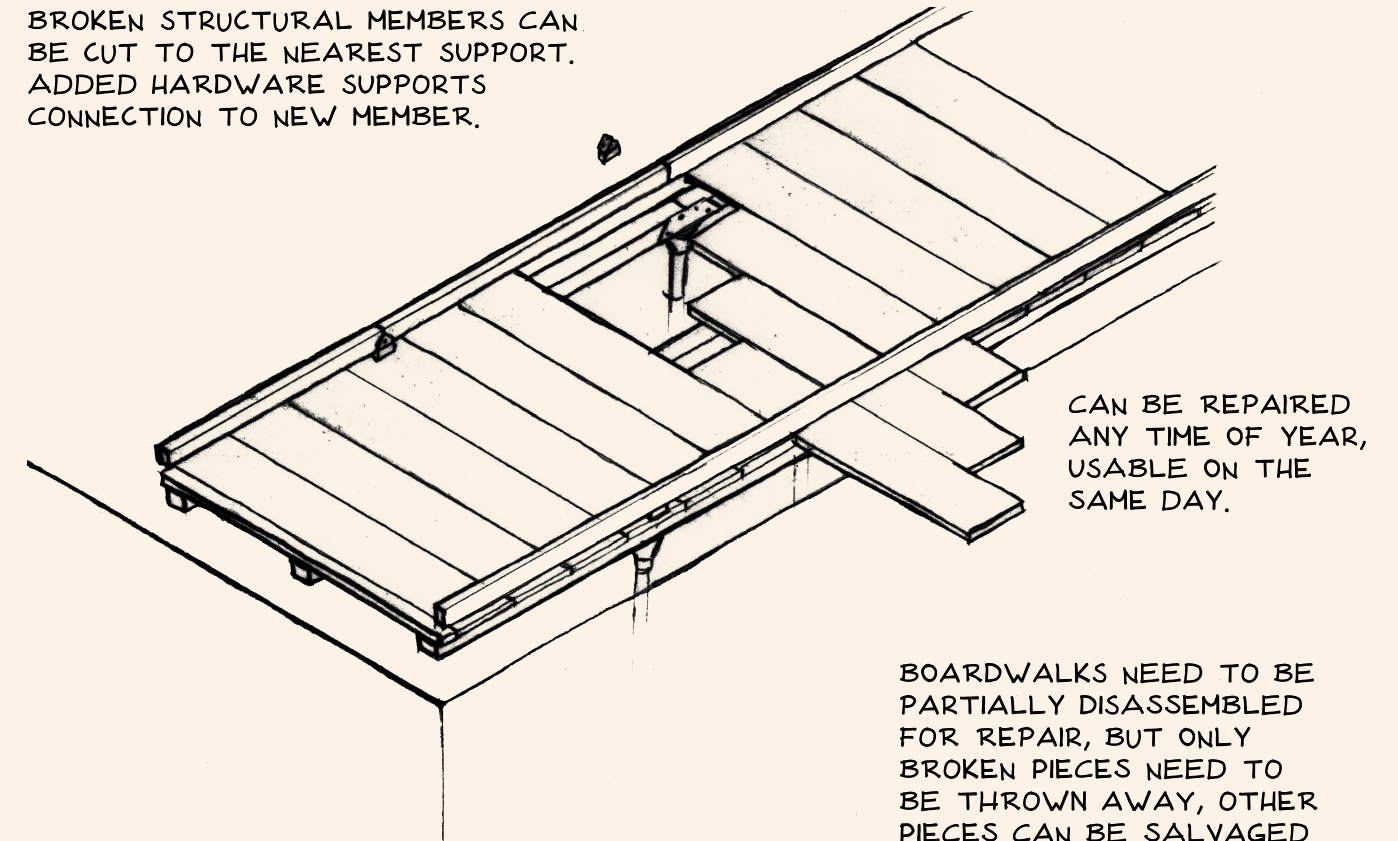
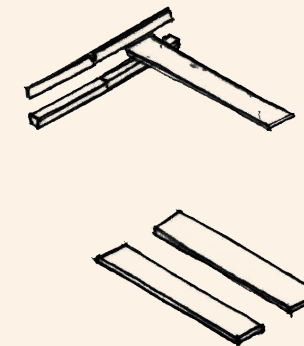
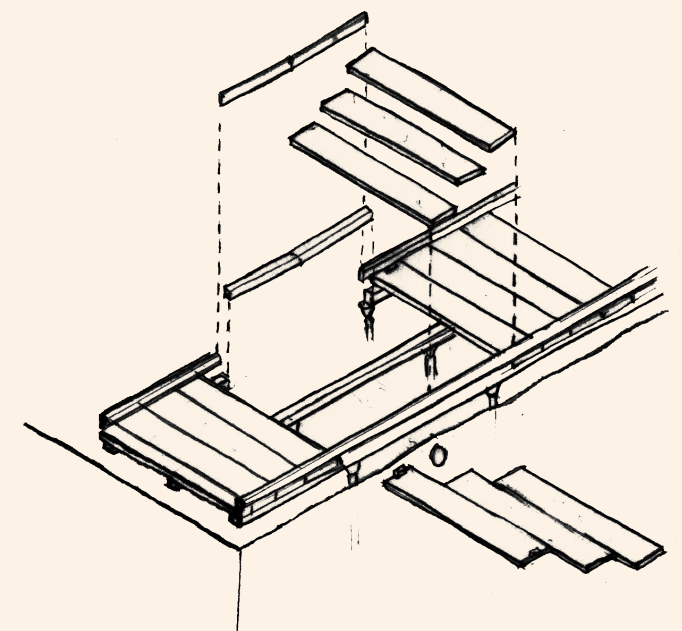
**Figure 3.4.5**  
**Means of Repair - Proposed System**

BROKEN STRUCTURAL MEMBERS CAN BE CUT TO THE NEAREST SUPPORT. ADDED HARDWARE SUPPORTS CONNECTION TO NEW MEMBER.

CAN BE REPAIRED  
ANY TIME OF YEAR,  
USABLE ON THE  
SAME DAY.

BOARDWALKS NEED TO BE PARTIALLY DISASSEMBLED FOR REPAIR, BUT ONLY BROKEN PIECES NEED TO BE THROWN AWAY, OTHER PIECES CAN BE SALVAGED AND RE-USED.

BOARDWALKS ARE TYPICALLY BROKEN BY WEAR AND/OR ACCIDENTAL DAMAGE.

Isometric illustration of repair required to fix WhitWalks.

The reality of concrete sidewalk repair is messy, expensive, and wasteful, but a modular system could trade upfront design and installation complexity for faster, cheaper, and less wasteful maintenance long-term.

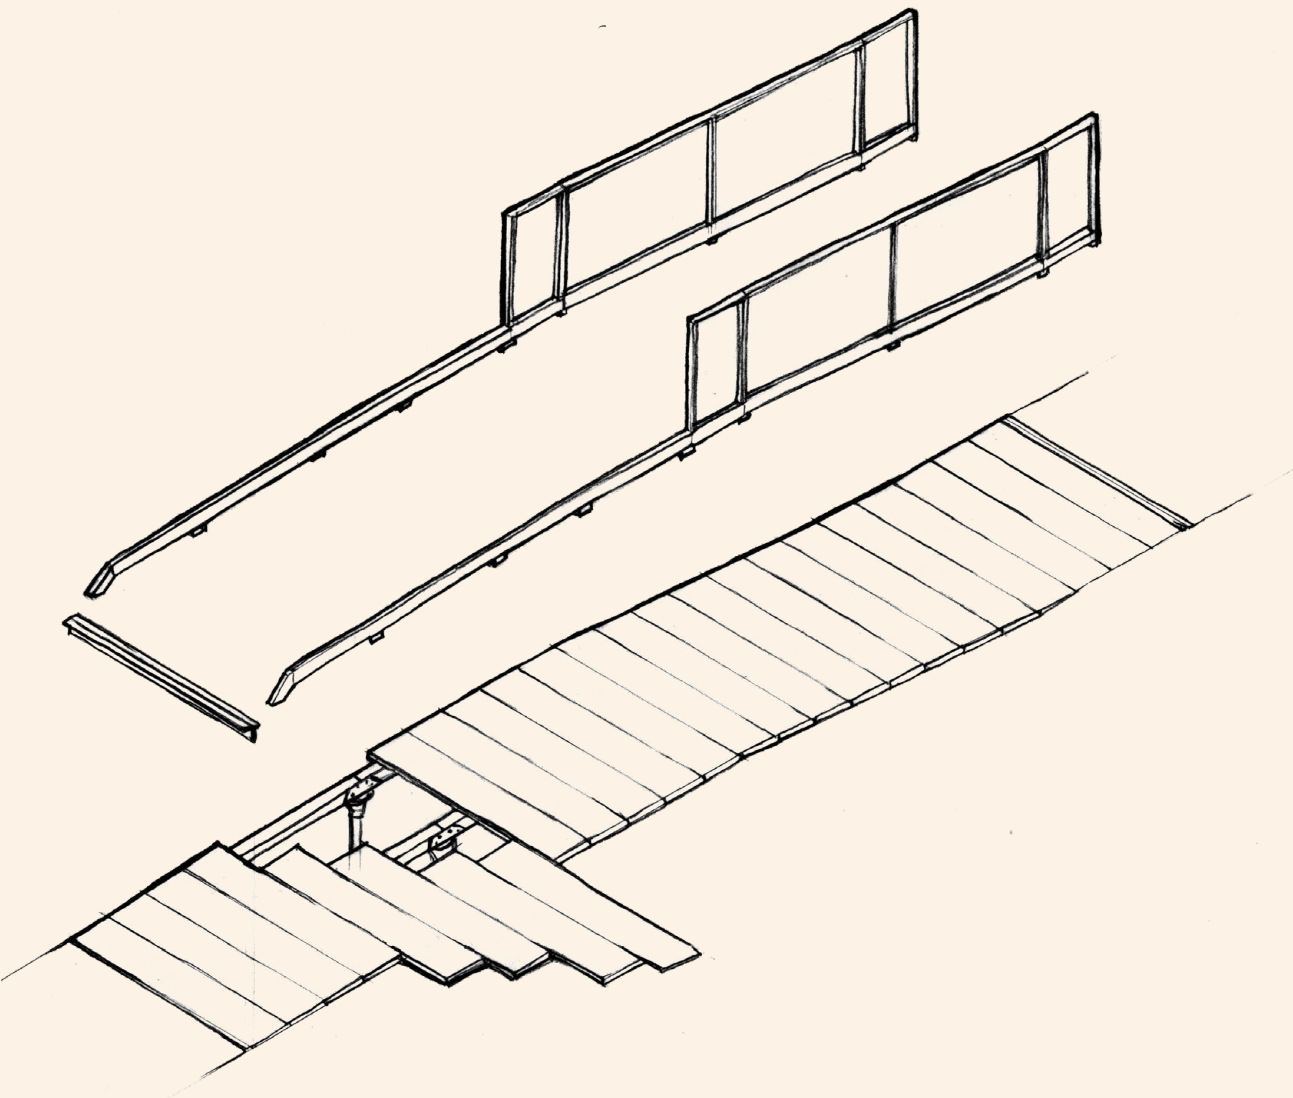
Figure 3.5.2  
**Assembly Determination**  
Isometric illustration of railings, edge protection, and a transition strip separated from the boardwalk surface annotated with key considerations for developing the assembly.

The prototyping process begins with identifying applicable materials (i.e. FRP, post-consumer waste plastic lumber, fiberglass, aluminum, and possibly wood with careful application to avoid slippery surfaces).

After determining the most viable assembly, a model portion of this proposed system must be **constructed and rigorously tested for safety, accessibility, and durability.** This includes structural stress tests, sight-cane tests, and

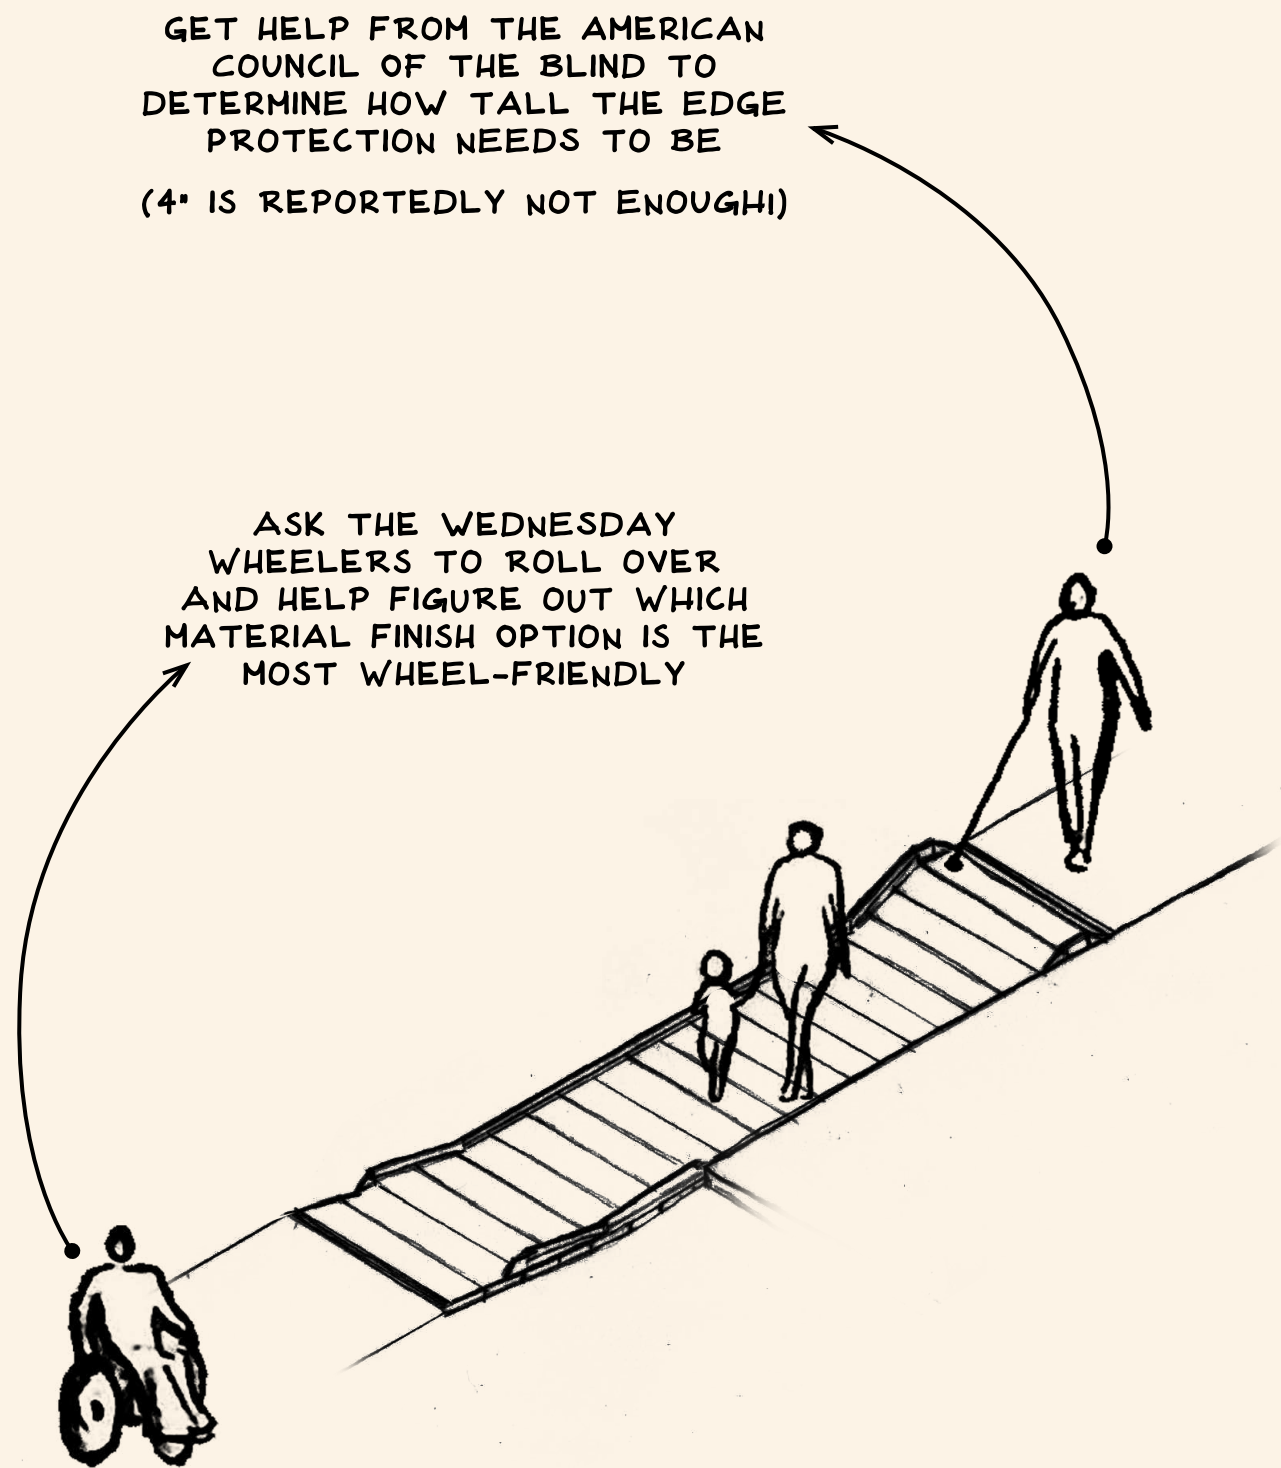
**Figure 3.5.3**  
**Testing**  
Isometric illustration of the user input that will be sought while prototyping the proposed system.

wheeling tests (see figure 3.5.3).
