Taking Shelter from the Rain:
Exploring Trailside Shelters in Olympic National Park

A Terminal Project
for the partial fulfillment of the requirements for the degree of
Master of Science in Historic Preservation
from the University of Oregon

June 2023

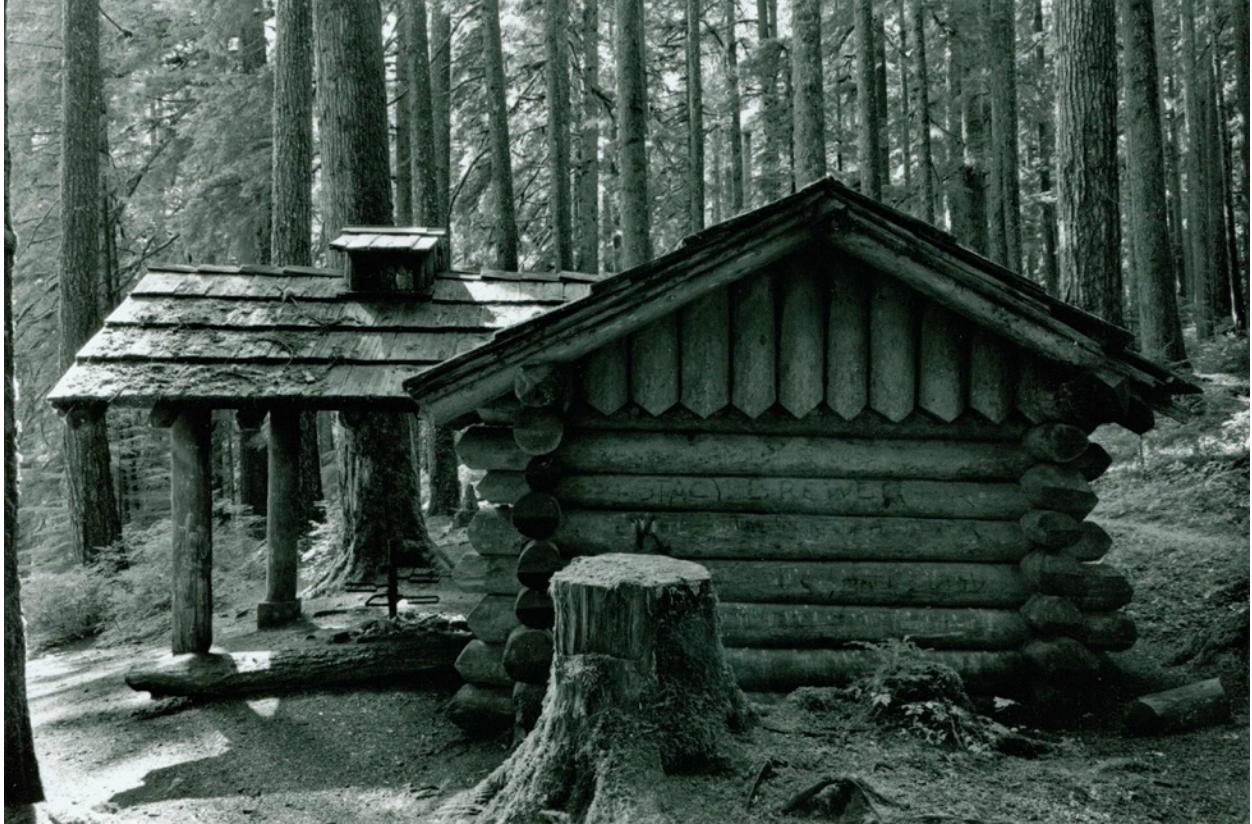
Canyon Creek (also known as Sol Duc Falls shelter) photo dated 1983. Note the concrete blocks supporting the vertical post as well as the firepit with iron or steel cooking rack. Source: *Olympic National Park Archives and Collections*.

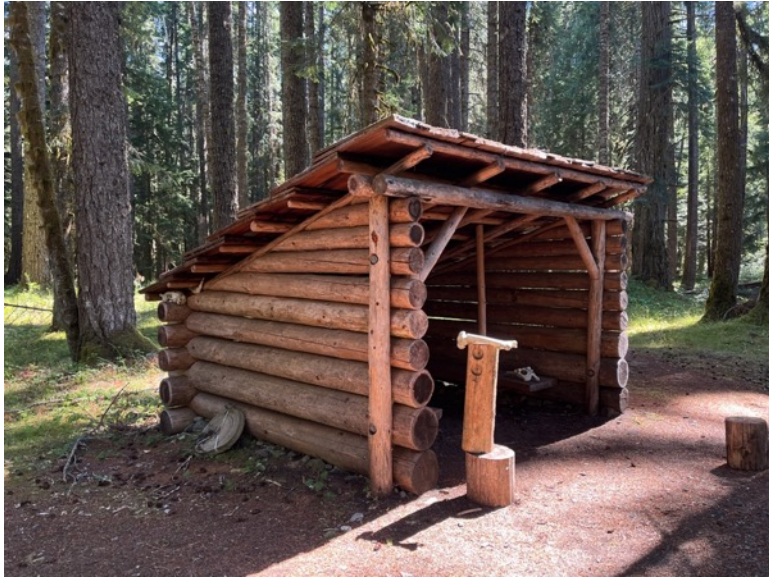
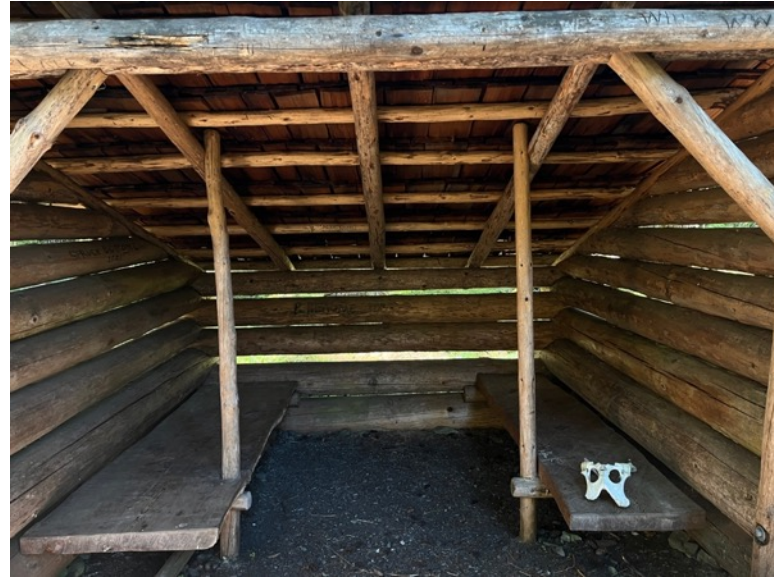
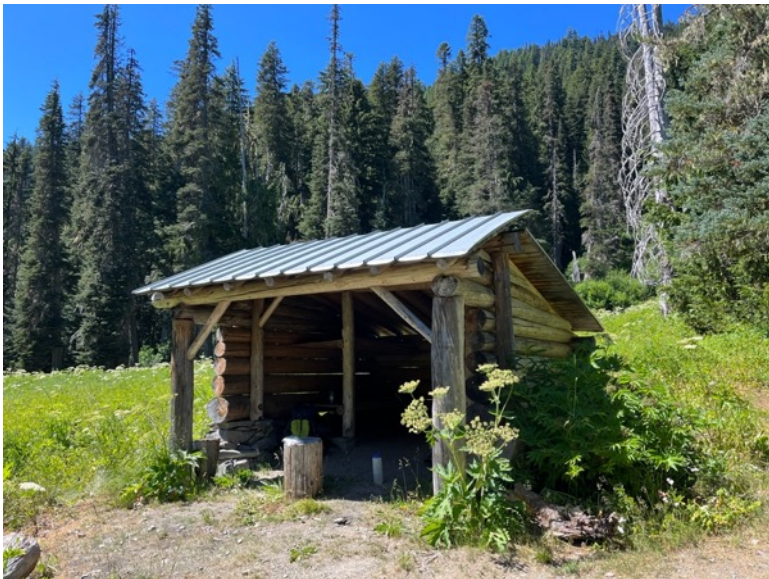
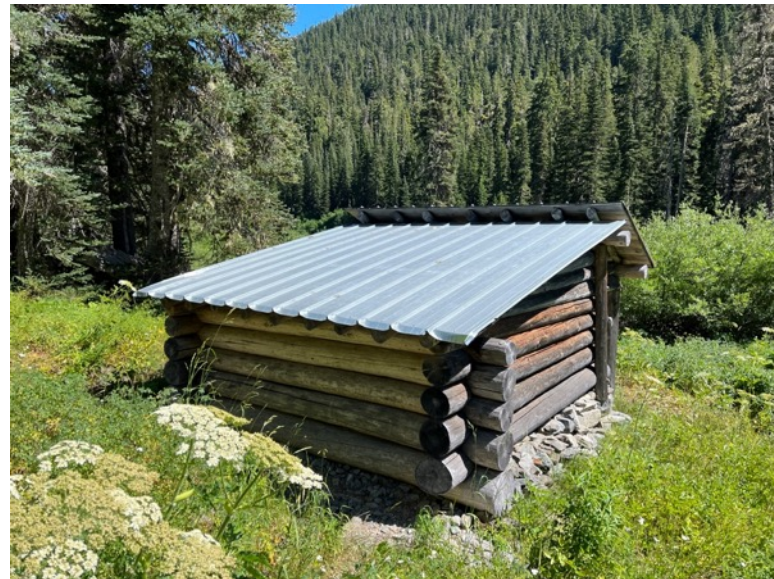
Along with the two shelters at Blue Glacier, Wilder (pictured top row) and Bear Camp (pictured bottom row) are the only remaining shelters of the early post-WWII years stacked log construction design. Built in 1951, Wilder most closely resembles what would be the Foster Plan proposed in 1953. It does not, however, feature a firepit near the entrance. Bear Camp shelter, built in 1952, shows a variation of the rounded stacked log construction with a modified gable roof. Both shelters have undergone extensive preservation due to major structural damage including the choice to replace the original split shake roof on Bear Camp with standing metal seam panels. This was done due to the substantial snow loads common at its location. *Photos by author 2022.*

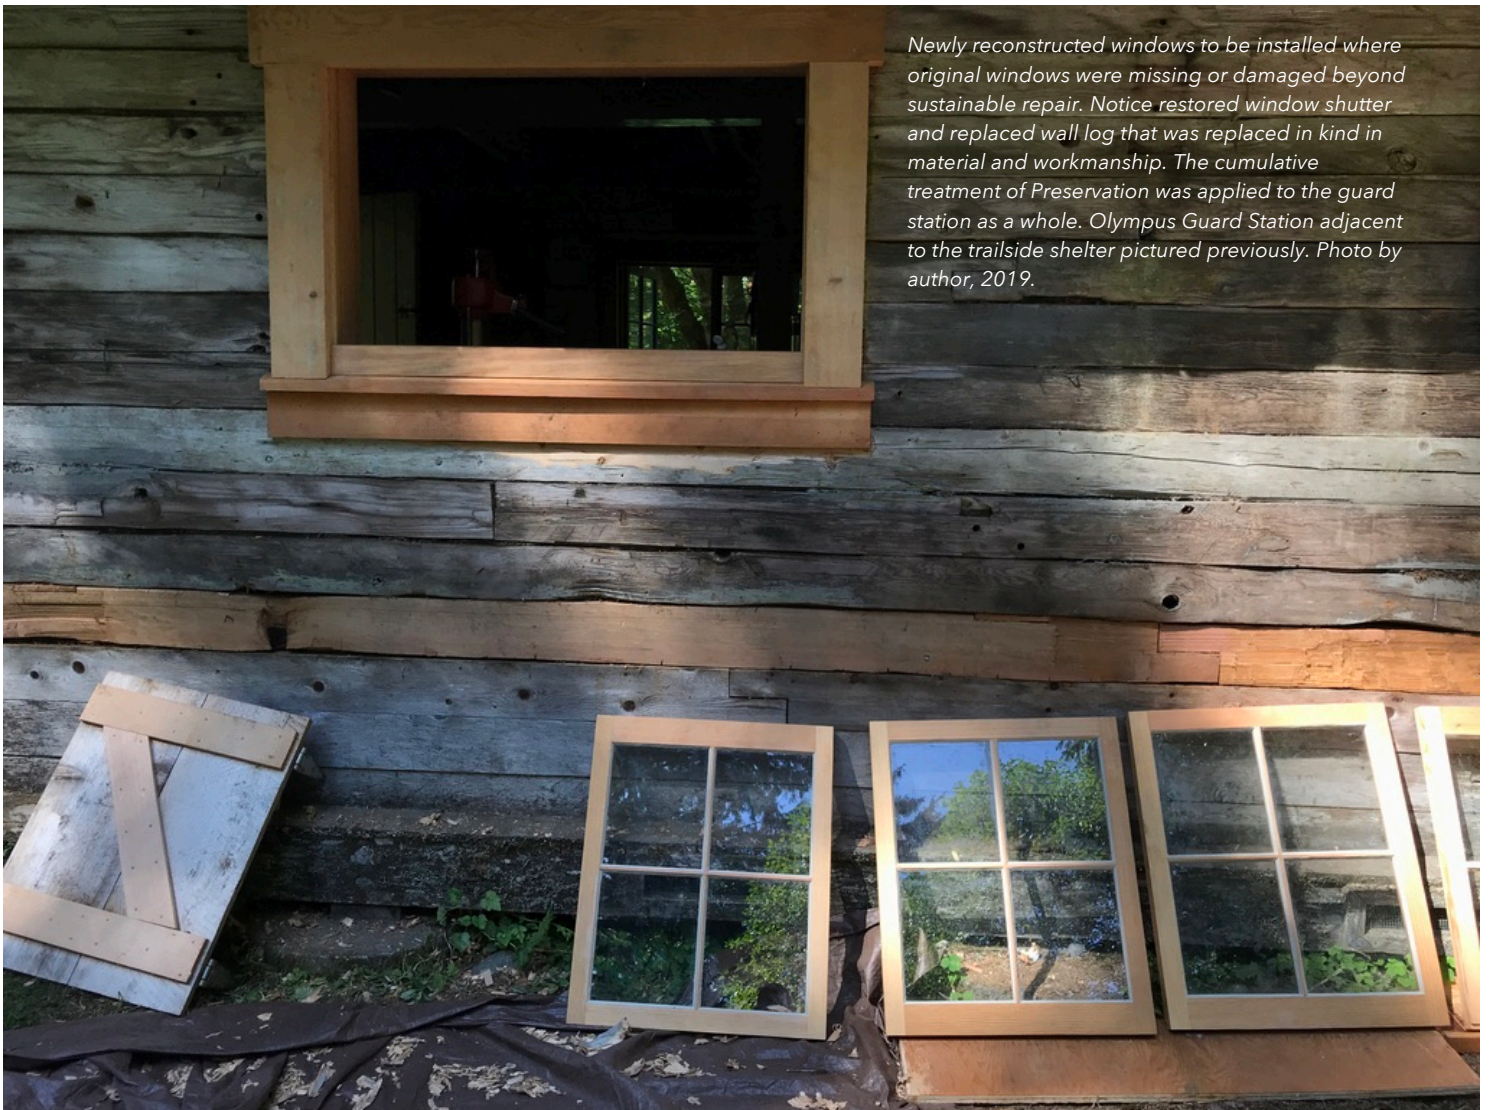
Newly reconstructed windows to be installed where original windows were missing or damaged beyond sustainable repair. Notice restored window shutter and replaced wall log that was replaced in kind in material and workmanship. The cumulative treatment of Preservation was applied to the guard station as a whole. Olympus Guard Station adjacent to the trailside shelter pictured previously. Photo by author, 2019.

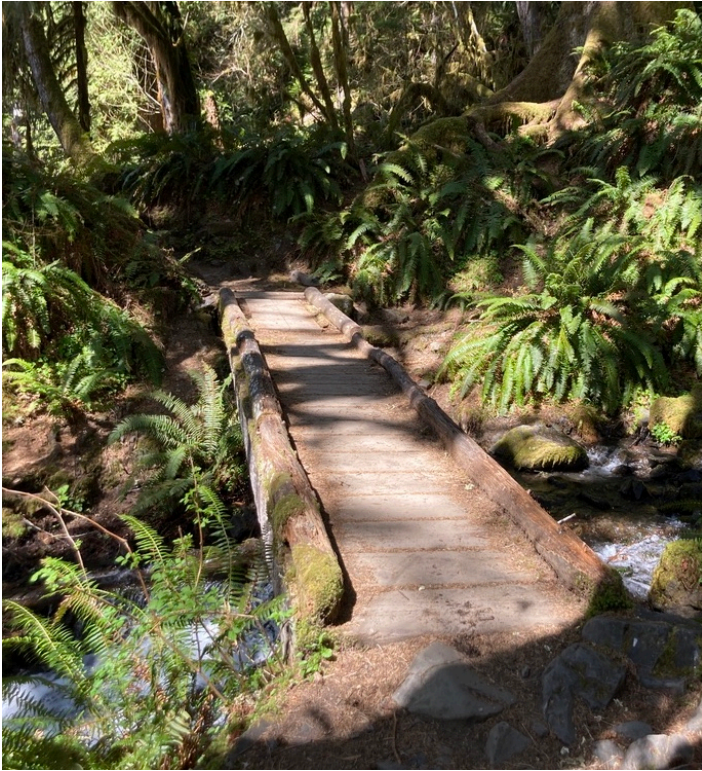
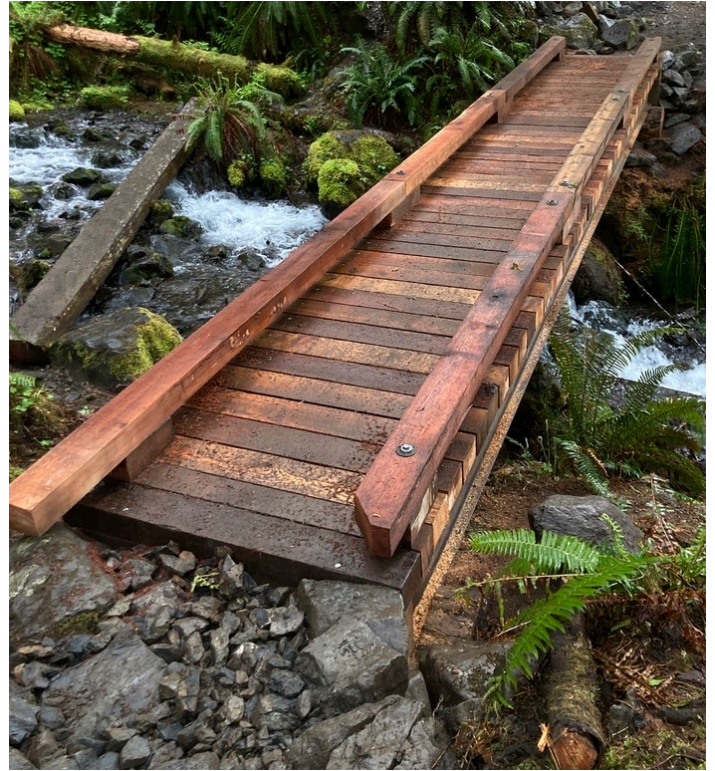
Example of trail bridge replacement before (left) and in progress (right) showing a rehabilitation approach to a landscape characteristic. While the new bridge meets contemporary needs of durability to withstand increased use, changes in materials and workmanship thus compromise the historic integrity of the landscape if considered individually.

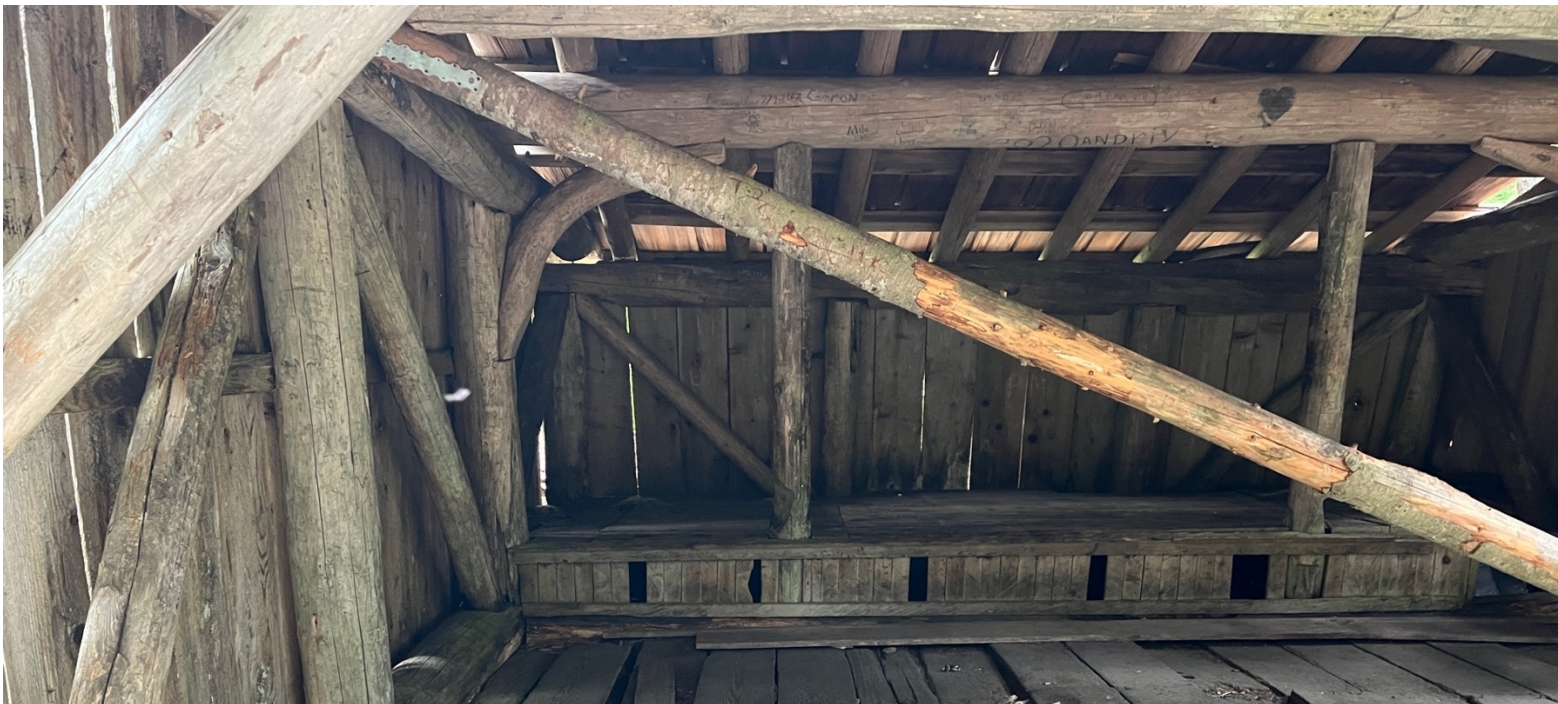
Interior of Anderson Pass shelter showing diagonal bracing log secured with metal strapping used to stabilize construction due to building's poor condition, 2022. Photo by author.

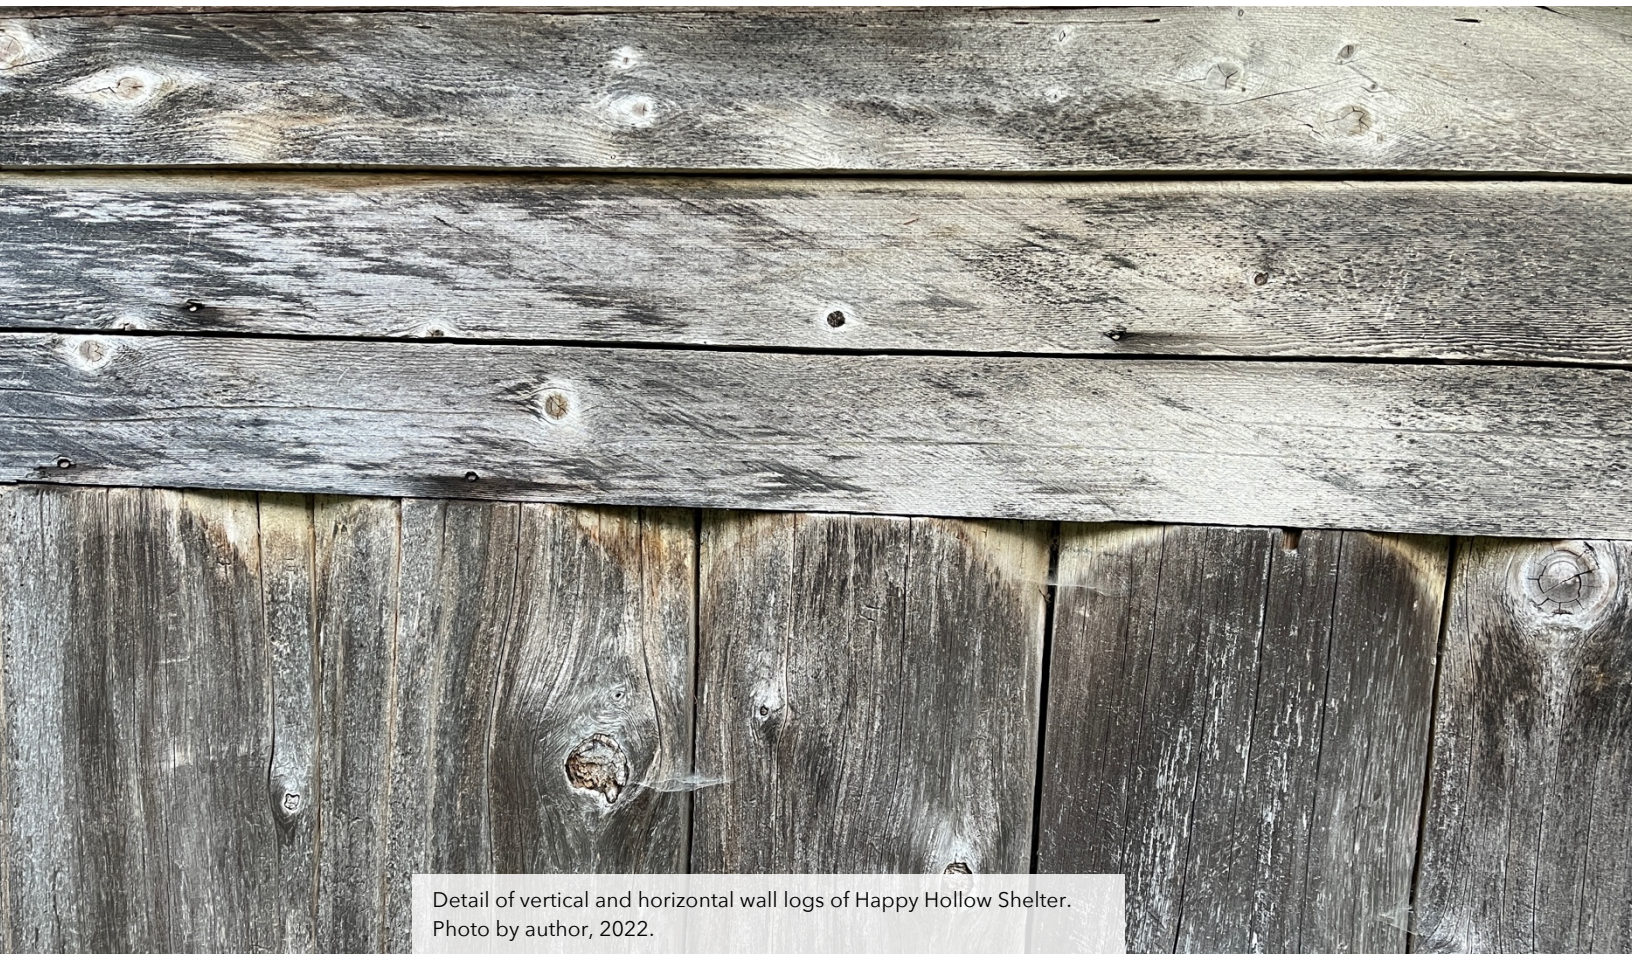
Detail of vertical and horizontal wall logs of Happy Hollow Shelter.
Photo by author, 2022.

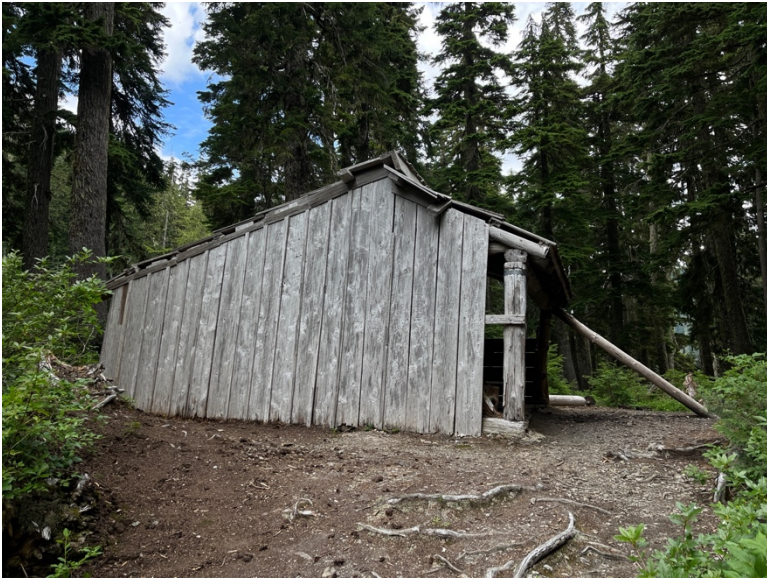
< West elevation showing missing board and batten siding; damaged purlin end; mild ground contact deterioration on siding boards; missing upper trim and fascia board on southwest edge

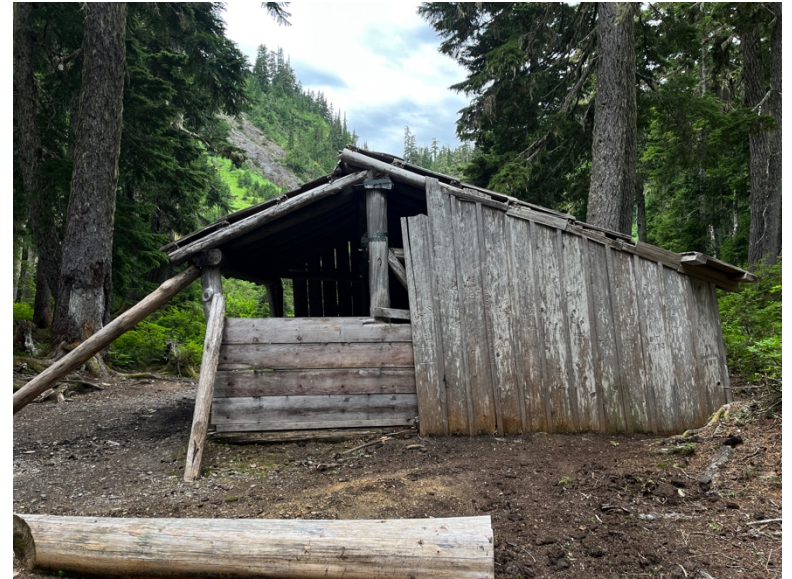
^ East elevations showing diagonal logs added to stabilize structure; missing east elevation siding boards replaced with horizontal boards

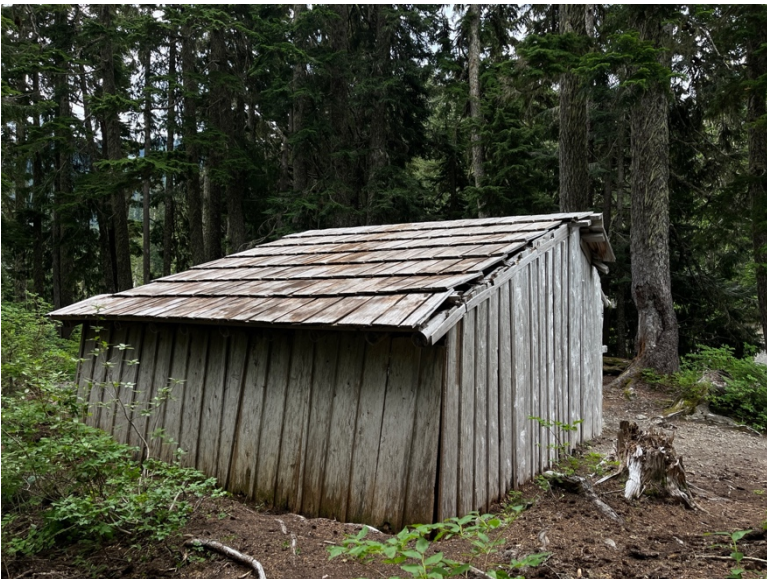
< North and west elevations showing ground contact deterioration on siding boards; roof and siding shifted due to structural lean toward east; exposed rafter missing shakes on western edge

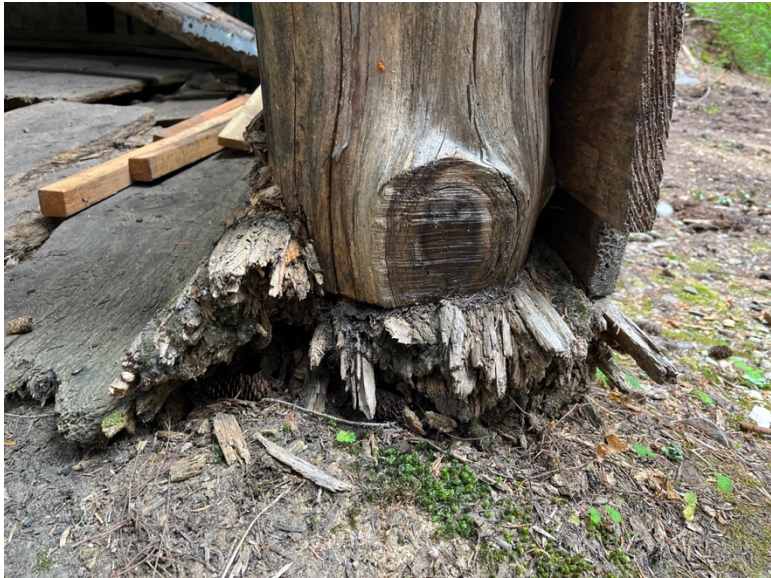
< Detail of sill rot on southeast corner

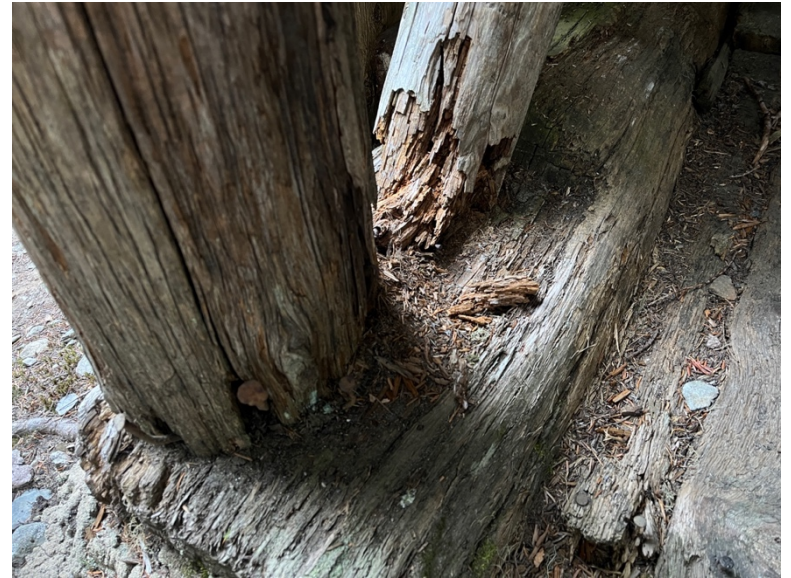
Detail of sill and post rot on southwest >

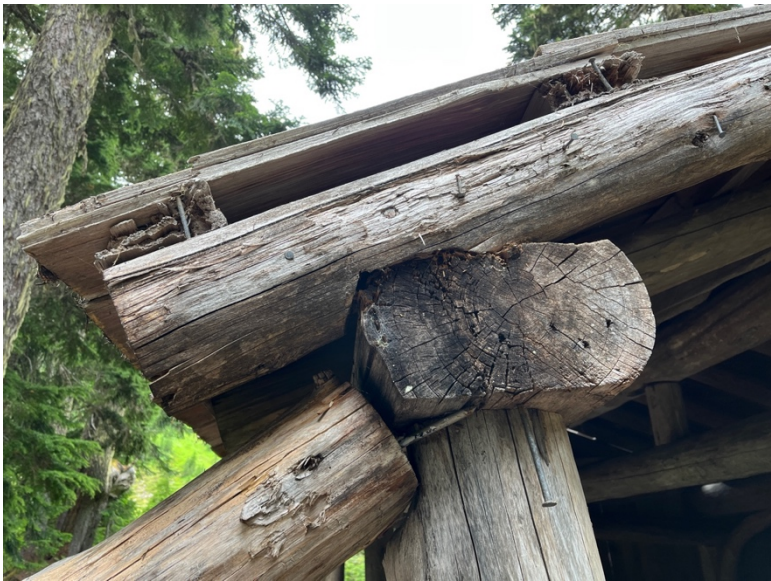
< Example of deterioration present on many of structural roof members

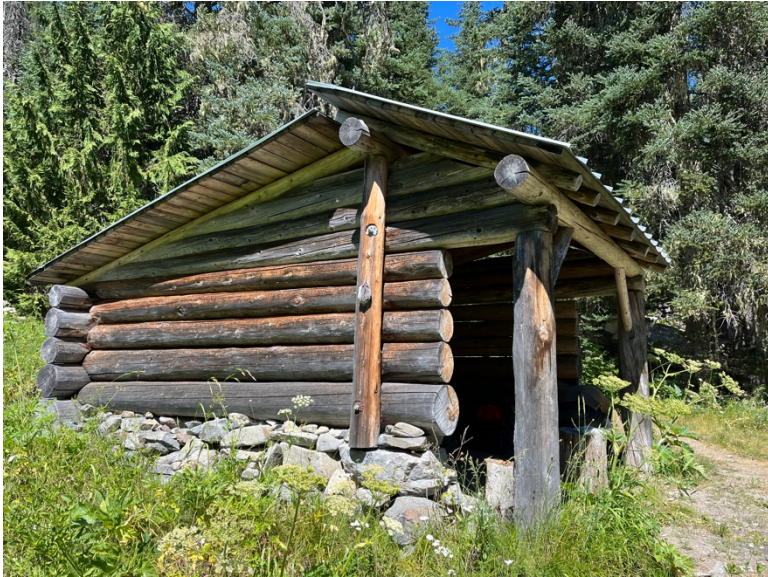
< West elevation showing extent of weathering on siding logs and condition of stacked rock foundation

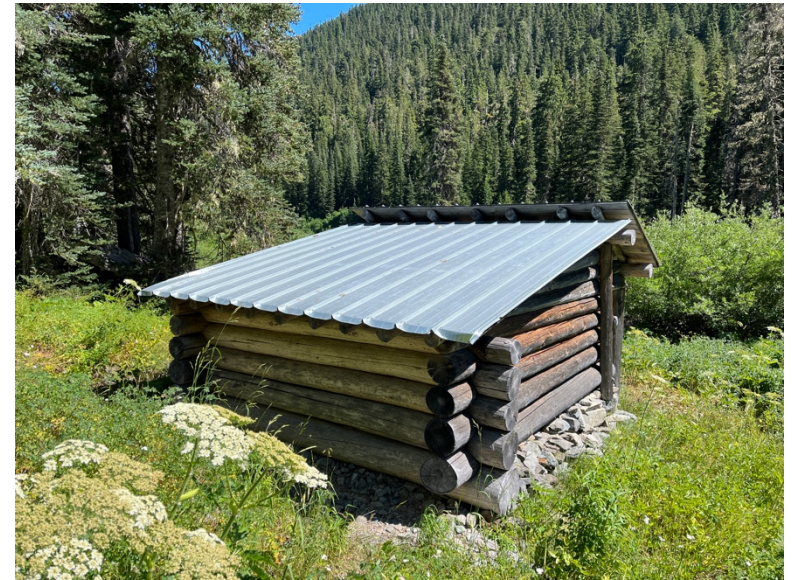
^ North and west elevations showing extent of vegetation encroachment around periphery of building

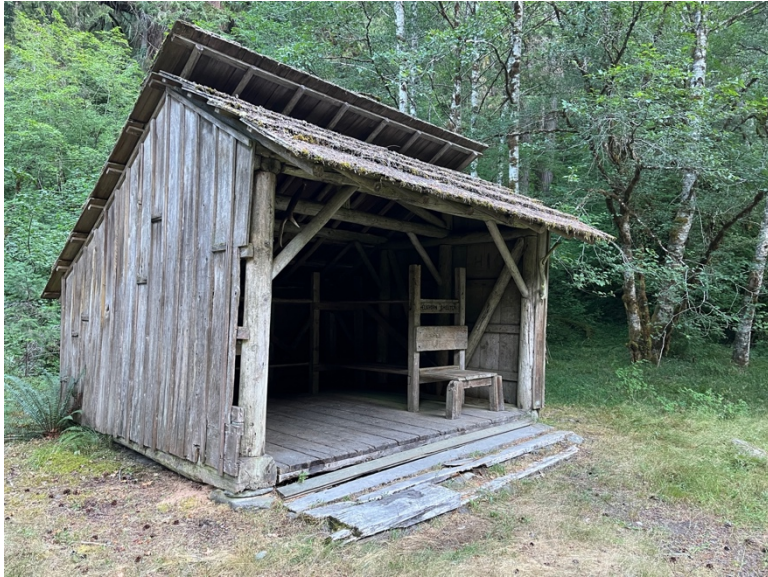
< West and South (primary) elevations. Note deterioration of exterior porch planks and half damaged siding board on SW corner

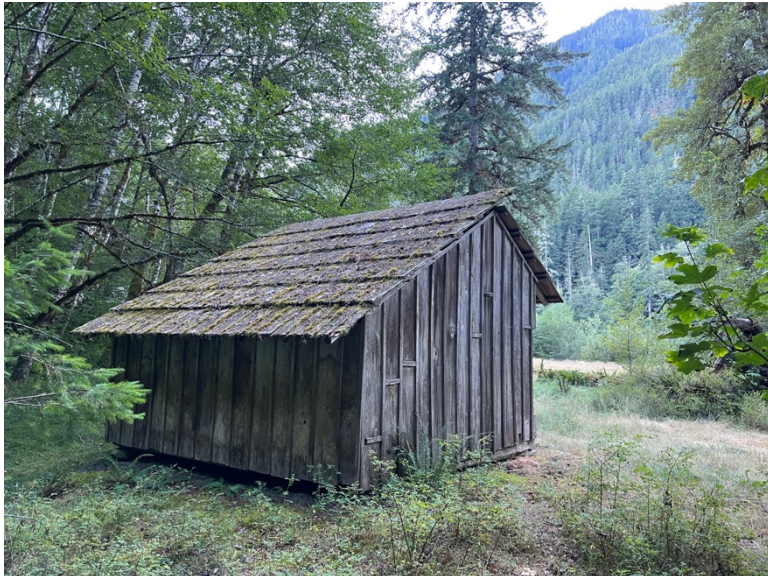
< North and west elevations. Note accumulation of debris on roof; note encroaching tree branches along east elevation

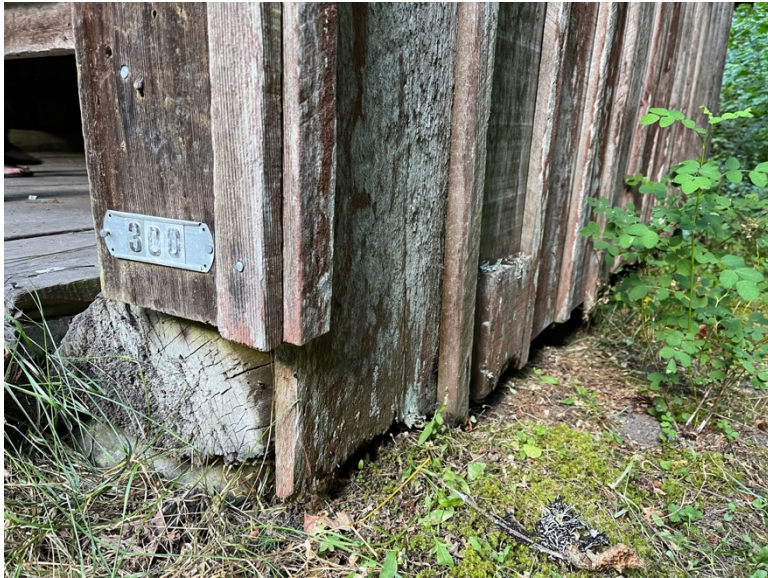
< Detail of mild water damage along east elevation siding boards; red bio growth throughout; organic growth on sill log

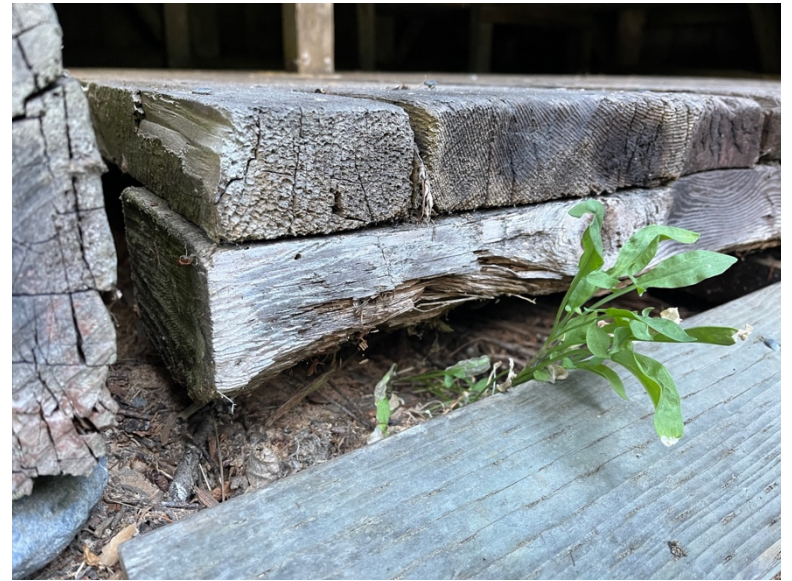
^ Detail of damage to SW corner floor joist

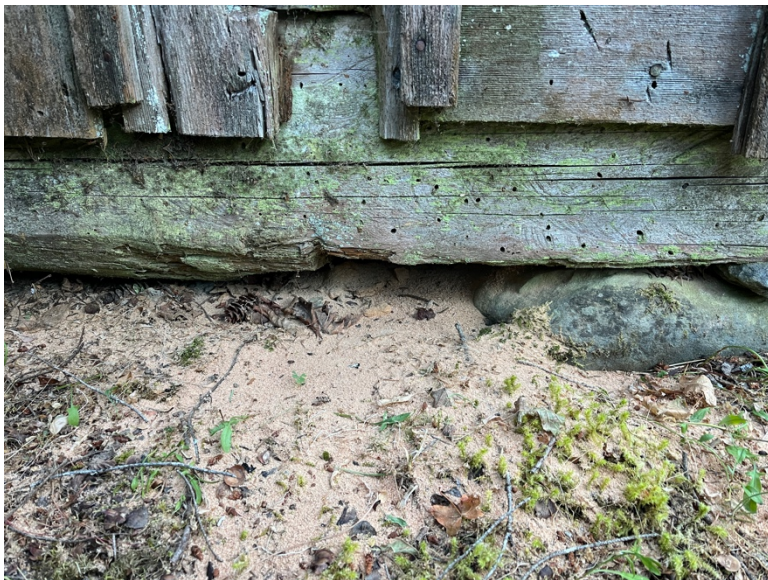
< Evidence of powder post beetle deterioration on west elevation sill log

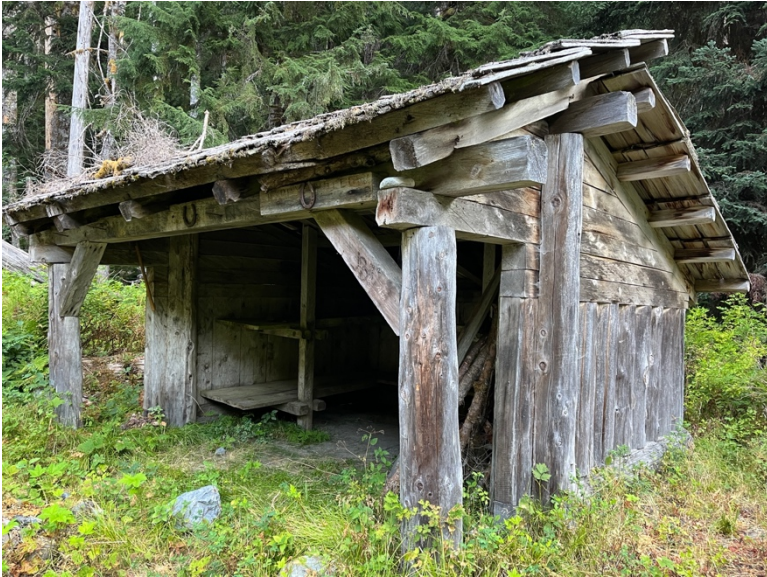
< South (primary) and east elevations showing vegetation encroachment on all sides including interior

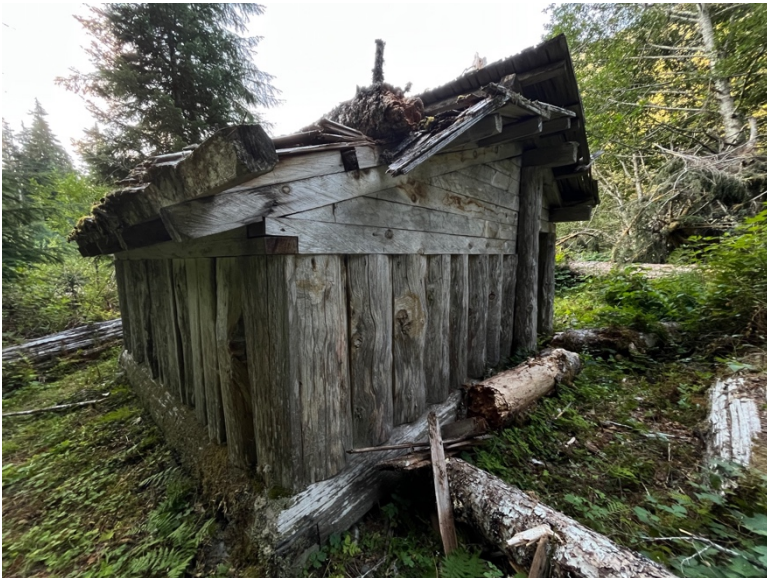
< North and west elevation showing tree damage to NW corner roof structure

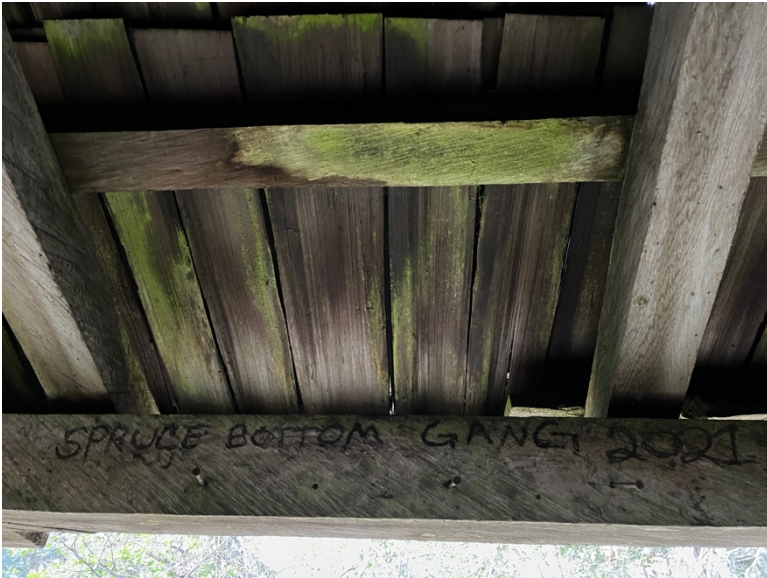
< Example of moisture damage on interior roof structure found throughout

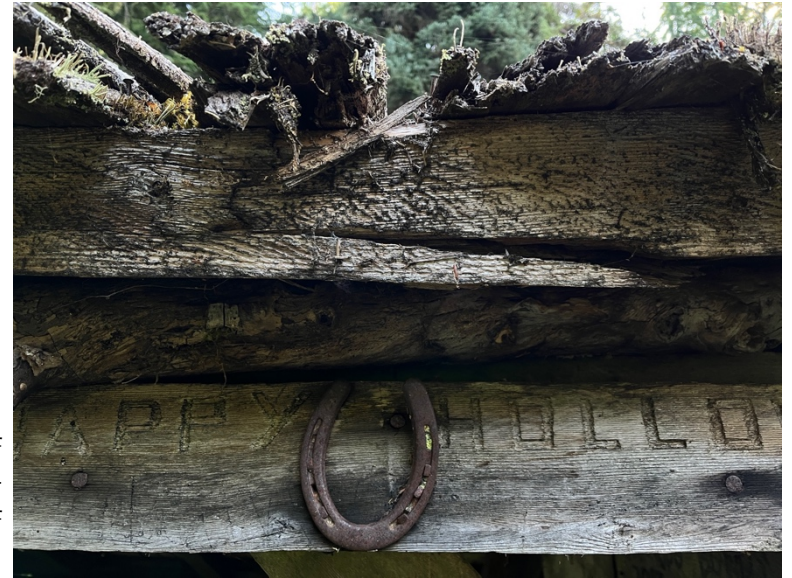
Split in south elevation roof structure; note poor condition of roof shakes >

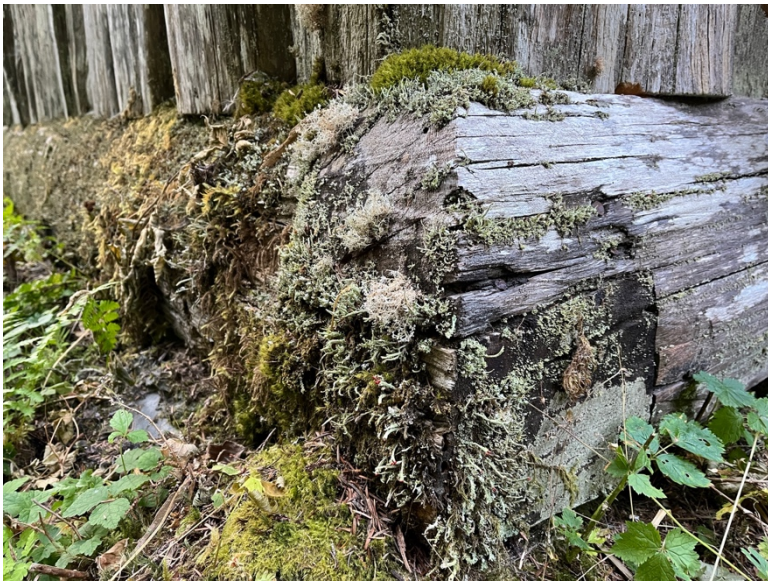
Detail of damage on NW corner of roof structure >

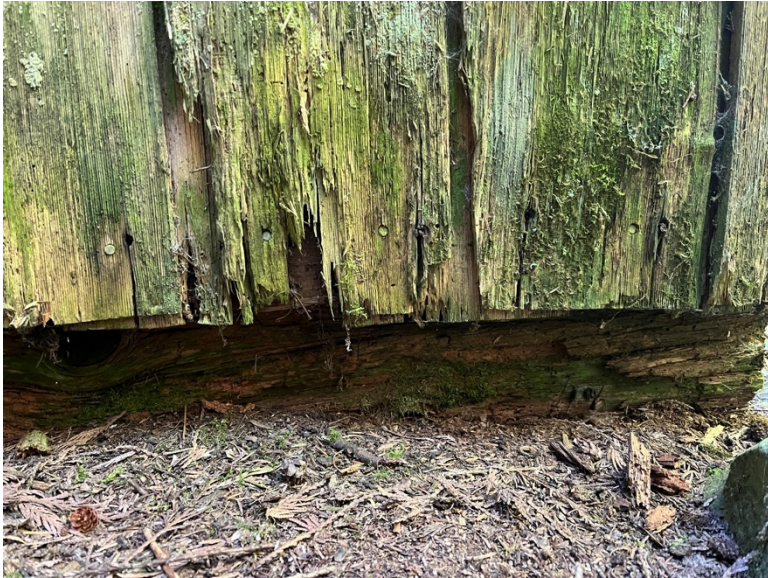
< Example of shake deterioration present along bottom course of north elevation; note deterioration of sill log at ground contact

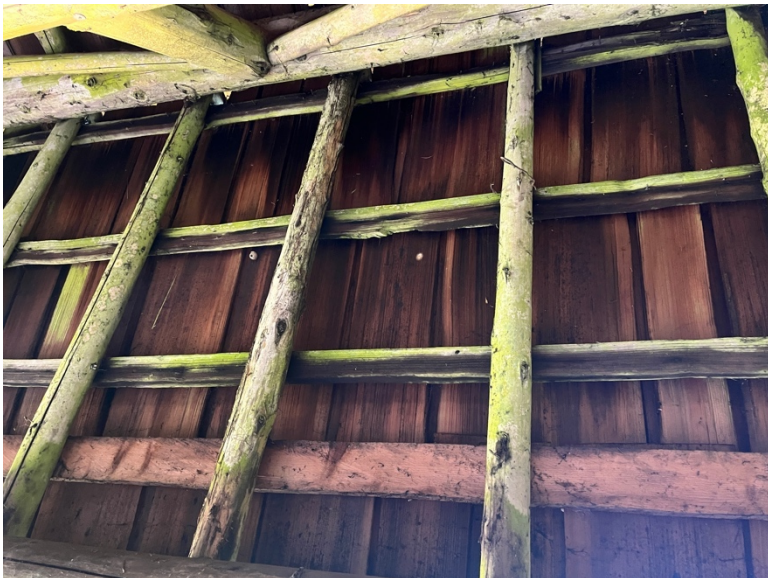
< Example of deterioration of purlins and rafters; note previous purlin replacement

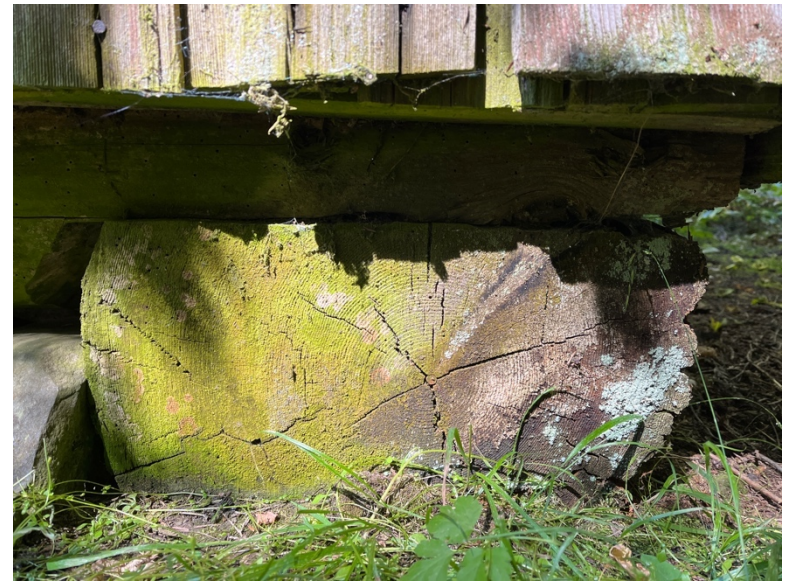
< End of sill log at ground contact; note extend of deterioration and what appears to be copper nail in the heart of the log

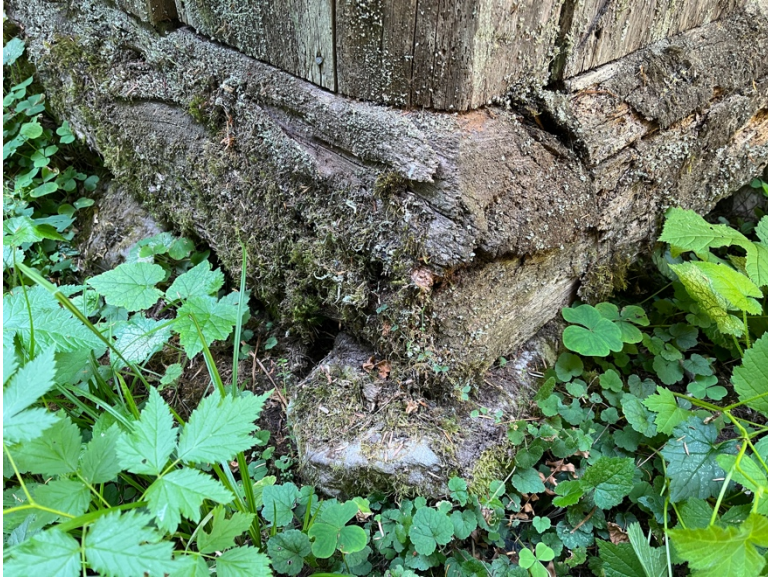
< NE corner sill log; example of deterioration found along extent of sill logs; note lap joint

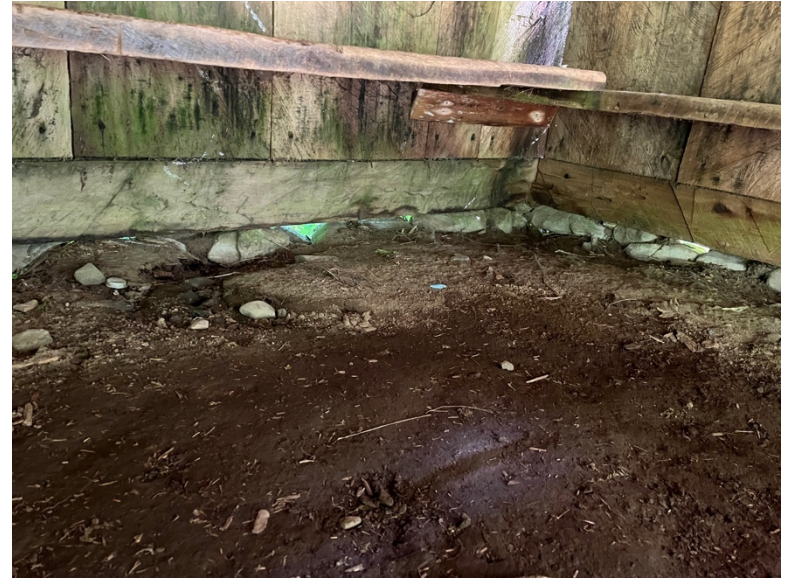
Evidence of moisture accumulation in interior >

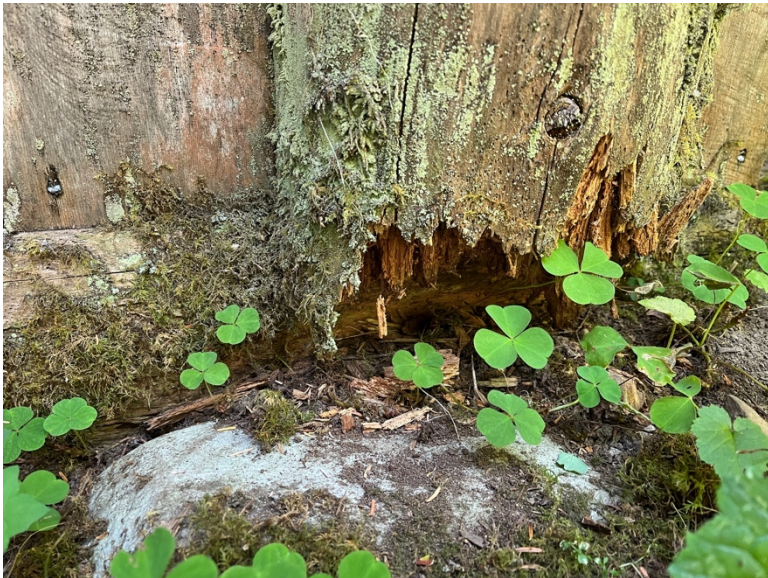
Example of deterioration found at both corner posts >

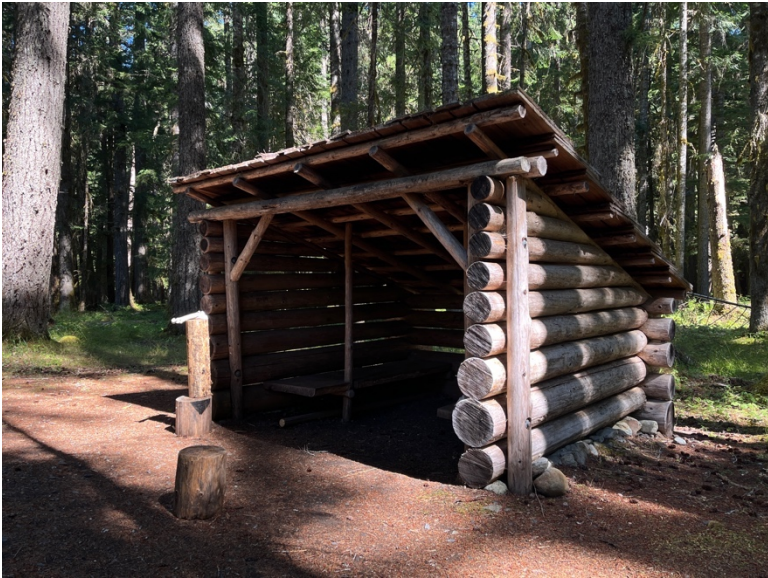
< West and south elevations; note double roof ridge beam

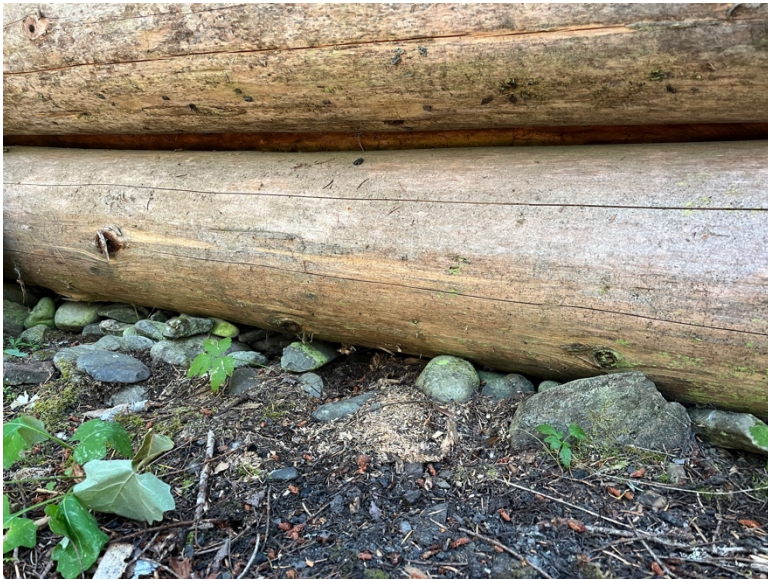
< Potential evidence of critter burrowing between foundation stones

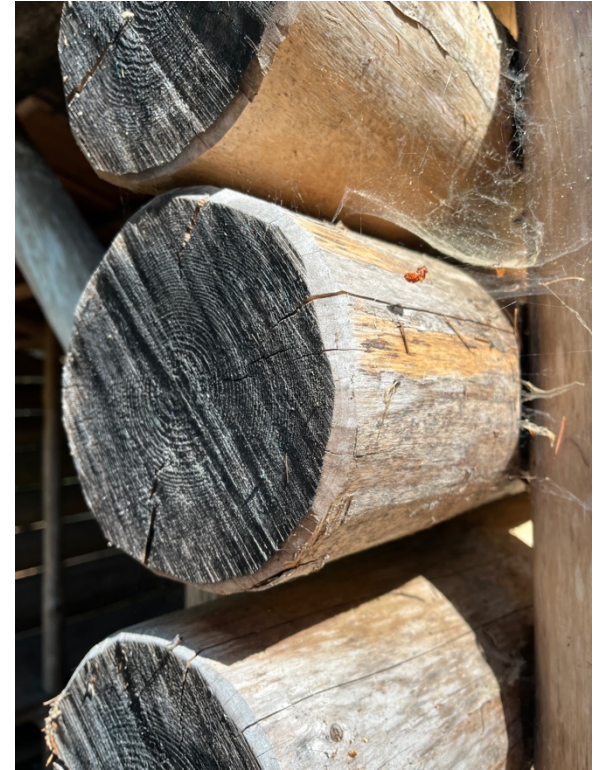
^ Detail of chamfering around log edges
