EXPLORING THE UTILITY OF BIM IN BUILDINGS ARCHAEOLOGY:  
A CASE STUDY AT THE HISTORIC BRIGGS HOUSE,  
SPRINGFIELD, OREGON

A TERMINAL PROJECT

Presented to the Historic Preservation Program  
and the Graduate School of the University of Oregon  
in partial fulfillment of the requirements  
for the degree of  
Master of Science

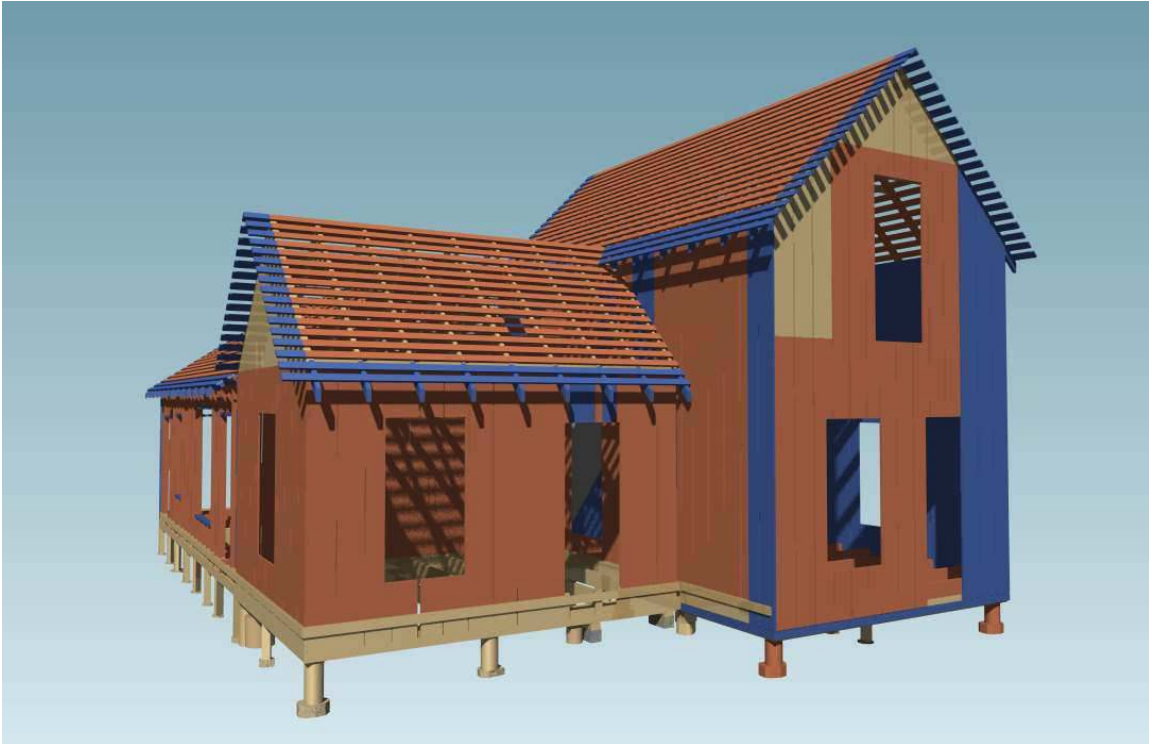
**Figure 1.3.** BIM rendering of the Briggs House.

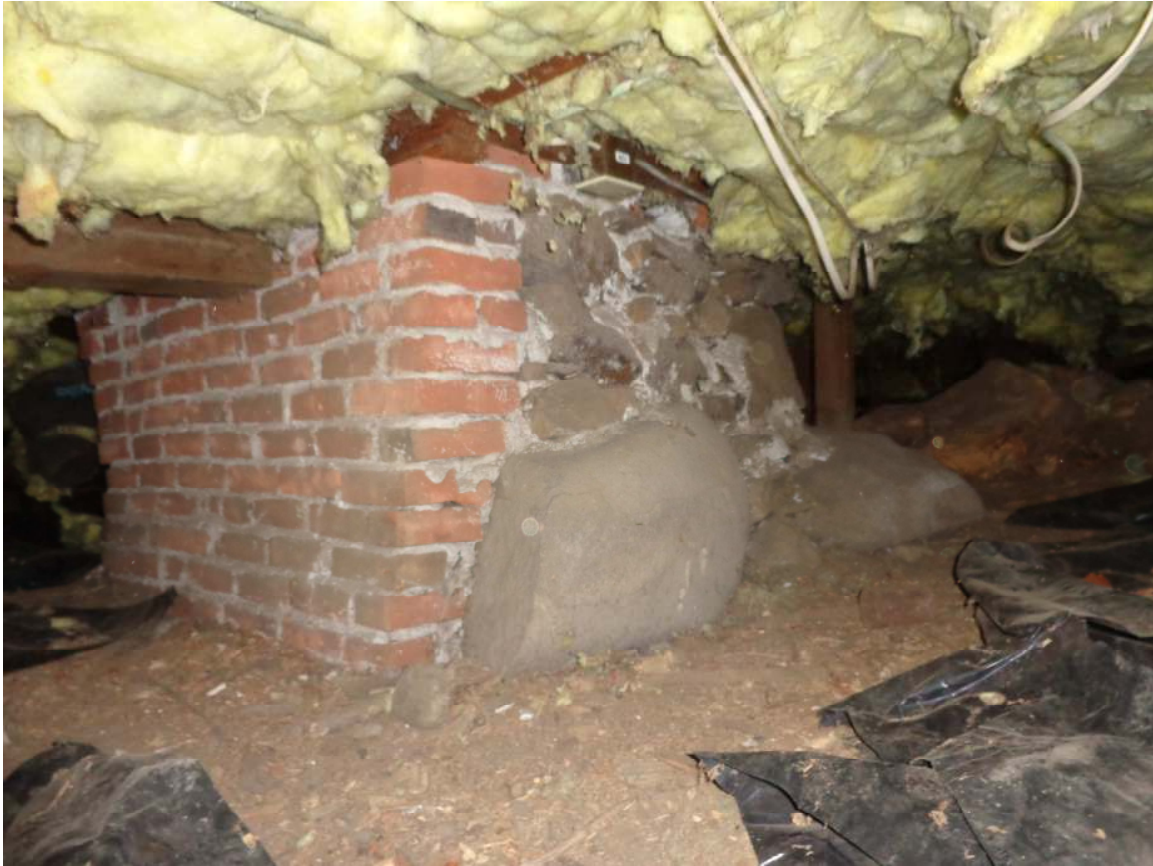
**Figure 1.5.** Brick chimney foundation built up on base of boulders.

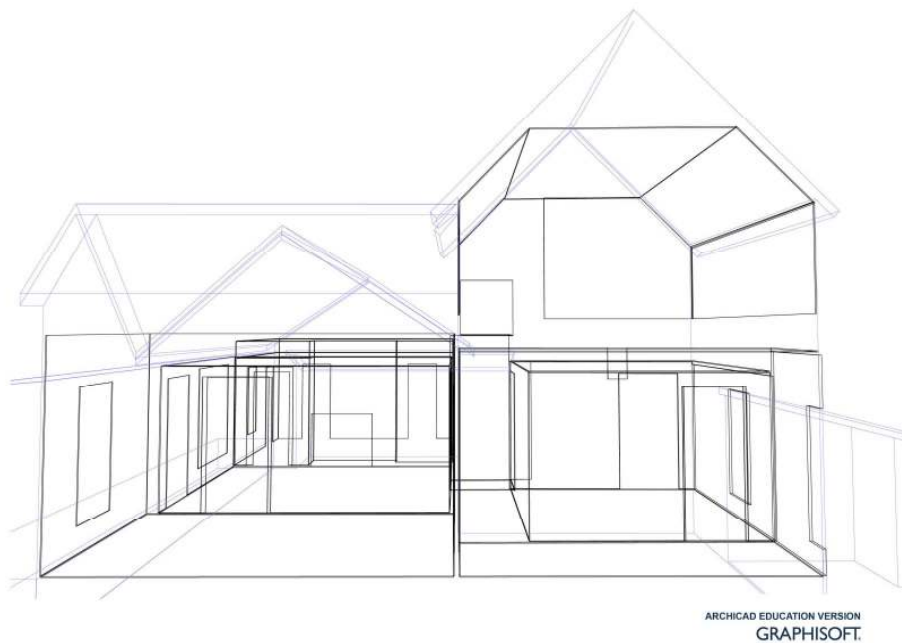
**Figure 5.7.** Section view of interior walls and massing alignment.

These assemblies were then moved to position within the originally modeled massing, and checked for fit (Figure 5.6). Measurements taken outside the building were compared to measurements taken inside the building to check for accuracy and to determine wall thicknesses (Figure 5.7).

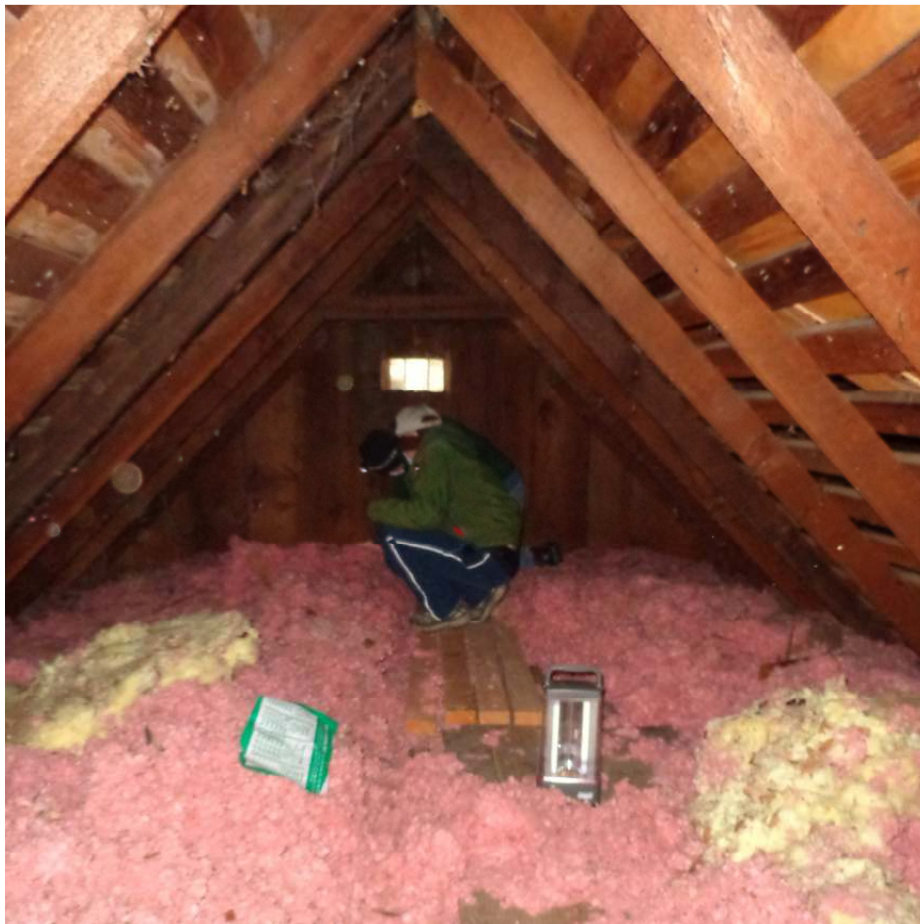
**Figure 5.8.** Locating and dimensioning framing of the First Build Wing attic.

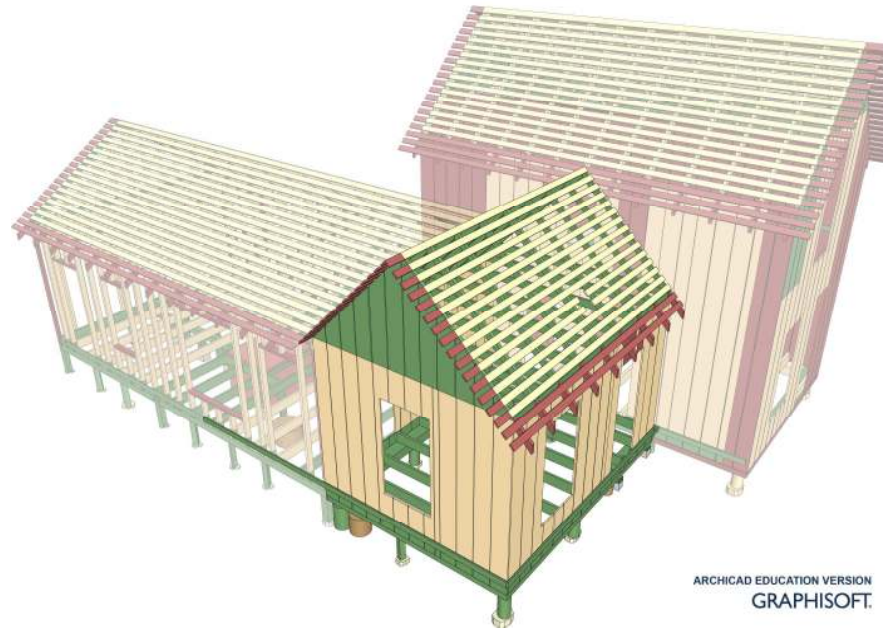
**Figure 6.6.** First Build Wing.

wing is a three-sided box. While very similar in construction to the upright, the substructure consists of only three total hewn sill logs: two oriented east-west, each connected by a half-lap onto the eastern sill of the upright, and connected at their eastern ends to the shorter north-south sill, again with half-lap joinery. Trunnels were located for only two of these connections. Floor joists span the short dimension. No squash blocks or blocking were found anywhere in the substructure. Again, vertical planks bear on ledgers on the three sides of this box, the planks of the gable end rise to the roof plane, and the planks of the long sides (north and south walls) connect to top plates. A relative dearth of fully exposed vertical planks in the wing prevented a search for pegs or splines between adjacent planks. The rafters are notched (with a birdsmouth cut) to bear on the top plates. The ceiling joists are also notched to bear on the top plates. Skip sheathing connects the rafters and supports the roofing.

<b>FIRST BUILD WING (Figure 6.6)</b>	
<b>Foundation Structure (Figure 6.7)</b>	
Posts	(2) each E-W sill, @ E end & midpoint (1) split log beneath each joist @ midpoint
Piers	stone
Sills	(2) E-W hewn logs, ± 9 ½" x ± 6 ½" high (1) N-S hewn log, ± 9 ½" x ± 6 ½" high E-W sills o/N-S sills w/half-lap joinery Pegged with single treenail at corners
Floor Joists	Roughsawn 2 ½" x 8" @ ± 24" o.c. Simple bearing on sills No blocking or rim joists
<b>Wall Structure (Figure 6.8)</b>	
Sill ledger	Roughsawn 1" x 4"
Wall planks	Roughsawn 1" thick x 9 ½" – 12" wide No pegging or splines Evidence of battens
Old deck ledger	Roughsawn 1" x 4"
Top Cap	Roughsawn 4" wide x 2" high
<b>Roof Structure (Figure 6.9)</b>	
Ties	Roughsawn ± 2" x 6" @ ± 24" o.c. Notched over top cap
Rafters	Roughsawn 2" x 4" @ ± 24" o.c. Roughsawn 2" x 4" high bird blocking (N side only)
Skip sheathing	Roughsawn 1" x ± 3" @ ± 5" o.c.

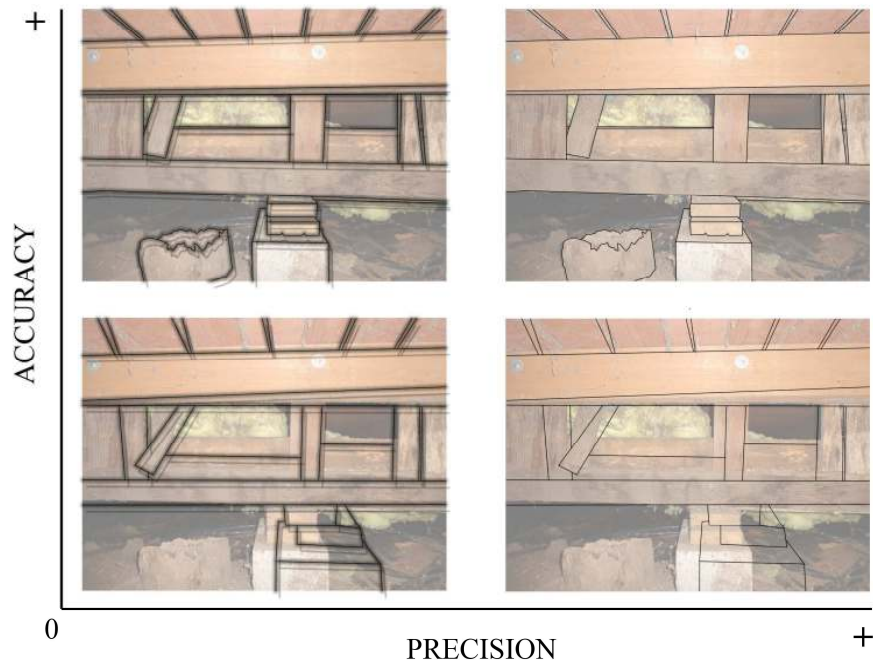
**Figure 7.1.** A graphic depiction of the difference between precision and accuracy.

There are a number of general limitations to BIM, as well as several limitations specific to this study, that became apparent early (Table 7.1). In writing about BIM, D.M. Foxe points out that “the certainty and precision of the model are only as powerful as the
