Geomorphic Response to Catastrophic Flooding on the Umatilla River, Oregon.

A thesis accepted and approved in partial fulfillment of the
requirements for the degree of

Master of Science

University of Oregon

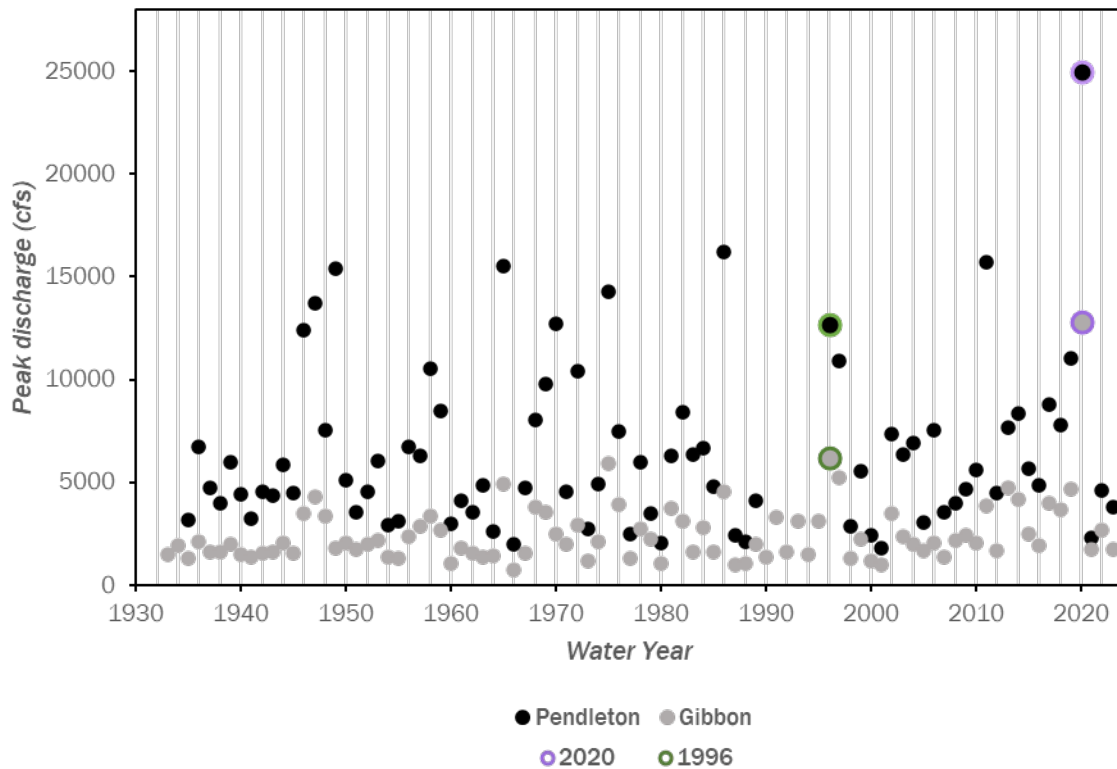
Figure 2. Annual peak flow (by water year) at both the Gibbon (upstream) and Pendleton (downstream) gages. See Figure 1 for their location. Peak discharge for the 1996 flood is highlighted in green, and peak discharge in 2020 is highlighted in purple. Between 1989 and 1996 the gage at Pendleton was taken offline and replaced, so there is no data there during that time.

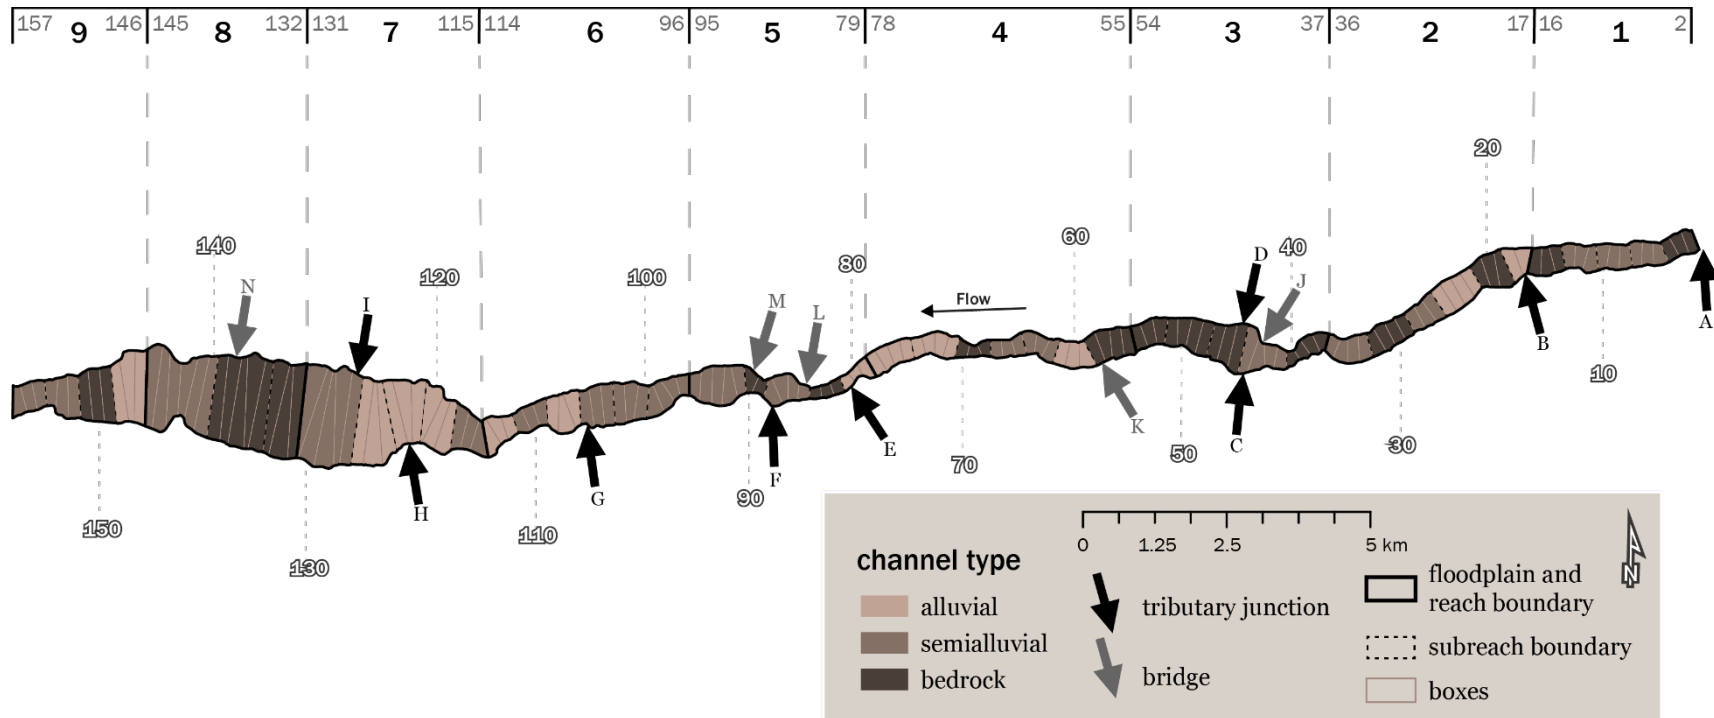
Figure 4. Reference map of all floodplain division (box, subreach, reach). Bridges and tributary junctions are indicated by arrows and letters, and subreach channel types are indicated by fill color. Reach numbers are shown at the top in black alongside the first and last box number of each reach in gray, and the number of every 10th box is shown connected to its corresponding box by a dotted line. Tributaries: A – Meacham Creek, B – Isqúulktpe Creek, C – Buckaroo Creek, D – Thorn Hollow Creek, E – Coonskin Creek, F – Moonshine Creek, G – Cottonwood Creek, H – Mission Creek, I – Spring Creek. Bridges: J – Thorn Hollow Road Bridge, K – unnamed railway bridge, L – N. Cayuse Road Bridge, M – unnamed railway bridge, N – S. Market Road (OR-331) Bridge.

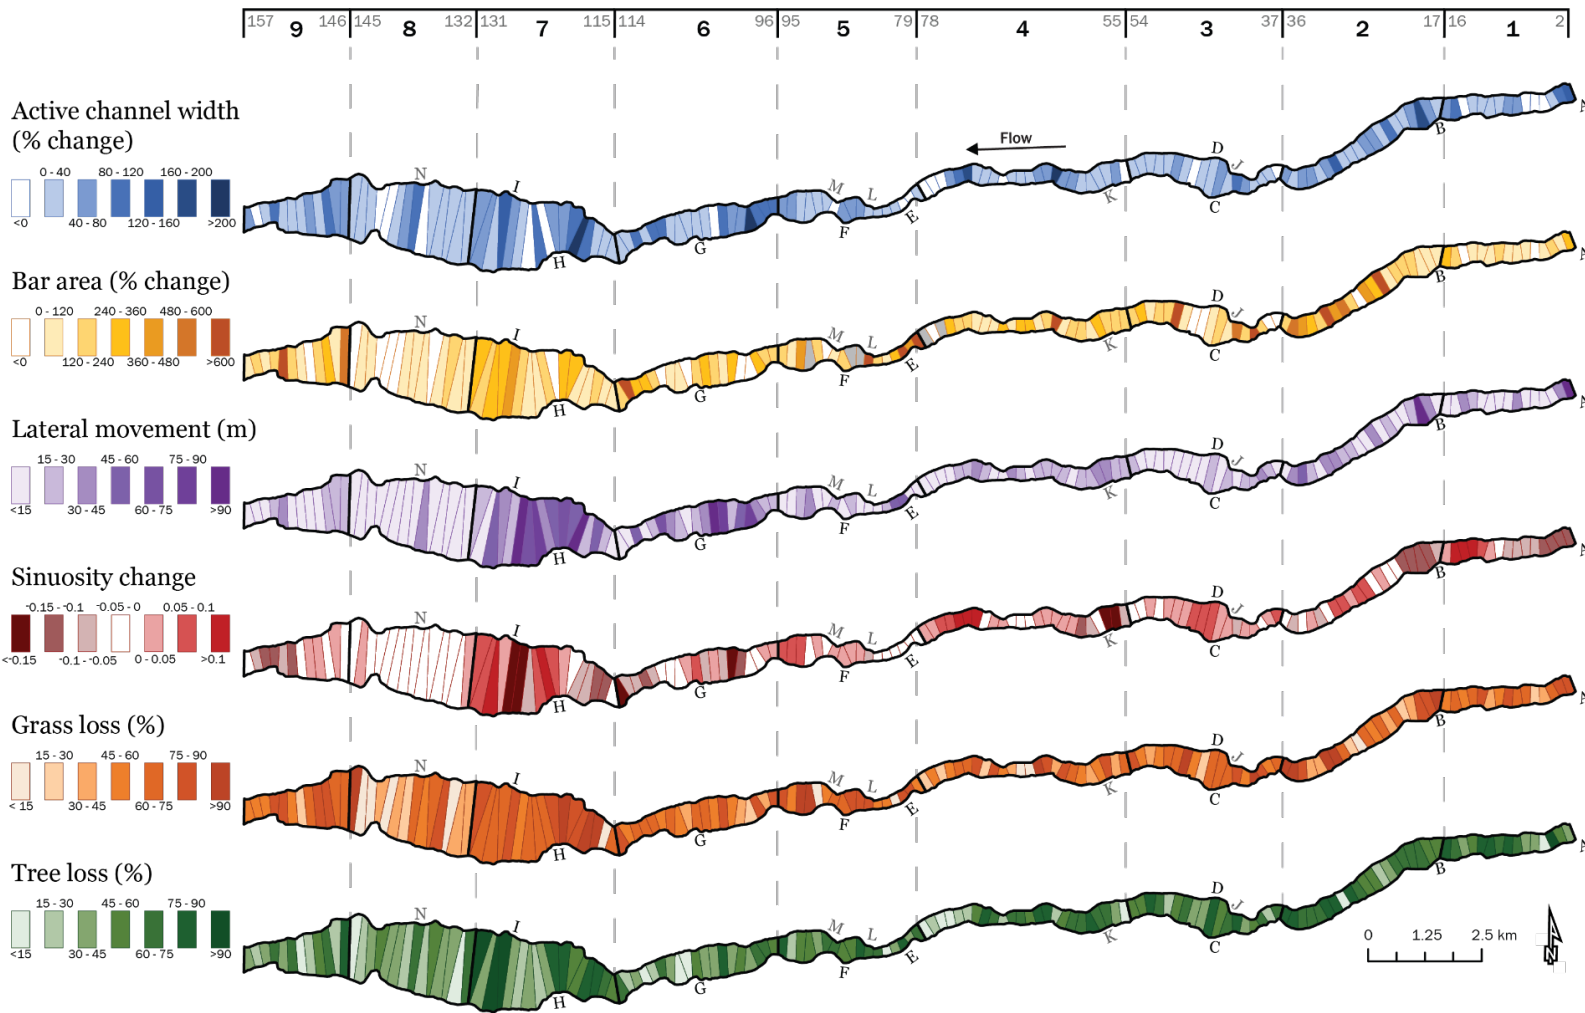
Figure 5. Response variable change map after the 2020 flood by box. Reaches are outlined and numbered on the top in black alongside the first and last box number of each reach in gray, and bridges and tributary junctions are indicated by the letters along the boxes. Boxes excluded from averages are gray. Tributaries: A – Meacham Creek, B – Isquúlktp Creek, C – Buckaroo Creek, D – Thorn Hollow Creek, E – Coonskin Creek, F – Moonshine Creek, G – Cottonwood Creek, H – Mission Creek, I – Spring Creek. Bridges: J – Thorn Hollow Road Bridge, K – unnamed railway bridge, L – N. Cayuse Road Bridge, M – unnamed railway bridge, N – S. Market Road (OR-331) Bridge).

In this section, I compared the changes from the 1996-7 floods to those of 2020 flood (Figure 21, compare with Figure 5). Like the first two questions, I described changes for each of the response variables (change in active channel width, lateral movement, change in sinuosity, and change in bar area) separately. Reach-average change and univariate statistics were summarized in Table 5. I also performed simple regression analysis on the reach-average data for the 1996-7 flood (Table 11, compare with Table 9). For each response variable, I investigated differences in the magnitude of change and any geographical patterns in variable response and proposed

Reaches 6 and 7 are the most morphodynamically active reaches in this site, as evidenced by channel widening and migration during the floods studied here (Figure 5, Figure 21) as well as in previous research by Hughes (2008). The dramatic increase in valley width, beginning in Reach 6 and continuing through Reach 8 (Figure 4), coupled with a lower valley gradient (Table 3) and far fewer lateral constraints from bedrock (Figure 4) have allowed the braided channel to persist, which means a large area of the floodplain has remained activated and connected with the channel. Previously abandoned channels are often rewetted in major floods, or else flood-driven avulsions may shift the thalweg so that it follows that path once more or shifts to secondary channels formed during the flood (e.g. Figure 7).

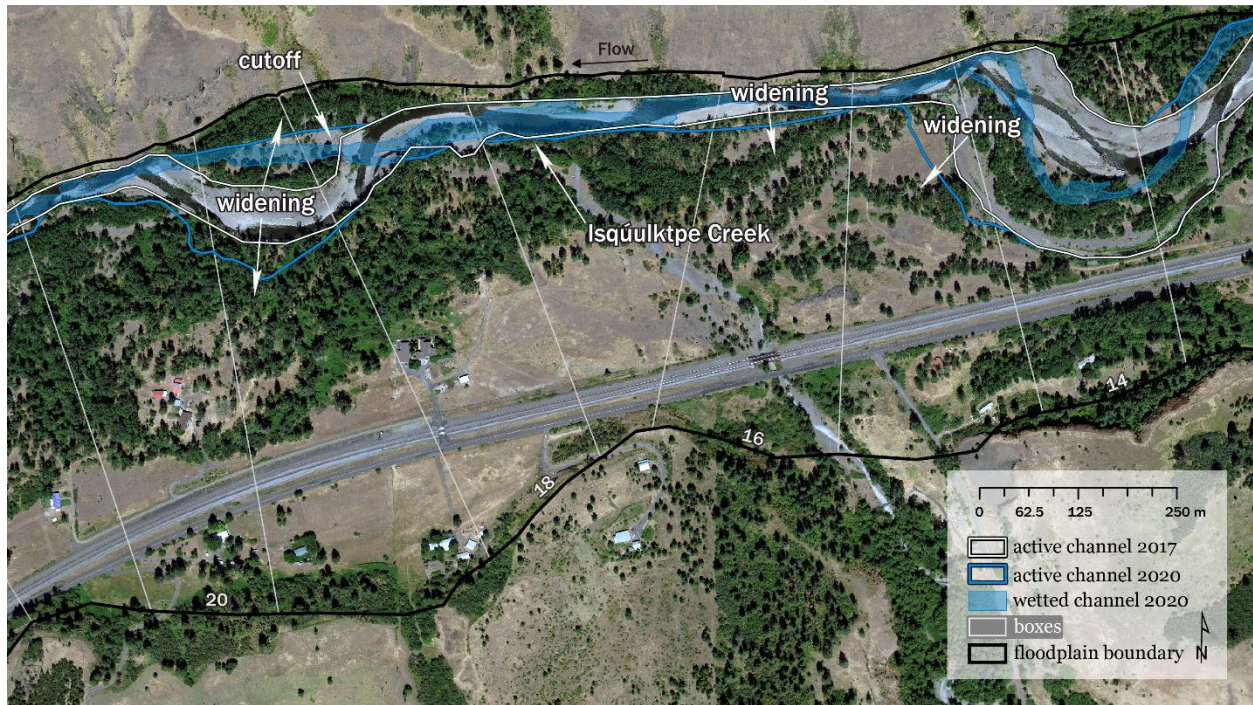
Figure 6. Active channel widening and lateral movement for the 2020 flood (shown on 2017 imagery) in Reach 1 – boxes 14 through 16 and Reach 2 – boxes 17 through 20.

Another factor influencing widening is tributary junctions. Where Isquulktpé, Mission, and Spring Creek join the Umatilla (Reach 2 – box 17, see Figure 6, and Reach 7 – boxes 122 and 127, respectively) significant widening occurred both upstream and downstream (B, H, and I in Figure 5). Tributaries increase discharge, introduce sediment, and lower slope, all of which may contribute to channel widening.

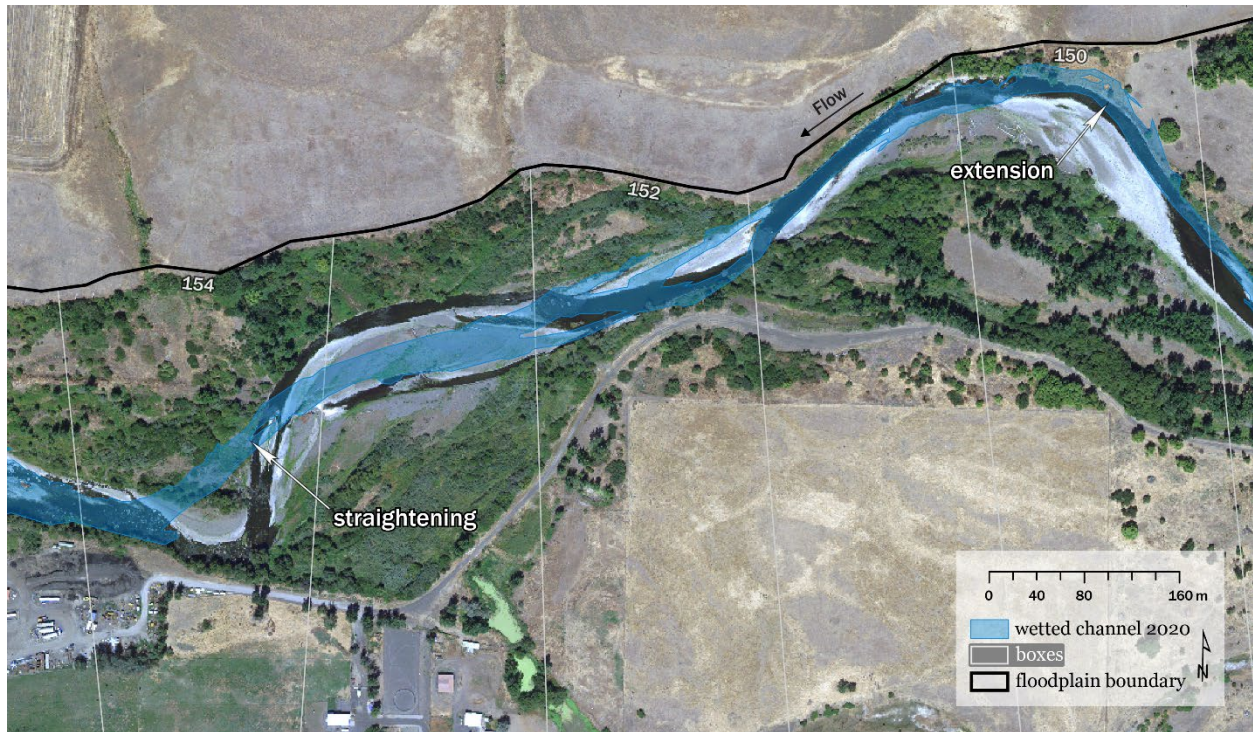
Figure 8. Two types of lateral movement with different impacts on sinuosity in the 2020 flood (shown on 2017 imagery) in Reach 9 – boxes 150 through 154. The slight extension in box 150 had much less of an impact on channel sinuosity than the straightening in boxes 153 and 154, despite both types of lateral movement being responsible for a similar distance of shifting (Table 6).

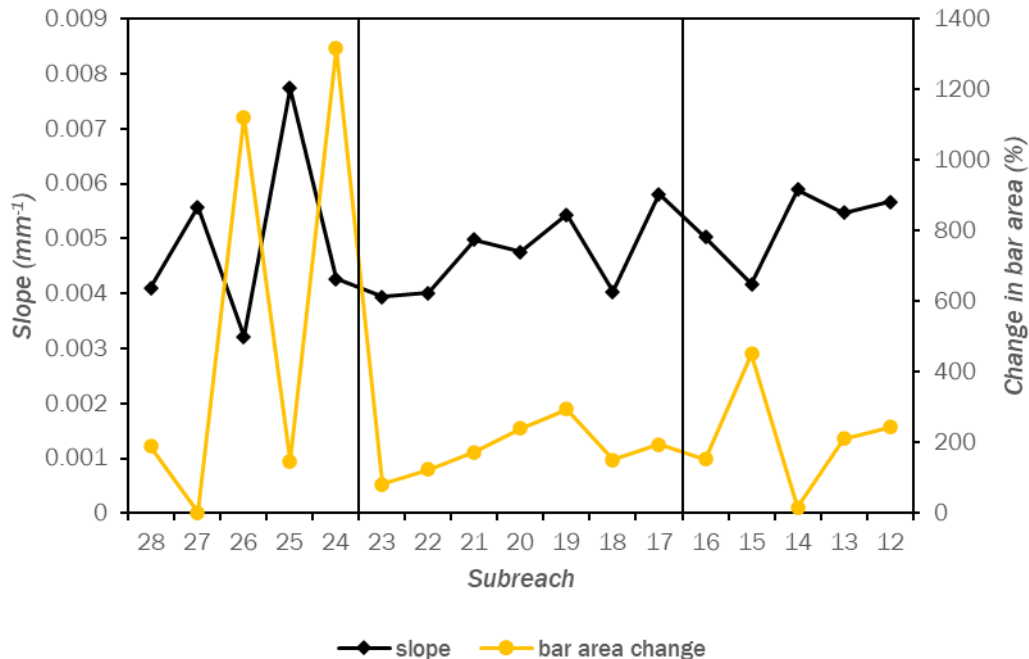
Figure 9. Subreach-average slope and bar area change in Reaches 3, 4, and 5 where steep sloped limited bar accretion near some tributary junctions in the 2020 flood. The vertical black lines show reach boundaries. Tributaries join the Umatilla in subreaches 13, 14, 24, and 26.

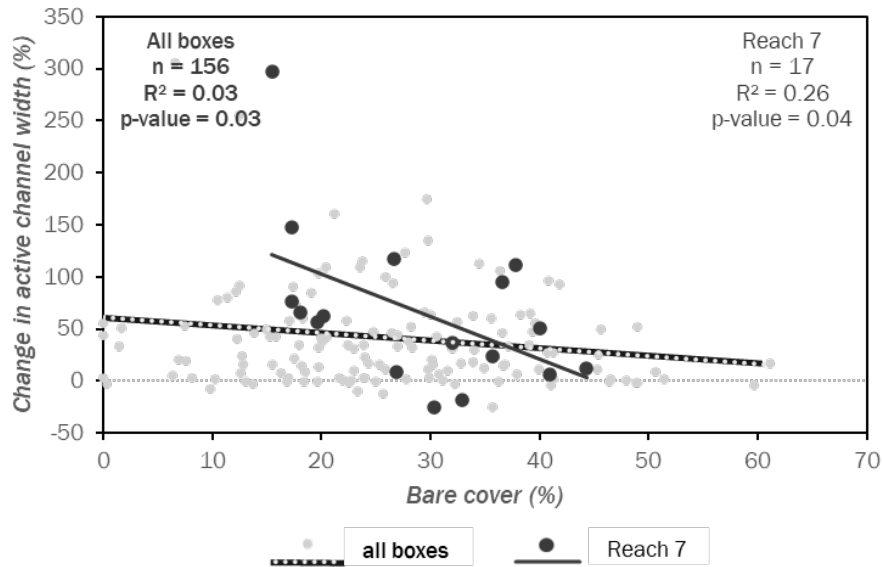
Figure 12. Scatter plot of box-level data showing the negative relationship between bare cover and change in active channel width. The R² and p-value of the regression of all 156 boxes is in the top left corner. On the right is the R² and p-value of the regression of the boxes in Reach 7, the only reach where the relationship between these variables was significant at the box-level.

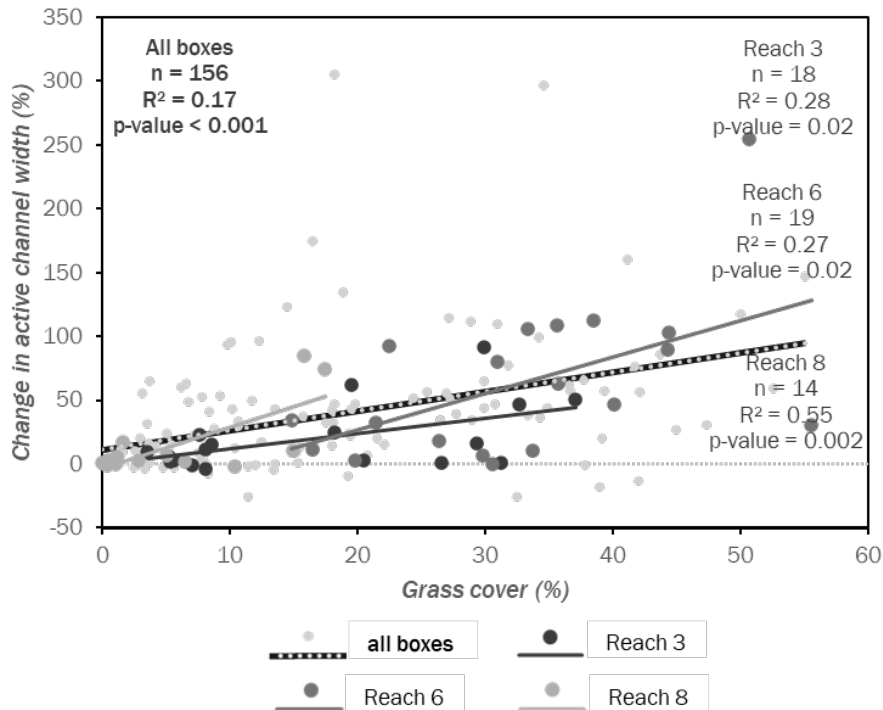
Figure 13. Scatter plot of box-level data showing the positive relationship between grass cover and change in active channel width. The R² and p-value of the regression of all 156 boxes is in the top left corner. On the right are the R² and p-values of the regression of the boxes in Reaches 3, 6, and 7, the only reaches where the relationship between these variables was significant at the box-level.

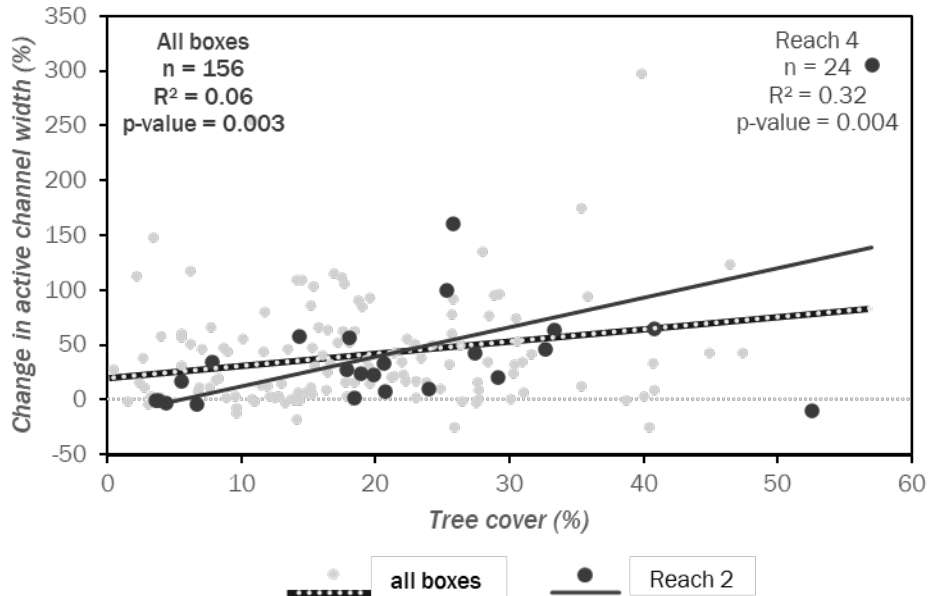
Figure 14. Scatter plot of box-level data showing the positive relationship between tree cover and change in active channel width. The R^2 and p-value of the regression of all 156 boxes is in the top left corner. On the right is the R^2 and p-value of the regression of the boxes in Reach 4, the only reach where the relationship between these variables was significant at the box-level.

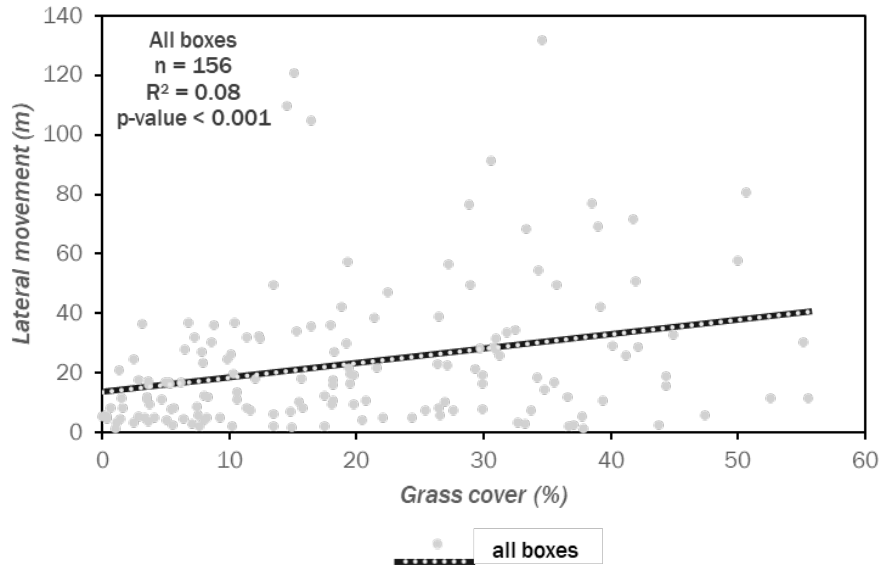
Figure 15. Scatter plot of box-level data showing the positive relationship between grass cover and lateral movement. The R^2 and p-value of the regression of all 156 boxes is in the top left corner. No single reach exhibited a significant relationship between these variables at this level of analysis.

Lateral movement was significantly and positively correlated with both grass and tree cover at the box level (Figure 15, Figure 16). Bare cover, although not significantly correlated with lateral movement, did have a positive relationship with this response variable, as it did at the subreach and reach levels.

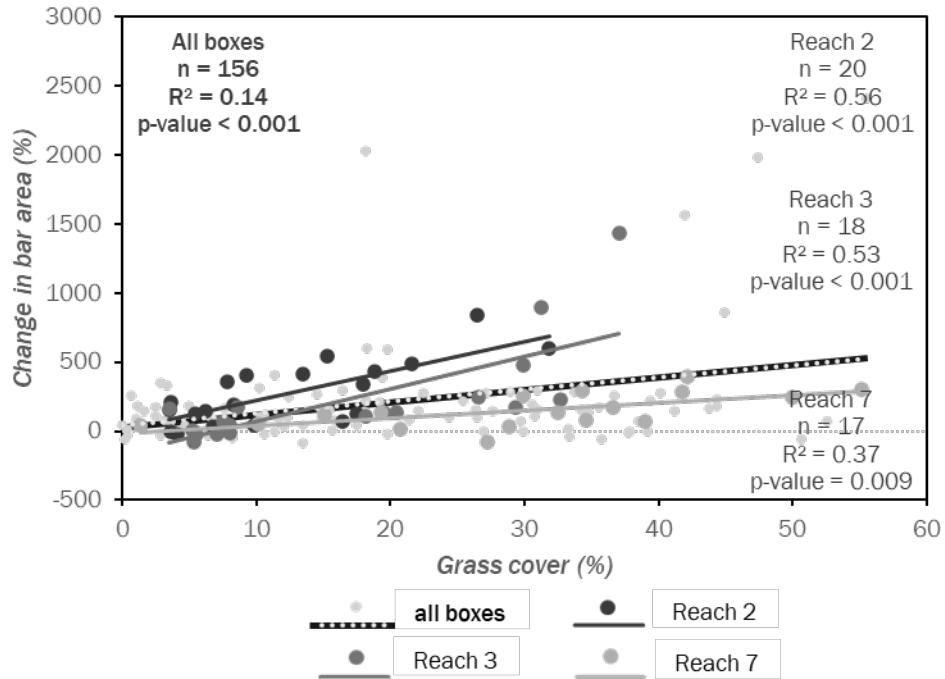
Figure 18. Scatter plot of box-level data showing the positive relationship between grass cover and change in bar area. The R² and p-value of the regression of all 156 boxes is in the top left corner. On the right are the R² and p-values of the regression of the boxes in Reaches 2, 3, and 7, the only reaches where the relationship between these variables was significant at the box-level.

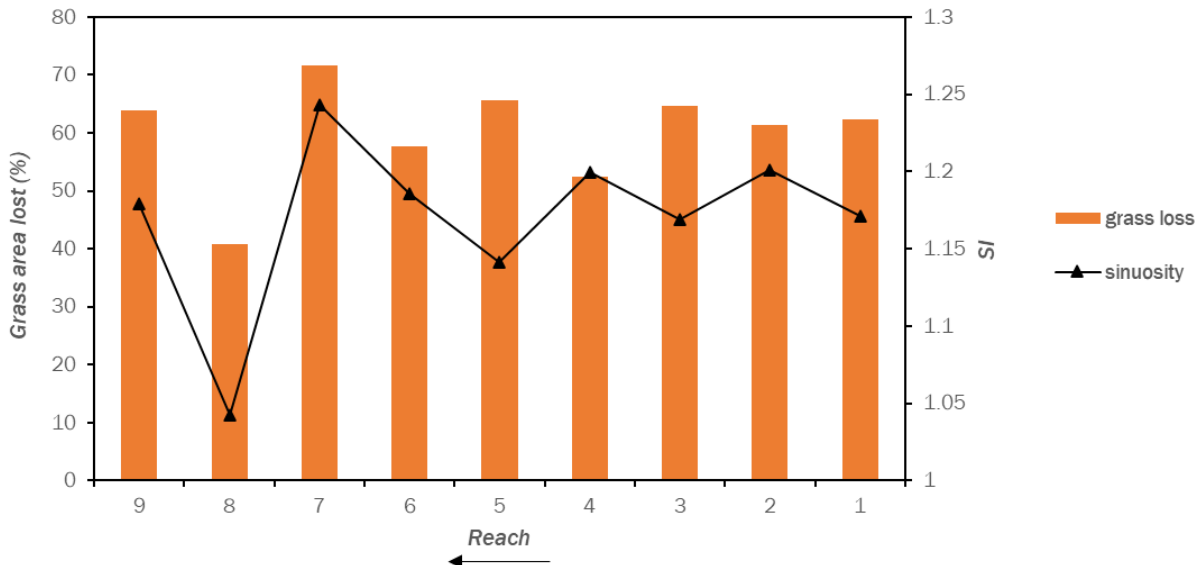
Figure 19. Bar and line graph of reach-average grass loss and SI. The response variable (grass loss) has its vertical axis on the left, while the control variable (sinuosity) has its vertical axis on the right.

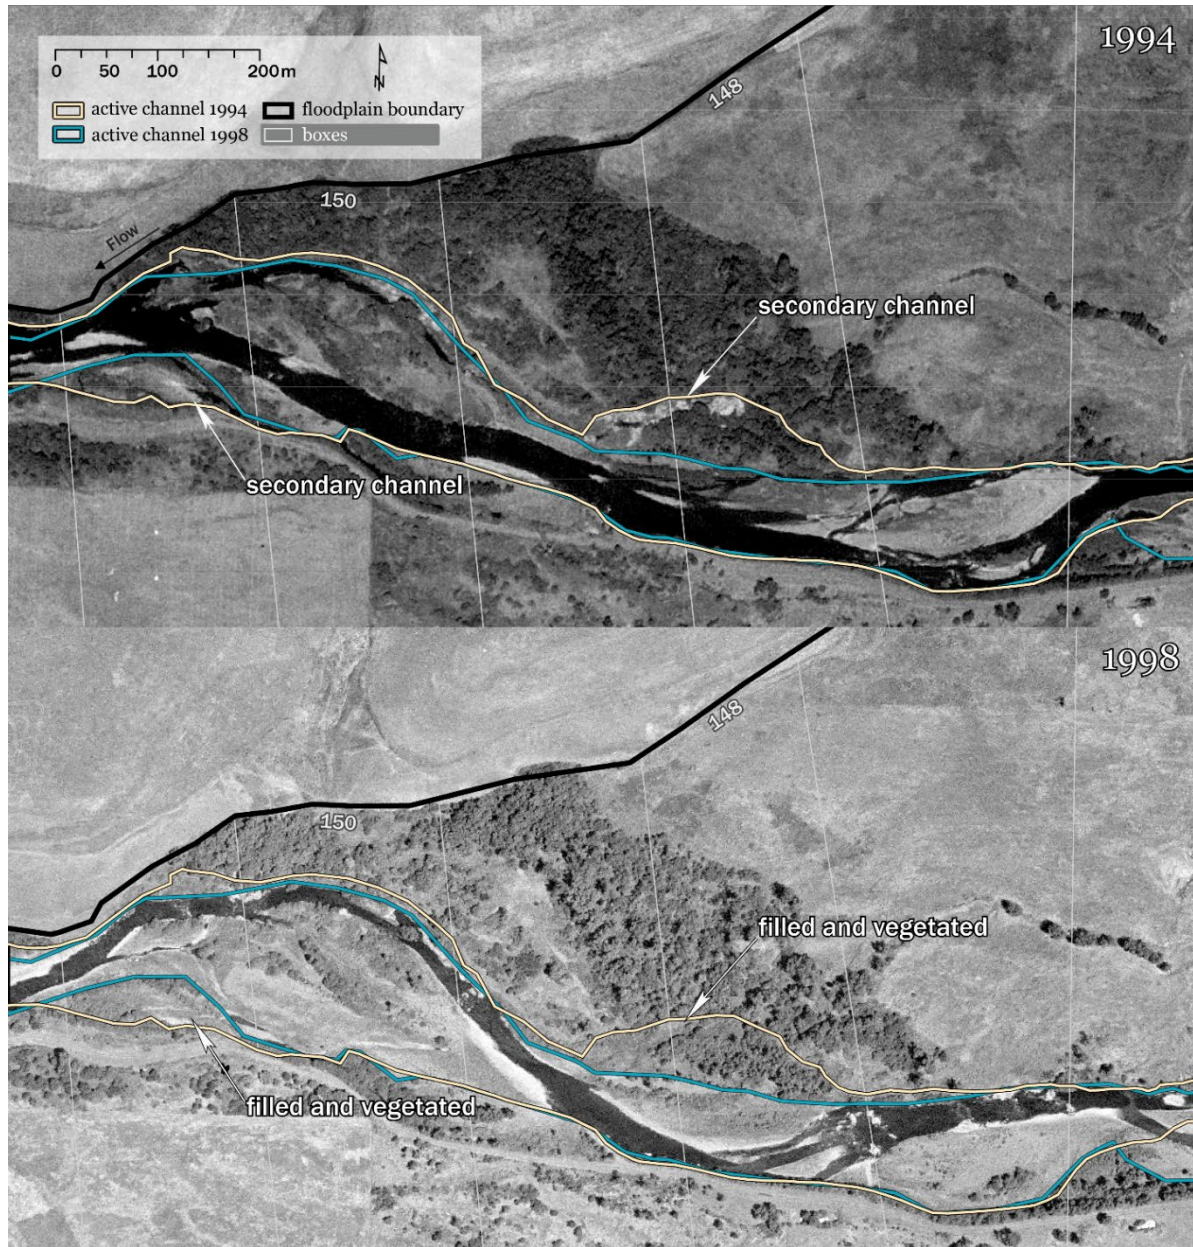
Figure 23. Active channel narrowing between 1994 and 1998 in Reach 9 – boxes 147 through 151, shown on 1994 and 1998 imagery. Side channels in boxes 148 and 151 visible on the 1994 imagery appear to have aggraded and been at least partially colonized by vegetation between 1994 and 1998. It is possible these channels aggraded during flooding with the introduction of large volumes of sediment and then grew vegetation between 1997 and 1998 before imagery was captured.

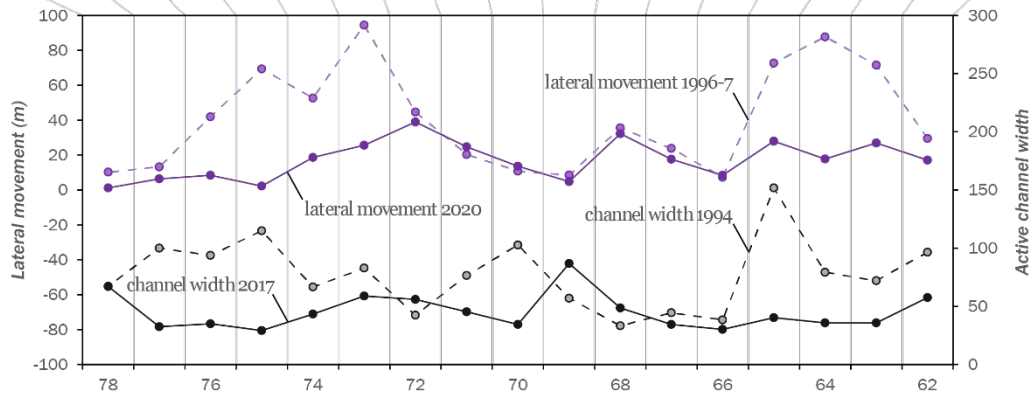
Figure 26. (next page) Active channel widening and lateral movement (shown on 1994 and 2017 imagery with pre-flood channel width) in Reach 4 – boxes 62 through 78. Lateral activity was greatest where the active channel was widest before the flood, and because the active channel was wider before the 1996-7 floods, lateral movement was more extreme as a result of those floods.

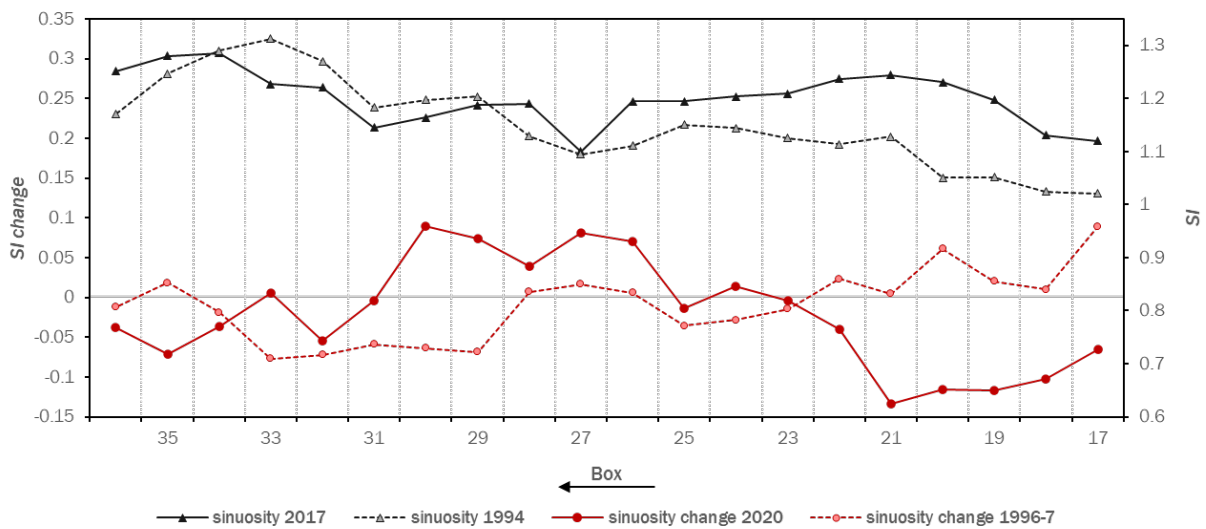
Figure 27. Comparison of pre-flood sinuosity and sinuosity change for the 1996-7 and 2020 floods in Reach 2 – boxes 17 through 36. The dark gray horizontal line indicates no change in sinuosity.

One of the few areas where sinuosity was greater in 1994 than in 2017 was Reach 2 – boxes 29 through 32, and sinuosity decreased there more than any surrounding areas (Figure 27). Similarly, peaks in sinuosity in Reach 6 – boxes 100 through 102 and 112 through 114 coincide with decreases in sinuosity as a result of flooding. Reaches 2 and 6 had smaller shifts from extensions than most other reaches, including reaches in 2020 (Table 6), and Reach 6 had the largest change due to straightening seen from any of the reaches, both of which may have contributed to the decrease in sinuosity there (Table 5).

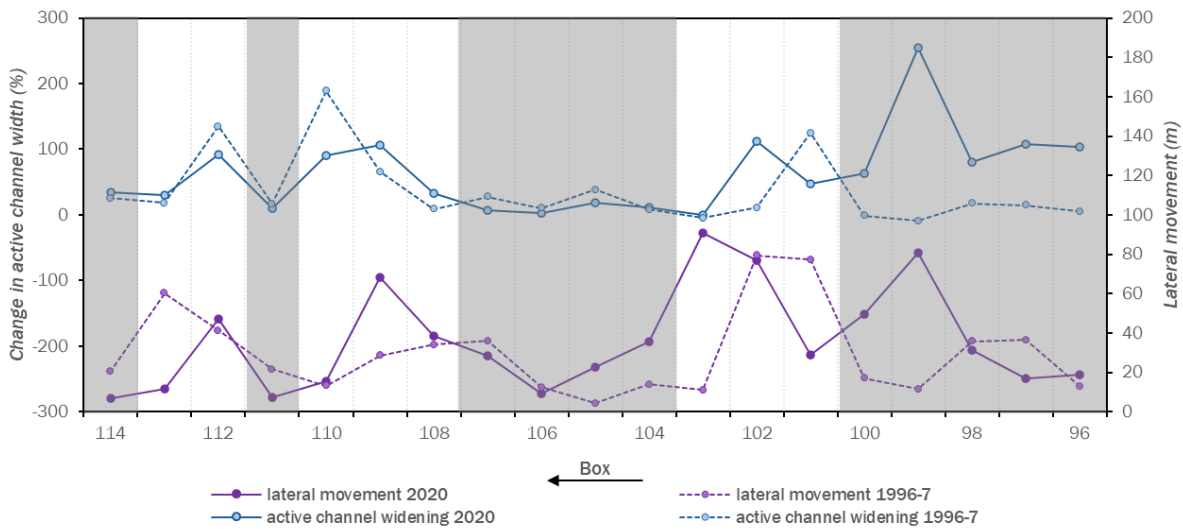
Figure 28. Lateral movement and active channel widening for each box in Reach 6 for the 1996-7 and 2020 floods. Boxes that have not been grayed out show where both channel widening and lateral movement peak in similar areas in 1996-7 and 2020. Imagery of most of Reach 6 can be seen in Figures 24 and 25.
