THE GEOMORPHIC LEGACY OF SPLASH DAMS IN THE SOUTHERN OREGON  
COAST RANGE

A THESIS

Presented to the Department of Geography  
and the Graduate School of the University of Oregon  
in partial fulfillment of the requirements  
for the degree of  
Master of Science

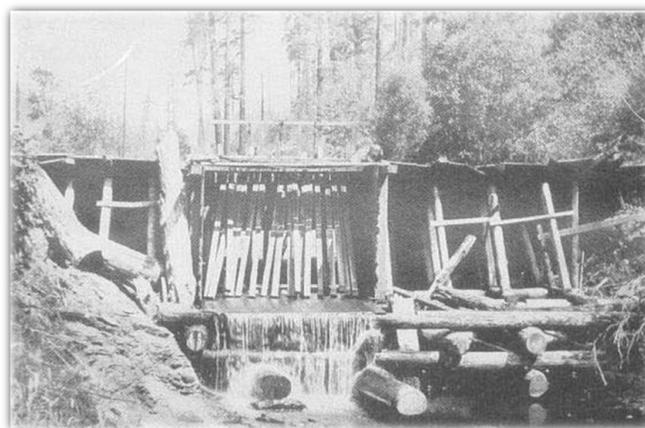
**Figure 1:** Splash Dam on Hamilton Creek, Oregon 1907  
Source: Horner Museum, Oregon State University

Splash dams were used to float timber from remote areas after harvesting. The dams were most common in mid-sized 3<sup>rd</sup> and 4<sup>th</sup> order streams (Sedell *et al.*, 1991) and ranged in size from approximately two to 10m high with widths that spanned the channel

(Figure 1). Loggers skidded timber into the impoundments behind the dams, and then released the water, often during winter or spring freshets to increase the flow. The larger dams operated for multiple years and had spill gates that would open and close, allowing the rush of water and logs to spill out. Smaller dams were sometimes built without spill gates to transport one harvest and were dynamited to release the water and logs (Beckham, 1990).

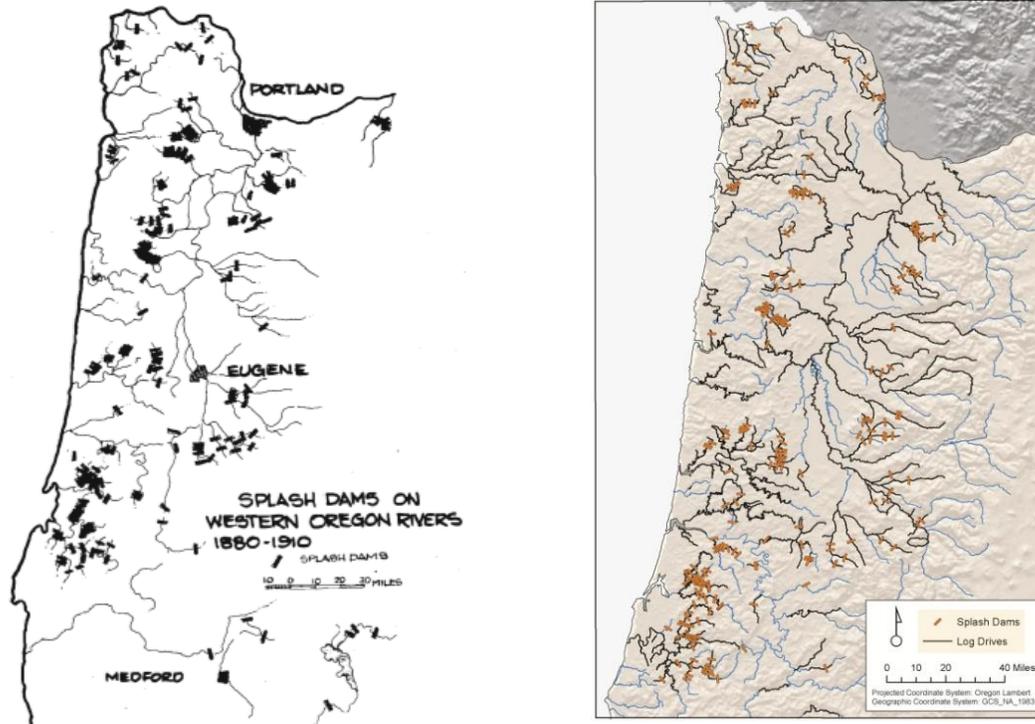
**Figure 2:** Splash Dam Maps a) Splash dam distribution in Western Oregon based on reports by James Farnell for the Oregon Department of State Lands (Sedell and Luchessa, 1982). B) Map of splash dam locations from Miller (2010) based on Sedell and Luchessa’s 1982 map, historical documentation analysis, interviews, aerial photo analysis and field verification.

More recently and concurrent with this study, Miller (2010) created a comprehensive GIS database and map of splash dams in Western Oregon using splash dam locations from Sedell and Luchessa's 1981 publication coupled with historical documentation analysis, interviews, aerial photo analysis and field verification (Figure 2b). Coupling these locations with regional data sets on channel widths, depths, sediment class, habitat units and slope (ODFW, 2010), Miller found 15% more bedrock channel area, fewer deep pools and fewer key pieces of large wood in splashed channels, suggesting that legacy effects exist 50 to 130 years after splashing (Miller, 2010).

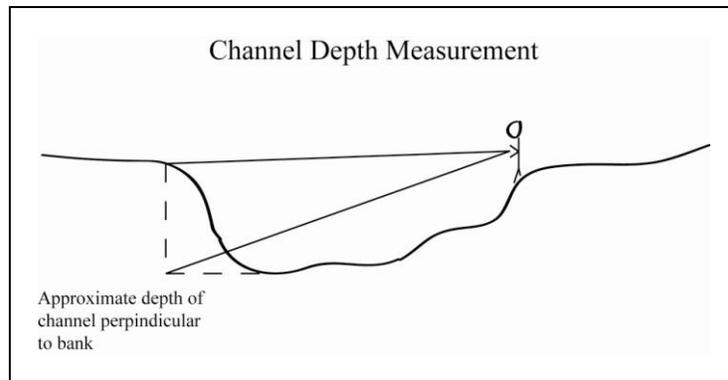
**Figure 4:** Diagram of depth measurement

At the upstream end of each 50 m section, I measured wetted channel width (defined as width of water surface), bankfull width, bankfull depth and maximum water depth with a survey grade laser range finder. Bankfull stage was identified based on changes in slope, bank shape, and high water marks or location of debris and sediment. I used the laser range finder to estimate water depth by shooting points at bankfull stage and at an estimated location for the channel bottom (Figure 4).

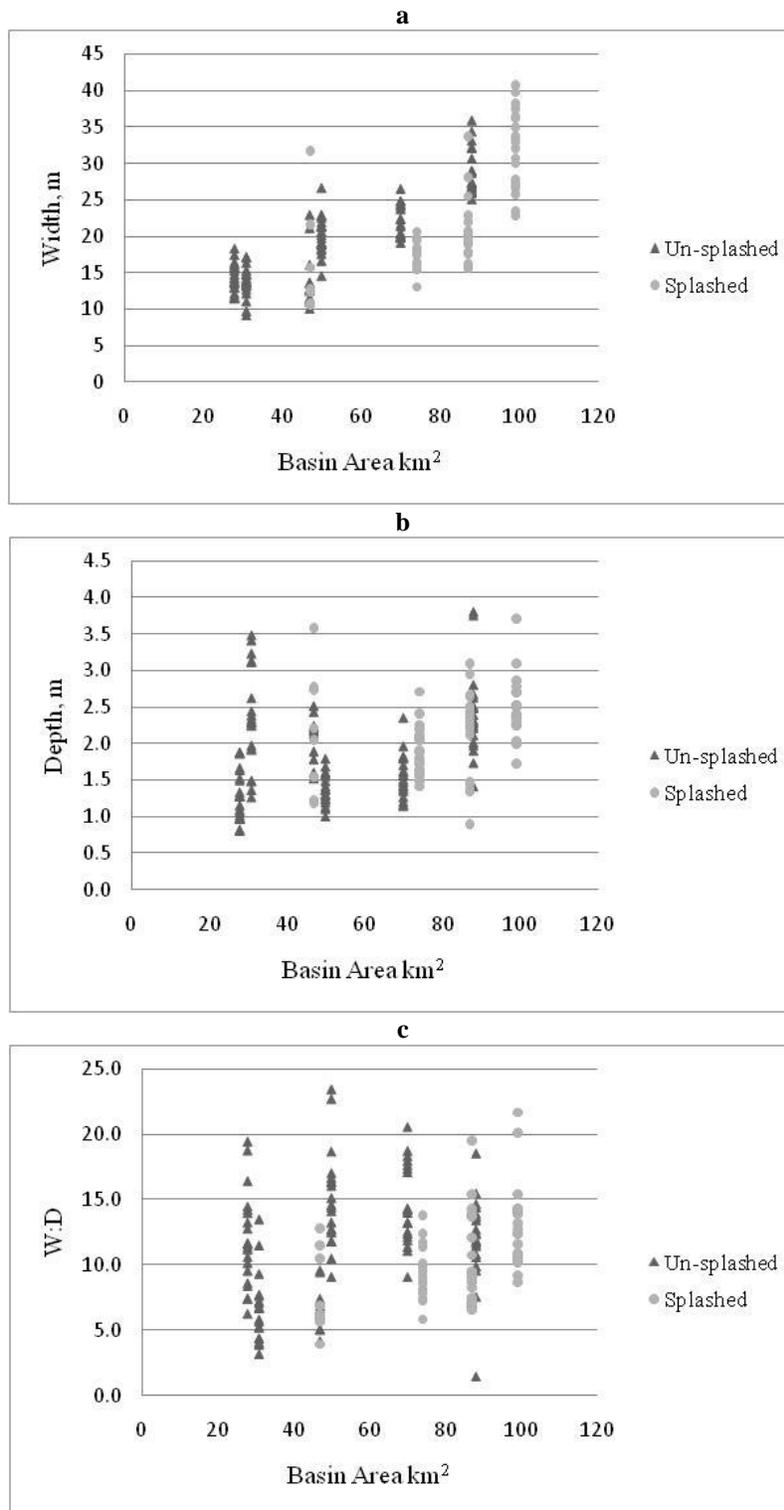
**Figure 5:** Morphological Variables **a)** width by basin area, splashed vs. un-splashed **b)** depth by basin area, splashed vs. un-splashed **c)** W:D ratio by basin area, splashed vs. un-splashed

(Table 4) showed that splashed reaches have slightly narrower channels than un-splashed reaches, although depths are comparable (Figure 5, Table 4). However, widths in the un-splashed portion of Camp Creek are also slightly narrower than the un-splashed sections of the WF Millicoma with a similar basin area, calling into question whether the width differences are related to splashing or other factors. Following the more narrow widths, the width/depth ratios are smaller for splashed reaches. For both width and W: D ratios the effect becomes less notable as basin area increases (Figures 5a,c).

Depths at paired basin areas were comparable and did not show a consistent relationship to splashing (Figure 5b, Table 4). This could indicate that depth of sediment over bedrock was a limiting factor to incision from splashing. During fieldwork high terraces were noted (but not measured) on Camp Creek, indicating that the stream may have cut down through a significant amount of sediment. Similar terraces were not seen

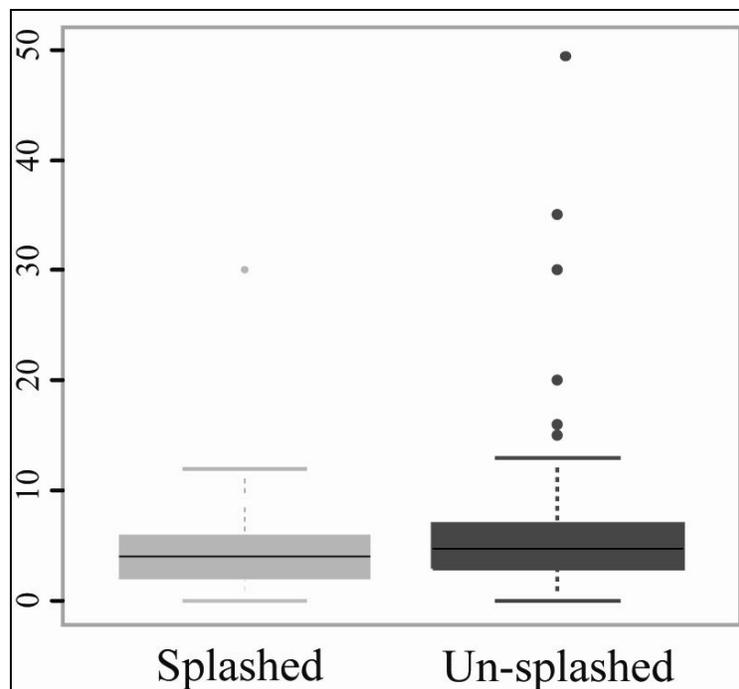
**Figure 6: Large Wood**  
Pieces of large wood per  
50m section. Outliers represent large log jams.

The abundance of pieces of large wood showed no clear difference between splashed or un-splashed reaches. The splashed reaches have an average of 4.6 pieces of large wood per section while the un-splashed reaches averaged 6.2 pieces of large wood per cross-section. There are more large complex log jams in non-splashed reaches but the data set regarding outliers is too sparse to reach a firm conclusion (Figure 6). The majority of the large complex log jams were found at the uppermost basin site (drainage are 31 km<sup>2</sup>) of Camp Creek, which was above all known splash dams. In this reach there were three large log jams composed of between 20 and 50+ individual pieces of large wood (Figure 7). Three log jams of similar size were found in the un-splashed reaches of the W.F. Millicoma, two in basin area 1 (28 km<sup>2</sup>) and one in basin area 4 (88 km<sup>2</sup>).

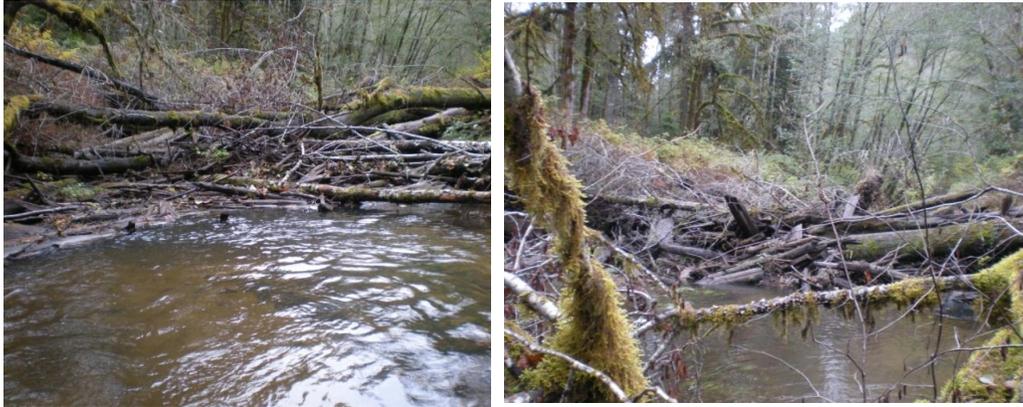
**Figure 7:** Photos of large log jams on the un-splashed reach of Camp Creek

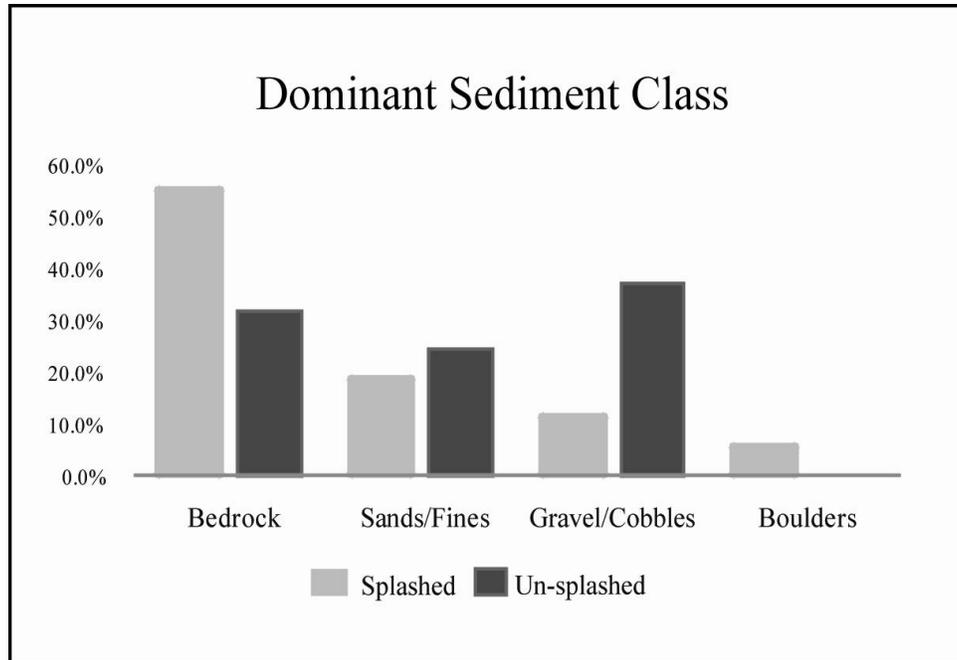
**Figure 8:** Percent dominant sediment class in splashed vs. un-splashed reaches

The aggregated data indicate that bed material in the splashed reaches is more often dominated by bedrock than gravels/cobbles or sands/fines when compared to un-splashed reaches. Bedrock is the dominant sediment class in 55% of splashed reaches while un-splashed reaches are dominated by bedrock 31% of the time (Table 5, Figure 8).

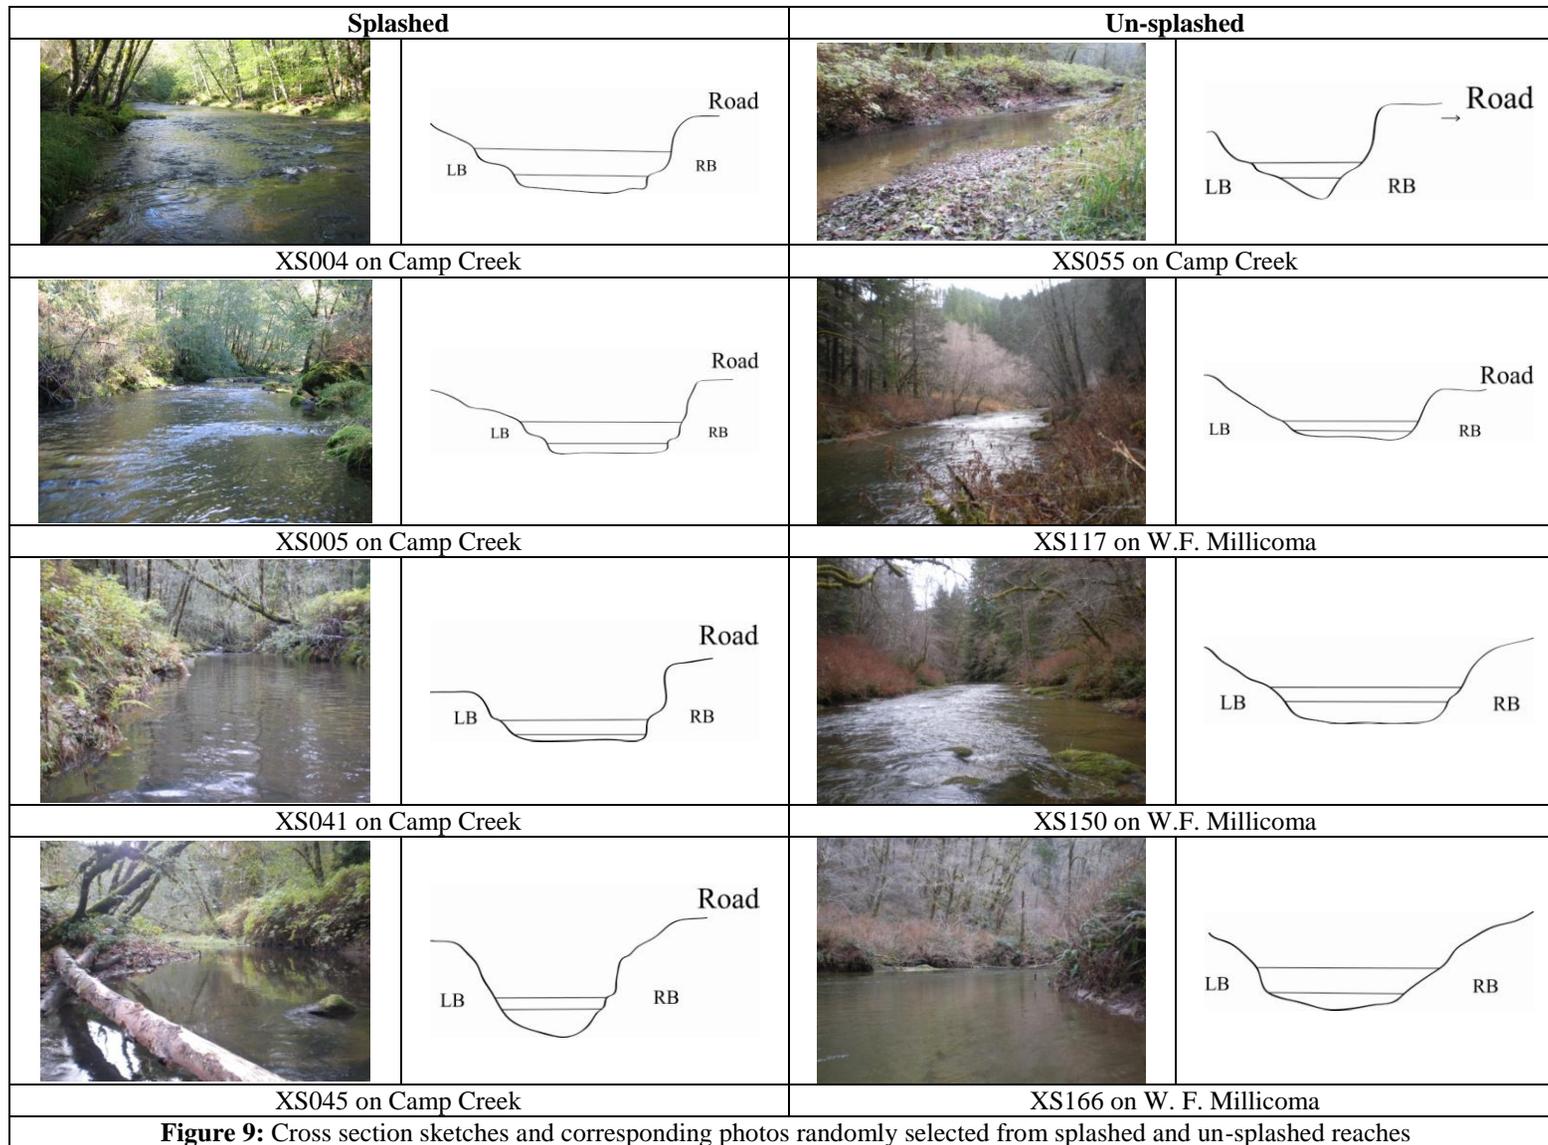
**Figure 9:** Cross section sketches and corresponding photos randomly selected from splashed and un-splashed reaches

Channel cross section sketches were randomly selected by survey number from both splashed and un-splashed datasets. I examined sketches and corresponding photos to determine if any distinct characteristics existed in channel shape between splashed and un-splashed reaches. I also used the sketches to determine whether individual cross sections were influenced by the presence of a road.

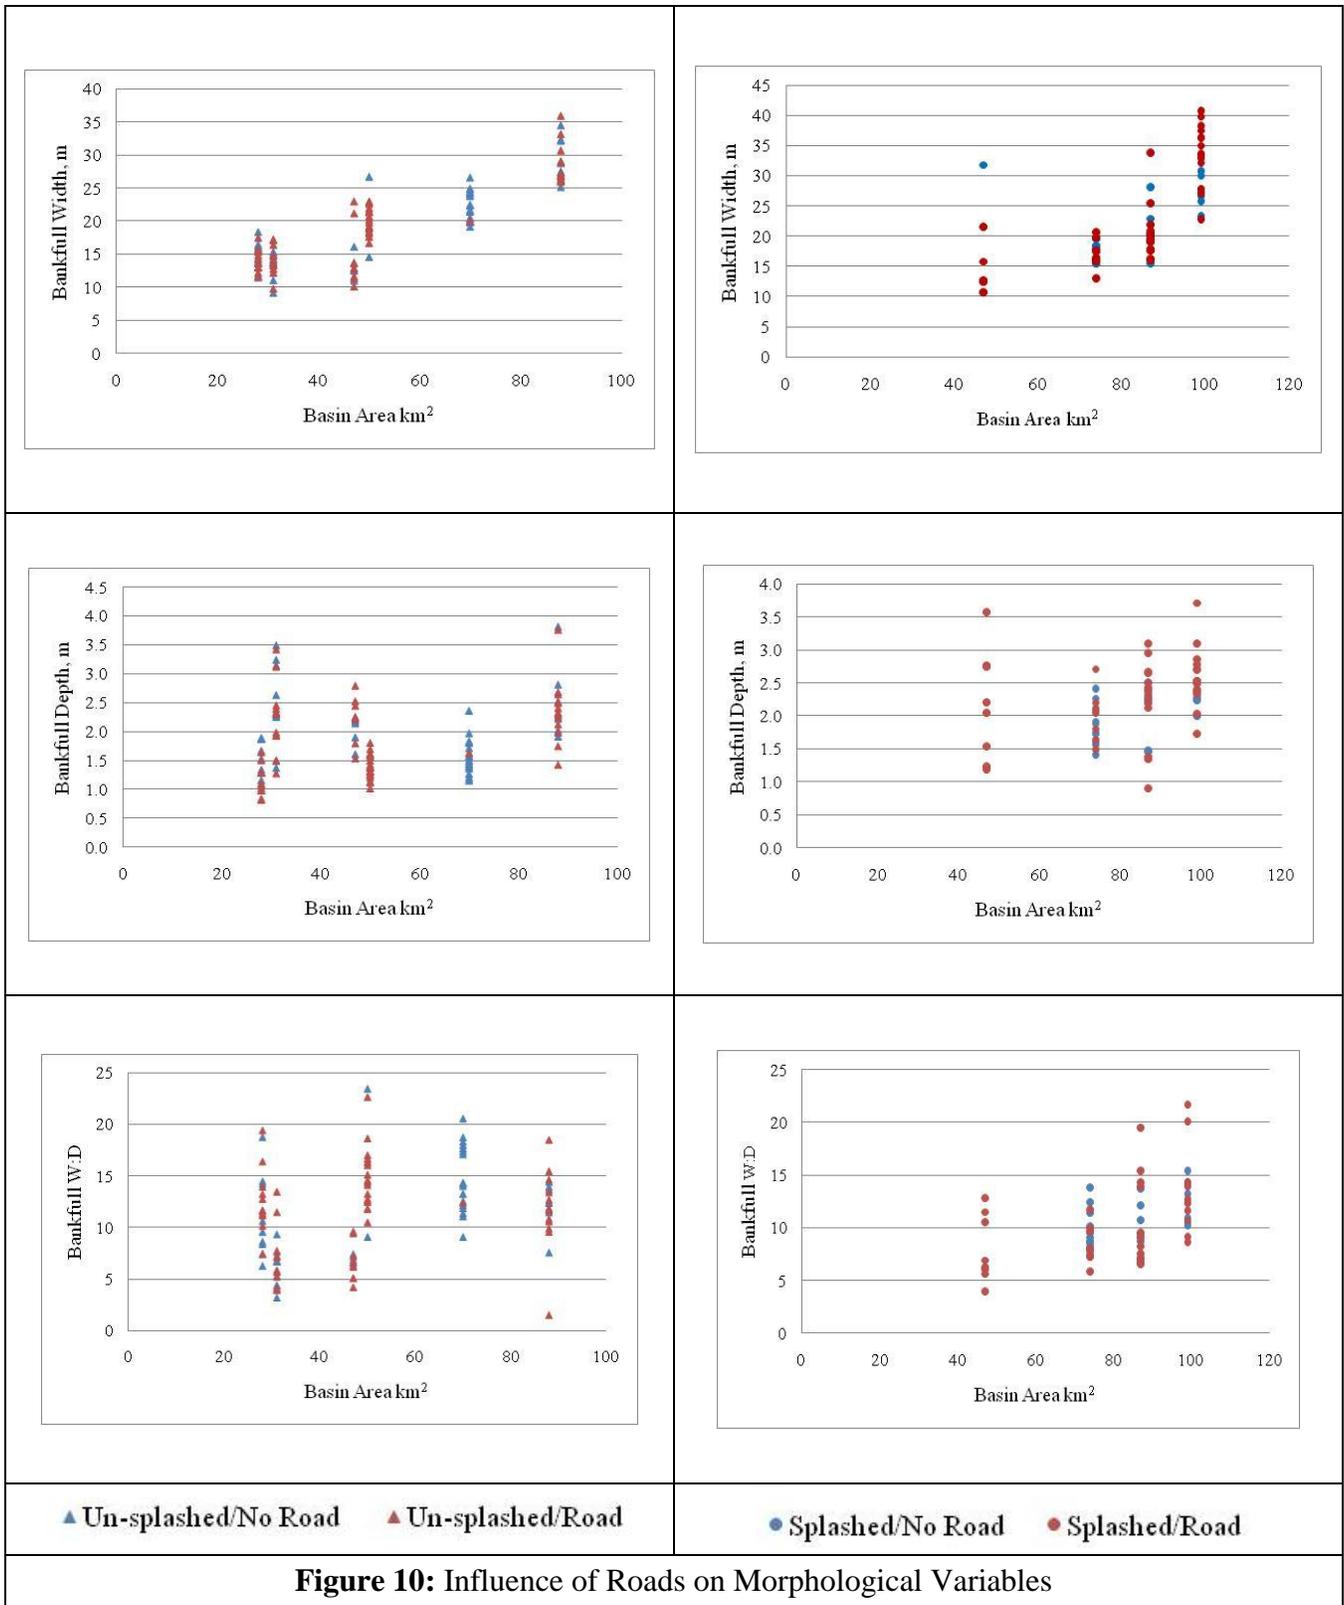
**Figure 10:** Influence of Roads on Morphological Variables

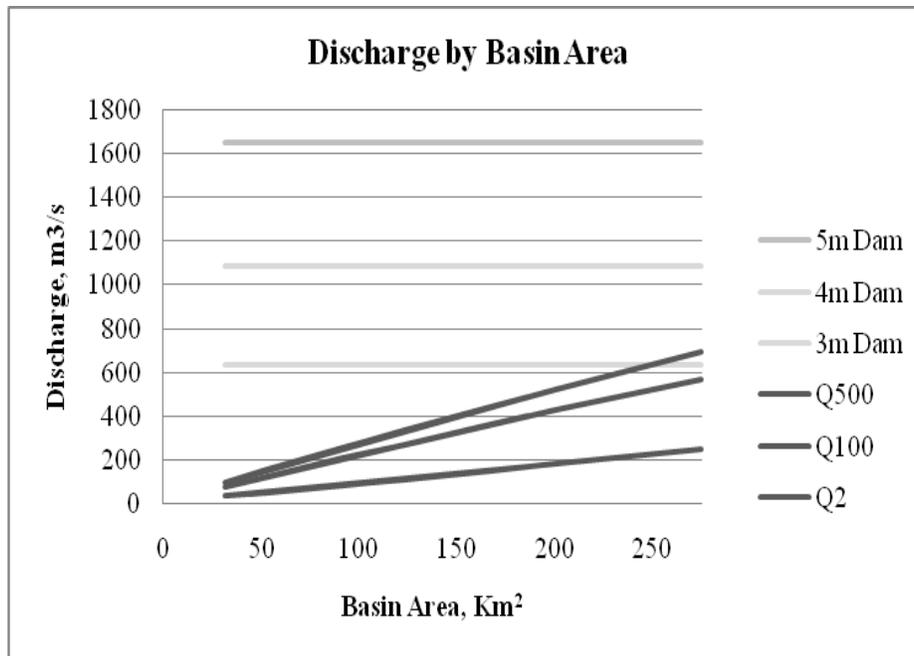
**Figure 11:** Modeled Natural Discharges vs. Dam Outburst Discharges

Figure 11 compares natural flows calculated using the NSS model to dam burst flows calculated using the dam burst model. Results of the Costa (1988) dam burst equation indicate that the flows generated by splashing significantly exceeded 100-yr flood magnitudes in headwater regions and were comparable to 100-yr flows in lower reaches.

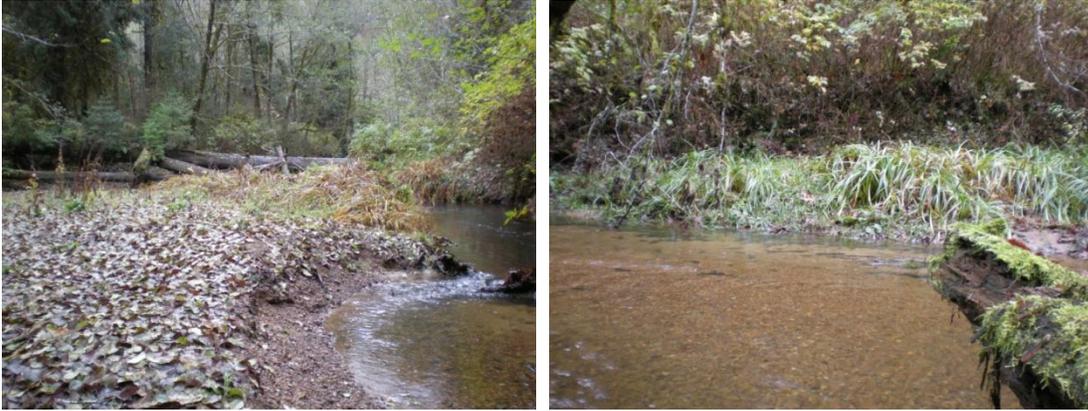
**Figure 12:** Photos of sediment in the un-splashed reach of Camp Creek

At individual dams sites there appeared to be a smaller percentage of fines below the dams, but the relationship was inconsistent, indicating that local factors not related to splashing might have generated the variability. Channel bed composition of splashed reaches on Camp Creek was dominated by bedrock, but this changed dramatically in the uppermost un-splashed reach. There were significant deposits of sediment ranging from sands to gravel/cobbles that were anywhere from a 0.05 to .5m deep (Figure 12). This sediment was associated with large log jams, suggesting that both removal of large wood below the dams and the increase in flow caused by the splashing may have depleted the sediment that would otherwise be found in mid sized basin areas in Coast Range streams. The sediment data for the W.F. Millicoma did not display such obvious trends, with many of the un-splashed reaches dominated by bedrock, although large deposits of sands and gravels were once again often associated with large wood. These findings, coupled with the results of the Miller (2010) who found a greater occurrence of bedrock in splashed reaches, show that splashing is a likely contributor to the dominance of bedrock in channels in the Oregon Coast Range that are surrounded by steep, soil-mantled hillslopes.
