NOTICE OF ADOPTED AMENDMENT

SUBJECT: City of Sisters Plan Amendment
DLCD File Number 002-10

**Watershed Professionals Network, LLC
Technical Report**

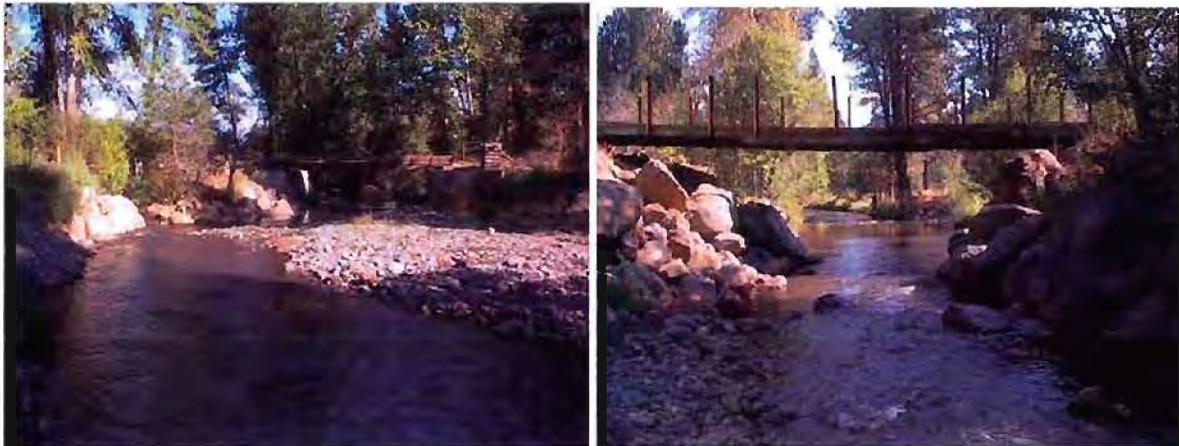
Figure 15. Bridge in Segment 1A showing deposition upstream of constriction (left), and narrow bridge in Segment 3B (right) causing downstream scour and bank erosion.

A total of eight bridges⁴ cross Whychus Creek within the project area. With the possible exception of the Highway 20 Bridge, all appear to be too narrow to pass LWM and other flood debris without danger of plugging. The bridge located at the downstream end of Segment 1A appears to be causing extensive deposition upstream of the bridge (Figure 15), and the narrow bridge abutments of the bridge in segment 3B is creating scour and bank erosion downstream of the site (Figure 15).

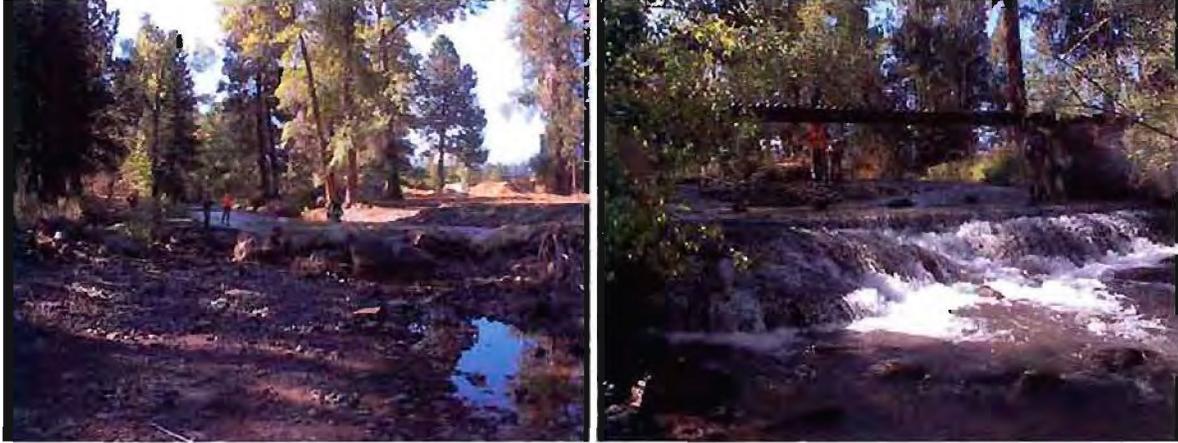
Figure 16. Boulder weir blocking side channel (left), and concrete weir (right) in primary channel, Segment 1C.

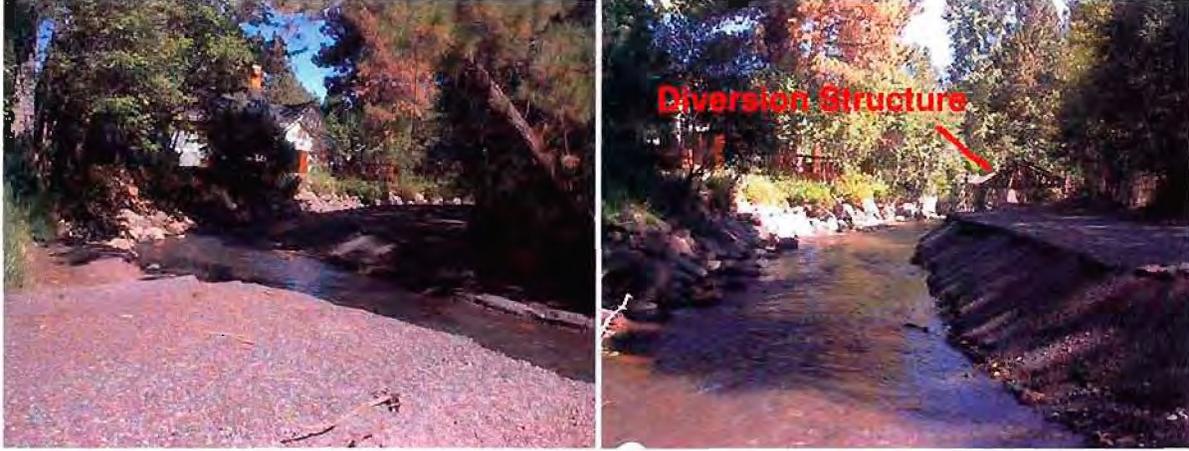
Figure 20. Sedimentation behind irrigation diversion located in Segment 1G.

The irrigation diversion located in Segment 1G consists of a cross-channel dam with removable splashboards. The splashboards are in place during the irrigation season, trapping and settling large volumes of material upstream of the structure (Figure 20). A secondary channel diverts high flows around the structure, and a tertiary channel has developed on the right bank that shows evidence of recent scour and bank erosion (Figure 21). Removal of this irrigation diversion dam and enhancement of the tertiary channel is recommended.

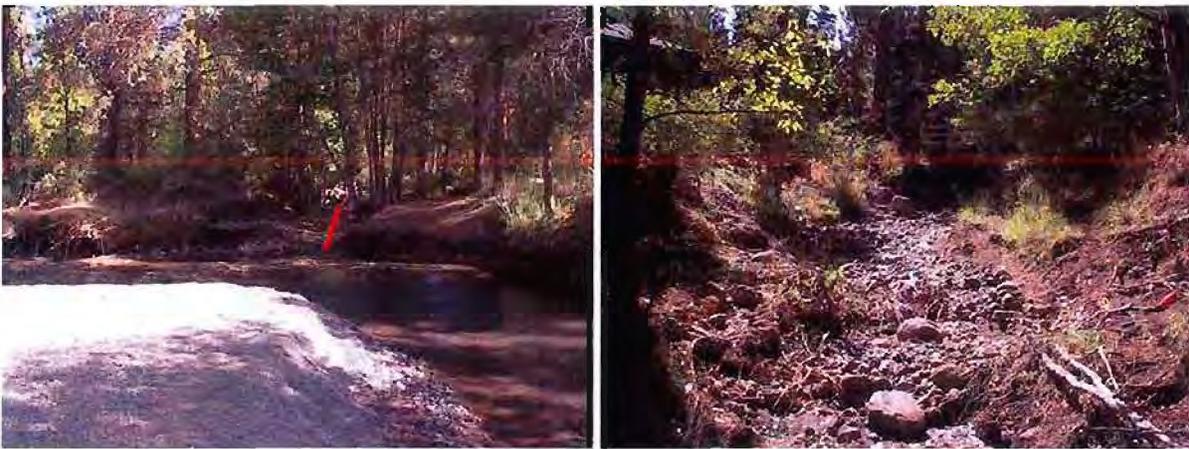
Figure 21. Tertiary channel adjacent to irrigation diversion in Segment 1G.

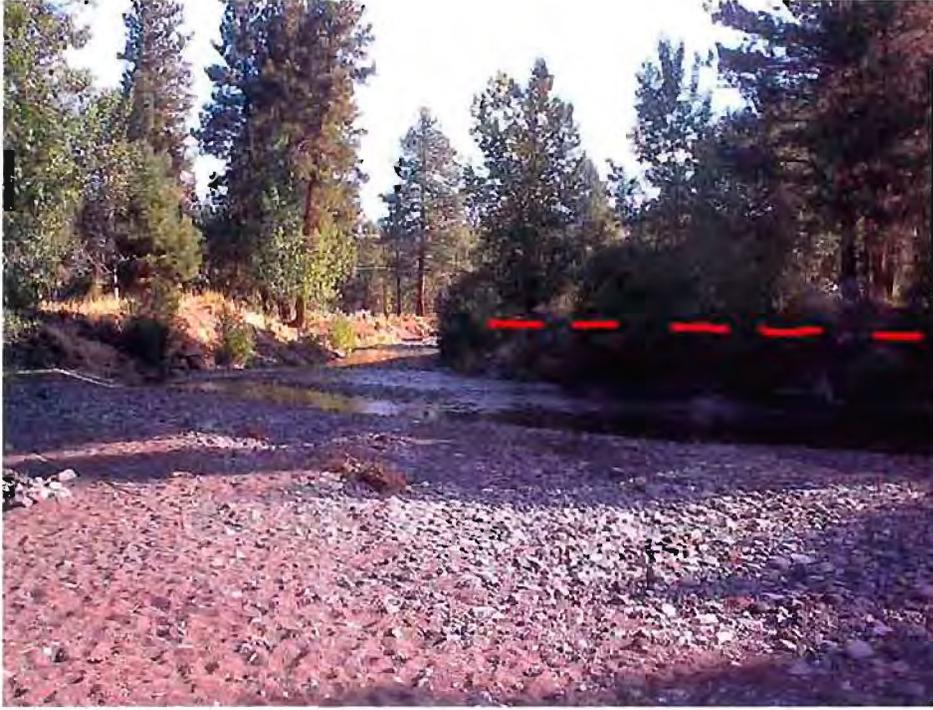
Figure 22. Pinch point in Segment 2A downstream of Timber Creek Bridge.

The floodway downstream of the Timber Creek Bridge (Segment 2A) has been significantly narrowed by placement of riprap on (primarily) the right bank (Figure 22). This area appears to trap ice flows, and may exacerbate deposition in the upstream portion of the segment.

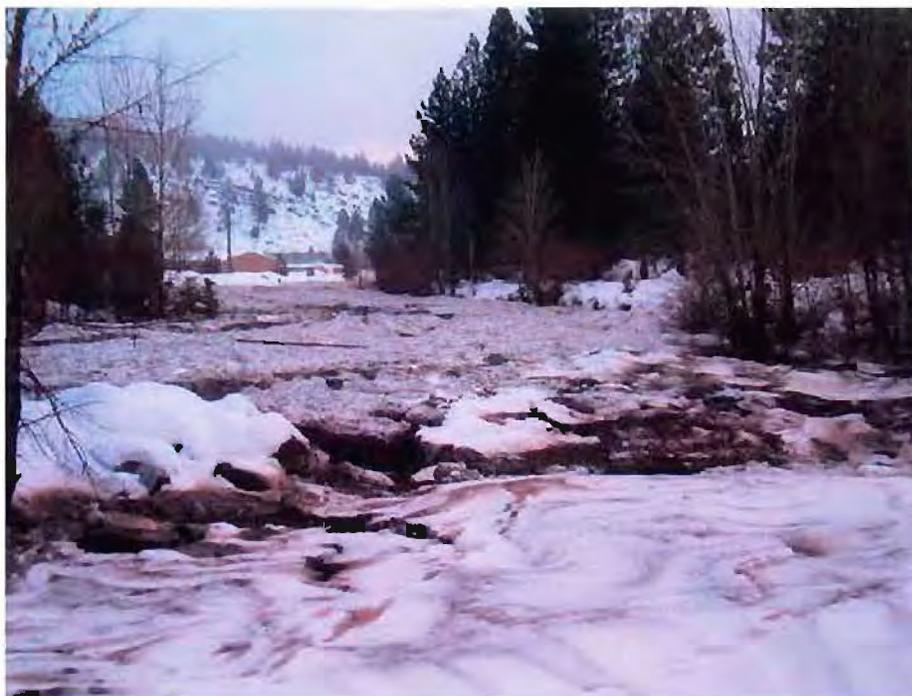
Figure 3. Ice jam in Whychus Creek in 2004. Location is downstream of City limits and upstream of Indian Ford Creek confluence.

In addition to the geomorphic processes associated with sediment, flow, and human influence, ice formation and movement are active in the project area (Figure 3). Ice dams not only impede flow and cause flooding, but movement of ice can affect channel geometry and bank and bed stability. No written record of ice impacts to Whychus Creek was located, though land owners provided some information on ice events. Ice jams have occurred within the last

few years at narrow points in the channel (see Segment Descriptions). These jams are known to exacerbate flooding upstream, and are suspected to cause some channel erosion as the ice moves. In addition, the ice disturbs riparian vegetation establishment on bars and terraces in and near the channel.

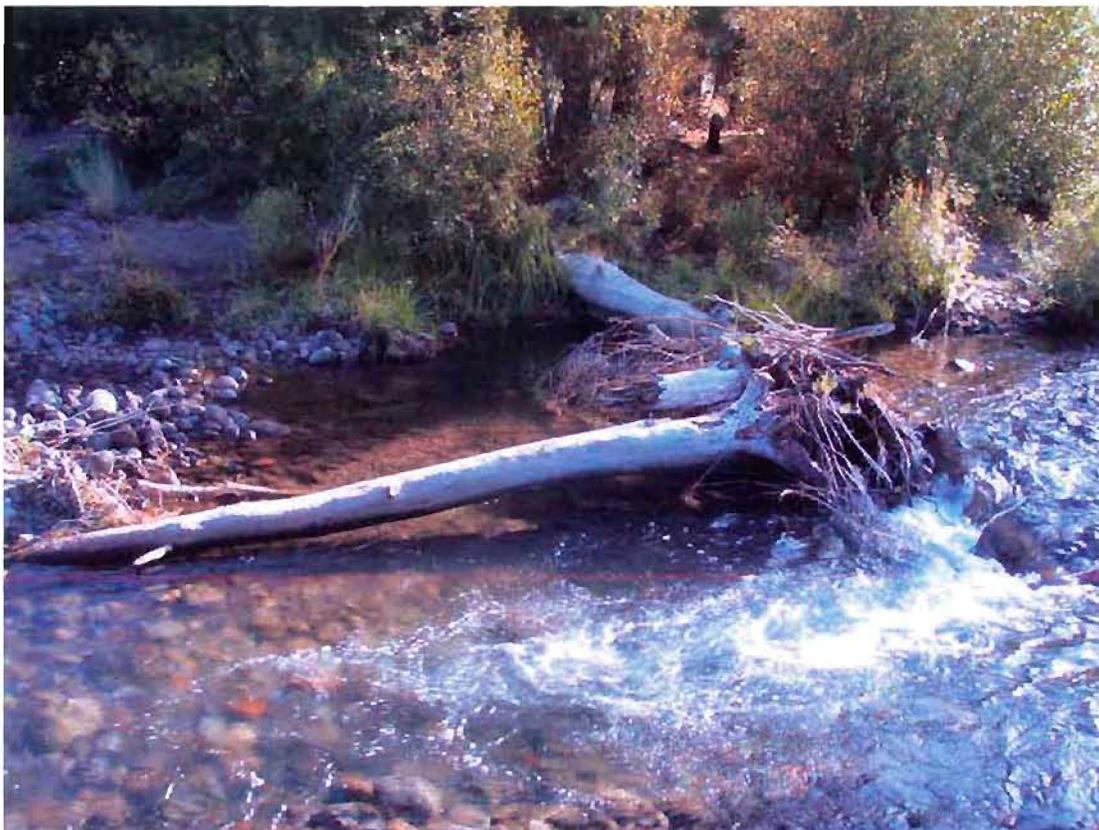
Figure 22. Evidence of LWD which allows some mid-cohort hardwood establishment and expansion of grasses and sedges immediately upstream from the cobble bar.

The cobble bars contain young hardwood establishment; age structures indicate a missing mid-aged cohort. There is high evidence of scouring disturbance on cottonwood communities, and where the few pieces of LWD are retained, vegetation establishment is providing some age structure diversity; young cottonwoods are able to avoid scour disturbance until age structure allows them to resist scour flow (Figure 22).

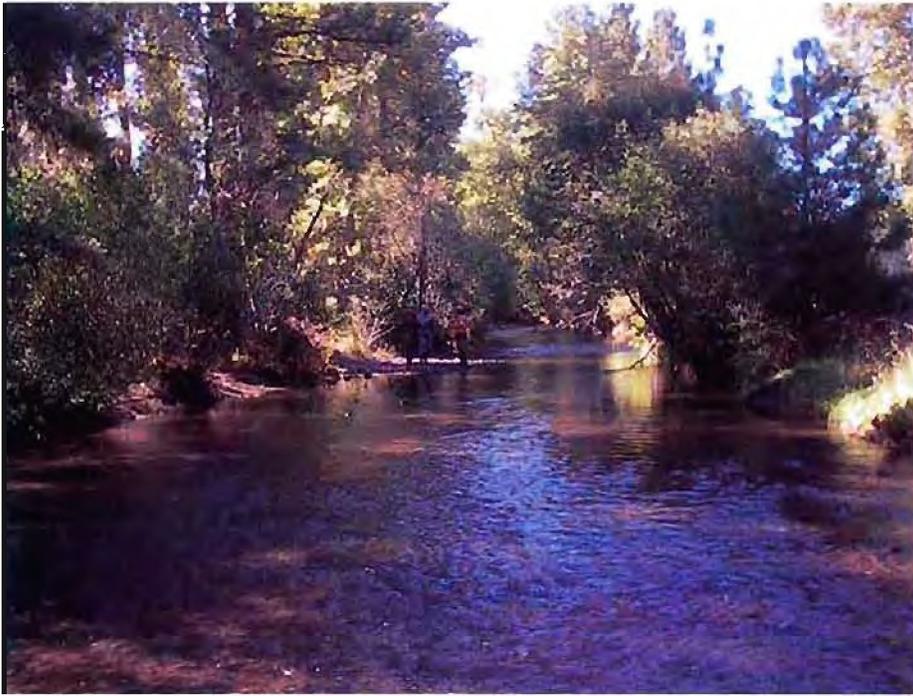
Figure 23. Typical view of Segment 1B; note relatively narrow interactive area and presence of berms on both banks.

Berms on the left bank protect infrastructure and cut off a relatively large (~200 ft wide, 325 ft long) moderate and low potentially interactive terrace. Applications to engage the potentially interactive zones on the right bank would require removal of a berm and reestablish channel structures. Available vegetation resources follow a wide mesic gradient, and as such, would likely respond quickly to active restoration.

Overall condition: The lack of roughness and high berms on the right are the two major limiting factors in this segment. Stream shade appears to be high (~36%) when structures ≥ 20 ft are reviewed in the active zone.

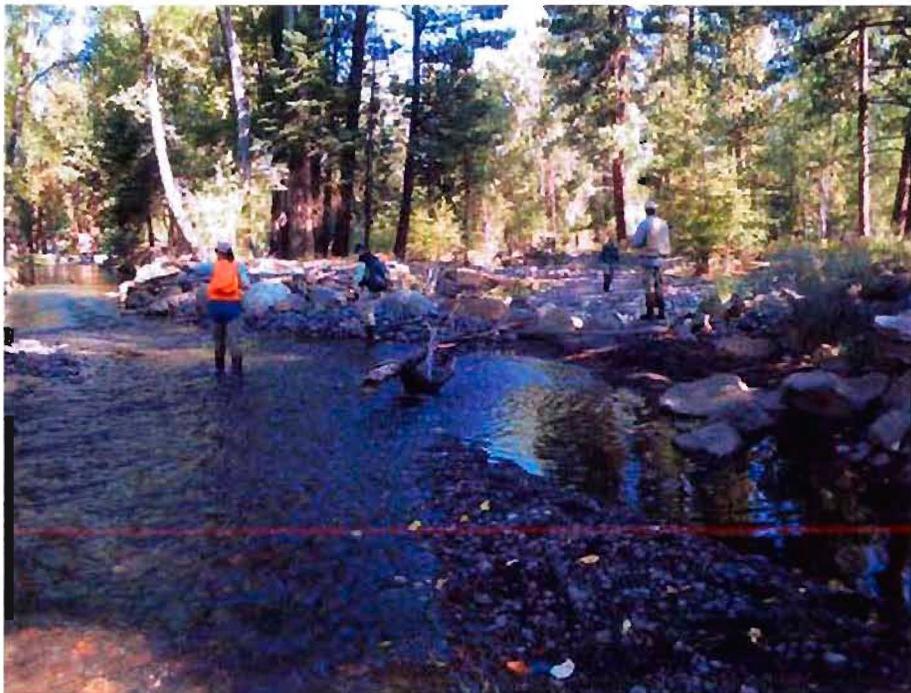
Figure 24. Top of Segment 1C; constructed weir is to the left; other channel to the right. Vegetation intact, though restricted from interaction due to berms throughout.

A potentially interactive floodplain and low terrace connects off of the right bank to the section found in Segment 1B. Good vegetative patterns of aspen, established cottonwoods and ponderosa pine overstories are present in these areas (canopy cover ~44%). Berms and the barrier on the right channel/right bank are limiting the

interaction with the stream channel. The left bank plant communities are encroaching within a private property boundary and infrastructure. Berms are installed to cut off the left bank floodplain and low terrace communities from direct interaction with the stream channel.

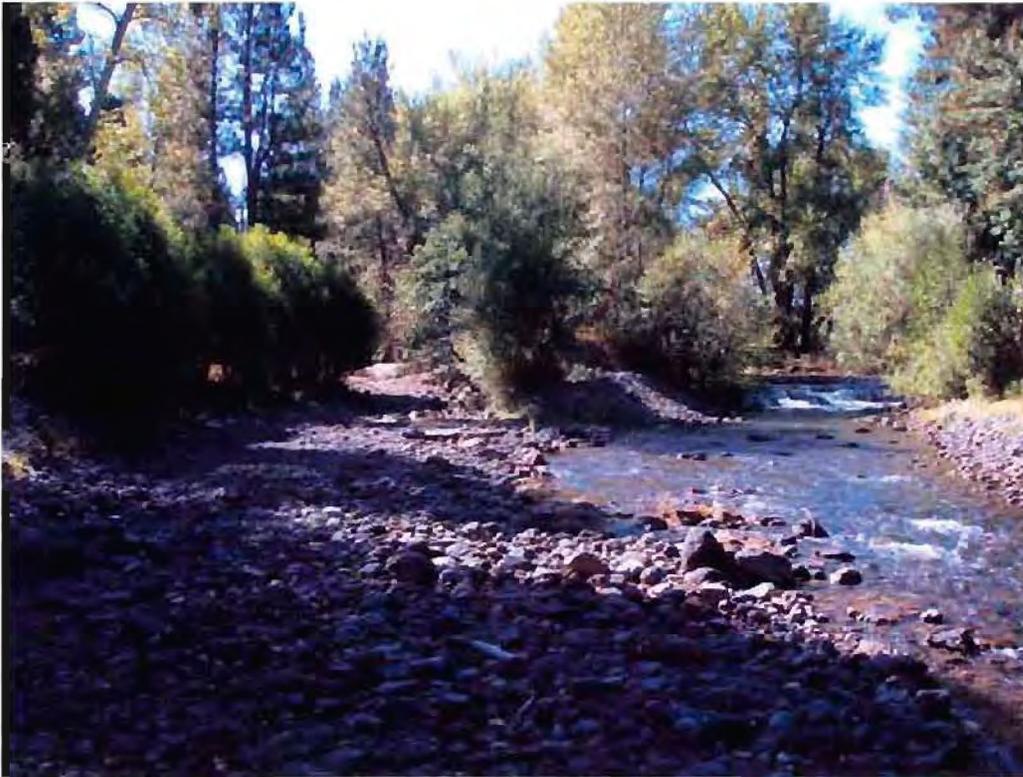
Figure 25. Looking upstream to split channel in Segment 1C. Riparian vegetation in right channel (left in view) provides hardwood and conifer stock for enhancement; berms and diversion restricts the interaction.

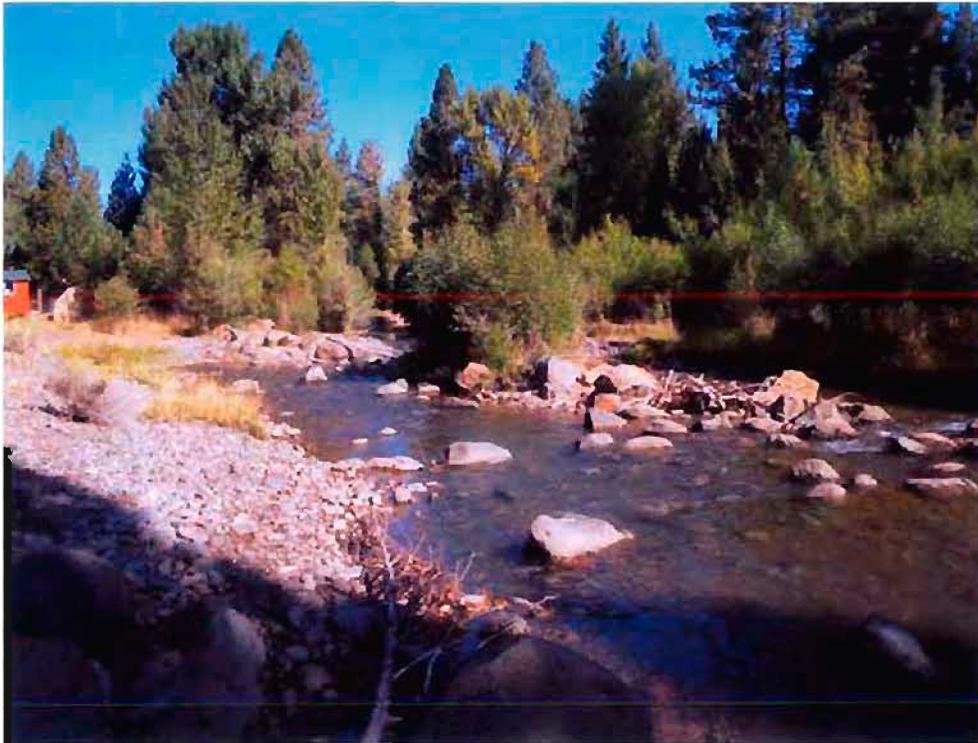
Figure 27. Upstream extent of Segment 1E. Note alder and side channel on extreme right bank with potential for low-moderate interaction. House structure is in areas of low interaction to the floodplain.

This segment is heavily engineered with riprap, prior water diversions, and rock barbs. There is a split channel with reasonably good diversity of riparian age structures; a relatively large (0.8 acre) high terrace is present on both banks. The left bank is incident with a house structure and is blocked by berms and riprap; the right bank has areas of high activity and a side channel (Figure 27). This tertiary channel has good numbers of wetland obligate sedges and rushes; younger age structure alder is plentiful in this area to provide stability, structure and nitrogen inputs.

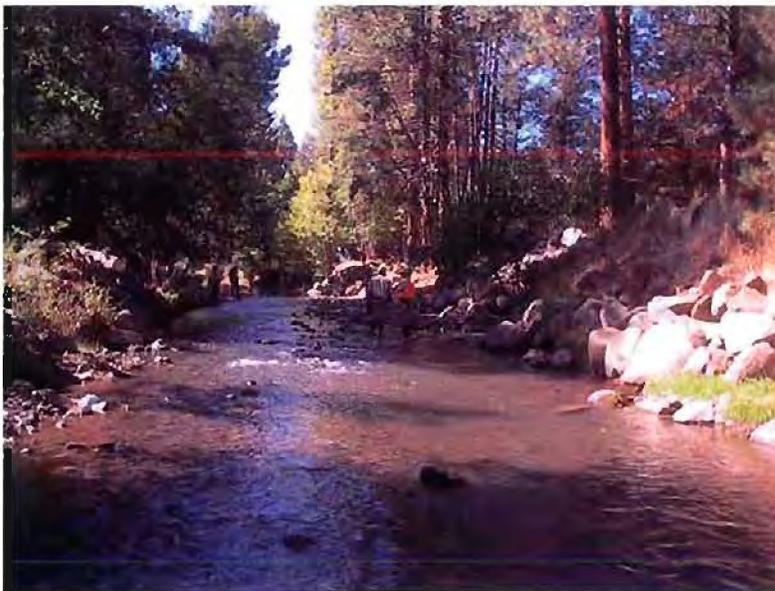
Figure 28. Typical view of Segment 1F. Note non-existent floodplains and rapid transitions to upland terraces limit width of interactive riparian zone.

This segment runs through developed neighborhoods and the active riparian zone is limited to the wetted channel (Figure 28). Additional areas have potential for interaction, though these areas are outside of the channel, separated by riprap and berms, and are situated near established homes.

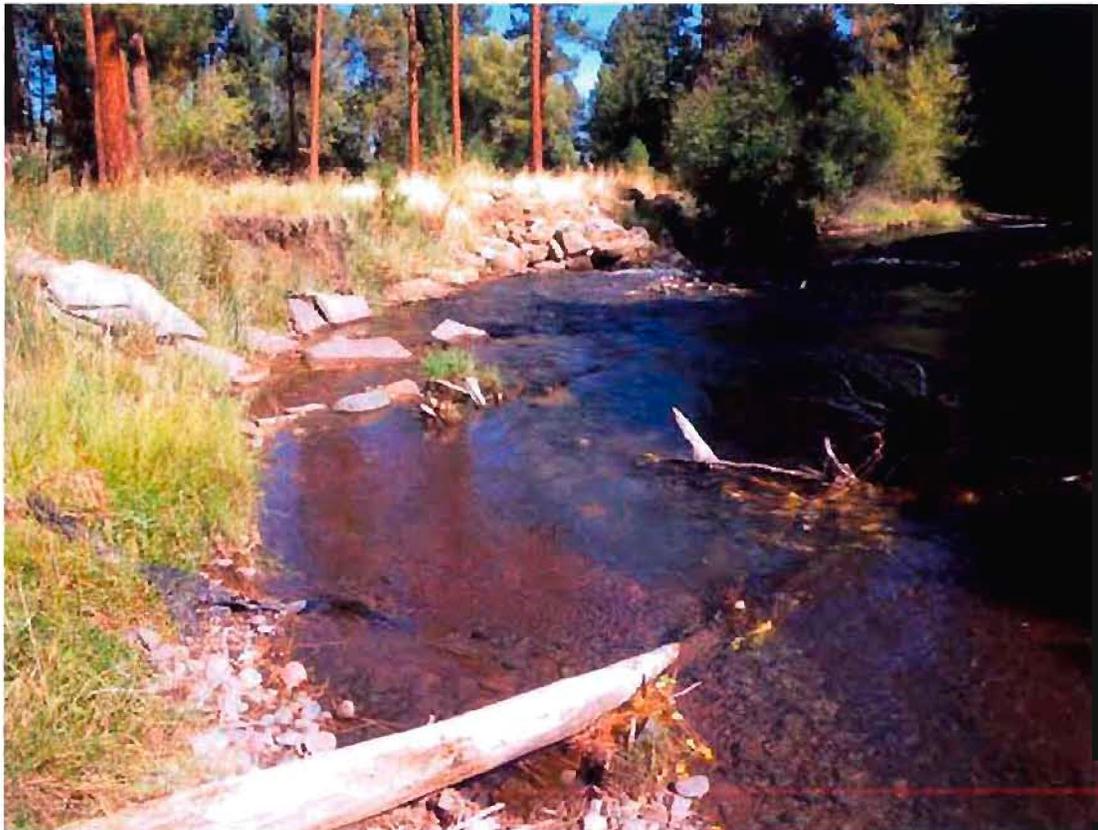
Figure 30. Riprap and berms severely limit interaction beyond the wetted channel.

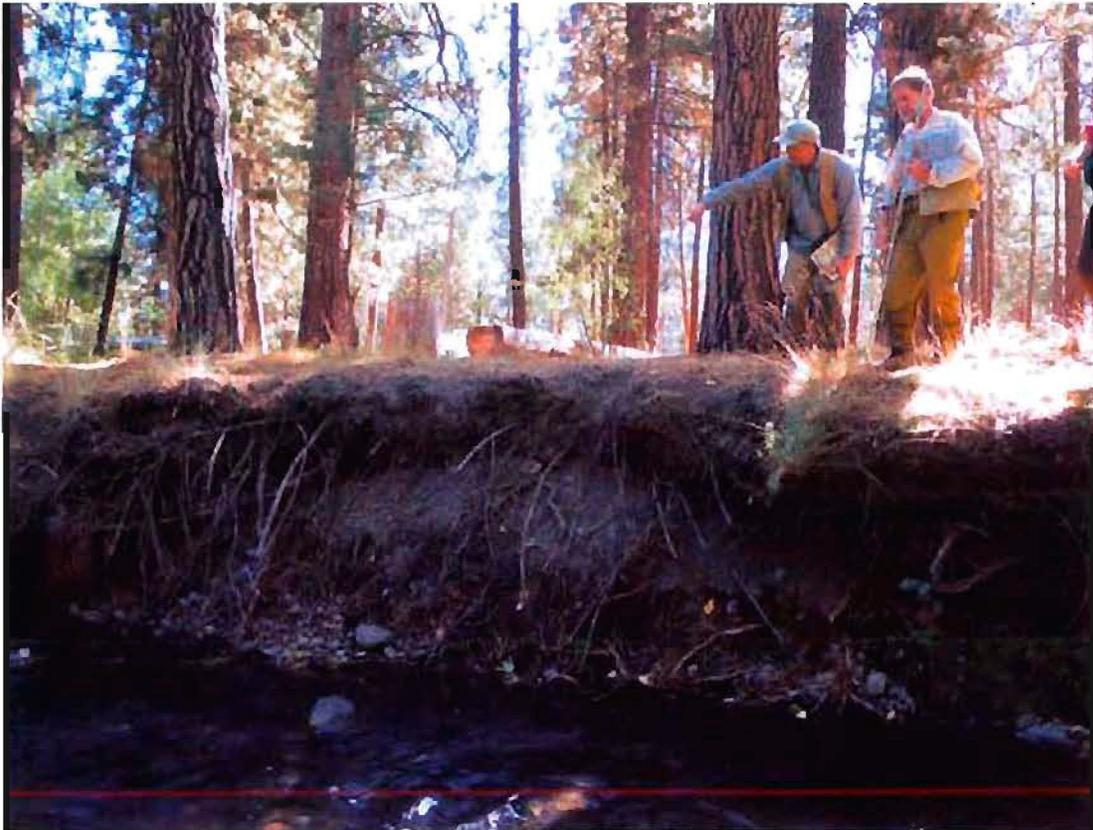
Figure 31. Area of bank instability. Plantings that also discourage people walking to stream would minimize erosion.

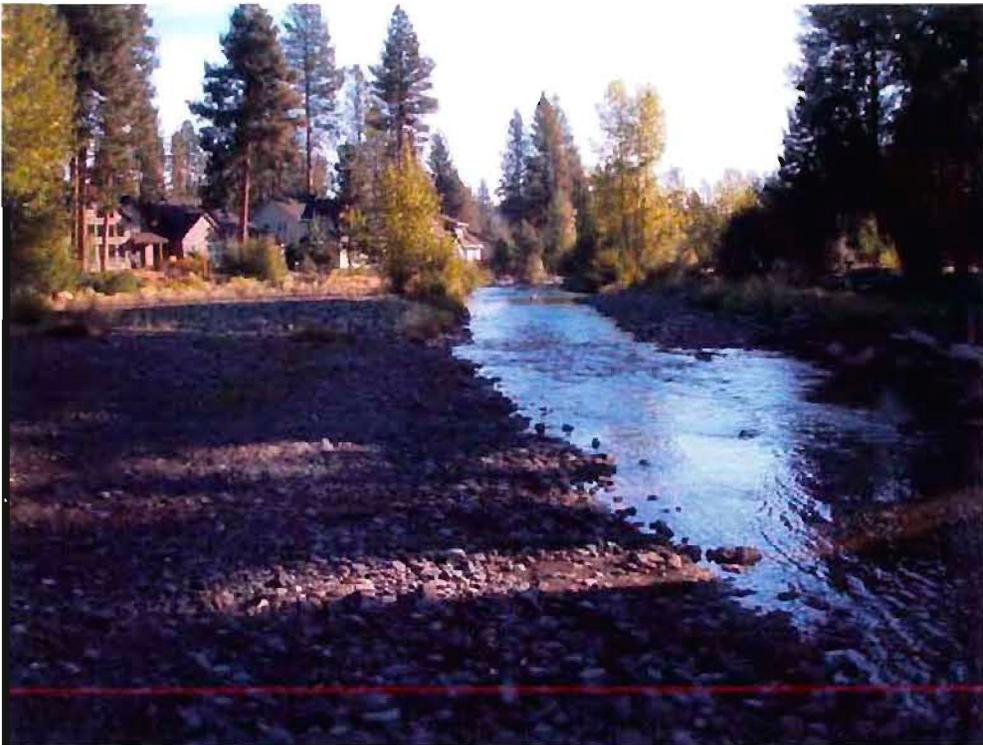
Figure 32. Typical view of Segment 2A with development constraints on both banks.

This segment is confined by riprap and other structures at a wider latitudinal spacing than in prior segments (Figure 32). The additional riparian zone “allocation” (between riprap) has allowed for a very dynamic system with large cobble bars containing various stages of riparian tree establishment. As with segments upstream of the urban growth boundary, focused flow has contributed to very high-force scour events, showing clear evidence of the scour-damage-deposition-sprout-establish sequence with cottonwoods and alders. This sequence typically forms multi-cohort stands that stabilize bars and

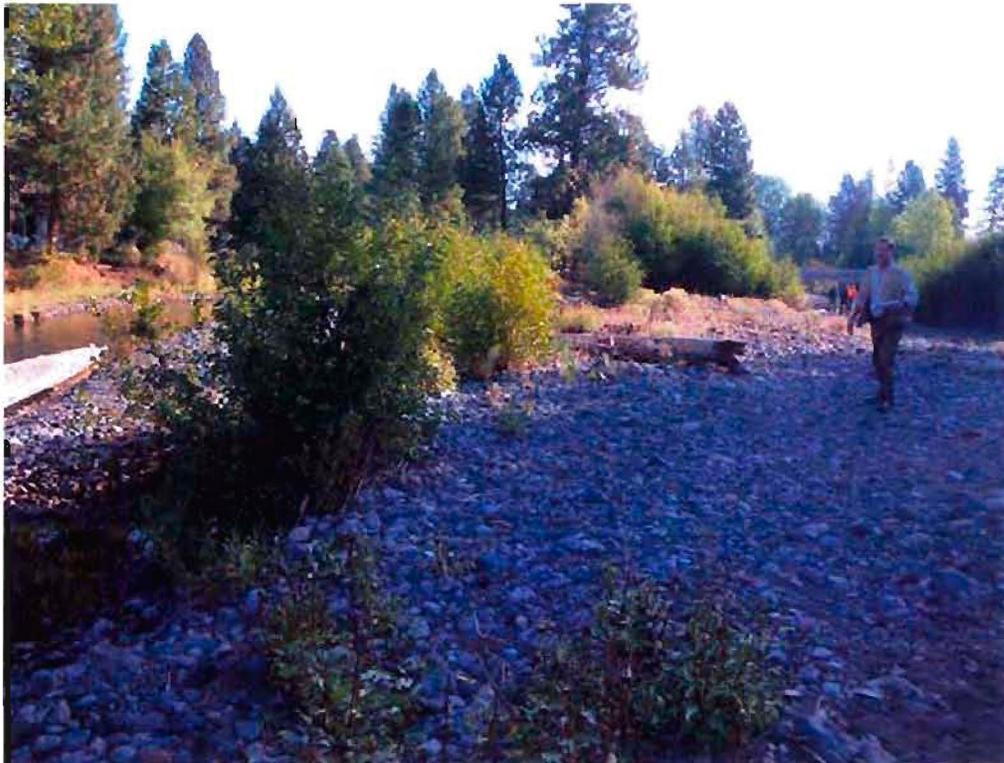
Figure 33. Example community structure in the interactive zone. This is evidence of the scour-damage-deposition-sprout/establish cycle – note cohort is biased to younger size classes in the foreground (leading edge), structures increase in size in the background (trailing edge). Stream roughness elements can slow flow and lower disturbance sizes and intensities on interactive gravel bars.

The community structure and composition is such that it appears to favor younger size classes and cohorts, indicating that stream flow may routinely exceed the "scour-damage" threshold (Figure 33). Canopy cover in the active zones reflects this, with 8% (≥ 20 ft height) and 16% (≥ 9 ft height) cover on open gravel bars. Areas of moderate interaction double in cover (16% and 33%), and low interactive areas double again in cover to 38% and 55%, respectively. Age structures in the moderate and low interaction zones could likely achieve higher cover estimates if in-stream roughness elements (LWD in particular) increased or were nominally present. Currently the roughness elements appear to be small-diameter debris flows that collect en-masse on younger cohort cottonwoods and alders. This does provide sprouting / establishment areas behind the debris flows, but evidence suggests that high-power scour events occur before full establishment can take place.

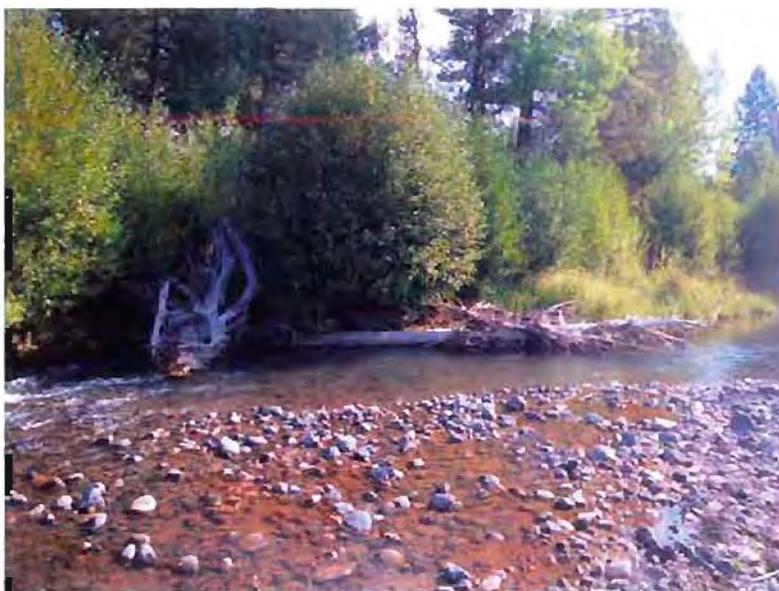
Figure 34. Wood deposited along interactive bank, building riparian sedge meadows and enhancing multi-cohort growth of hardwoods.

There was one example in this segment of how instream complexity can have a beneficial effect on riparian and stream functioning (Figure 34). This area at the very top of the segment created a small split channel and showed good floodplain development with multi-cohort hardwood structures. It should also be noted there was a significant berm that was perpendicular to this area, extending laterally to the left bank riprap. Removal of this berm would allow for additional riparian development immediately downstream.

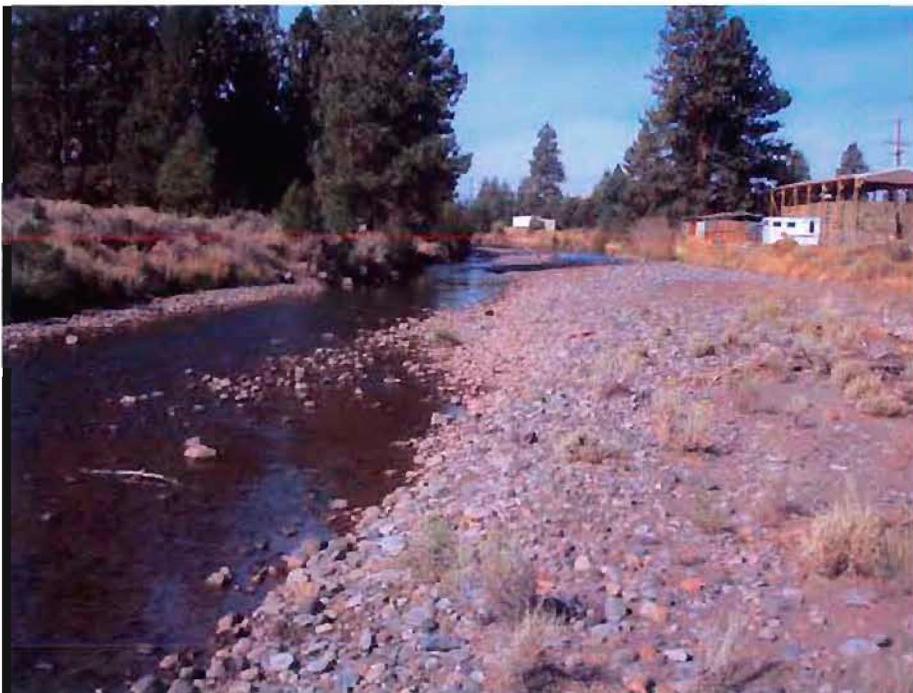
Figure 35. Typical view of segment 2B.

Aside from this feature, the majority of the segment had little vegetation or instream structure components to provide substrate for riparian development (Figure 35). The downstream extent of this segment had some minor hardwoods (willows and cottonwood) that established in riprap, as well as few areas where small pieces of wood have slowed flow and small sprouts of cottonwood and sedge patches were able to persist (several square feet in size). However, no substantial communities were present.

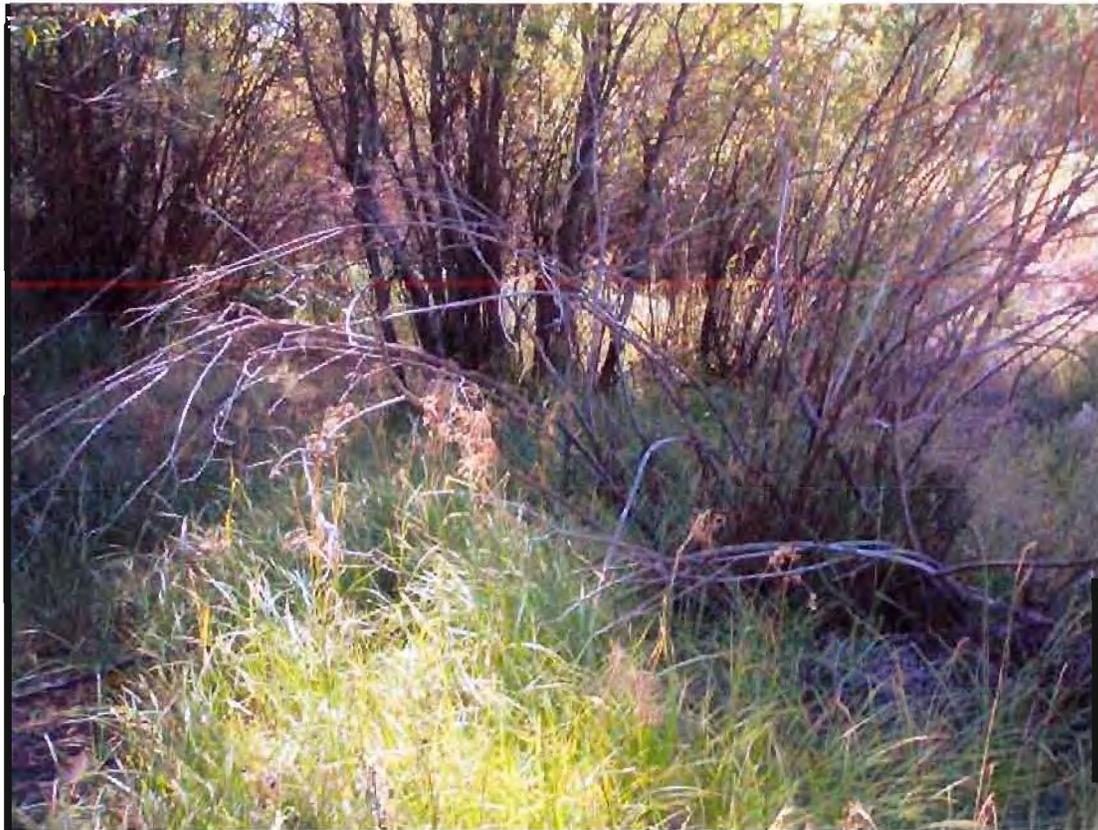
Figure 36. Example of high diversity of willows and sedges that occupy the relatively large highly interactive zone.

In marked contrast to the upstream segment (2B), this segment has high complexity, excellent cover in the interactive zones, and high levels of species diversity (Figure 36). The interactive riparian zones are all highly developed and in all stages of succession /

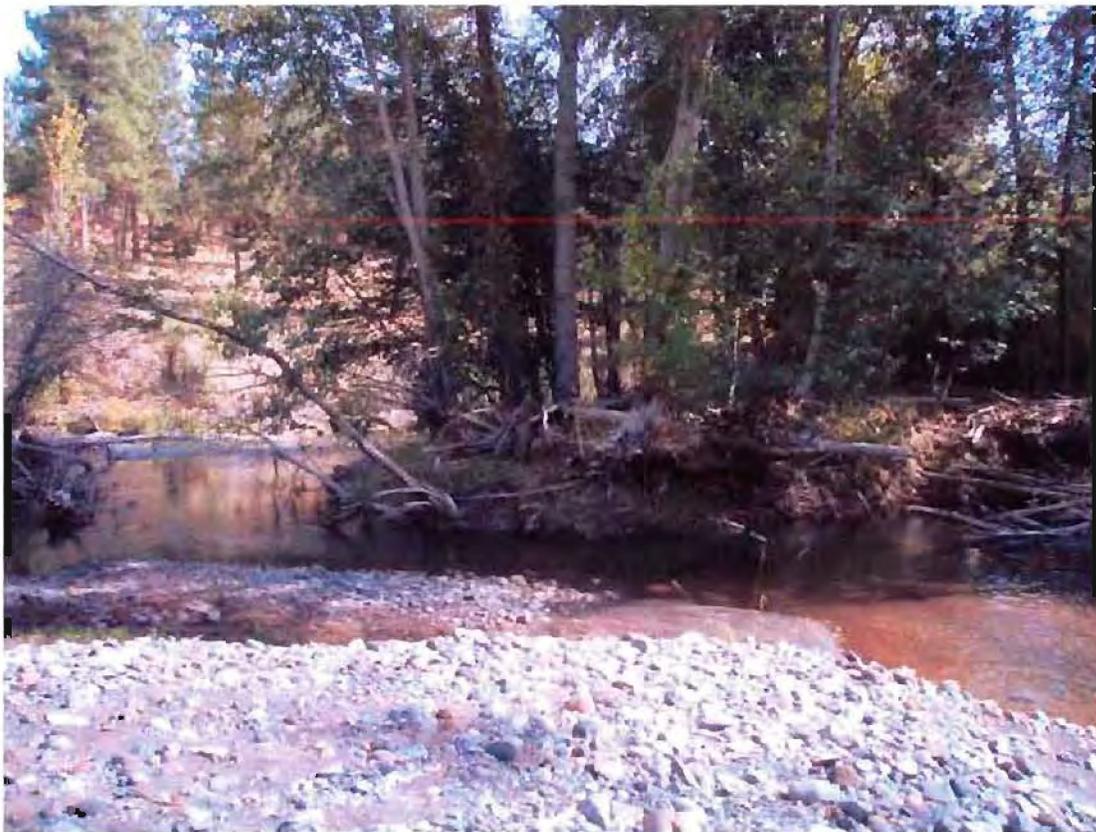
Figure 37. Upstream extent of cottonwood gallery on elevated floodplain.

This segment flows mostly west to east, with the southern aspect lined with a very tall berm and tall tree structures (Figure 37). As such, stream shading in this segment is relatively high, especially in the moderate and low interactive zones. Canopy cover ranged from 53 and 43% in these zones (respectively), though topographic shade likely had a large influence on effective shade. This contributes to excellent allochthonous inputs from hardwood sources.
