# Eugene Millrace: Headworks

## Harnessing the Willamette

## The Headworks of Today

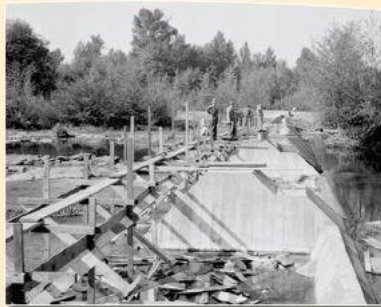
Construction of Diversion Dam.  
 Photo provided by Lane County Historical Museum

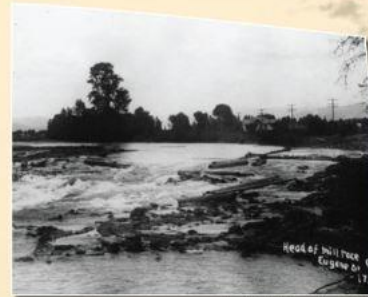
Head of Millrace (c. 1933).  
 Photo provided by Lane County Historical Museum

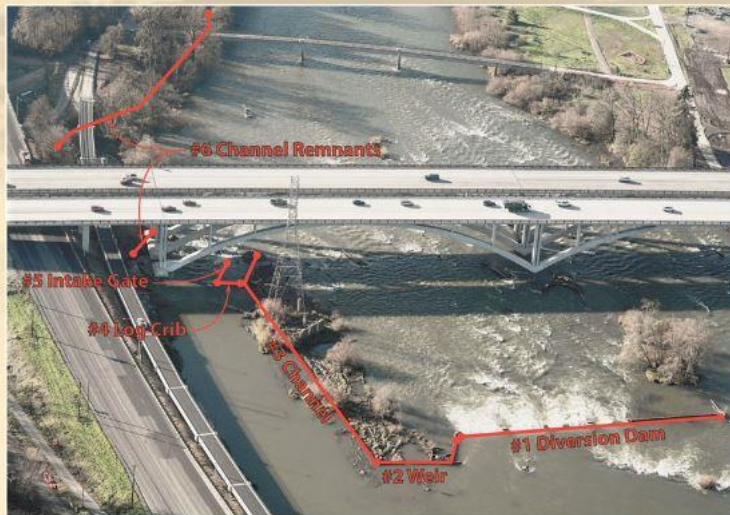
The Eugene Millrace is no longer used for industry; mechanical pumping is necessary for it to flow today. However, there are still signs of the historic gravity-fed system in existence. These artifacts are primarily seen in the Willamette River, but traces of the channel can be seen on what is now dry land. Pictured below are images of these channel remnants. Item #3 on the aerial diagram shows the approximate path of the original channel.

Aerial of Millrace and I-5 Bridge (2014). Photo provided by Oregon Department of Transportation

- #1 Diversion Dam** - The diversion dam raised the water level and conducted it toward the millrace. Construction may have occurred as early as 1891.
- #2 Weir/Intake Bay** - The weir rerouted a portion of the Willamette's flow and directed it into the head of the millrace.

- #3 Channel** - These remnant concrete walls conveyed the water toward the primary channel of the millrace. Historical photographs indicate that this system created a fairly uniform 100-foot-wide channel.

- #4 Log Crib** - This section likely functioned as a removal area for log rafts. These rafts were massive bundles of lumber, lashed together with large chains, to be floated down the river. This method was used to economically transport millions of board feet of lumber down the Willamette River.

- #5 Intake Gate** - This angled concrete wall constricted water and directed its strengthened flow into the millrace channel.
- #6 Channel Remnants** - These concrete wall sections likely relate to the 1910 channel improvements. Floating debris from high floodwaters clogged the millrace intake in 1942, preventing continued flow and temporarily drying out the channel. Businesses along the millrace had converted to electricity by this time and it was left to deteriorate until the City of Eugene purchased the land in 1949.
