EFFECTS OF ENGINEERED LOG JAMS ON CHANNEL MORPHOLOGY,
MIDDLE FORK OF THE JOHN DAY RIVER, OREGON

A THESIS

Presented to the Department of Geography
and the Graduate School of the University of Oregon
in partial fulfillment of the requirements
for the degree of
Master of Science

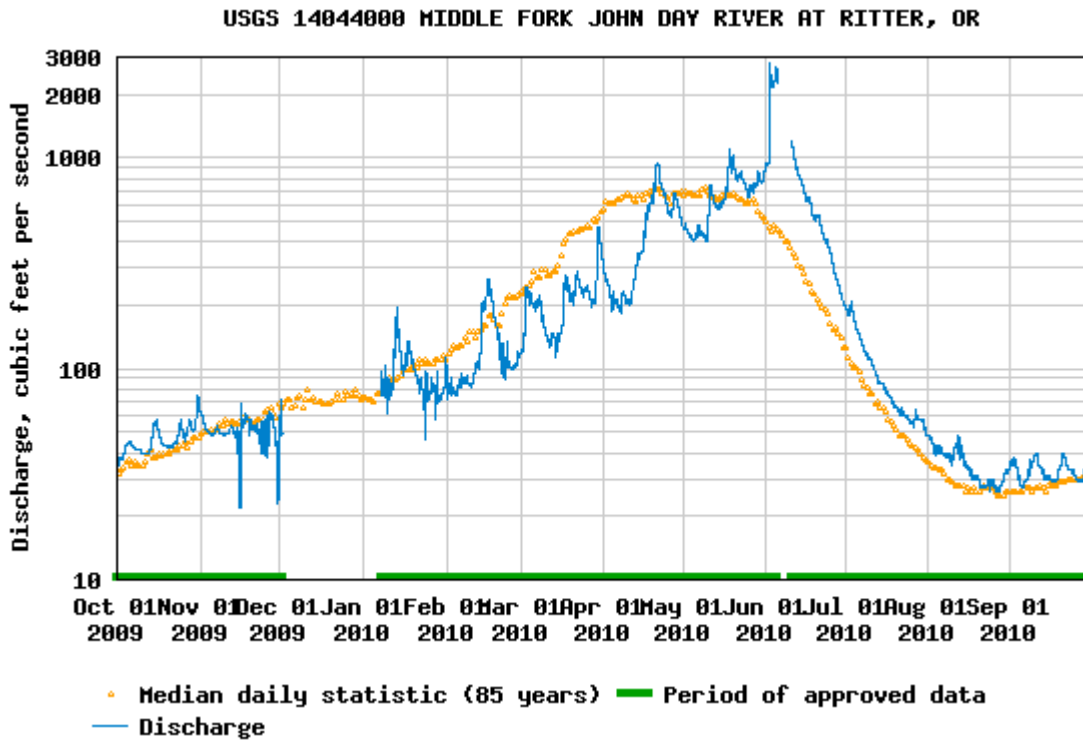
Figure 2: Hydrograph of the 2010 water year at the Ritter gauging station. The yellow line represents the average daily flow. Most recent water years, including 2010 (which has the smallest gap), have missing water data in the winter. Source: waterdata.usgs.gov

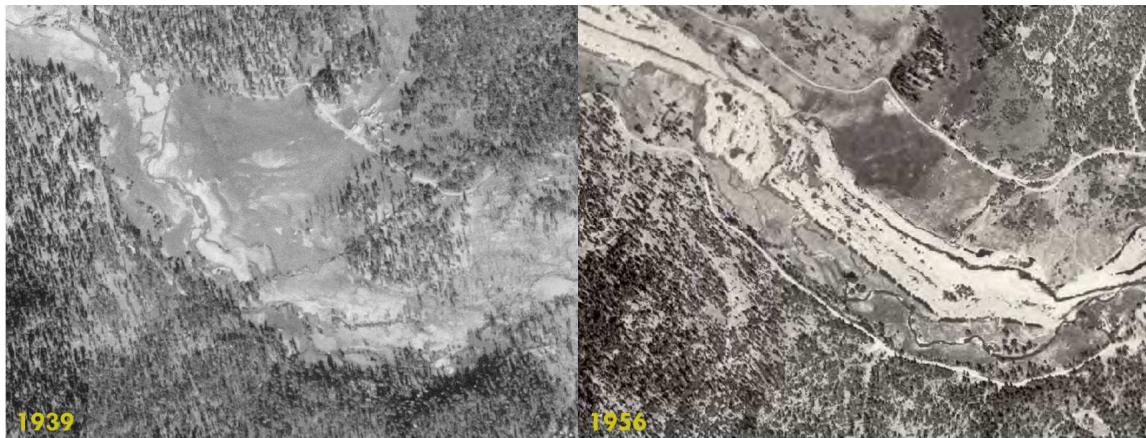
Figure 3: River channel pre and post dredge mining. In 1939 the channel meanders along the southern part of the floodplain. After dredge mining (1956) the channel is left abandoned and the channel runs straight alongside the tailing piles, which are the white areas. Source: Bureau of Reclamation 2008a.

The most visible and direct of all the human alterations in the valley was gold mining. This started in 1860s with instream placer mining and bank and terrace hydraulic mining. These forms of mining directly disturb the channel bed and sediment supply. Fines are exposed and washed away and natural banks and floodplain surfaces are disturbed. From 1933 to 1942 a several segments of the river was dredge mined (Figure 3). This devastated the channel and floodplain.

The dredge moved through the valley, digging up wide swaths of the channel and surrounding floodplain, while processing the sediment for gold. It then dumped the unwanted sediment in tailings piles on the side of a now straight, narrow, deep channel that was no longer able to laterally or vertically migrate because it was not competent enough to move the coarse sediment that was dug up from deep in the floodplain. The river was left channelized and disconnected from its floodplain and alluvial fans.

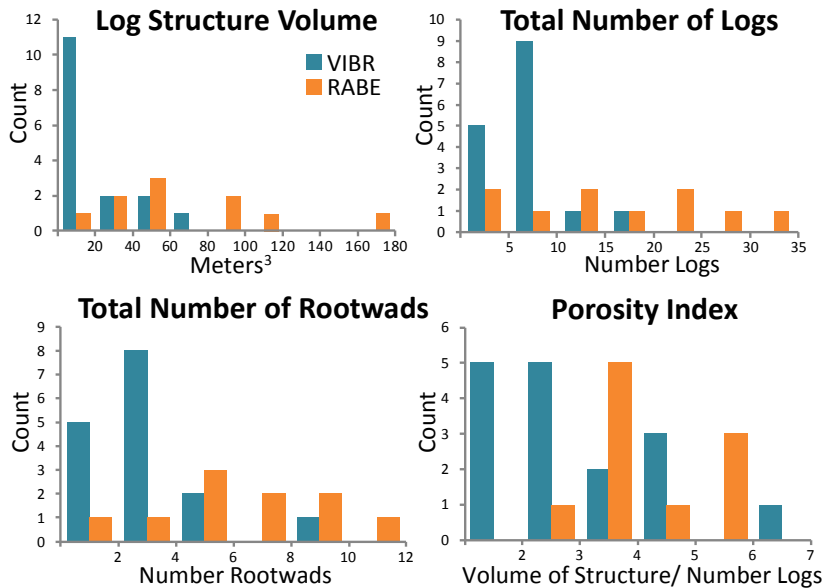
Figure 6: Log structure composition. Histograms for log structure volume, total number of logs in the structures, total number of rootwads, and the porosity index (volume of structure/number of logs).

volumes than VIBR on average, they are slightly more porous on average than VIBR structures. When the volume of log structures are normalized by the reach average bankfull widths, the volume of log structures are still on average larger in RABE.

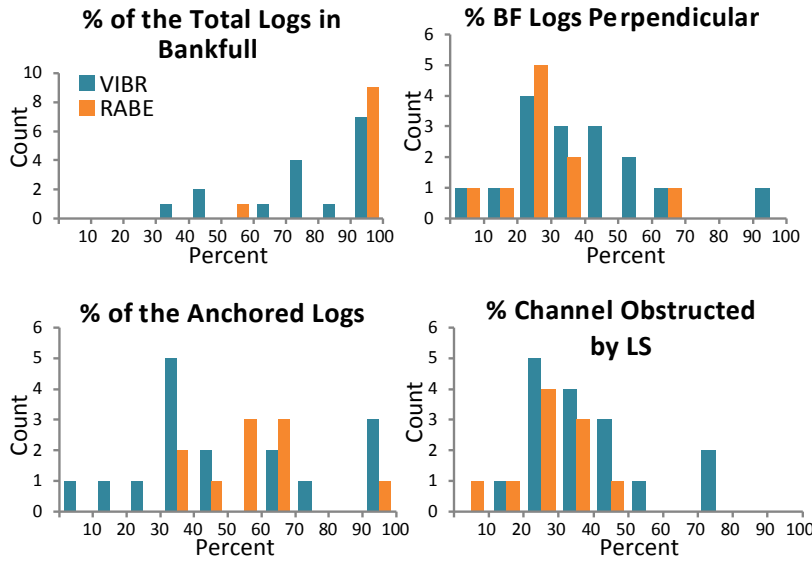
Figure 7: Log structure composition by percent. Histograms for percent total logs in bankfull, the percent bankfull logs that are perpendicular to flow, percent anchored logs and the percent of channel obstructed by the log structure.

Figure 7 and table 4 show that on average, the structures in RABE have a higher percent of logs within the defined active channel width, or bankfull, and a smaller percent of anchored logs than VIBR. The VIBR structures have a higher percentage of perpendicular bankfull logs than RABE.

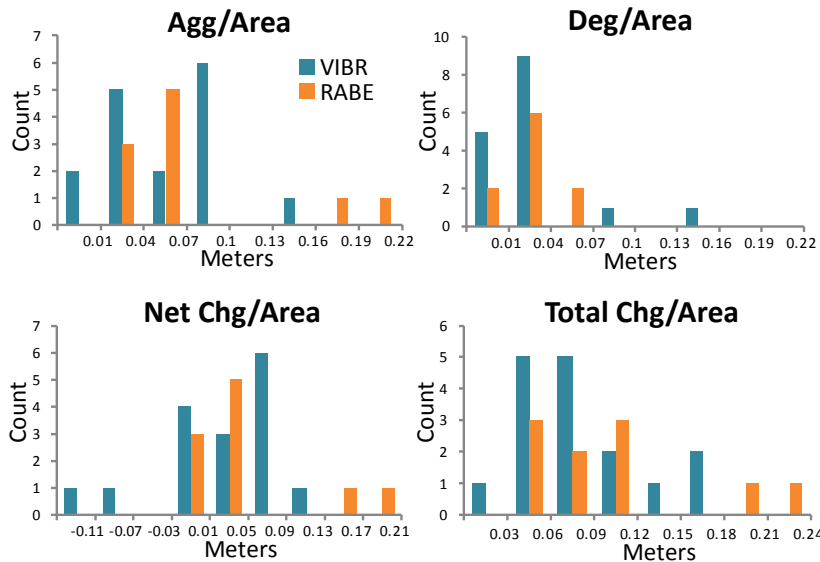
Figure 9: Sediment response around log structures. Histograms for both VIBR and RABE for aggradation per survey area (Agg/Area), volume of degradation per survey area (Deg/Area), net volume of change per survey area (Net Chg/Area), and total volume of change per survey area (Total Chg/Area). All have units of meters.

The variables collected from the DoDs show differences between the two reaches as well. Overall there was more aggradation per area than there was degradation per area (Table 4). This is also shown in figure 9, the average values for the net change for the reaches, which are positive for both, showing more aggradation overall. VIBR has less aggradation and slightly more degradation than RABE. Total change per area shows that on average there was a higher volume of sediment moved per survey area in RABE than in VIBR.

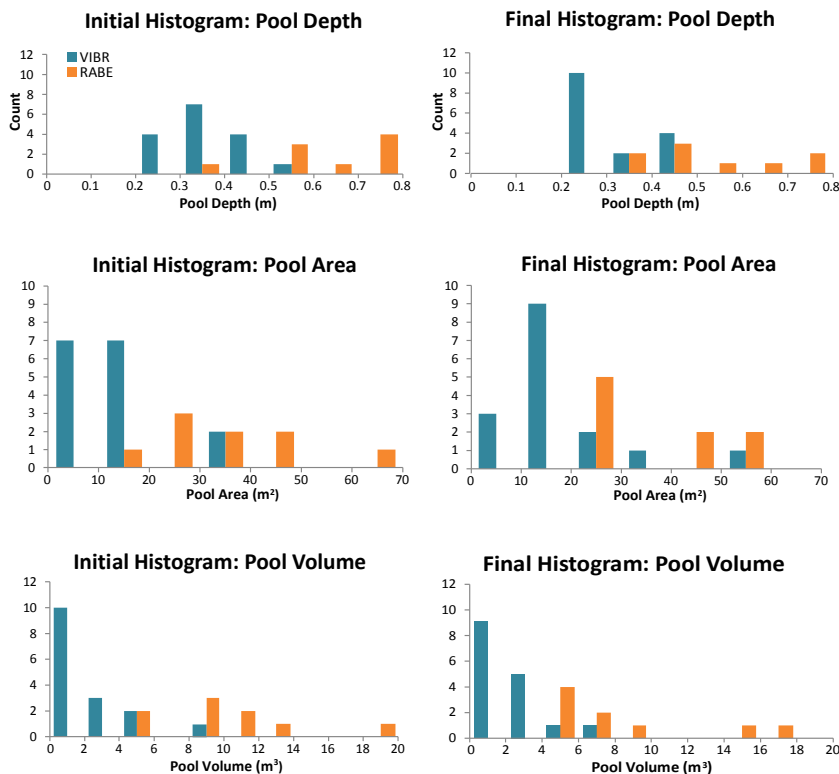
Figure 12: Histograms for the initial and final values of pool depth, pool area, and pool volume for each pool in each reach.

Histograms of the initial and final values of the different pool characteristics demonstrate the initial and final differences in values by reach (Figure 12). Pool depths in VIBR were initially shallower than in RABE. The histograms for pool area show that pools were initially smaller in VIBR, but they are expanding more than RABE pools. Pool volume distributions do not change as much as the others, but pool volumes do appear to be increasing some in VIBR and decreasing in RABE.

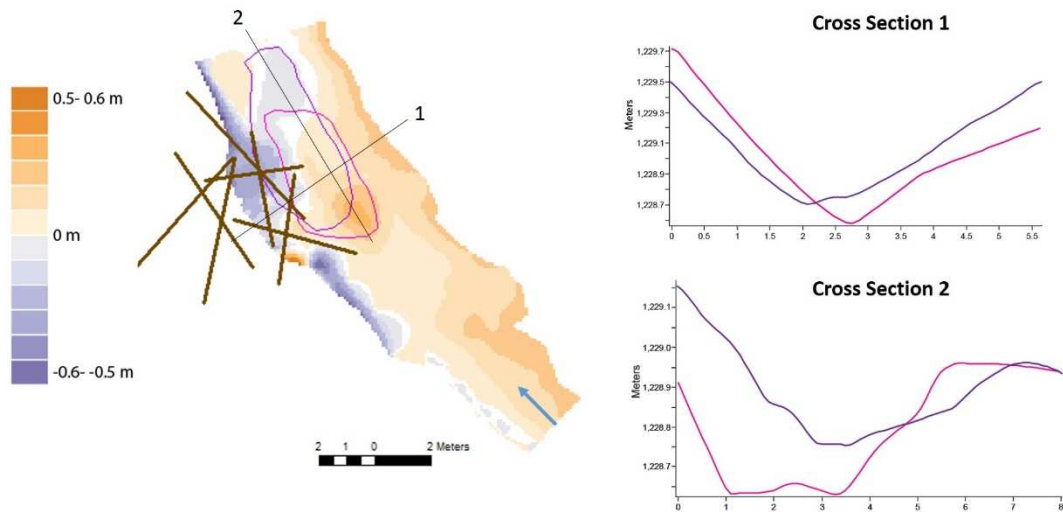
Figure 20: Pool cross sections at VIBR 2. DoD for VIBR 2 from 2008 to 2014, the pool area for 2008 is outlined in pink and the pool area for 2014 is outlined in purple. Cross section 1 is from left bank to right bank and cross section 2 is from upstream to downstream. Both cross sections show the 2008 pool in pink and the 2014 pool in purple.

expanding in the downstream direction, creating more natural shaped pools with long tails in the downstream direction and curved pool bottoms (Figure 20). Pool volumes only decreased 11% overall, even with the consistent decreases in residual pool depths. Most of the pools are now adjacent to or extend slightly downstream of the structures. This contradicts Brooks et al. (2004) findings that pools formed upstream of the log structures in their restoration site.

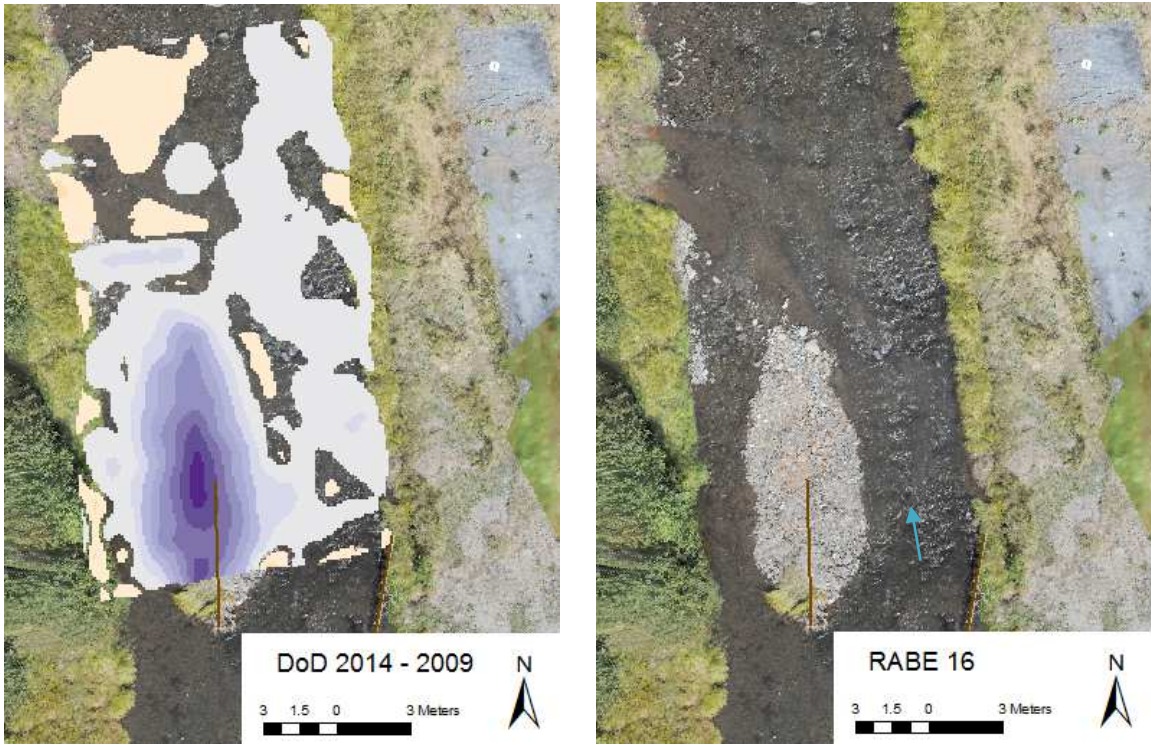
Change in Meters

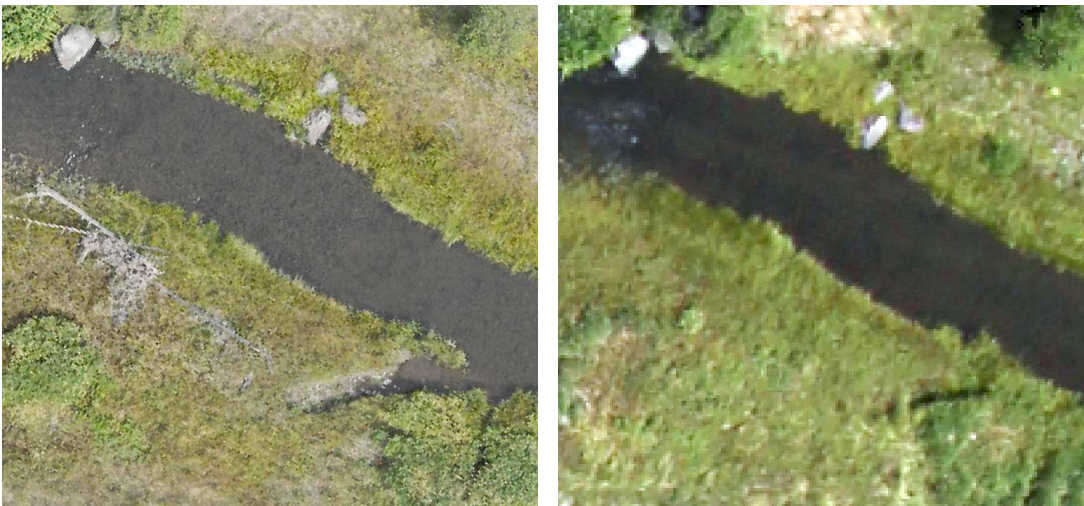
Aerial photos of **VIBR log structure 10**. Photo from 2009 is on the left and 2013 is on the right. This log structure was completely washed away and the alcove has been filled.

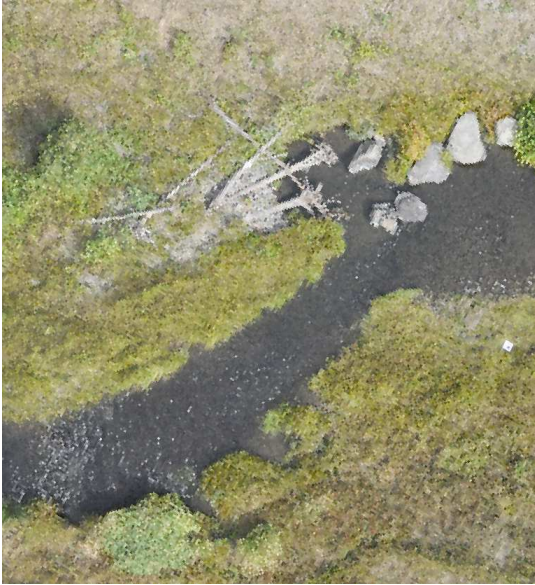
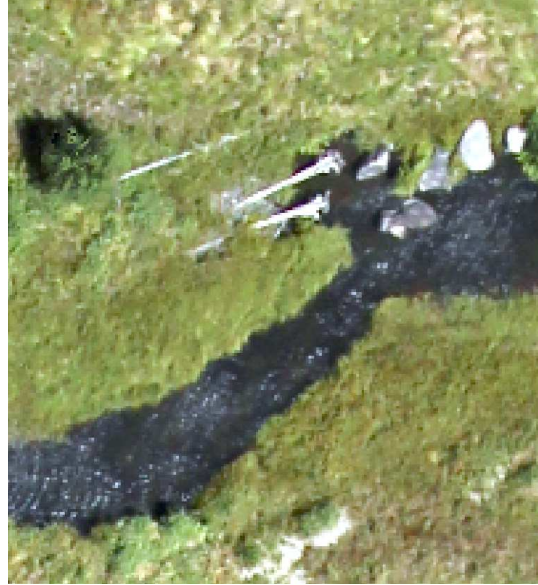
Aerial photos of **VIBR log structure 11**. Photo from 2009 is on the left and 2013 is on the right. This minor changes to the structure are the removal of several logs from within the structure and on the bank.

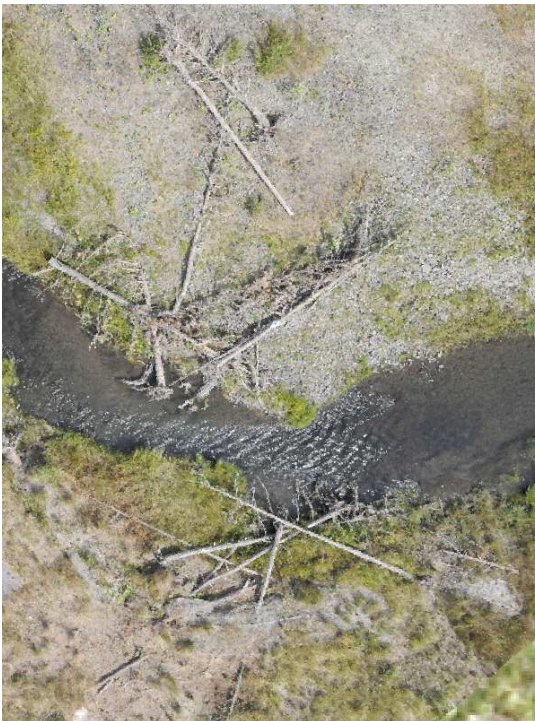
Aerial photos of **VIBR log structure 16**. Photo from 2009 is on the left and 2013 is on the right. The minor changes to the structure include the removal of several loose bar top logs.

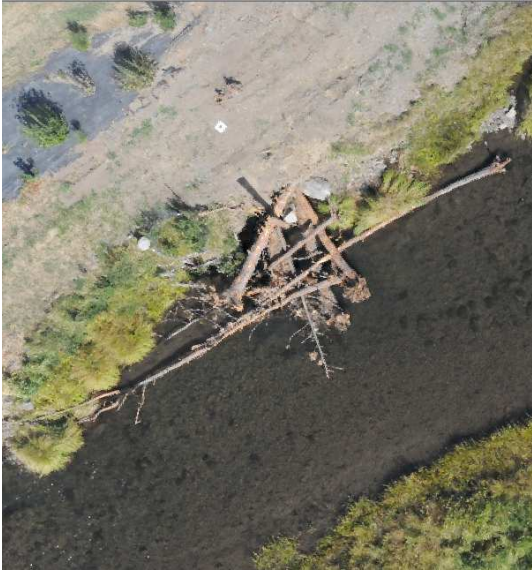
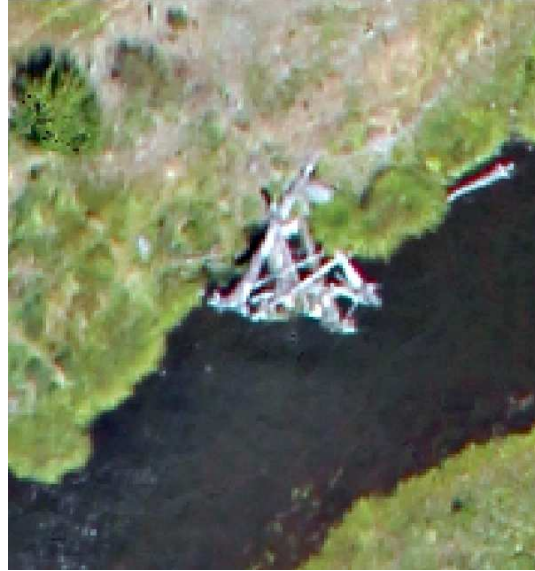
Aerial photos of **RABE log structure 8**. Photo from 2009 is on the left and 2013 is on the right. The minor change to the structure was the removal of one loose log in the structure.

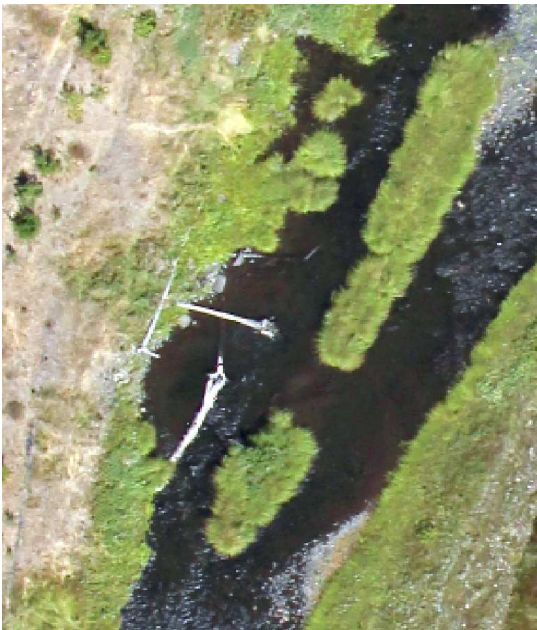
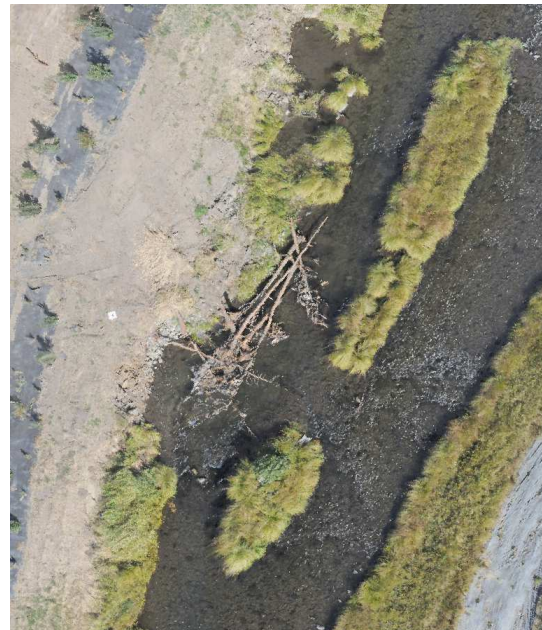
Aerial photos of **RABE log structure 10**. Photo from 2009 is on the left and 2013 is on the right. The major changes to the structure include the removal and addition of many logs along with the complete rearrangement of the existing logs.

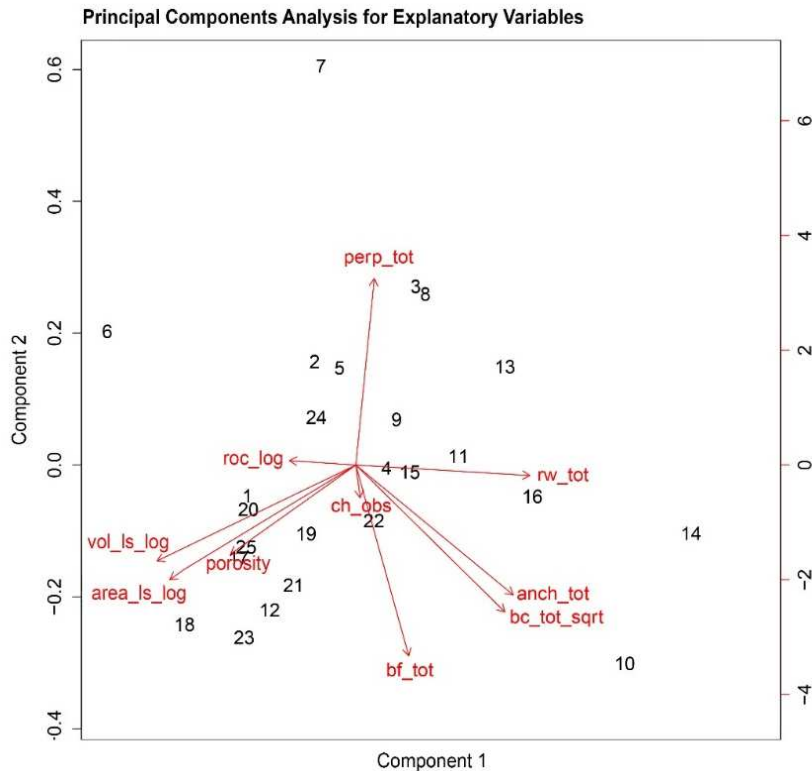
PCA biplot showing the loadings of the explanatory variables (red arrows show direction and length of arrow shows relative loadings). The plotted numbers display how each observation relates to component one and two. Variable descriptions are shown in Table 3 in the text
