# a past arrive<sup>yet to</sup>

"hindsights" from flood-resilient, culturally-significant built features  
for cultural landscape climate change practices in the National Park Service

submitted in partial fulfillment for the Master of Landscape Architecture,  
Department of Landscape Architecture, University of Oregon, on June 15, 2018

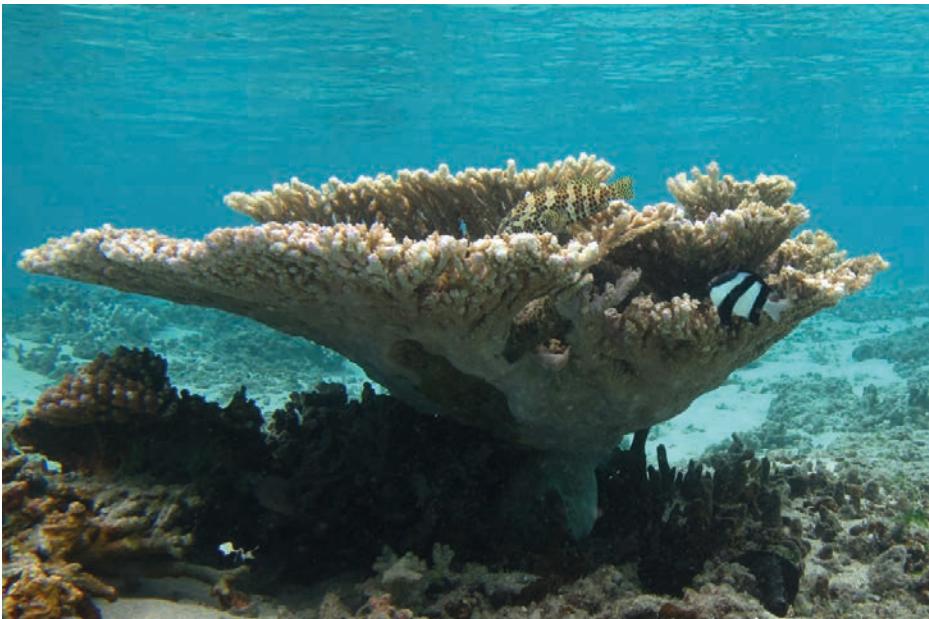
**Figure 1.4** The table coral *Acropora hyacinthus* demonstrates a heritable capacity to adapt to changing temperatures especially when allowed to acclimate prior to sudden changes.

An example of adaptive capacity at work can be seen in a species of table coral known as *Acropora hyacinthus* (Figure 1.4). Corals are known for their sensitivity to oceanic temperature changes—higher temperatures can cause the corals to jettison their symbiotic algae, a process known as bleaching—which often leads to the death of the coral. Corals generally require shallow, moderately warm water to survive due to their symbiont's' specific requirements. However, a 2014 study by Palumbi et al. revealed that *A. hyacinthus* can live in both cool and warm pools. When exposed to higher water temperatures, about half of the exposed cool pool corals bleached whereas only 20 percent of the warm pool corals suffered the same fate. Additionally, cool pool corals that spent one year in a warm pool prior to being tested demonstrated a higher resistance to increased

Thus, the presence of a heritable AC reduced the populations' overall vulnerability to temperature change by decreasing the populations' future sensitivity. It did not alleviate the coral's exposure to temperature changes since the species is already found in a variety of micro-climates and is immobile. An example of AC ameliorating exposure can be found in national park boreal conifer forest communities, which are shifting toward present-day tundras and away from warmer, southern climates (Gonzalez 2017). In these examples, AC ameliorates exposure and sensitivity (Figure 1.5), demonstrating its critical role in mobilizing scarce resources within a natural resource system in response to environmental stressors (Engle 2011). This highlights the

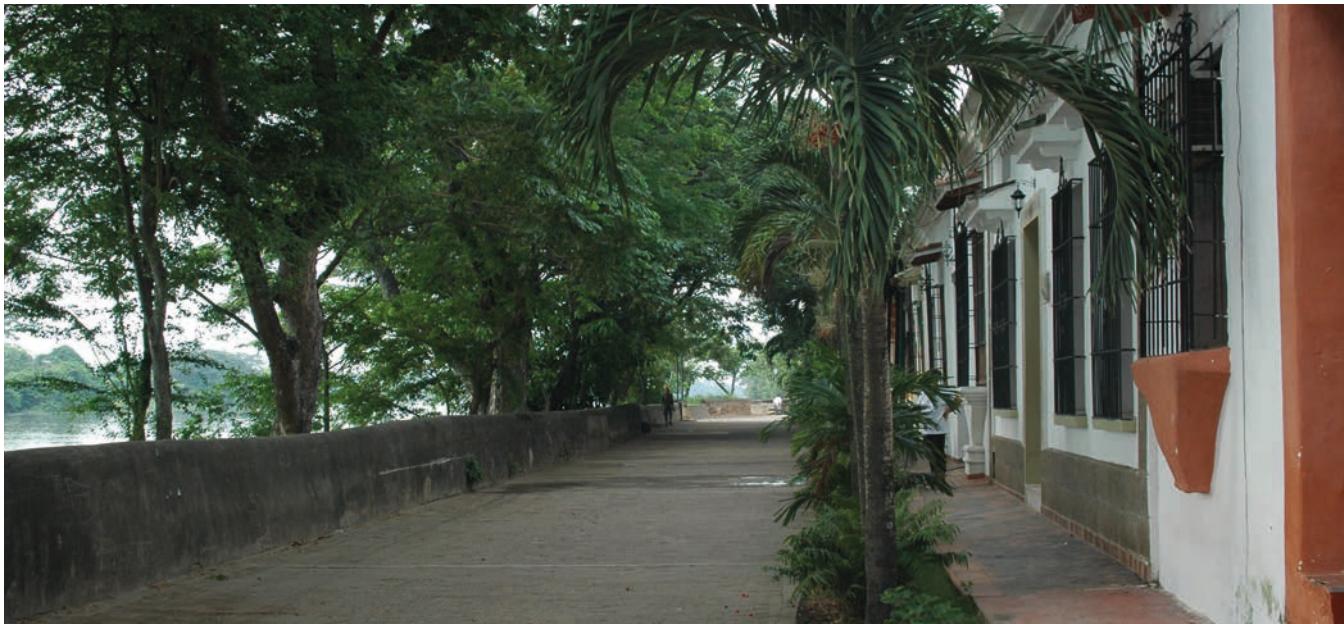
**Figure 3.4** a view of Albarrada del Alba, one of the main streets with a visible barricade (image source: Wikimedia Commons)

What makes the city center unique as a Spanish colonial settlement is its pattern of development with respect to the Magdalena River (Figure 3.3). The main street of the center was built upon a dyke that defines the west bank of the river and the eastern edge of the center. Barricade walls, or *albarradas*, were built upon this dyke to provide additional protection from floods (Figure 3.4). The city center thus expanded linearly rather than

(Figure 3.4) while in other places the dyke shows a continued use of brick masonry right up to the water's edge (Figure 3.7).

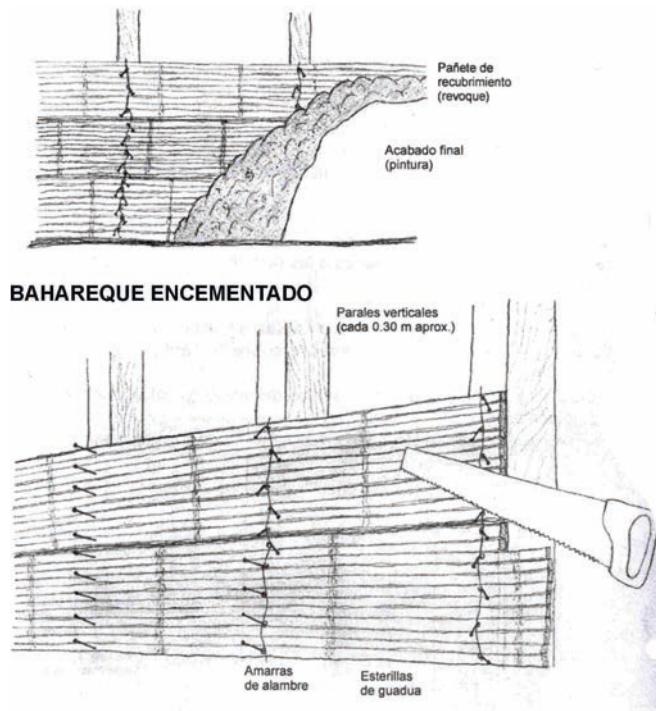
**Figure 3.5** (left) diagram of wall construction using the tapía pisada technique atop a masonry foundation (source: Bustamante et al. 2014)

**Figure 3.6** (right) diagram of wall construction using the indigenous bajareque technique (source: Bustamante et al. 2014)

The architectural craftsmanship found in Nueva Granada combines imported techniques, *tapía pisada* (rammed earth and masonry), and local, indigenous techniques, *bajareque*. Imported techniques used brick, rounded and ashlar stones, or a mixture of the two in combination with modified mud and plaster (Figure 3.5) Bajareque, on the other hand, represents a conglomerate of pleated cane and liana vines that are plastered together with mud (Figure 3.6). Spanish colonists

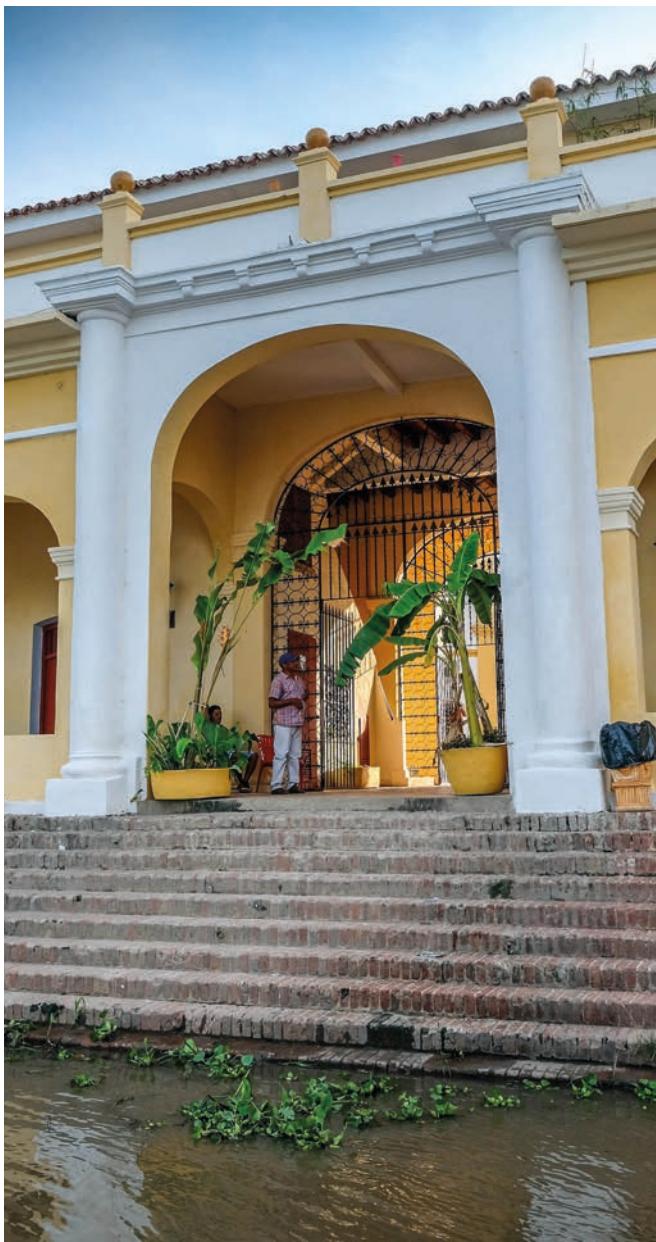
**Figure 3.7** a view of the Plaza del Mercado building as approached from the river shows brick masonry steps to the water's edge (image source: sergejf, Flickr)

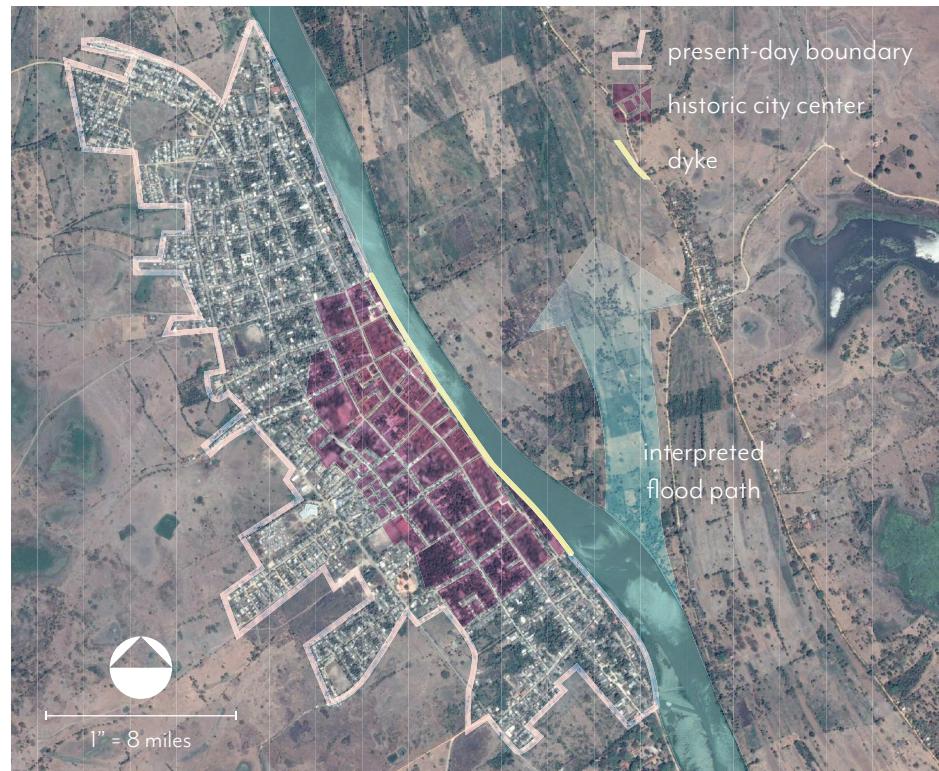
**Figure 3.8** plan view of the city center in relation to the present-day city boundary and adjacent floodplains and wetlands

judging by the persisting integrity of the original structures. It should be noted, however, that flood breaches may still have occurred. The albarradas are physically discontinuous in order to provide direct access to the river which is especially common near plazas, suggesting that water levels could easily breach the dyke through the gaps. A study of the site in relation to its context reveals that although the city is built right on the water's edge, subsequent urban development remained rather dense (Figure 3.8). Judging by the proliferation of swamps and marshes immediately

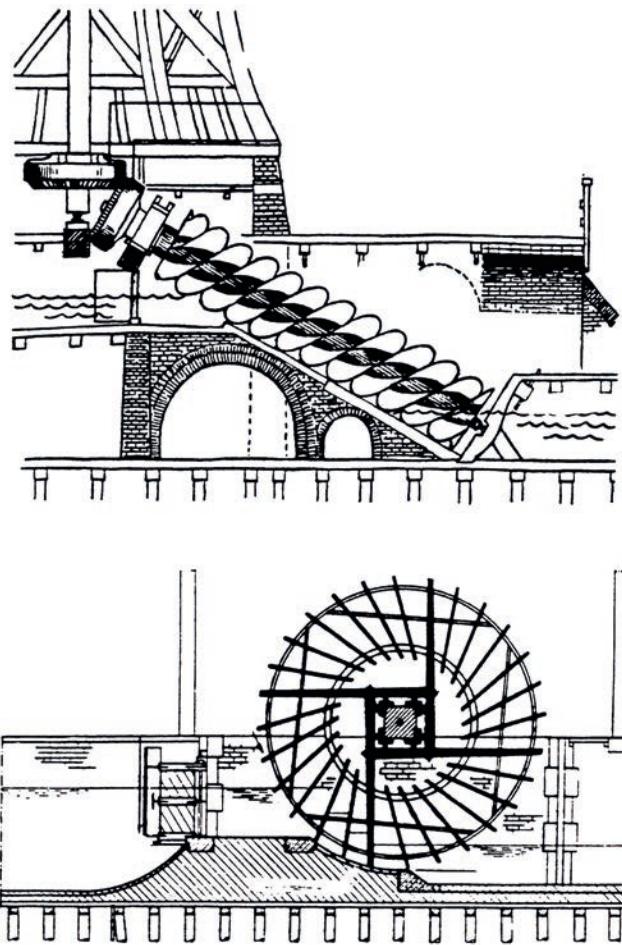
**Figure 3.10** the archimedean screw pump (top) which replaced the traditional paddle, or scoop, wheel (bottom) (image source: Stokhuyzen 1963).

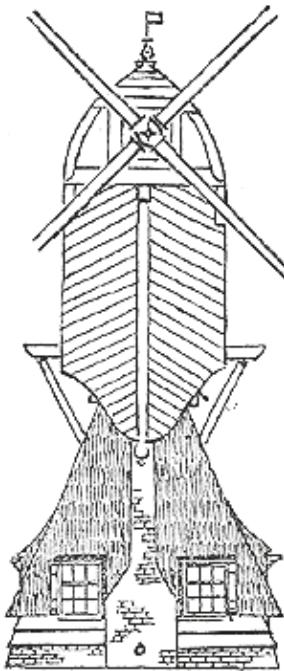
**Figure 3.11** (above) elevation side and front view of a wipmolen, or hollow-post mill (image source: Stokhuyzen 1963)

representative of the most common styles found in South Holland. The hollow post mill, or *wip* mill, is one of the oldest drainage mill designs and was derived from the post mill (Figure 3.11). Made primarily of wood, the defining mechanisms consist of an upright shaft inside a hollow support

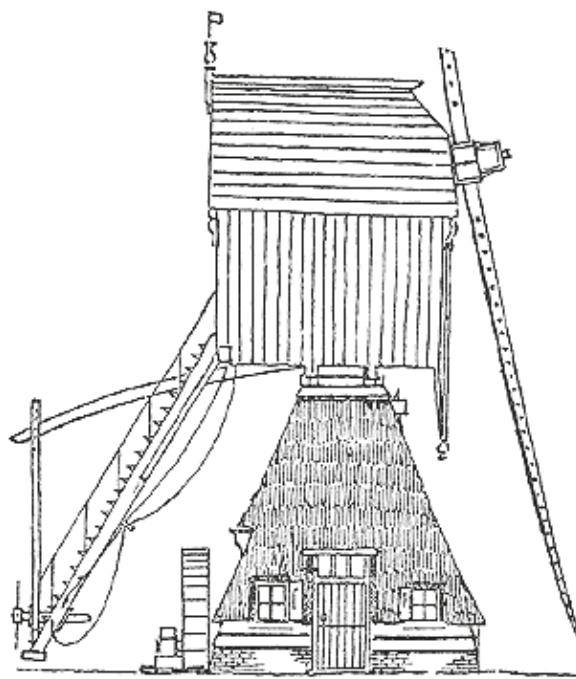
**Figure 3.12** (right) section elevation of an octagonal smock mill with a scoop wheel (image source: Stokhuyzen 1963)

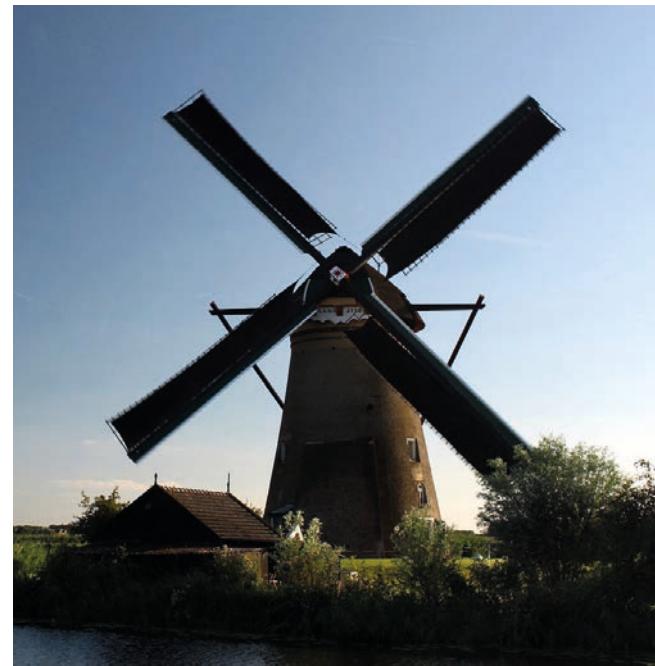
**Figure 3.13** a brick grondzeiler, or ground-sailor, at Kinderdijk (image source: pixabay)

exterior lines help to reduce the wind resistance of the descending blades of the sail. The last style represented at Kinderdijk are the brick ground-sailors, or grondzeiler (Figure 3.13). Because winds are stronger in the flat fields and polders, there is little need for elevated bases to lift the blades into the air. This style is derived from the stellingmolen, or tower mill, and where height isn't necessary, the towers were shorter and more commonly used as industrial mills or corn mills. However, at Kinderdijk, all of the mills are technically grondzeilers (with the exception of the hollow post

mill) because their blades nearly touch the ground. The only difference amongst the 18 large windmills is that the round grondzeilers are made of brick and the smock mills are thatch with brick foundations (Stokhuyzen 1963).

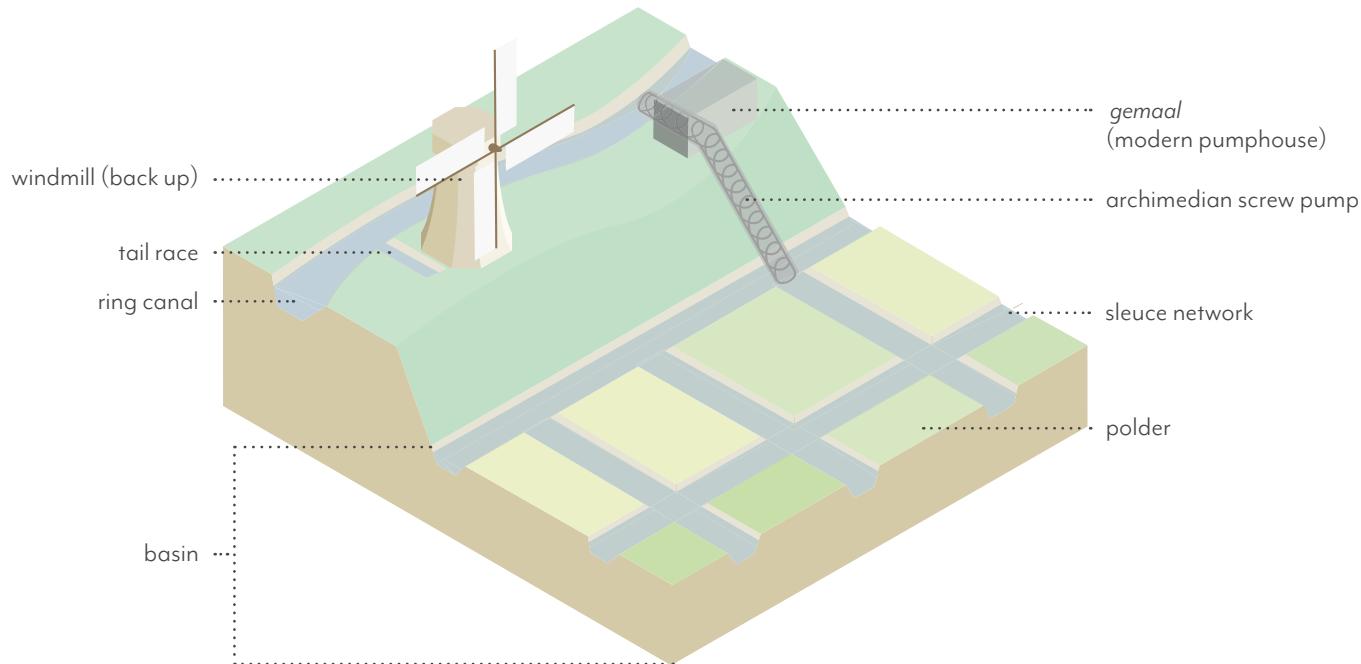
**Figure 3.15** diagram of the windmill-polder system and its constituent landscape features as they remain today

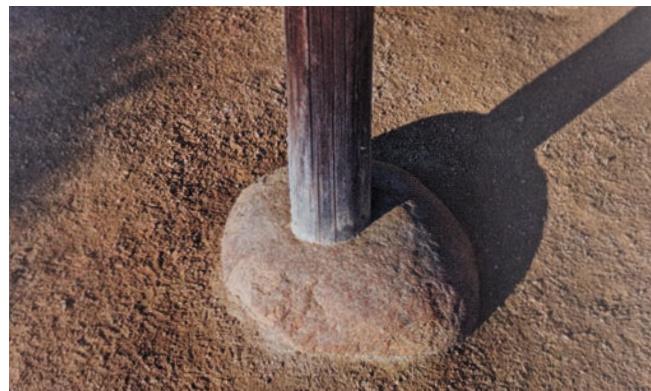
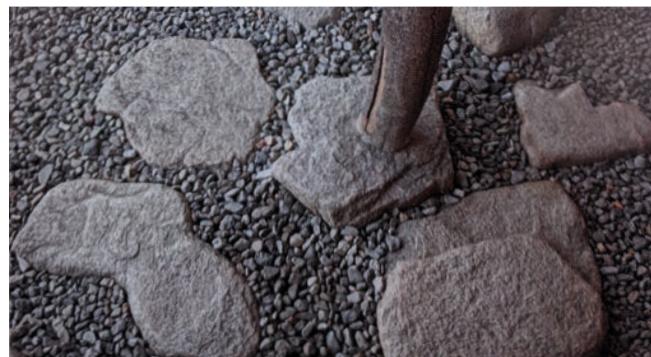
**Figure 3.17** examples of sukiya-style foundation piers showing variations in base stone shapes and sizes (image source: Locher 2010)

The *shoin-zukuri* style evolved from the original Japanese floor plan in which 2 partitions were created to separate indoor work from sleeping. Over time, more partitions with various heights, or ranking, were added as Japanese homes evolved along with accumulating wealth. The *shoin-zukuri* style is further characterized by wooden or paper covered doors along the exterior hallway, or *engawa*, a deep eave in front, and an elevated foundation (Ishimoto and Tange 1972). It was common for foundation footings, or piers, to be set upon carved or rough base stones, depending on the formality of the structure (Figure 3.17; Locher

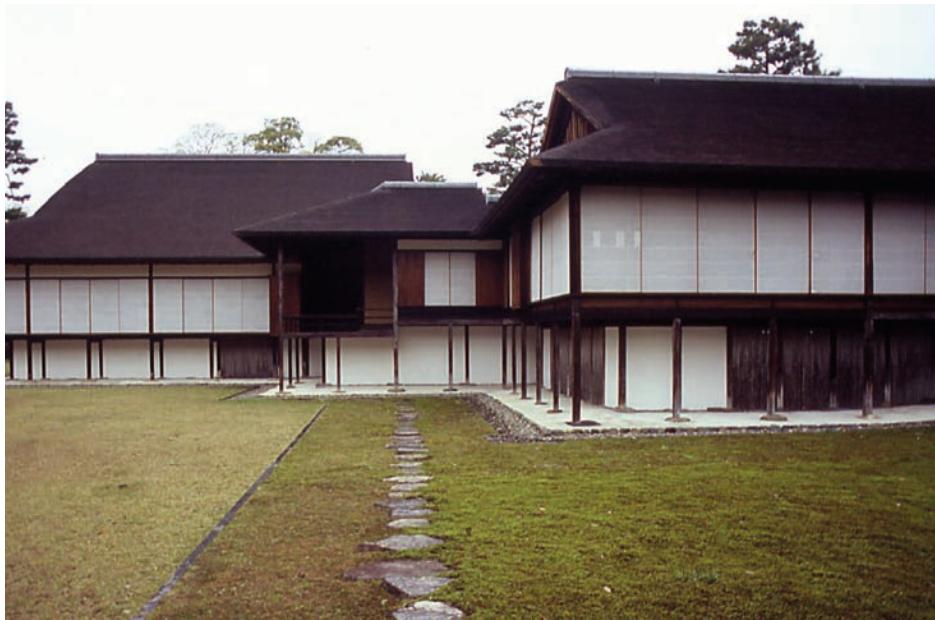
**Figure 3.18** (above)  
view of the middle  
shoin (right) and new  
palace (left) with  
foundation bamboo  
slats showing high water  
marks (image source:  
Wikimedia Commons)

Additionally, some of the spaces between piers are plastered or lined with bamboo slats, forming continuous walls that more closely resemble a *renzoku-kiso*, or continuous footing foundation (Figure 3.18). The plastered foundational walls adjacent to the moon-viewing deck are exposed, which is surprising since plaster absorbs water and deteriorates over time. Those along the southern sides of the middle shoin and new palace are set

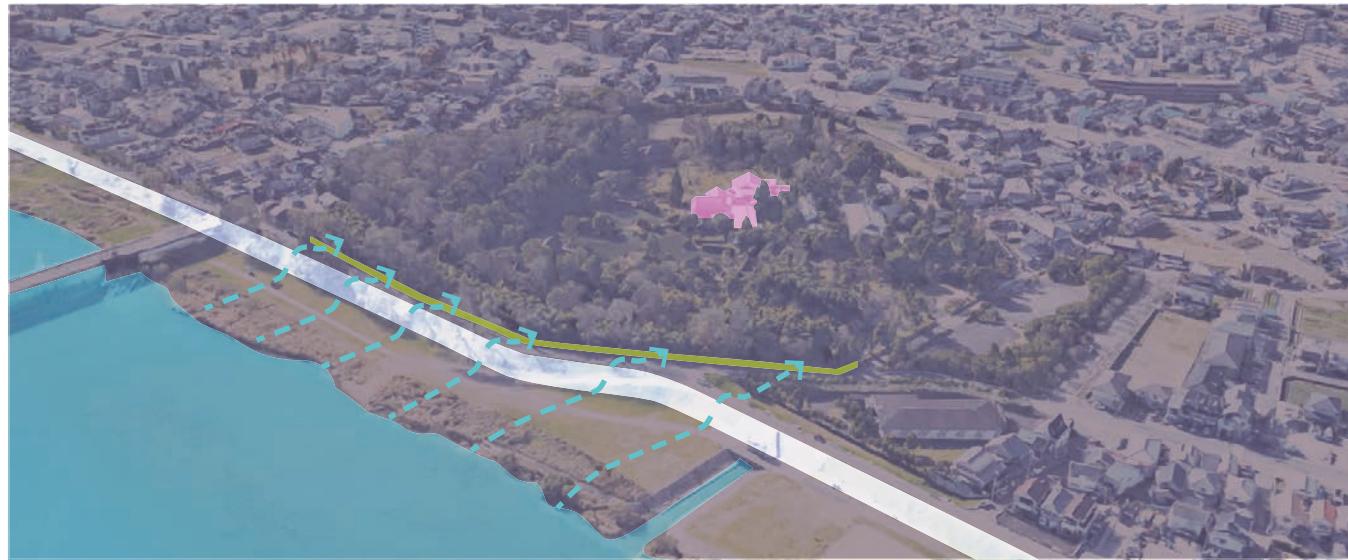
**Figure 3.19** modern-  
day aerial view of the  
villa with dyke (white)  
and water intake along  
riverside (adapted from:  
Google Maps)

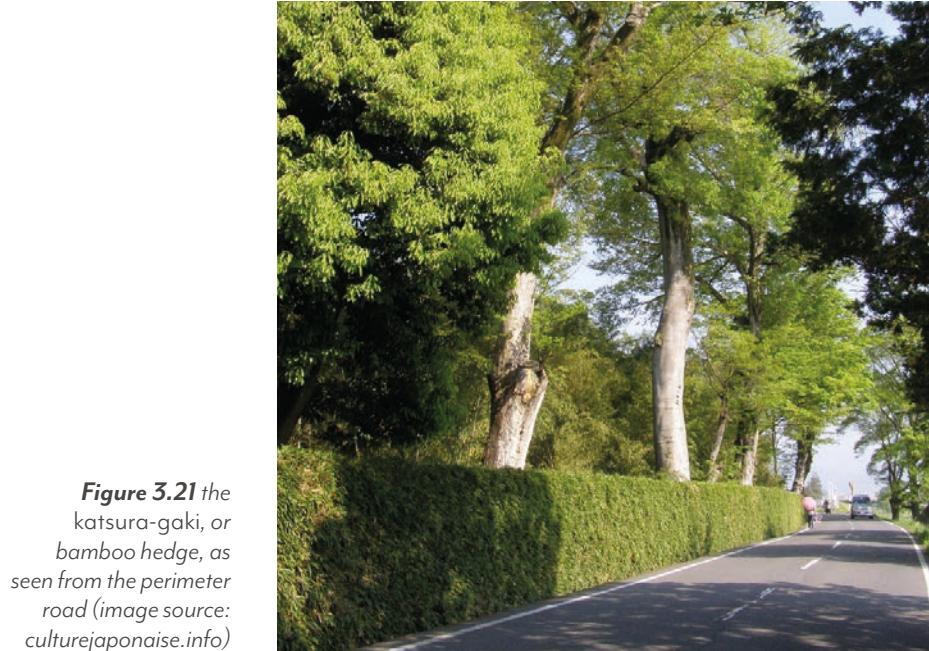
**Figure 3.21** the katsura-gaki, or bamboo hedge, as seen from the perimeter road (image source: culturejaponaise.info)

Another flood-resilient feature that is still present today is the historic bamboo hedge, or *katsura-gaki*, that wraps around the site's riverfront boundary (Figure 3.21). The hedge is made of living bamboo stalks that have been woven together to form a fence (Okubo 2017). This living fence serves as a filter for incoming flood debris, thereby preventing water from surging into the complex and damaging its features. The pliability of the bamboo hedge, in conjunction with its spreading, fibrous roots, allows for a high degree of flexibility without the risk of uprooting—a quality that can be easily observed during strong winds. This attenuation of floodwaters demonstrates a mentality of seeking harmony with nature through

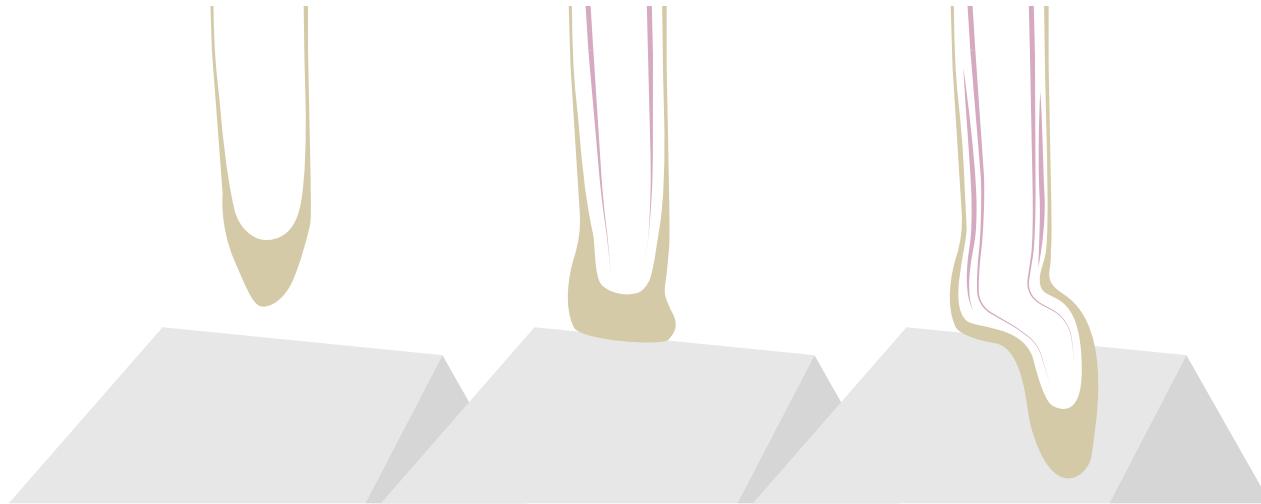
**Figure 3.23** time lapse diagram of gelatinous fiber growth within anchoring aerial roots

The key to the success of the living root bridges lies within the adaptive capacity of the *Ficus elastica* tree, also commonly known as a banyan tree. Like most evergreen fig species, *F. elastica* begins its life cycle as an epiphyte—a plant that grows on another plant, or in this case, another tree. Young *F. elastica* saplings send aerial roots down from the canopy and to the forest floor where they wrap firmly around boulders and infiltrate cracks along the river bank (Mathew 2005). The process of attaching and anchoring triggers the growth of gelatinous fibers within the roots, making them able to withstand the dynamic stresses of rushing water or the weight of human movement (Figure 3.23). When building a new bridge, the Khasis use bamboo as scaffolding and

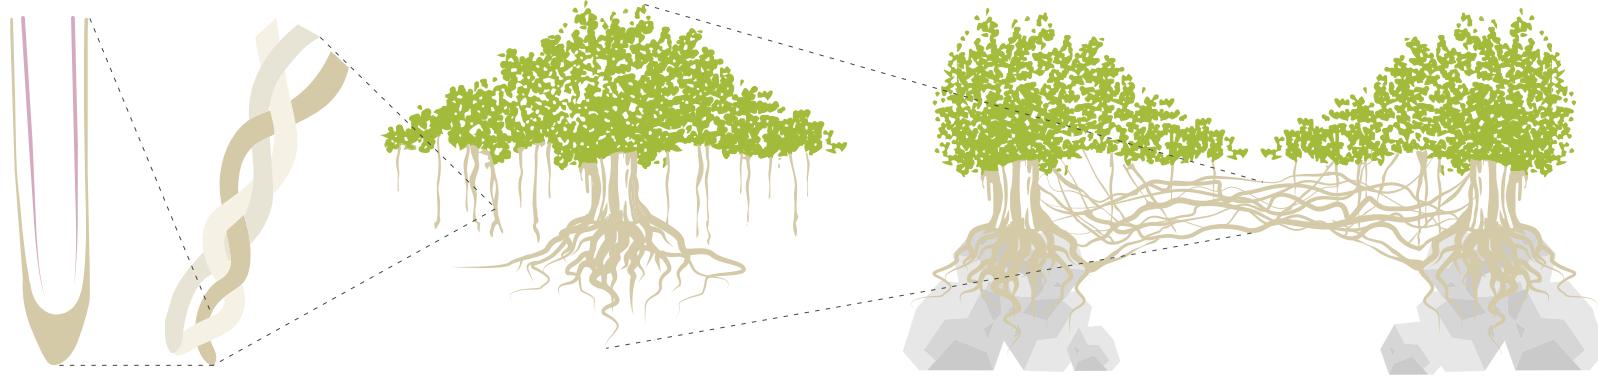
**Figure 3.24** diagram of the many levels of redundancy found within each living root bridge

This physical robustness is also reflected at the genetic and tissue levels since no fungus, disease, or pests have been observed attacking the bridges. Finally, no mechanical failure has been observed to date, which serves to further demonstrate the bridges' immense engineered resiliency (Shankar 2015).

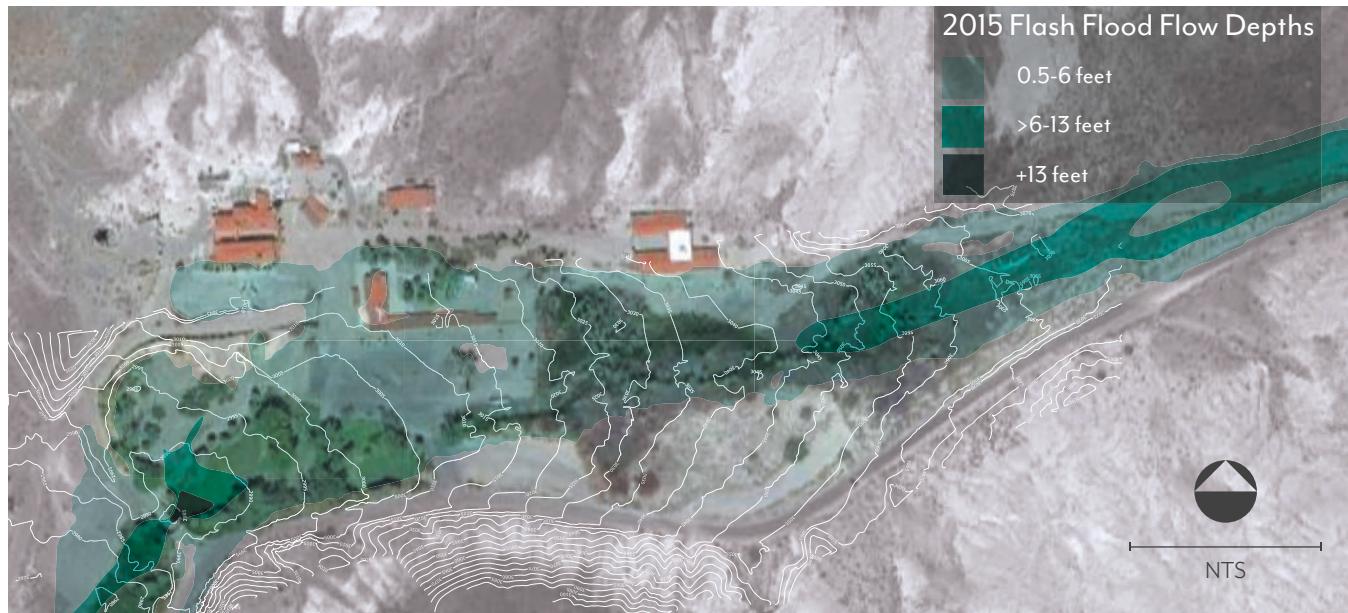
**Figure 4.2** (adapted from post-flood assessments by Louis Berger for the NPS)

In October 2015, this cultural landscape was impacted by a 1000-year flash-flood event (Figure 4.2). The motel unit/garage was directly impacted by flows, depositing sediment throughout the structure while erosional flows from the northern slopes abraded the exterior of the stables. Additionally, the basement of the guest house has been impacted by erosion and/or debris flows in the past although it's unclear what the extent of the damage was most recently. Damage to other features includes missing vegetation within the riparian corridor and designed watercourse, altered topography and scouring within the spring channel, and sediment deposition within the underground

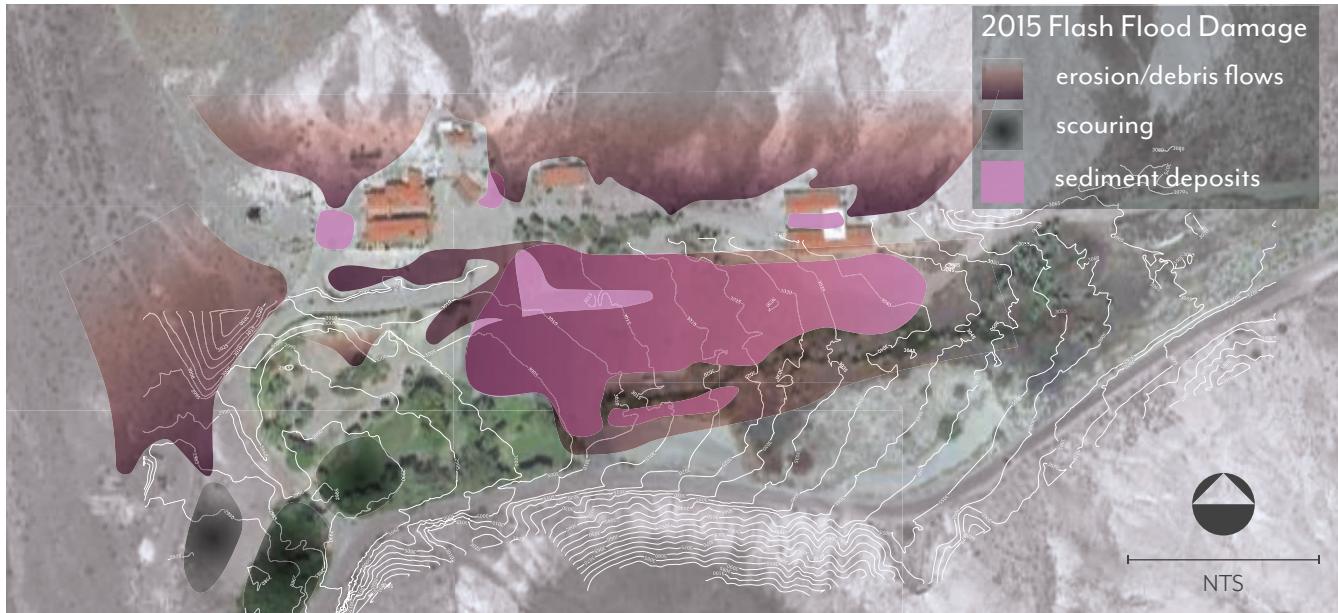
**Figure 4.3** (adapted from the NPS's cultural landscape preliminary damage assessment, October 30, 2015)

tunnel system and swimming pool (Figure 4.3). Impacts to park service infrastructure include missing fences and parking lot damage. Beyond the site's boundaries, infrastructural damage includes the historic Bonnie Clare Road (and prehistoric Timbisha Shoshone tribe travel corridor) and parallel power lines. These features were completely washed away at various locations, rendering the site inaccessible and incapable of providing year-round caretaker housing and visitor interpretive services (Figures 4.4A-4.4B) ("Bonnie Clare Road Reconstruction" 2018).

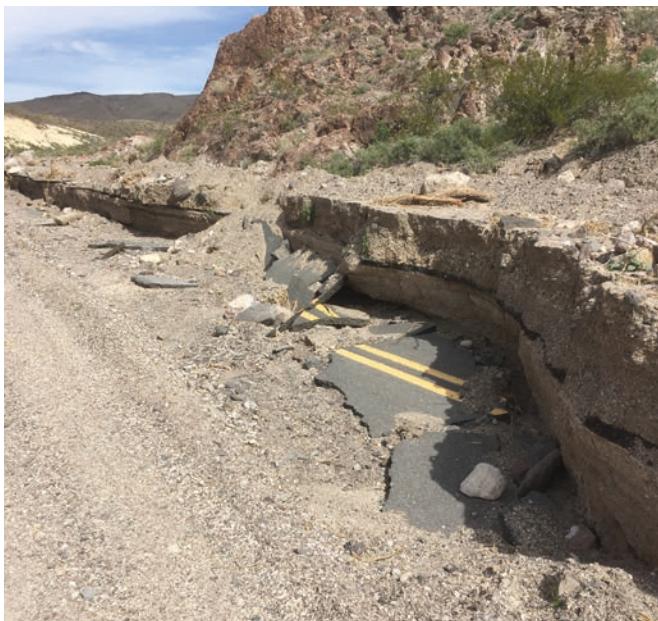
**Figure 4.4A** (right) portion of historic Bonnie Clare Road after the 2015 flash flood

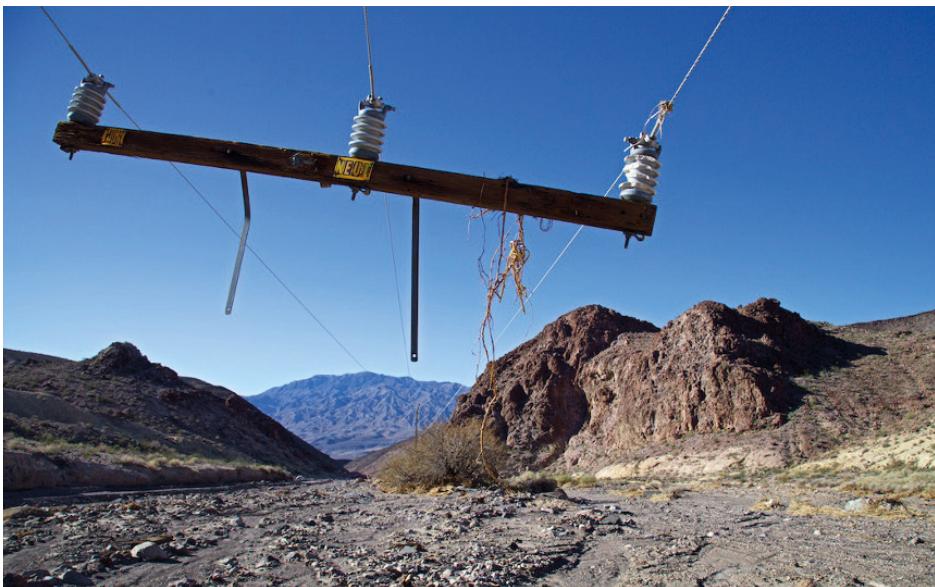
**Figure 4.4B** (below) flood damage to powerline poles (photo credit: Osceola Refetoff)

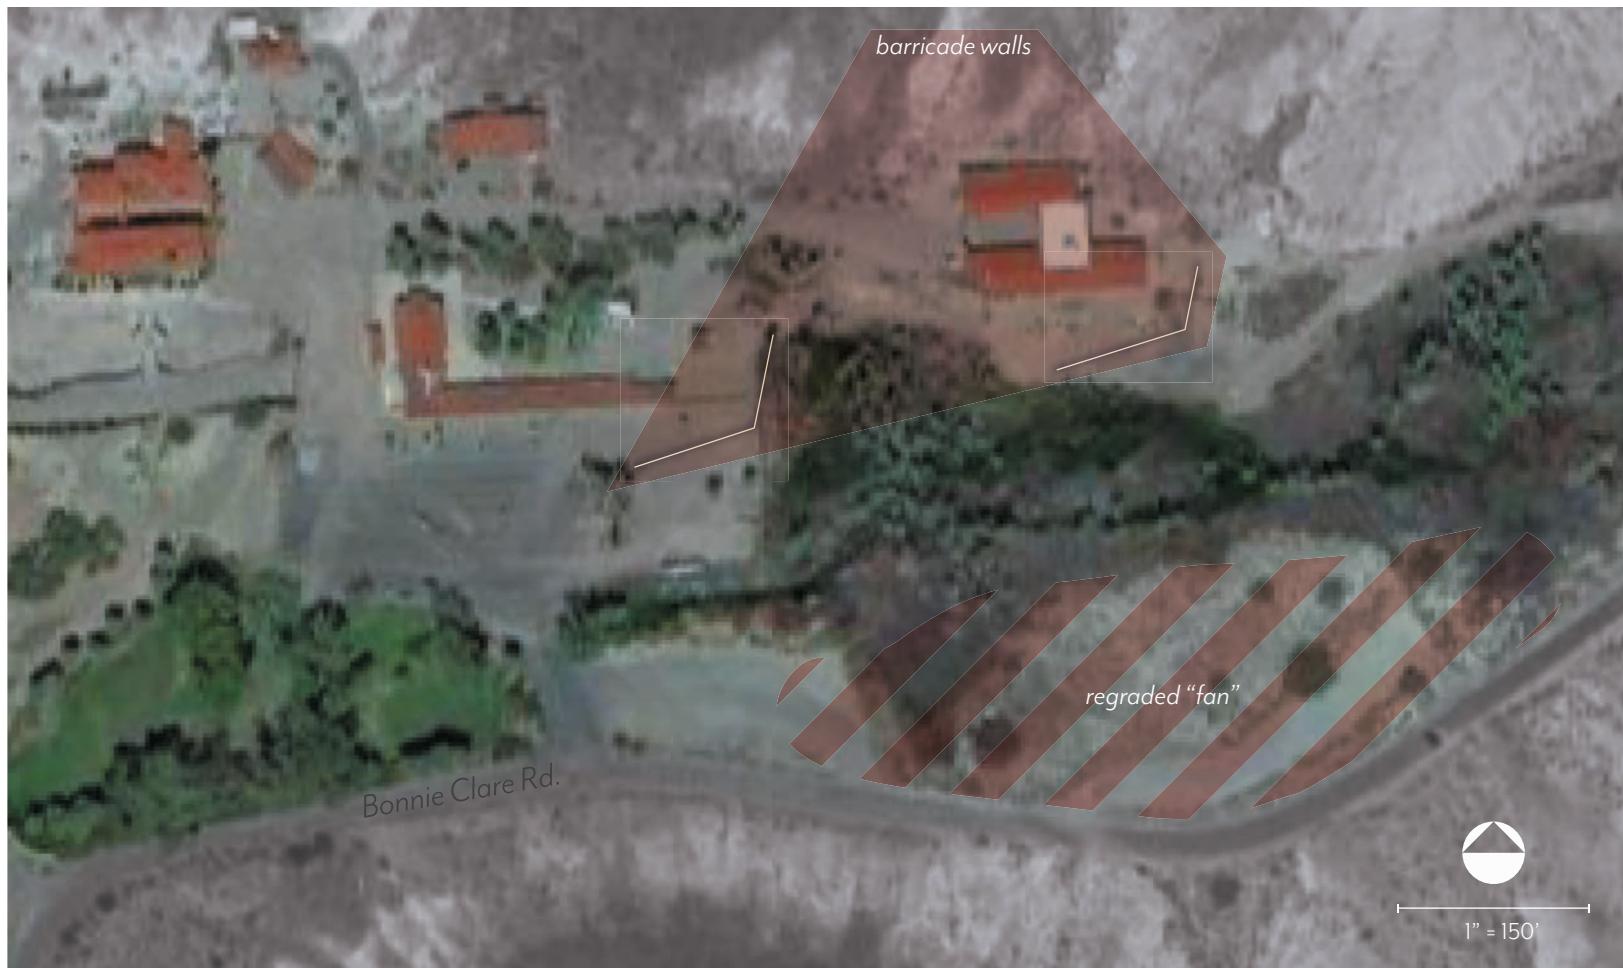
**Figure 4.6** plan view  
of two proposed barrier  
walls and reggraded flood  
"fan"

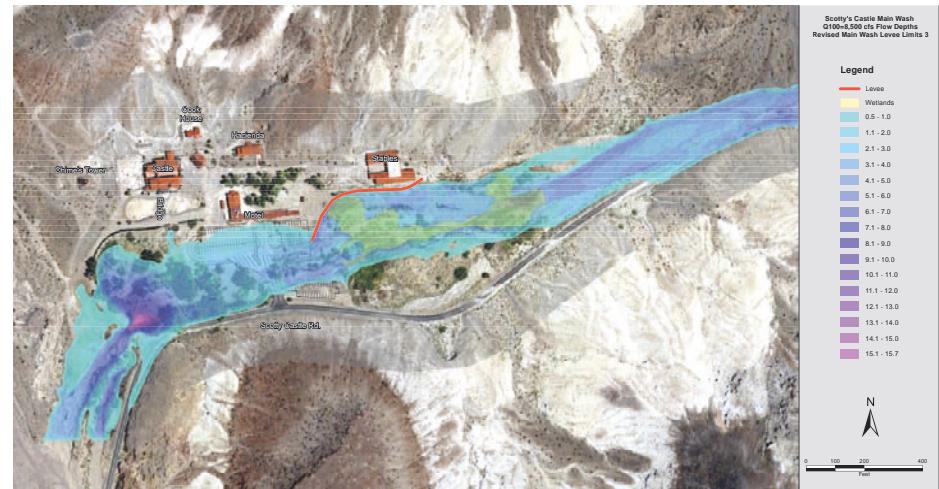
**Figure 4.7** the NPS's post-2015 flood diversion strategy for Scotty's Castle

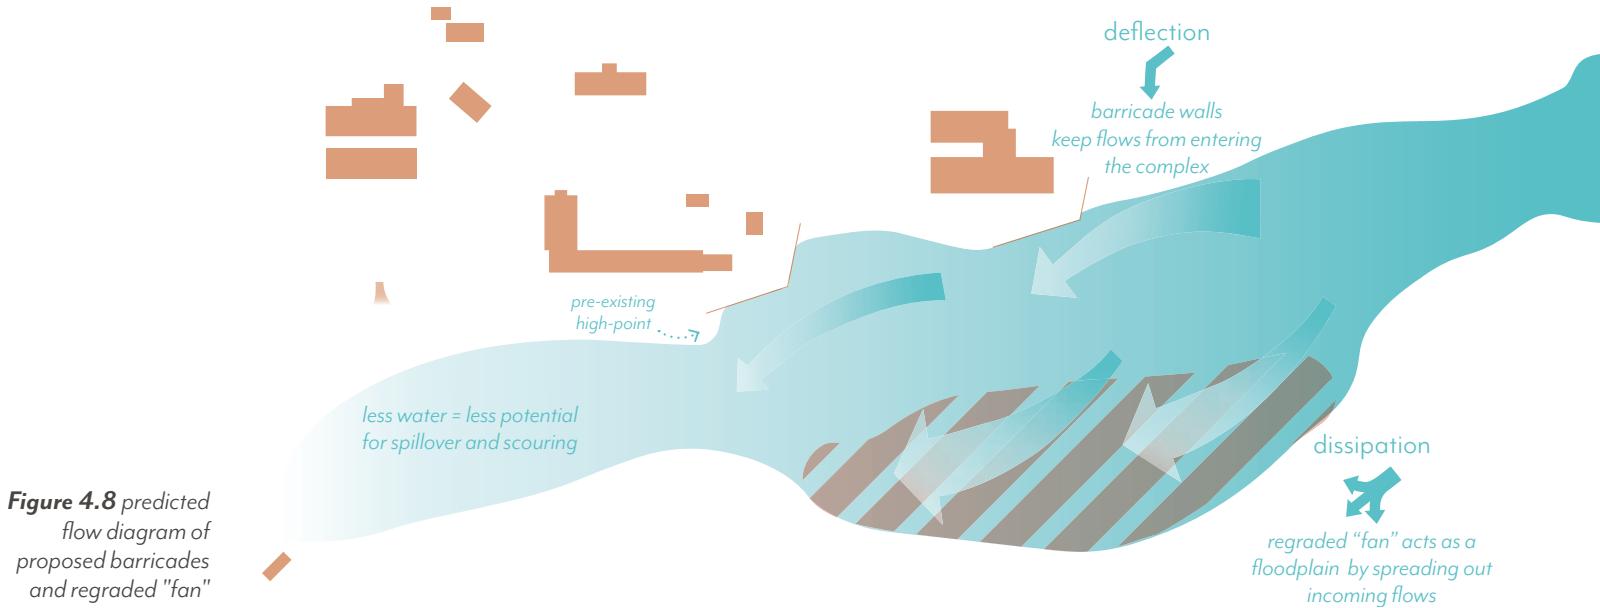
**Figure 4.8** predicted flow diagram of proposed barricades and regraded "fan"

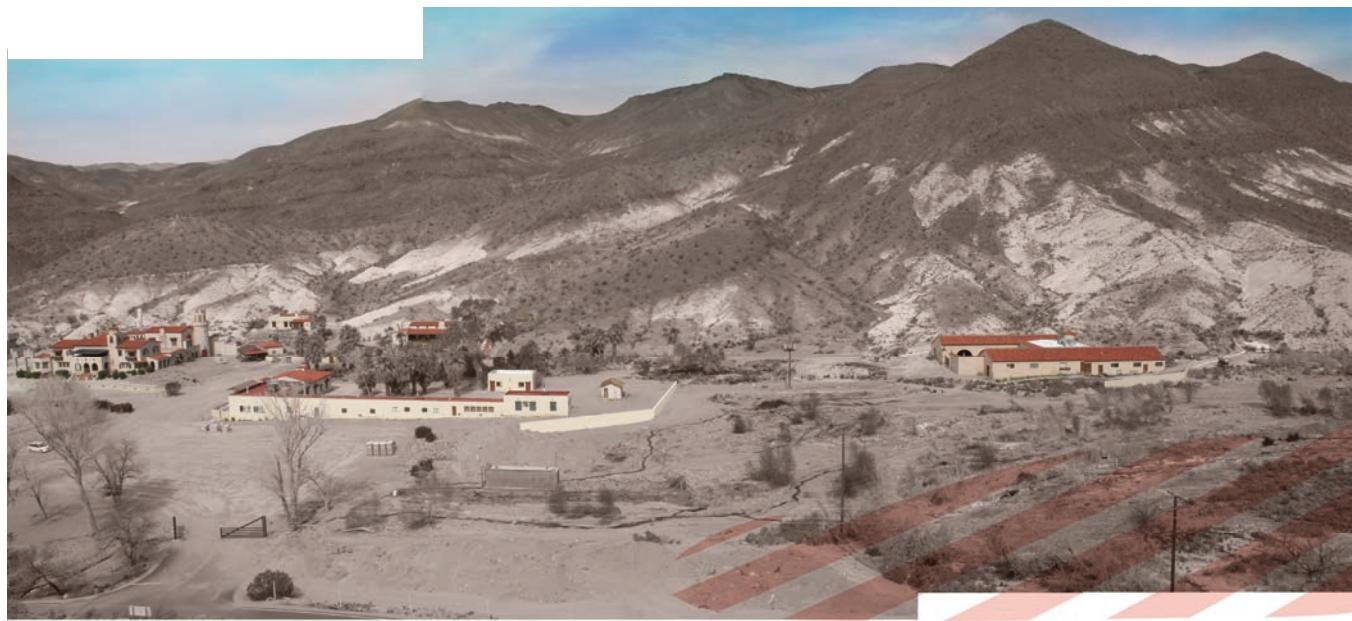
**Figure 4.9** perspective view of the two barrier walls on the eastern edge of the complex and reggraded "fan"

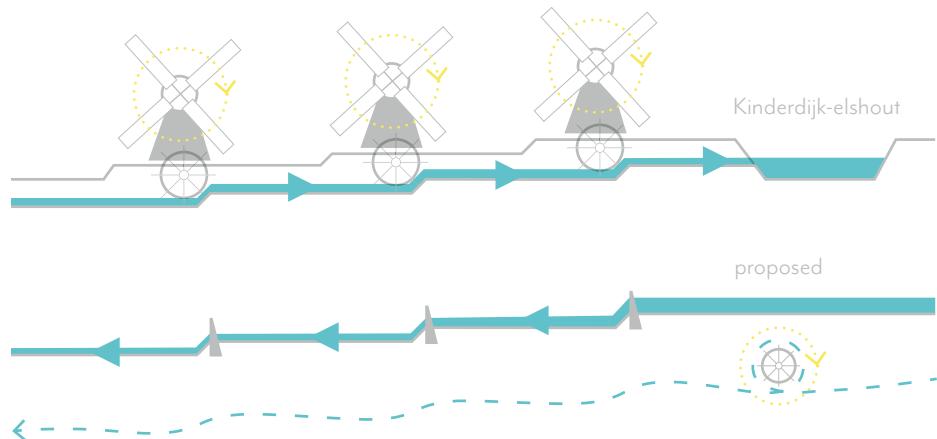
The first dam in the series is connected to the existing spring harvesting system via a diversion pipe. Non-diverted spring water is allowed to flow through below-ground perforations in the dams, surfacing intermittently as it presently does. These points of surface flow correlate with shallow places in the bedrock which could provide an ideal footing for each dam. The dams are secured into the bedrock, ensuring structural integrity and complete flood retention.

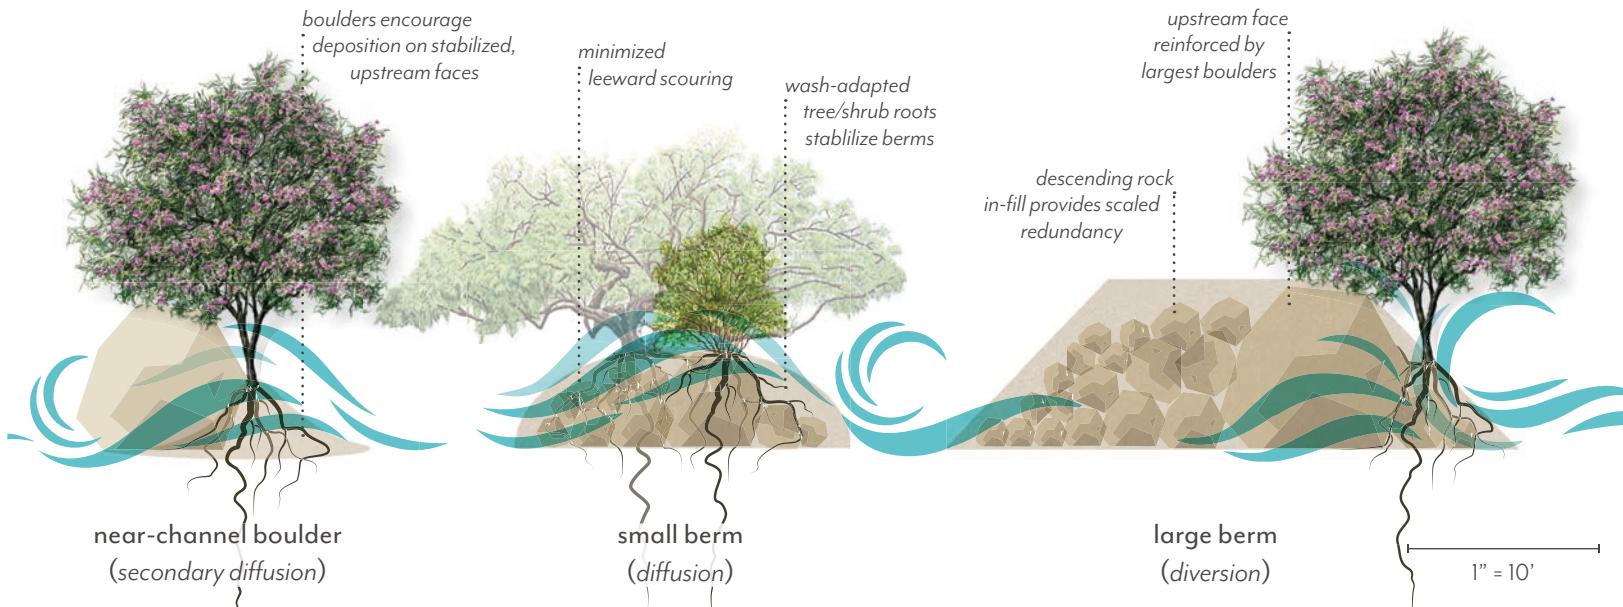
**Figure 4.16** section elevation of the earth forms showing scaled redundancy within each

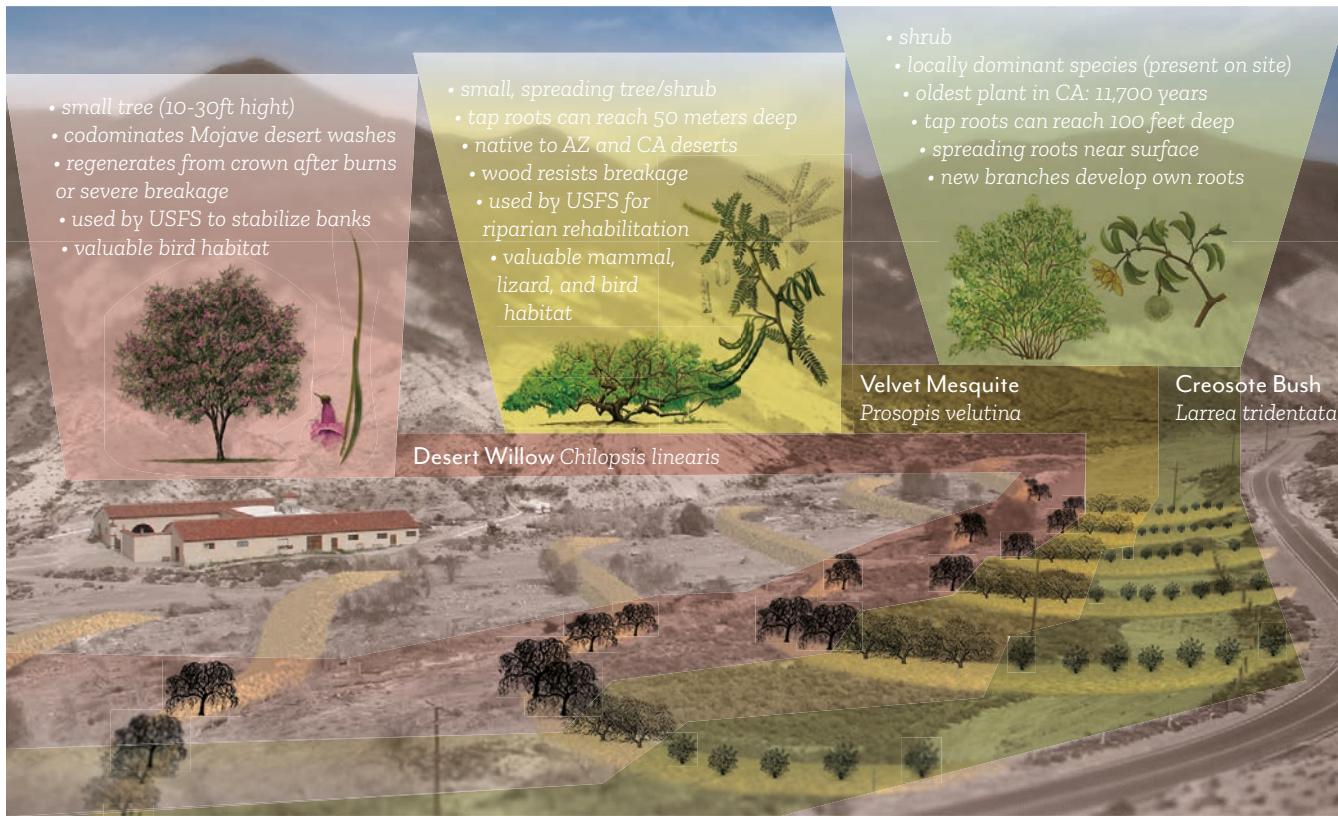
**Figure 4.16** perspective looking upstream with the stables in the background with adaptive plantings information
