OREGON MODERN IN BOHMANN PARK: A CASE STUDY OF
NORTHWEST MID-CENTURY ARCHITECTURE

Presented to the Historic Preservation Program
and the Graduate School of the University of Oregon
in partial fulfillment of the requirements
for the degree of
Master of Science

June 2018

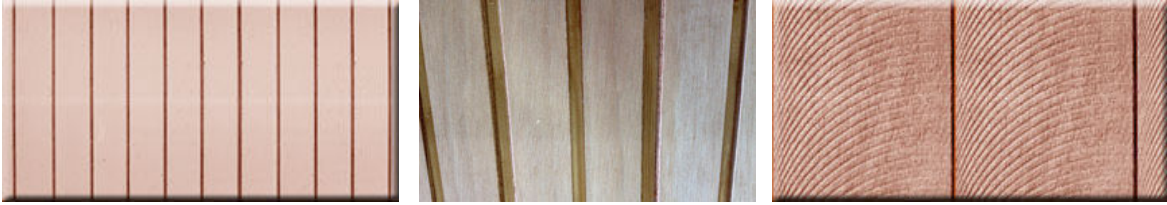
Figure 9 - Thinline and wideline siding patterns as supplied today by Eichler Siding (left, center), and Plank-Tex siding as supplied today by Eichler siding, based on pattern originally made by US Plywood (right).

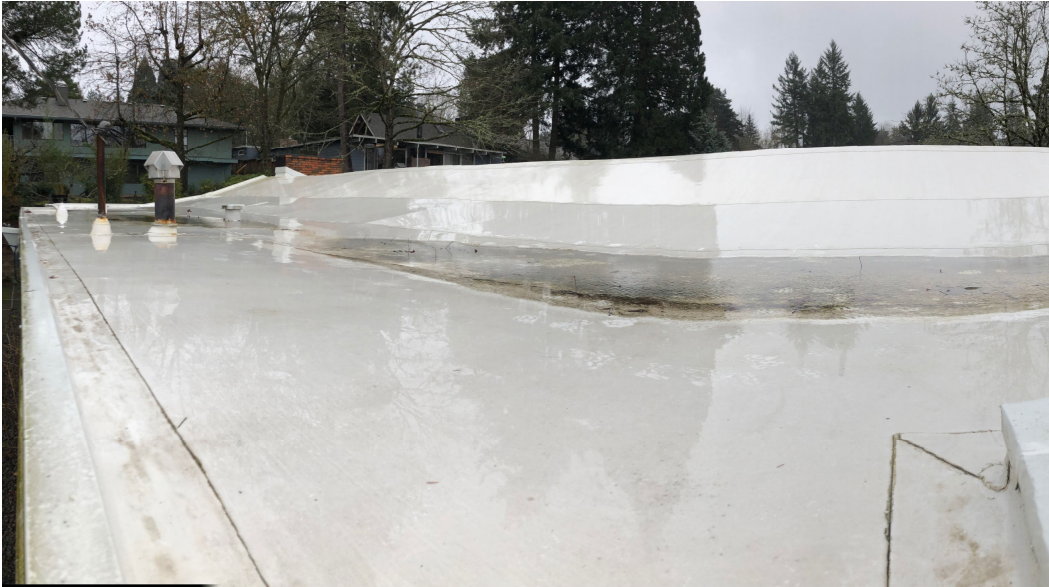
Figure 14 - Metal roofing and vents, north façade facing east.

The powder coating on the roofing material appears in good condition, and there was no breakage or gapping in the aluminum or the seams between pieces. However, interior water damage indicates that seams, especially in areas with high risk of standing water, are not watertight. There was some biogrowth along many of these seams, as well as rust from the metal roofing nails and screws. These areas should be cleaned, and the nails and screws replaced as needed.

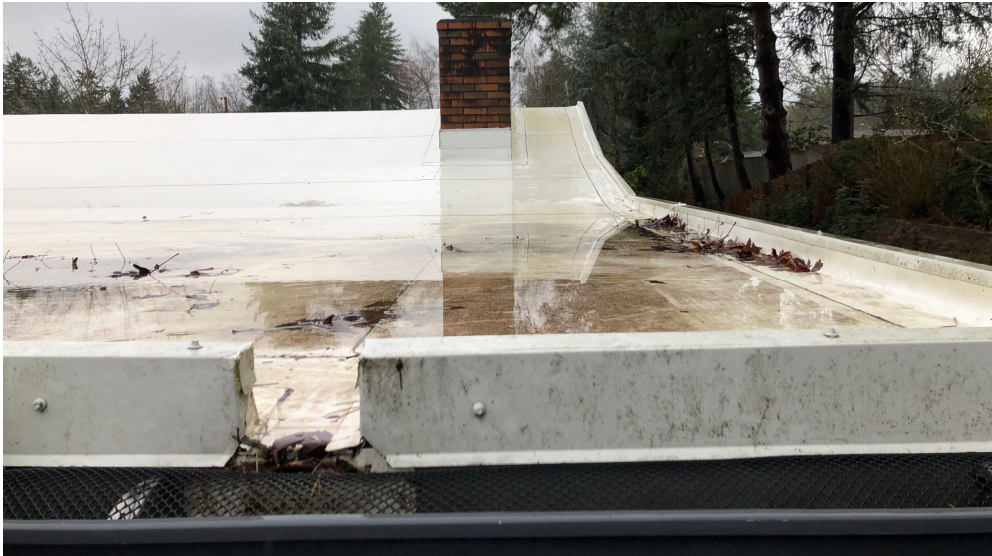
Figure 15 - Metal roofing, east parapet, and south chimney flashing, south and east façades facing north.

chemicals to remove existing biogrowth and discourage further propagation. Most importantly, options for creating additional scuppers or other roof drainage without altering the building's façades should be explored.

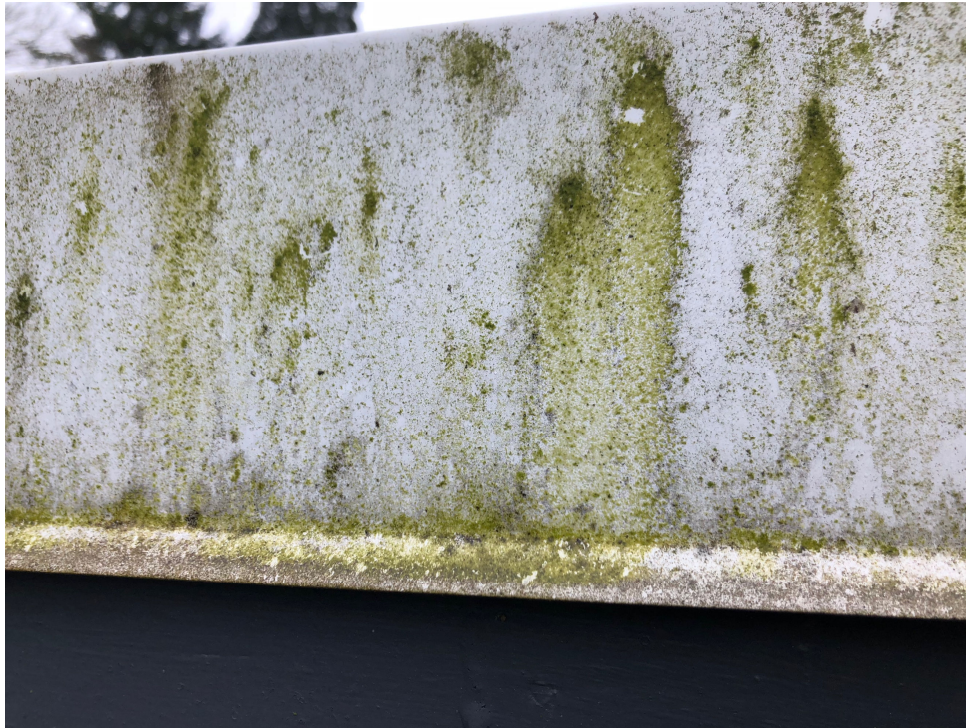
Figure 16 - Biogrowth along cornice, north façade.

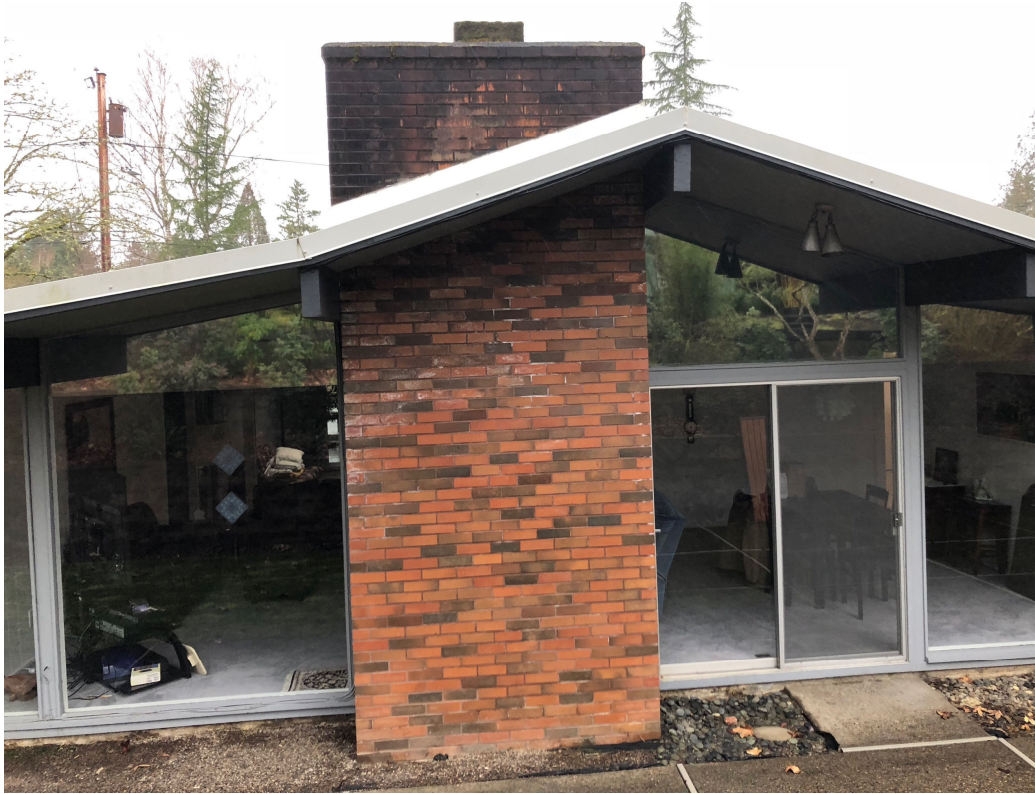
Cleaning this efflorescence is not essential to the building condition, but it will improve the appearance and provide a cleaner surface if there is a future need to repoint the mortar. Additionally, there is a great deal of dark, low-profile biogrowth on the portion

Figure 17 - Chimney, east façade facing west.

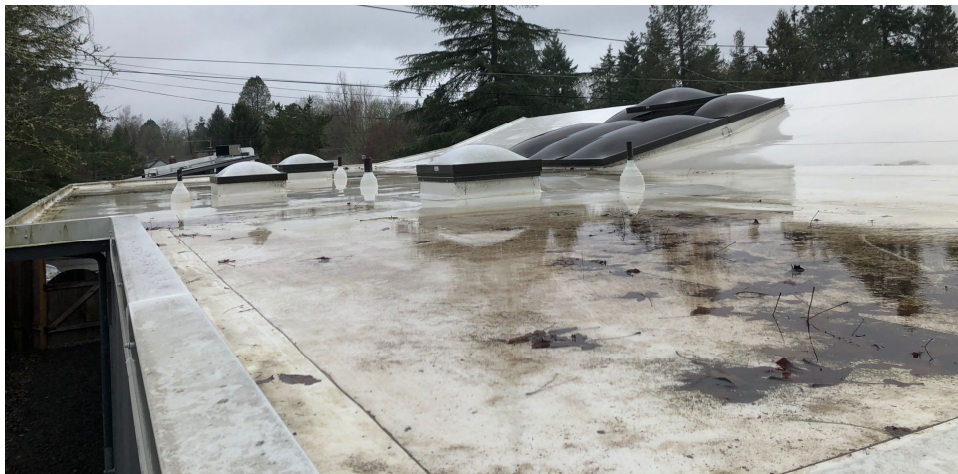
Figure 18 - Skylights on roof, south façade facing west.

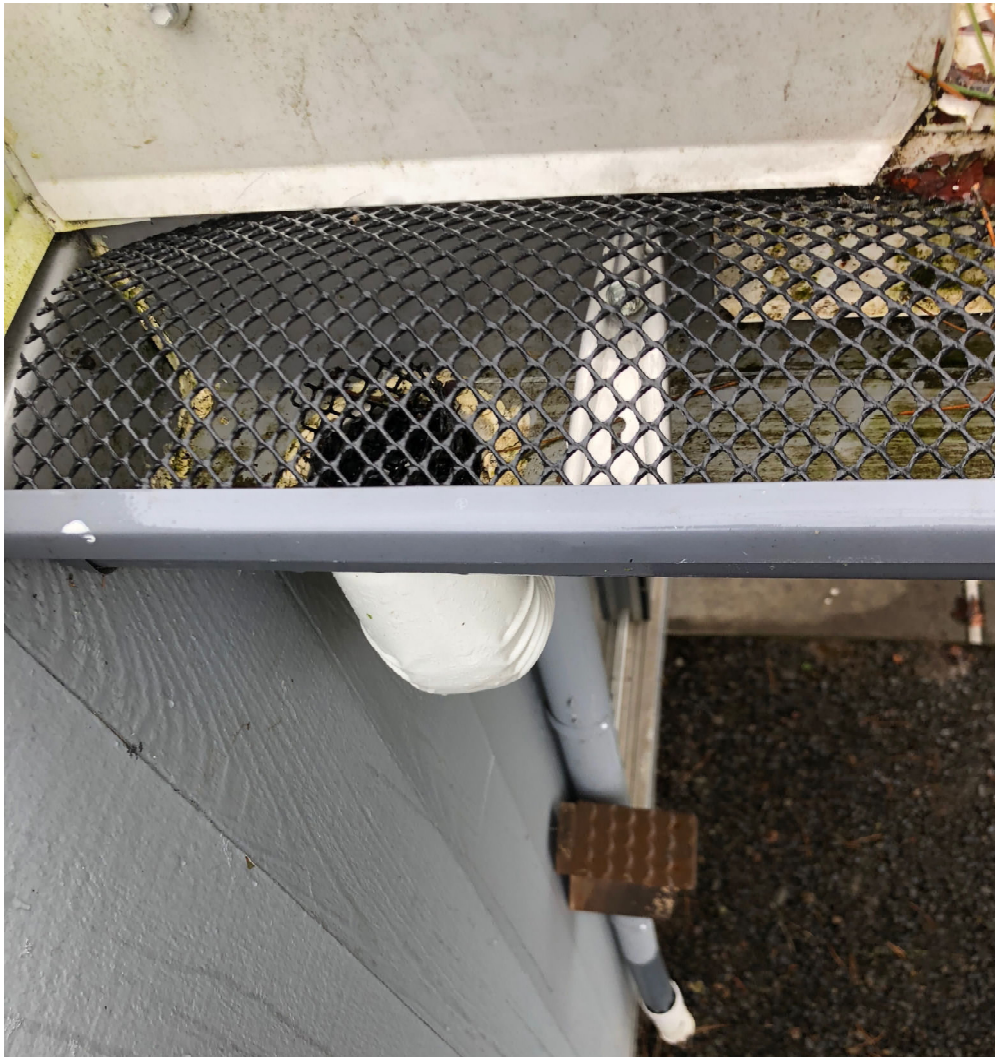
The gutters are contained to the east and west façades, and there are six downspouts of three-inch diameter on the building. Two downspouts each are located on the east and west façades and one each on the north and south façades. The gutters have a mesh over them that is meant to prevent large pieces of debris from blocking the gutters or downspouts, but there were enough smaller pieces of foliage, sticks, and other debris that went through the mesh to block the gutters and downspouts (Figure 19). There are

Figure 19 - Gutter and downspout detail, east façade.

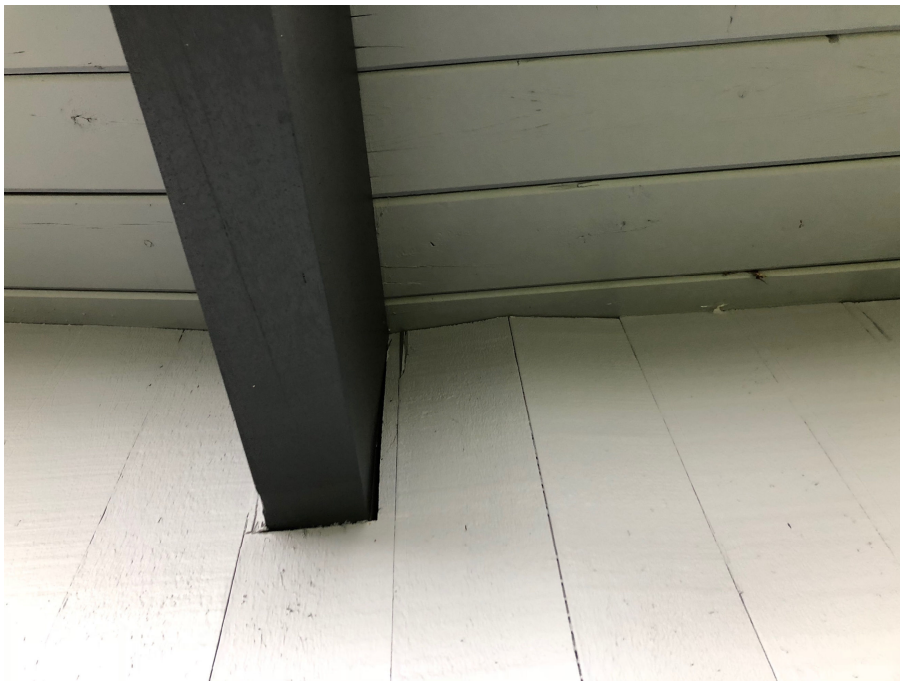
The south façade is in fair to good condition. The east and west corners of this elevation show more weathering than other areas of the house. The paint has worn off or chipped in several places on both corners, exposing the vertical board siding more directly to water, insects, and other potential damage. Warping of boards is most pronounced at this façade, especially in places where roof planks and the fascia board are also damaged from water infiltration (Figure 20).

Figure 20 - Warped vertical board siding detail, south façade.

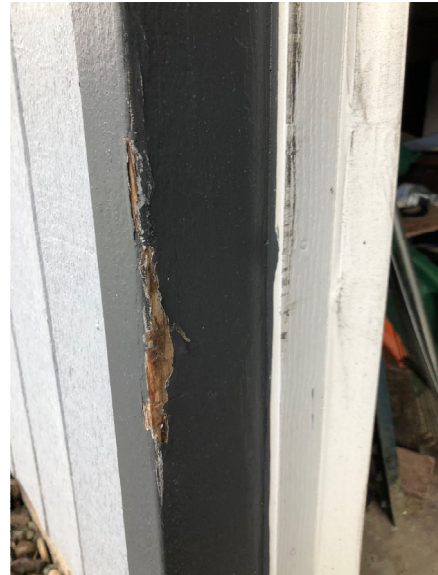
The sliding glass doors at the east façade and their aluminum frames and sashes are all in excellent condition, with the only suggested maintenance being regular cleaning and oiling of the sliding track to prevent sticking. The hollow-core door at the north façade is in good condition, as is the frame. The hardware on this door does not appear to be original. This door shows only minor wear. The garage doors are in excellent condition, and the frames are in fair condition. The garage doors are not original to the building, as they were replaced by the current owners for safety, but are similar in design to what the originals would have been. There are several spots along the garage door frames where blunt force has damaged the wood (Figure 21), removing small chunks and exposing the wood to water and weather damage where paint is missing. The paint is also peeling heavily at the top of the garage door frames, although the exposed wood does not show signs of rot. These areas should be repainted, but do not require further repair as long as they are not damaged further.

Figure 21 - North garage door frame damage detail, west façade.

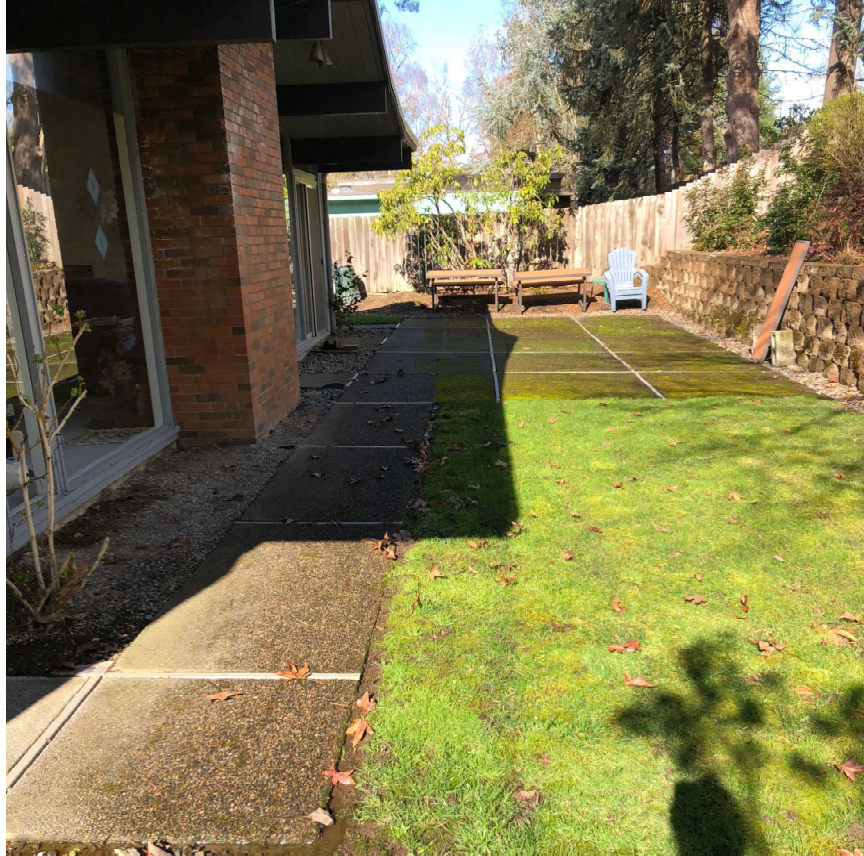
levels and make it more difficult to keep water away from the house, and thus should be maintained. Non-historic vertical board screening fences at the north, east, and south are in fair to good condition.

Figure 22 - Terracing, lawn, fence, and concrete pathways and deck, east façade facing north.

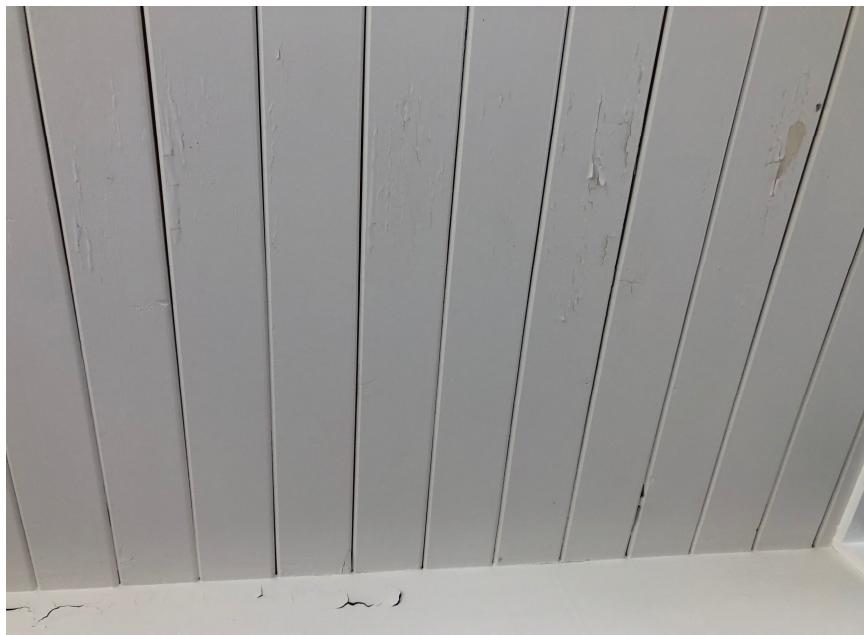
There are several places in each room of the house where planks have begun to separate, creating gaps of up to about one inch. Major evidence of water damage can be seen directly under pools of standing water on the roof, specifically in the front children's bedroom (Figure 23). Peeling paint on the planks and roof beams in the northeast indicates that beams are consistently exposed to water and at risk for rot, if they have not already begun to rot under the paint. There is notable warping and discoloration of roof planks in the garage, indicating water damage from the standing water on the roof directly above. A portion of the roof beams in the atrium was recently replaced due to severe water damage and brown rot, and it is likely that at least some of the other beams and planks in high-risk areas such as the meeting of the gable and flat portions of the roof also have brown rot. There is some checking in exposed roof beams throughout the house, but no indication of torsion or warping in these structural beams or water damage and rot unless mentioned above.

Figure 23 - Ceiling and top of wall, northeast corner of front bedroom.

The wall paneling is in generally good condition throughout the house. A major exception is in the front bedroom. The area where the wall meets the ceiling in the northeast corner exhibits cracking and peeling paint, and the meeting of the west wall and ceiling has a large crack, both of which indicated water damage. The crack on the west wall should be monitored to ensure that there is no further separation, which would indicate continuing water damage to post or beams or foundation settling, which may compromise structural integrity. There is also some paint peeling on the south wall of the walk-in closet of the master bedroom, which corresponds approximately with the location of an exterior downspout, which is the likely source of the water damage. There is some non-historic molding missing from the southwest corner of the southwest corner bedroom.

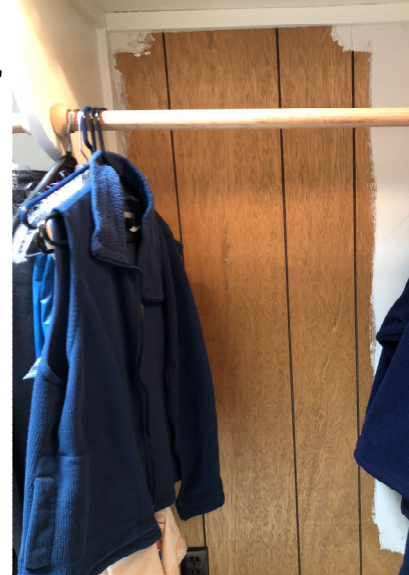
The interior walls of this post-and-beam light-frame constructed building are plywood paneling and sheetrock applied to the cedar two-by-four studs. This paneling has been painted white in the entire house, with the exception of a small portion of the storage closet, which exhibits the original finish (Figure 24).

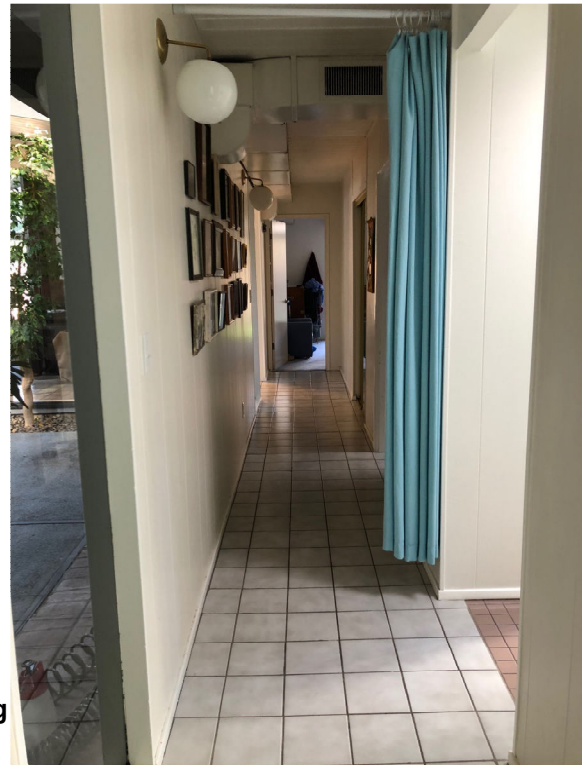
Figure 28 - Bedroom wing hallway facing east.

bedroom hallways, kitchen, laundry room, dining room, and living room hallway are all tiled in a mottle light gray tile with dark grout (Figure 28). This tile was installed by the previous owner as a do-it-yourself project. Despite being in overall good condition, this tile is misaligned and detracts from the historic character of the rooms in which it is found.

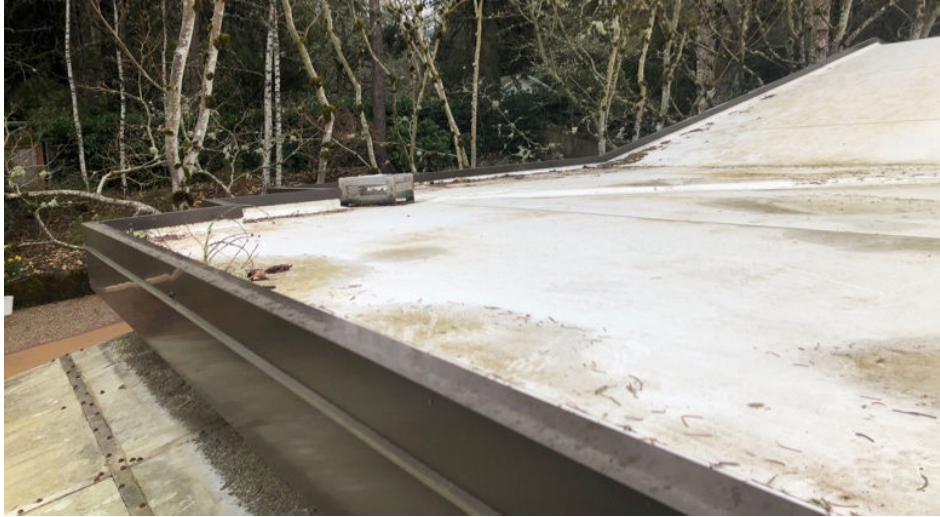
Figure 31 - Membrane roofing and vents, north façade, facing southeast.

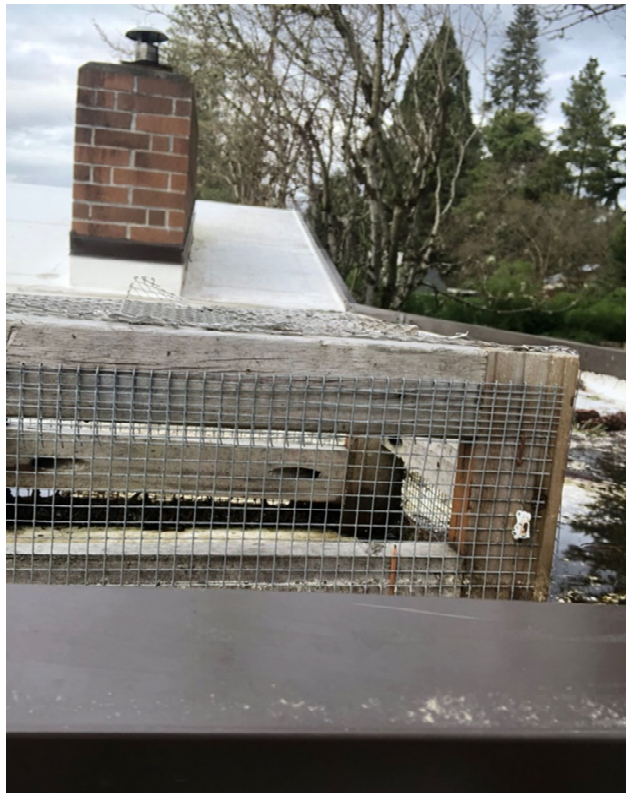
Figure 32 - Membrane roofing, east parapet, wood and chicken wire grating over skylight, and south chimney flashing, south and east façades facing northeast.

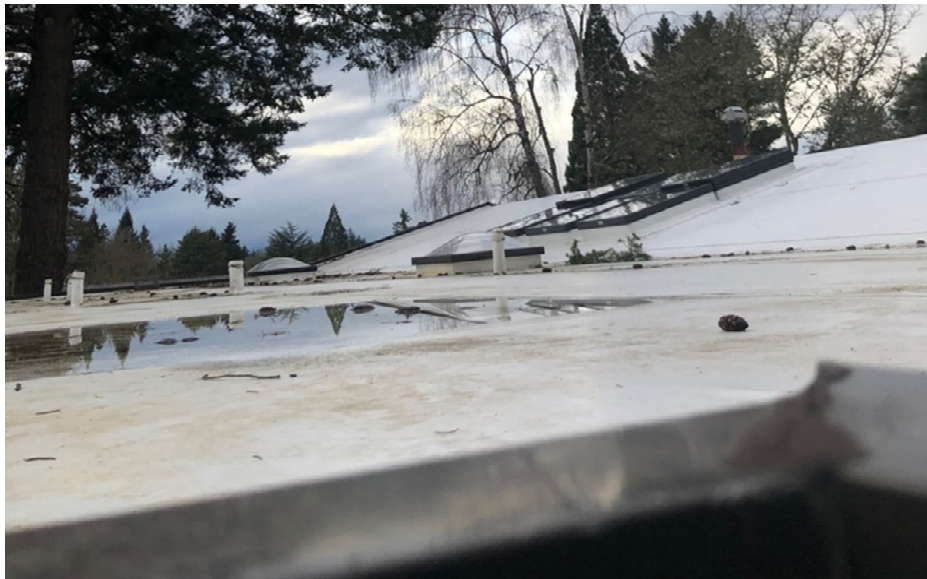
Figure 34 - Skylights and pooled water from poor drainage on roof, south façade facing north.

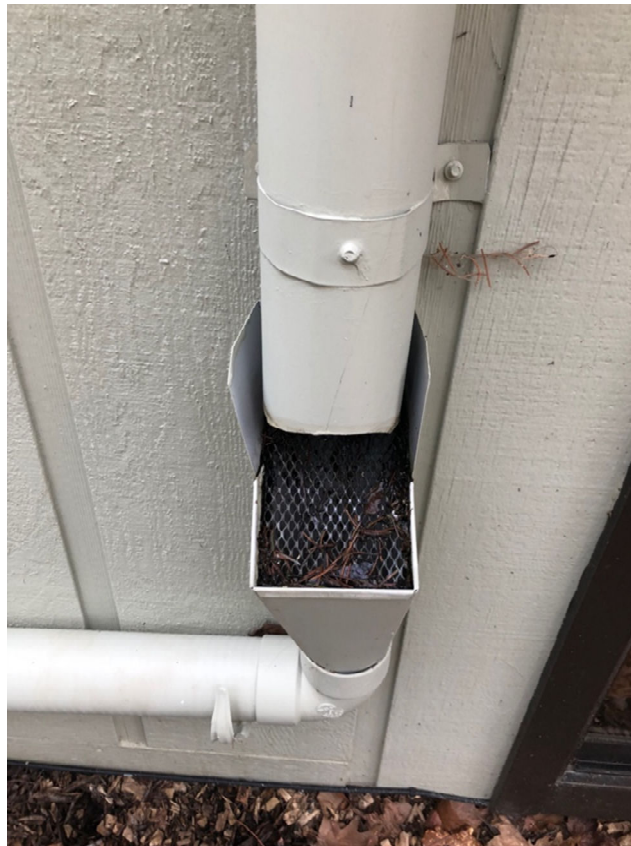
Figure 35 - Downspout and drainage join detail, south façade.

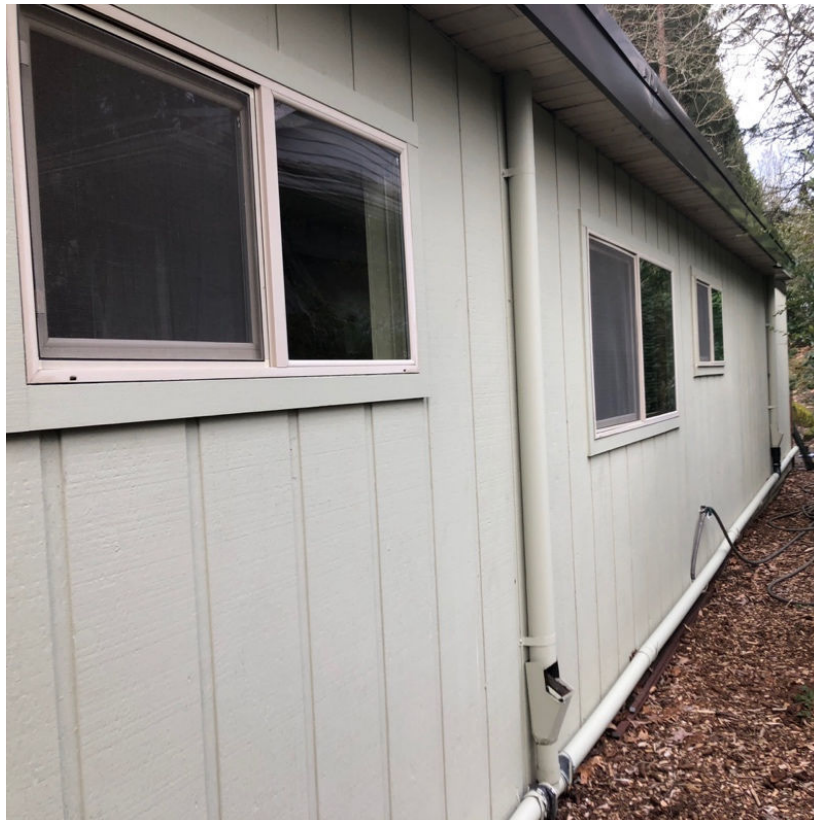
Figure 36 - Siding and windows, south façade facing east.

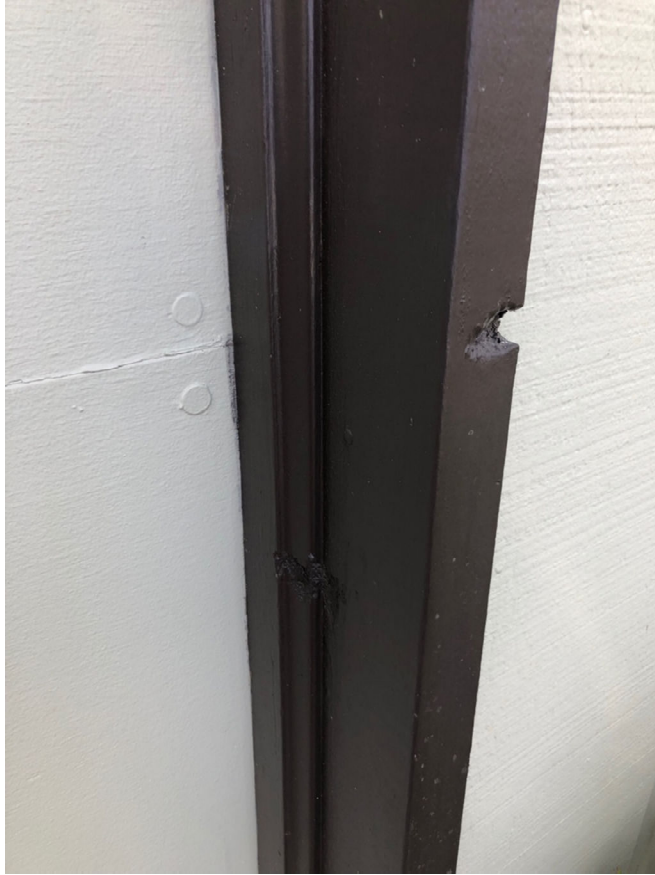
Figure 38 - South garage door and frame detail, west facade.

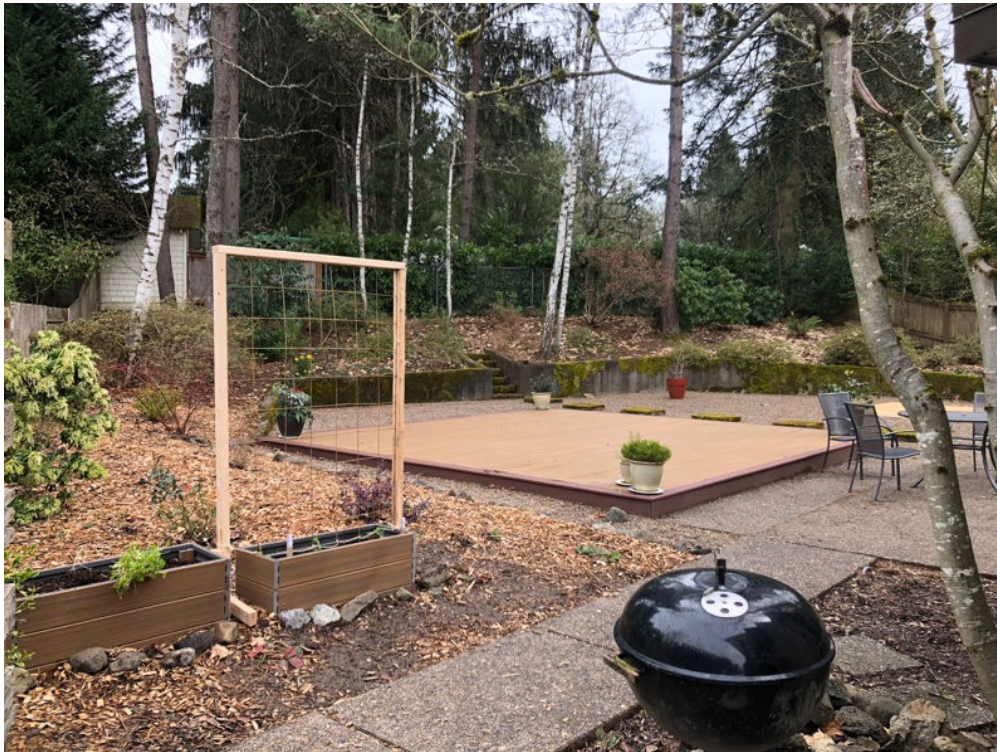
Figure 39 - Terracing, landscaping, wooden deck, fence, and concrete paths and deck facing southeast.

treated with appropriate chemicals to discourage future growth as much as possible, as the biogrowth will speed deterioration of the historic landscaping concrete.

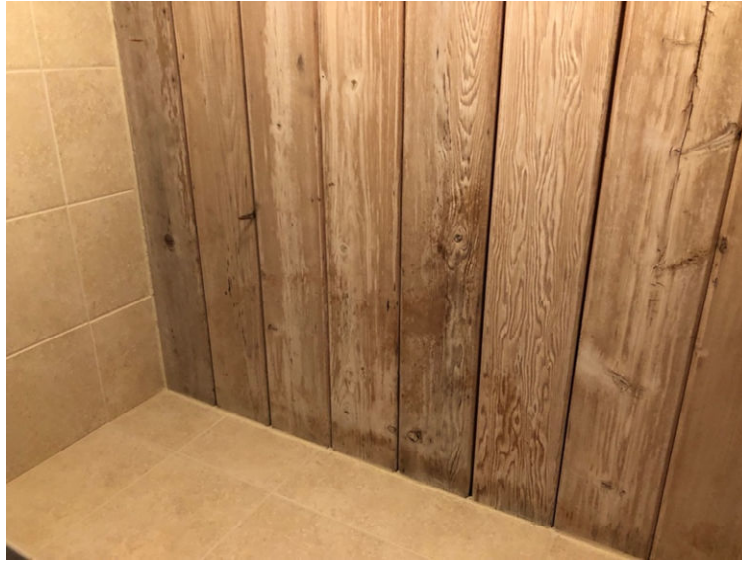
Figure 40 - Ceiling and top of wall, master bathroom.

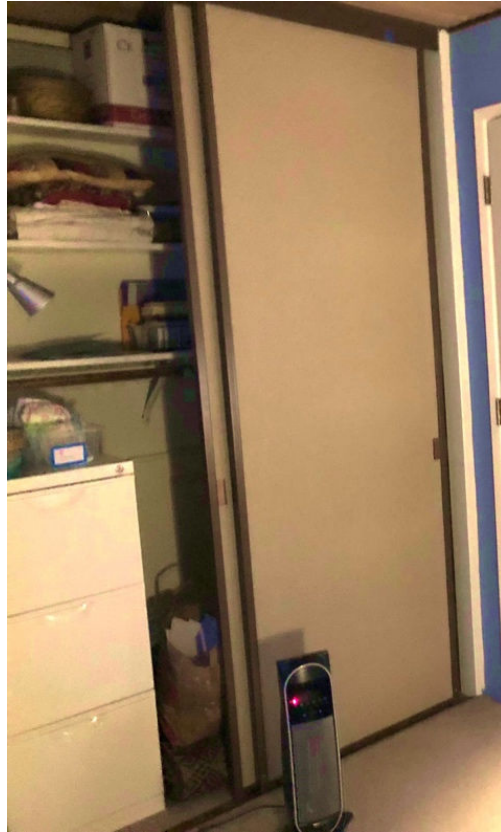
Figure 41 - Closet and built-in shelving, east children's bedroom.

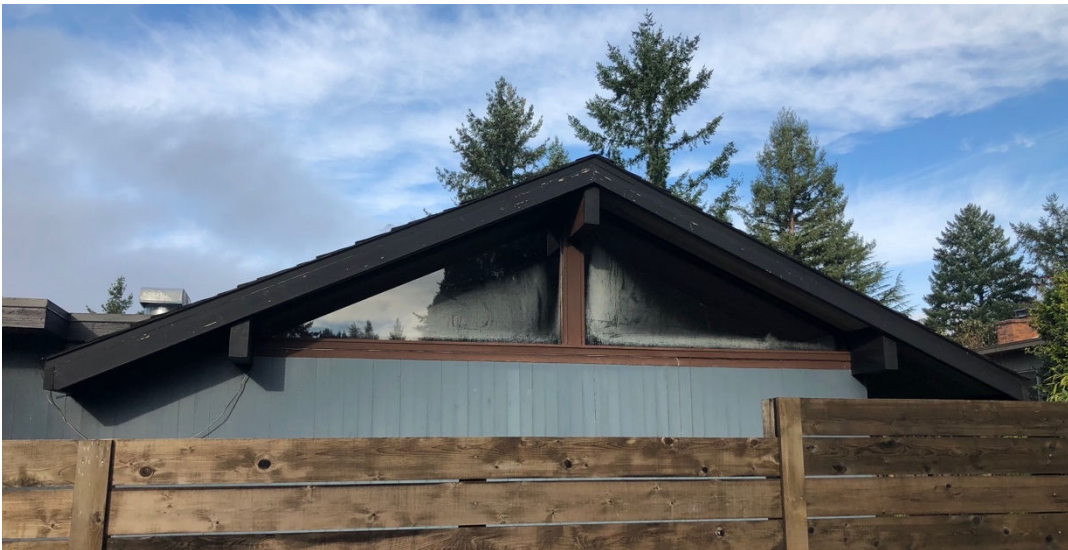
Figure 59: Condensation in a clerestory window of a Rummer house in an offshoot of 84th Avenue, facing north (Samantha Gordon, November 27, 2017).
