RETURN TO THE FLOODPLAIN: THE ROLE OF BEAVERS (CASTOR  
CANADENSIS) IN RESTORING CHANNEL COMPLEXITY AT  
WASSON CREEK

SARAH MARIE MARSHALL

A THESIS

Presented to the Department of Environmental Science and the  
Robert D. Clark Honors College of the University of Oregon  
in partial fulfillment of the requirements  
for the degree of  
Bachelor of Science

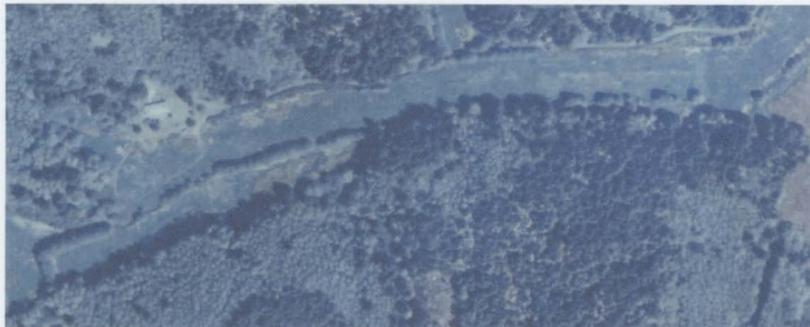
**Figure 4. Active Restoration at Anderson Creek**

1991 Aerial photo  
with the straightened  
and ditched Anderson  
Creek

2003 Aerial photo  
showing the new,  
sinuous channel and  
large woody debris at  
Anderson Creek

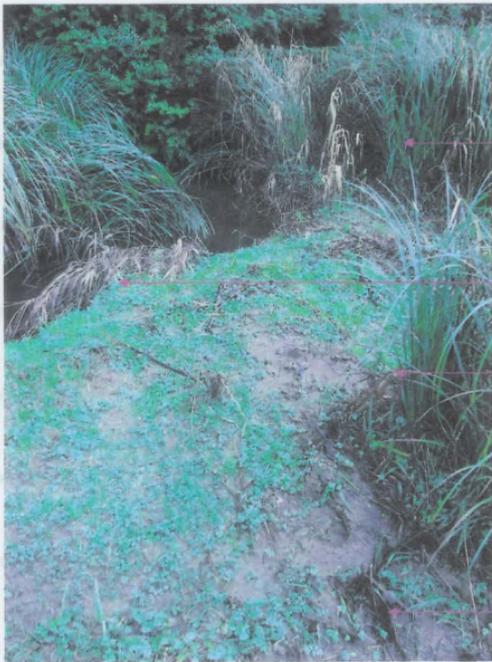
**Figure 10. Flooding Evidence at the W.L.L.2 Site, 1/9/04**

Future W.L.L.2 Site

Sediment and Debris Deposits

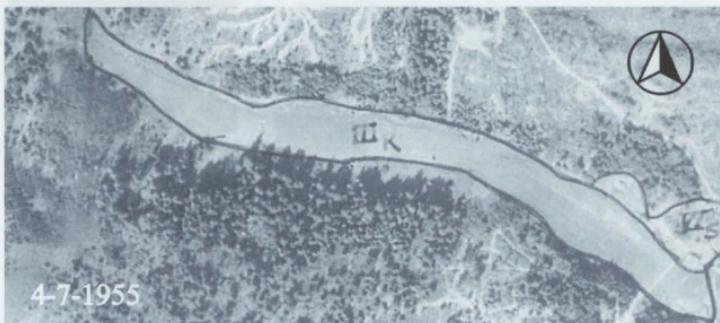
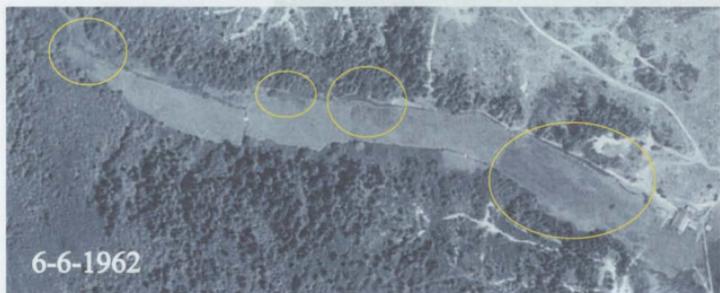
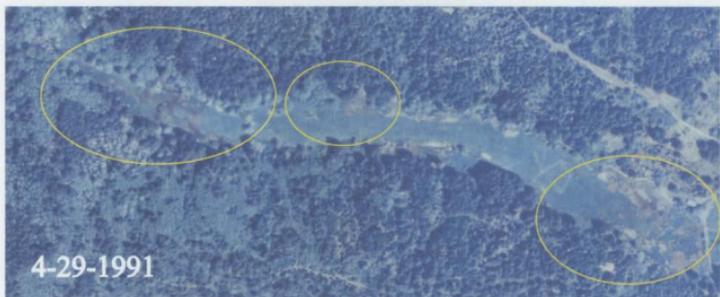
**Figure 17. 1955-1991 Wasson Creek aerial photo series, (changes in floodplain vegetation highlighted in yellow).**

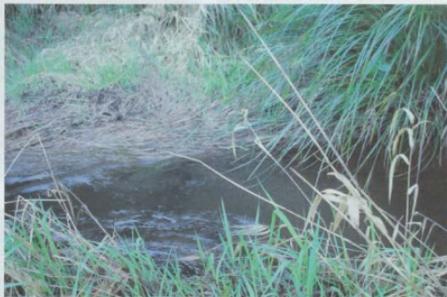
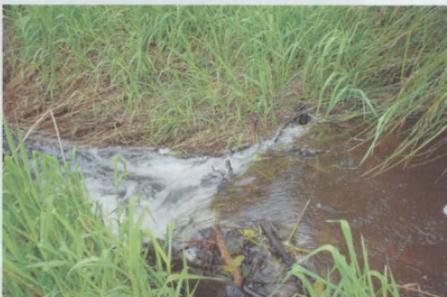
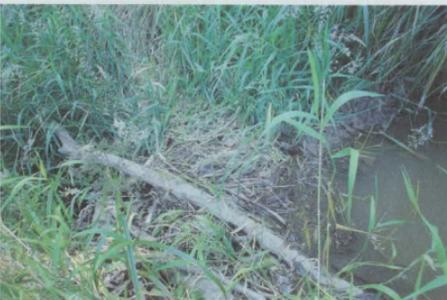
## Figure 18. BD1 Photo Series

November 10, 2003

January 30, 2004

March 26, 2004

November 7, 2003

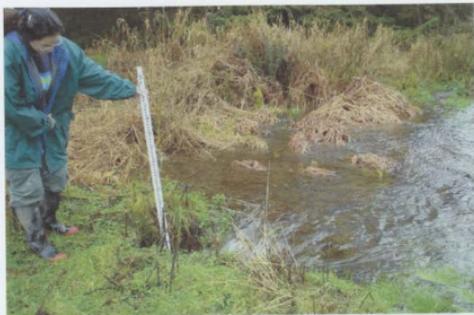
**Figure 19.**

Overland flow between BD6 and BD7 (left), terminating in a beaver plunge hole (below).

January 9, 2004

What was initially constructed as a beaver escape tunnel between the floodplain and the main channel turned into a drain for much of the overland flow caused by flooding of the channel above BD6 and BD7 (Figure 5; Figure 19). By early May, when surveyors constructed an elevation profile of the site, the plunge hole had developed into a hollow that declined 0.30m from the surrounding floodplain and had a maximum diameter of ~8m. Other plunge holes are abundant around BD6 and BD7, but none were observed to drain significant volumes of water off the floodplain.

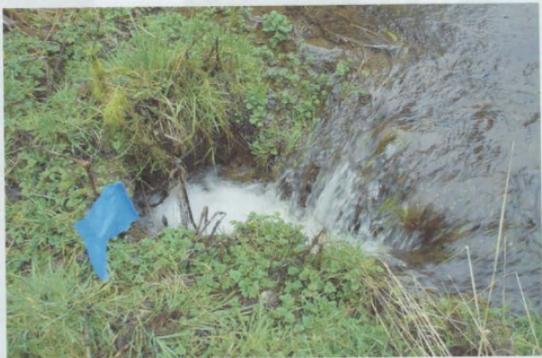
**Figure 20.**

Beaver-excavated channel, upper Wasson Creek floodplain.

November 7, 2003

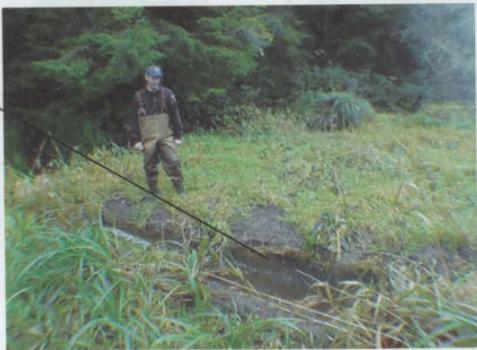
BD7 and upstream pond,  
November 10, 2003

By May 14, 2004, the pond upstream of BD7 was mostly drained, with only several of the beaver-excavated channels still holding water (above). Following the reconstruction of the entire floodplain reach of the dam, however, the pond was again filled with water by July 2, 2004.

As water continued to flow across the floodplain toward BDH between early January and early June, 2004, I saw the water impounded behind BD7 go from a pond spanning nearly the entire width of the floodplain to barely a trickle by mid-May (Figure 21). Meanwhile, water level in the secondary channel remained over bank full in most places. On June 9, water was again backed up behind the full extent of BD7, but the secondary channel was still flooded in many areas—particularly around BDG-H. Beavers had repaired the full extent of BD7, added onto BDH, further excavated ditches extending up the floodplain from the pond, and created a marsh. By July 2, despite little rainfall in the summer months, the pond was deeper and more expansive than it had been in the spring (Figure 21).

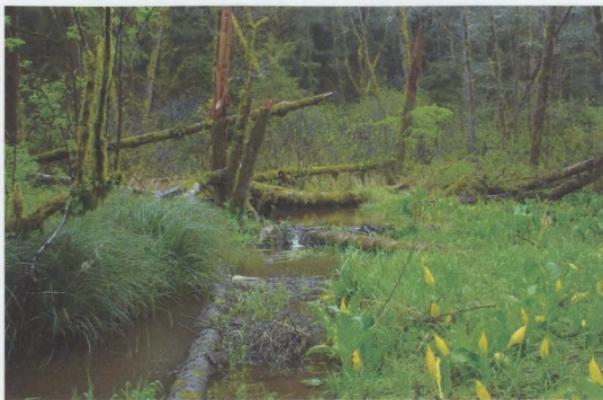
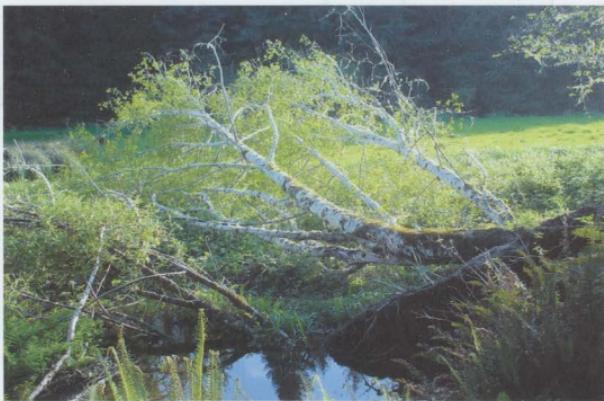
**Figure 22.** Large woody debris in the upper Wasson Creek channel (above; March 26, 2004 photo) and in the study area, upstream of BDA (below; April 23, 2004 photo). Trees in beaver-influenced systems are often felled by beavers or killed by raised water tables. Regardless of how they enter a stream, logs often increase habitat and structural diversity in the channel and on the floodplain as they dissipate a stream's energy, create shelter for aquatic species, add nutrients to the system, and provide surfaces for plant growth.

of their activities, we should expect the maintenance of an open-canopy zones on the floodplain due to beaver foraging and some vegetation killed by a raised water table (personal observation; Figure 22), further retention of debris, sediments, and water across the floodplain, a higher incidence of floodplain wetlands, and an increase in anaerobic conditions in some of the soil on the floodplain (Naiman et al., 1986). In the main Wasson channel, a pool-drop character (Hillman, 1998), which we can already begin to see in the current longitudinal profile (Appendix C), should continue to develop.
