*Rehabilitation Best Practices of Portland Commercial Properties*  
By: Celeste M. Cuti  
Winter 2011

TERMINAL PROJECT APPROVAL PAGE

Title: Rehabilitation Best Practices of Portland Commercial Properties

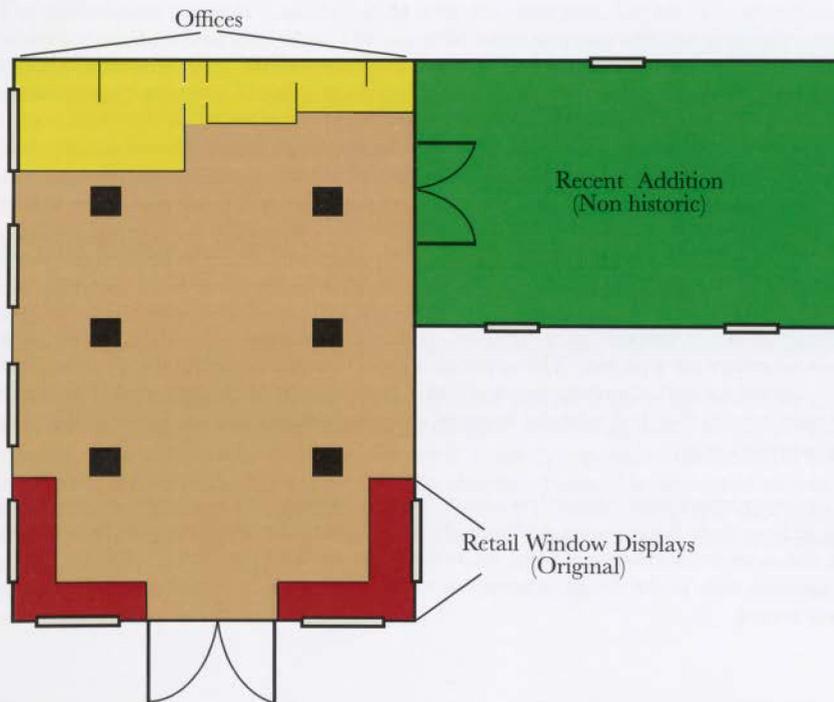
A series of preservation zones should be developed to help identify and rate spaces and features within a building. This will ultimately denote the range of historic significance throughout a property and should be shared and distributed among the development team. The highest level, Level 1, will be the features that are character-defining in the space and must be retained and restored. Levels digress to Level 4, representing a zone that is not historic or has been changed beyond reasonable repair. In this zone significant alteration will be allowed without harming historic fabric.

In this example, a building functioning as a retail space has a historic main section with a later, non historic addition. The original window displays are character-defining features and therefore must be preserved. The interior of the building retains a fair amount of integrity and therefore is zoned a Level 2. In the back, offices have been altered over time so they can be rehabilitated as needed. Since the addition is not historic, it is a free zone that can be altered significantly without risk of damaging significant historic features.

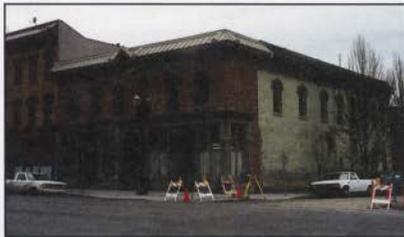
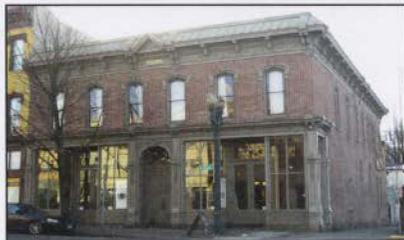
Architectural Heritage Center before and after rehabilitation. Top Left: Prior to rehabilitation in 2004. Photo courtesy of Oregon State Historic Preservation Office. | Bottom Left: After rehabilitation in 2010, photo by author. | Right: AHC is located on the corner of SE Grand Ave and SE Alder St.

As a nonprofit, rehabilitating a property can be challenging. A preservation nonprofit with the goal of returning a more than century old building to its original appearance adds even more pressure. But the years long efforts of the Bosco-Milligan Foundation paid off in 2005 when work concluded on West's Block, now named the Architectural Heritage Center (AHC).

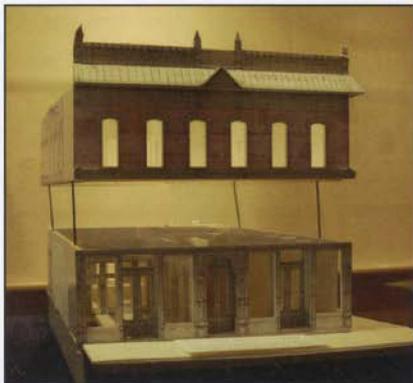
A model of West's Block on display at the Architectural Heritage Center illustrates the building's prominent bays and recessed entrances.

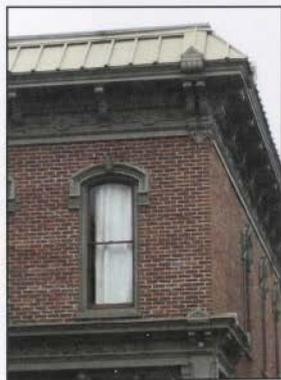
West's Block creative solution of a "brick flip" along the north facade was repeated on the front facade after it was proven to be a perfect solution to uncover the building's original brick color.

During this dilemma, a surprise arose when a beam on the front facade was found in extremely poor condition. It had

to be replaced. But to do so, the bricks above the beam had to be removed. As a creative solution to both problems of the beam and painted bricks, teams painstakingly removed the bricks one

the remaining facades were flipped to display their original coloring.

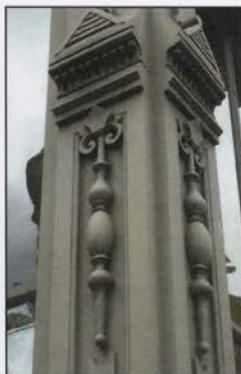
The intricate architectural details on West's Block were carefully restored during the building's rehabilitation into the Architectural Heritage Center.

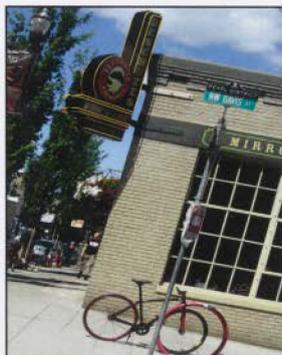
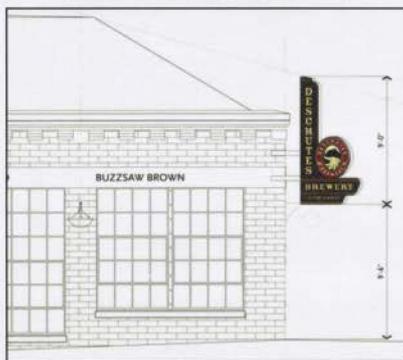
A scaled drawing of the southwest corner of the rehabilitation illustrates the new signage for the Deschutes Brewery. Bottom photo courtesy of OregonLive.

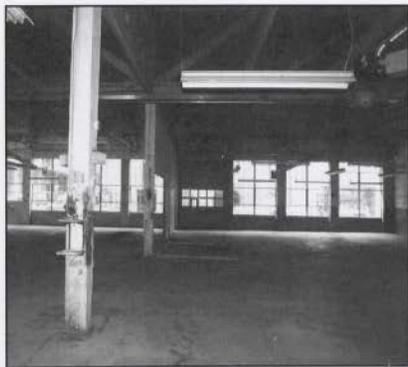
Left: The historic interior of the G.G. Gerber automobile repair center illustrates the building's open interior and bay system along the facade. Photo courtesy of Oregon State Historic Preservation Office. | Right: The interior of the redeveloped Deschutes Brewery include salvaged wood, much of which was carved and displayed throughout the restaurant. Photo courtesy of OregonLive

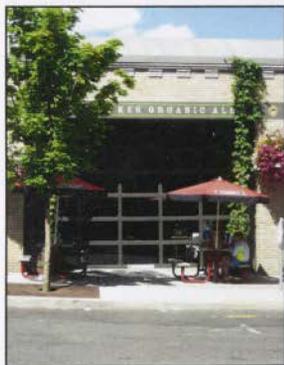
The building's rehabilitation provided a modern upgrade that was historically sensitive. New roll-up doors were installed, the entrance has a sleek new design and the banner along the roofline was altered to display the brewery's selection of beers.

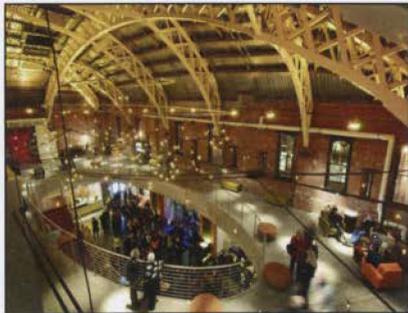
Left: The modern interior lobby proudly gives homage to the building’s historic truss system. With an oval cutaway in the second story floor, the open space and architectural features are also prominent from the main level. Photo courtesy of the Architectural Heritage Center. | Right: A video of the history and rehabilitation of the Portland Armory Annex awaits visitors in the lobby of the renamed Gerding Theater at the Armory. Photo courtesy of Lee’s Better Letters.

In the end, all projects were approved, albeit with some reconfiguring, allowing the multi-phased, 60-month construction plan to begin. On the exterior, the bricks and stonework was cleaned and repointed. New windows matching historic ones were installed and period windows were repaired. The building was seismically

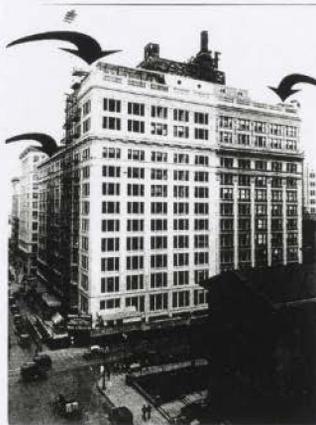
1932

1909

1915

The Meier and Frank building additions, photo circa 1931. Photo courtesy of "Meier and Frank: Saving One of America's Great Stores," Heritage Consulting Group, Jul 2008.

also added to the 1909 portion of the building. During the rehabilitation, there were several surprises when construction crews found floors they didn’t know where there, and in addition, they were oddly sized, originally designed to match up with previous additions.

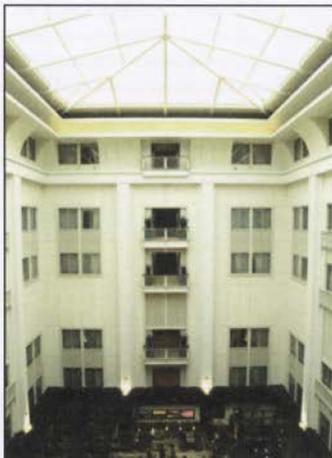
An atrium was punched into the core of the historic Meier and Frank building, creating a dramatic interior lobby in The Nines hotel. Photo courtesy of SERA Architects.

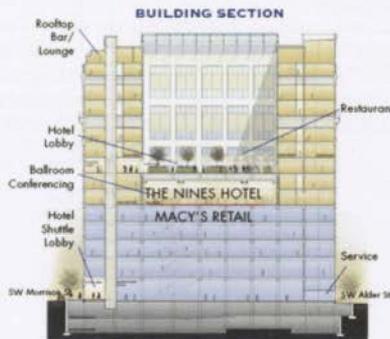
The Meier and Frank Building rehabilitation plan. Courtesy of the PDC.

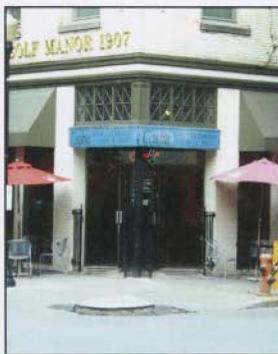
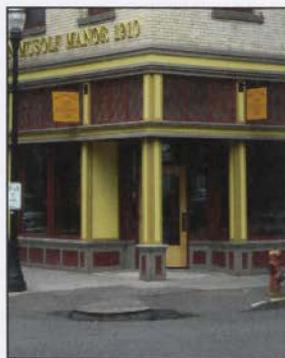
Left: Entrance of the historic Foster Hotel before rehabilitation in 2007. Photo courtesy of Oregon State Historic Preservation Office.

| Right: During the rehabilitation, the building's entrance was returned to its historic appearance. Photo by author.

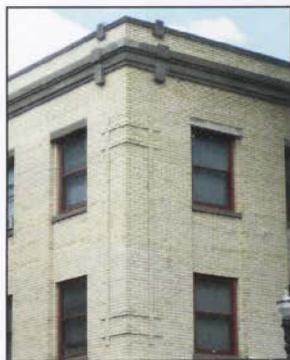
Left: The building's residential windows became a point of contention during design review as hard evidence could not be found to support their date of installation. As a result, they were removed, repaired and reinstalled. | Right: The building's lobby was reconfigured for greater functionality and ease of use. Photo courtesy of Carleton Hart Architects. | Far Right: The construction schedule of the rehabilitated Musolf Manor was completed in three phases, allowing nearly continuous occupancy of the building by retail and residential tenants.

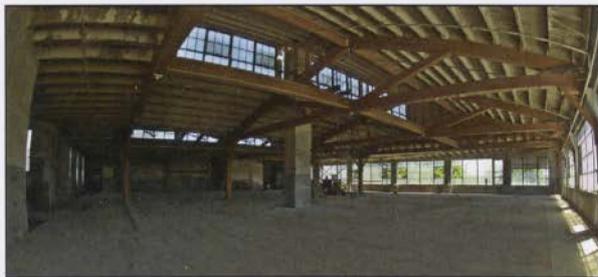
The interiors of the three buildings that comprise the White Stag Block had open layouts for the original warehouse programming. The fifth floor of the White Stag building with original light monitor was retrofitted as an architectural studio for The University of Oregon.

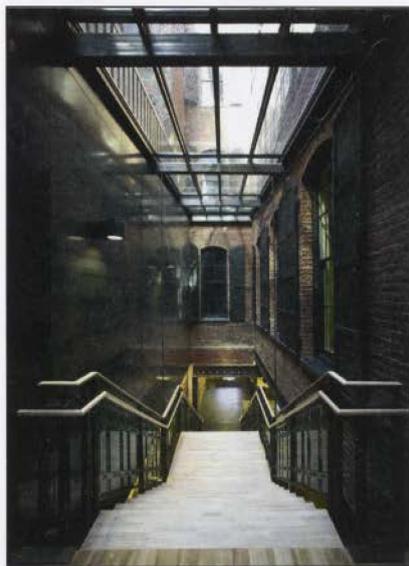
An interior light well was created where two of the White Stag Block's buildings meet. This was not only a solution for bridging the gap between buildings, but also to increase daylighting in the corridor. Photo courtesy of The University of Oregon.
