# Luper Pioneer Cemetery: A Cultural Landscape Report

A Terminal Project

Presented to the Interdisciplinary Studies Program:  
Historic Preservation  
and the Graduate School of the University of Oregon  
in partial fulfillment of the requirements  
for the degree of  
Master of Science

June 2014

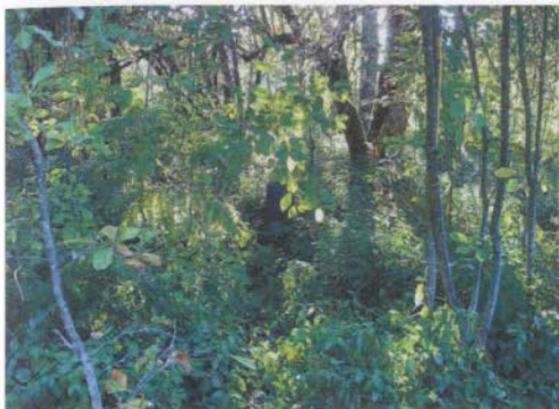
Luper Cemetery Prior to 2009 Cleanup (Unknown, Russ Carrey Binder, 2009)

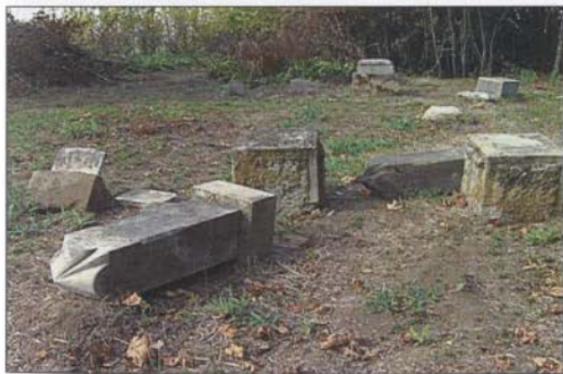
Luper Cemetery following major 2009 vandalism event. (KVAL News, Photographer Unknown, 2009)

As the Luper Cemetery Inc. non-  
profit was nearing completion of  
the 2009 cemetery restoration,  
vandals struck. The four vandals,  
who were later caught, jailed,  
and fined, damaged nearly eighty  
markers in the cemetery. Several

burial markers were stolen from the Luper Cemetery and were soon  
discovered on South Garden Way near Harlow Road in east Eugene.  
The damage from the major damage continues to be addressed  
and burial markers and fragments continue to be discovered on the  
site and elsewhere. In 2012 Ted Baker with Roberts Surveying,  
Inc. in Springfield, Oregon provided a much needed cemetery plot

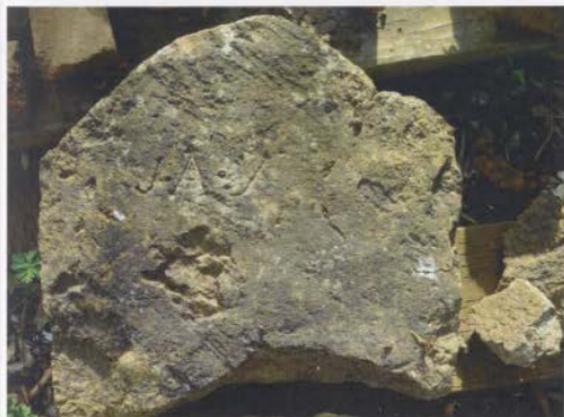
Heavily fragmented "J.A.Y." marker (Author, 2014)

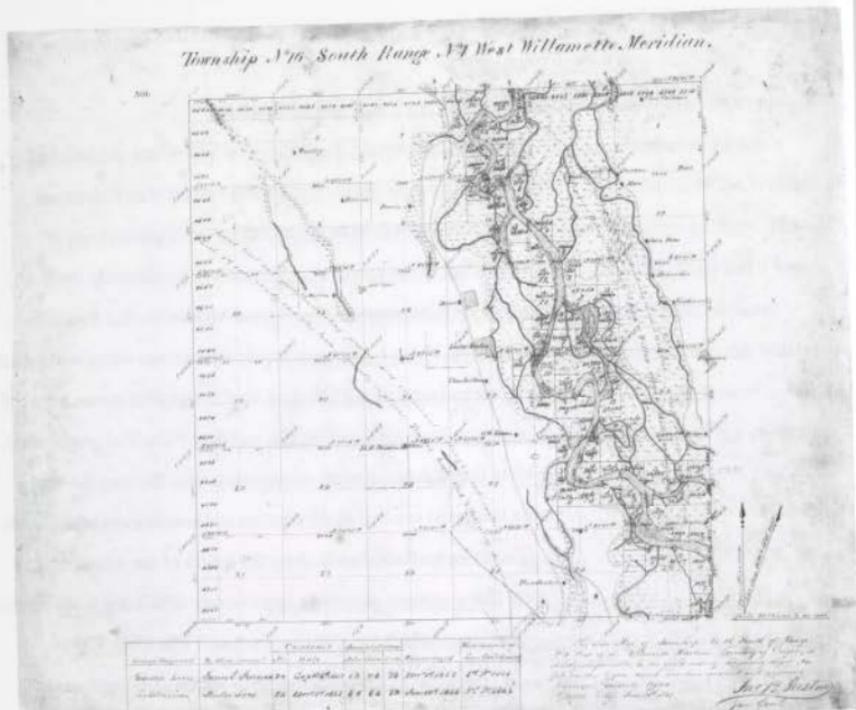
1852 survey of the township in which Luper Cemetery was established (United States Bureau of Land Management, Accessed 2014)

and described the landscape as being “level and gently undulating prairie with occasional sloughs, and swales. Soil first rate sandy and clay loam, gravelly in places, little Oak and Ash along the swales.”<sup>18</sup> This prairie landscape did not occur naturally. The Kalapuyas who once lived in the valley allowed, and sometimes introduced, fires that developed and sustained the prairie landscape. The prairie landscape in return sustained the pre-settlement humans, and provided habitat for wildlife.<sup>19</sup> Seasonal burning also allowed for the growth

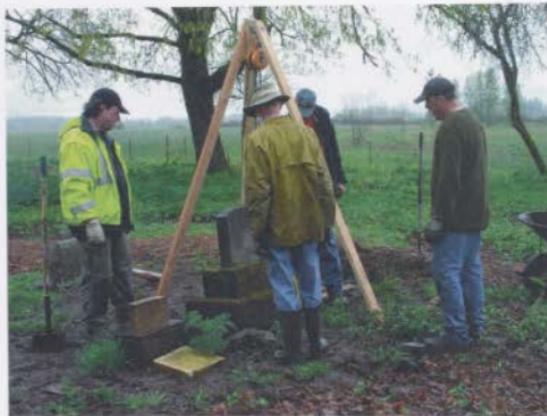
Luper Cemetery Inc. board members and volunteers reset burial markers (M. Boulton, April 2011)

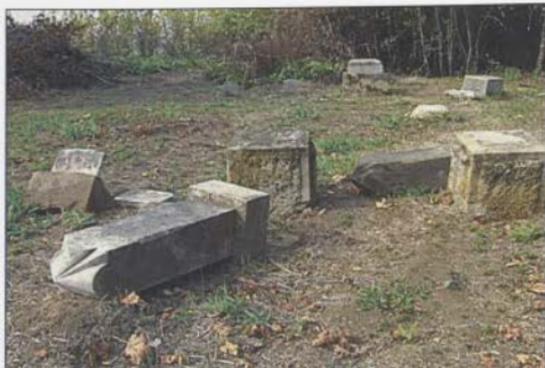
Vandalism at Luper Cemetery  
(Unknown, KVAL News, October  
2009)

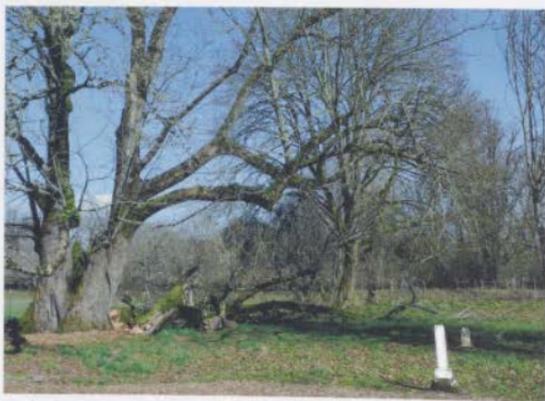
Big leaf maple loses branch in ice  
storm (Author, 2014)

In the spring of 2014 a major ice  
storm heavily damaged a section

of the old growth maple tree growing in the northwest corner of the  
cemetery. The fallen branch is to be cut into slabs for benches to  
be placed in the cemetery. During this same period, a marble burial

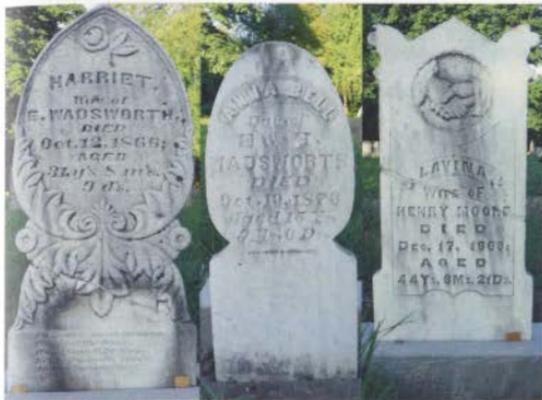
Harriet Wadsworth, Anna Bell Wadsworth, and Lavina Moore burial markers (Author, 2014)

marker with the name John Paul Legate was discovered buried along the west fence line. Several months later, Luper Cemetery, Inc., the cemetery's managing organization, located three original marble burial markers at Eugene Monument, a local burial monument business. The markers had been dropped off for repairs in the early 1990s and had been

storage for nearly 25 years. The located markers belonged to Lavina Moore, Harriet Wadsworth, and Anna Bell Wadsworth. Anna Bell's marker has been returned to the cemetery, and Harriet's and Lavina's markers will be returned upon the installation of replacement concrete bases.

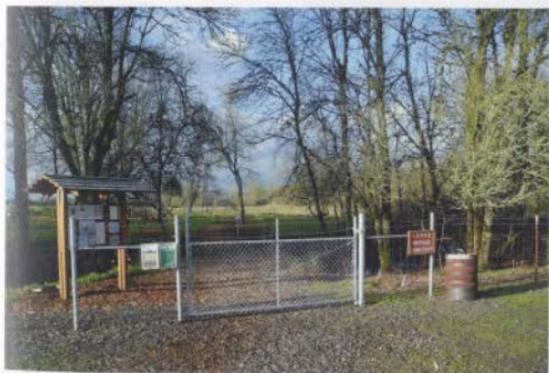
holder containing interpretive handouts, which explain the history of the Luper Cemetery, is affixed to the fence. This parking area is approximately 1/2 mile south of the cemetery.

Cemetery gate and adjacent parking (Author, 2014)

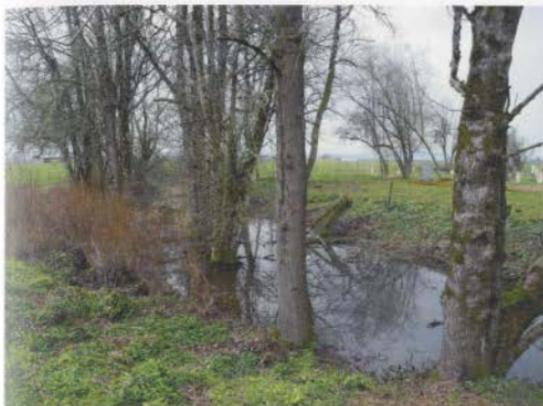
Slough on south boundary of cemetery (Author, 2014)

The soil has a high water capacity, which results in it being very soft during the spring rainy season. Flat Creek, a tributary of the Willamette River, and its floodplain border the cemetery near its east side. The southern property boundary is formed by a deep but narrow slough. The slough is possibly part of the extensive infrastructure that was

built for the purpose of draining the Willamette River valley during the mid to late nineteenth century. The landscape surrounding the Luper Cemetery is heavily altered as a result of the wastewater treatment plant, which was constructed in the early 1980s. A large amount of re-grading occurred during the construction process which resulted

in the slough being filled in up to the cemetery fence line, and large amount of fill material being deposited directly north of the site.

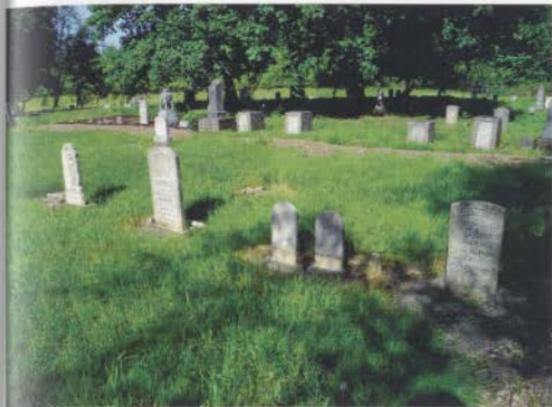
Cemetery burial markers (Author, 2014)

The cemetery is the site of 134 burial markers and bases. Many years of deferred maintenance and vandalism have taken their toll on the burial markers as many have been stolen, broken, lost, or

damaged beyond recognition.

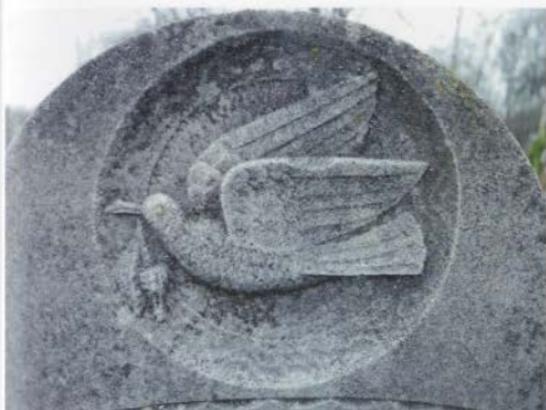
Dove design on George C. Baker burial marker (Author, 2014)

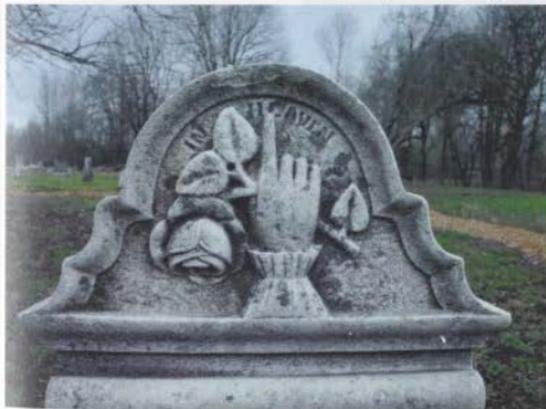
Decorative detail of Almira Cummins burial marker (Author, 2014)

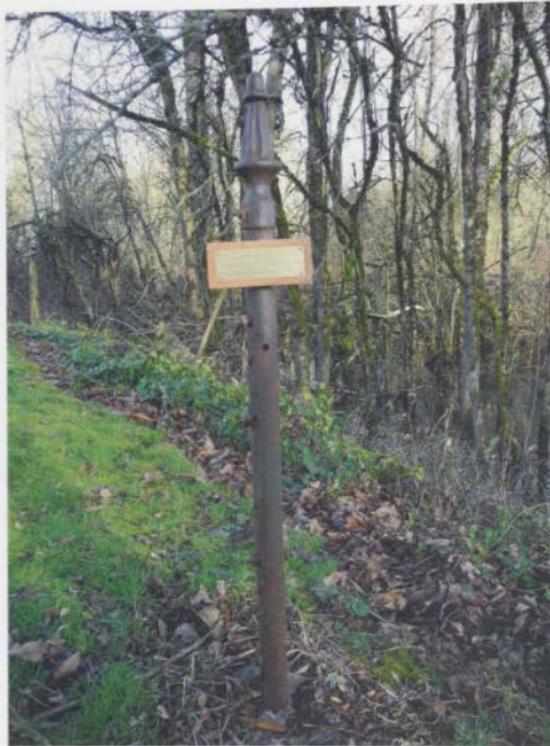
Cast iron fence post discovered on east fence line (Author, 2013)

posts. One complete post was discovered buried on the southeast corner of the cemetery, a second broken fence post on the north fence line, and a third post missing its ornamentation on the west fence line. The period in which these fence posts were installed is unknown, but they likely date from the end of the nineteenth century. Two small contemporary rustic wooden benches with narrow profiles have been installed within the historic cemetery core. A sign measuring approximately one-foot by two-feet constructed of foam board has been nailed to a cherry tree on the west side of the cemetery. A second sign of the

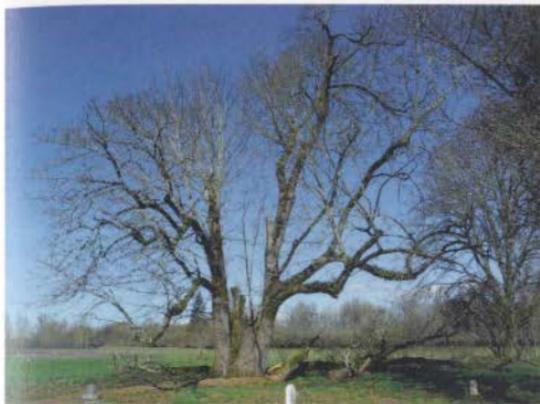
Throughout its history, the cemetery has experienced cycles of maintenance and abandonment. The cemetery is anchored on the northwest corner by a large old growth maple tree. The

Big leaf maple in northwest corner of the cemetery (Author, 2014)

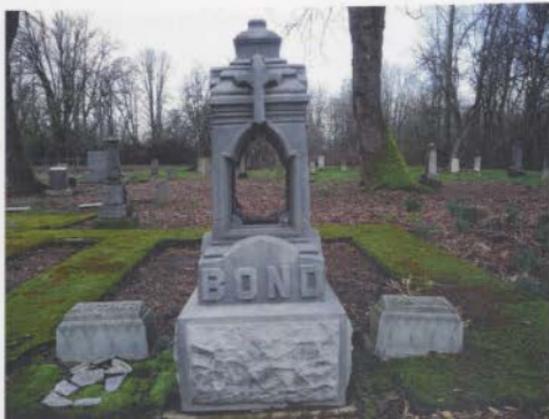
Cast zinc burial marker for Isaac, Hettie, and William Bond (Author, 2014)

markers date from 1857 to 1995 and are carved and constructed from a wide assortment of natural and engineered materials such as marble, limestone, sandstone, granite, concrete, zinc, and brick. The wide range of materials corresponds to the evolution of material availability and carving technology used to create and decorate the stones. The use of cast iron fence posts to mark the cemetery boundary further adds to the variety of materials present on the site.

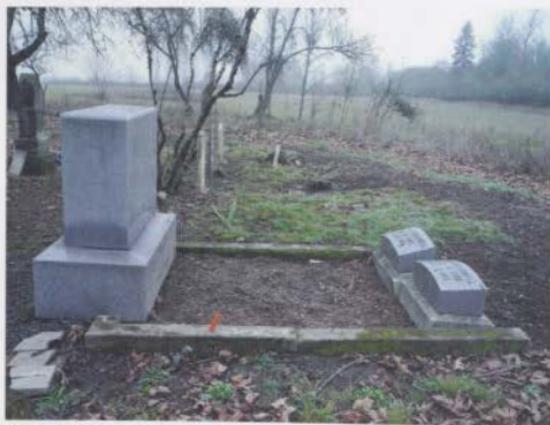
Granite monolithic burial markers for J.A. and Sarah Bushnell (Author, 2014)

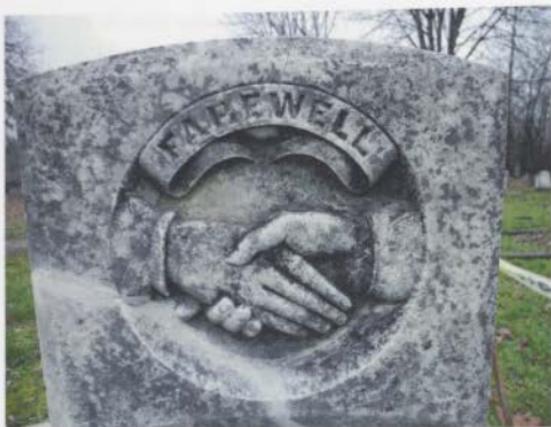
Clasped hands motif on the Eliza J. Ford burial marker (Author, 2014)

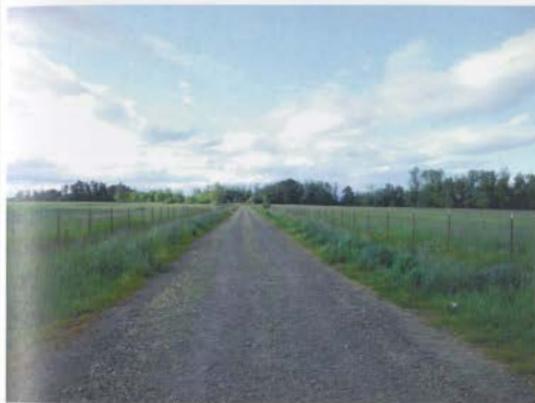
Cemetery approach north of W. Beacon Drive (Author, 2014)

south cemetery property boundary is non-historic as it was completed in 1984 upon the removal of the 1880s roadway. The approach is compatible, as it does not detract from the cemetery landscape and provides a similar experience to that of the original location.

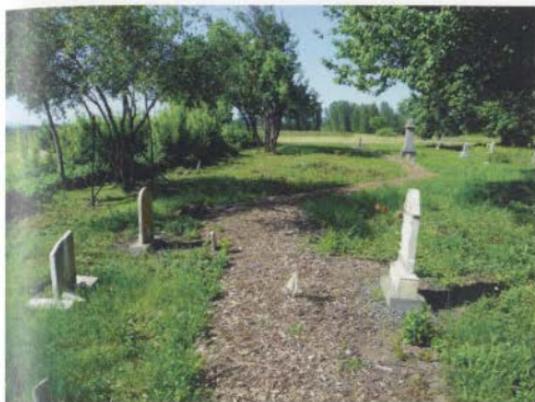
Mulch pathway in the cemetery core  
(Author, 2014)

of mulch walkways that were installed using mulch donated by a local tree care company. The mulch pathways begin south of the swale, near the entrance gate and interpretive kiosk, and pass over the drainage culvert where they branch out into the cemetery. The pathways circle the core of the site and pass through areas with higher densities of burial markers.

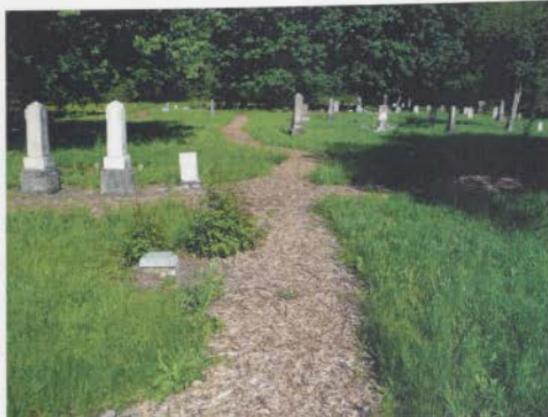
West to east contributing cemetery pathway alignment (Author, 2014)

The west to east pathway passing south of the Robinson family plot and through the middle of the Maxwell family plot follows the approximate alignment of the path visible in the 1930s aerial imagery. The contemporary mulch pathways are non-contributing, but are compatible with the cemetery's historic character.

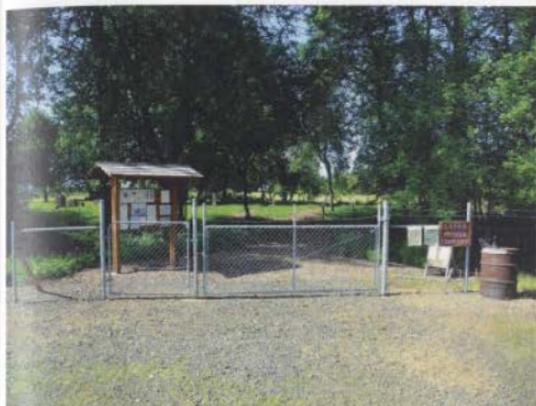
Contemporary entrance gateway and filtered views across slough into the cemetery core (Author, 2014)

contemporary parking area immediately adjacent to the cemetery and entrance zone, where the path crosses the slough, provides filtered views of the cemetery. Visitors entering the cemetery from the contemporary entrance experience spatial compression as they pass from the open parking area across the slough where there is dense tree canopy and shade, and finally enter into the much more open expanse of the two acre cemetery. While this entry sequence is not historic, it is compatible.

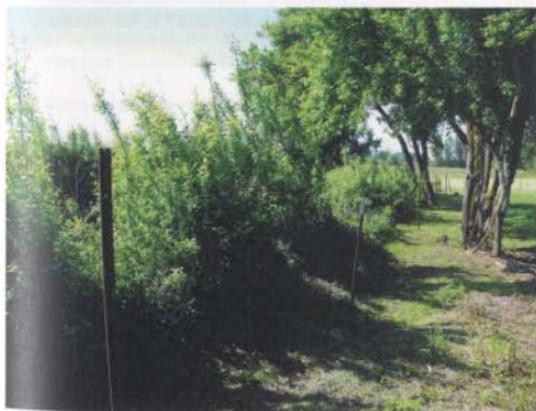
Overgrown trees and shrubs on west buffer zone block views to the Coastal mountain range (Author, 2014)

The cemetery itself retains the majority of its historic vistas. Historical aerial imagery depicts the floodplain east of the cemetery to be largely clear of shrubs and trees. This likely provided a much clearer view of the foothills of the Cascade Range from within the cemetery. Currently the Flat Creek floodplain is heavily overgrown which largely blocks all views to the east. The southern vista is largely blocked as a result of a dense tree canopy in and adjacent to the slough. The views to the north and west remain largely clear except for some small trees and shrubs growing in the buffer zone between

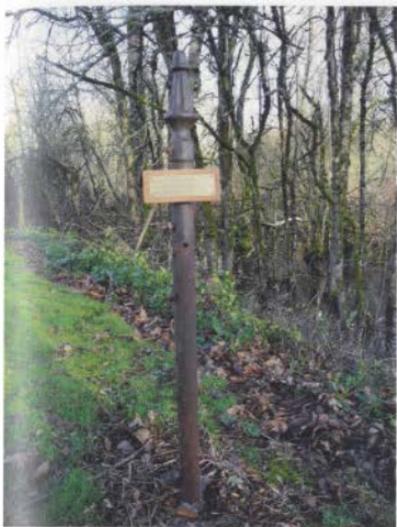
Cast iron fence post discovered on east fence line used as interpretive display near entrance (Author, 2014)

boundaries of the Luper Pioneer Cemetery. Cast iron fence posts, such as the one discovered along the east fence line and currently set in concrete near the contemporary entrance, should be left in the location that they are originally found. Moving fence posts outside of their historic placement negatively affects landscape integrity. The broken cast iron fence post discovered on the north fence line in the spring of 2014 should be re-welded to its base at the location it was found. Future fence post discoveries should be documented and reset in the location along the property line that they are found. Remnant fencing material located along the slough should not be removed, as it is the last remnant of the likely pre-1980s fencing material and provides

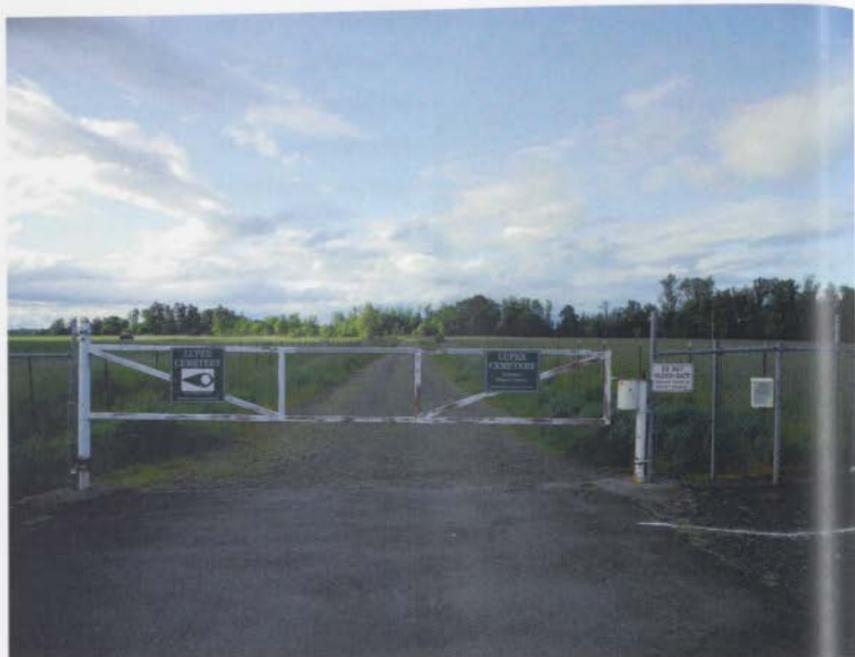
Zone 1 including primary and secondary gates, parking areas, interpretive zone, and all-weather road(Author, 2014)

**Zone 1:** The first zone consists of the entrance parking at West Beacon Drive, the entry drive contained within the two wire fences, the secondary parking adjacent to the cemetery, and finally the interpretive zone, which spans from the second gate to the earthen bridge across the slough. The width of the interpretive zone spans from the west support post of the interpretive kiosk to the proposed location of the memorial stone as determined at the April 9, 2014 Luper Cemetery Inc. board meeting. The area that falls beyond these two locations is part of Zone 2.

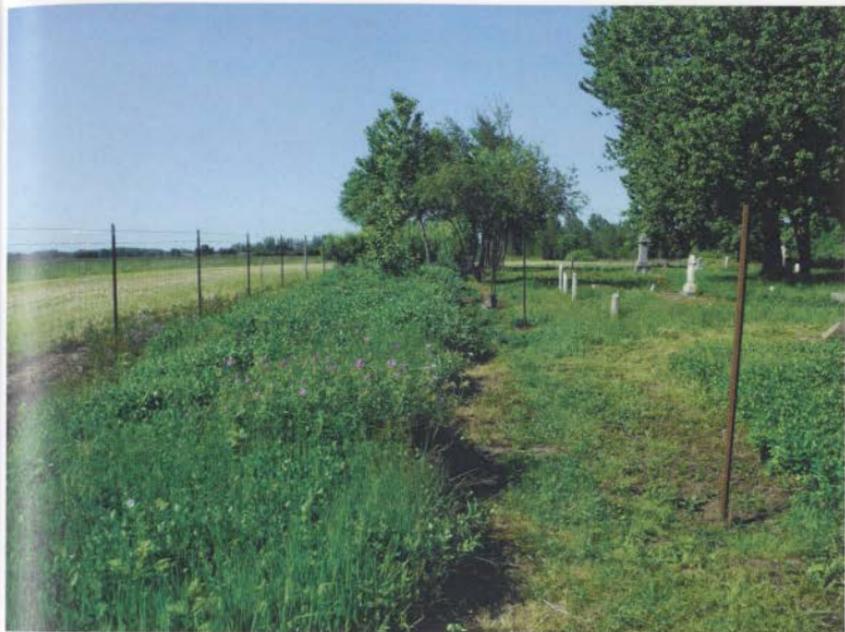
Zone 2 includes the 1983 buffer and natural slough. (Author, 2014)

**Zone 2:** The second zone consists of an approximately 12' buffer strip created in 1983 with the construction of the waste water treatment plant. The buffer is comprised of the land between the historic fence posts and the contemporary wire fence that borders the north, west, south, and a portion of the east cemetery historic property boundary. The buffer zone includes the slough.

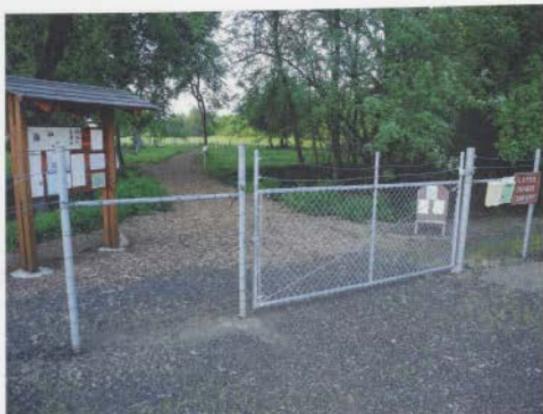
Secondary gate and interpretive area  
(Author, 2014)

The entrance zone adjacent to the slough currently serves as an interpretive area with an existing redwood kiosk and planned memorial stone to be installed in the fall of 2014.

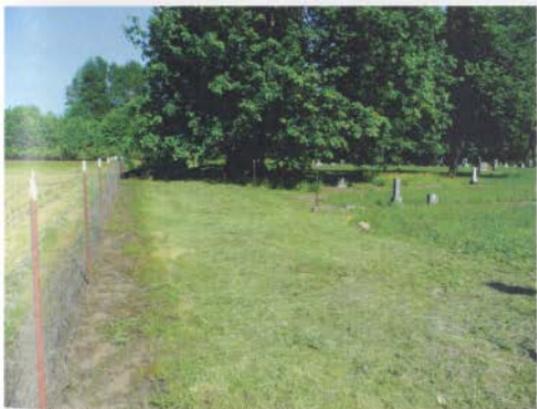
Buffer near the northwest corner of the cemetery looking east towards old maple. (Author, 2014)

of the cemetery buffer zone is varied. The buffer excluding the slough should have a singular management strategy. Areas within the buffer with *Vinca minor* as a ground cover should be maintained with the only management being the removal of invasive blackberry and volunteer trees. Areas that are currently mowed should continue to be maintained in the same way.

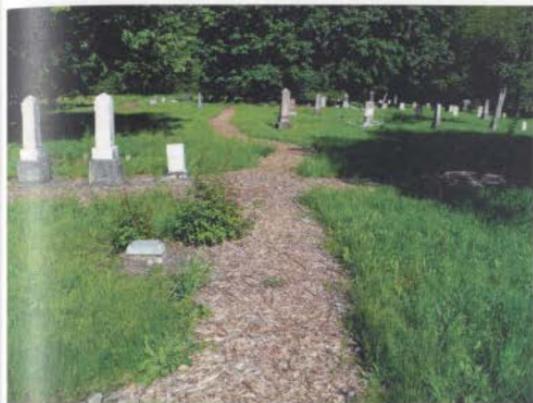
The wood chip pathways located throughout the Luper Pioneer Cemetery are contemporary additions. A portion of the pathway extending from the area of the historic gate on the west property

West to east contributing cemetery pathway alignment (Author, 2014)

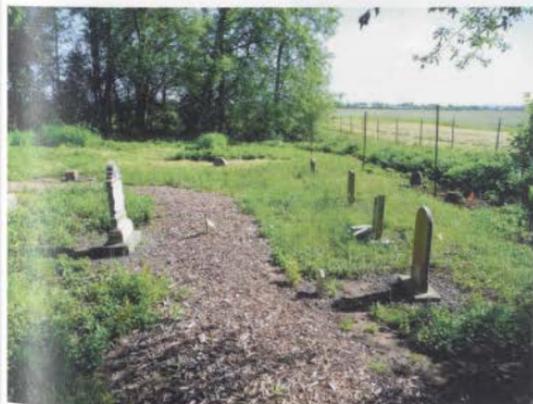
Pathway located between Almira Cummings and Laura Butler markers should be relocated. (Author, 2014)

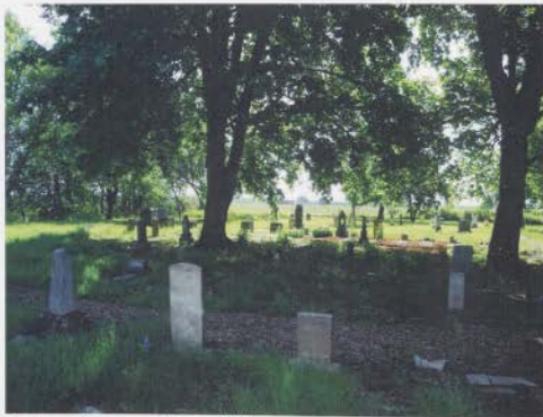
Low branches on maple trees block views to the western agricultural fields and Coastal Mountain range (Author, 2014)

The preservation of the external views to the surrounding landscape including agricultural fields and coastal mountain range are essential to preserving the cemetery's landscape setting. Internal views should be retained within the cemetery's historic property boundaries through the selective pruning of the two large maples on the east side of the

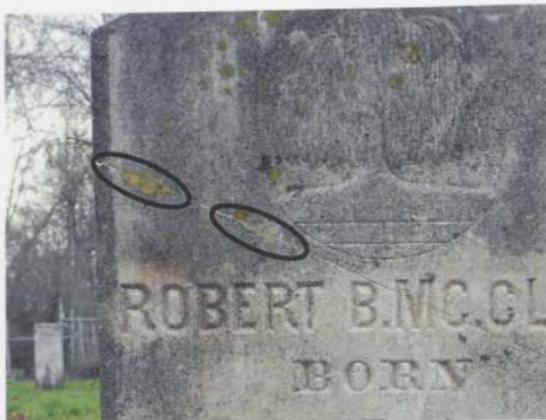
Dripping epoxy on Robert B. McClure burial marker is irreversible. (Author, 2014)

Future burial marker conservation should be completed with continued direct guidance from a qualified materials conservator. All burial markers and repairs are different and as a result will require that treatment decisions be made on a case-by-case basis. Burial markers undergoing conservation should be photographed before, during and after the repair/stabilization. Upon the completion of the repair, a treatment report with photographs and a detailed explanation of the scope and extent of repairs completed should be compiled. The treatment report should be added to the 2014 and future cemetery inventory and assessment reports as documentation of completed repairs. Burial markers continue to be discovered on site and elsewhere. Upon the future discovery of any future markers, fragments, and other archaeological features, it is important that these are photographed and mapped on the 2012 cemetery survey completed by Roberts Surveying, Inc. Great care should be taken not to rush the repair process, as a high level of craftsmanship is more important than speed in conservation work. Several recently repaired

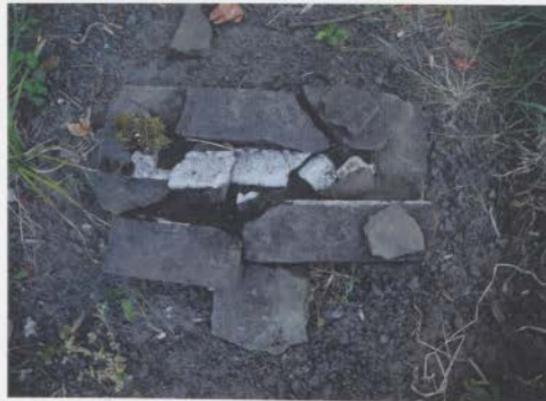
Heavily fragmented base for unknown marker. (Author, 2014)

fabric and should not be removed or relocated. The replacement base should be set onto pea gravel rather than the current large diameter grey stone material being used. The pea gravel has a finer texture that is much more similar to the texture of the stone markers located in the cemetery dating from the historic period.

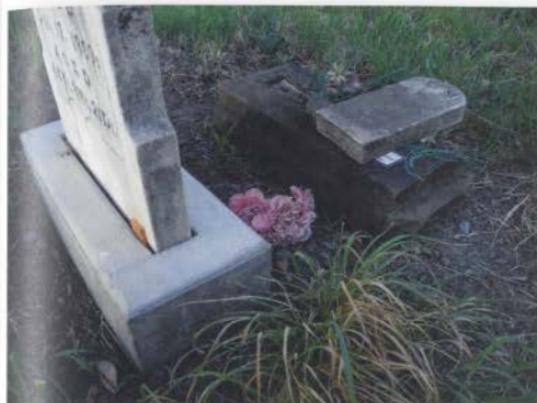
Replacement base for Lavina Moore placed in front of original base. (Author, 2014)

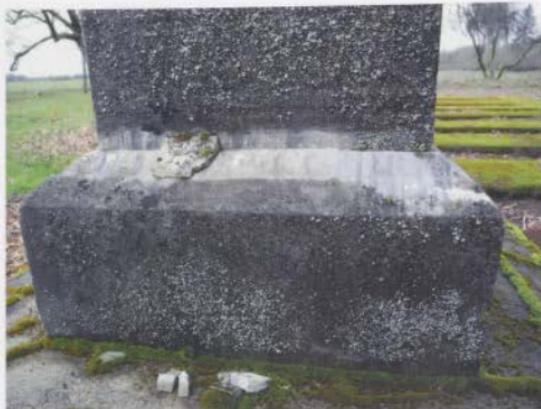
Dark veining on the light grey marble marker is visible where mortar has detached. The exposed stone color is how the marker was intended to be viewed in the cemetery. (Author, 2014)

The cemetery markers in the Luper Pioneer Cemetery are heavily soiled as the result of nearly 150 years of exposure to the elements and biological growth. Many markers are in stable condition and could benefit from careful cleaning by a qualified materials conservationist. The cleaning of burial markers should be addressed on a case-by-case basis, as each marker will require different approaches to ensure

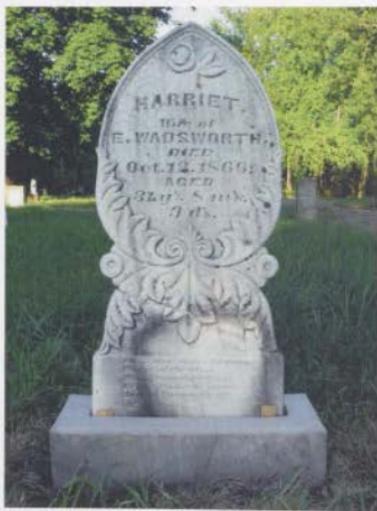
The original location of the Harriet Wadsworth burial marker is unknown. The marker is set into a replacement base (Author, 2014)

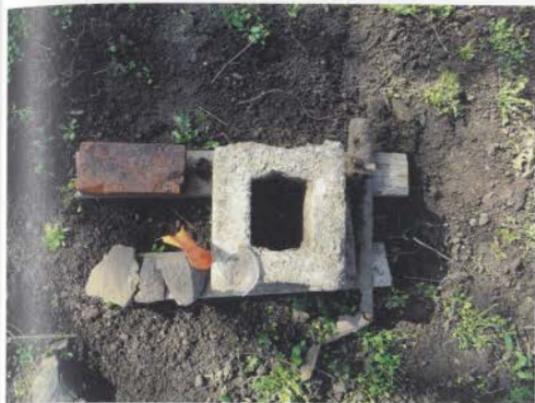
Bricks and other lightweight materials discovered through probing should be photographed, mapped, and reburied as they are contributing archaeological features and are highly vulnerable to being moved.

Unidentified fragments should be documented, mapped, and reburied. (Author, 2014)

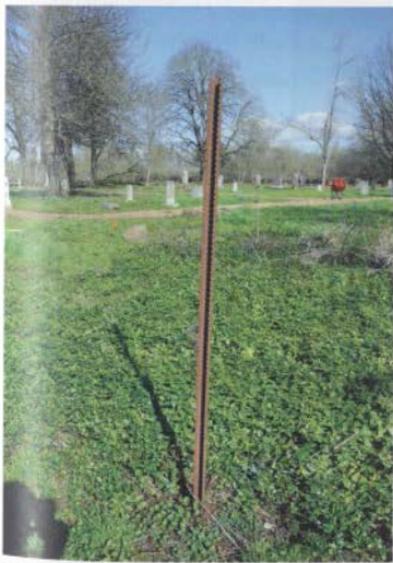
T-Post from pre-1983 fence. (Author, 2014)

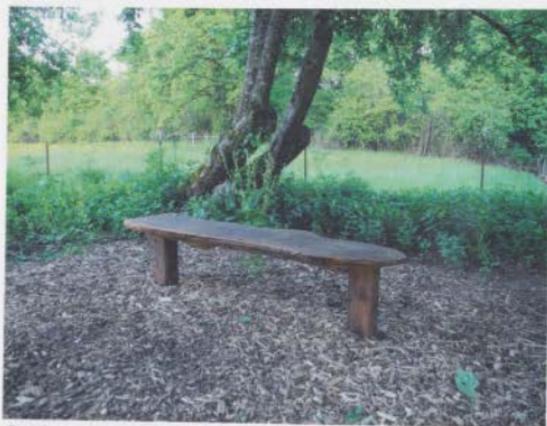
Contemporary rustic bench beneath apple tree adjacent to east buffer. (Author, 2014)

located on the periphery near the historic property boundaries. The rustic benches are nondescript and do not distract from the landscape itself. The use of a large branch from the old maple tree as a bench in the northwest corner where it fell is appropriate as it continues the rustic design vocabulary using natural materials.

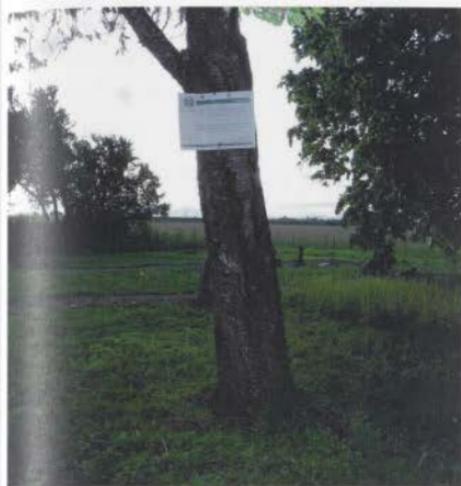
Sign attached to cherry tree near northwest corner of cemetery near old Big Maple. (Author, 2014)

Signage within the historic boundaries of the Luper Pioneer Cemetery is a major concern. Two large white signs indicating volunteers affiliated with Stop Oregon Litter and Vandalism (SOLV) organization cleaned the cemetery have been nailed approximately nine feet above the ground in two separate mature trees within the historic property boundaries. These signs are modern intrusions that heavily detract from the historic character of the pioneer cemetery. The two large signs nailed to trees within the historic core of the cemetery have become excessively worn due to exposure to the elements over a period of several years. These signs and the nails supporting them should be removed. A third sign, consisting of a laminated sheet of paper has also

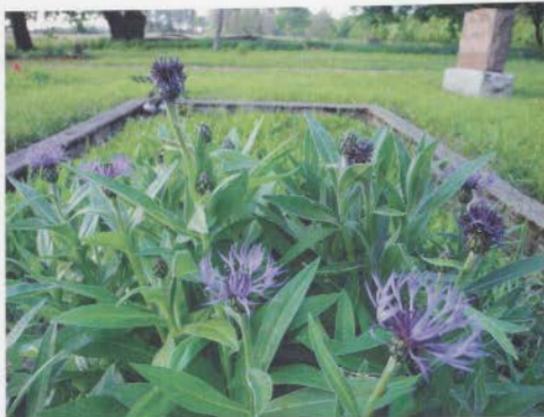
Bachelor's button (*Centaurea montana*), a perennial, grows in a burial plot bordered by a concrete curb. (Author, 2014)

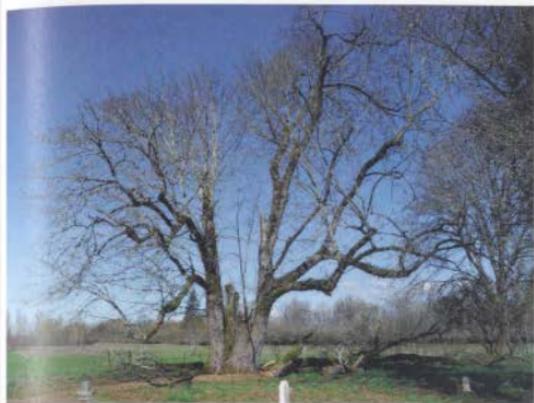
The Big leaf maple (*Acer macrophyllum*) in the northwest corner of the cemetery is estimated to be 140 years old. (Author, 2014)

The replacement of this integral landscape feature should be planned in advance to mitigate the impact of the tree's unavoidable loss. There are several alternatives available from the preservation of the tree's genetics to its replacement in kind. The first option, which is the preferred alternative, is to create a graft and grow a genetic clone of the tree. The creation of a clone will ensure the historic tree's genetic

The second alternative is to harvest and plant a seed from the tree that will share some of its parent's genetic material. This seedling should be grown for several years on or off site and planted into the cemetery landscape in the location of the old maple upon its removal. The final alternative is to replace in kind with a tree of the same species. This tree will not share

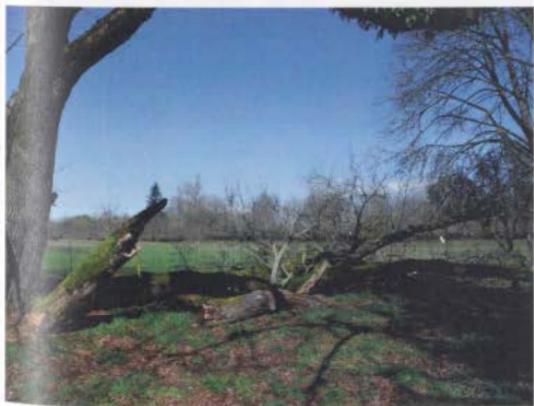
The large multi-trunk Big Leaf Maple (*Acer macrophyllum*) in the northwest corner of the Luper Pioneer Cemetery is approximately 140 years old. This date was determined through the non-invasive coring of the largest branch located on the southeast side of the tree. The tree has stood as a silent witness for nearly the entire history of the cemetery's development. The maple tree is in poor condition and is in a state of decline. A certified arborist should monitor the maple tree and remove limbs that are deemed by the arborist to be unsafe.

Several large branches fell from the maple during a spring ice storm. (Author, 2014)

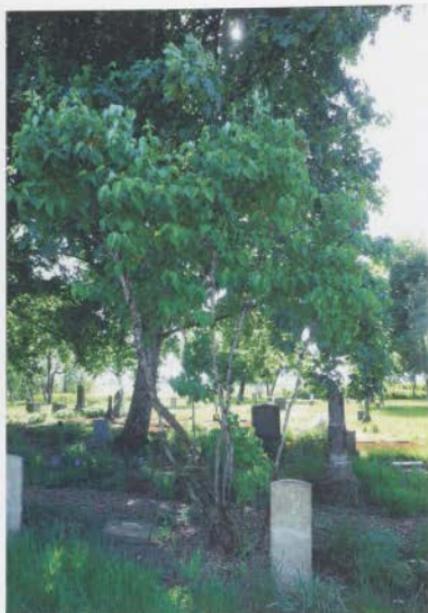
Lilac shrub grows in the Jennings family burial plot on the east side of the cemetery (Author, 2014)

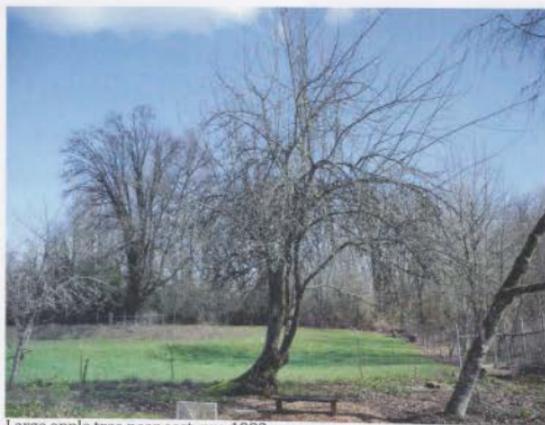
Large apple tree near east pre-1983 fence line (Author, 2014)

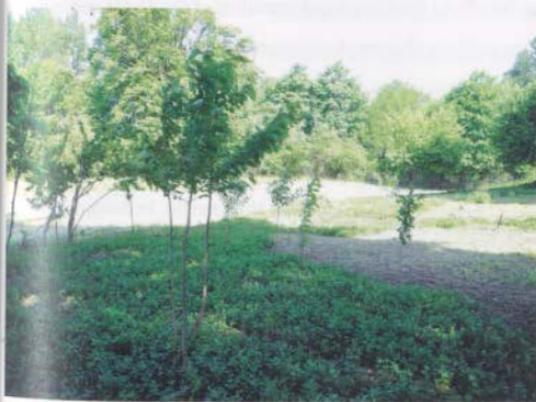
be removed so that character-defining features are not damaged or destroyed. These trees seed profusely and the majority of trees under 5" diameter at breast height (DBH) are of these three species. Visible damage to many burial markers, curbs, and slabs can be attributed to the maple, cherry and hawthorn seedlings and saplings.

Sapling cherry trees growing near the northeast cemetery corner should be removed. (Author, 2014)

DBH determined to be non-contributing should be removed. The preservation of character defining landscape features in the cemetery should have a higher priority than the seasonal aesthetics of these three primary tree species. All trees growing along the historic fence line, excluding the apple trees should be removed as they block the external views and are their growth is the direct result of deferred maintenance

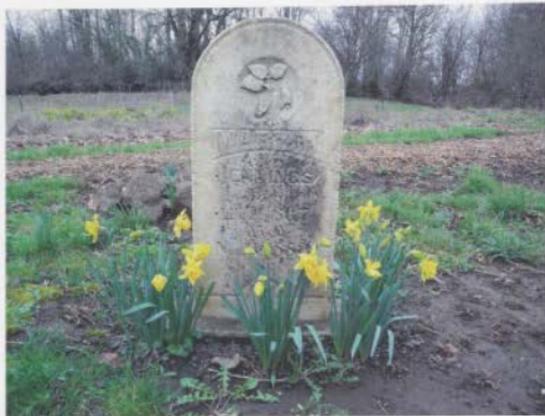
Daffodils growing around Mary Jennings burial marker. (Author, 2014)

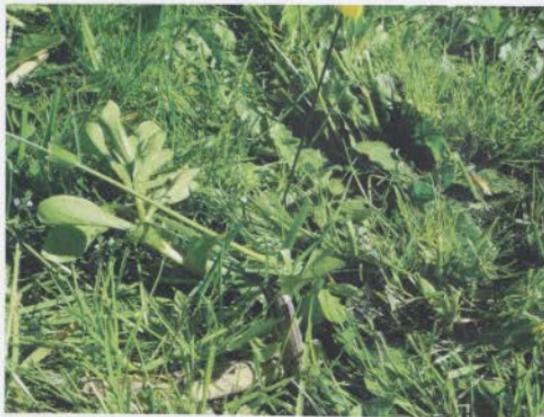
A lilly mowed down by a lawnmower (Author; 2014)

a short height. In doing this ornamental bulbs such as the lilies are allowed to grow, however, others that have not been identified are mowed down and as a result are unable to successfully photosynthesize. The repeated mowing of these contributing ornamental plants and the loss of their leaves will result in their inability to photosynthesize and

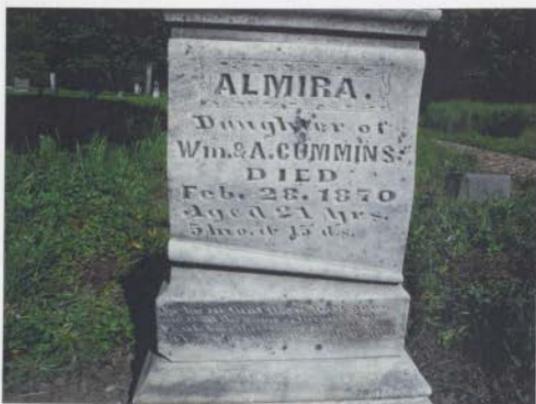
Documentation is important in determining changes that have occurred to the landscape over time. (Author, 2014)

retention of the cemetery's sense of place and identity. Cultural landscapes are dynamic as they are composed of both natural and cultural features that can change and evolve over both short and long periods of time. Complete documentation and assessment of the Luper Pioneer Cemetery landscape should occur at least once every five years. The

documentation and assessment will provide a set point in history to which future landscape evaluations can be compared to have a detailed understanding of changes that have occurred to the Luper Cemetery during the interim years. With the ever-present possibility of vandalism and other sources of damage or alteration, the documentation will provide a detailed primary source resource providing invaluable information about the cultural and natural landscape features.

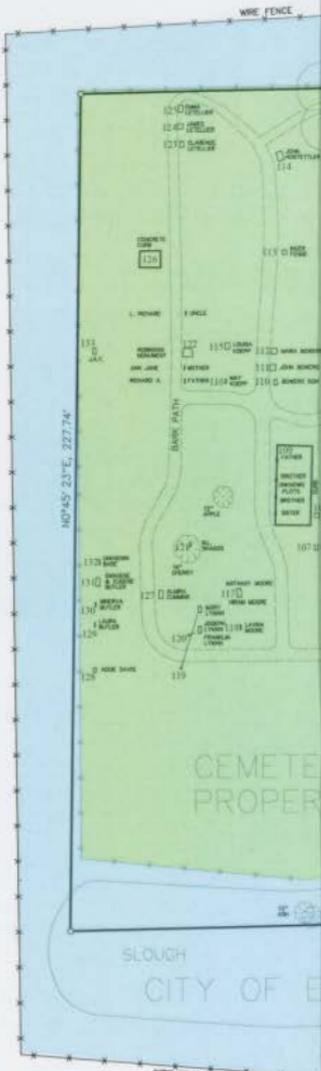
<b>NW 1/4 SECTION 34, T16S, R4W, W.M. LANE COUNTY, OREGON</b>	
CLIENT: LUPER PIONEER CEMETERY	
DRAWN BY: TB	
DATE: 4-09-12	
REVISION DATE: 5-12-13	
JOB NO: 12-SURVEY-008	
SHEET 1 OF 1

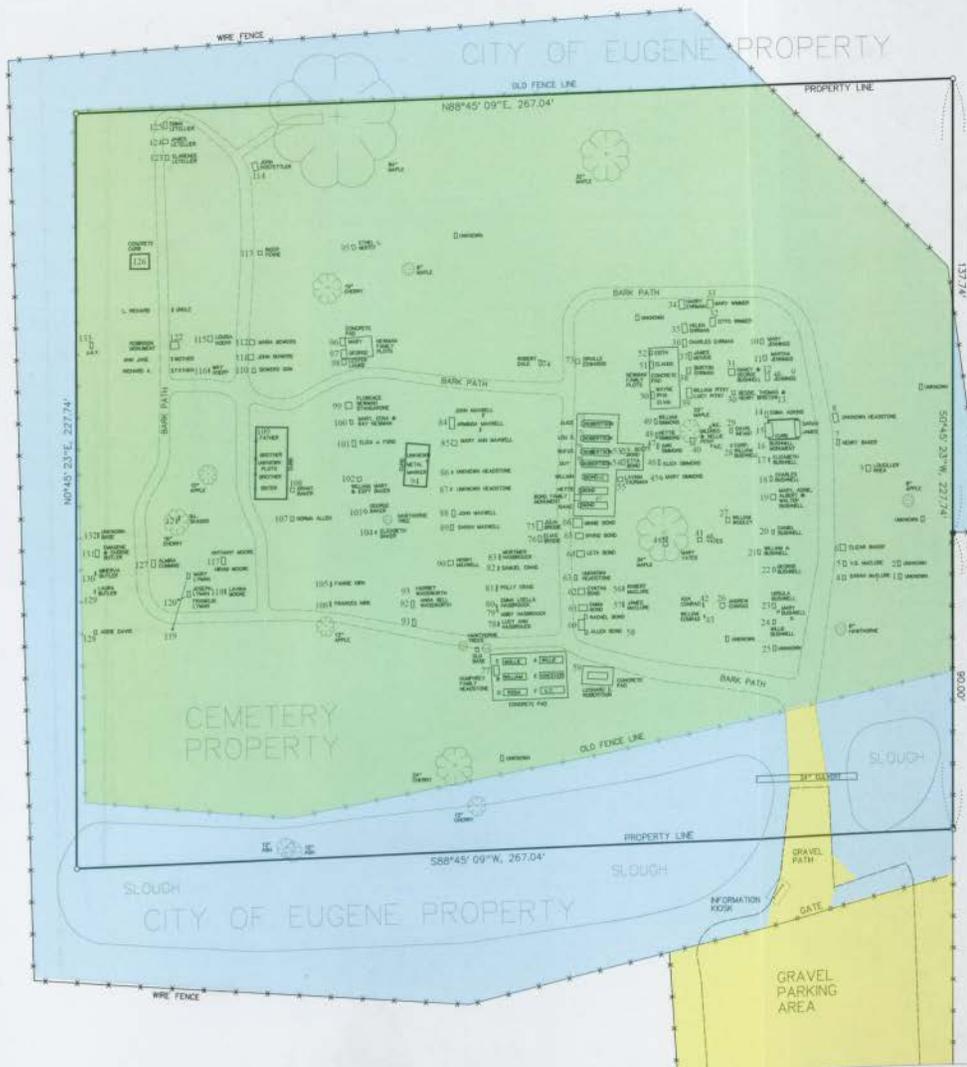
Landscape Treatment Zones  
Adapted from Roberts Surveying Inc.  
Luper Cemetery Survey 2012
