RESIDENTIAL PORTLAND 1911: THE VIEW FROM 2002

A Case Study in Preservation

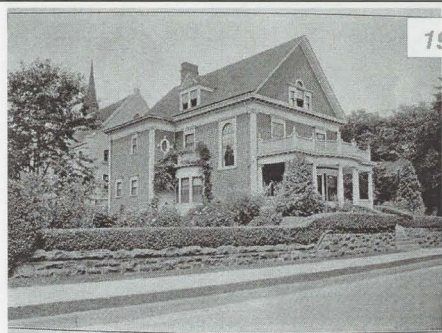
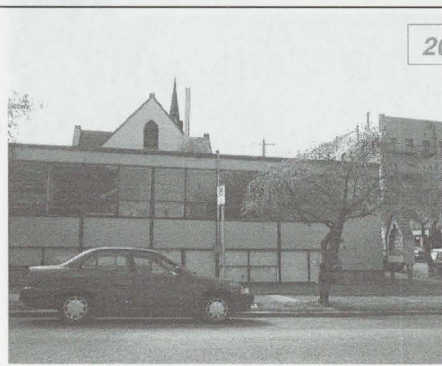
#2

COMMENTS: The existing building was constructed in 1957. The property at that time was known as the 1st Immanuel Lutheran Church parsonage with Sunday school; it is known as such today. This property is located in an area where many large residences were demolished in the 1950s and 1960s.

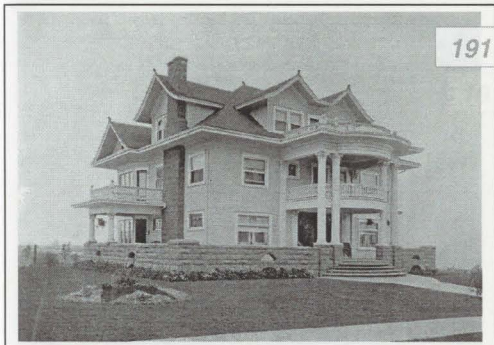
#4

COMMENTS: Construction of the current apartment complex began in 1968. The area is adjacent to the Lloyd Center shopping area and also to the Interstate 84 freeway, which accounts for deterioration of the originally single-dwelling residential area.

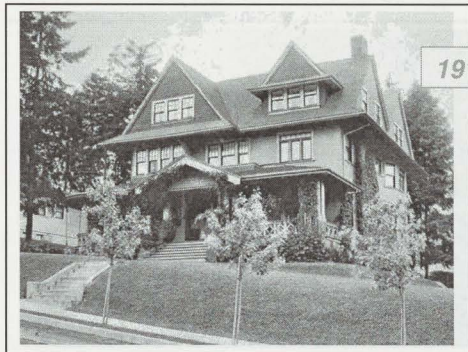
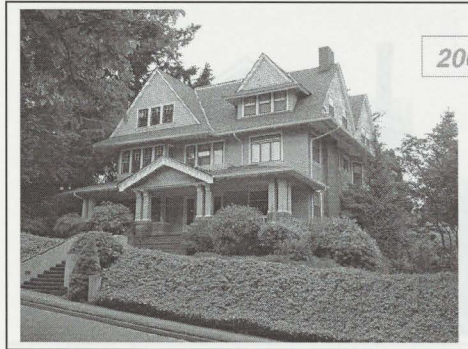
#6

COMMENTS: This property retains its historic appearance.

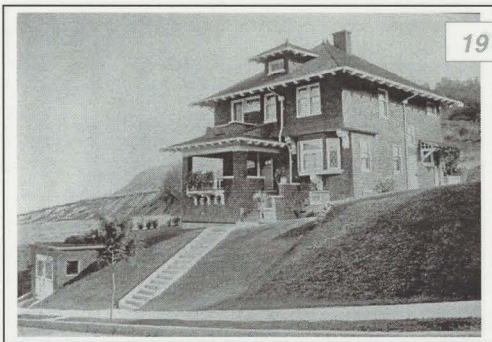
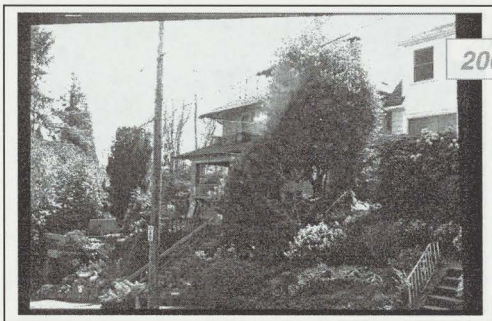
#9

COMMENTS: It is interesting to note that the surrounding area in the 1911 photo was under development when the picture was taken. Techniques for clearing the land were fairly intensive, including the use of high-pressure hoses to slice down the earth to create terraced lots and streets.

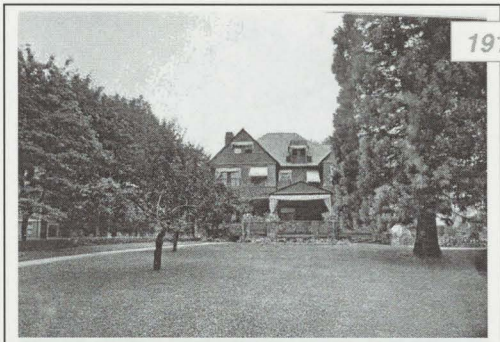
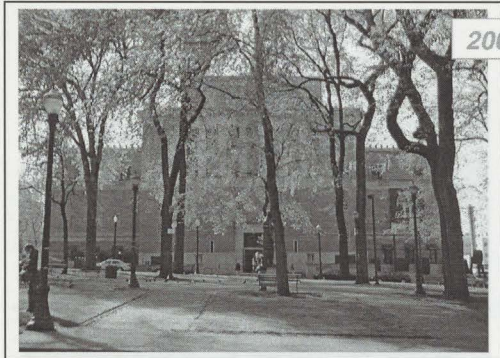
#18

In 1925 the 4-story Masonic Temple was constructed on the site of this and other residences for approximately \$1,000,000. See also #18.

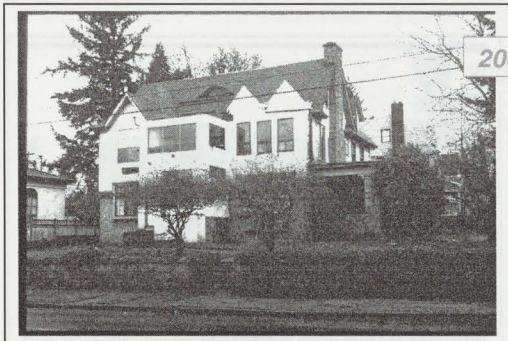
#22

COMMENTS: This property was extensively rehabilitated in 2001 following a long period of neglect.

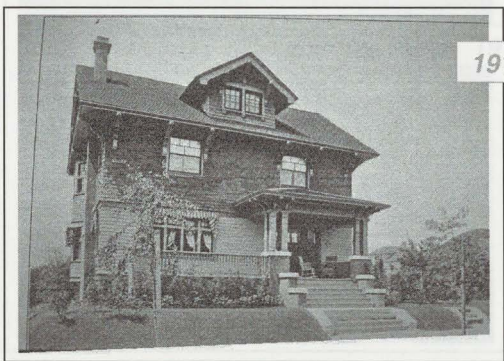
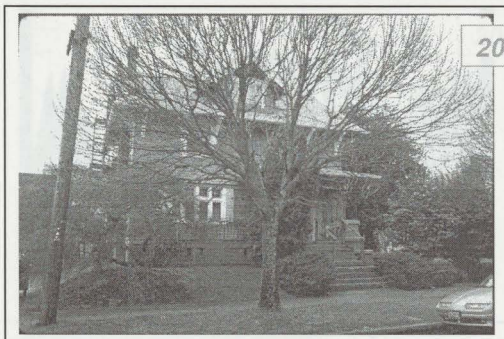
#27

COMMENTS: This residence is currently used as a halfway house for men and is owned by the city. It is located in an "edge" environment, with commercial activity and public transportation routes nearby.

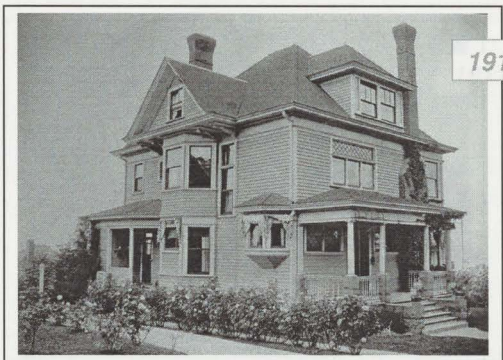
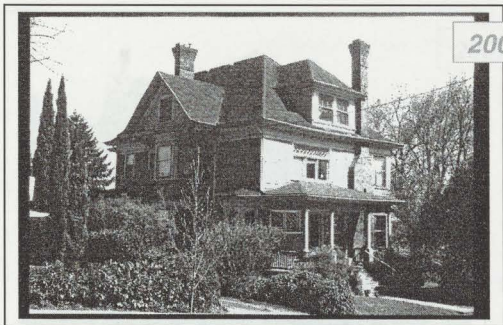
#28

COMMENTS: Properties in this residential neighborhood of northwest Portland have generally been well maintained and were not demolished. It is possible that this is because the area is fairly homogeneous, with many contemporaneous buildings and long-time homeowners.

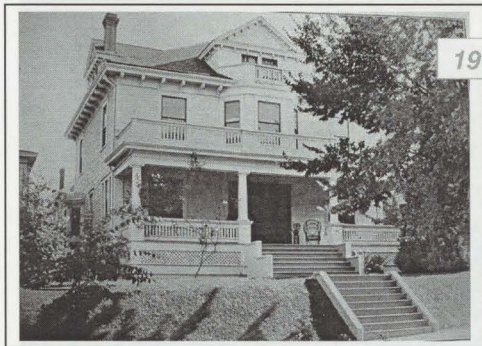
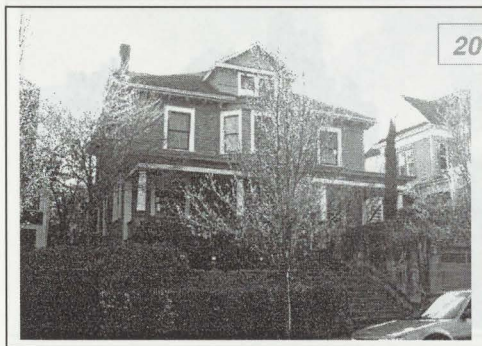
#29

COMMENTS: It is possible that the surrounding area in the 1911 photo was masked or blocked out, because this area was well developed by 1910. The property is currently used as a 3-plex.

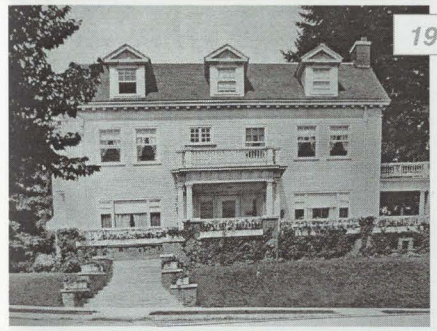
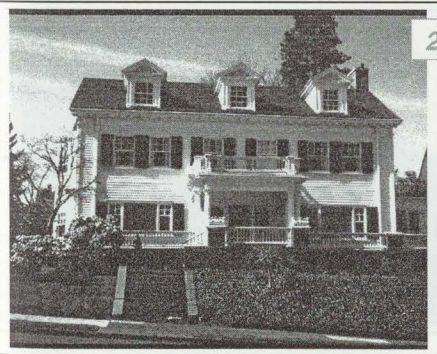
#42

COMMENTS: This residence is located in an exclusive neighborhood of southwest Portland. As a measure of the current value of this property, the tax assessment is approximately \$19,000 per year. Most properties in the area are well maintained and many are contemporaries of this one.

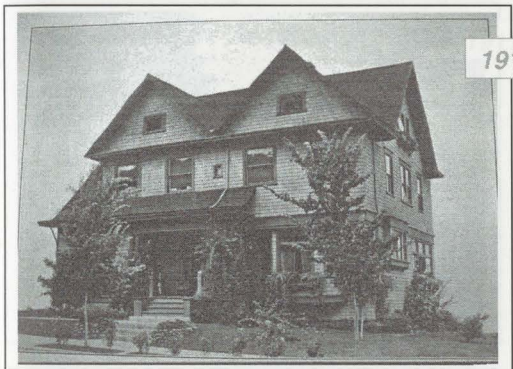
#44

COMMENTS: With the modified front porch addition, possibly dating to 1926, the house has lost one of its defining characteristics.

8/26 Re-shingled west half of house; foundation placed under porch

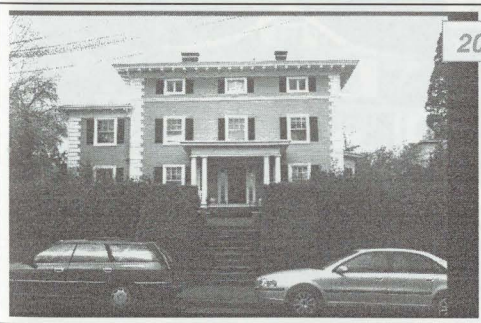
#58

COMMENTS: This property is listed in the National Register of Historic Places and is located in the King's Hill Historic District. The property has been well maintained and is a fine example of the Colonial Revival style.

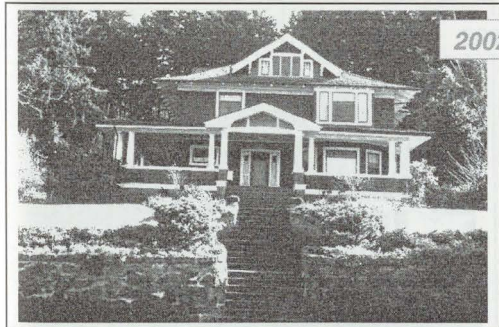
#59

COMMENTS: This property is remarkably unchanged since 1911 and has been well maintained. It is located at the edge of Mt. Tabor Park in an area that is zoned for single-dwelling residences.

8/83 Replaced steps; project valuation \$1,600

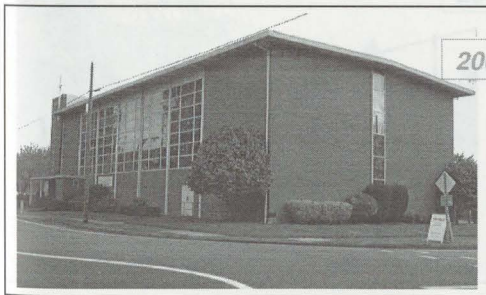
#62

COMMENTS: Currently this property is owned by the Holladay Park Church of God; also see #67. It is located near a busy commercial corridor, NE Broadway, in the Irvington neighborhood. Several newer, low-rise multi-dwelling residences are nearby.

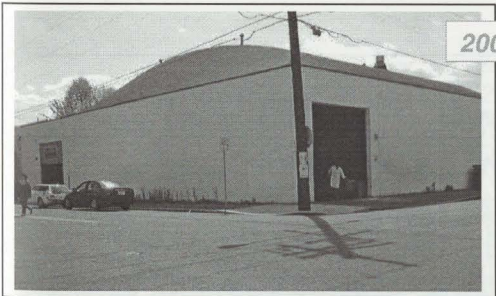
#65

COMMENTS: The existing building was constructed in 1973 on the same block as the historic residence was once located. The area is adjacent to the Interstate 84 freeway and now contains a mix of light industrial buildings, such as this one which produces a food product, and modest residences. The commercial zoning allows intensive use.

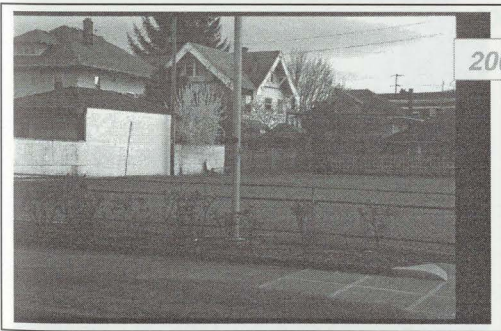
#67

COMMENTS: Currently this is a parking lot owned by Holladay Park Church of God property -- also see #62. The property is located near several low-rise, multi-dwelling buildings.

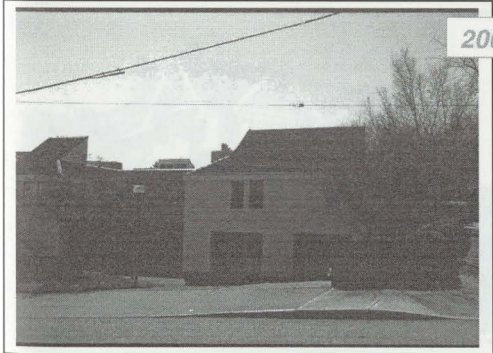
#68

COMMENTS: Currently this property is the Saxon House Condominiums, a high-priced multi-dwelling residence in the heart of the Nob Hill neighborhood of northwest Portland. The property is a historic landmark and has been well maintained.

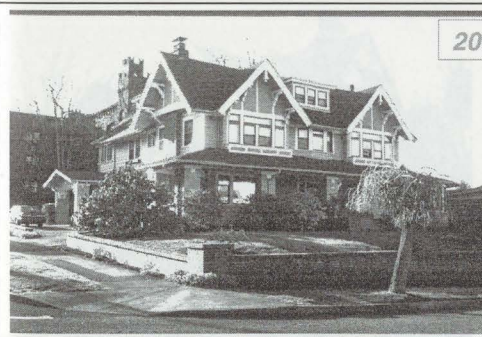
#70

COMMENTS: Currently this property is the Sanborn House Condominiums, a high-priced multi-dwelling residence in the heart of the Nob Hill neighborhood of northwest Portland. The property is a historic landmark and has been well maintained.

9/50 Repaired fire damage; \$3,500 valuation

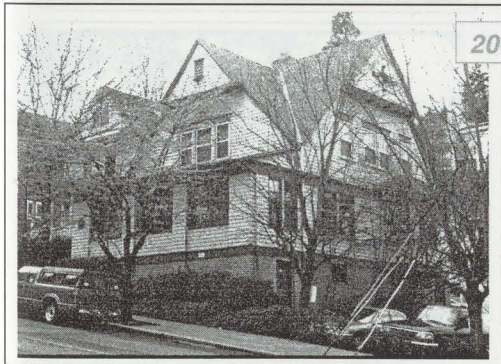
#71

COMMENTS: This property, once the residence of architect Emil Schacht, is currently occupied as a duplex. It is located in the King's Hill Historic District on a busy street. The 1992 modification to porch considerably masked the front elevation of the residence. Zoning for this property would allow redevelopment.

7/77 Replaced outside stairs; \$50 valuation

10/92 Replaced 8'x31' porch with "new enclosed heated porch, same size"; \$28,000 valuation

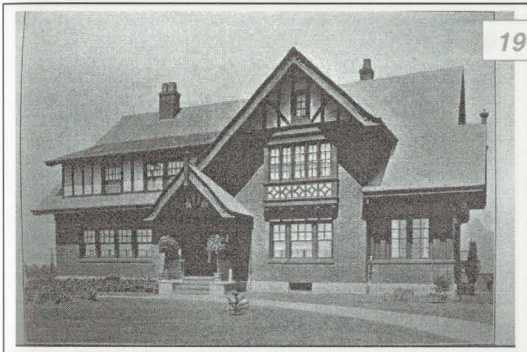
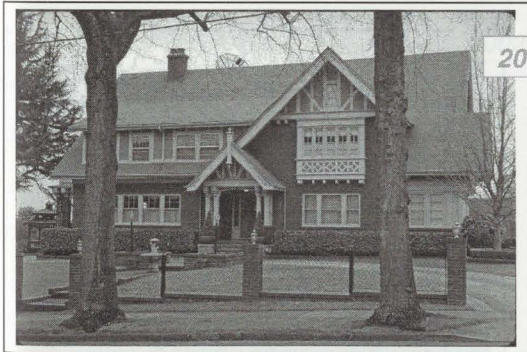
#75

COMMENTS: This building, designed by Ellis Lawrence, remains in excellent condition, except for the historically inappropriate new fence. The property is listed in the National Register of Historic Places. It is currently used as a bed and breakfast. It is located on a busy street that has mixed residential and commercial use.

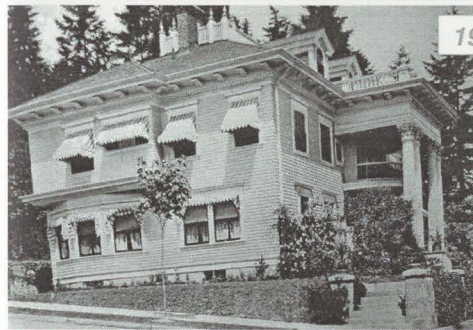
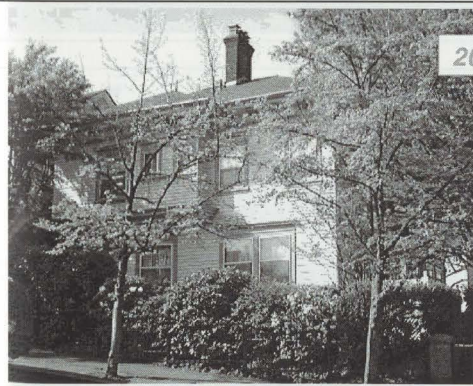
2500 SW Park Pl.

COMMENTS: This residence is located in the King's Hill Historic District. It is camouflaged by the landscaping, which acts as a buffer for the busy street immediately adjacent. However, the building remains in excellent condition and has not been greatly modified, although it is right next to a high rise building constructed in the 1960s under generous zoning allowances.

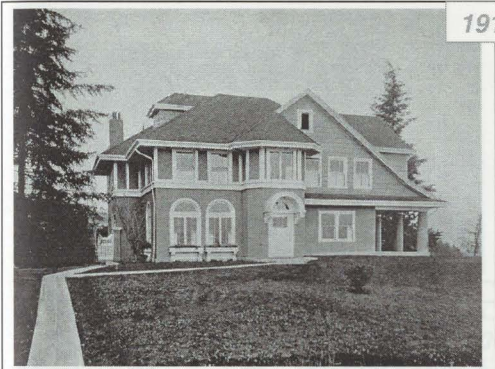
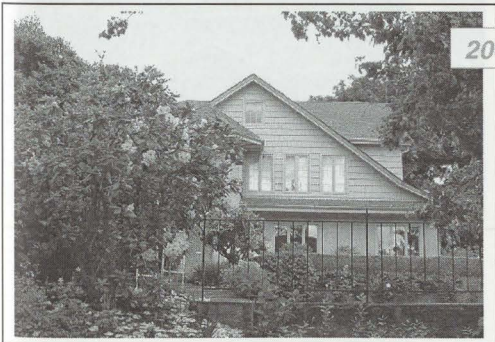
16th & SW College St.

COMMENTS: This residence is located in the Portland Heights neighborhood, an area where houses have been preserved to a great degree -- although somewhat altered, like this property.

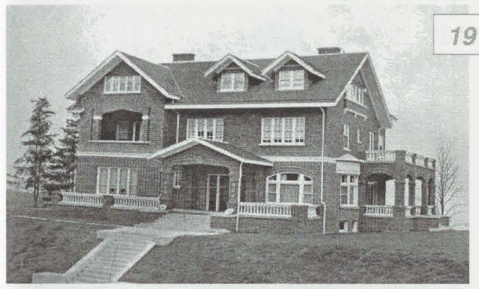
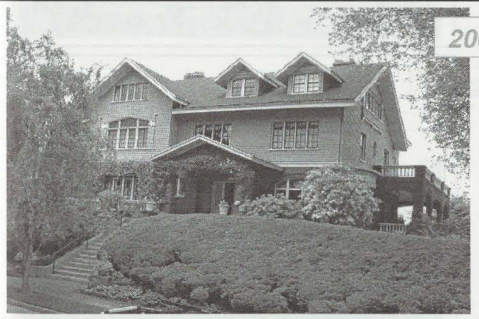
1515 SW Clifton St.

COMMENTS: This residence is listed in the National Register of Historic Places. It is located in the Portland Heights neighborhood and is a fine example of Craftsman style architecture. In 1910 this house was close to a public trolley line, although sited in an exclusive neighborhood. The garage was added at a later, unknown date.

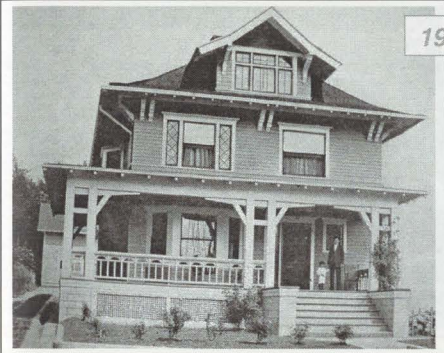
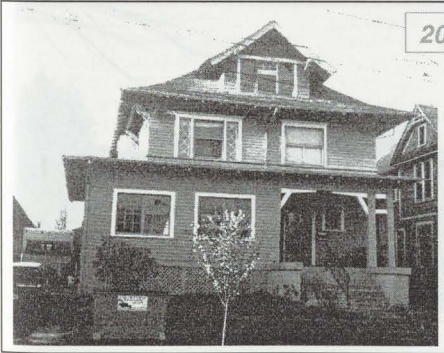
23 NE San Rafael St.

COMMENTS: Zoned for 3-20 units, "Commercial Apt." This property is located at an "edge," with a mix of residential and commercial properties nearby. It is sited on NE Weilder, a transportation route. The residence has been modified on the interior several times, mainly to accommodate more intensive use. Modifications to the exterior increased the building footprint and changed the upper porch. The historic stone wall remains in good repair.

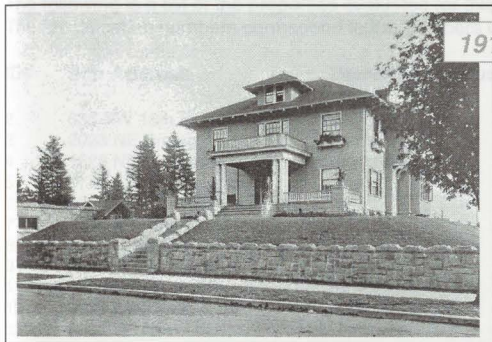
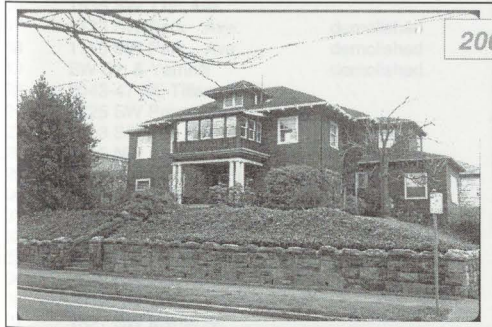
#85

COMMENTS: Zoned for 5-20 units, "Commercial Apt." This property is located at an "edge," with a mix of residential and commercial properties nearby. It is sited on NE Weidler, a transportation route. The residence has been modified on the interior several times, mainly to accommodate more intensive use. Modifications to the exterior increased the building footprint and changed the upper porch. The historic stone wall remains in good repair.

3/37 Remodeled one bedroom, 9'x12', with two windows
36"x26"; \$50 valuation
3/38 Constructed 18'x21 garage; \$200 valuation
4/41 Changed single family residence to six apartments; \$1,100
valuation
6/68 Rebuilt loose stone work in front of lot, "fallen-down
section, 30 feet"; \$1,480 valuation
5/71 Repaired stone wall 50'x3 1/2', mortared stone; \$600
valuation
