WENDEL HOUSE

HISTORIC STRUCTURES REPORT

OLYMPIC NATIONAL PARK

UNIVERSITY OF OREGON - HISTORIC PRESERVATION - TERMINAL PROJECT - 2012

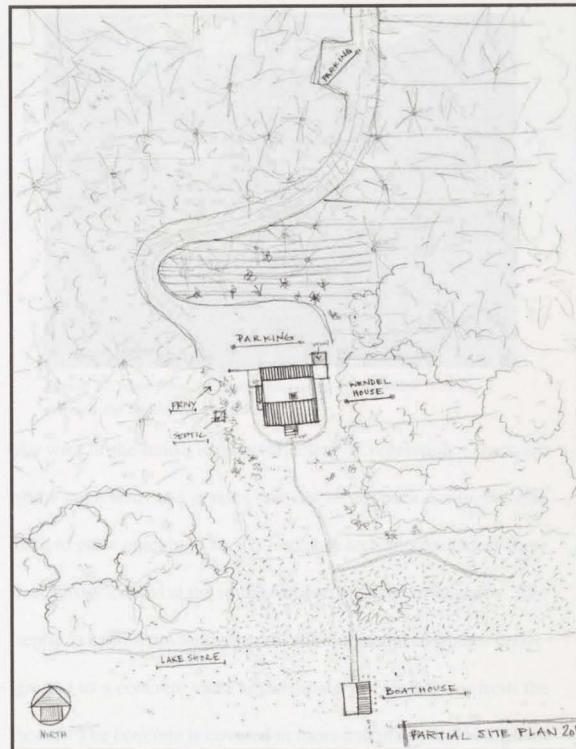
Figure 21. Site plan sketch, not to scale. The old privy which was removed in the 1970's was located approximately ten yards to the west of the house.

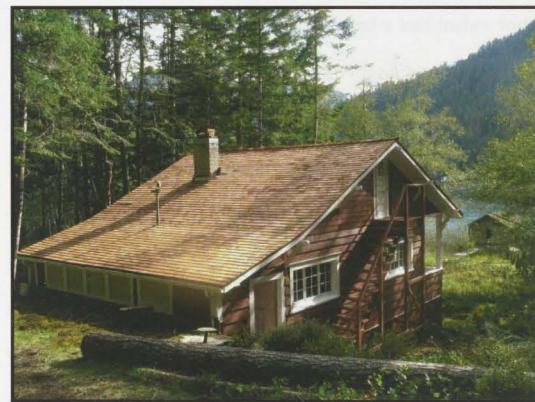
Windows are 6-over-6, double hung sash on the south elevation; multi-paned, casement sash on the west. All the windows have plain surrounds with a decorative trim across the top. The front door opening is situated off-center, and is now missing due to theft. The door was originally a multi-paned door which accessed the front porch. True to the Bungalow style, the porch is the full width of the house taking advantage of the lake views. Decorative boxed columns set onto a wood clapboard half-wall support the roof above the porch. The half-wall wraps around and connects with the body of the house, the stairs from the porch to the yard are situated at the center of the porch. Later additions to the house include an exterior wooden stairway on the west elevation and the addition of the enclosed back porch and bathroom. The addi-

Figure 24. View of the Wendel house approaching from the road.

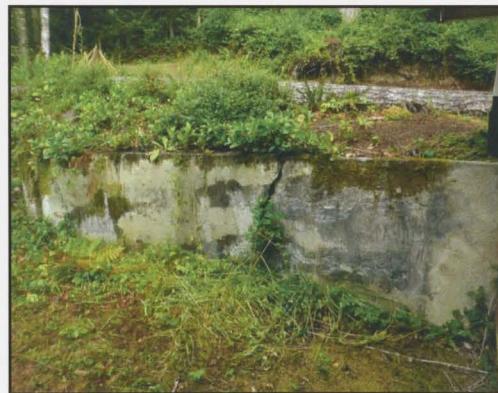
Figure 25. Crack in the center of the retaining wall was caused by a tree that has since been cut down.

- The crack in the retaining wall is a concern and will need to be repaired or rebuilt. There is also a crack in the foundation on the east side towards the front of the house that should be monitored. Overall the foundation is in good condition.

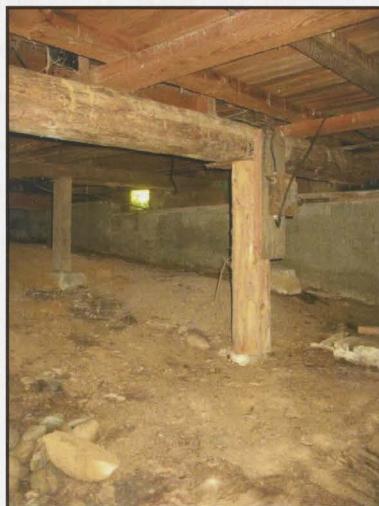
Figure 26. Floor structure supports, peeled log posts. Concrete foundation in the background.

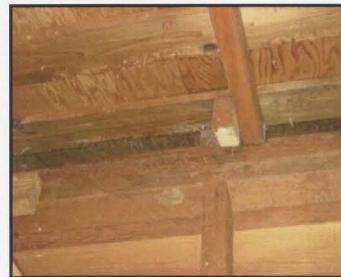
Figure 27. Cut rafter tail exposed in back addition.

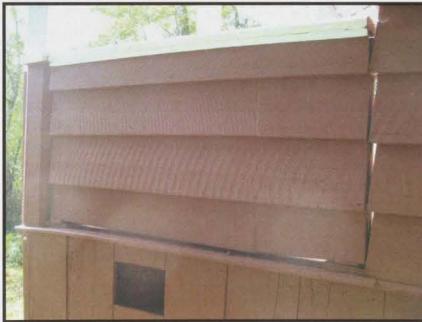
Figure 29. It appears as though the east half-wall of the porch was altered at some point. It looks like there was originally no wall in this location and that it was filled in. The wall does not match up with the house flush like the wall at the west end. The configuration of the stairs may have originally been at the side and later changed to the front.

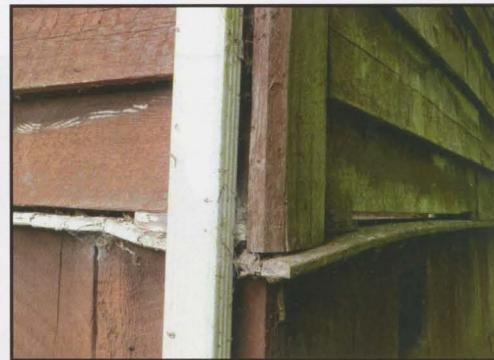
Figure 30. Southeast corner of porch which is experiencing decay and sinking.

- The southeast corner of the porch deck is rotten and has sunk under the corner of the wall and column approximately one inch. Deteriorated decking in this corner should be removed. Upon doing so, the corner post under the deck should be inspected to see how advanced it has decayed; any rotten material should be removed and the post should be repaired before replacing the decking. This would be a good opportunity to further inspect the condition of the upper post at the wall corner.

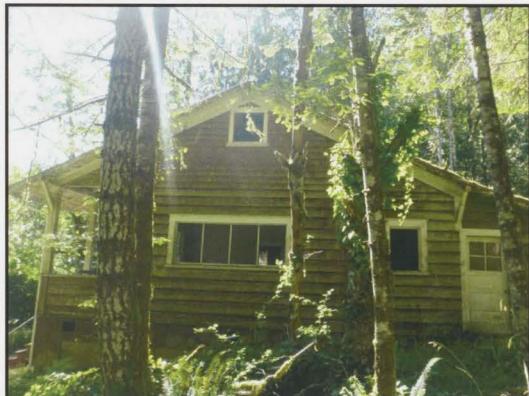
Figure 31. East elevation.

evidence of powder post beetle infestation both here and on some of the horizontal boards. The gable ends are clad with shingles. The exterior of the building has recently been cleaned and freshly painted with a historically accurate Russet color and white trim.

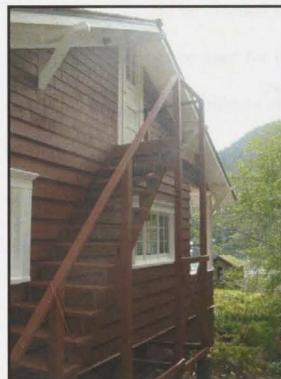
Figure 32. West elevation with fresh paint.

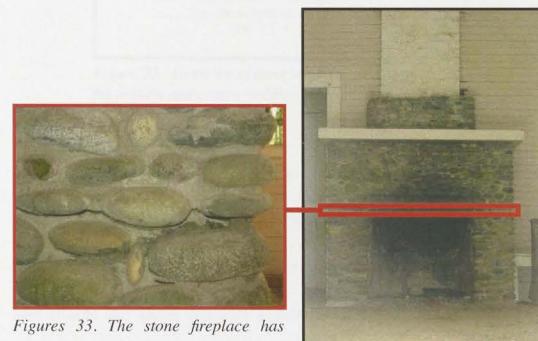
Figures 33. The stone fireplace has cracked across the front and around the sides due to chimney settling over time.

- A structural engineer should review the condition of the chimney and it's foundation for stability.

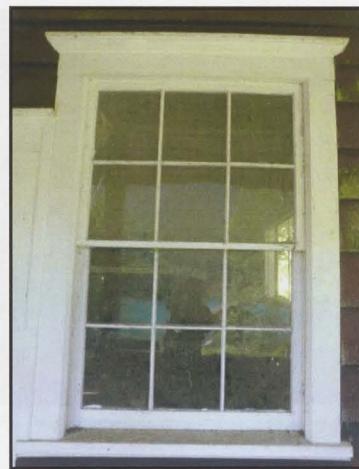
Figure 34. One of two large south facing windows next to the front door.

- The existing windows need to be cleaned and the hardware stripped of paint.
- Windows should be weatherized using weather stripping to tighten the seal around the perimeter of each window.
- Simple wood storm windows should be manufactured to fit the window openings.
- The restoration of the missing window sash should be a high priority and should be replaced with either reconstructed windows using the existing sashes for a pattern, or salvaged windows that are historically accurate and match the existing. The open window space is allowing weather and animals to enter directly into the building and is creating moisture issues on the interior of the house.

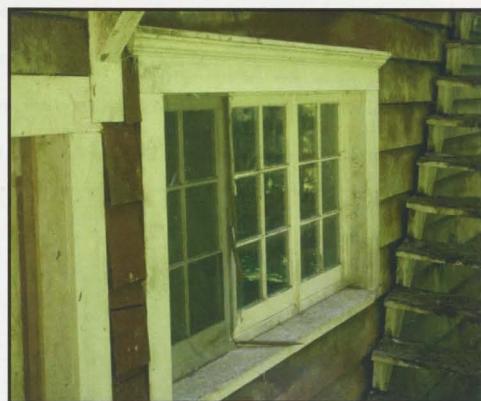
Figure 36. Bank of three bedroom windows, west elevation.

The other window type used are two banks of windows on the west elevation for the bedrooms. Each bank has three six light windows. The windows on the outer end are casements and swing inward. The center window is fixed in place.

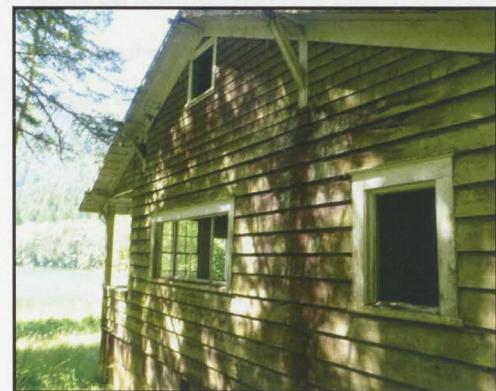
originally had a bank of windows similar to the bedroom windows but with four framed windows, the center two fixed, and the outer ones casement. The kitchen window shared the same dimensions as the other six pane windows but consisted of just a single framed casement window. The attic space also once had a window that is no longer there. It is assumed in regards to the size of opening and the style of the other windows, that this window had four lights.

Figure 37. East elevation showing missing windows.

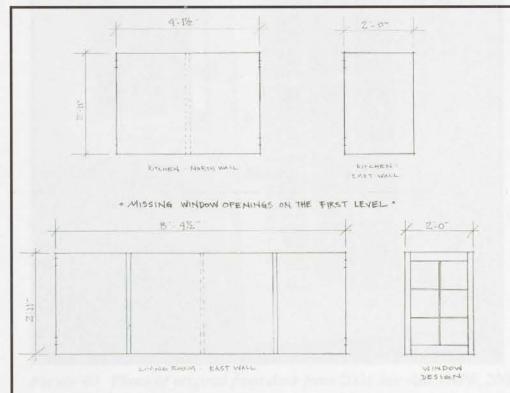
The final window on the east elevation is the kitchen window that now looks into the back addition. The window sash is missing here; the opening measures wide enough to hold two casements. All of the interior and exterior window trim is still in place.

Figure 38. Measurements of empty window openings on the east elevation.

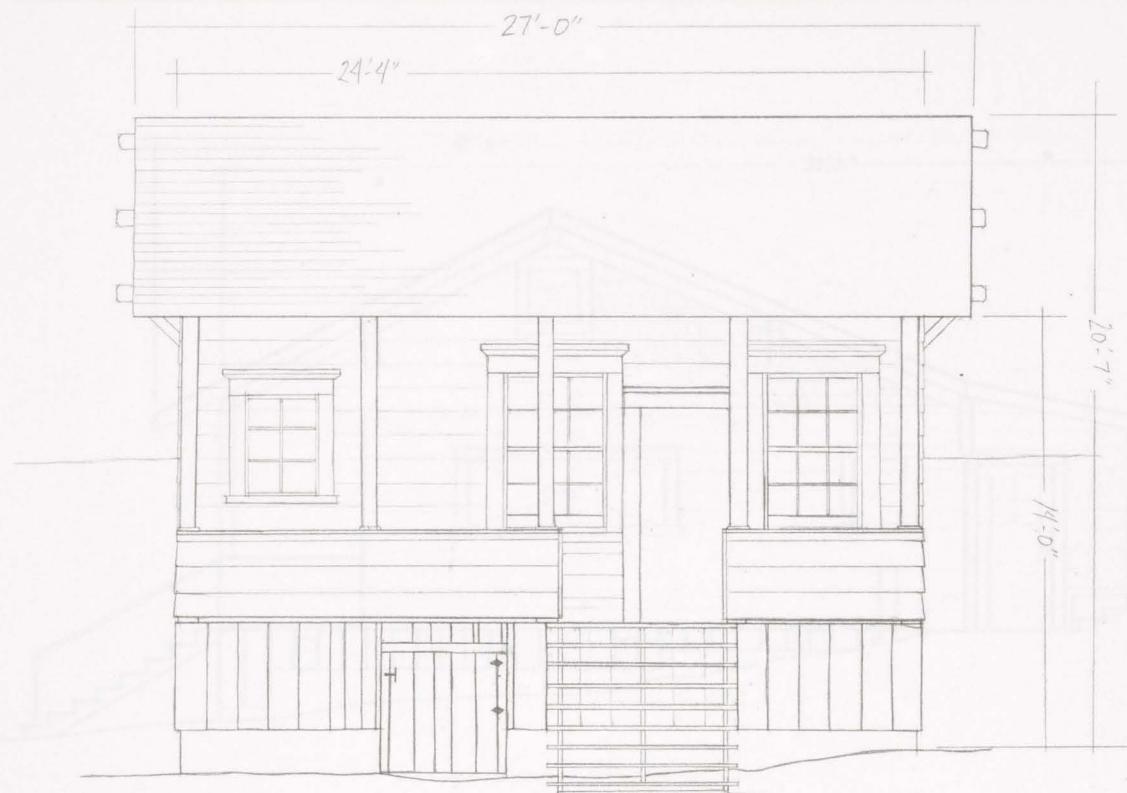
Figure 41. Wendel House, south elevation, drawn to scale. Drawing by L.Over

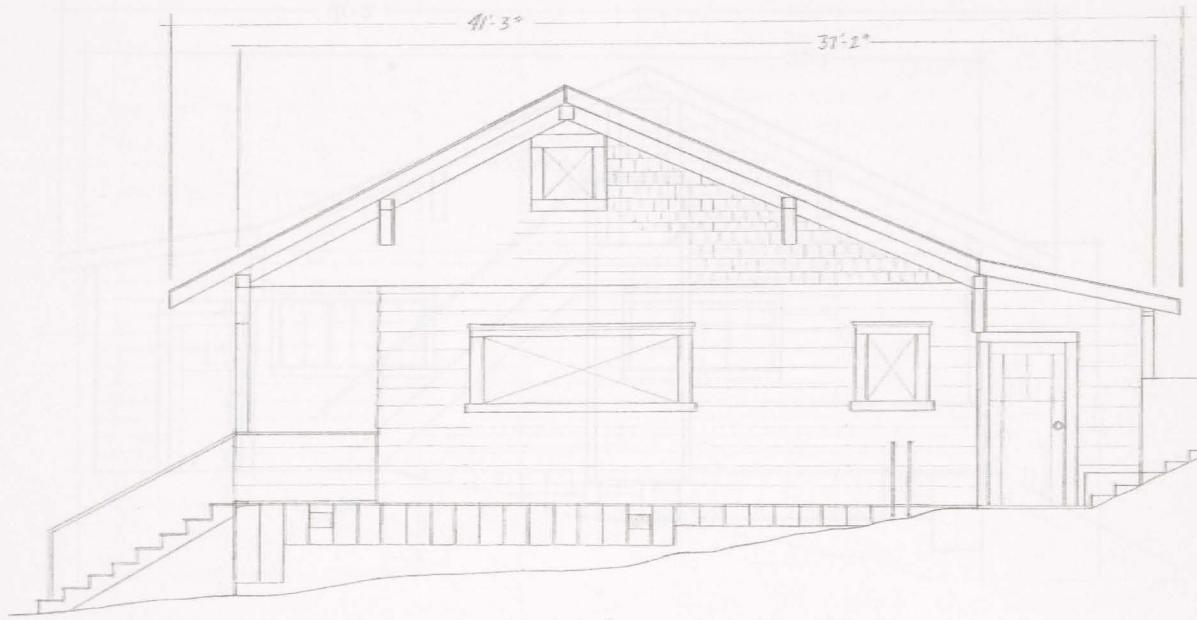
Figure 42. Wendel House, east elevation, drawn to scale. Drawing by L.Over

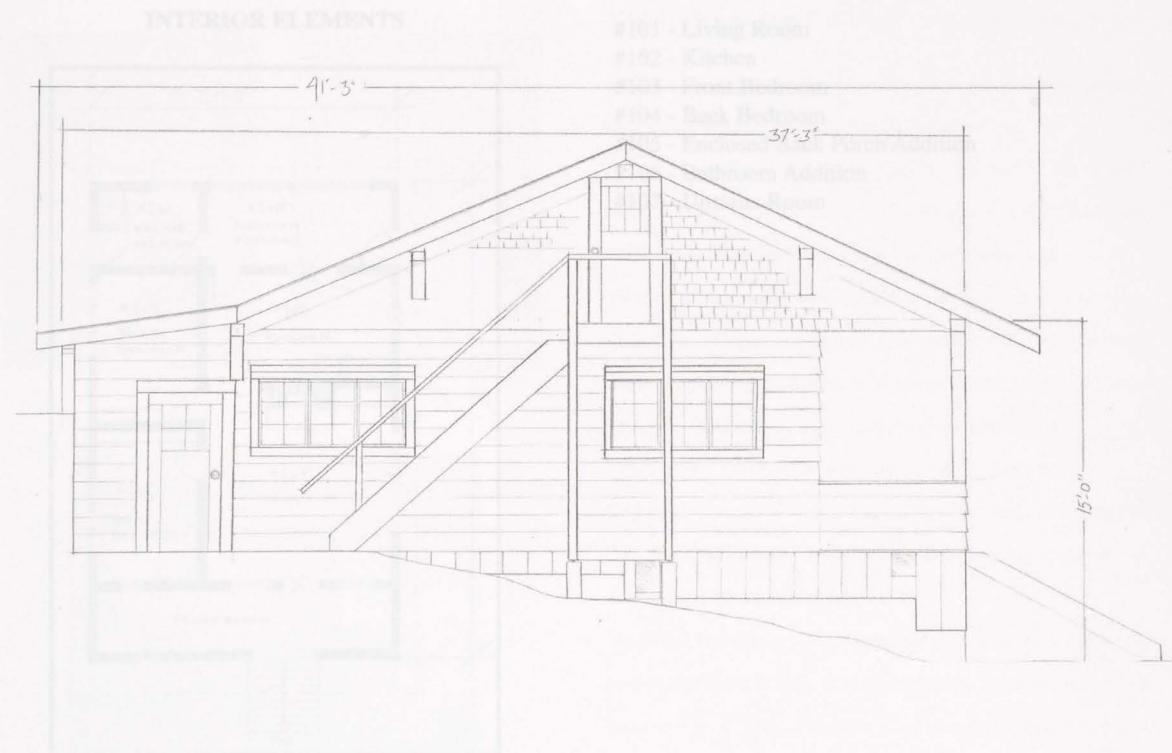
Figure 43. Wendel House, west elevation, drawn to scale. Drawing by L.Over

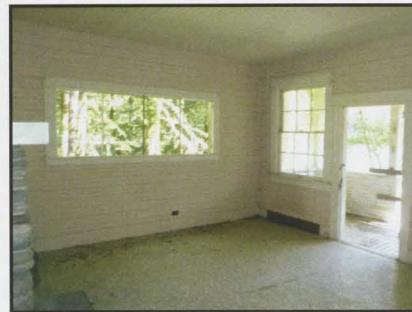
Figure 47. Missing bank of windows in living room.

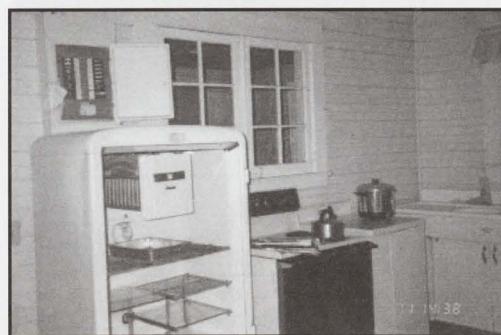
Figure 49. Kitchen with appliances and windows in place. (NPS, 2003)

Walls: The kitchen walls and ceiling are clad with painted horizontal double v channel drop lap wood siding.

Floor: The floor is covered in the same linoleum as the rest of the house. The linoleum is laid over 5"x5" tiles which are glued down to the fir floor. The floor in the kitchen is rotten and should be replaced in kind or with a compatible material.

Doors: The original back door is on the north wall. It now opens into the back addition and is not in good condition. The panels are peeling and delaminating. Evidence of a hinge on the molding of the opening between the kitchen and living room indicates there may have been French doors separating these two spaces.

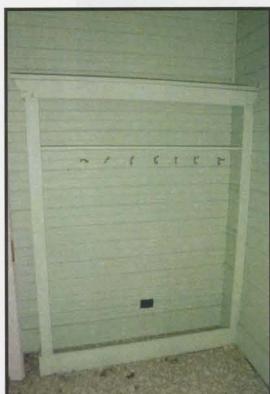
Figure 52. Open built-in closet.

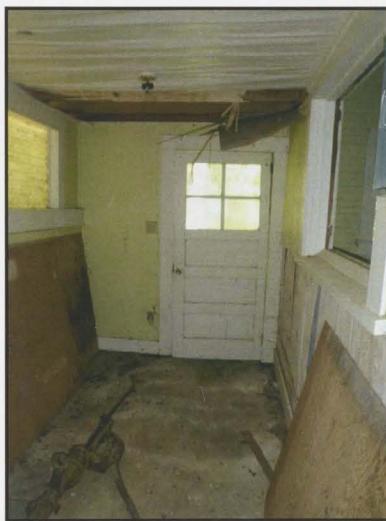
Figure 53. Enclosed back porch addition, east facing door.

Other: The thin sheet veneer on the ceiling and walls is failing and falling off. This material should be removed and replaced with a thin plywood or similar type of material.

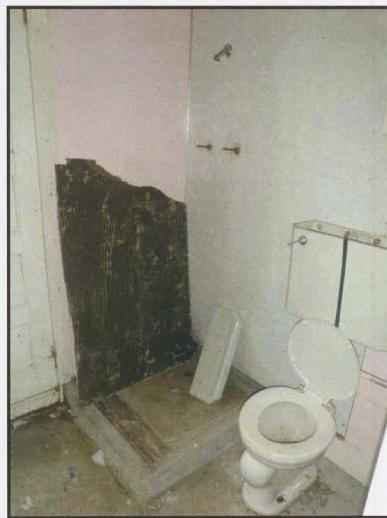
Figure 54. Bathroom located at the back of the house, part of the later addition of the enclosed back porch.

The bathroom will need to be **fully** rehabilitated. The extent of rehabilitation, however, will depend upon the determined use of the building.

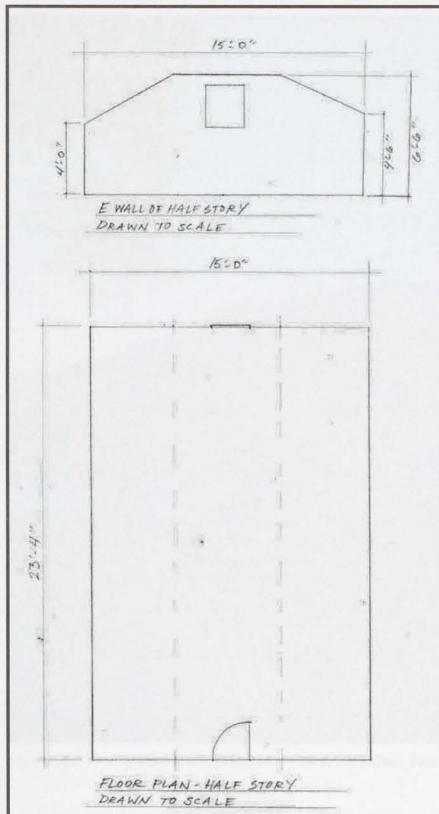
Figure 55. Upper half level floor plan and east elevation wall.

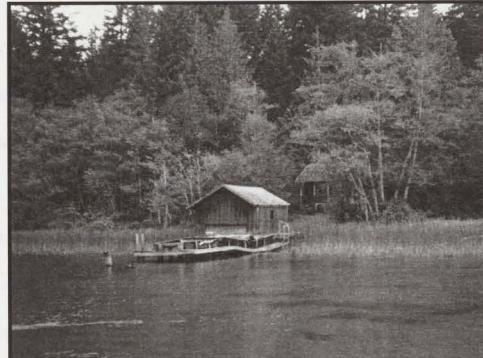
Figure 58. Photo of boathouse and dock 1999 (photo courtesy NPS, 2003).

What remains of the dock is unusable and dangerous. The entire dock will need to be replaced to enable safe and adequate use, as well as to retain the important historic function it originally provided. The decking boards are 2x6 milled lumber approximately 2 feet wide. A proposal to remove all of the pilings and replace at least some of them with hollow galvanized steel pilings are being put into place. It would be preferable to restore the entire length of the dock including the extension beyond the boathouse into the lake. The lake depth fluctuates seasonally. Restoring the full length of the dock would aid in protecting the shore line from people trying to access the property from the water or vice versa.

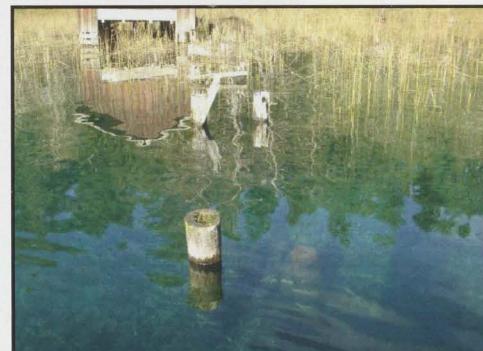
Figure 59. Remaining pilings from old dock, 2011.

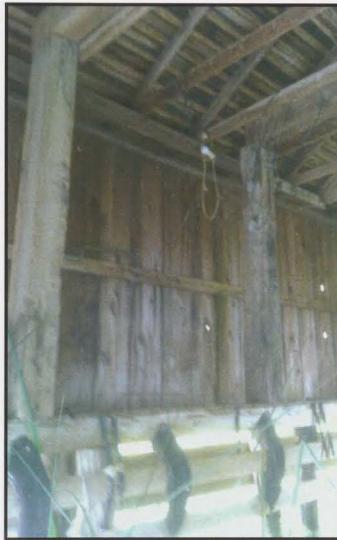
Figure 60. Interior boathouse wall (west).

The boathouse walls are a single frame construction with board and batten siding. The bottom half of the board and batten siding is deteriorating and should be replaced in kind. This work

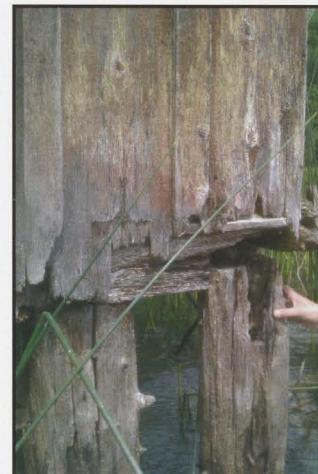
Figure 61. SE corner of boathouse. Deteriorating sill logs on deteriorating piling.

should be done by a trained preservation specialist. As much original material should be saved and only the significantly deteriorated material should be replaced. Original design elements such as the window and door openings should be preserved in their original location. The integrity of the stringers should be assessed more closely before moving the structure. They are deteriorated from years of close contact with the lake water.

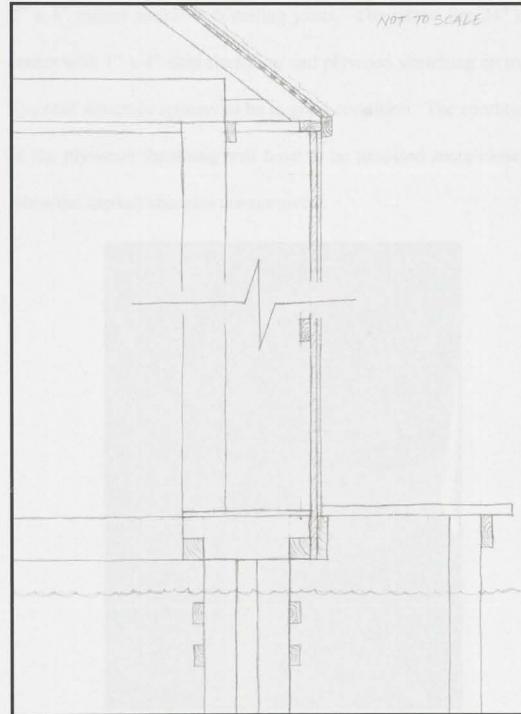
Figure 62. Boathouse construction drawing. Not to scale. Drawn by L. Over

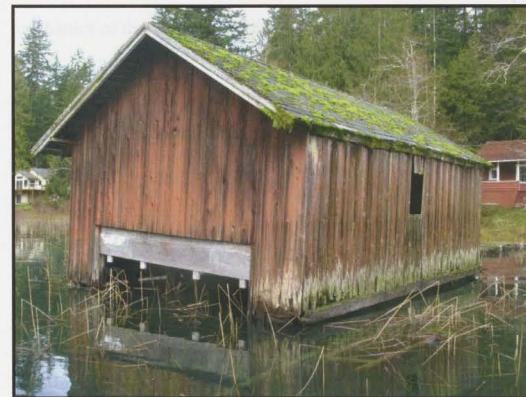
A gable roof covers the boathouse. The current roof cladding is modern composite asphalt shingles that was installed in the 1960's by the Wendel family. Originally the roof was covered with cedar shingles. The roof cladding has exceeded it's life expectancy and is in need of replacement. The new roof should be finished with cedar shingles to match the roof of the house.

Figure 63. Photograph of the mossy exterior of the boathouse roof.

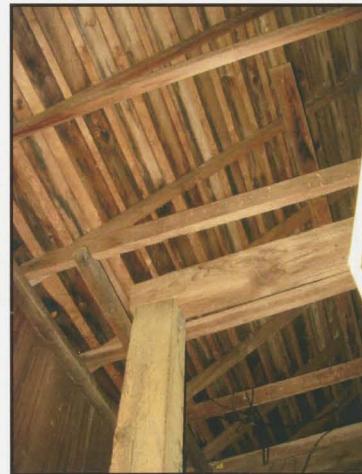
The roof has a 6:12 pitch and is a stick-frame construction with 2" x 4" rafters and 2" x 6" ceiling joists. The rafters are 24" on center with 1" x 4" skip sheathing and plywood sheathing on top. The roof structure appears to be in good condition. The condition of the plywood sheathing will have to be assessed more closely when the asphalt shingles are removed.

Figure 64. Interior view looking up at exposed rafters, joists, and sheathing.

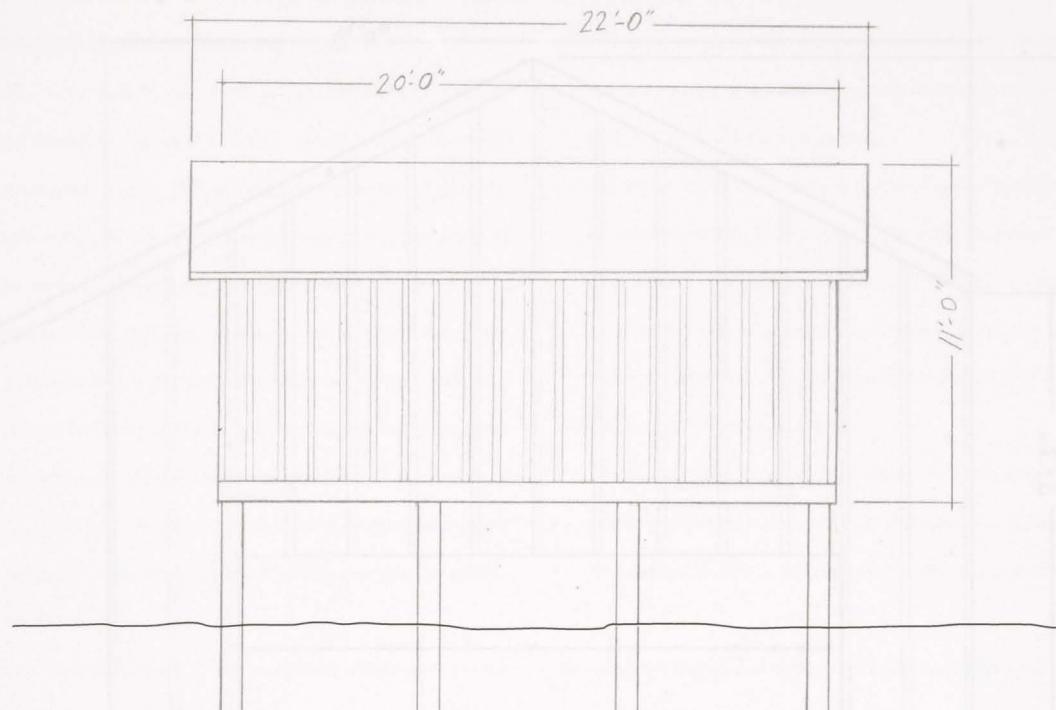
Figure 66. Wendel boathouse, east elevation, 1/4"=1'-0", water level changes. Drawing by L.Over

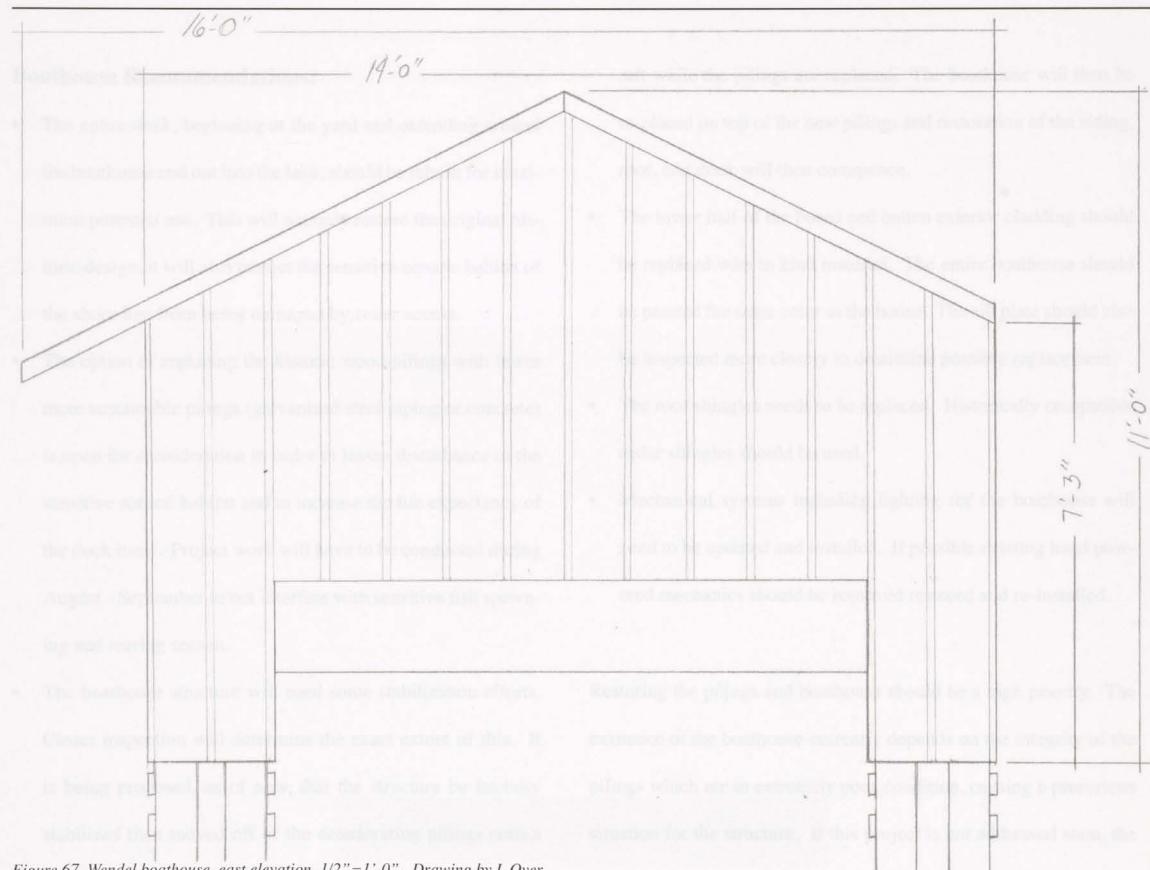
Figure 67. Wendel boathouse, east elevation, 1/2"=1'-0". Drawing by L.Over
